RAGING RIVER (RM 0.0–11.0), SEPTEMBER 11–13, 2002

Snoqualmie Watershed Stream Habitat Reconnaissance Report

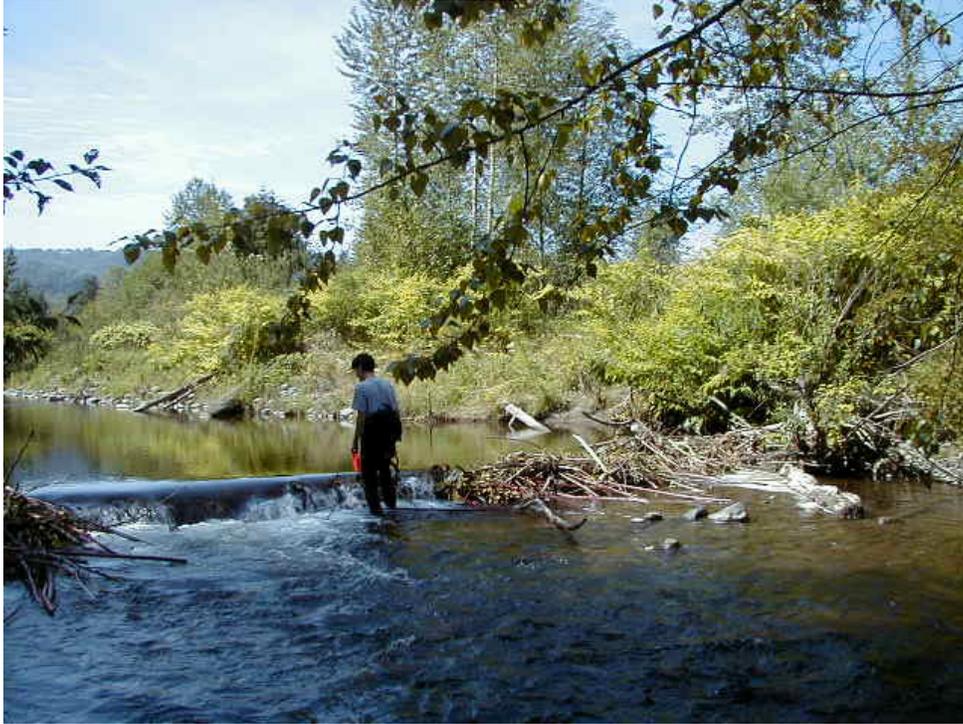
There was evidence of beaver activity between RM 0.4–0.8. A small woody debris jam at RM 0.6 was created by a beaver and included one small channel-spanning piece of wood (Photo RA1). A property owner on the LB expressed some concerns about the woody debris but the field technicians assured him that any high flow would knock out the jam.

Photo RA1. Log felled by beaver at RM 0.6.

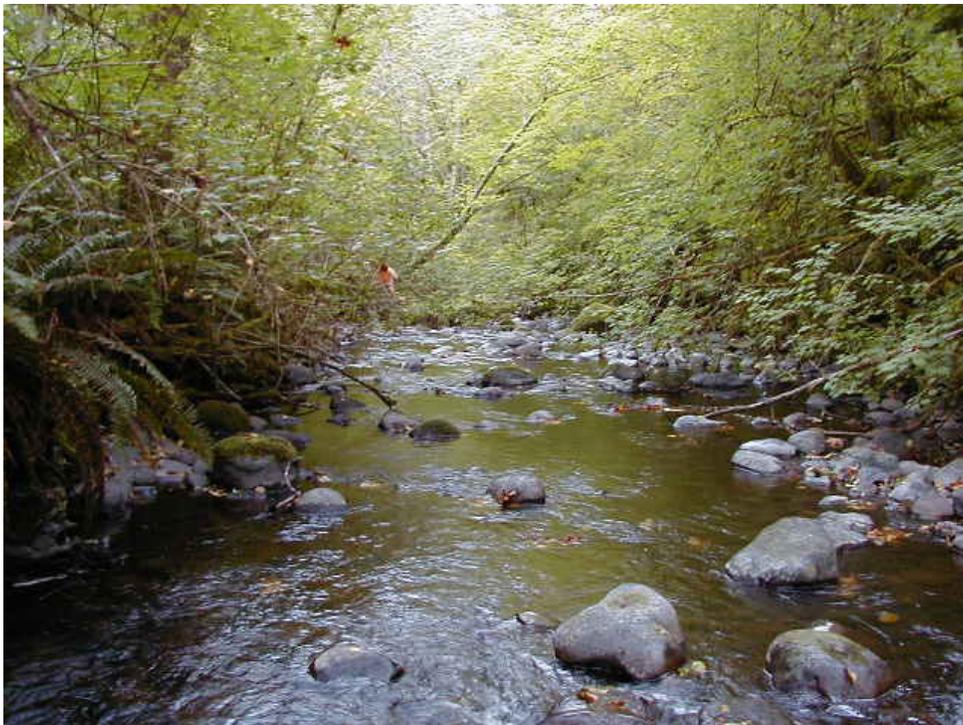
Between RM 1.3 and 2.0, the riparian vegetation was of better quality than in the most downstream reach (RM 0.0–1.3) (Photo RA2). There were mature conifers, deciduous trees, and dense shrubs on both banks, although invasive shrubs such as English ivy and Japanese knotweed were still frequent. Upstream of RM 2.0, the riparian vegetation was patchy, with predominantly immature or sparse trees due to the frequency of homes and road crossings. The riparian shrubs were dense where there were no homes and cleared for yards where houses were present. The shrubs were mixed invasives and some natives such as salmonberry and vine maple. The upstream extent of budlea (butterfly bush) invasion was at RM 5.0 and the farthest upstream sighting of Japanese knotweed was at RM 7.4.

Photo RA2. Healthy riparian vegetation.

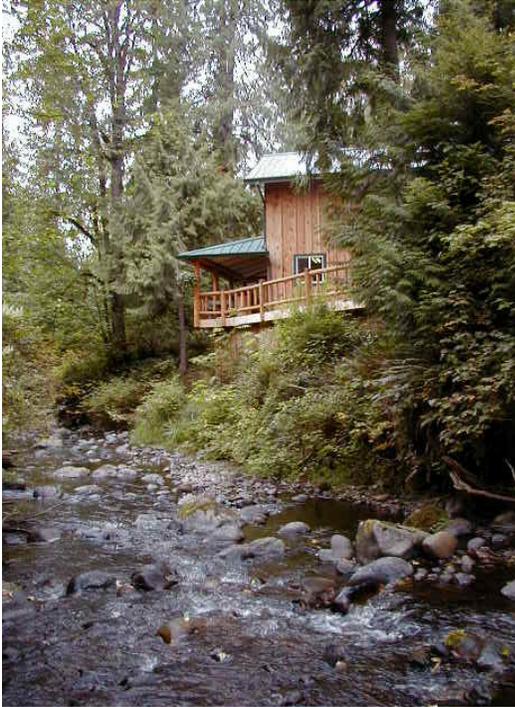
Homes along the river were very close to the banks (Photo RA3); some homeowners have built revetments to protect their properties from flooding and erosion. Riparian vegetation was completely cleared from some yards (Photo RA4). Others had lawns that were contained to small areas; therefore, mature trees and native shrubs were still present.

Photo RA3. Home perched on left bank.

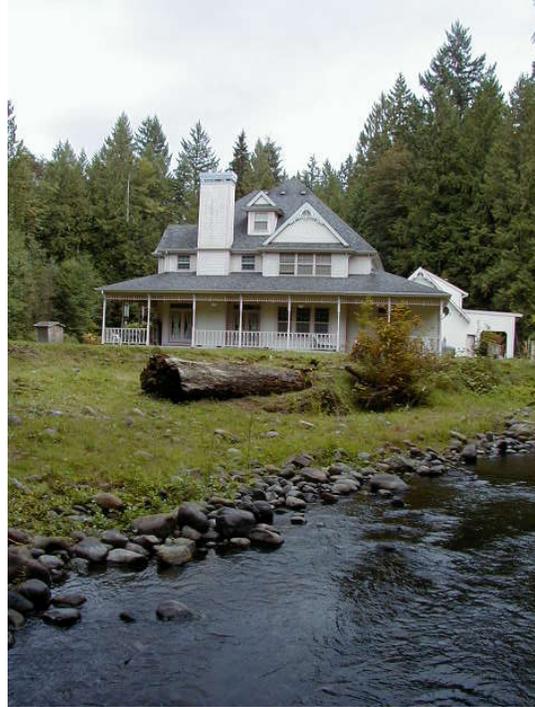
Photo RA4. Home with cleared riparian vegetation.

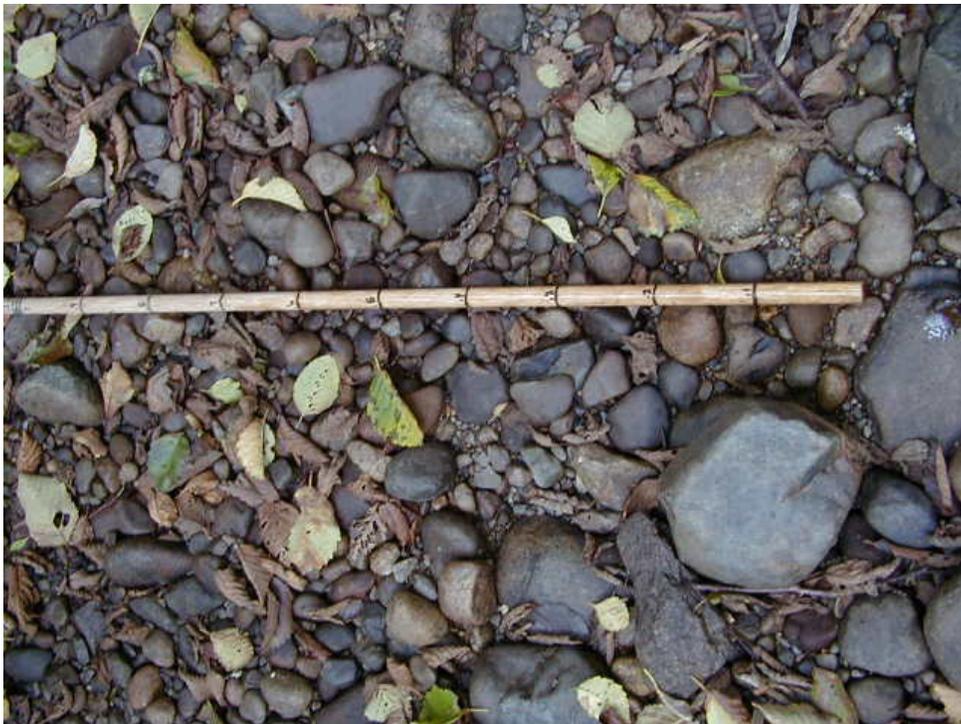
Photo RA5. Unsorted gravels.

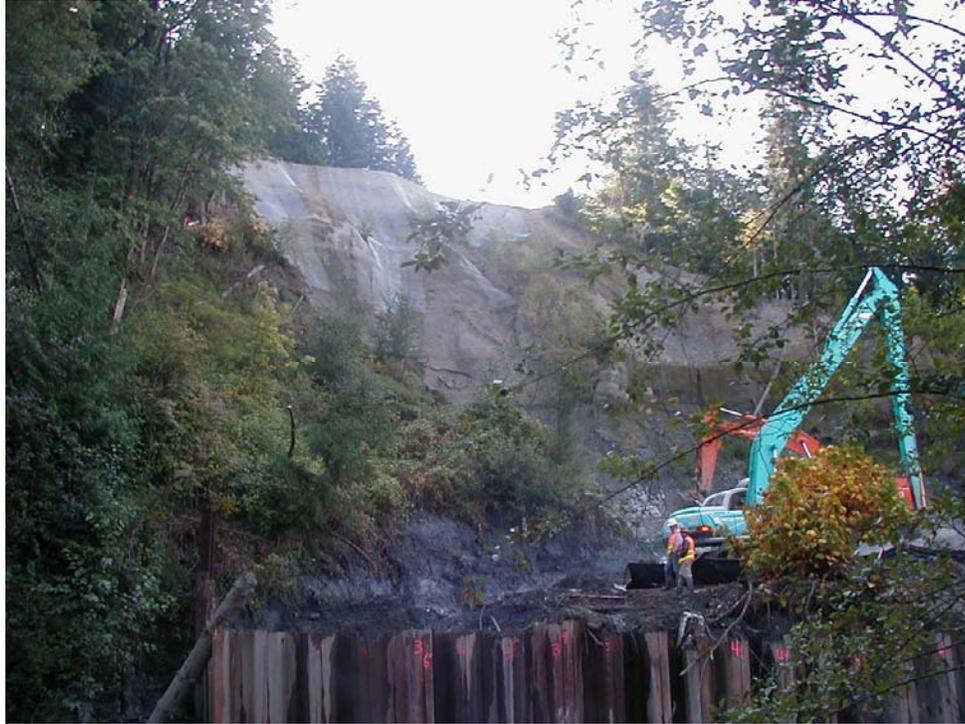
Access to Tokul Creek from the mouth to just upstream of the slide at RM 0.3 was not possible because the area was too dangerous to walk. Some photos of the slide area that were shot from the fish hatchery illustrate a substantial construction effort to contain the slide area (Photos Tokul1-2).

Photo Tokul1. Construction on landslide at RM 0.3

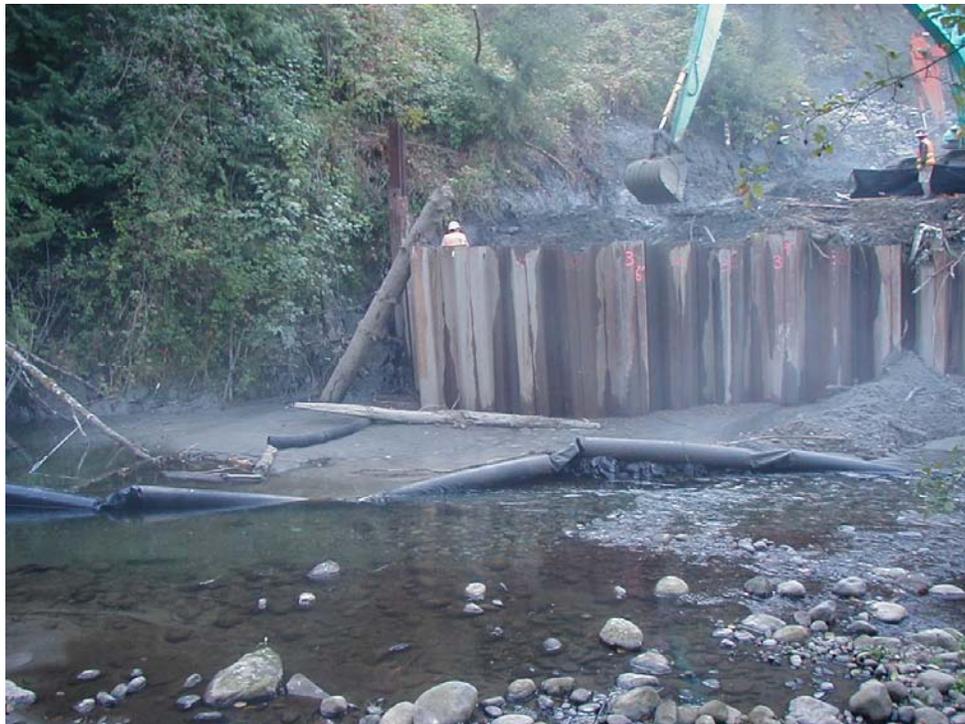
Photo Tokul2. Efforts to contain sediments at RM 0.3

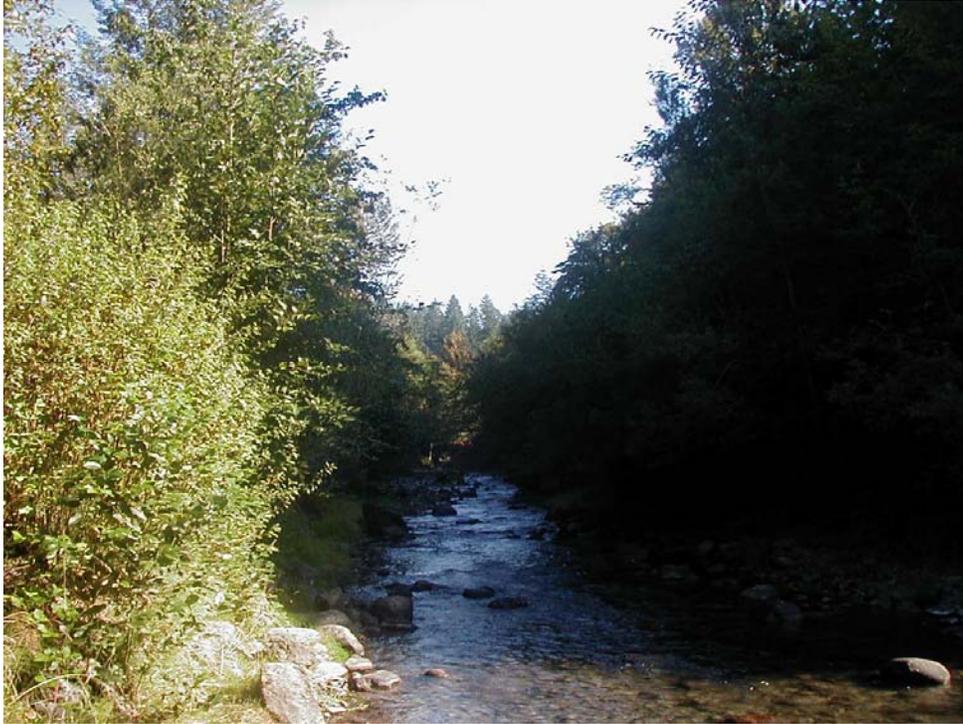
Upstream of RM 0.3, the wetted width was 36 feet with a 50-foot OHW. The canopy was composed of immature conifers, alder, and maple (Photo Tokul3). The water was very turbid; visibility was only 1.5 meters on September 24 and 1.4 meters on September 25.

Photo Tokul3. Looking upstream from SR 202 bridge.

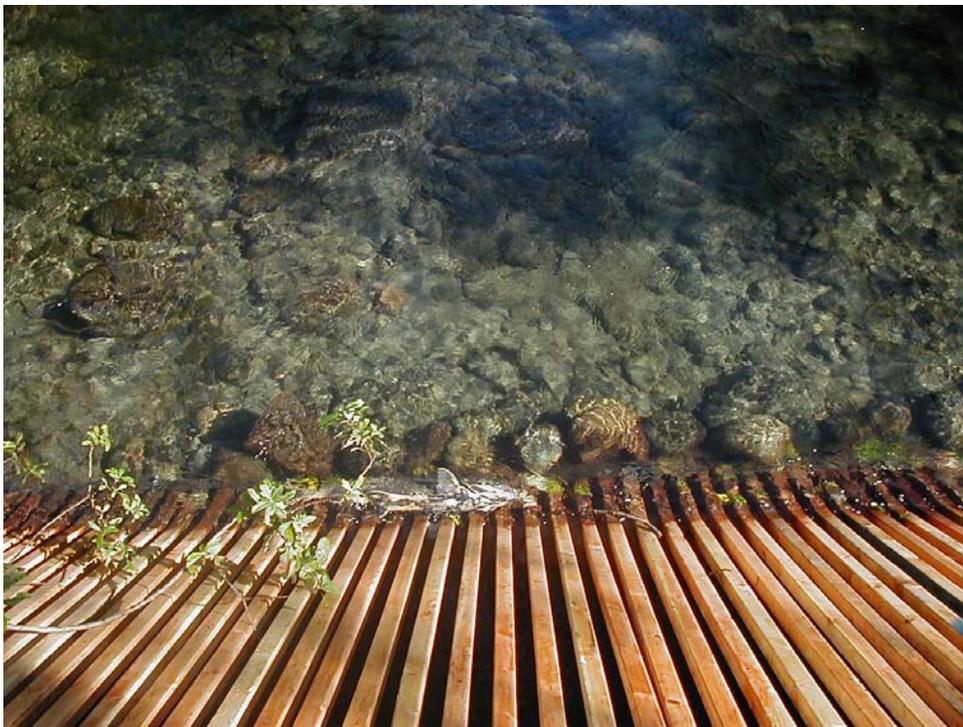
A pair of chinook spawners was observed near the SR 202 crossing. An adult chinook carcass was observed washed against a fish weir for the hatchery intake near the live fish (Photo Tokul4).

Photo Tokul4. Chinook mortality at hatchery intake.

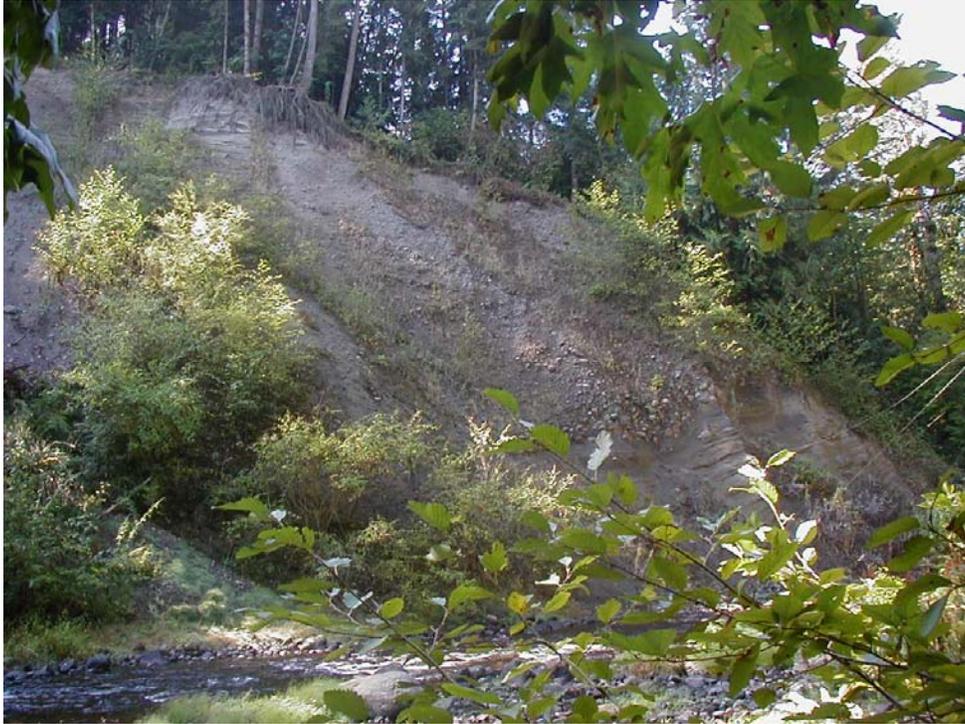
A photo of the landslide at RM 0.5 shows some immature vegetation beginning to stabilize the slide area (Photo Tokul5). At this location, residents of the area advised the field technicians to leave Tokul Creek because of safety concerns around a gun range at RM 0.8.

Photo Tokul5. Old landslide caused by previous SR 202 bridge.

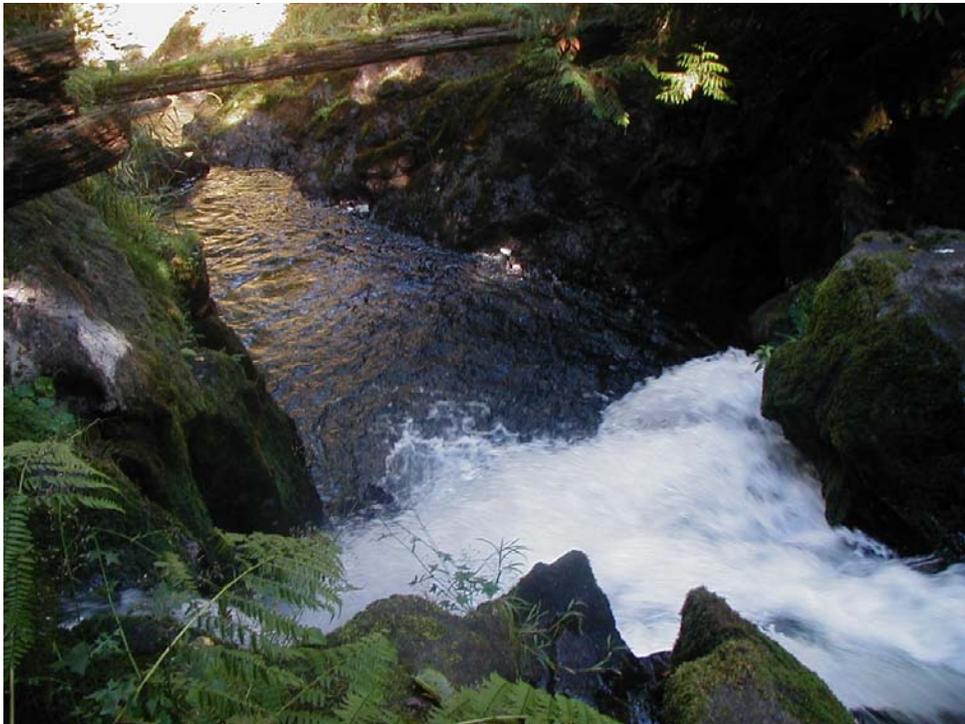
The approximately 70 foot high waterfall at RM 1.4 is a certain barrier for all salmonids except possibly steelhead (Photo Tokul6). A resident downstream of the waterfall told the field technicians that salmonids are not able to migrate past the SR 203 bridge, and that any salmonids upstream of the bridge have been transported by the hatchery.

Photo Tokul6. Fish passage barrier at RM 1.4.
