Figure 1. Brightwater Wastewater Treatment Plant Site near Route 9 and Route 522 in southern Snohomish County, Washington. Base is composite Landsat image.

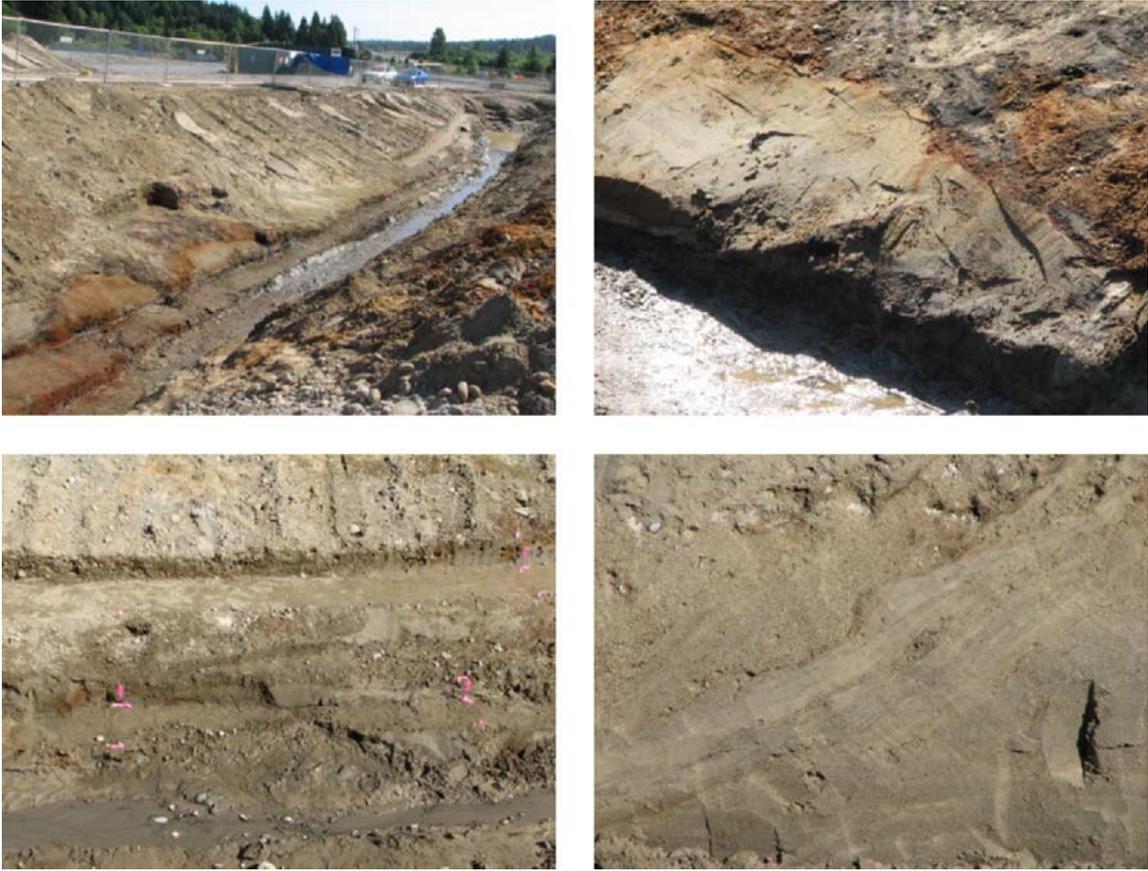
Figure 9. Liquefaction features in Trench South 1 and Trench South 1c.

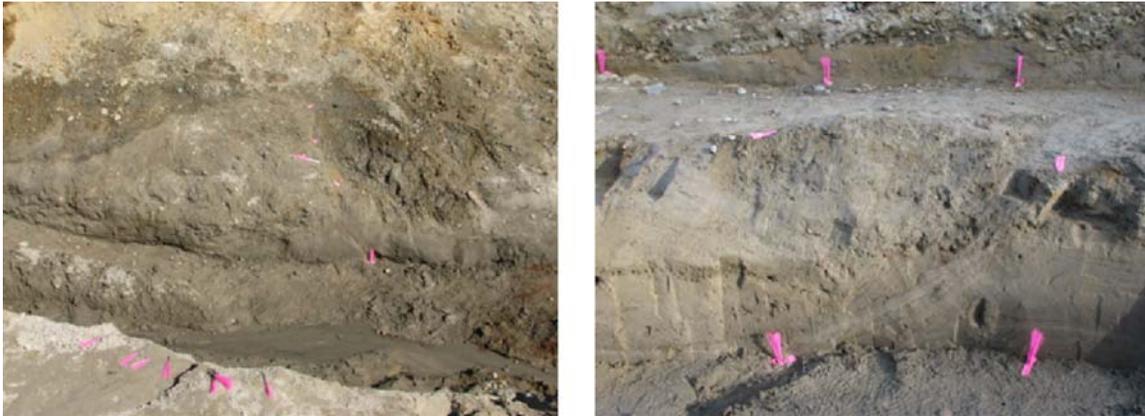
Figure 10. Curvi-planar feature at about Sta 0+28 in Trench South 1 and on the opposite side of the excavation in Trench South 1c.

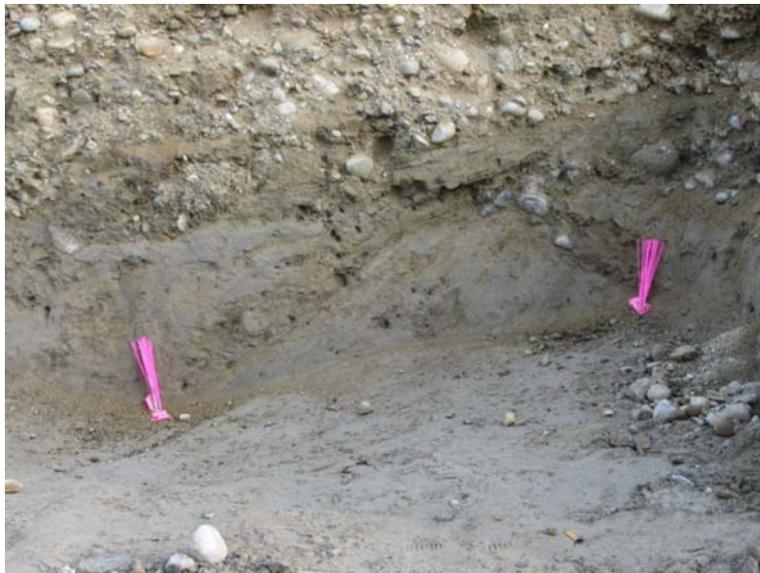
Figure 11. Undeformed deposit of very dense stratified gravelly sand-sandy gravel overlying the curvi-planar feature in Trench South 1c.

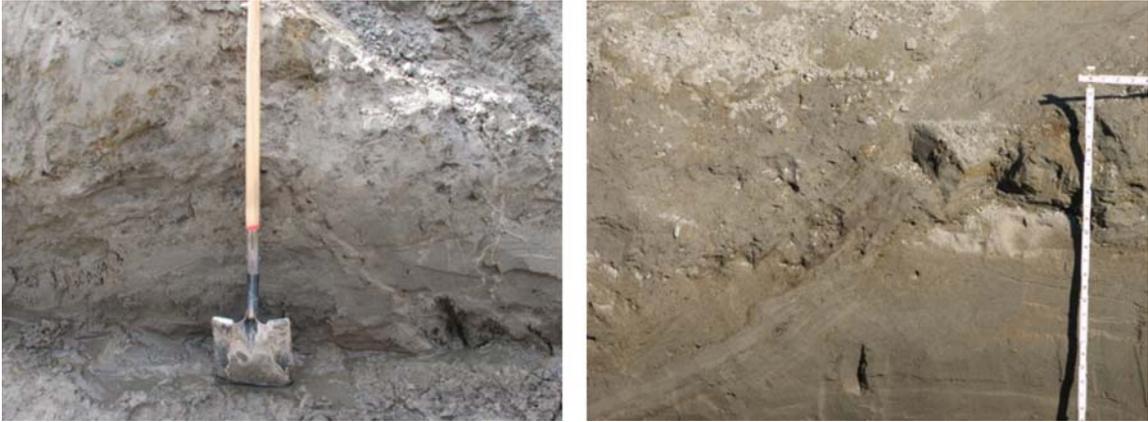
Figure 12. Base of the diamict unit at the location of the curvi-planar feature in Trench South 1 and Trench South 1c.

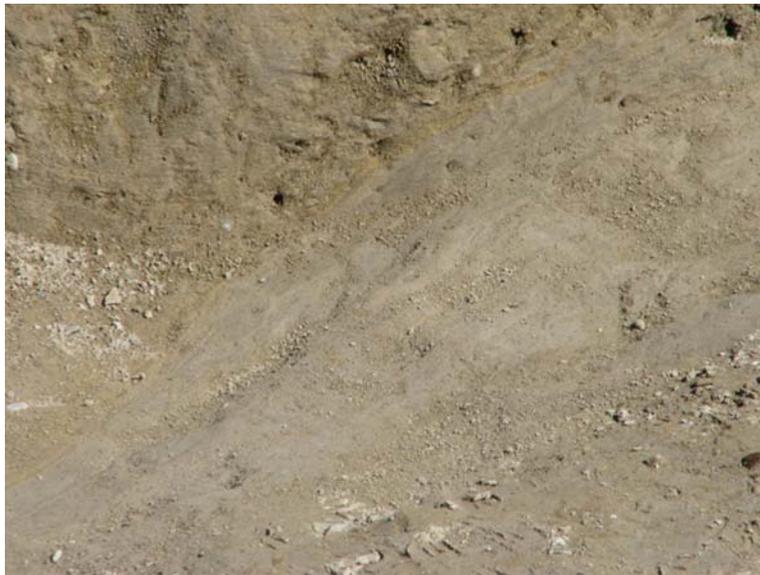
Figure 13. Thin fine sand and silt filaments along the curvi-planar feature in Trench South 1c.

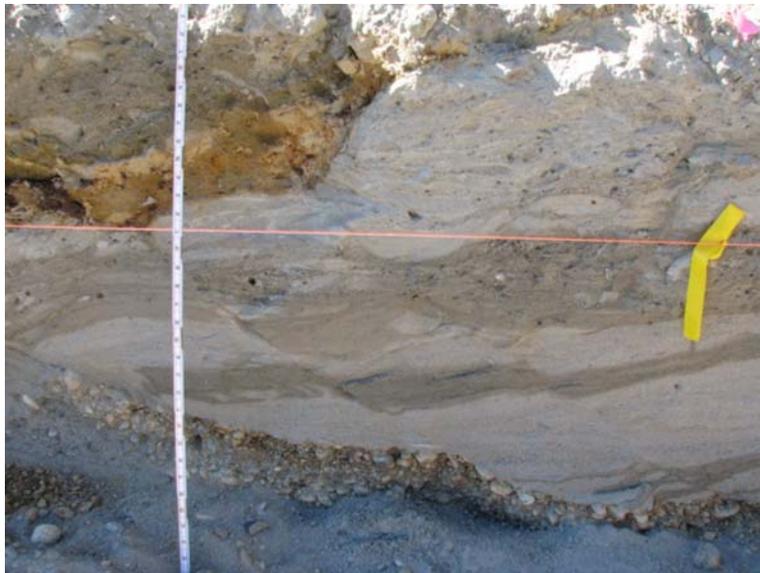
Figure 15. Two small glacial faults with approximately one inch of down-to-the-east normal separation observed in a sand unit at Sta 0+47 to 0+50 in Trench South 1b.

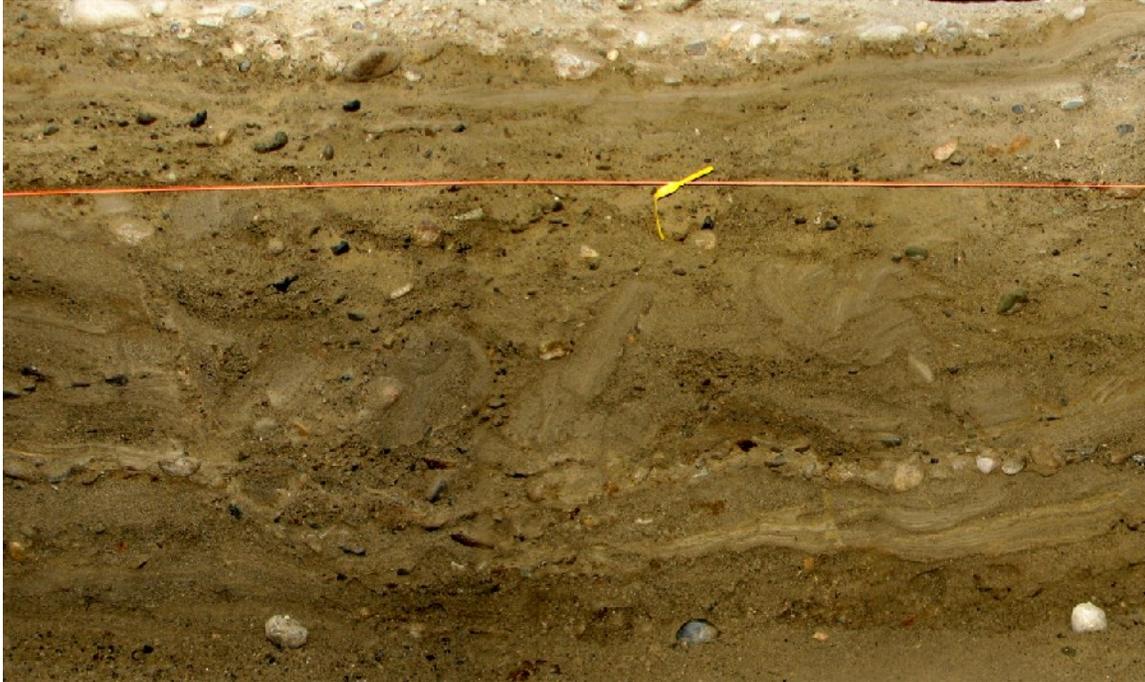
Figure 19. Liquefaction feature at Sta 0+97 in Trench South 2a showing disturbed sand containing moderately large rotated fragments of laminated silty sand.

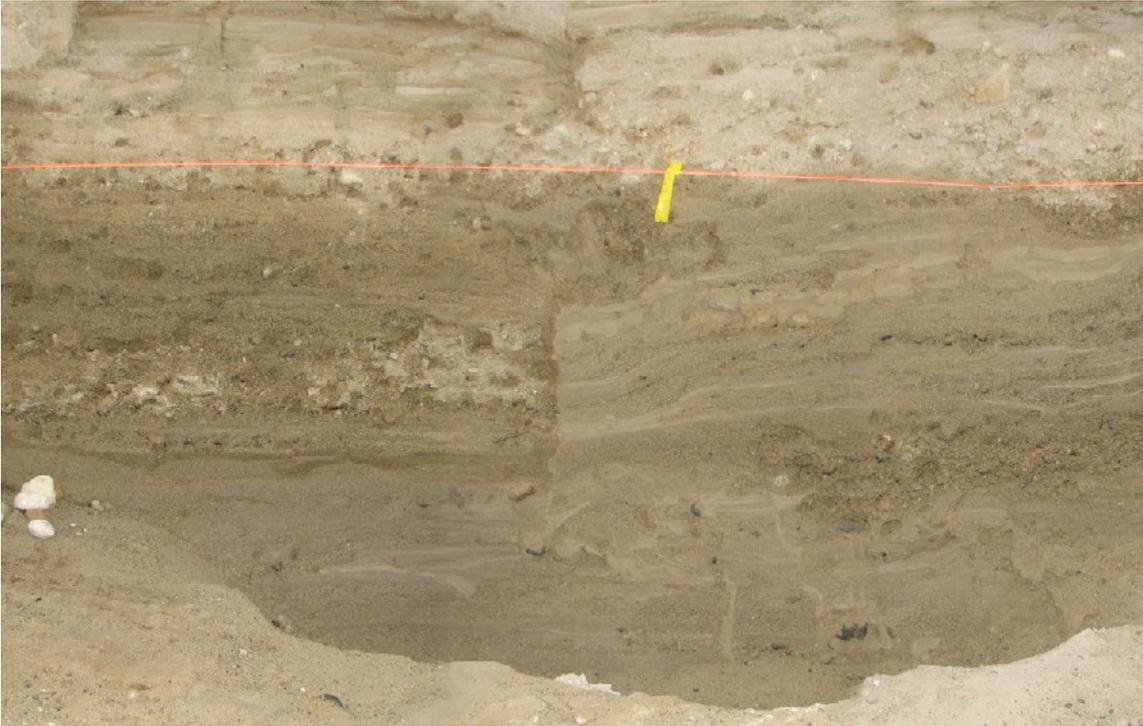
Figure 20. A small, steeply dipping liquefaction "fault" on the bench above the liquefied zone in Trench South 2a at Sta 0+99.

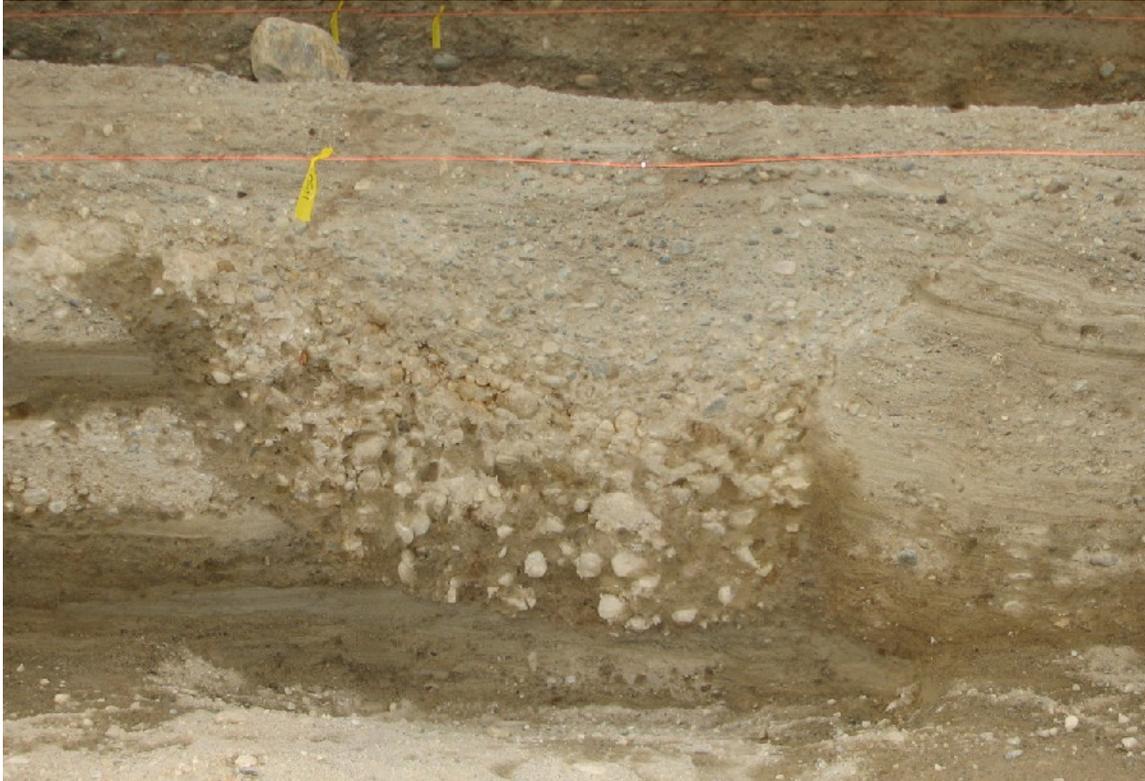
Figure 21. Gravel channel above liquefaction feature at Sta 1+05 in Trench South 2a. The shape and configuration of this channel is similar to a feature described by Obermeier (1996, Figure 7.10) in Charleston, SC, which he interpreted to be a filled crater created by liquefaction in an event that predated the 1886 Charleston earthquake. The liquefaction feature appears to be eroded and preferentially backfilled with late-stage Vashon recessional deposits.

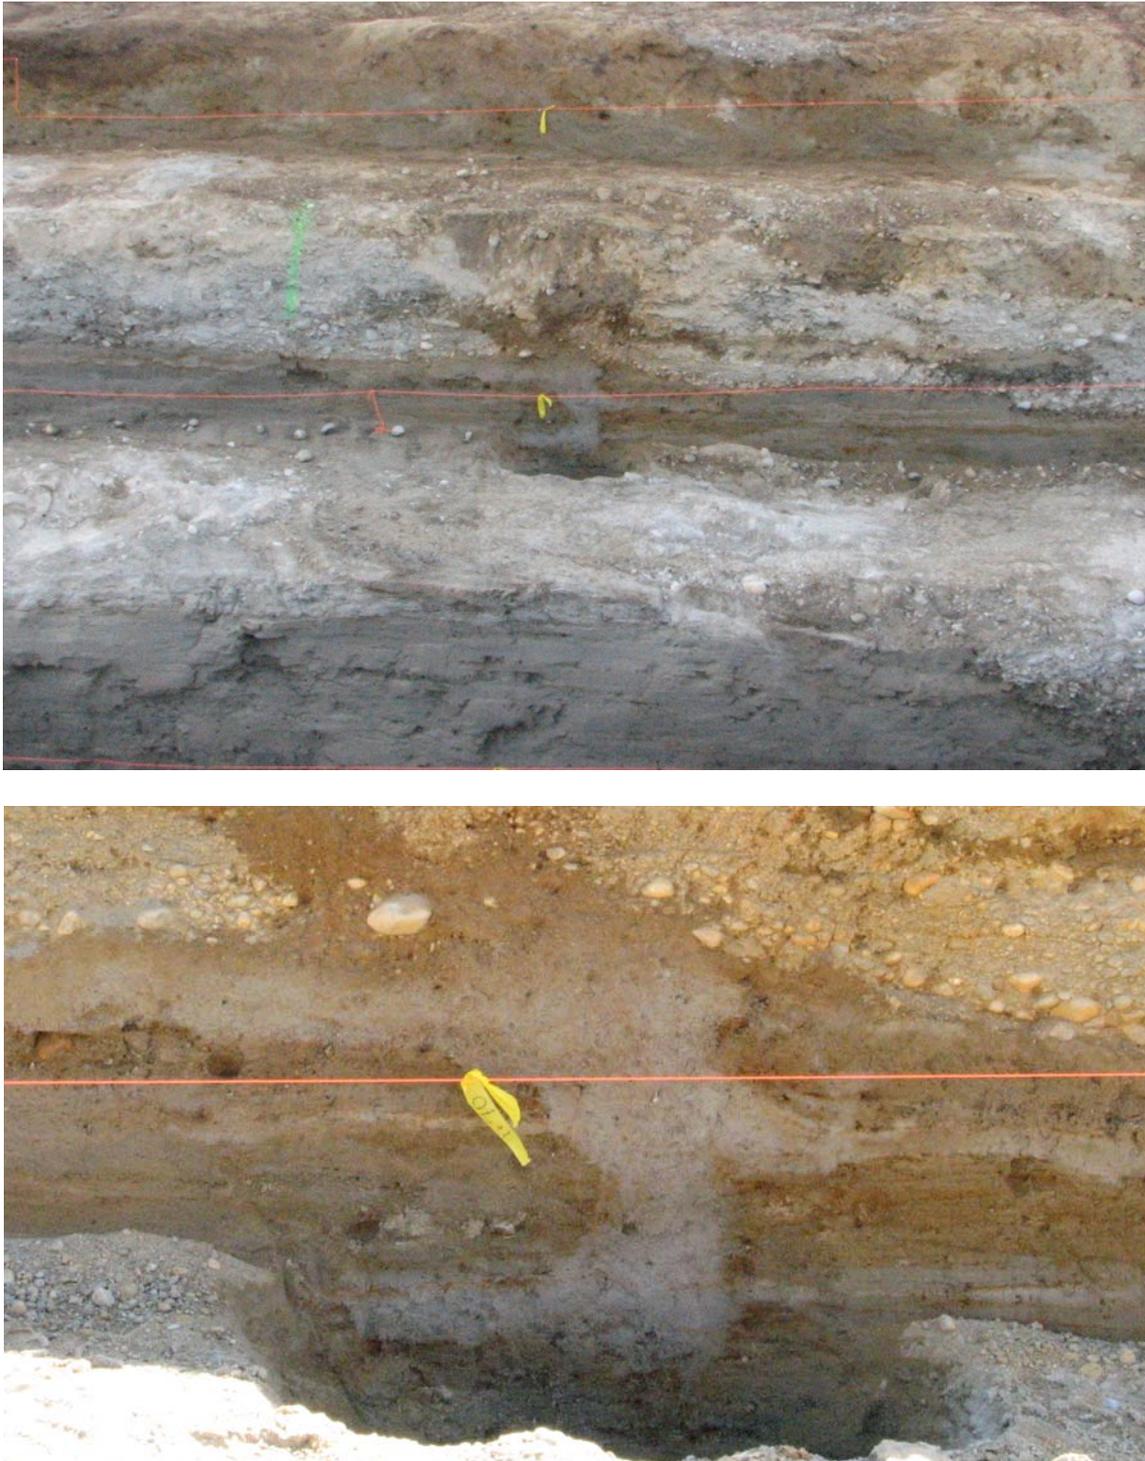
Figure 22. Liquefaction- feature exposed at Sta 1+70 in Trench South 2a.

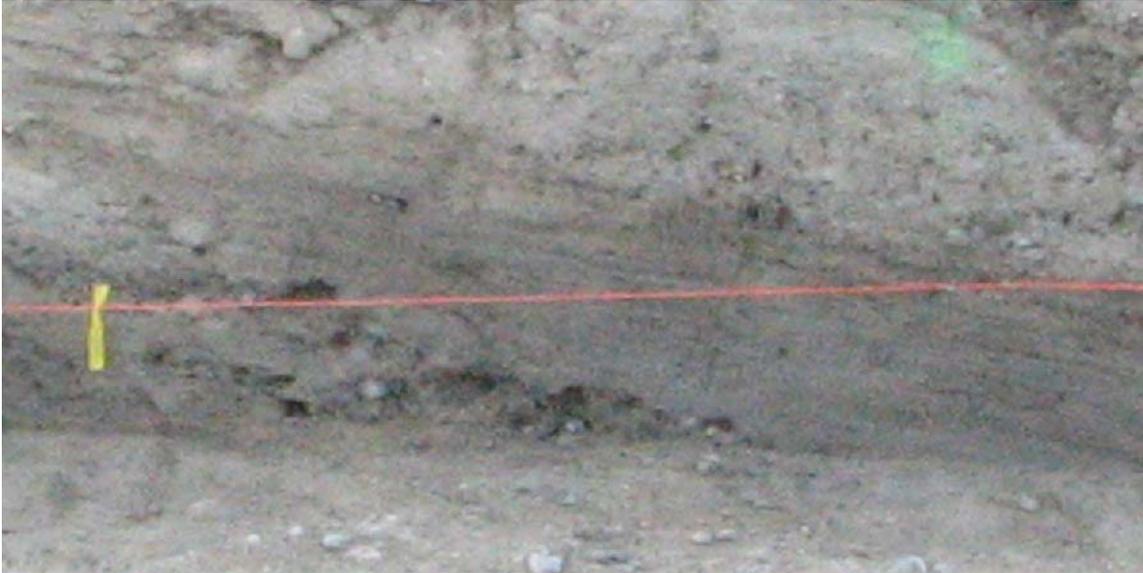
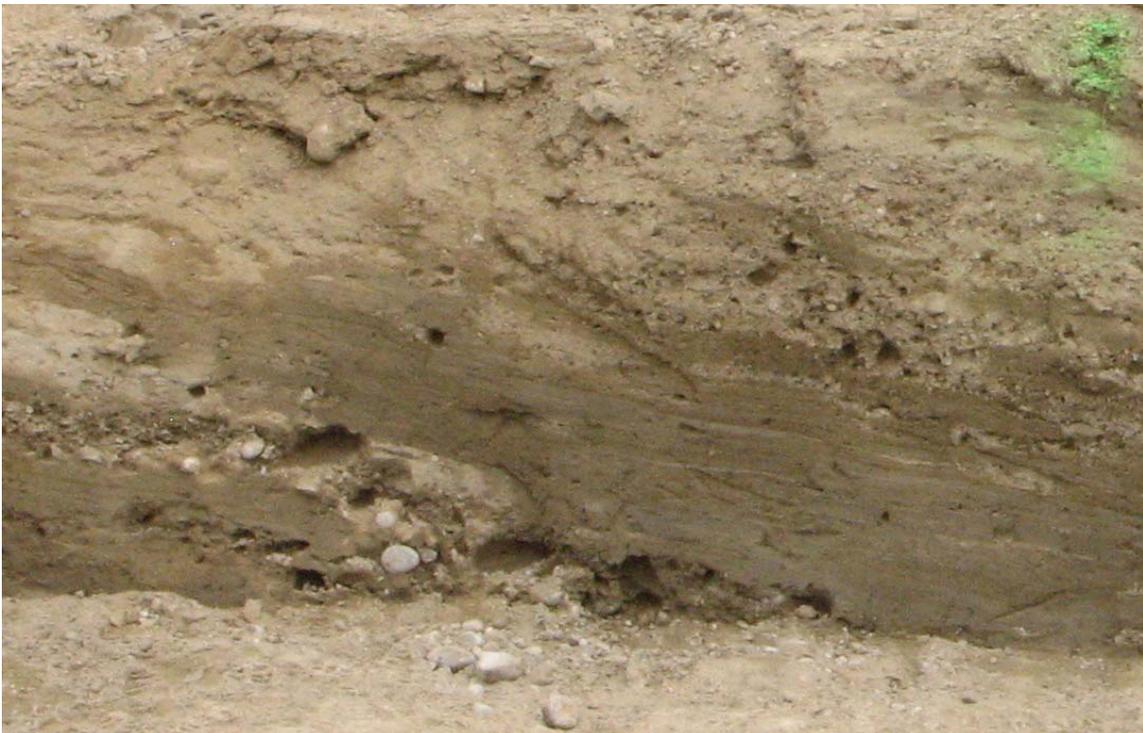
Figure 23. Several small glacial faults at Sta 0+72 in Trench South 2a.

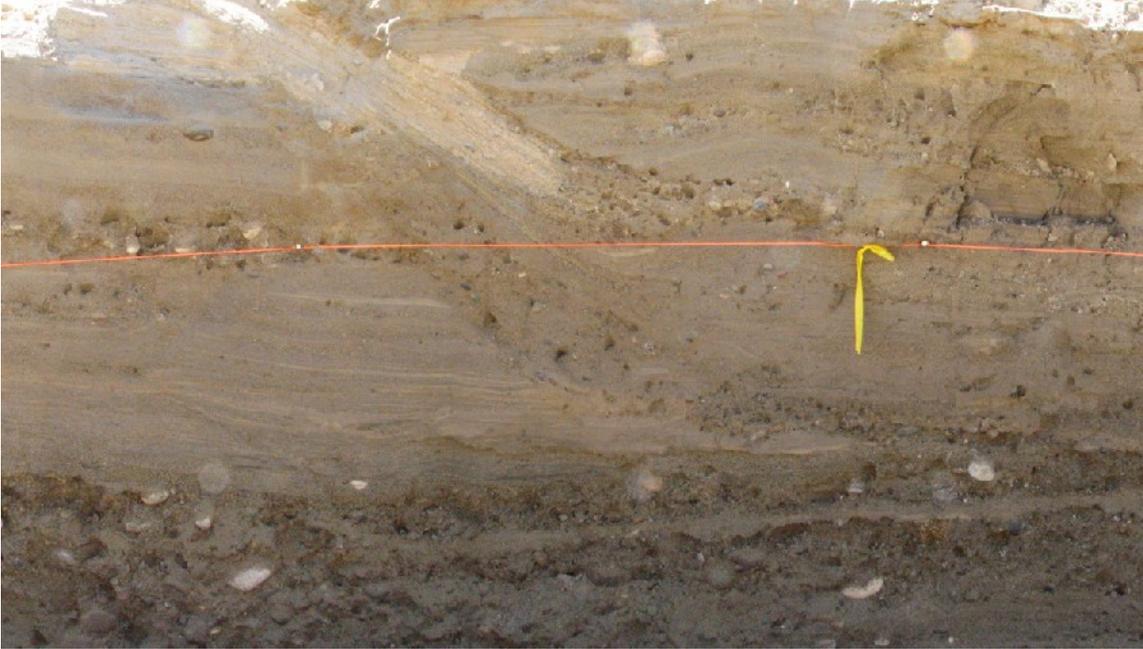
Figure 24. Buttress unconformity feature exposed in Trench South 2a at Sta 1+57.

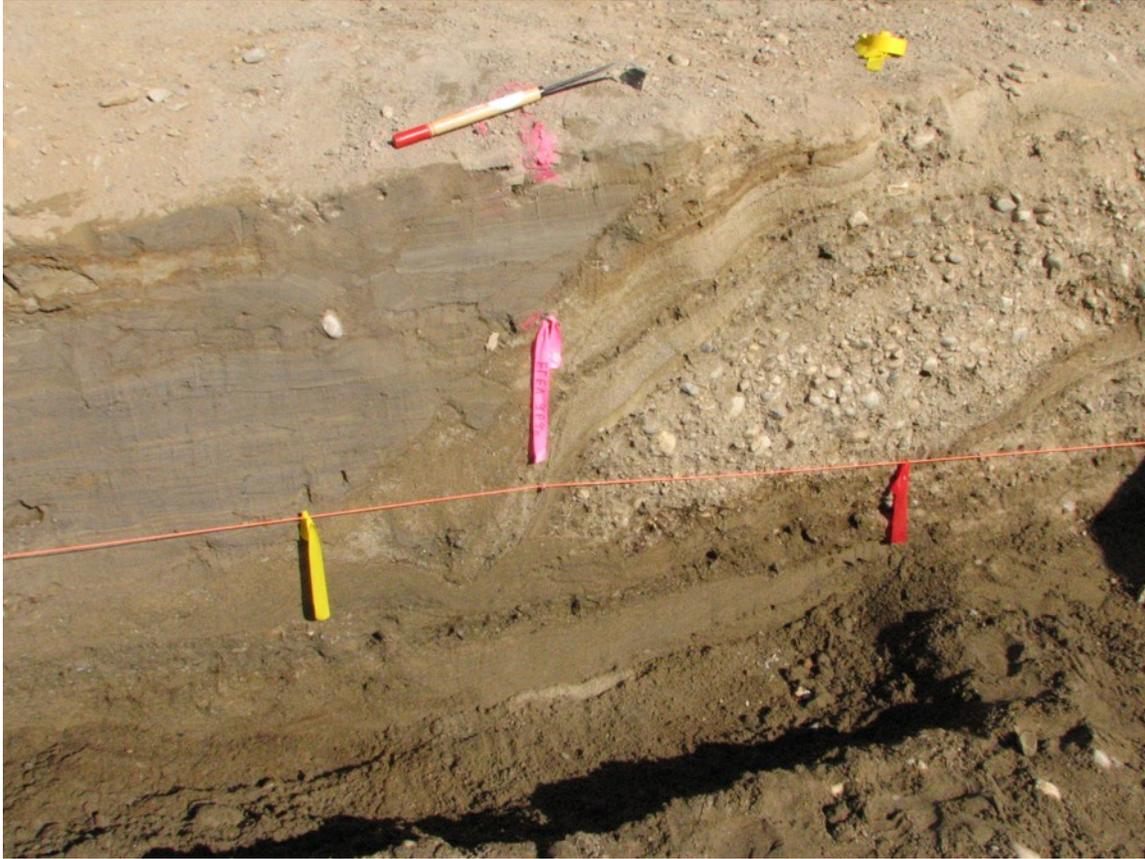
Figure 27. Buttress unconformity at Sta 1+22 in Trench South 2b.

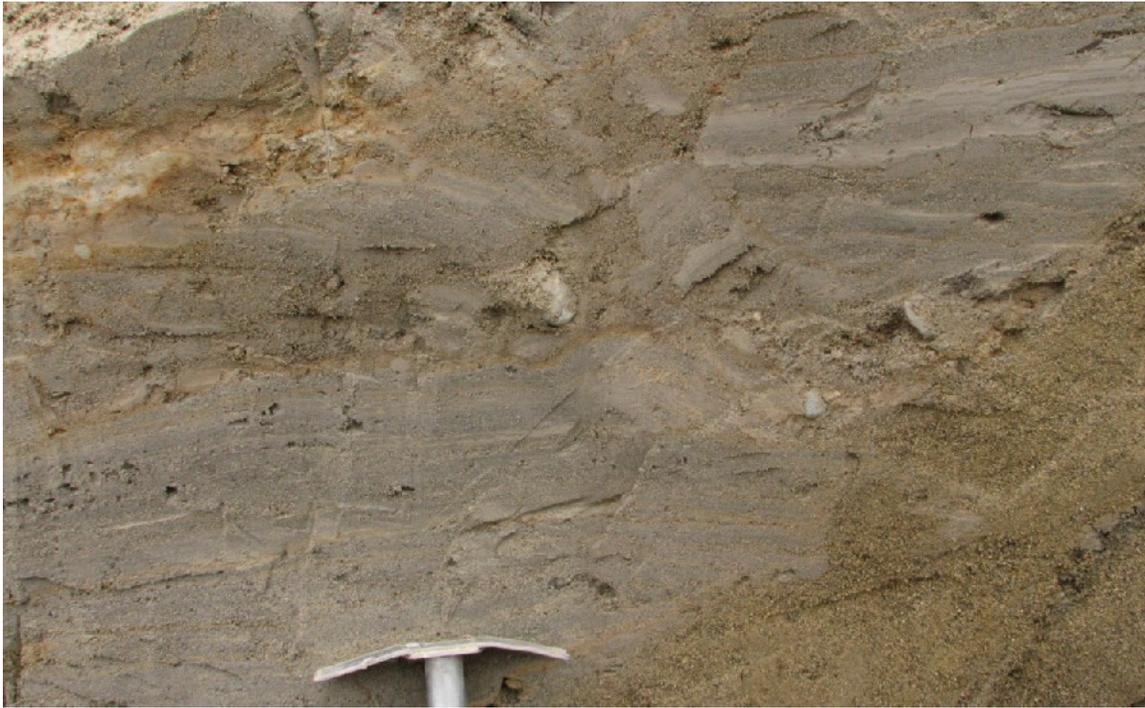
Figure 28. Contorted beds and small glacial or liquefaction faults in sand and silt layers adjacent to buttress unconformity in Figure 26.

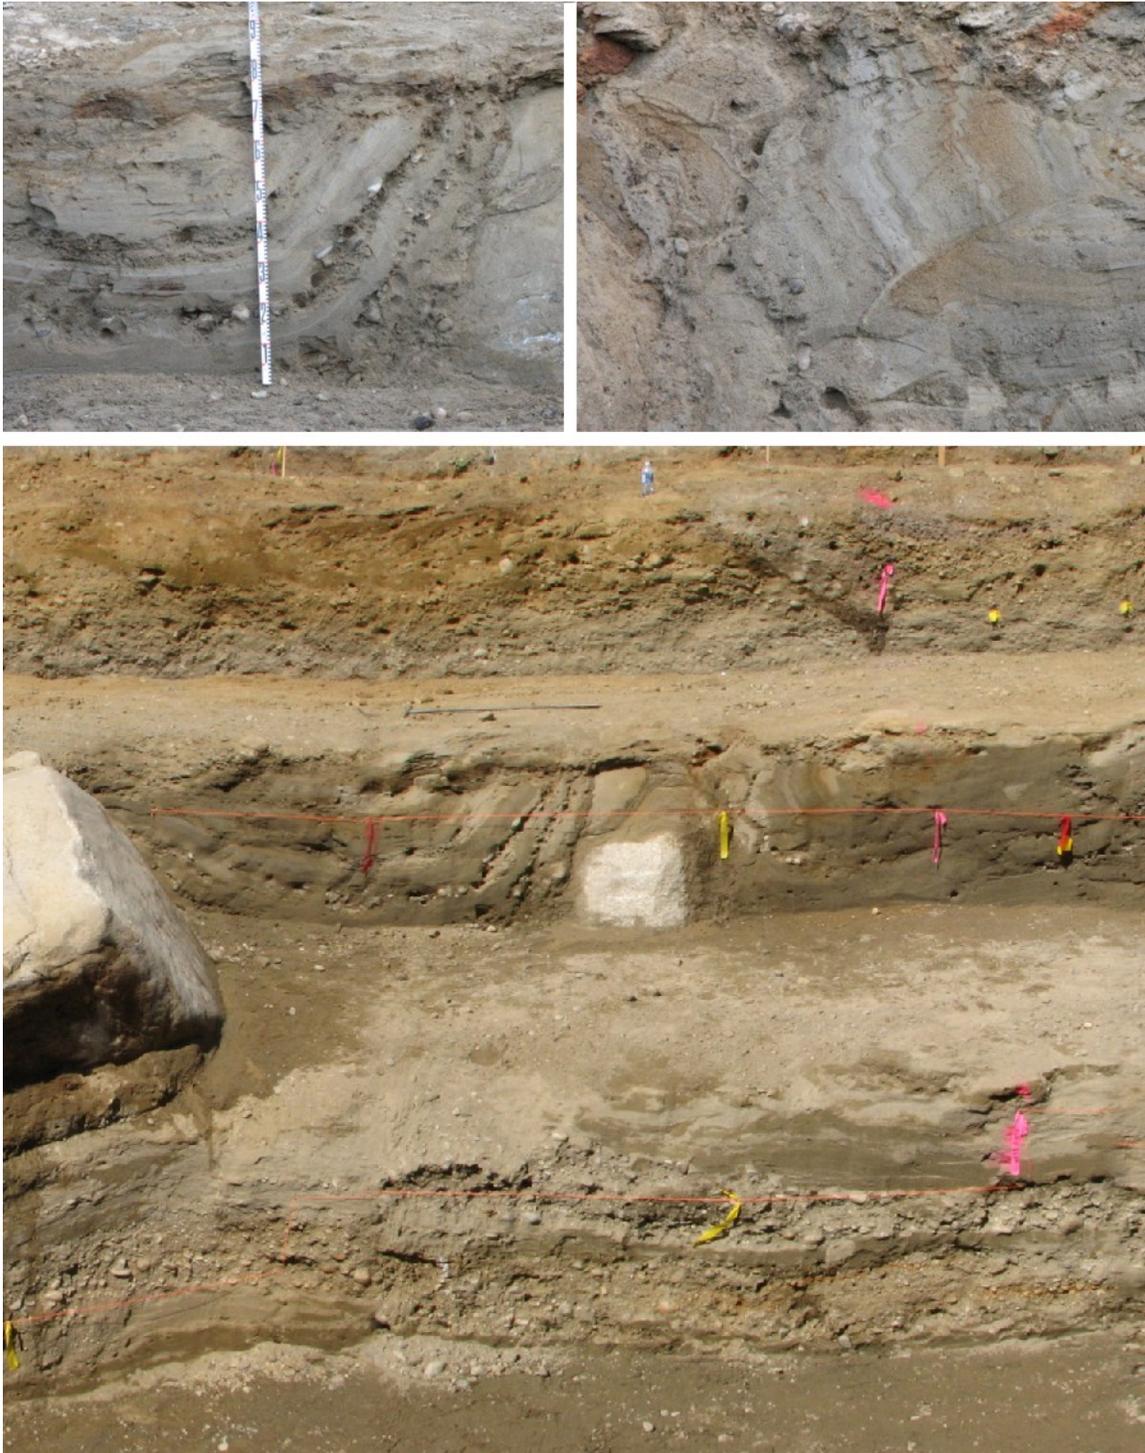
Figure 29. Local deformation in silt deposits adjacent to glacial erratic boulder at about Sta 0+93 and Sta 1+00 in Trench South 2b.

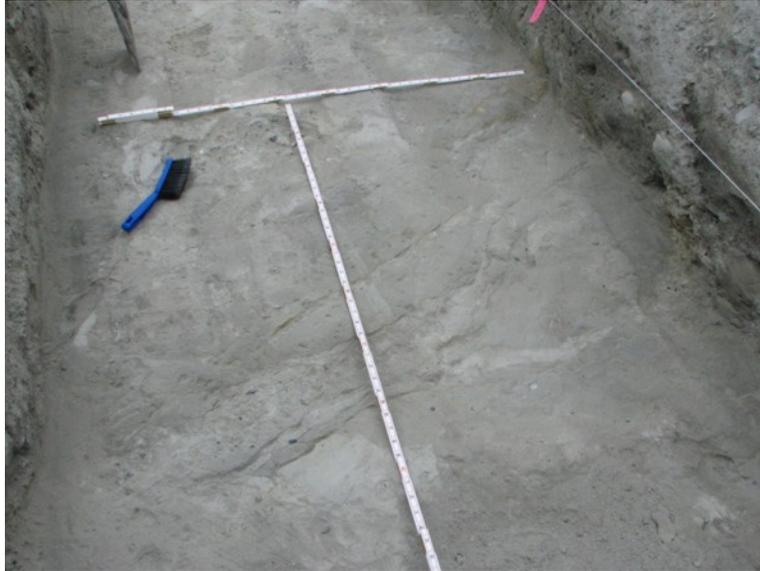
Figure 30. Cracks in the diamict in the North Trench.

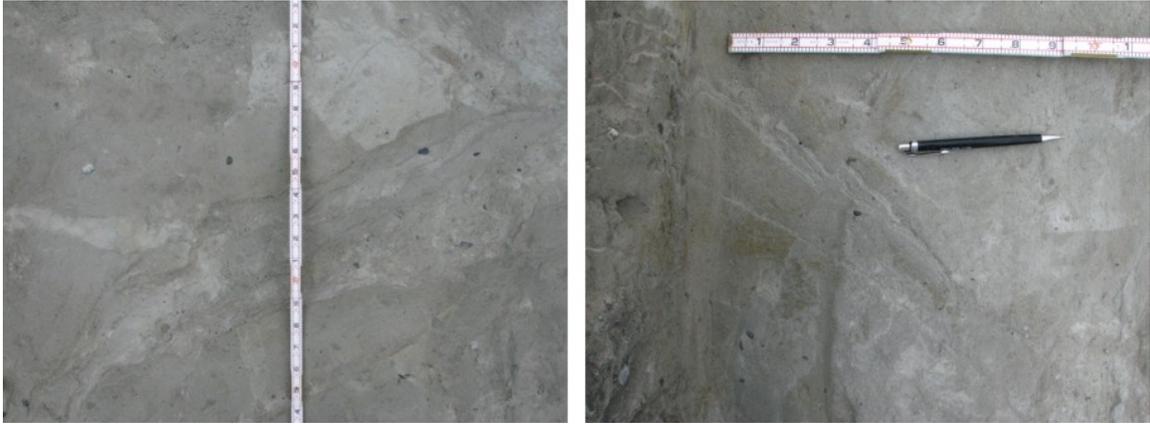
Figure 31. Very small component of left lateral separation on crack in the North Trench.

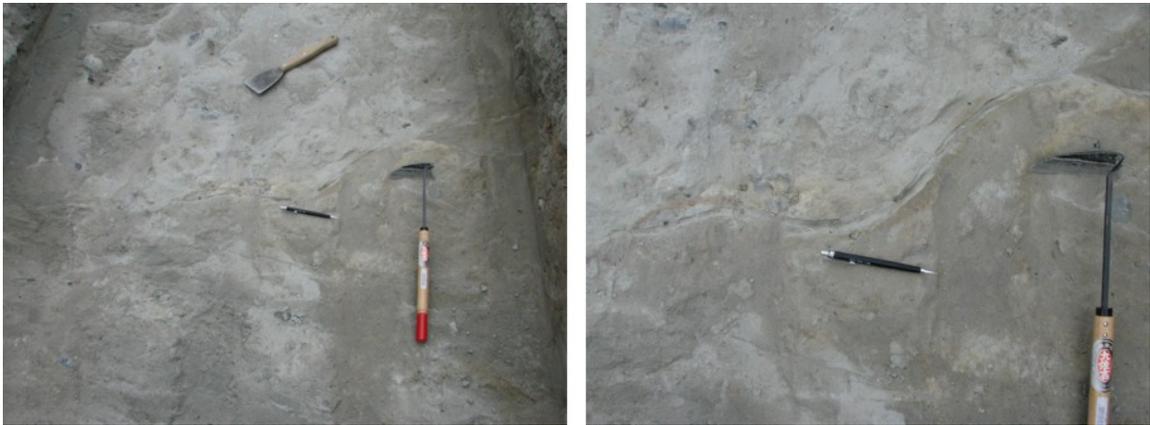
Figure 32. Simple tension cracks in the North Trench.

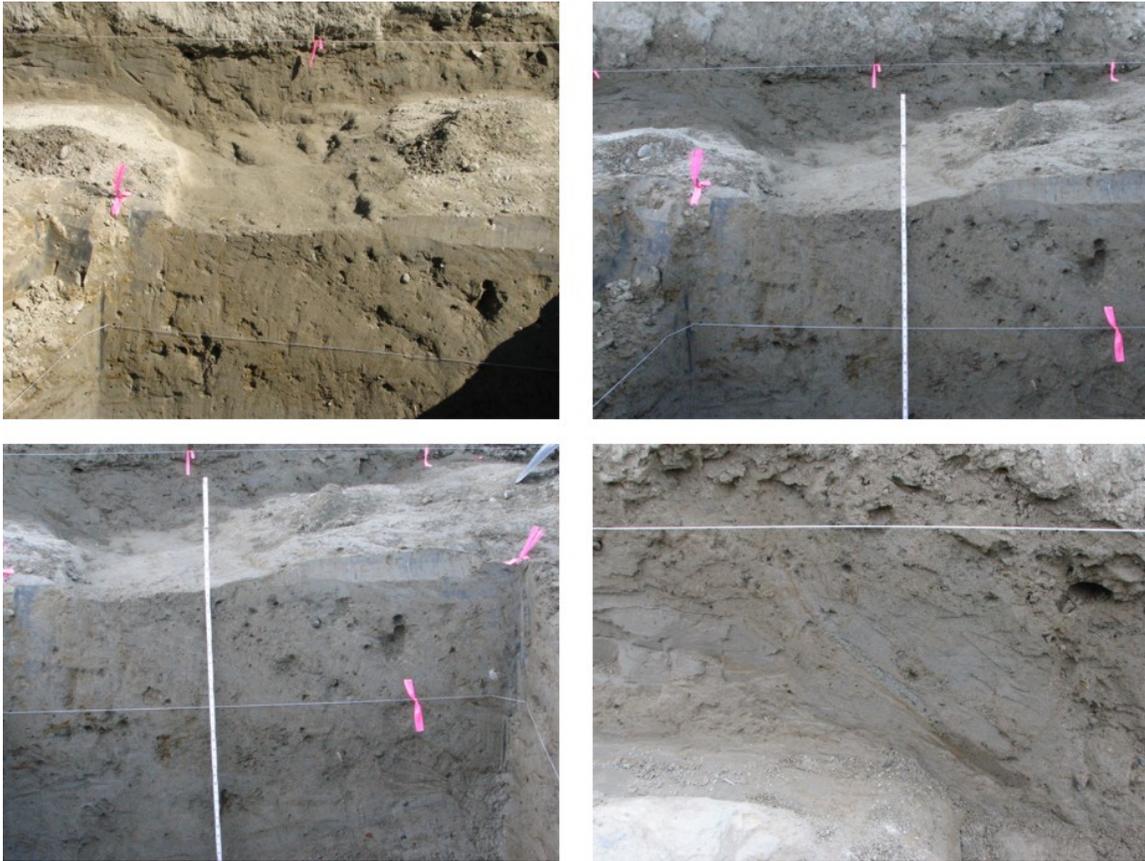
Figure 33. Curvi-planar feature exposed at about Sta 1+08 in the North Trench.

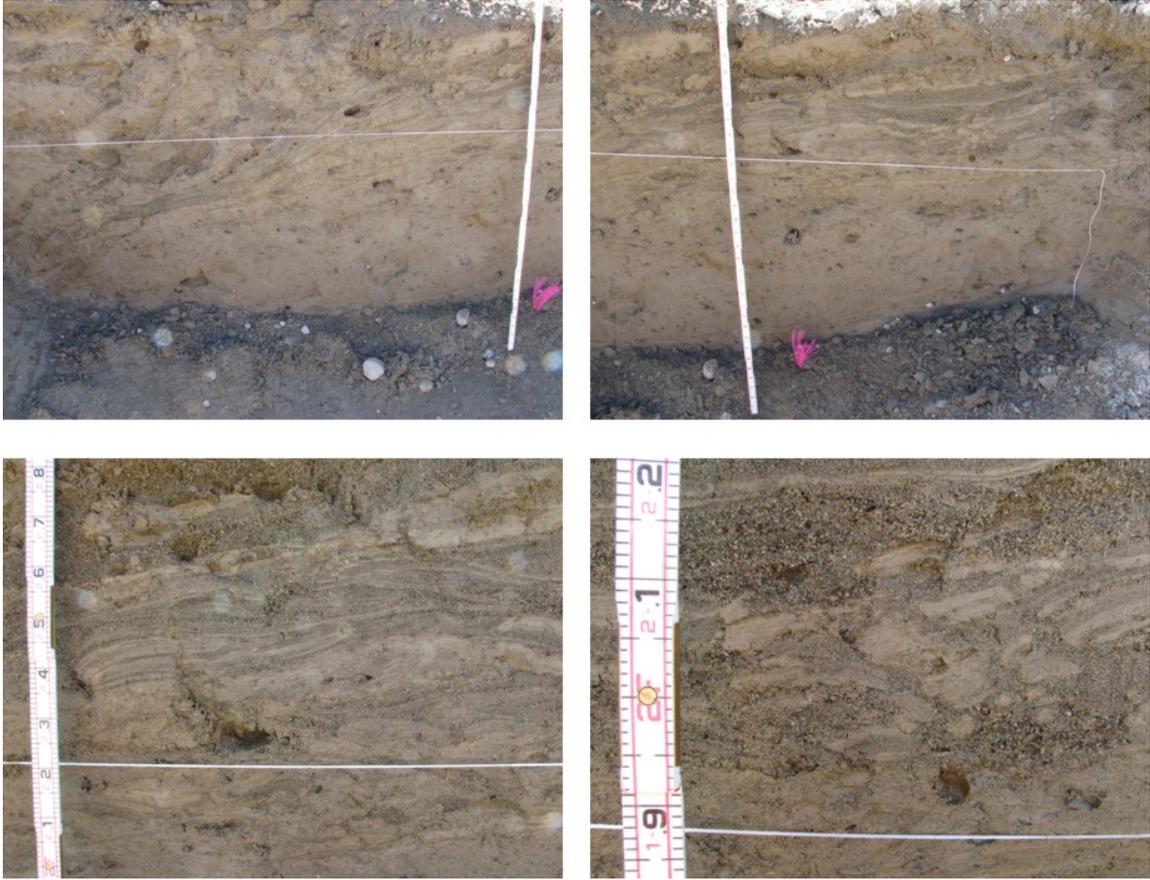
Figure 34. Wavy, thin sand and silt filaments along the curvi-planar feature exposed in small pit adjacent to the North Trench.
