Green River System Wide Improvement Framework (SWIF) – Symposium

Current Conditions Report Risk Assessment Overview – Geomorphology, Geotechnical, Hydraulic, and Economic Analysis

April 16, 2014

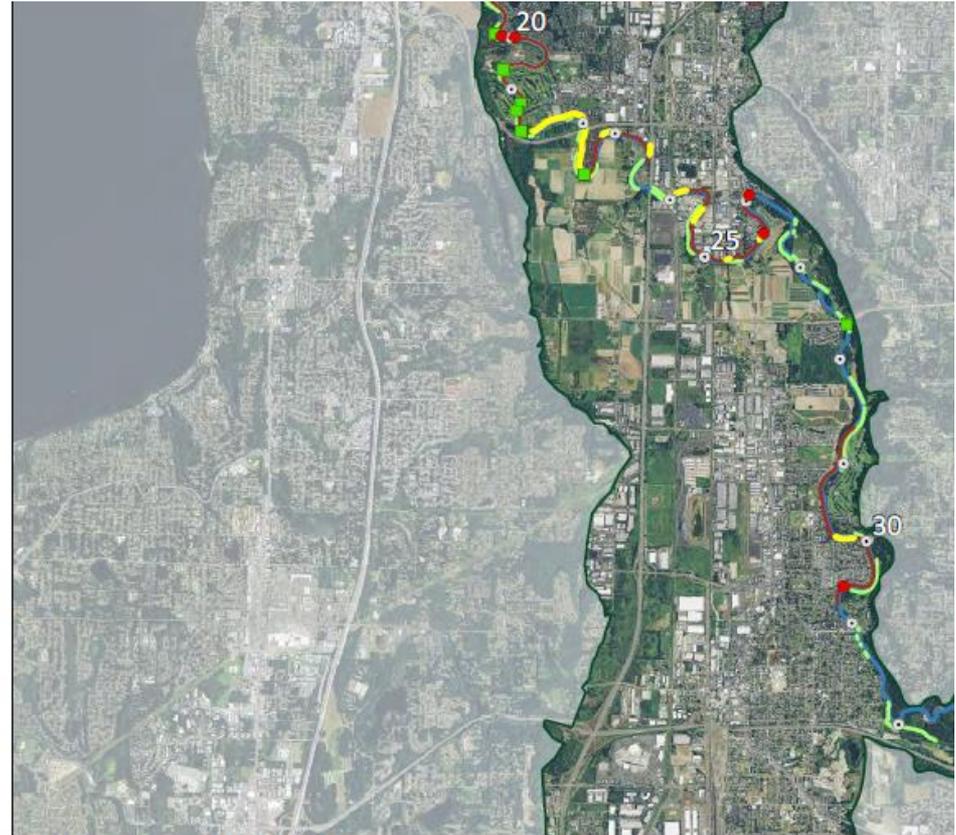
Figure X.X (DRAFT)

**Existing
Condition
Vulnerabilities**
Green River SWIF

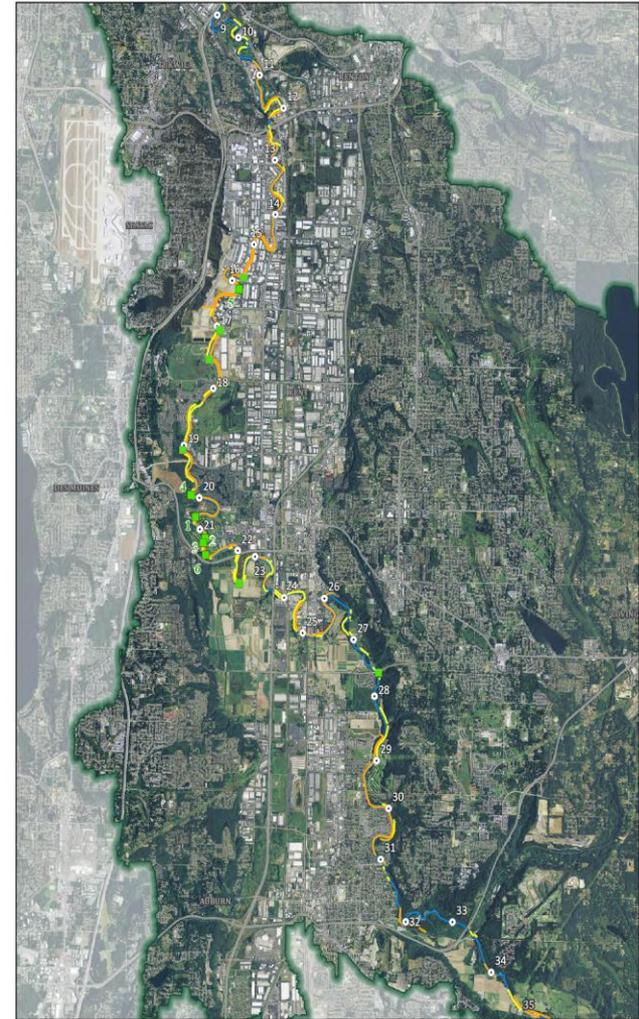
Figure X.X (DRAFT)

Green River SWIF
Significant
Incision Point
Locations

- Since 1986, stream bed erosion has lowered channel bed from 1-2 feet; greater incision on channel bends, with several bends having incision >5 feet
- Seven locations with incision of 5-10 feet
- Bend incision common due to high velocities, and is exacerbated by armoring that prevents lateral migration, thus increasing shear stress along toe of levee
- Most damaged levees and revetments located around channel bends
- Findings indicate channel cross sections with >5 feet of incision represent a substantial risk of future damage to adjacent levees and revetments

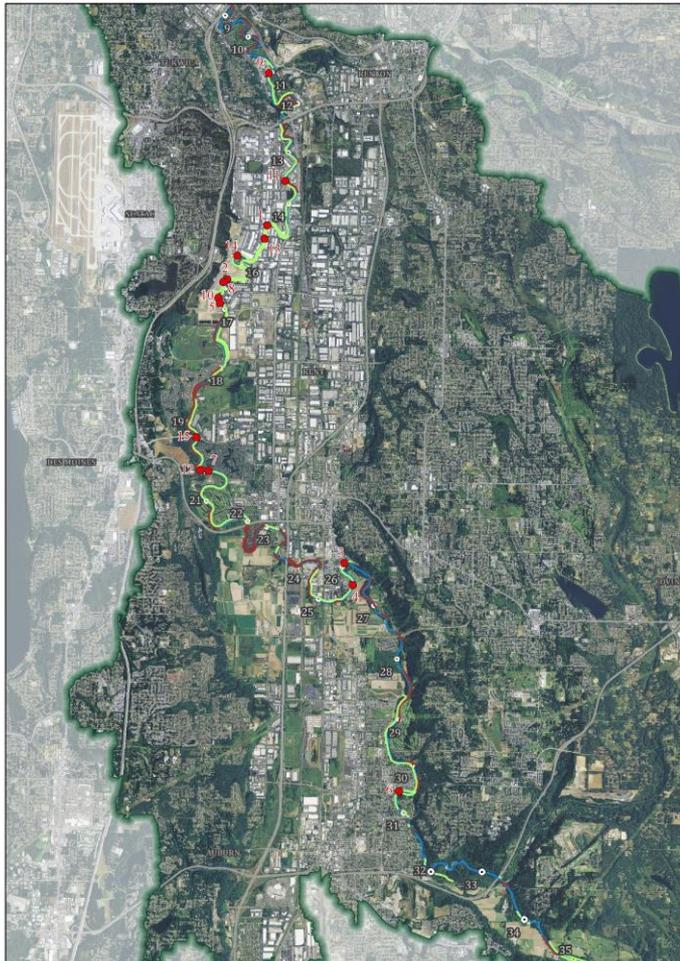
Figure X.X (DRAFT)

Green River SWIF
2014 Potential
Geotechnical
Breach Locations

Potential Breach	Levee Reach	River Bank	River Mile
1	Dykstra	Left	30.69
2	Tukwila 205	Left	14.83
3	Horseshoe Bend	Right	25.50
4	Meyer's Golf	Right	21.80
5	Lower Russell Road	Right	18.60
6	Briscoe-Desimone	Right	16.62

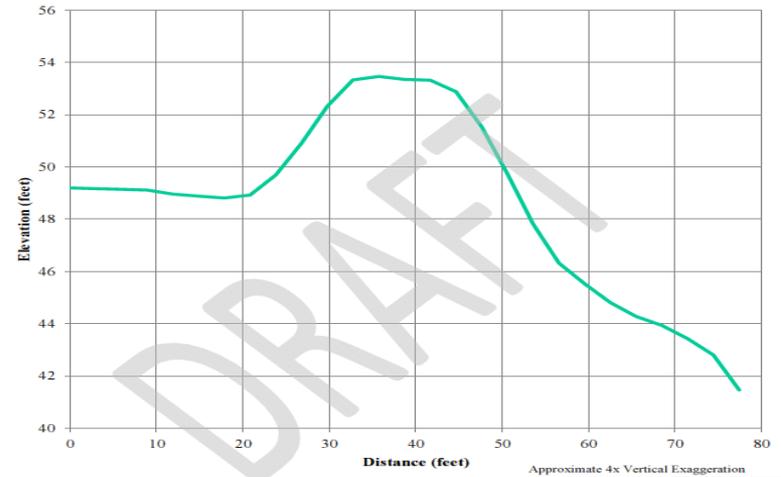
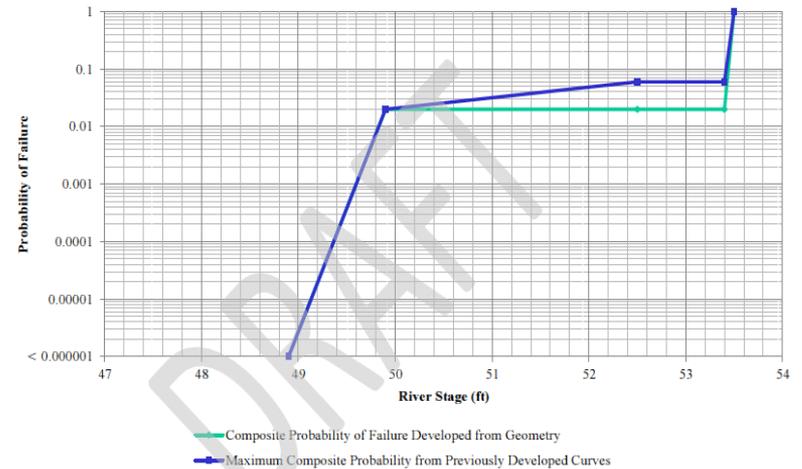
Horseshoe Bend (RB 25.5) – cross section and stage probability of failure

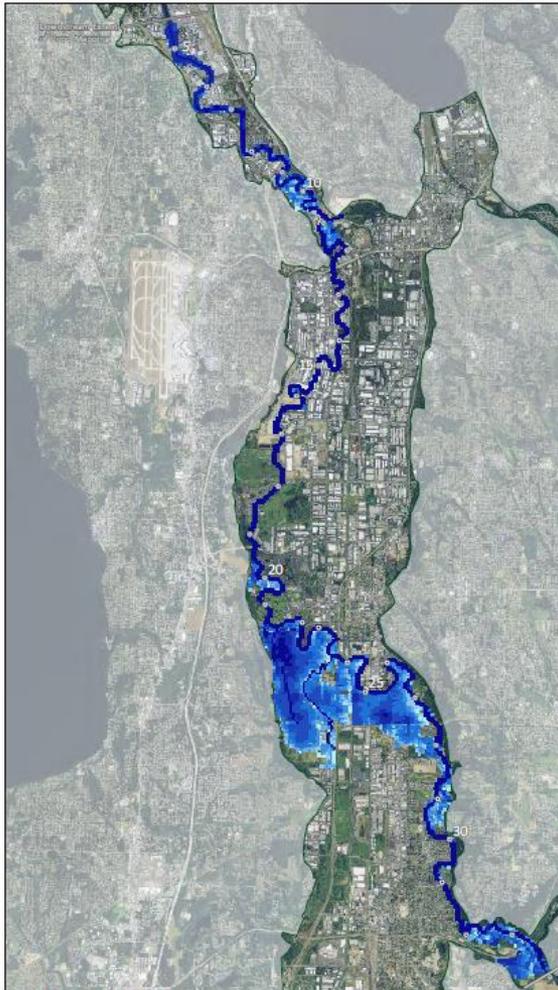
Figure 3.24 (DRAFT)
**Levee Overtopping
 no Breach**
 12,600 cfs
 200-year, Median Flood
 Green River SWIF

- Auburn Damage Area (Focus on urban Auburn)
 - Upstream levees on left bank (RM 28 to 31.75) convey flows between 15,100 cfs and 18,800 cfs, respectively
 - Lowest capacity in reach near RM 29.8; overtopping occurs at ~12,600 cfs
 - Reddington setback levee (RM 28.25 to 29.5) contains 18,800 cfs with some freeboard; 70-90% probability of containing 26,800 cfs (NHC 2013)
- Tukwila Damage Area
 - Tukwila Levee has some of lowest landward toe elevations in Lower Green; there is some chance (albeit very low) of a levee breach in flows below 12,000 cfs
 - Should levee breach, floodwaters entering damage area are confined by levees and must exceed downstream levee crest to spill back into river
 - Tukwila 205 levee provides a high level of protection from overtopping: it only occurs at 26,800 cfs, and in low amounts over the downstream end of the levee
