PROJECT INFORMATION REPORT
REHABILITATION OF FLOOD CONTROL WORKS
GRN-01-14

H&H APPENDIX: Desimone Levee

Summary: Hydraulic analysis performed in support of the Desimone levee rehabilitation.

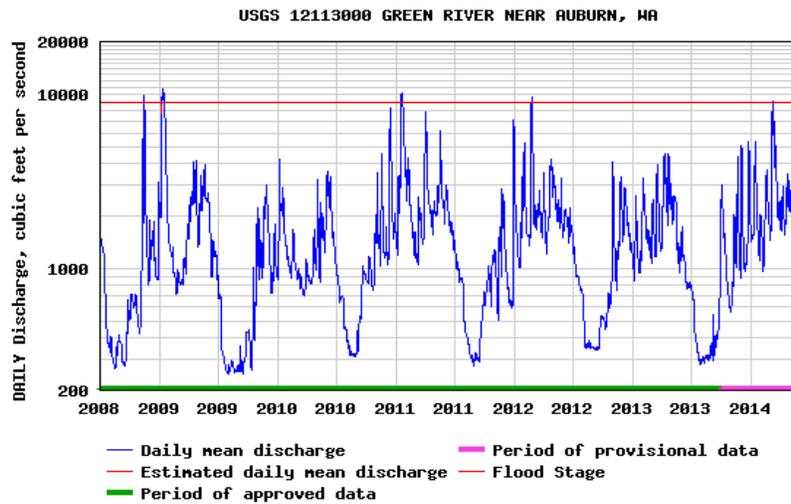
Figure 1. USGS Gage Peaks 2009 - 2014

Desimone levee is on the right bank of the Green River approximately 15 miles downstream of the USGS gage #12113000, Green River near Auburn, WA. The Green River is regulated by Howard Hanson Dam, which is operated to prevent downstream flows at Auburn from exceeding 12,000 cubic feet per second (cfs) at the USGS gage. Several high flow events exceeding flood stage occurred over the last few years: 11,100 cfs (2009), 10,400 cfs (2011) and 10,100 (2012). Recent damages were observed subsequent to a daily maximum discharge of 9,090 cfs on March 10, 2014 reported at the gage. Accounting for the drainage area of Green River between the gage and the levee, the approximate discharge at the levee was 10,000 cfs (a 2 yr event). These events are estimated to be approximately 2-yr to 10-yr return period, or 0.5 to 0.1 chance of exceedance, for a given year.

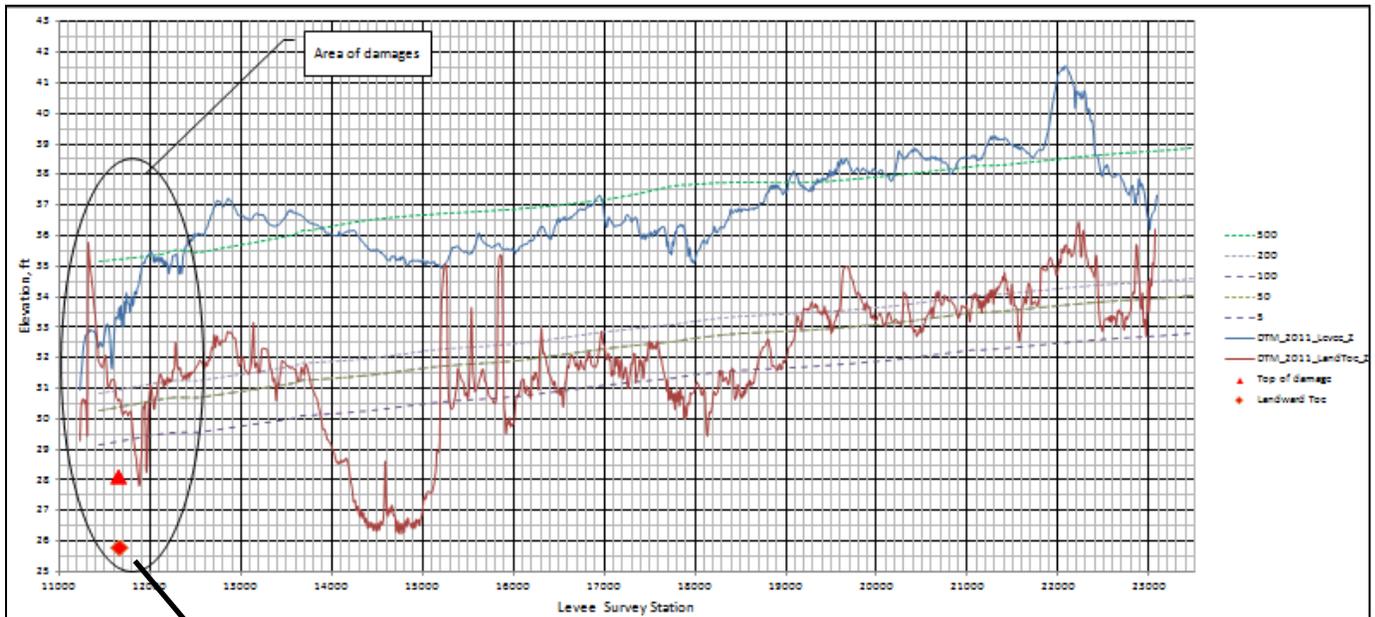
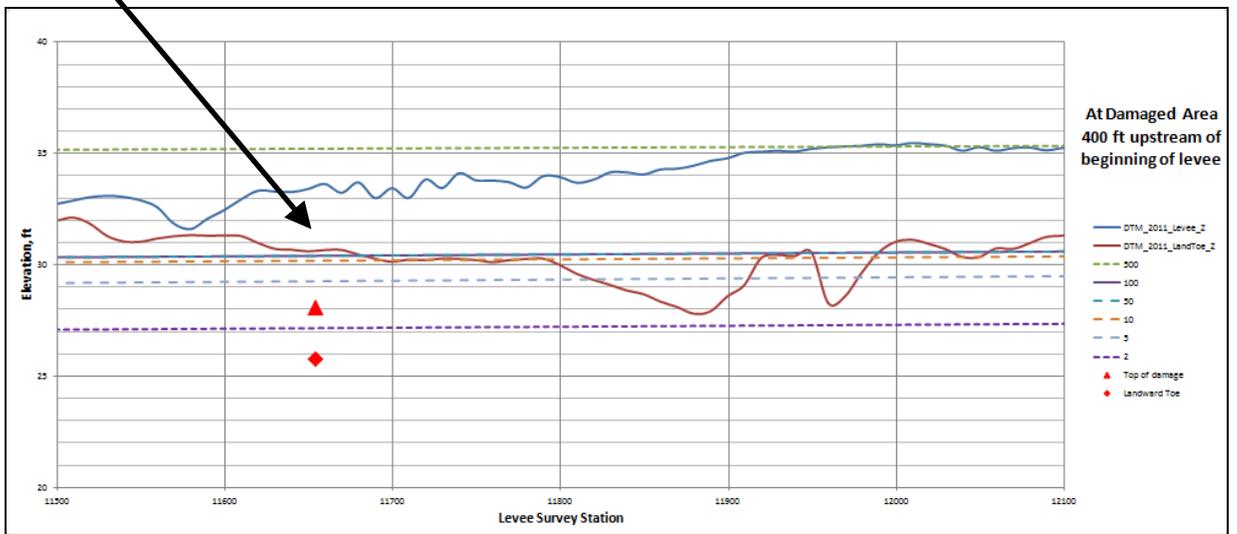
Figure 2. Desimone Levee Flood Profiles (from HEC-RAS 2012)

Review of hydraulic analysis suggest that the levee would be overtopped with a flood event associated with a 250-yr or greater return period (based on HEC-RAS model flood profiles). The loss of scour protection in the damaged area has compromised the pre-flood level of protection offered by the Desimone levee. Flows contacting the damaged section could erode the remaining armoring and exposed soil. Protective armoring along the toe is missing allowing scouring of in-situ material to occur causing additional sloughing. Therefore, the estimated level of protection provided by the Desimone levee in its current condition is from a flood event with a 2-yr return period and corresponds to the point where damages would occur with some certainty if the levee provided no flood mitigation. This is roughly consistent with the existing ground behind the levee (i.e. if the levee were not there the existing ground would flood from a 2 yr event). The remainder of the levee and toe is assumed to be intact as no damage was reported.

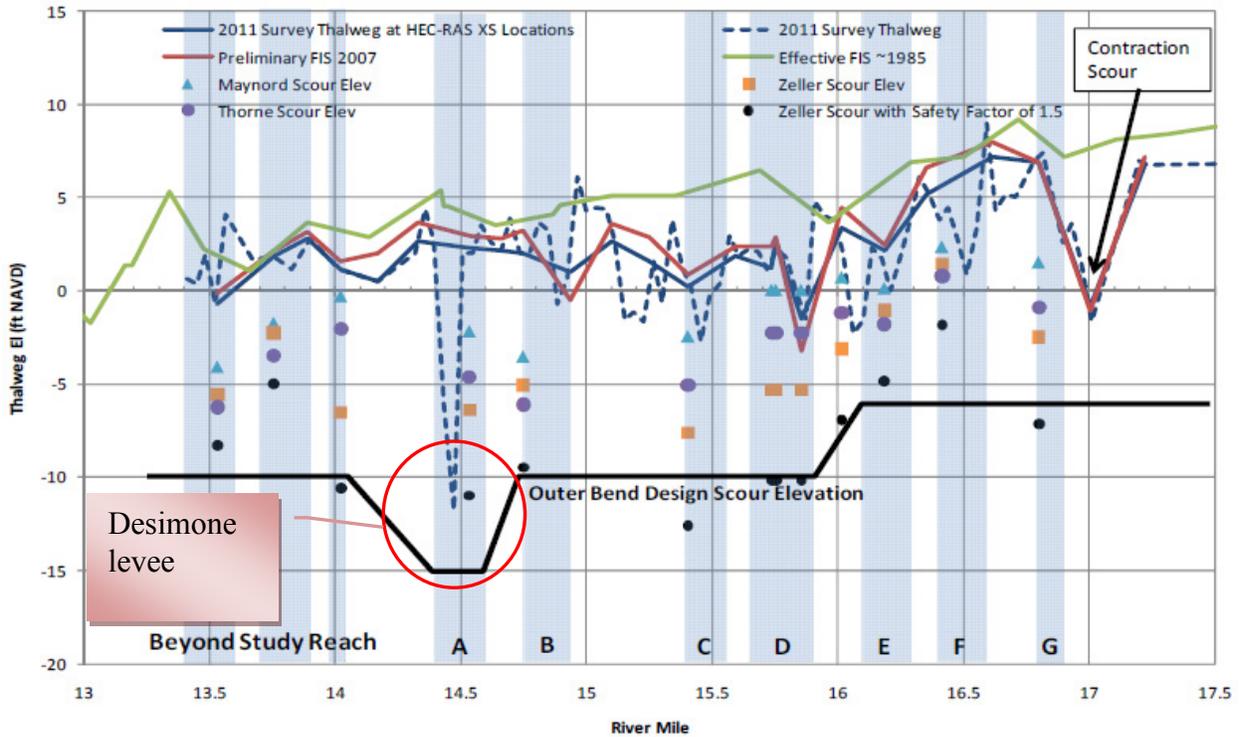
Figure 6. Recommended scour estimate (courtesy NHC 2011)

This area of the Green River has been studied extensively for scour. In 2007 a COE study proposed bend scour depths of a maximum 46 ft being possible at the Tukwila 205 levee just downstream on the opposite bank (using EM 1601 methods, USACE 2007). Methods employed in the EM are known to be very conservative and typically aren't used without further calibration. In this area of the Green scour depths of this magnitude have not been seen. In 2011 NHC evaluated several sites from RM 13.5 to 17 for bend scour and calibrated the Zeller equation to the system (NHC, 2011) using a safety factor of 1.5, which predicted bend scour of 15 ft at the Desimone site. These estimates through the reach are shown in Figure 6 below. The NHC effort used extensive 2011 survey data and HEC RAS modeling to calibrate the scour estimates for this area of the Green. The results were checked and are reproducible, and the Zeller equation was found to be generally applicable to the system. The reader is referred to the NHC 2011 report for additional detail. In 2014 borings were done from RM 12.5 to 16.6 (USACE, 2014). The closest boring to the Desimone site was RM 14.748 (roughly 0.2 miles upstream) which revealed the existence of a sand/silt layer down to 25 ft below the river bottom. Borings are shown in Figure 7 below. The boring did not go below this depth so the composition of lower substrate is unknown. Synthesis of these three studies suggests that scour in excess of 15 ft may be possible. Greater scour depths may be possible during flood events. Gravel and sand bed rivers often scour at bends and structures during the rising limb of a flood hydrograph and fill in during the falling limb, revealing an observed net change less than the actual maximum that may have occurred. This phenomenon is almost entirely due to bed composition. If the depth of sub-surface layers vulnerable to scour was factored into calibration of scour

equations it would suggest use of a greater safety factor. Increasing the safety factor to 2.7 in the Zeller equation for example gives a scour depth of 25 ft at the site. In the absence of additional sub-surface information, the estimate of a 25 ft depth of scourable material shown in the borings is recommended. If a launching toe is used, for a launch distance greater than 15 feet the toe rock volume should be increased by 75% (EM 1601). This equates to a total launching stone volume in cubic feet of:

It is recommended that the scour estimate for toe protection at this site incorporate available boring data for this section of the Green River, which shows the existence of scourable material down to 25 ft below the bed. This is greater than the previous estimate provided from the local sponsor of 15 ft (NHC, 2011), and amounts to use of a greater safety factor in scour equations to account for uncertainty in bed composition. The proposed repair extends the full rip rap blanket thickness one channel top width upstream of the bend and ends at the adjacent levee at the downstream end.

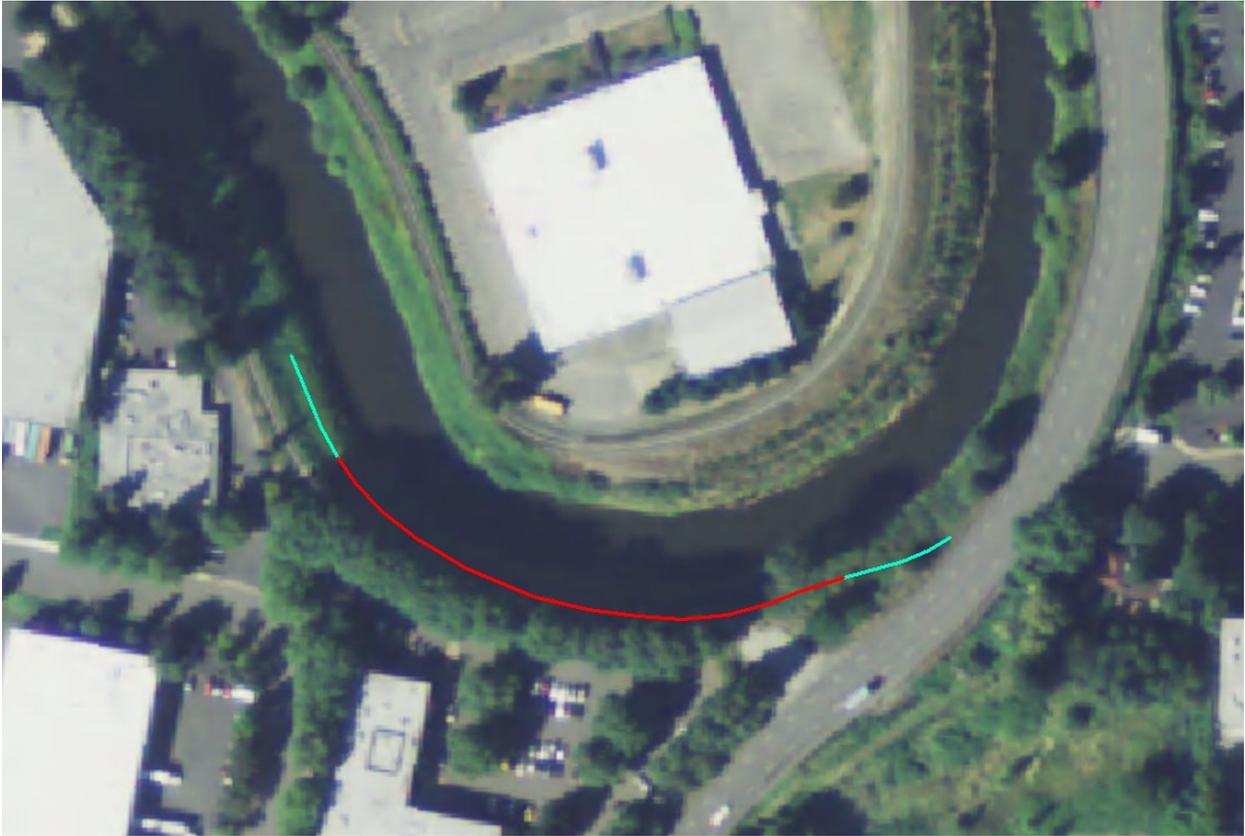
The damaged area is directly in line with approaching flow as it enters the bend. The repair needs to be sufficiently long that: 1. The transition to the existing rock is not subject to excessive stress and, 2. The repair should be long enough that the bend is adequately protected from future erosion. Typically this involves extending the rip rap blanket at least 1 channel top width upstream from the point of curvature and at least 1 to 2 channel top widths downstream from the point of tangency (USACE, 1994). This is to prevent flanking of the repair. At this site one top width is sufficient to get out of the erosive bend. Another top width is also recommended for tapering the design into the existing levee upstream. It is important that the transition be smooth at not create a constriction along the bank. At the downstream end the repair is ended at West Valley Highway at the adjacent levee. As of this design the repair could not extend into the adjacent levee due to land ownership constraints. The repair is being terminated in an erosive zone of the bend, so it is recommended that the end be keyed into the bank with at least two times the normal blanket thickness (USACE, 1994). The downstream end should also be tapered to a smooth transition into the existing slope. At a minimum the existing slope outside of the damage area should be assessed for adequate protection.

Figure 8. Recommended full rip rap layer thickness shown in red, tapered into the existing slope over the green.
