SUBJECT: Dykstra Levee Rehabilitation – City of Auburn, King County, Washington, GRN-02-14 –
Request for project approval

PROJECT INFORMATION REPORT
REHABILITATION OF FLOOD CONTROL WORKS
DYKSTRA LEVEE, CITY OF AUBURN, KING COUNTY, WASHINGTON
GRN-02-14

PROJECT NAME: Dykstra Non-Federal Levee

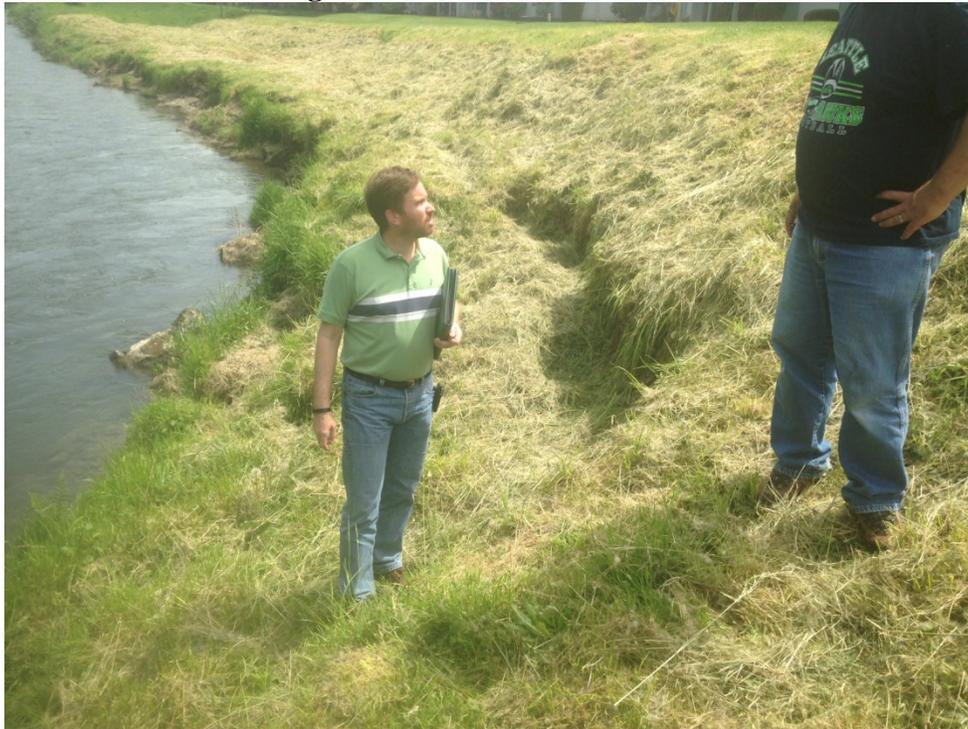
- a. The high river flows caused scour and loss of embankment material and toe rock, which produced an unstable, oversteepened slope. This levee requires an emergency repair to restore flood protection.

Photo C-1: Damaged portion near downstream end of levee (site 1). Station ~2+50 - Looking upstream. (Corps photo).

PROPOSED REPAIR: The proposed repair includes replacement of approximately 850' of the riverward levee toe and slope embankment for three sections of this levee. The three levee sections will be graded to allow a 2H:1V slope and a 3 foot blanket and buried toe of class IV riprap armor rock. Soil lifts with willow plantings will likely be included. The proposed repair will return the damaged portions of the levee to the pre-flood 0.002 ACE (200 yr) for overtopping Level of Protection (LOP). The remainder of the levee and toe is assumed to be intact and provide a 200 yr level of protection which is consistent with overtopping. The site 1 repair, see Figure B-3, has a 42 inch corrugated metal pipe (CMP) culvert near the downstream end (see photos C-3 & C-4). The downstream tie-in will likely encroach on the culvert headwall. Consequently, the headwall, Tideflex gate, and about a 20 foot section of culvert will need to be replaced.

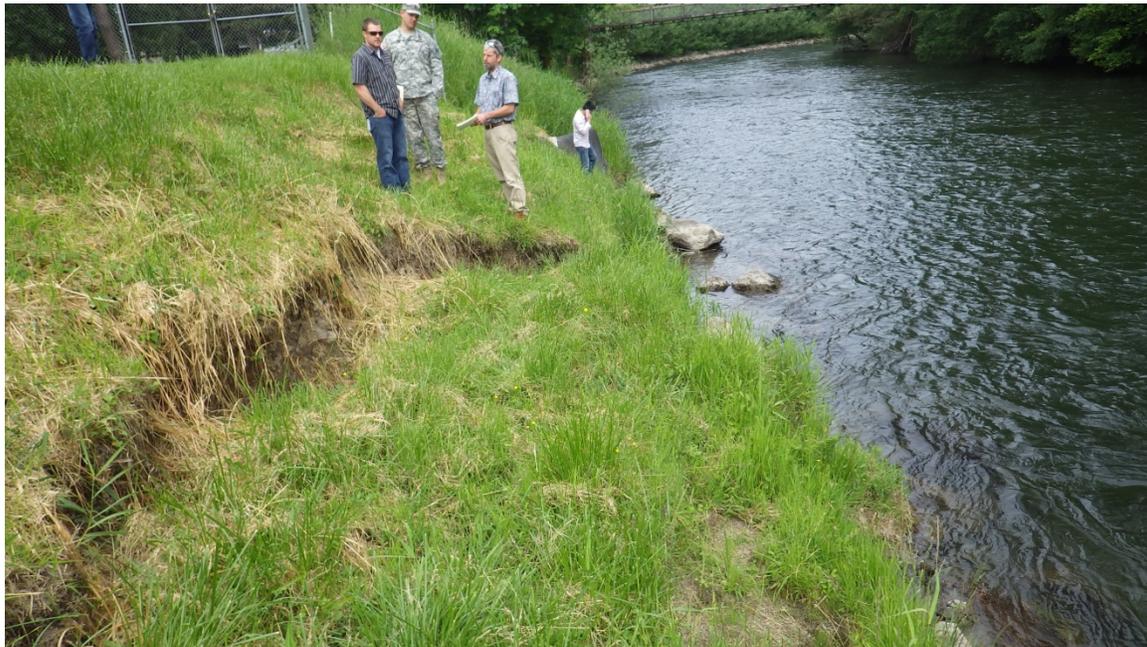
Photo C-2: Damaged section looking downstream (site 1). Station ~2+50 (Corps photo)

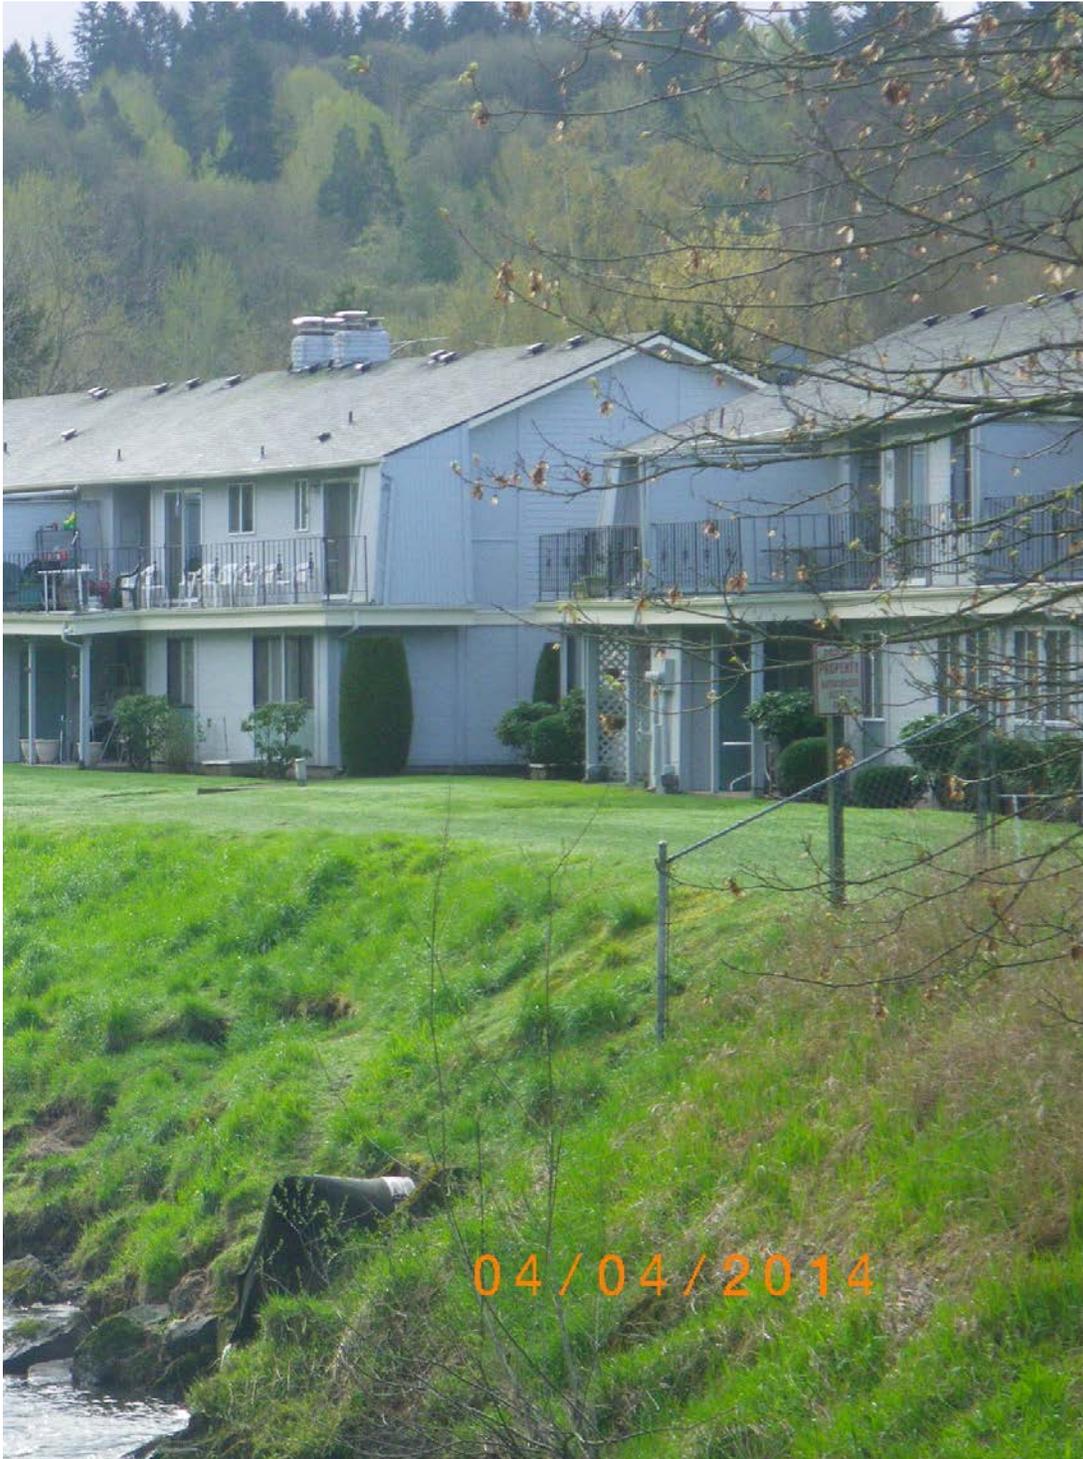
Photo C-3: 42" CMP culvert that will need to be partly replaced during the repair to site 1. Looking upstream

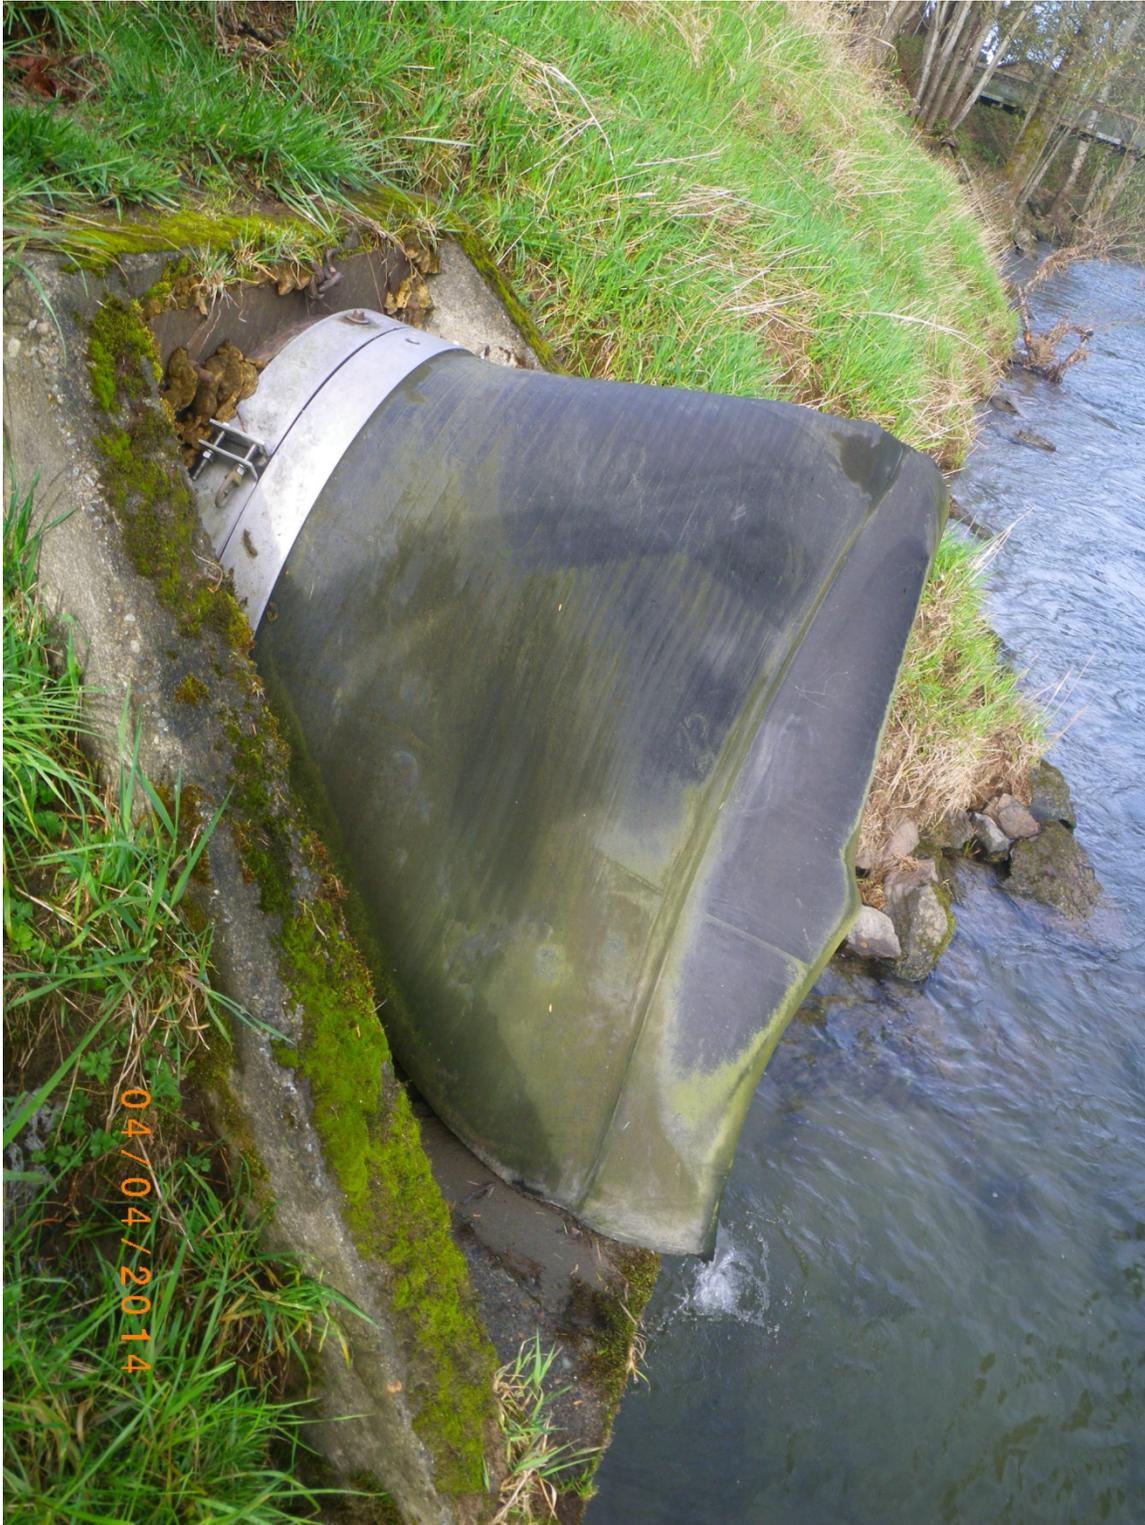
Photo C-4: Close up of culvert from Photo C-3, approximate Station 2+00.
