# GEOMORPHIC HAZARDS AND RISKS ASSESSMENT AND ALTERNATIVES ANALYSIS

SOUTH FORK SNOQUALMIE RIVER  
CIRCLE RIVER RANCH NEIGHBORHOOD

Prepared for  
King County  
Water and Land Resources Division  
River and Floodplain Management Section

July 31, 2012

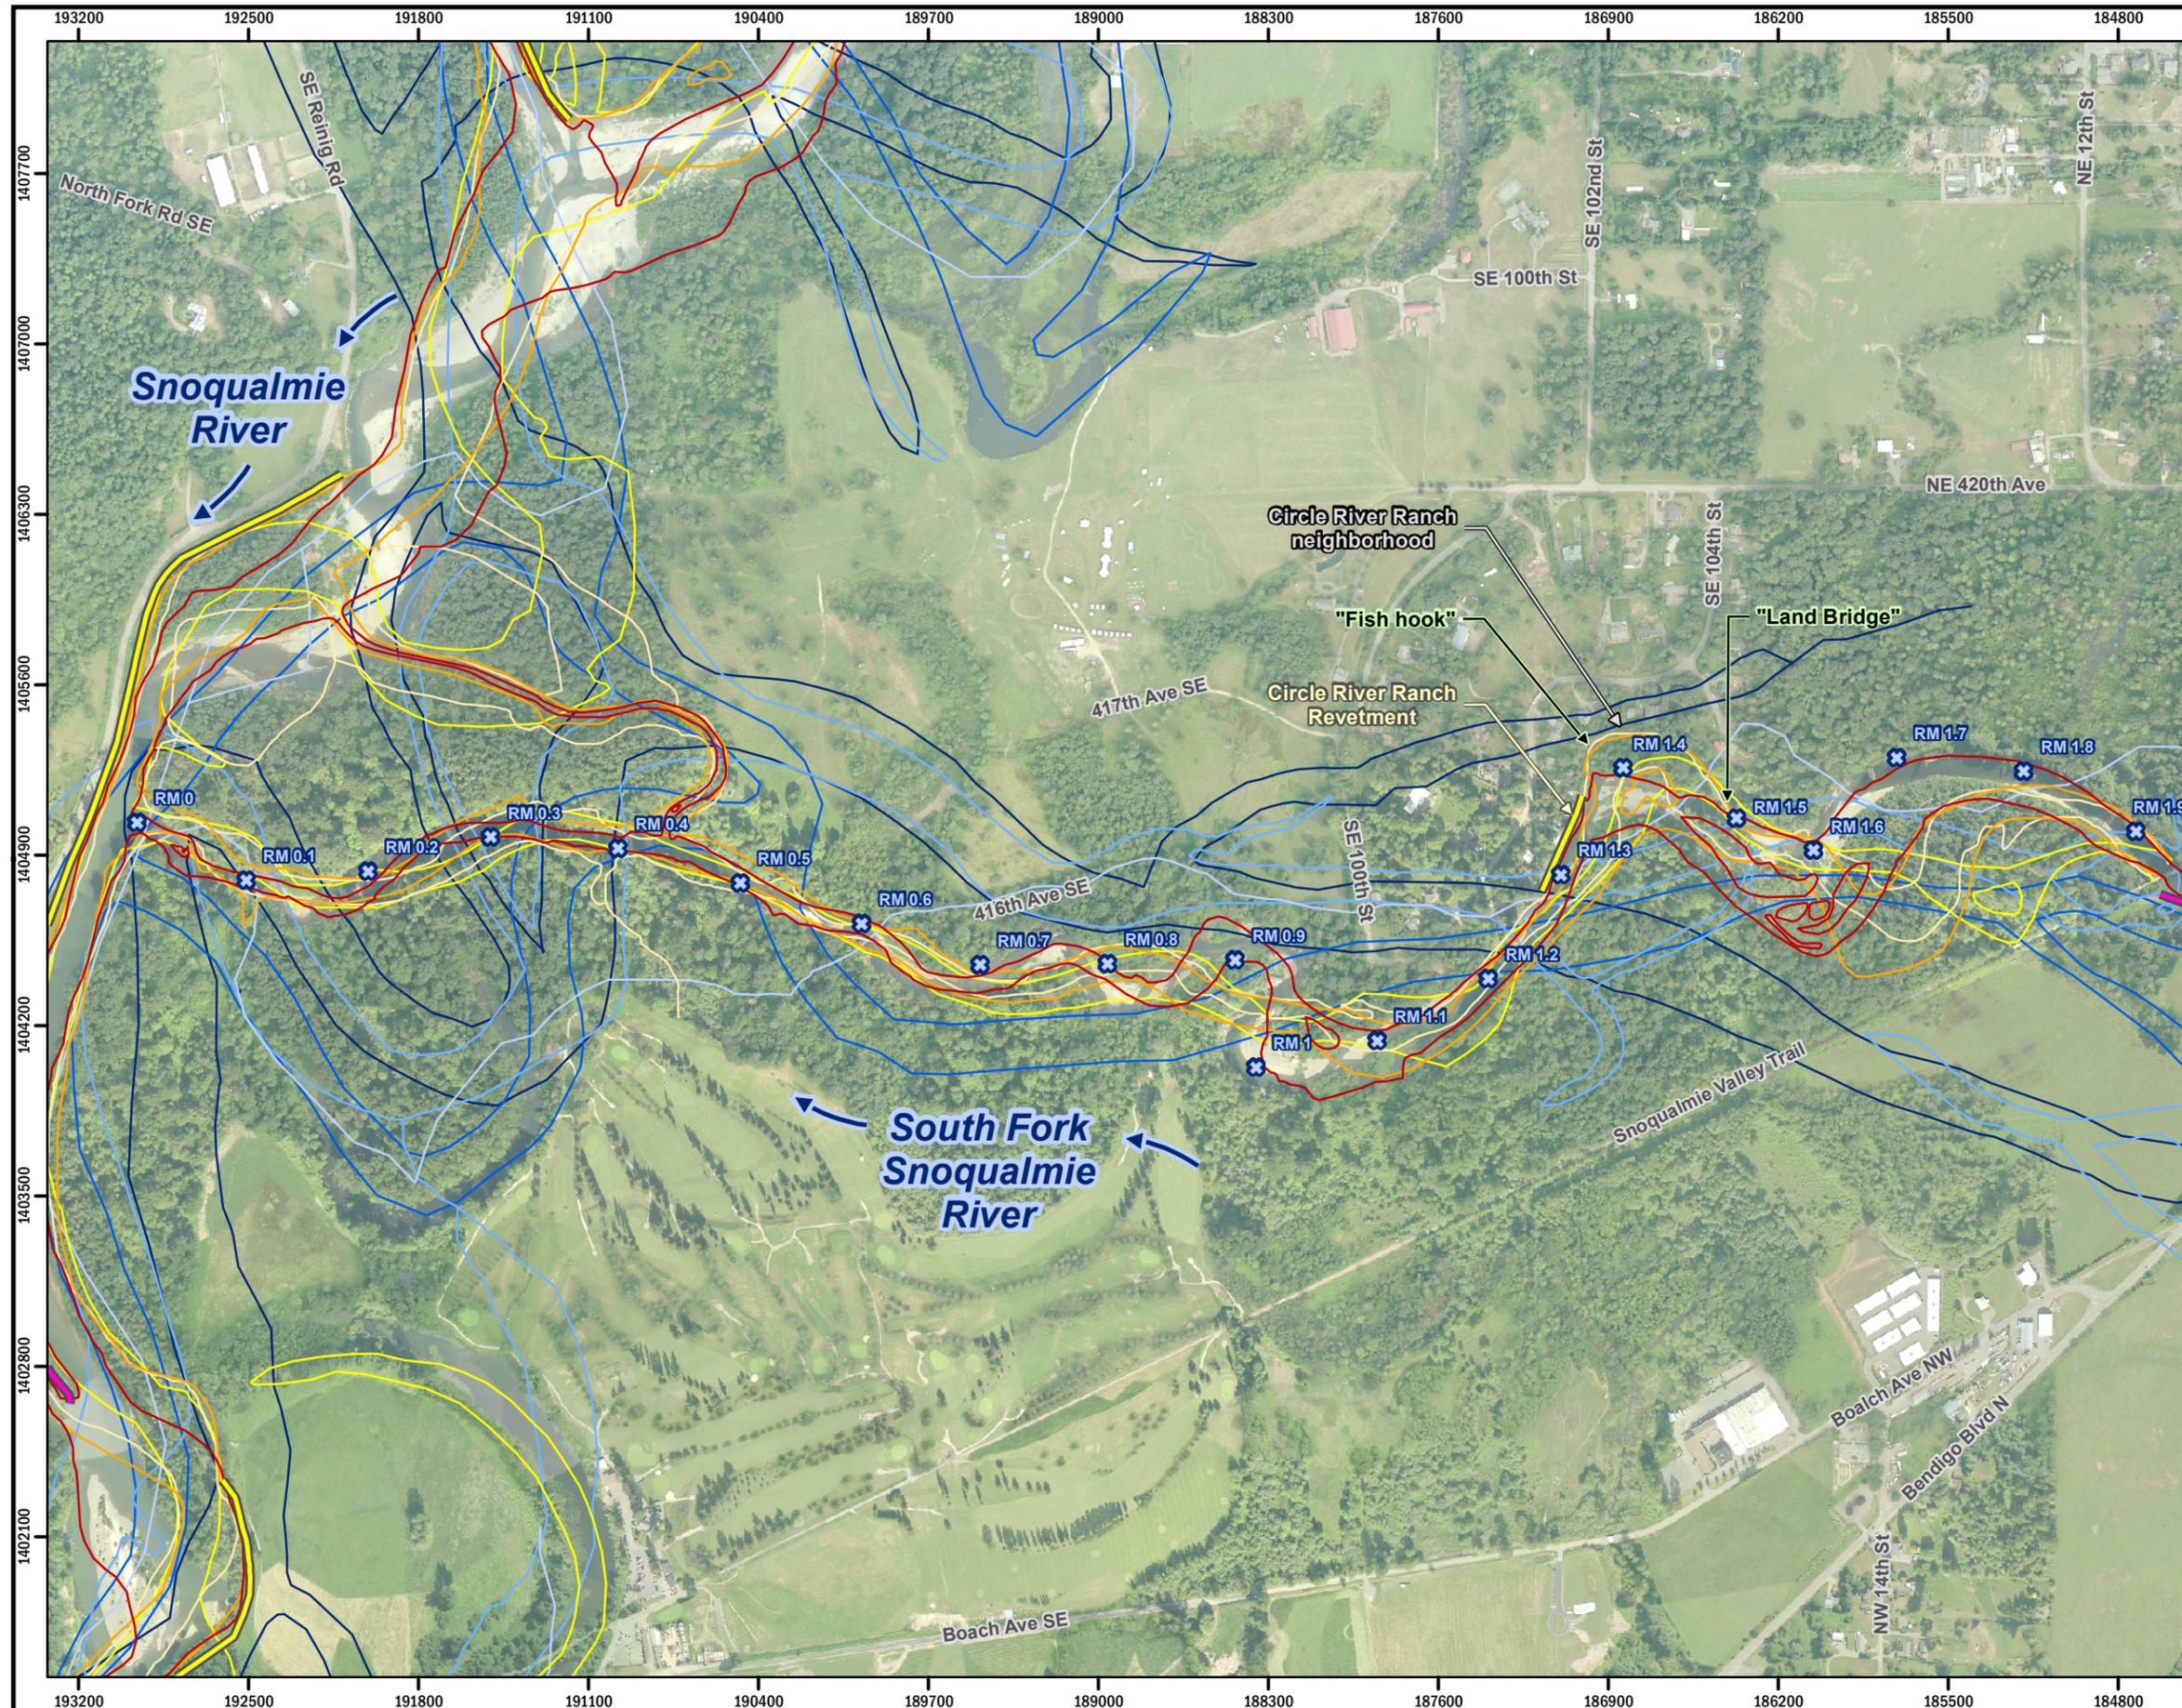
**Figure 2.**  
Project reach overview and historical  
channel locations.

In general, the zones of high and medium geomorphic hazards identified in this study coincide with areas previously delineated as within the severe channel migration hazard area (Attachment B). In addition, the entire project reach and adjacent properties of the Circle River Ranch neighborhood lie within the 100-year floodplain of the South Fork, and much of it is within the floodway; thus, adjacent low-lying, over-bank areas in the floodplain are likely to be inundated by any over-bank flooding (Attachment B). The main channel is likely to avulse into a high or medium geomorphic hazard zone near the Circle River Ranch neighborhood given the presence of both a side channel and historical river channels that the main channel could reoccupy (Figure 2).

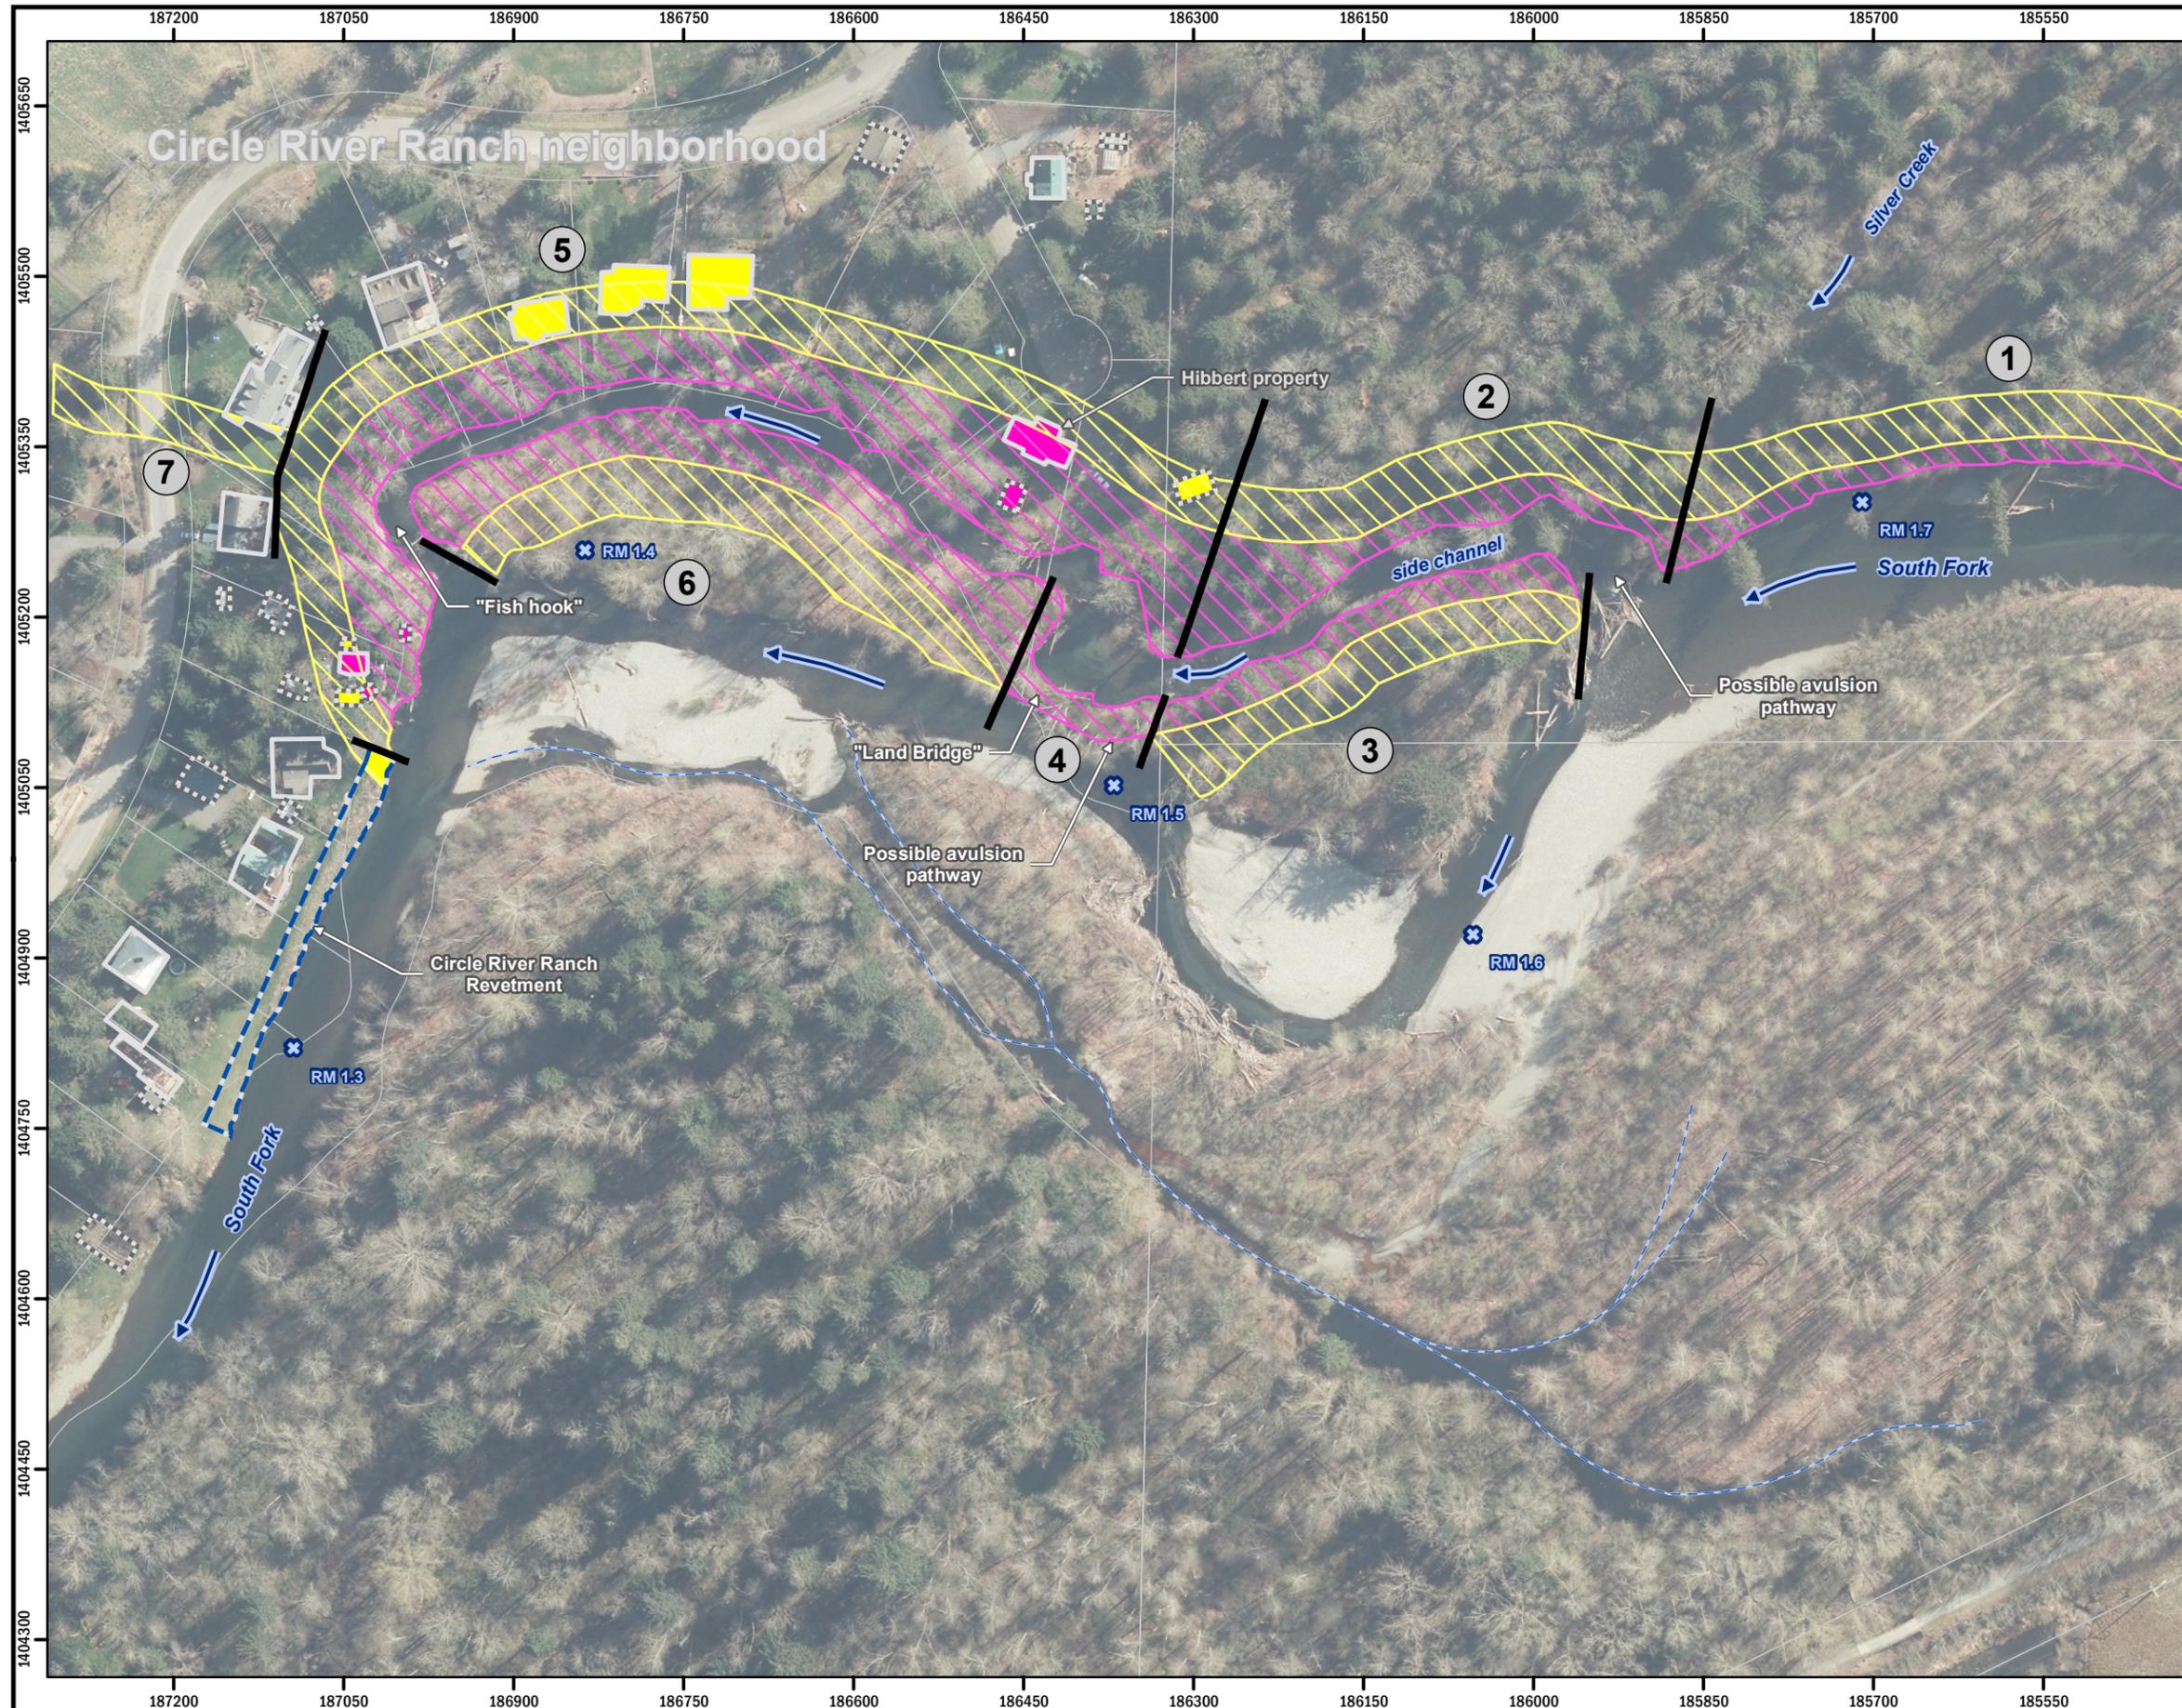
**Figure 3.**  
**Geomorphic Hazard and Risk in the**  
**Circle River Ranch neighborhood**  
**vicinity, South Fork Snoqualmie River.**

The geomorphic hazard and risk zones relative to the Circle River Ranch Revetment and neighborhood are shown in Figure 3 and defined in Table B-1 (Attachment B). Given the recent channel changes observed and documented in the previous sections, an emphasis was placed on geomorphic hazards that could be experienced within the next 15 years. Thus a “high hazard zone” is defined as an area that is likely to be occupied by the main channel in the next 5 years. A “medium hazard zone” is defined as an area likely to be occupied by the main channel South Fork in the next 10 to 15 years.

Risk is defined as the intersection of a hazard zone with a house, outbuilding, or revetment, with the assumption that such impacts represent a threat to public safety. The greatest risks identified included structural damage or property loss along several residential properties due to bank erosion resulting from a channel avulsion or channel migration into the side channel. The geomorphic hazards and risks are subdivided into zones corresponding to RMs and are discussed below.

This zone is susceptible to continued right bank erosion and tree recruitment as the main channel continues to migrate toward the right (east) bank. The estimated high hazard width is 20 feet based on an average annual change of the right bank position of 4 feet per year (*Aerial Photo and Lidar Analysis*, Table 2), over a 5-year period. The medium hazard width of 40 feet is based on the same rate of bank position change, 4 feet per year (Table 2), over a 10-year period.

Zones 2 and 3 represent the right and left banks, respectively, of the upstream portion of the side channel. Both banks are susceptible to continued bank erosion and channel migration, consistent with the average annual rates of change reported in Table 2 for the right bank of the main channel (4 feet per year) and the side channel inlet (5 feet per year). The high hazard widths of 20 feet and 25 feet for Zones 2 and 3, respectively, correspond to these average annual rates of bank position change over a 5-year period.

The medium hazard widths for Zones 2 and 3 (47.5 feet and 42.5 feet, respectively) correspond to a partial avulsion capturing 75 percent of the South Fork flow (see Table B-1). This avulsion could occur at the inlet of the side channel during a small-magnitude (bankfull) or greater flood event, especially if gravel and LWD deposition in the main channel continue to encourage more flow into the side channel. A partial avulsion could cause tens of feet of increased bank erosion along the entire side channel length through this reach. Although there is no infrastructure at risk within Zones 2 and 3, an avulsion through the side channel inlet could cause property damage and loss to all properties along the side channel as discussed below. A full avulsion, not considered in this analysis, could cause the side channel to expand up to 90 feet wide (approximately equivalent to the current bankfull width of the main channel upstream).

The geomorphic hazard widths in Zone 5 correspond to substantial risks in the Circle River Ranch neighborhood. The high hazard width for Zone 5 intercepts the house and an outbuilding on the Hibbert property as well as an outbuilding at house number 10119. The medium hazard width for Zone 5 intercepts another outbuilding near the Hibbert property as well as three more houses (house numbers 10235, 10227, and 10219), another outbuilding at house number 10119, and the upstream portion of the Circle River Ranch Revetment near house number 10113. Zone 5 also risks loss of the ad-hoc riprap placed upstream of the Circle River Ranch Revetment. There is also a risk that the main channel flow will continue to migrate and flank the revetment (i.e., begin eroding the back side of the revetment) if the river migrates to the north through the upstream residential properties (see Figure 3). The log jutting out from the right bank here may act like a weir, initially causing bank erosion along the unprotected bank and toe as the channel widens in this area.

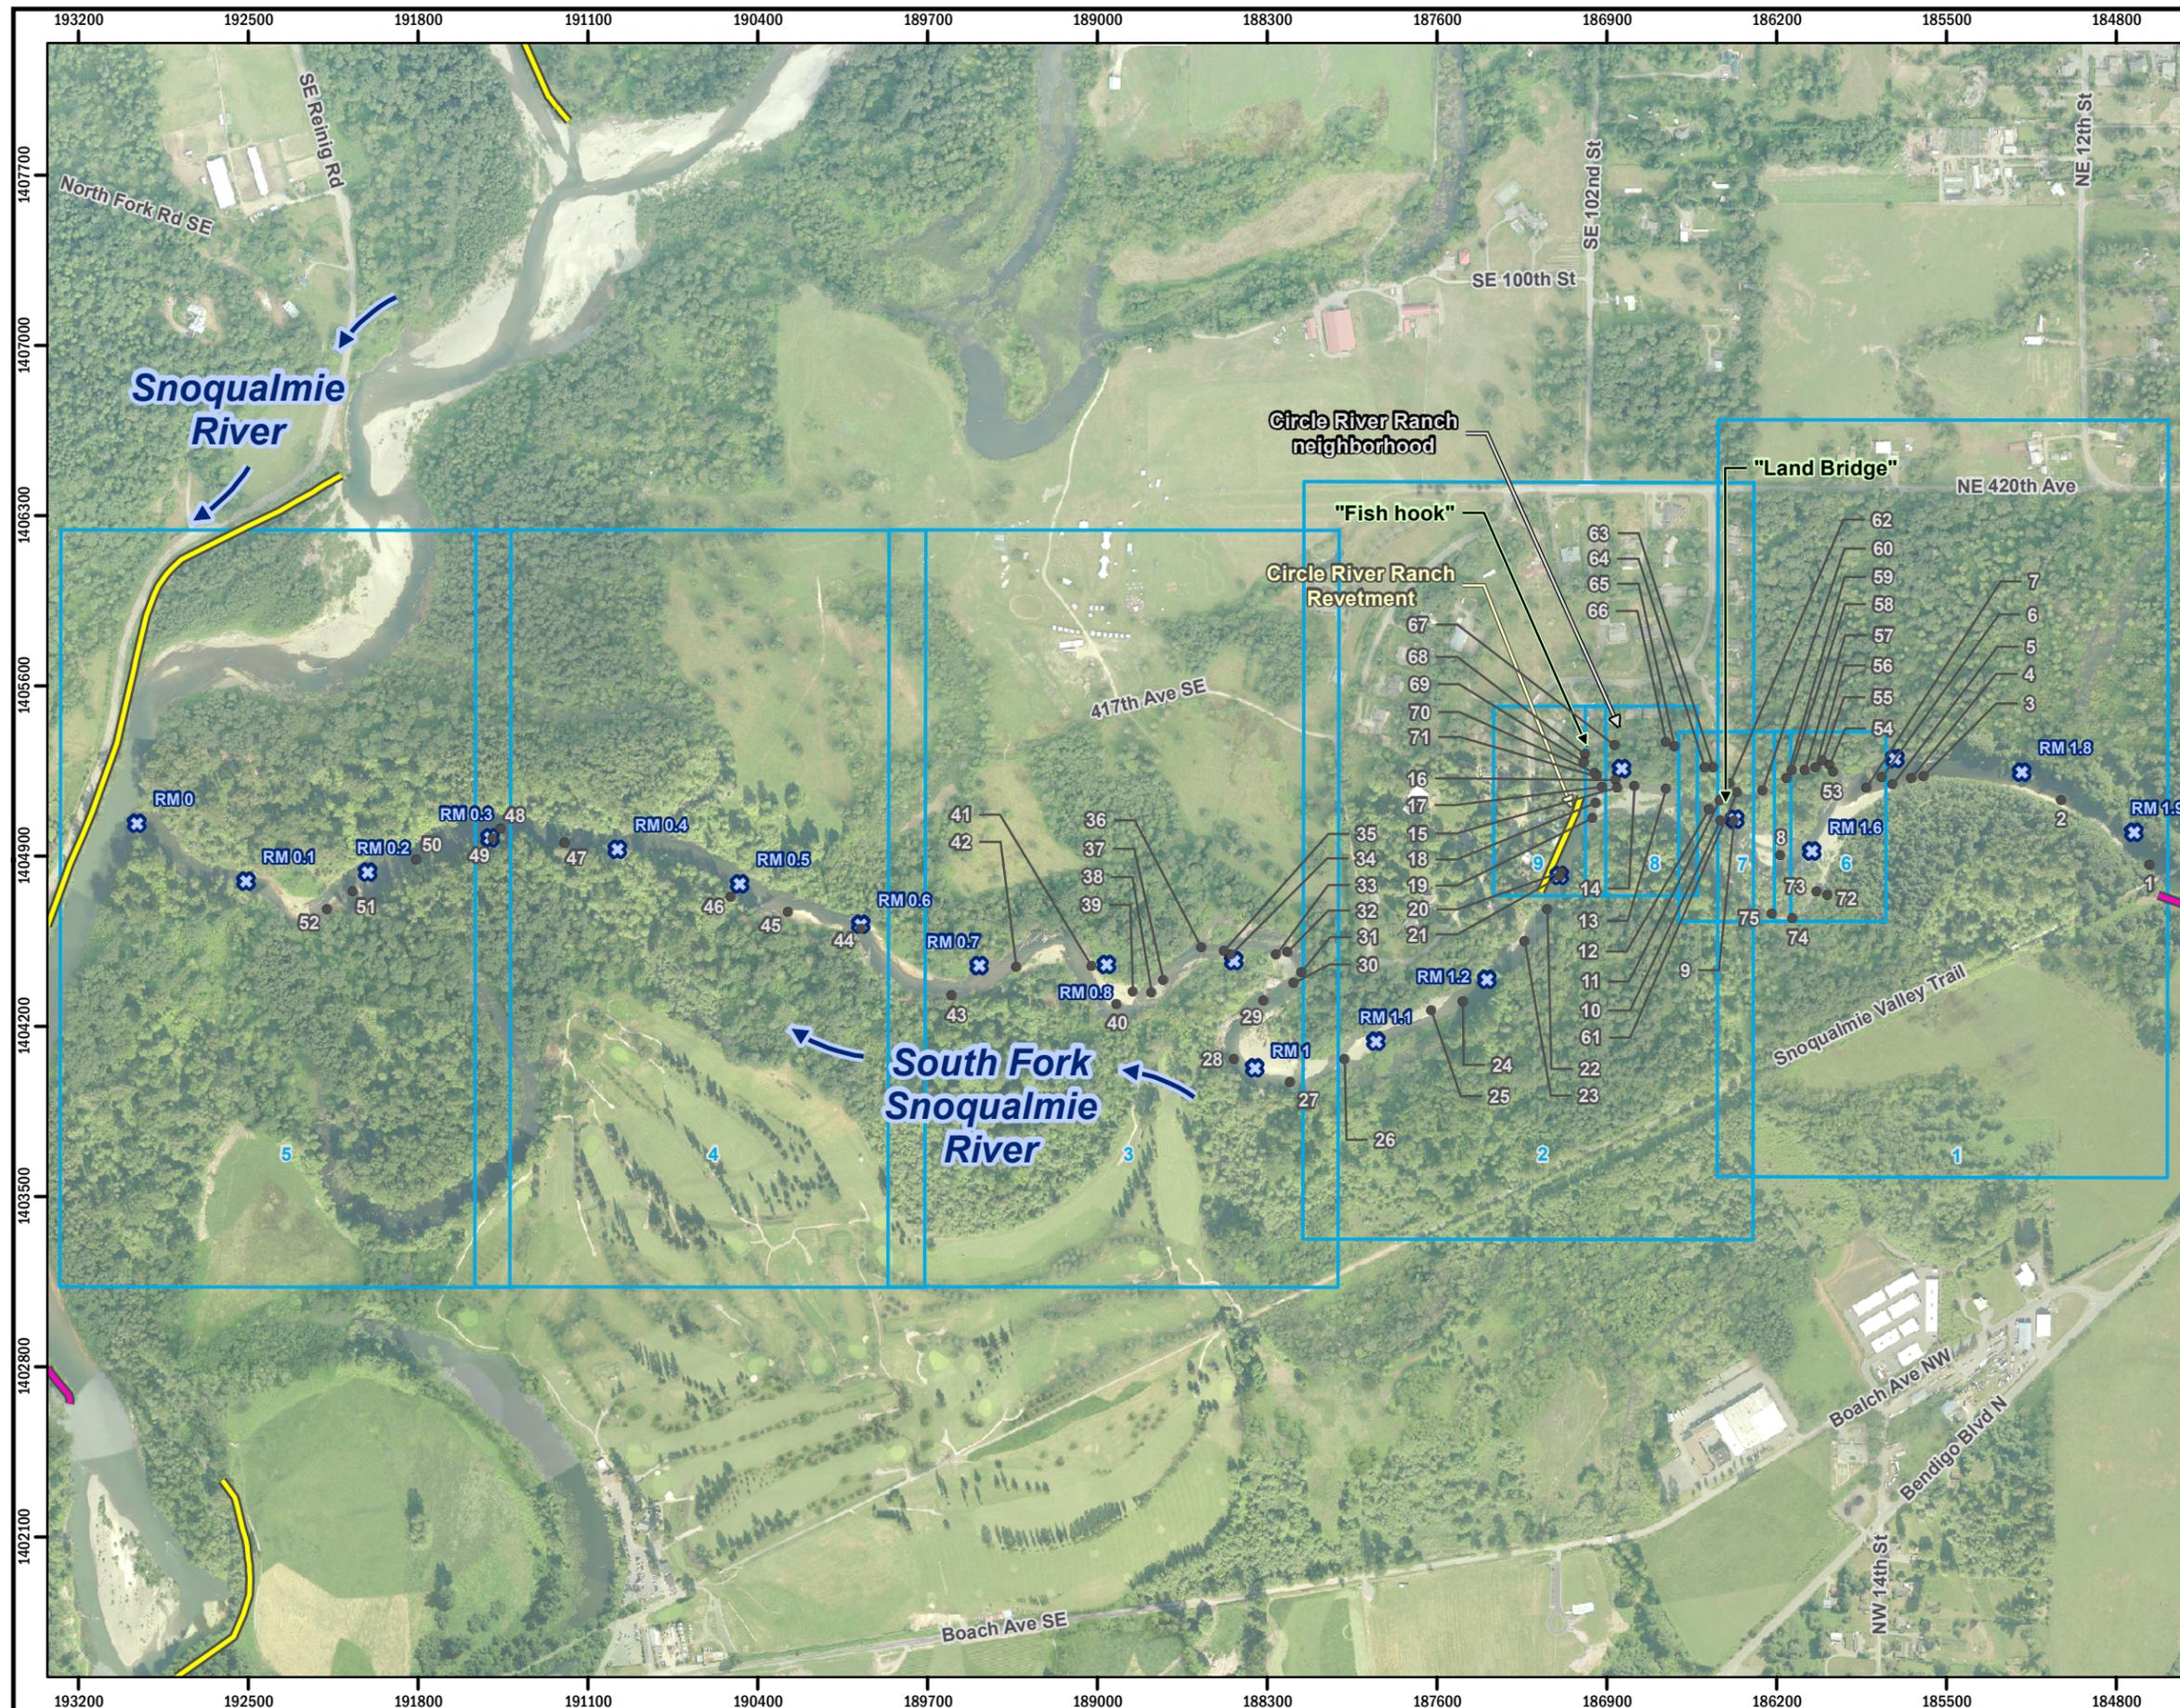
Figure A-1.  
Field map overview and photo point locations.

Findings from the field reconnaissance on August 16 and 17, 2011, are presented in relation to RMs from the upstream limit of the surveyed project reach (RM 1.9) to the downstream limit (RM 0.2) along the South Fork. General sub-reach geomorphologic characteristics are presented according to the Montgomery and Buffington (1997) classification system. Observed changes were noted in channel and bar positions relative to the 2009 aerial imagery (King County 2009), the 2010 lidar (King County 2010), and the channel alignments mapped by Perkins (1996). Field notes and photo point locations are included in Attachment A. Photographs are provided on an attached compact disc.

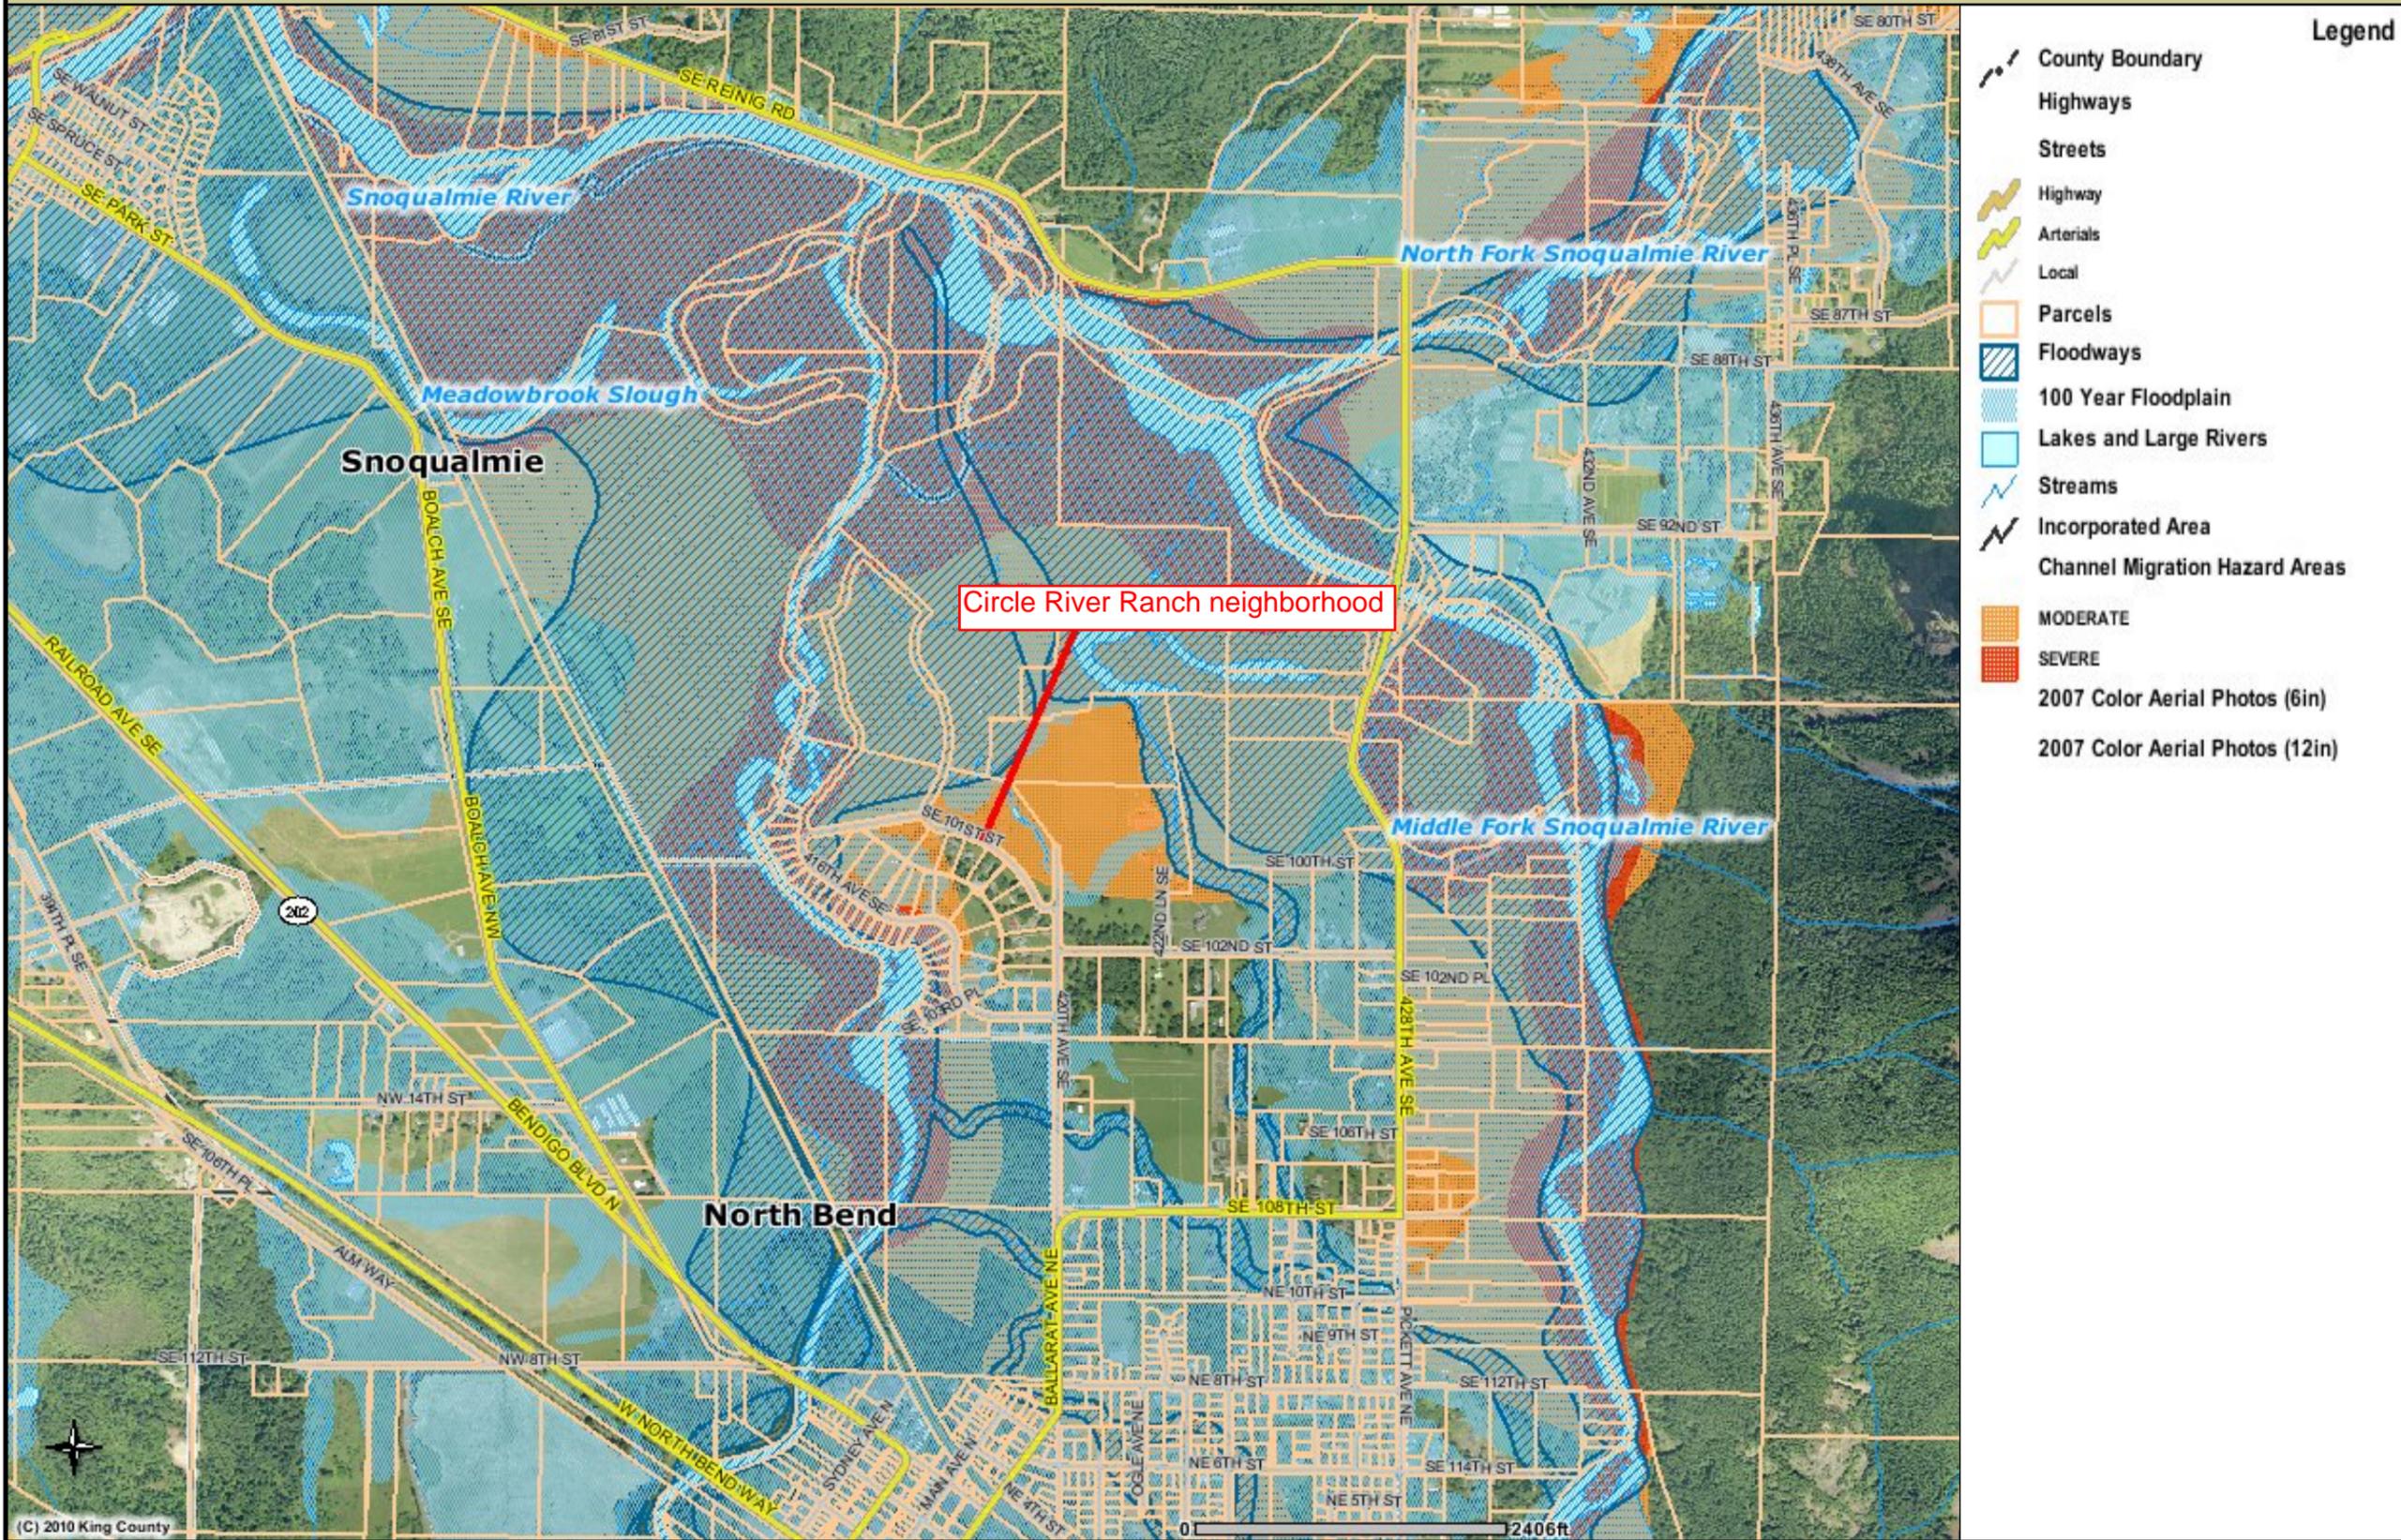
# Figure B-1. Mapped SFS Floodplain and Channel Migration Hazard Areas.

Figure B-1 illustrate the 100-year floodplain, floodway, and the channel migration hazard areas in the project reach. Figure B-2 shows the channel migration hazard areas and the construction dates of houses within the Circle River Ranch neighborhood. Several homes were built within moderate and severe channel migration hazard areas following adoption of these hazard areas by King County in 1999 (King County 1999, 2006).

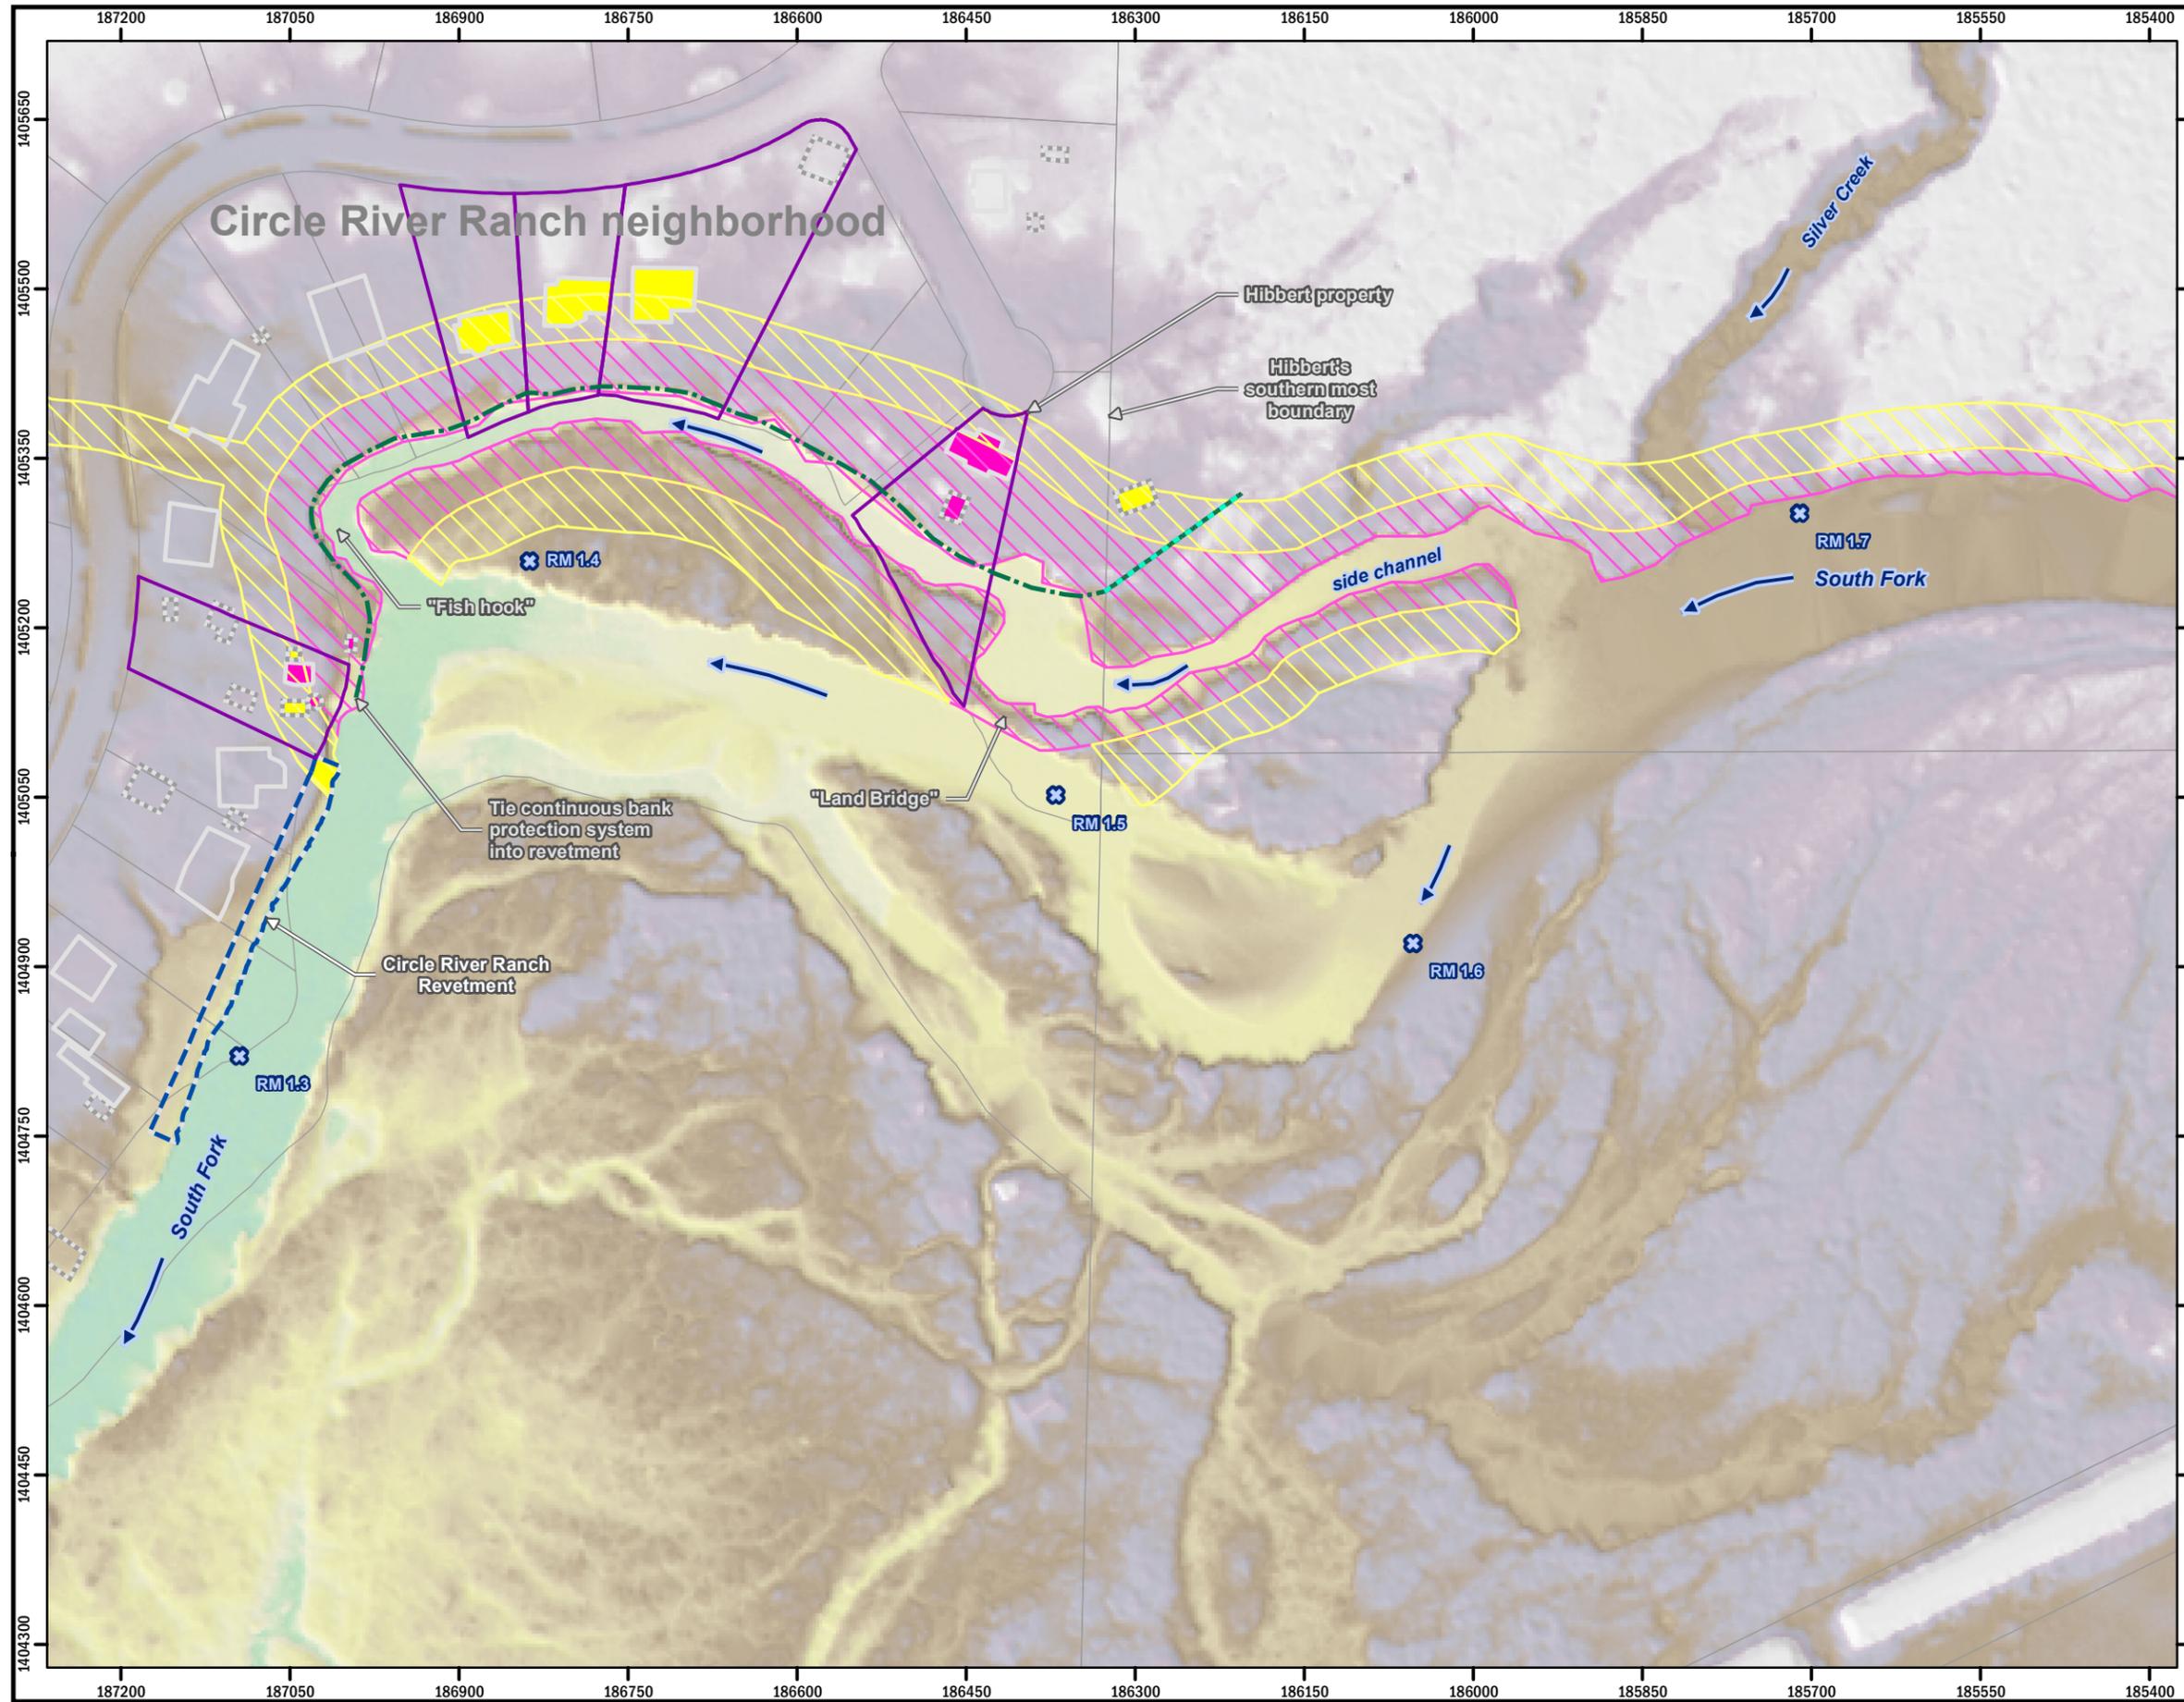
**Figure E-1.**  
**Alternatives 1 and 2 for addressing risks to the Circle River Ranch neighborhood, South Fork Snoqualmie River.**

Alternative 1 includes the acquisition of five properties with residential structures in the South Fork floodplain and along the side channel that are located within either the high and/or medium geomorphic hazard zones (Figure E-1, Attachment E). This alternative would include the removal of all infrastructure from the properties including houses, outbuildings, fences, paving, and utilities. Following demolition of the existing infrastructure, the site and river bank would be planted with native vegetation to re-establish riparian zone conditions.

The geomorphic response to Alternative 1 would be the same as under existing conditions. Removal of the residential infrastructure and planting with native vegetation would have a negligible effect on the avulsion and bank erosion hazards over the next 10 to 15 years.

Alternative 1 would eliminate the risk to the acquired properties by removing the infrastructure and restoring the land to a natural area. However, the existing erosion hazard along all properties adjacent to the side channel would not change because no additional measures would be taken to reduce the likelihood of bank erosion. The results of the geomorphic hazard assessment, which evaluated risks over a 15-year period, indicate that channel migration after this time frame could place three to four additional homes in the vicinity of the “fish hook” at risk.

The hydraulic roughness provided by a log cribwall or well-vegetated soil lifts would reduce water velocities along the right bank relative to the existing bank conditions. If additional flow is introduced to the side channel (either from increased flow at the side channel inlet or from an avulsion at the “land bridge”), widening of the side channel by means of bank erosion would occur on the opposite (left) bank of the side channel. Trees recruited from the left bank of the side channel could form a logjam and divert flow either into the cribwall or vegetated soil lifts (possibly resulting in needed repairs to damaged sections) or toward the left bank, away from the cribwall or soil lifts.

Alternative	Description
1	Acquire five properties situated along the side channel, each with buildings located within either high or medium hazard zones; remove all infrastructure on those properties and restore the land to riparian zone conditions.
2	Install a continuous bioengineered bank protection system along the right bank of the downstream half of the side channel.
3	Install large logs to roughen the side channel inlet and protect the Silver Creek overflow channel outlet, install multiple bank deflector and apex (mid-channel) type engineered logjams (ELJs) in the South Fork main channel immediately upstream and downstream of the inlet, and excavate a new channel through the floodplain at RM 1.55 to convey flow from the main channel to the left bank side channel.
4	Install multiple bank deflector and apex ELJs in the South Fork main channel between the Snoqualmie Valley Trail bridge at RM 1.95 and RM 1.7 and construct four new channels between RM 1.9 and RM 1.6 to convey flow from the main channel across the left bank floodplain and into existing relic side channels.

Alternative 2 includes installation of a bioengineered bank protection system along approximately 1,150 linear feet of the right bank of the downstream half of the side channel (Figure E-1, Attachment E). Two types of systems were considered in this evaluation to provide a range of probable construction costs and effectiveness in reducing hazards and risks: 1) a log cribwall structure and 2) reconstruction of the right bank using reinforced soil lifts.
