# GEOMORPHIC HAZARDS AND RISKS ASSESSMENT AND ALTERNATIVES ANALYSIS

SOUTH FORK SNOQUALMIE RIVER  
CIRCLE RIVER RANCH NEIGHBORHOOD

Prepared for  
King County  
Water and Land Resources Division  
River and Floodplain Management Section

July 31, 2012

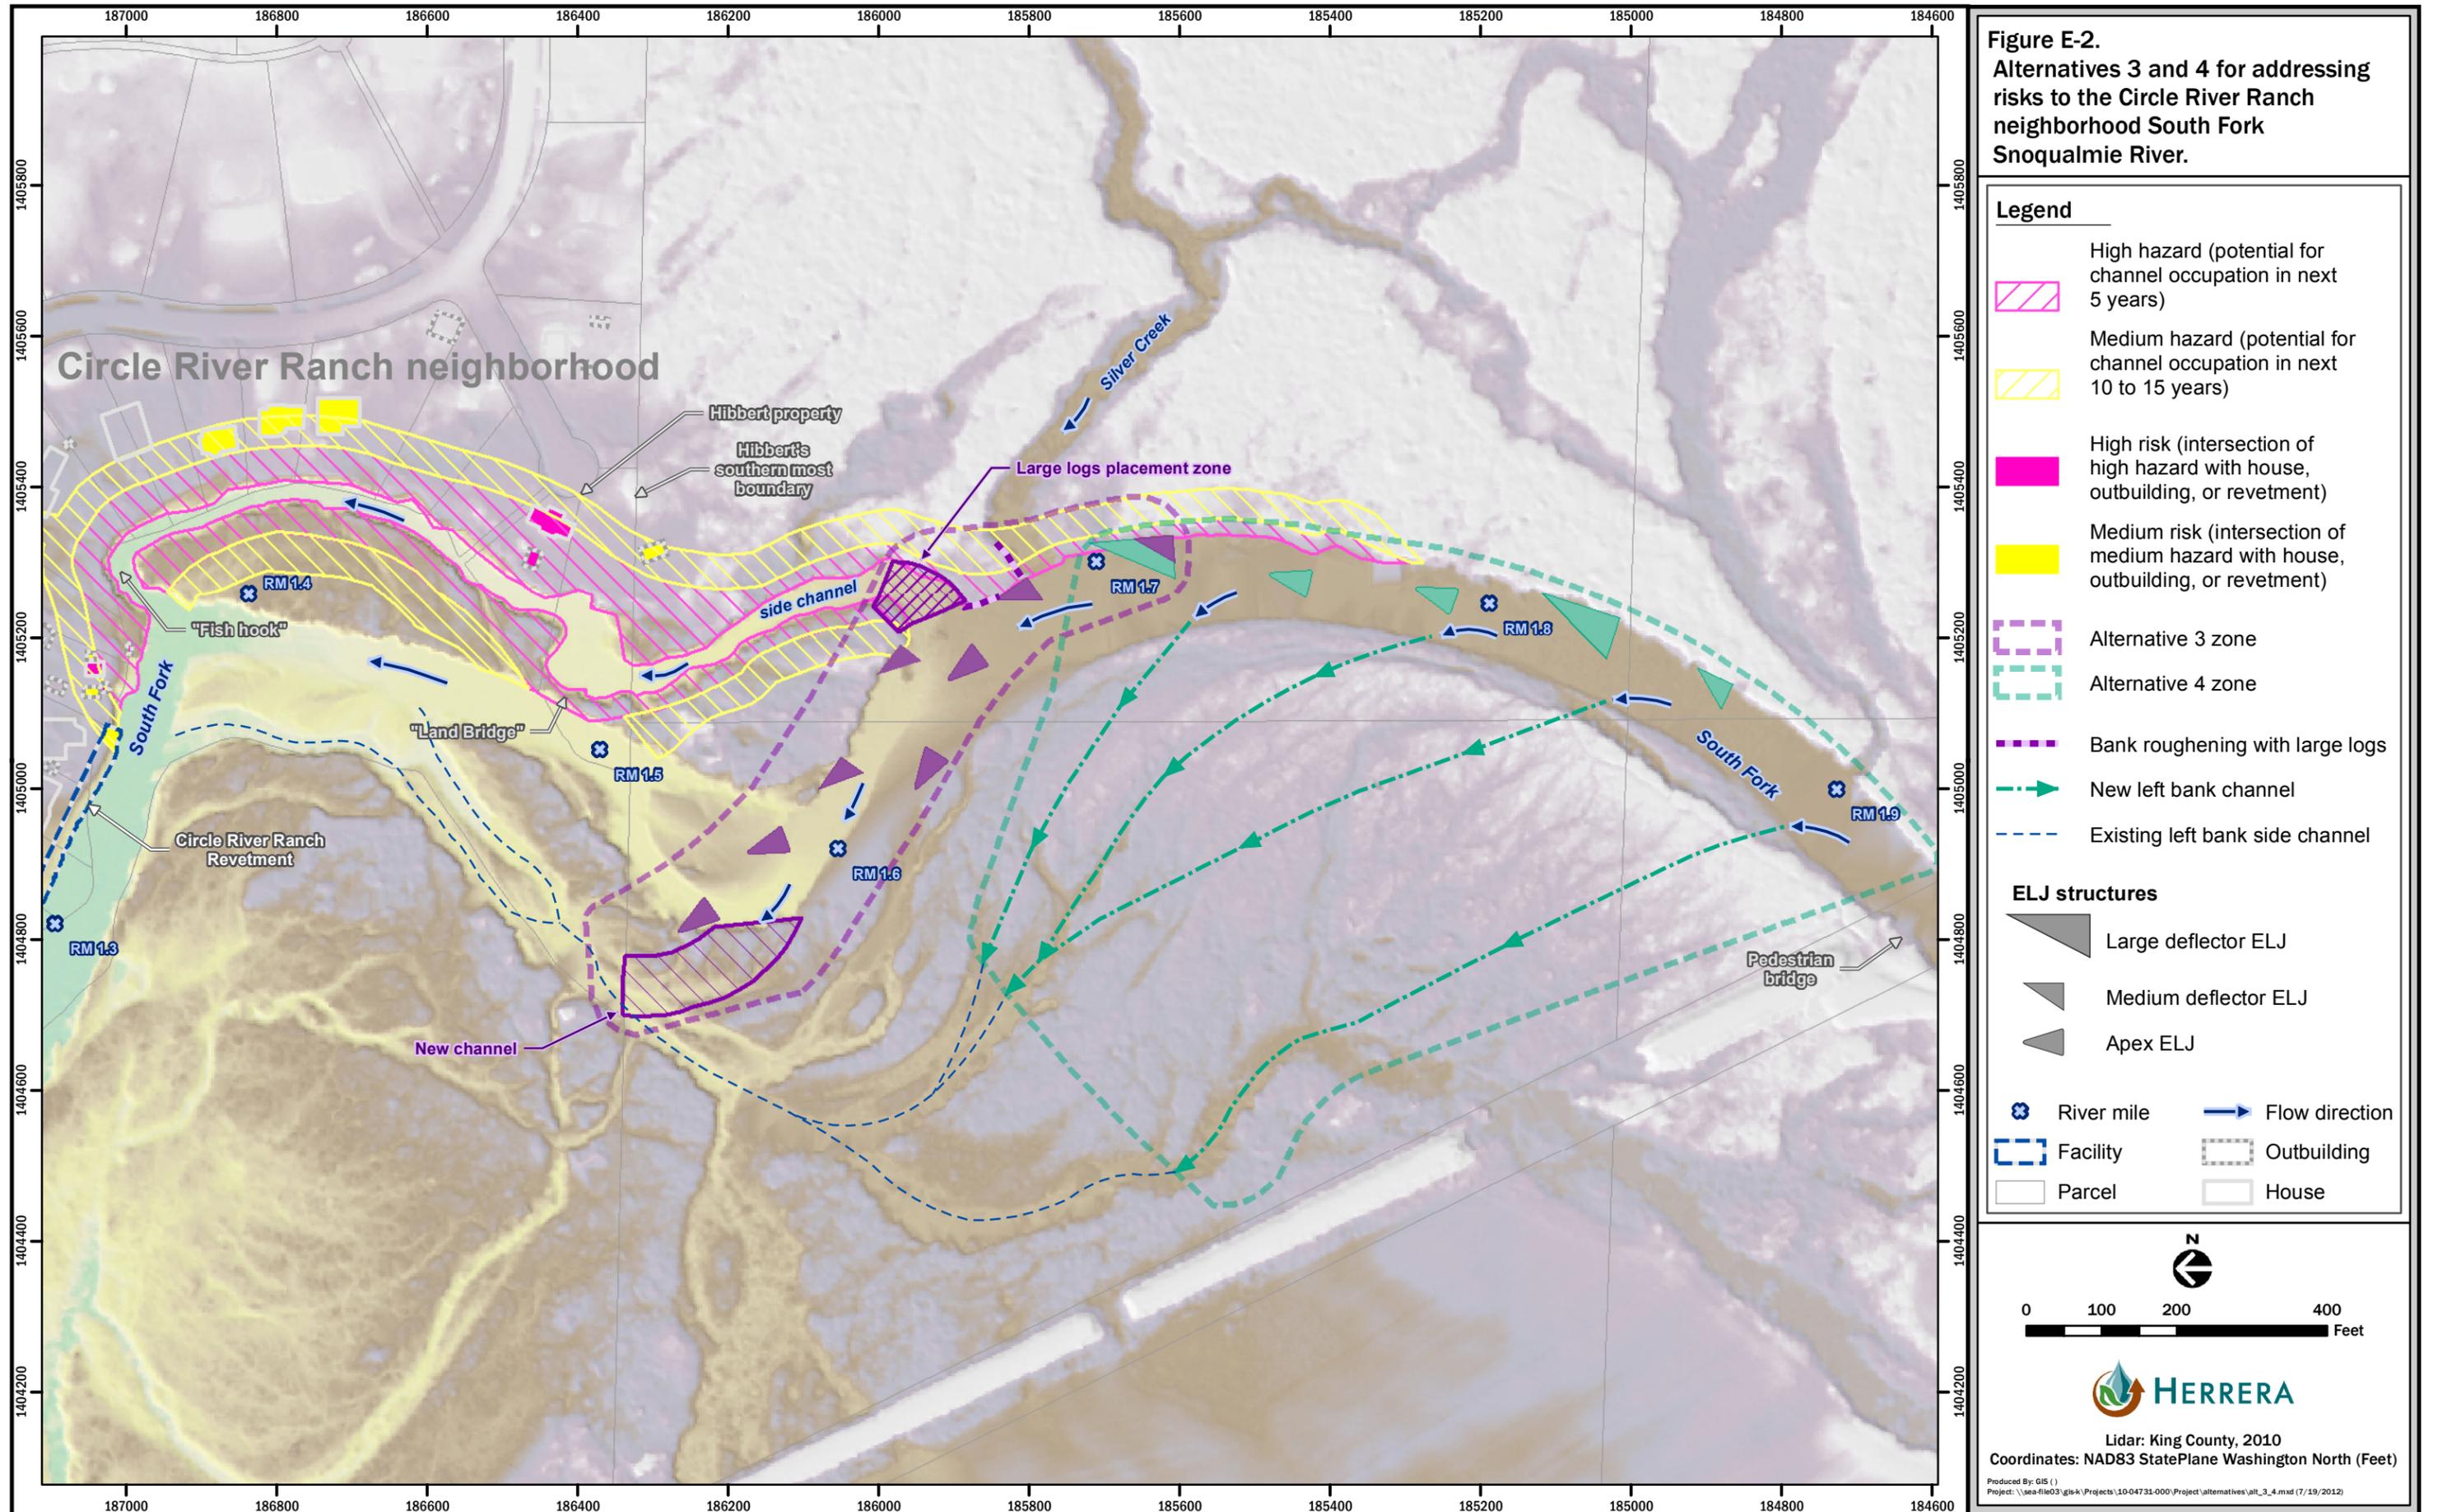
**Figure E-2.**  
**Alternatives 3 and 4 for addressing risks to the Circle River Ranch neighborhood South Fork Snoqualmie River.**

The upstream bank ELJs would cause the main channel to widen on the left bank and deposit sediment in the wake of the ELJs on the right bank. The new left bank side channels would enlarge and deepen during overbank flooding, thereby conveying increasingly more flow away from the main channel. The inlets to these new side channels may fill with sediment and become disconnected from the main channel during low flows. The combination of the added hydraulic roughness from the proposed ELJs and the loss of sediment transport capacity as flow is lost to the new side channels would promote sediment deposition in the main channel upstream of the (right bank) side channel inlet. This would increase the likelihood of an avulsion into the relic channels to the west, away from the Circle River Ranch neighborhood. Downstream of RM 1.8, sediment would be expected to fill the channel between the two apex

Sediment deposition induced by Alternative 4 upstream of the side channel inlet would temporarily reduce future aggradation at the gravel bar in the main channel that is currently responsible for deflecting flow into the side channel. Alternative 4 would be effective at reducing the erosion and avulsion hazards in the short-term, but it would become less effective as the sediment storage capacity of the Alternative 4 area (main channel upstream of the side channel inlet) is reached and sediment conveyance to the side channel area is restored. An avulsion to the west into relic channels would be highly effective at reducing short-term avulsion and erosion hazards in the Circle River Ranch neighborhood.
