**2013 Post Construction Monitoring Report
King County Multiple Stormwater Facility Retrofits**

**DOE Stormwater Retrofit Grant
Grant Agreement Number G1100216**

November 14, 2013

King County

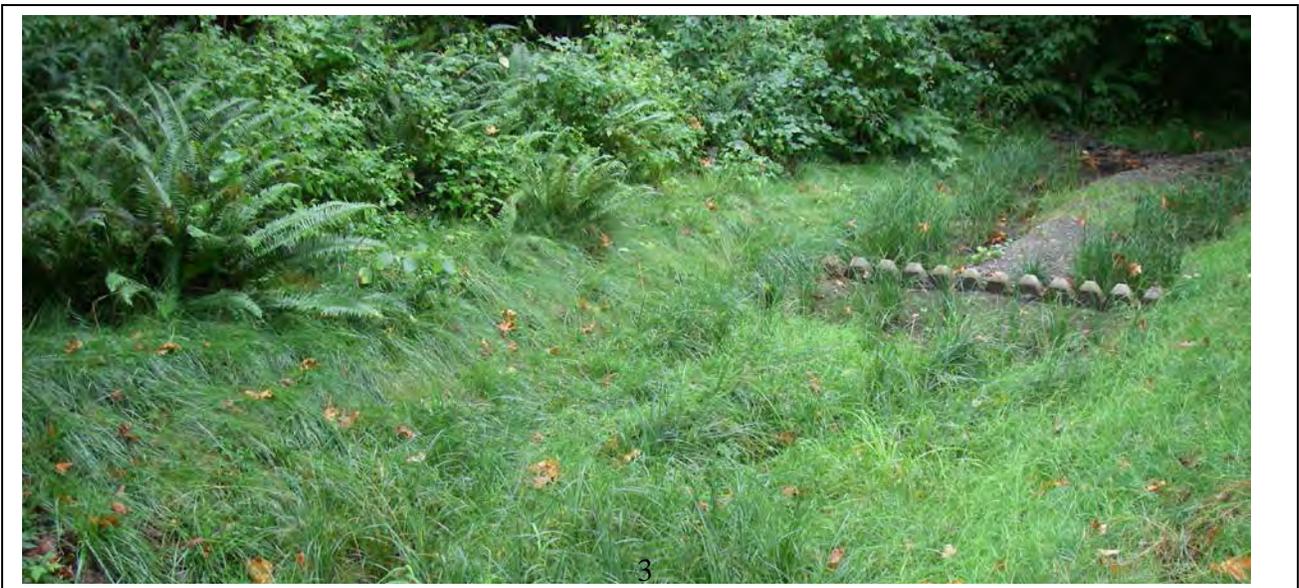
Shadow Ridge D91750 Upper Cell

The Shadow Ridge D91750 bioswale was planted with a total of 1028 emergent plugs including 5 different species. Plant survival is variable throughout the swale. In the first cell closest to the inlet, survival and cover is close to 100%. All species survived in this cell. The second cell splits into two flow paths. Here survival and cover is closer to 40%. Definitely not as high as the first cell. Here the slough sedge and small fruited bulrush did well but not the manna grass. This swale is very shady and there was a thick covering of Big Leaf Maple leaves for most of the winter and spring growing season. Both of these factors may have contributed to the low survivorship. Recommend planting approximately 200 additional emergent plugs to fill the gaps in the vegetation or it just may fill in on its own over time. No rivulets or avulsions have formed in the substrate. Both inlet and outlet are clear.

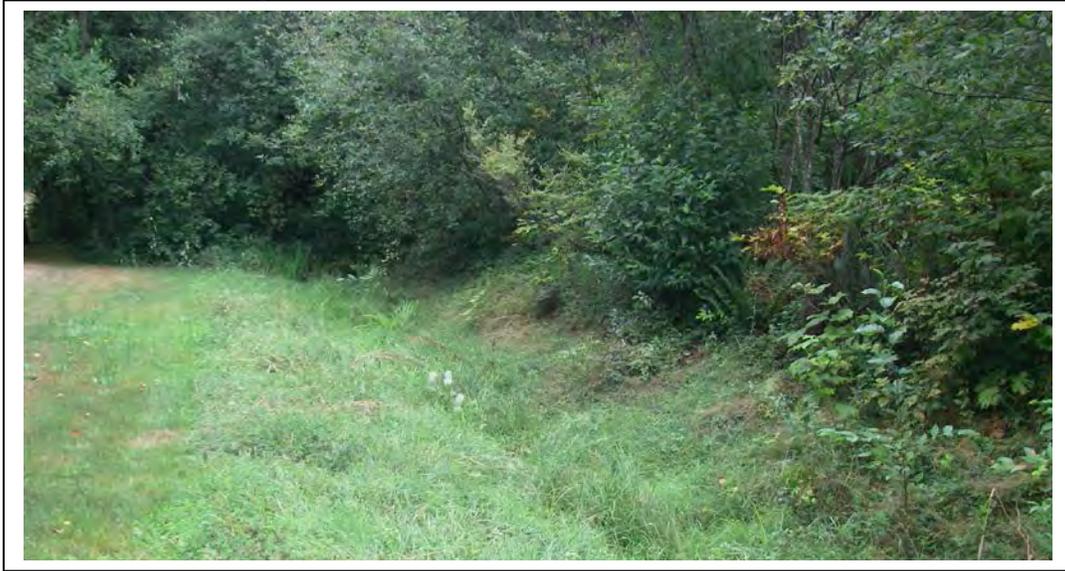
The Kirkland Short Plat D92308 bioswale was planted with a total of 700 emergent plugs including 6 different species. Project location is moderately sunny. Plant survival is close to 100% and cover is very good throughout the swale. No supplemental planting is needed. Swale appears to be functioning as designed. Both inlet and outlet are clear. There are some cattails in the swale, as well as some alder saplings and blackberry that could be removed with routine maintenance.

Kirkland Short Plat looking towards inlet

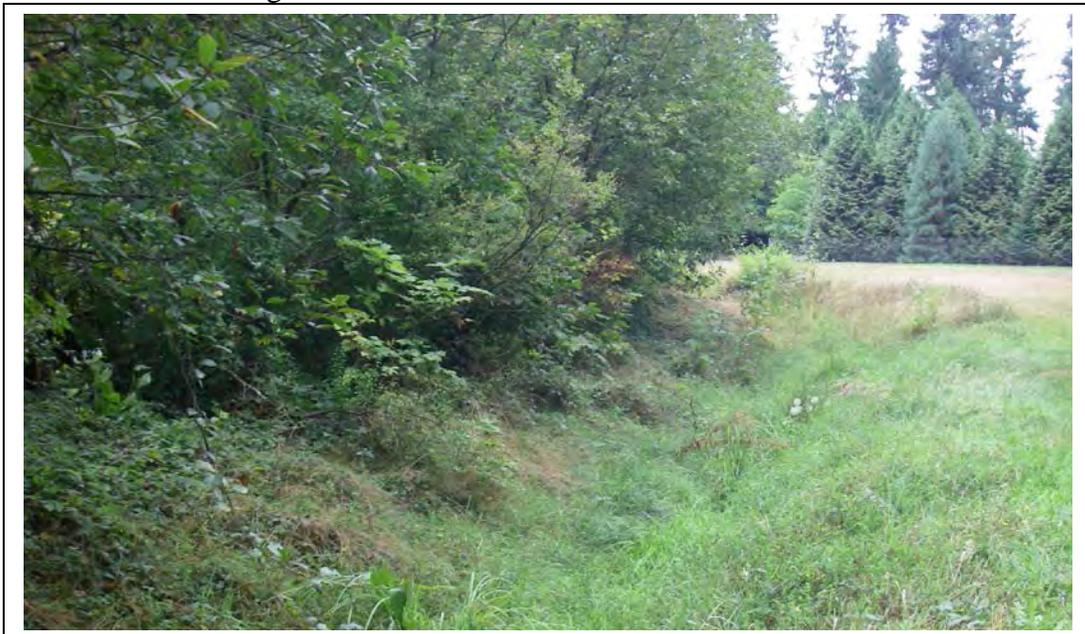
Kirkland Short Plat looking towards outlet

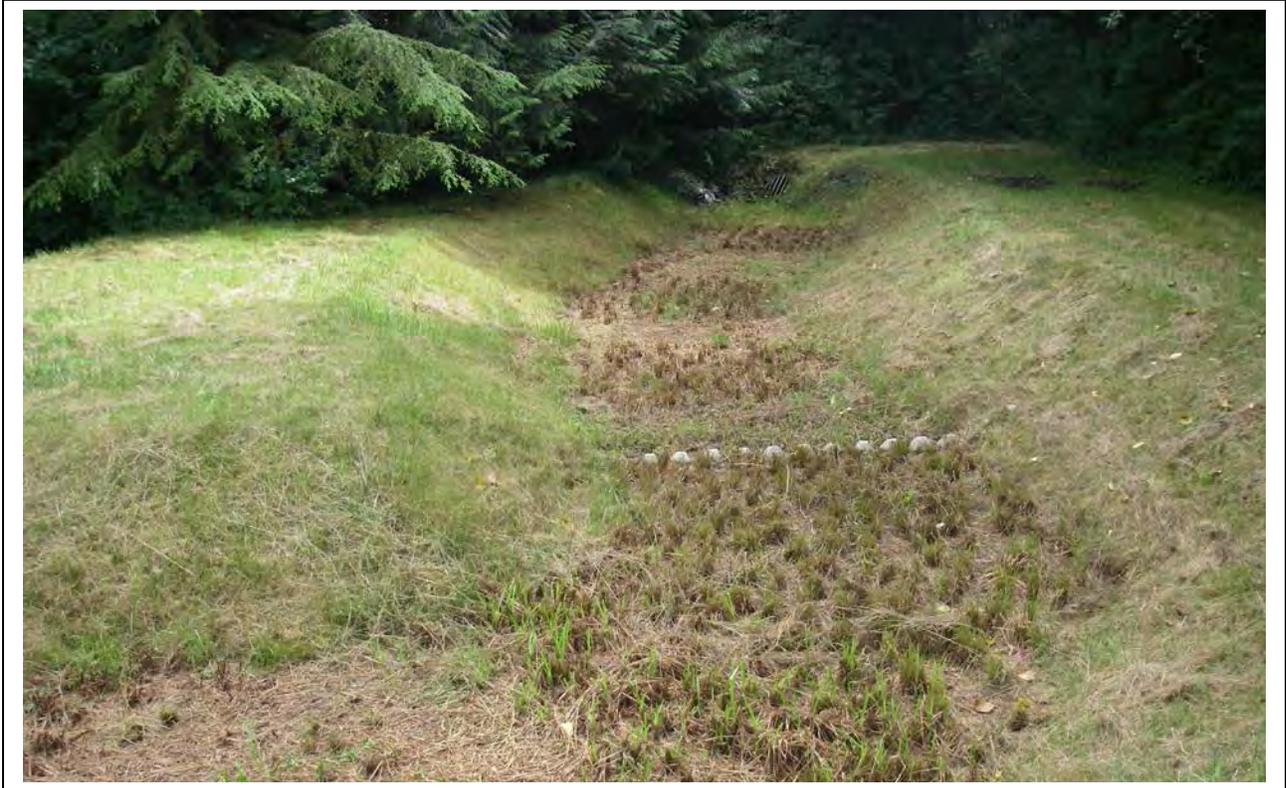
The Aspenwood Tract H D91708 bioswale was planted with a total of 1500 emergent plugs including 10 different species. This swale is very sunny. The swale and surrounding area have been recently mowed and maintained. Plant survival and cover is over 85%. No supplemental planting is needed. No rivulets or avulsions have formed in the substrate. The swale appears to be functioning as designed. Both inlet and outlet are clear.

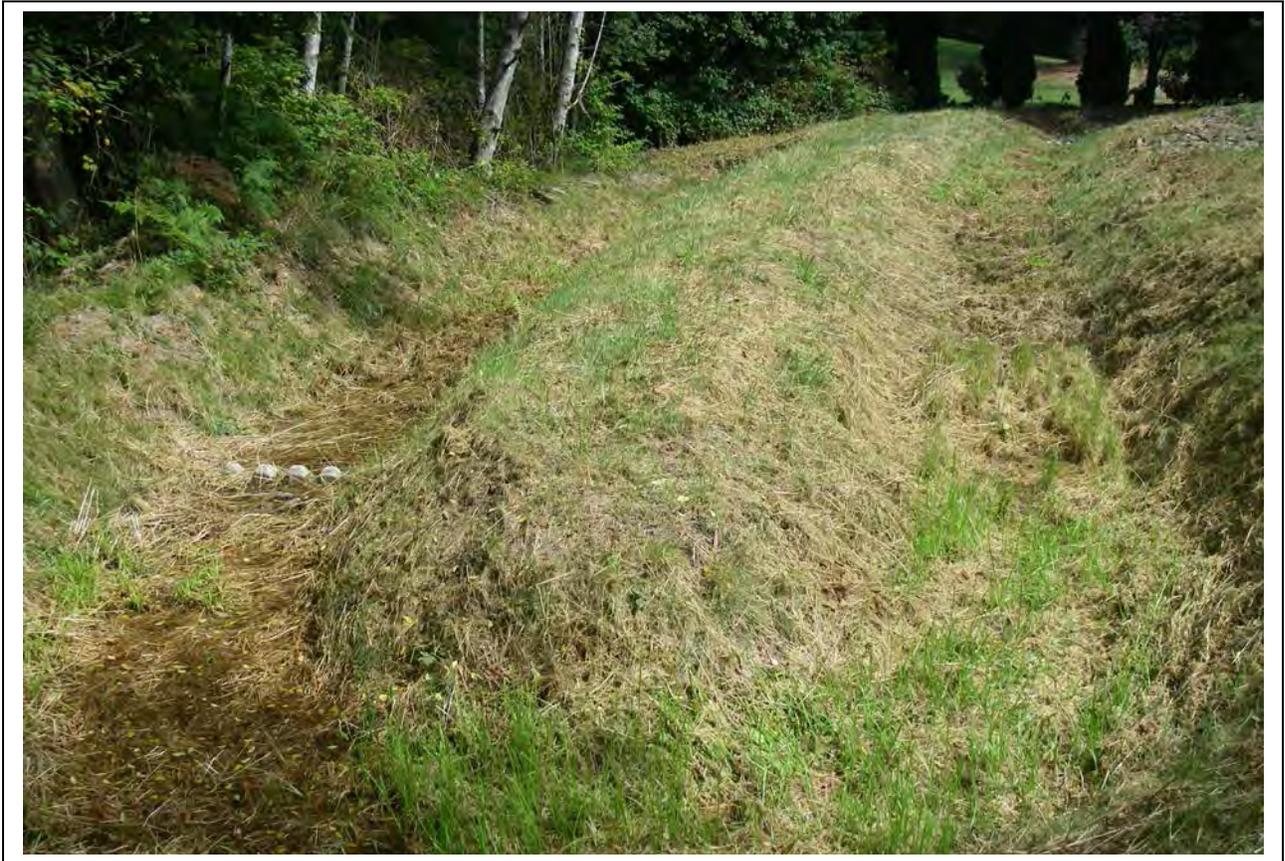
The Aspenwood Tract I D91705 bioswale was planted with a total of 2000 emergent plugs including 8 different species. This swale is very sunny. The swale and surrounding area have been recently mowed and maintained. Plant survival and cover is over 75%. No supplemental planting is needed. No rivulets or avulsions have formed in the substrate. Water is ponded or very low flow in the swale. The swale appears to be functioning as designed. Both inlet and outlet are clear.

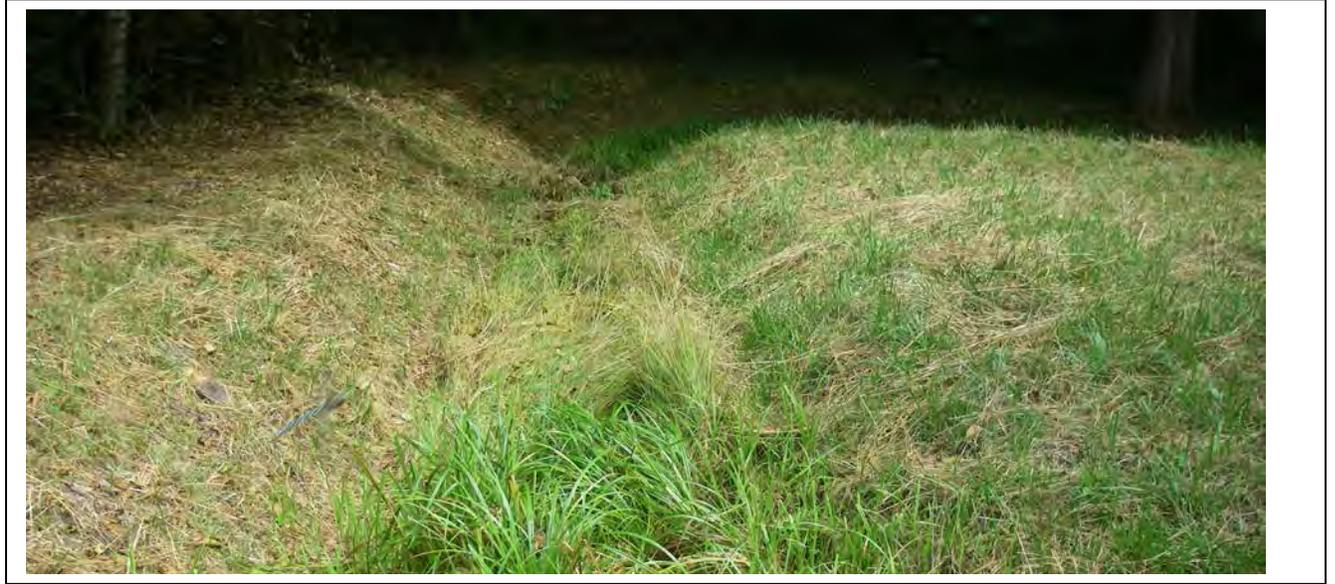
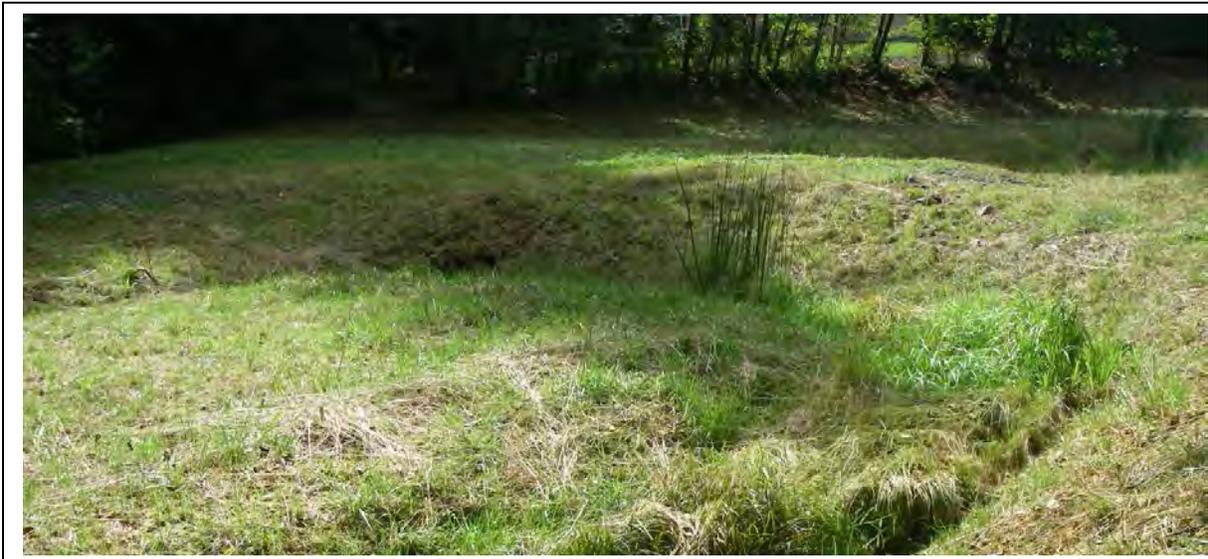
The Aspenwood Tract J D91706 bioswale was planted with a total of 1050 emergent plugs including 9 different species. The surrounding area has been recently mowed and maintained but swale itself was not mowed. Plant survival and cover is over 75%. No supplemental planting is needed. Some Arrowroot and exotic grasses have mixed in with the native plants. No rivulets or avulsions have formed in the substrate. Open water is ponded in two locations near the inlet and one near the flow spreader. Swale appears to be functioning as designed. Both inlet and outlet are clear. Purple loosestrife is present in the pond above the swale.

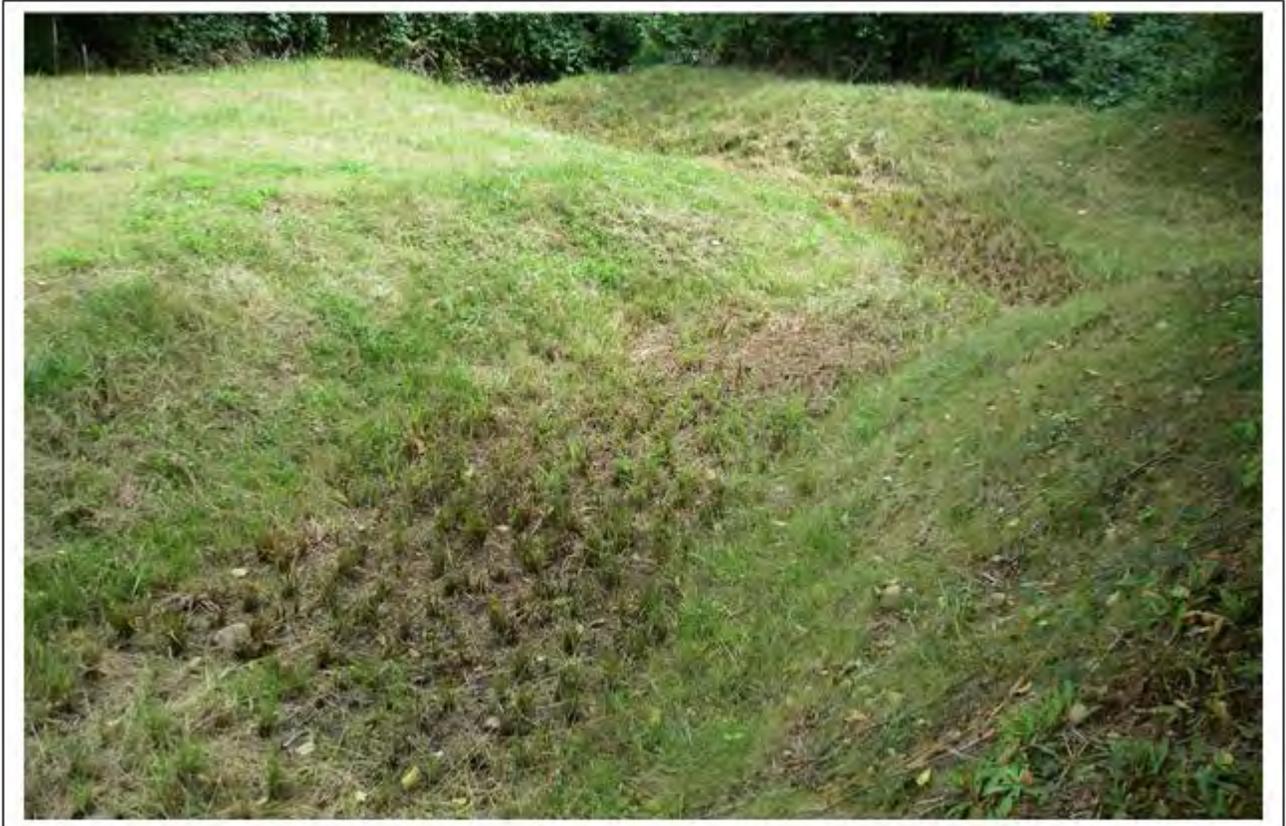
The Aspenwood Tract K D91707 bioswale was planted with a total of 1550 emergent plugs including 10 different species. Both the surrounding area and swale have recently been mowed and maintained. Plant survival and cover is over 85%. No supplemental planting is needed. Some Arrowroot and exotic grasses have mixed in with the native plants. No rivulets or avulsions have formed in the substrate. The swale appears to be functioning as designed. Both inlet and outlet are clear.

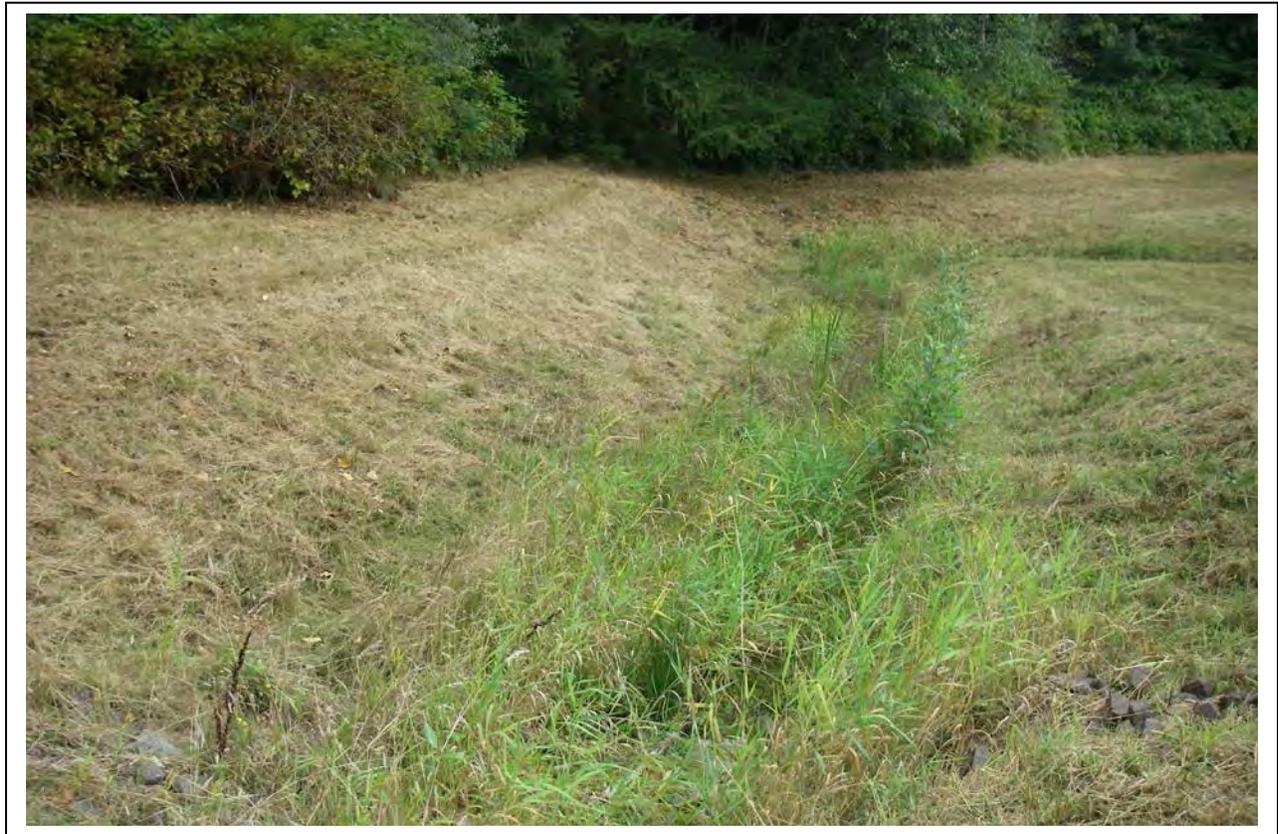
The Aspenwood Tract L D91704 bioswale was planted with a total of 1200 emergent plugs including 9 different species. The surrounding area has been recently mowed and maintained but the swale itself was not mowed. Plant survival and cover is close to 100%. No supplemental planting is needed. Some Cattail, Arrowroot, trefoil and exotic grasses have mixed in and are competing with the native plants. No rivulets or avulsions have formed in the substrate. The swale appears to be functioning as designed. Both inlet and outlet are clear.

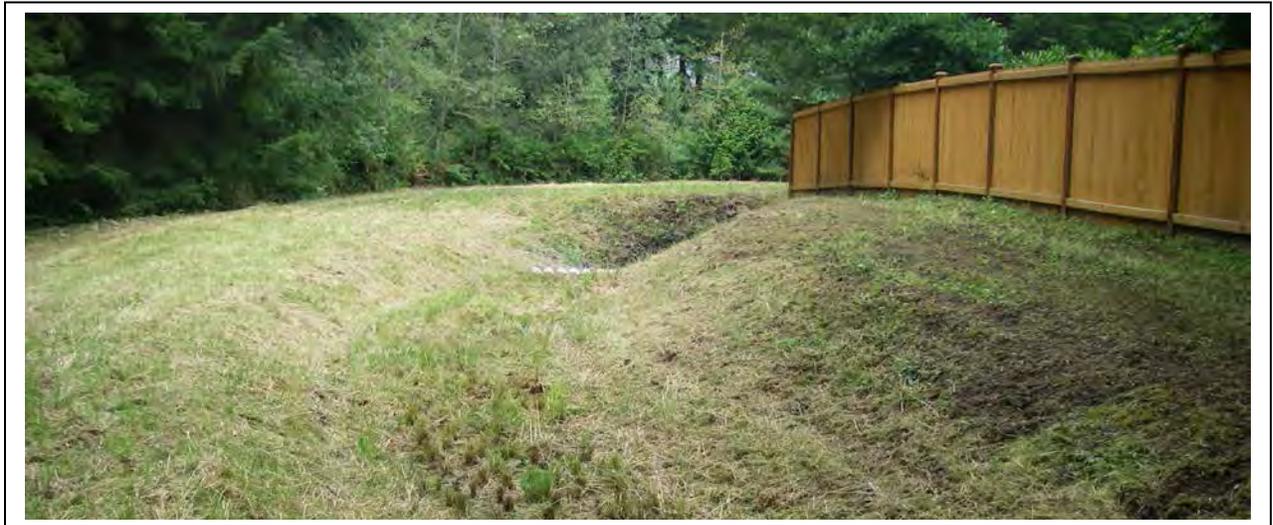
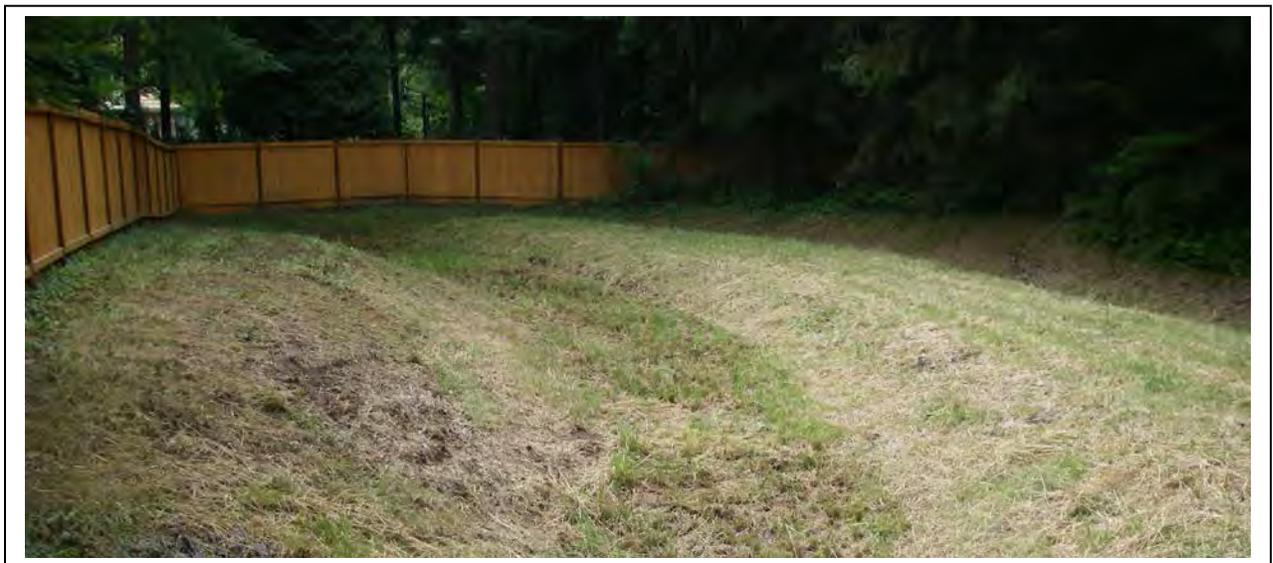
The Aspenwood Tract M D91703 bioswale was planted with a total of 1850 emergent plugs including 10 different species. The swale and surrounding area have recently been mowed and maintained. Plant survival and cover is over 85%. There are a few bare spots that could use a small supplemental planting. No rivulets or avulsions have formed in the substrate. Swale appears to be functioning as designed. Both inlet and outlet are clear.
