2014 Post Construction Monitoring Report King County Multiple Stormwater Facility Retrofits

**Department of Ecology Stormwater Retrofit Grant
Grant Agreement Number G1100216**

December 16, 2014

King County

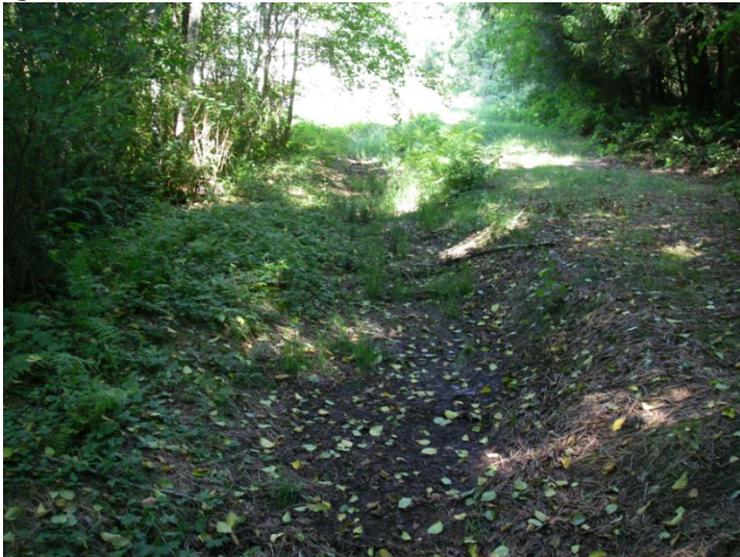
Quail Creek Bioswale D92191

The Quail Creek D92191 bioswale was planted with a total of 1,000 emergent plugs including three different species. This swale is in almost complete shade. There is a thick covering of deciduous leaves in many areas. Both of these factors may have contributed to a low survivorship. The surrounding area is vegetated with both native and invasive species and has not been maintained. Plant survival and cover is 30 to 40% for Slough sedge and Small-fruited bulrush, and a bit higher for the Mannagrass. Supplemental plantings are recommended. Recommending the planting of approximately 300 additional emergent plugs to fill the gaps in the vegetation, or wait for it to fill in on its own over time. No rivulets or avulsions have formed in the substrate. The swale appears to be functioning as designed. Both inlet and outlet are clear of obstructions or debris.

Bioswale Facility:	Minor maintenance that is recommended:
Quail Creek D92191	Approximately 300 additional emergent plugs to fill the gaps in the vegetation is recommended or it just may fill in on its own over time.
Ridge Point Estates D92026	Non-native vegetation, Bird's Foot Trefoil, removal is recommended to allow the other native plants to grow.
Rock Creek D92035	Add soil to fill the standing water at the apex of the switchback in the upstream channel and replant additional bioswale grasses.

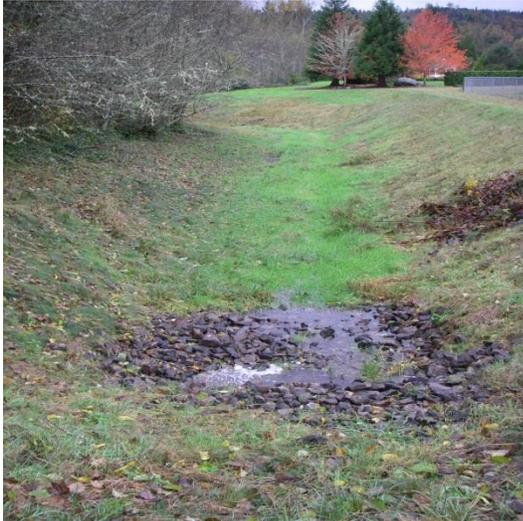
The Ames Lake Hills D92379 facility was operating at an optimal depth for water treatment when it was inspected. While the splash pad was working well in preventing erosion, flow dispersal was concentrated to the right of center. This was adjusted during the field visit, and flows are now being spread evenly at the start of the swale. Note the strong growth of the bioswale vegetation.

Problems that need to be corrected: None, the project is functioning as designed.

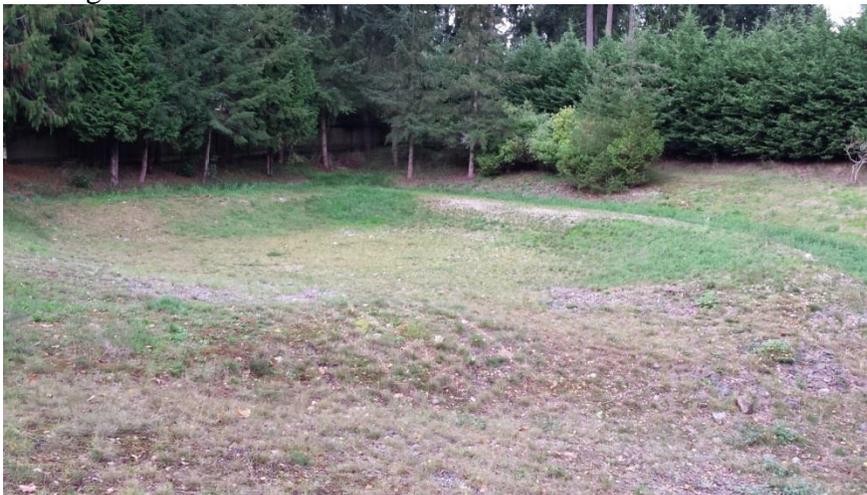
The Ridge Point Estates D92026 facility had undergone a re-grade of the bioswale. It was also replanted, as invasive vegetation had displaced many of the original plants and grasses. A constant grade was established, yard waste was hauled off and excessive vegetation that was shading the bioswale was removed.

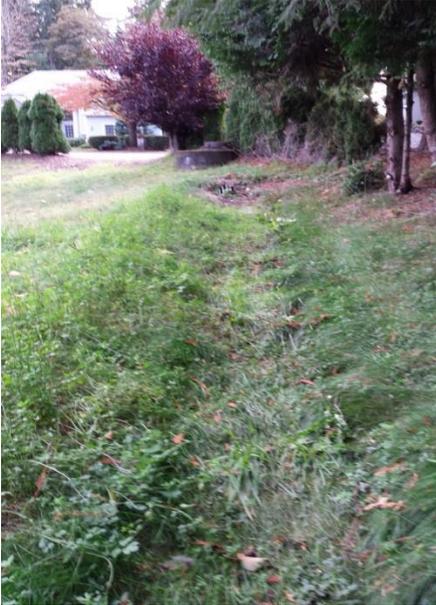
Ridge Point Estates

This photo shows the site. The bioswale runs along the far perimeter of the site and the infiltration basin is in the middle.

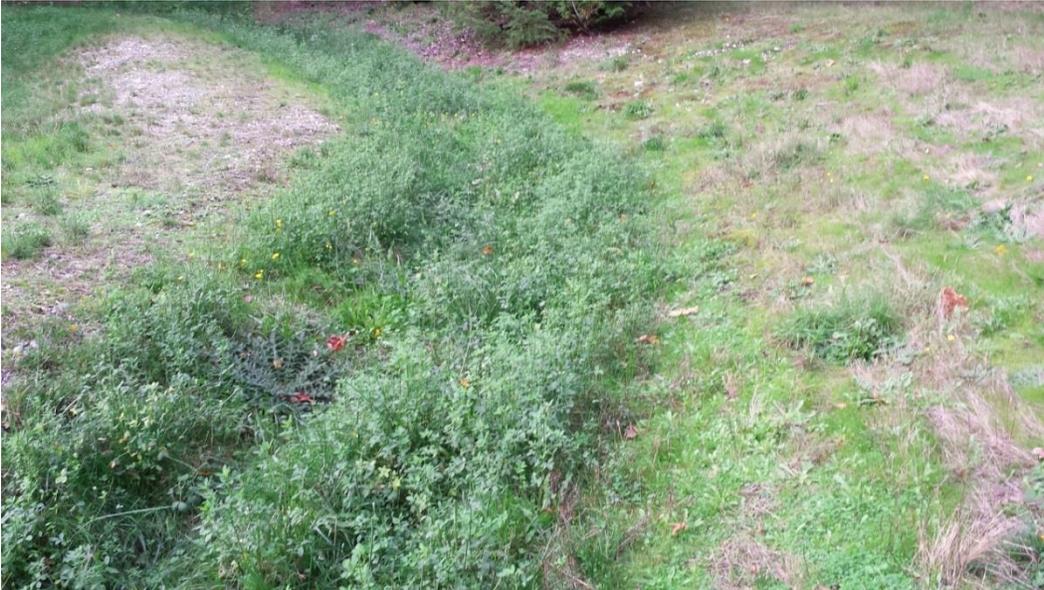
This photo shows the discharge pipe that feeds the bioswale and infiltration basin. Note the evidence of recent flow indicated by the bent over grass.

In the lower part of the swale, non-native vegetation, Bird's Foot Trefoil, has taken over and outgrown the rest of the bioswale plants and grasses. The non-native vegetation, Bird's Foot Trefoil, should be removed to allow the other native plants to grow.

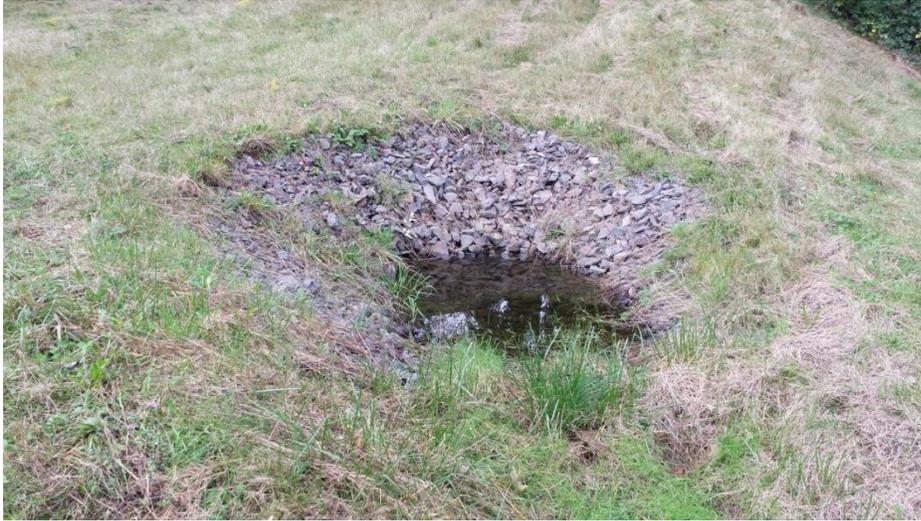
The Rock Creek D92035 facility showed strong growth of the bioswale grasses.

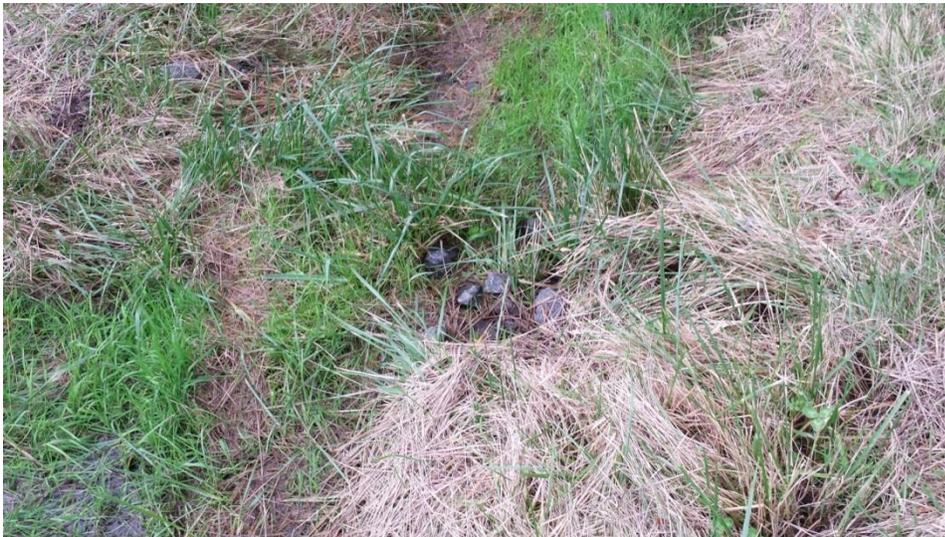
The retrofit design changed a catch basin to an open rock-lined basin for energy dissipation due to the limited drop in the channel. This would have resulted in a flattened channel slope and standing water would have been a significant problem. The open basin works well with no signs of erosion.

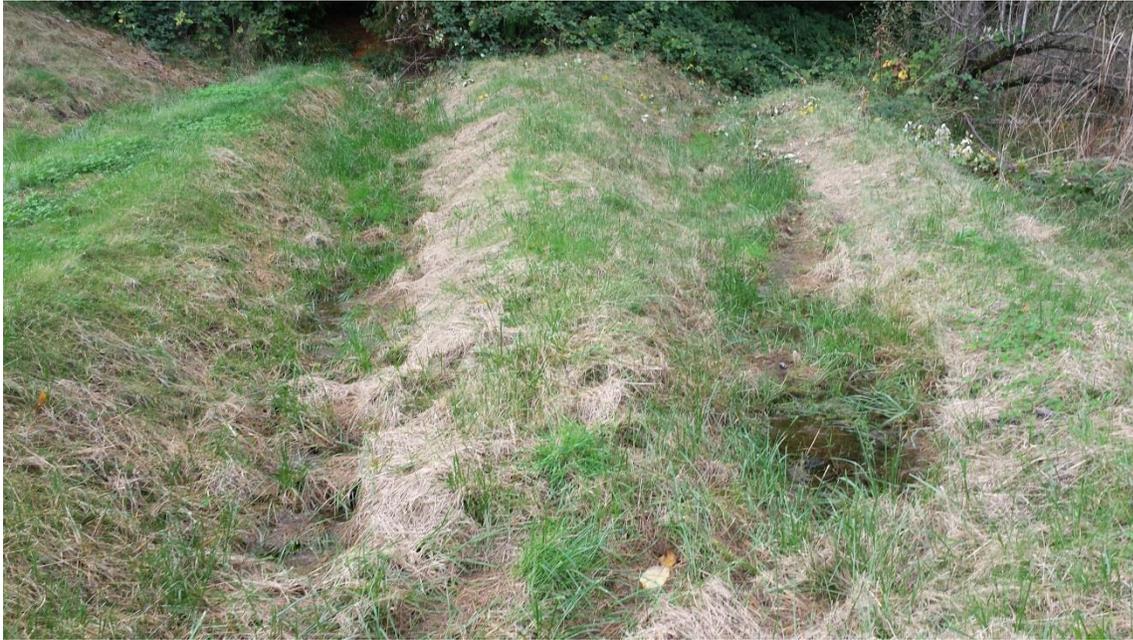
This photo shows ponding in lower right of the picture. There is also a 4 foot length of standing water at the apex of the switchback in the upstream channel. Ponding takes up approximately 6 of the 191 feet of the bioswale, or about 3% of the length. This can be corrected by adding soil to fill these areas and then planting additional bioswale grasses.

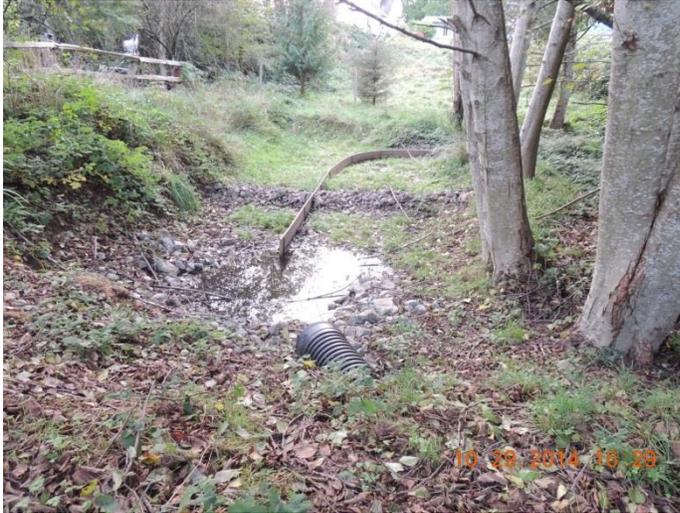
The Fournier D92350 facility needed to be repaired since the shade from trees had killed the bioswale vegetation, and a single channel had formed, providing virtually no biofiltration. Trees were removed and others were trimmed to allow more sunlight to reach the bioswale, rock flow spreaders were added to disperse the flow and a flexible flow splitter was installed to keep the flows separated.

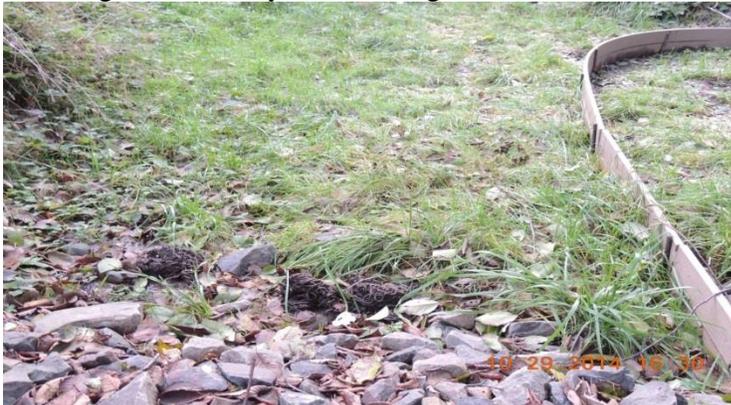
This photo shows the density of the bioswale grasses that are now growing in the facility. On the right is a flexible flow divider that keep flows to either side separated. It is made from recycled polyethylene that is impervious to rotting in the saturated soils.

Problems that need to be corrected: None, the project is functioning as designed.
