MAY CREEK EROSION STABILIZATION DRAFT REPORT

MAY CREEK SEDIMENT TRANSPORT STUDY PHASE 3

King County
Department of Natural Resources and Parks
201 Jackson Street, Suite 600
Seattle, Washington 98104

Anchor QEA, LLC
1605 Cornwall Avenue
Bellingham, Washington 98225

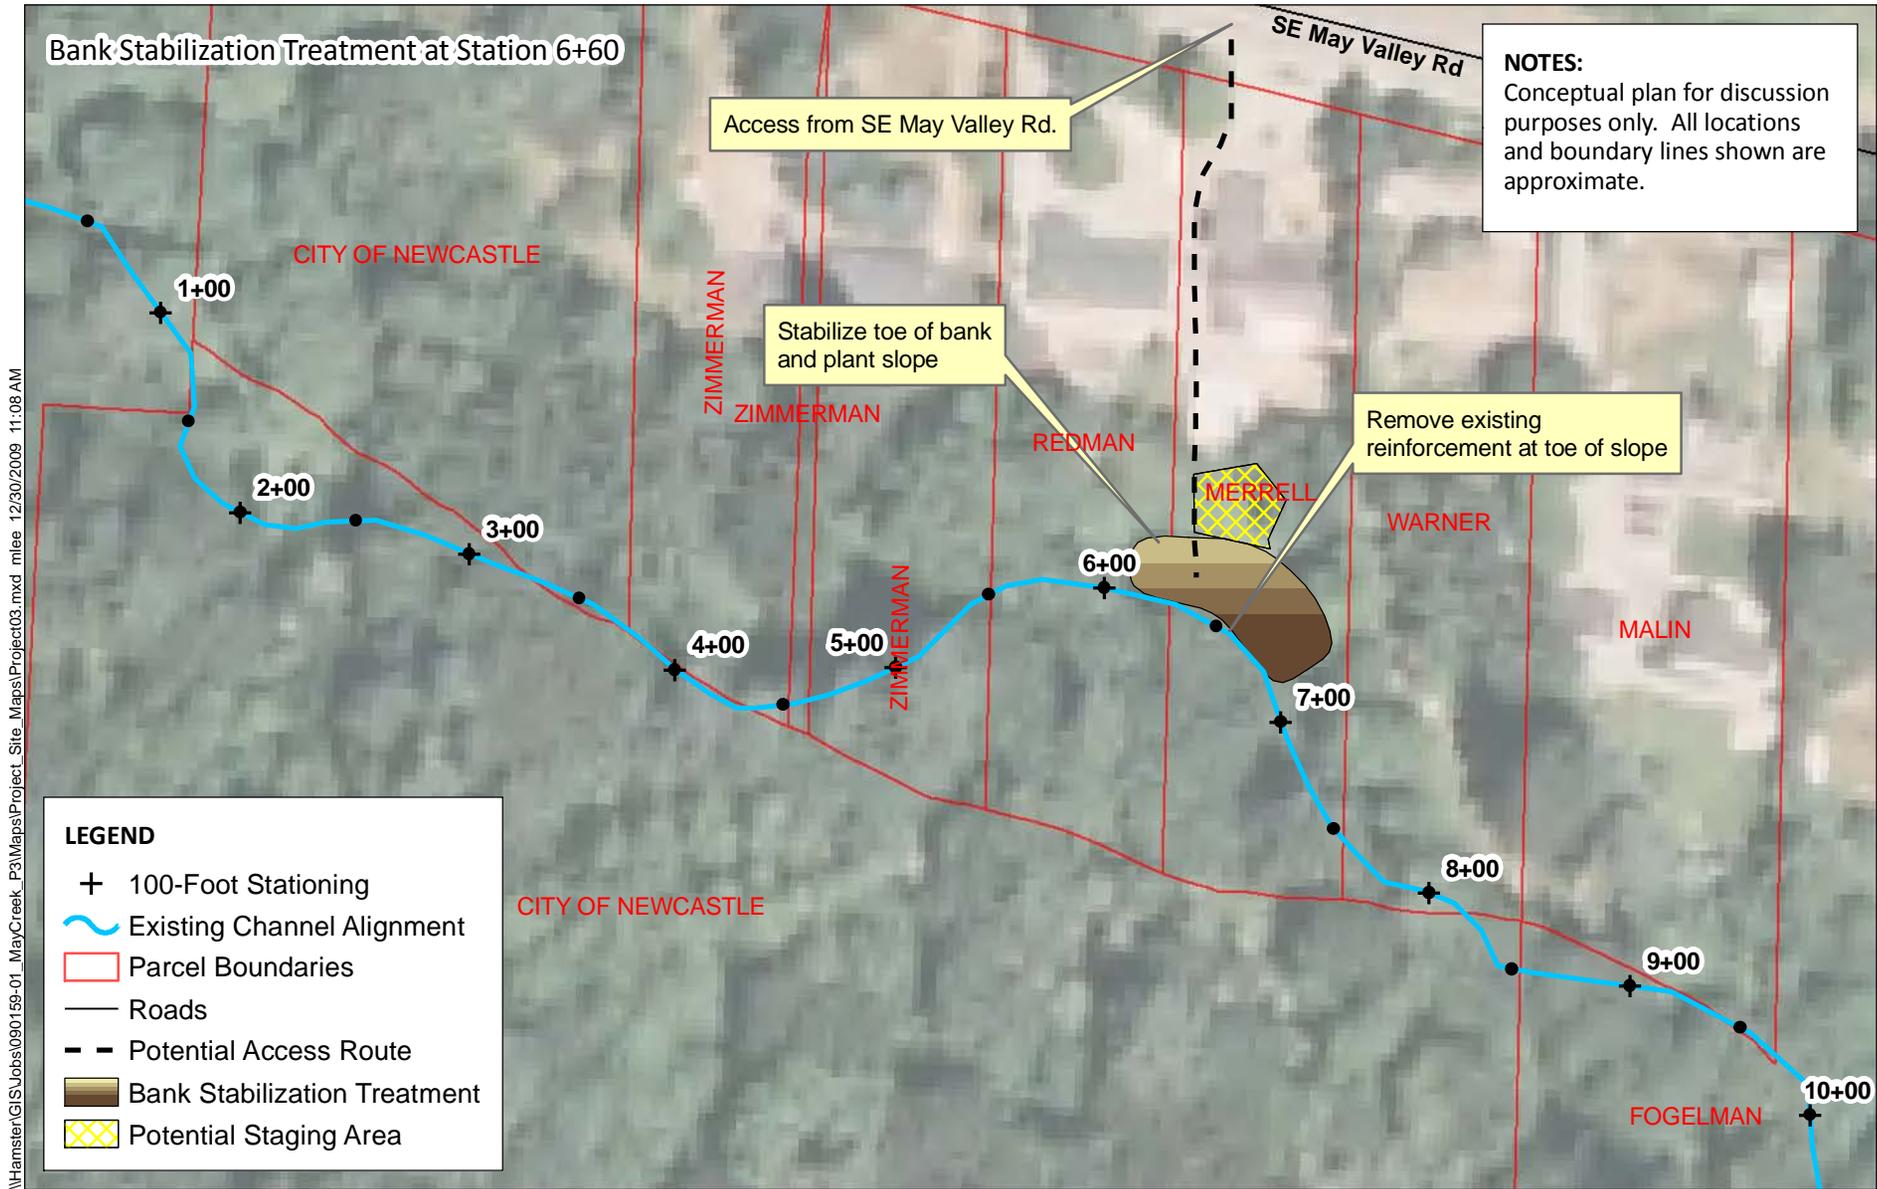
Figure 8
 Conceptual Plan View, Project 3
 May Creek Erosion Stabilization Report
 King County/ May Creek Sediment Transport Study Phase 3

The left bank is stable and would not be influenced by the proposed project action. The right bank is presently stable with armoring. While the existing armor material inhibits channel movement, it does not provide natural, habitat-enhancing bank stabilization. Currently, a large gravel and cobble deposit separates the thalweg from the armor along the right bank, however, the channel likely moves throughout the valley bottom during higher flows. Banks are steeply sloped and approximately 20 feet high, therefore there is no floodplain connectivity at this location.

Project 3 will remove existing bank armoring and provide a more naturally appearing bank stabilization treatment that will enhance both instream and riparian habitat conditions near Station 6+60 (Figure 8).

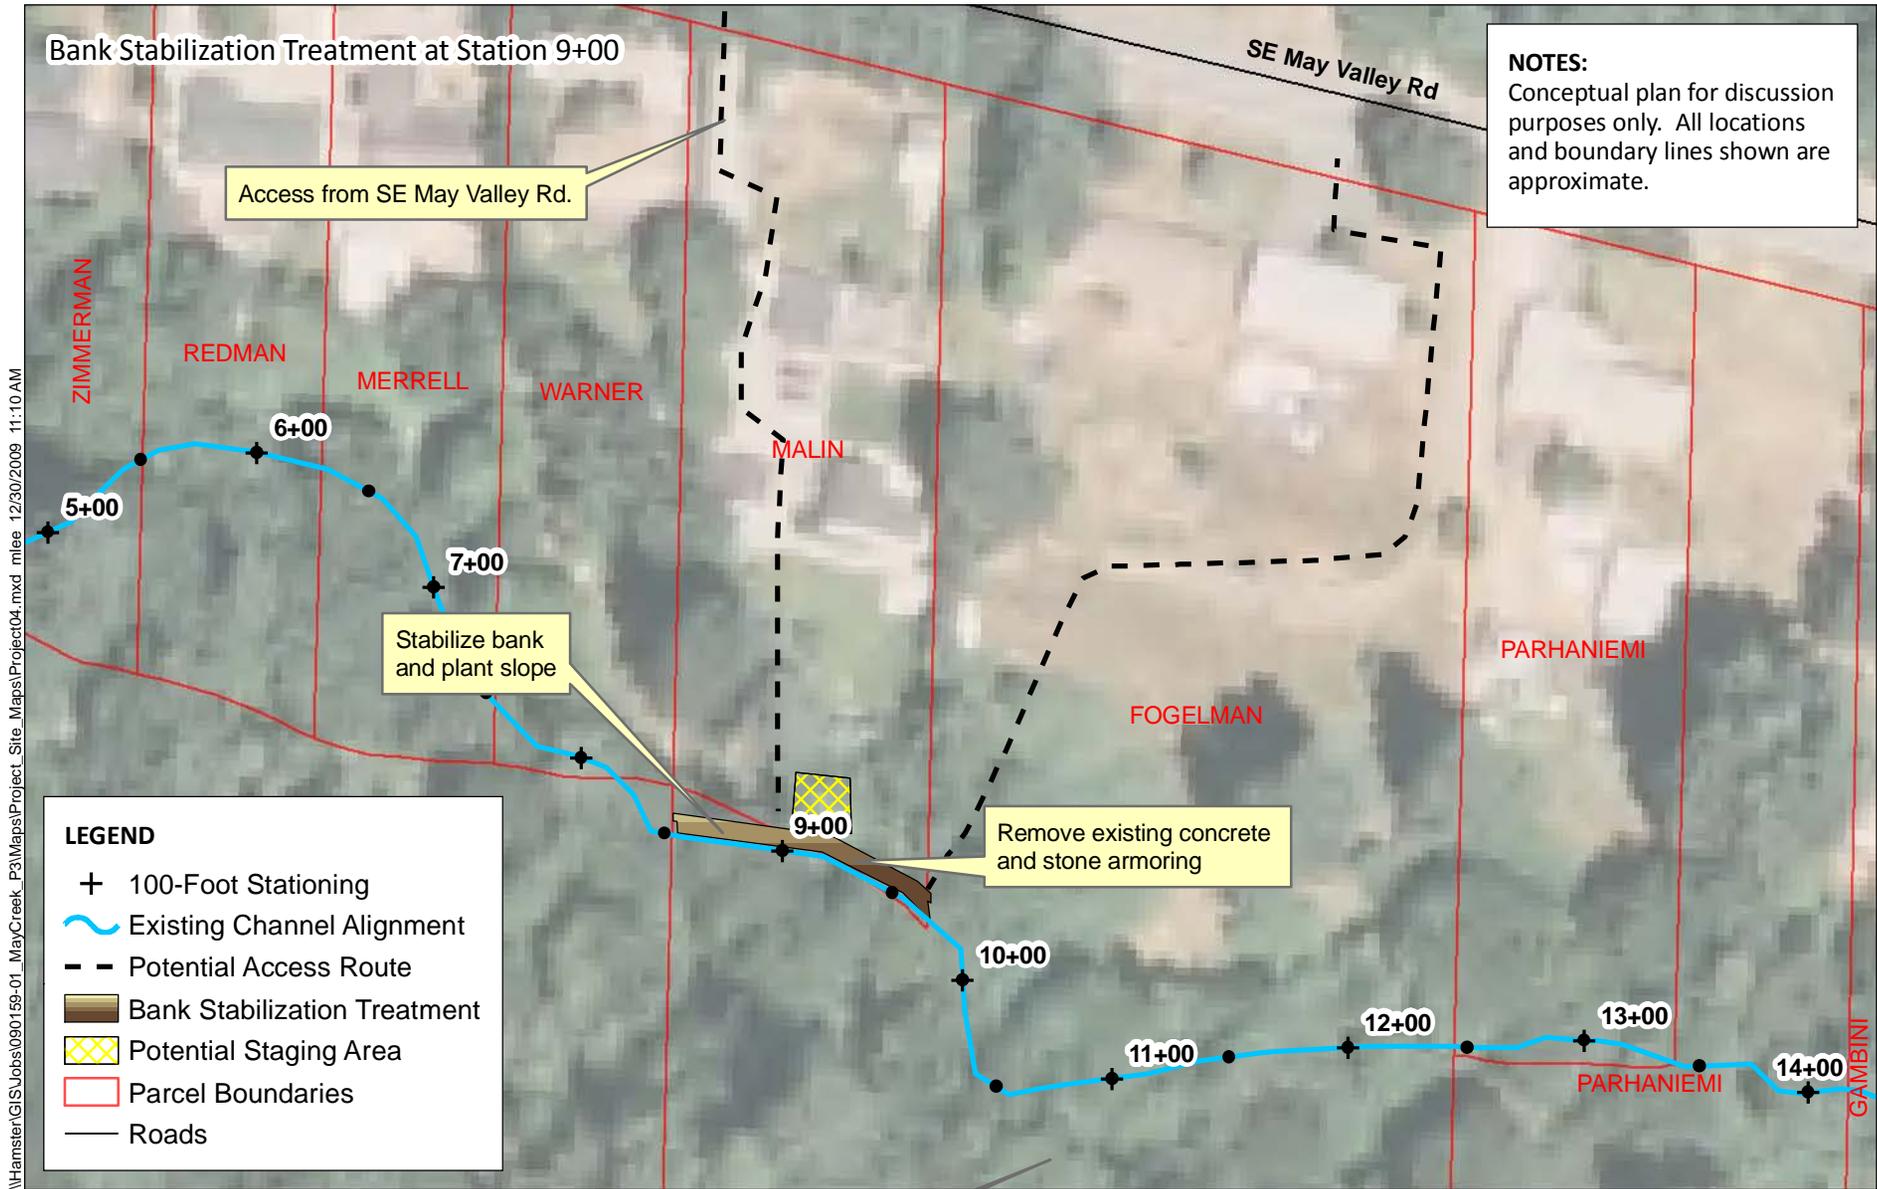
Figure 9
Conceptual Plan View, Project 4
May Creek Erosion Stabilization Report
King County/ May Creek Sediment Transport Study Phase 3

Riparian habitat conditions for the left bank are characterized by mature trees that provide stream cover and shading. The understory is composed of immature trees and native woody plants and shrubs, interspersed with moderate to sparse Himalayan blackberry and other invasive plants. The right bank has few mature trees and thick understory composed of immature deciduous trees, woody native bushes and shrubs. Some invasive growth was identified including Himalayan blackberry vines and thick reed canarygrass along the banks, including a large patch of grass atop the existing armoring.

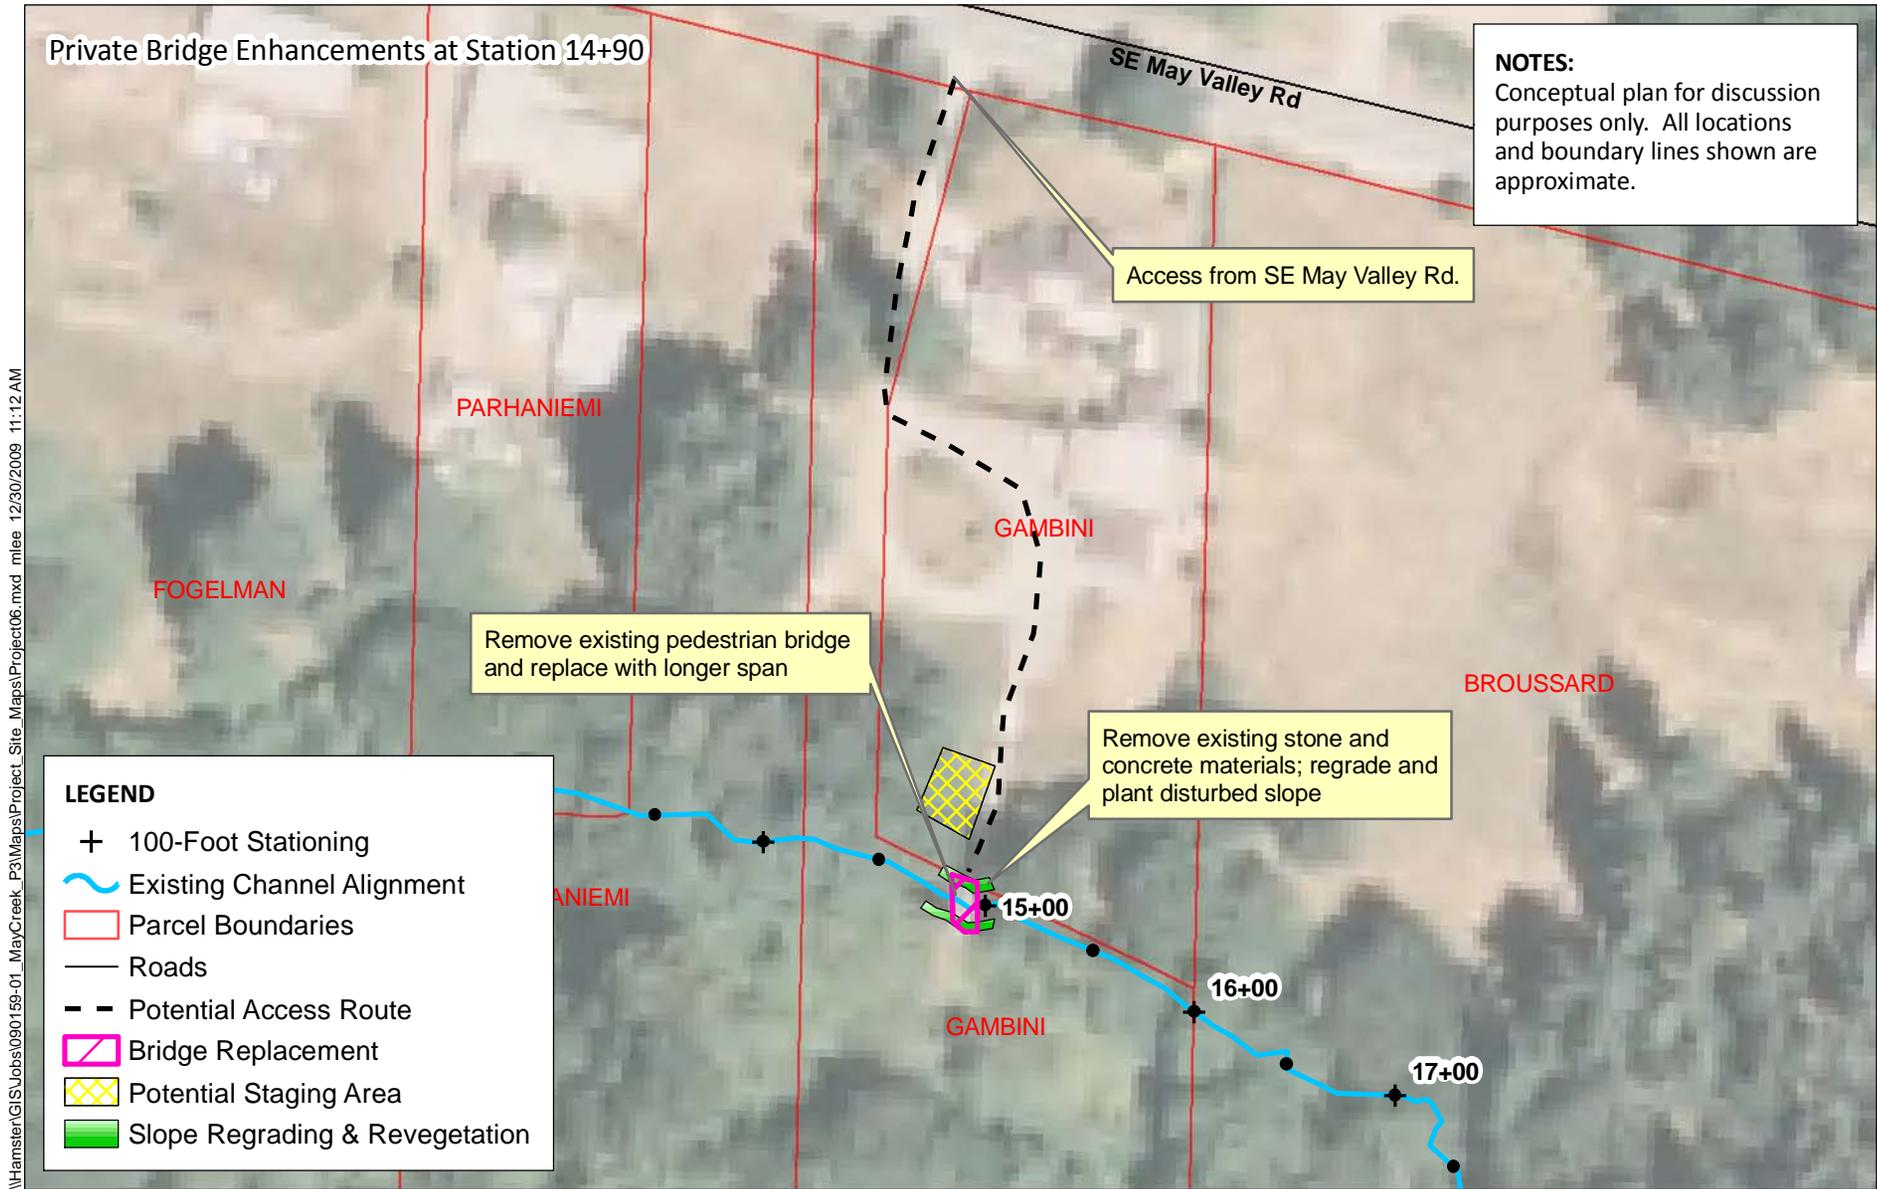
The right bank is currently stable and protected by a relatively large volume of concrete fragments on the upstream and downstream sides of the bridge. The left bank, which is also stable, contains a less extensive amount of armoring that is limited to within a few feet of the existing bridge abutment. Concrete and stone associated with the bridge is located in the channel bed and along the banks, possibly to reduce local scour and incision at the bridge. It appears that high flows are contained within the channel banks and there is no connectivity with the floodplain terrace.

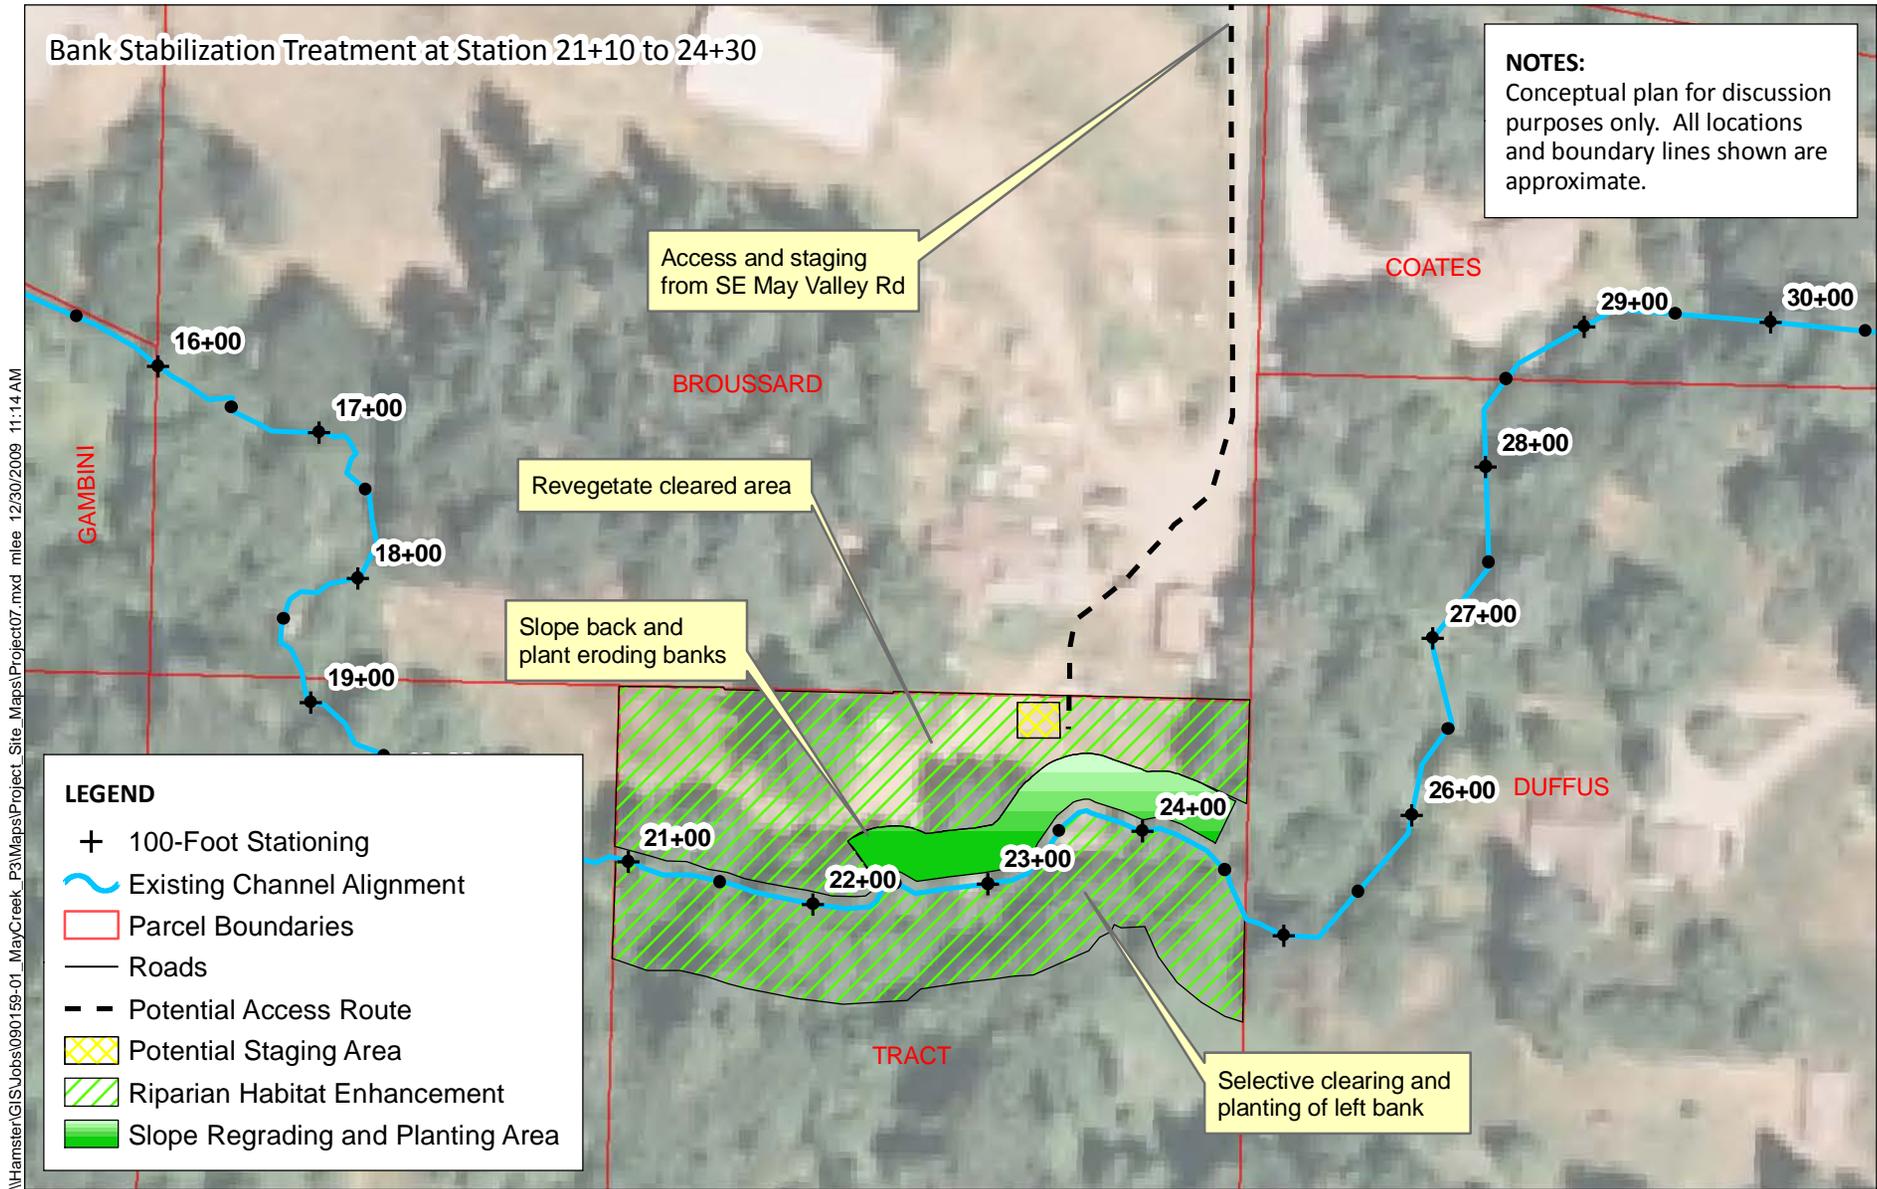
The left bank from approximately Station 21+10 to 22+20 and the right bank from approximately Station 22+20 to 24+30 are slightly unstable. Bank soils are composed of highly erodible glacial outwash. Several exposed tree and plant roots were observed, particularly along the right bank. According to observations over the previous winter season, channel widening in this area has occurred where the right bank experienced severe erosion during high flows. A large gravel deposit along the left of the active channel was likely deposited concurrently, and at least two moderate-sized trees were downed across the channel during this time. The steep banks have incised several feet in the past three decades, cutting off any connectivity with the floodplain that may have existed (Duffus 2009).

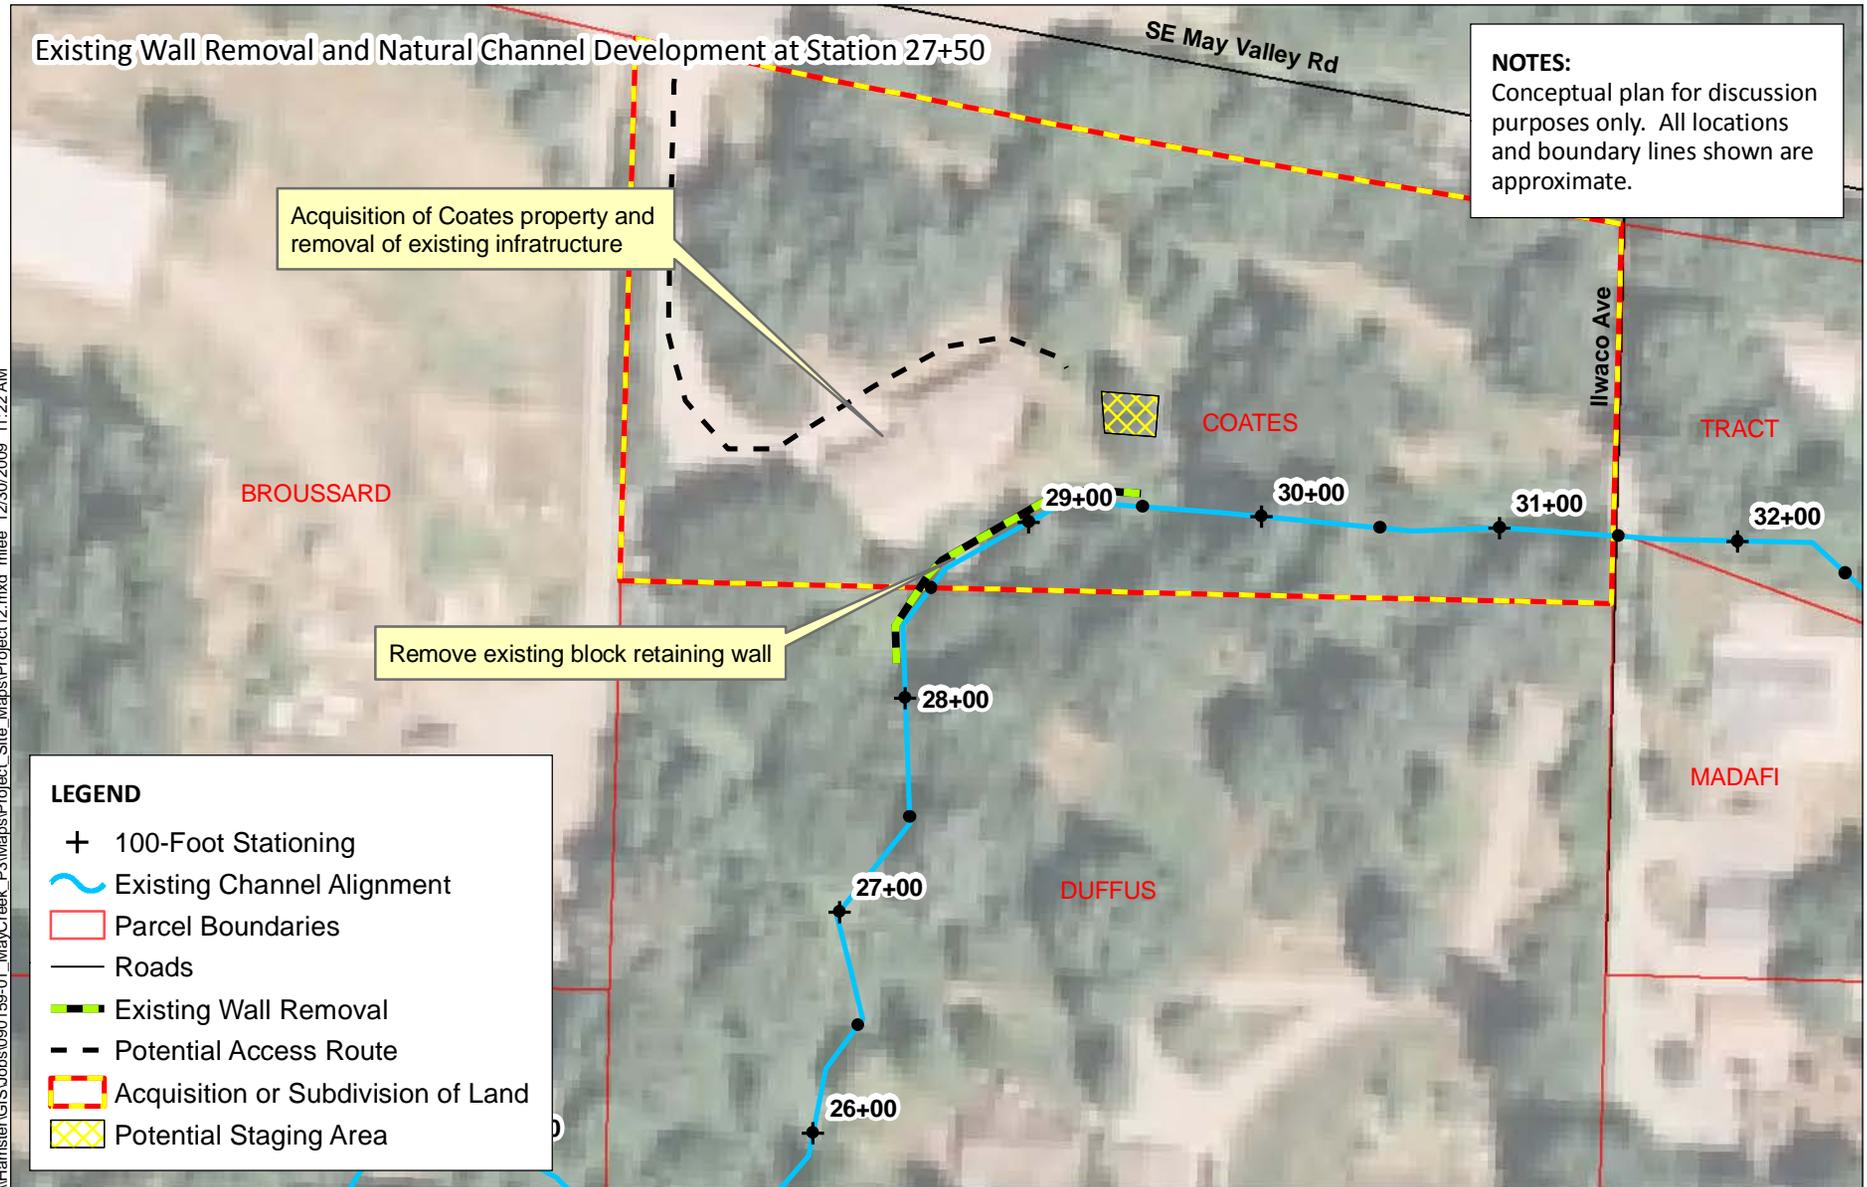
Figure 17
Conceptual Plan View, Project 12
May Creek Erosion Stabilization Report
King County/ May Creek Sediment Transport Study Phase 3

Some mature deciduous trees, a moderately thick understory of immature deciduous trees, and other plants overhanging the left bank providing some stream shading. The right bank lacks tree cover and only sparse immature (approximately 3 to 4 feet tall) deciduous trees were observed. The slope behind the wall is primarily vegetated with a wide variety of native and non-native shrubs, bushes and vines including Himalayan blackberry and morning glory. Some large patches of reed canarygrass were also observed growing along a gravel accumulation at the upstream end of the wall.

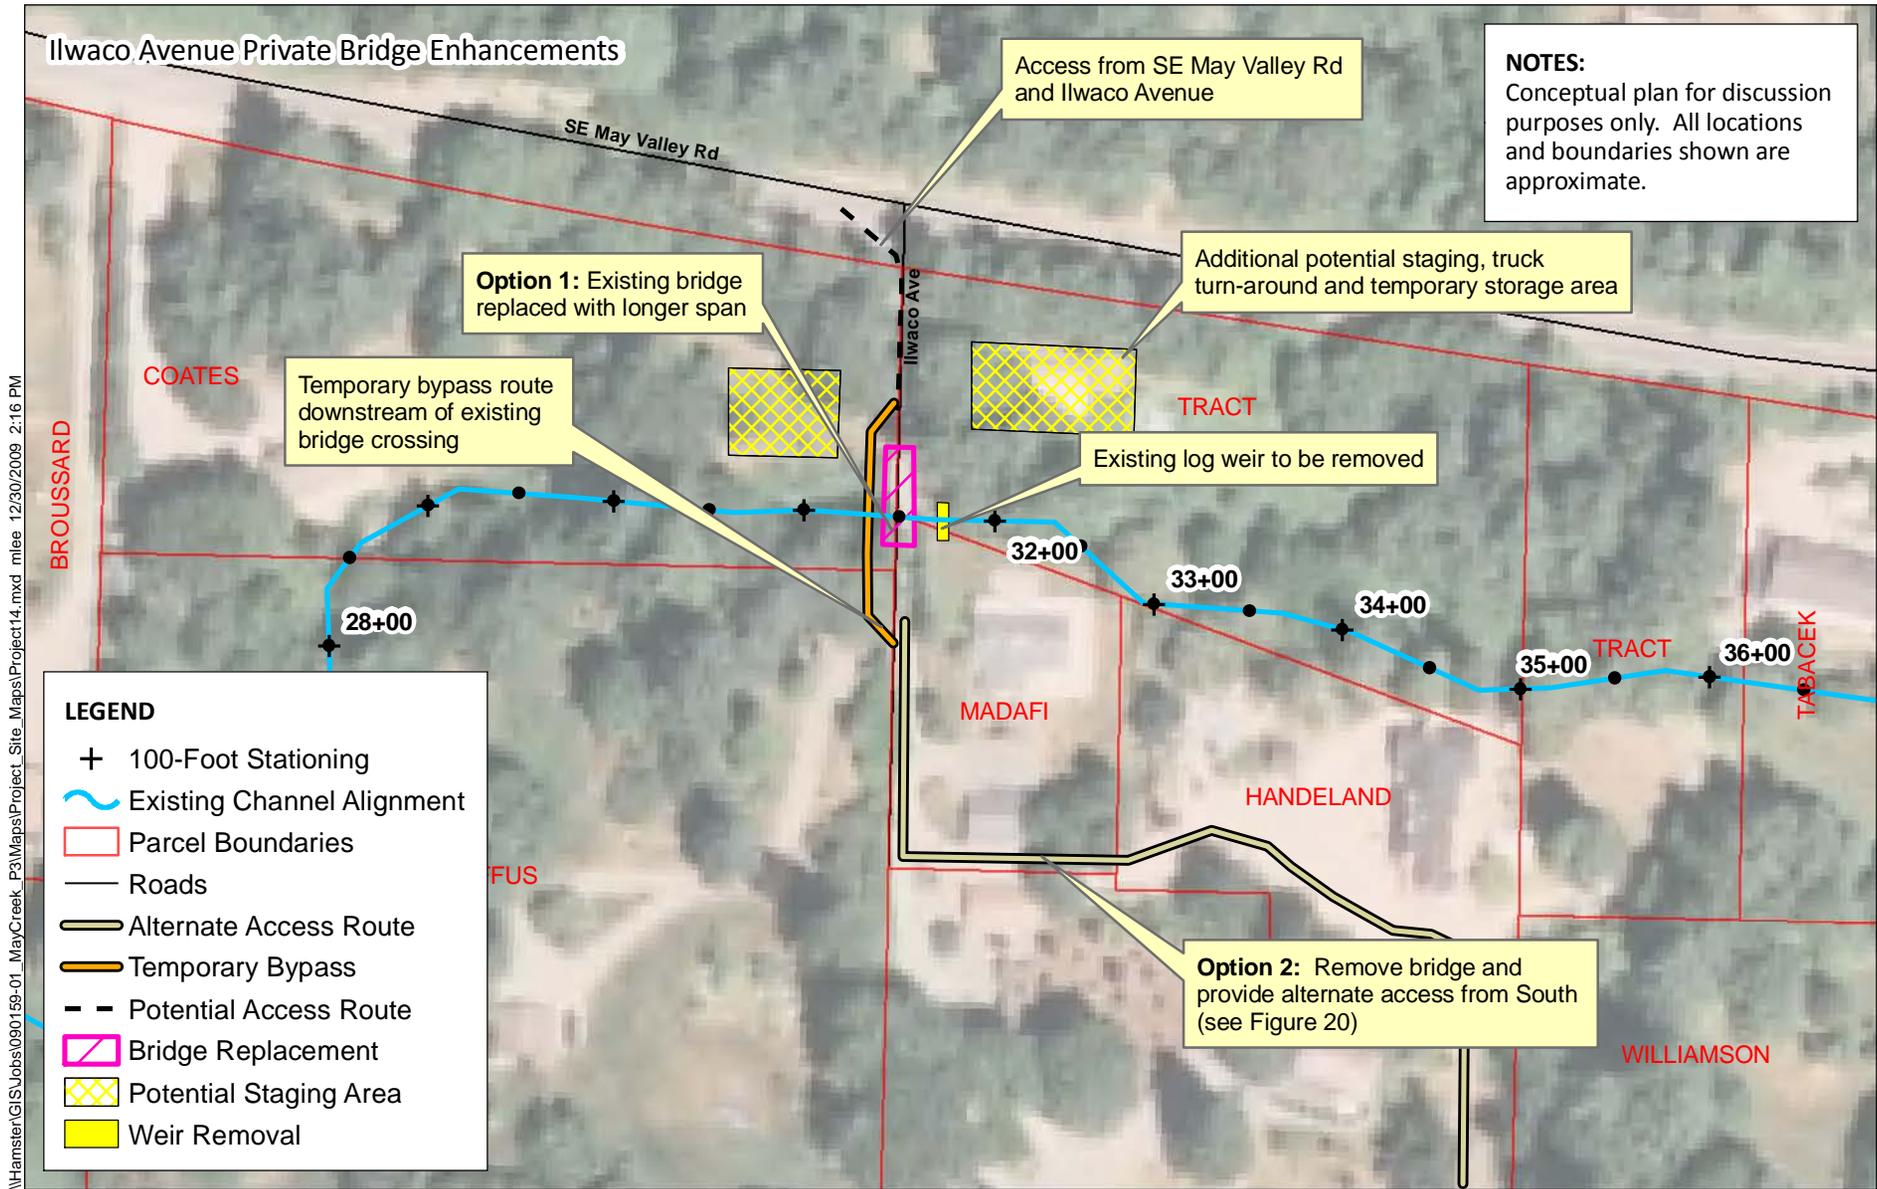
Figure 19
Conceptual Plan View, Project 14
May Creek Erosion Stabilization Report
King County/ May Creek Sediment Transport Study Phase 3

The Ilwaco Avenue bridge crossing is a private concrete structure with a 6-foot high arch and 15-foot span. The left and right banks through the bridge opening are presently stable with armoring. The channel bed beneath the bridge has been augmented with riprap, cement and rebar to reduce local scour and head cutting at the bridge. A log weir approximately 10 feet upstream of the bridge produces an extensive backwater pool at low flows. At higher flows the bridge opening constricts flows, thereby increasing upstream water levels.

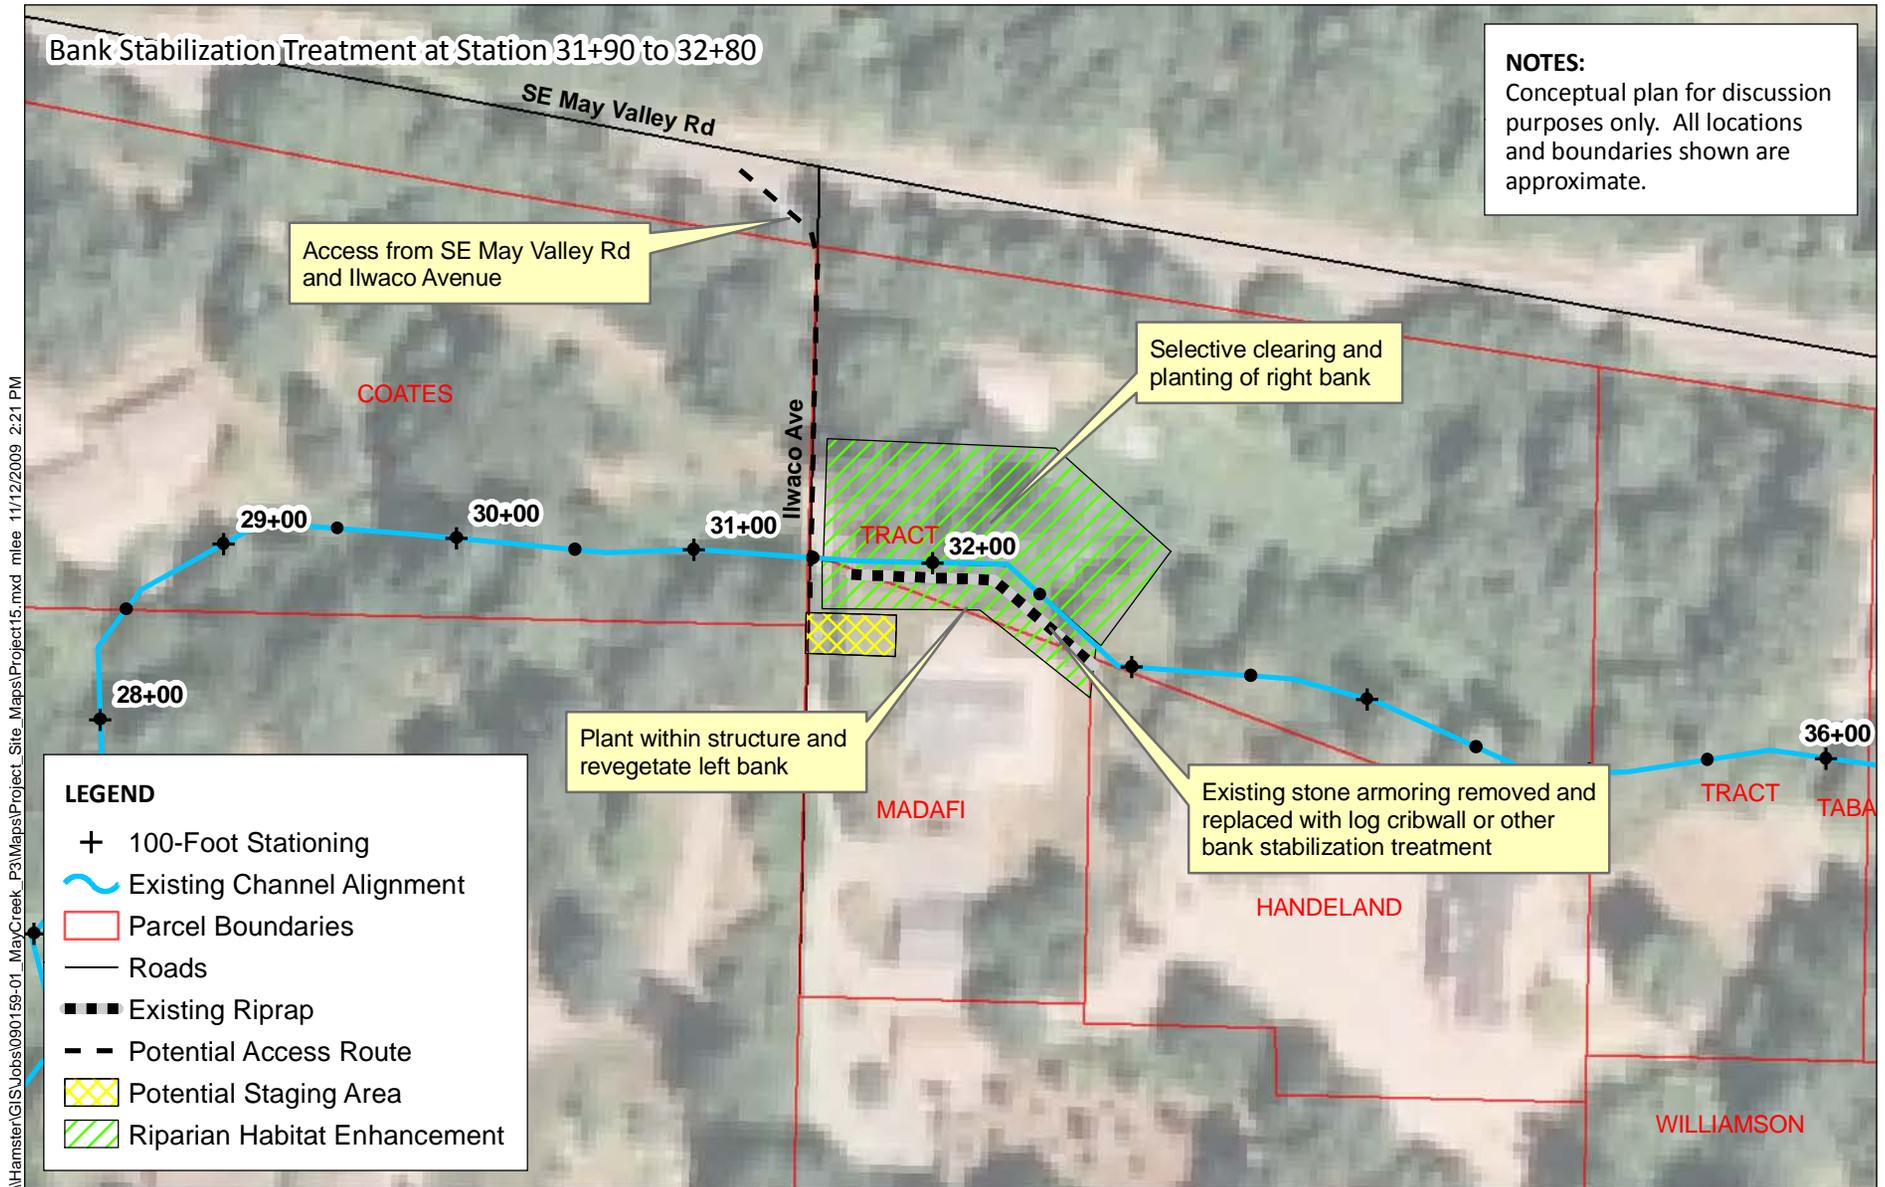
Figure 21
Conceptual Plan View, Project 15
May Creek Erosion Stabilization Report
King County/ May Creek Sediment Transport Study Phase 3

The left and right banks are presently stable. The left bank is currently armored with stone boulders. The banks are relatively low (approximately 3 feet high) and likely have good floodplain connectivity on both sides of the channel.

The channel is a slow-moving pool at low flows. The pool is created by a log weir on the downstream end of the armored bank that produces extensive backwater during low flows and limits sediment transport through this section of the channel. The effect of the weir likely decreases during high flows, although it may continue to contribute to flooding. Instream habitat conditions are characterized by embedded gravel with a moderate amount of silt infilling, low velocities, and moderate water depths at low flow. At the upstream end of the site the channel is constricted by a gravel bar along the right bank that forces the thalweg along the base of the armored bank, accelerating velocities through this area.

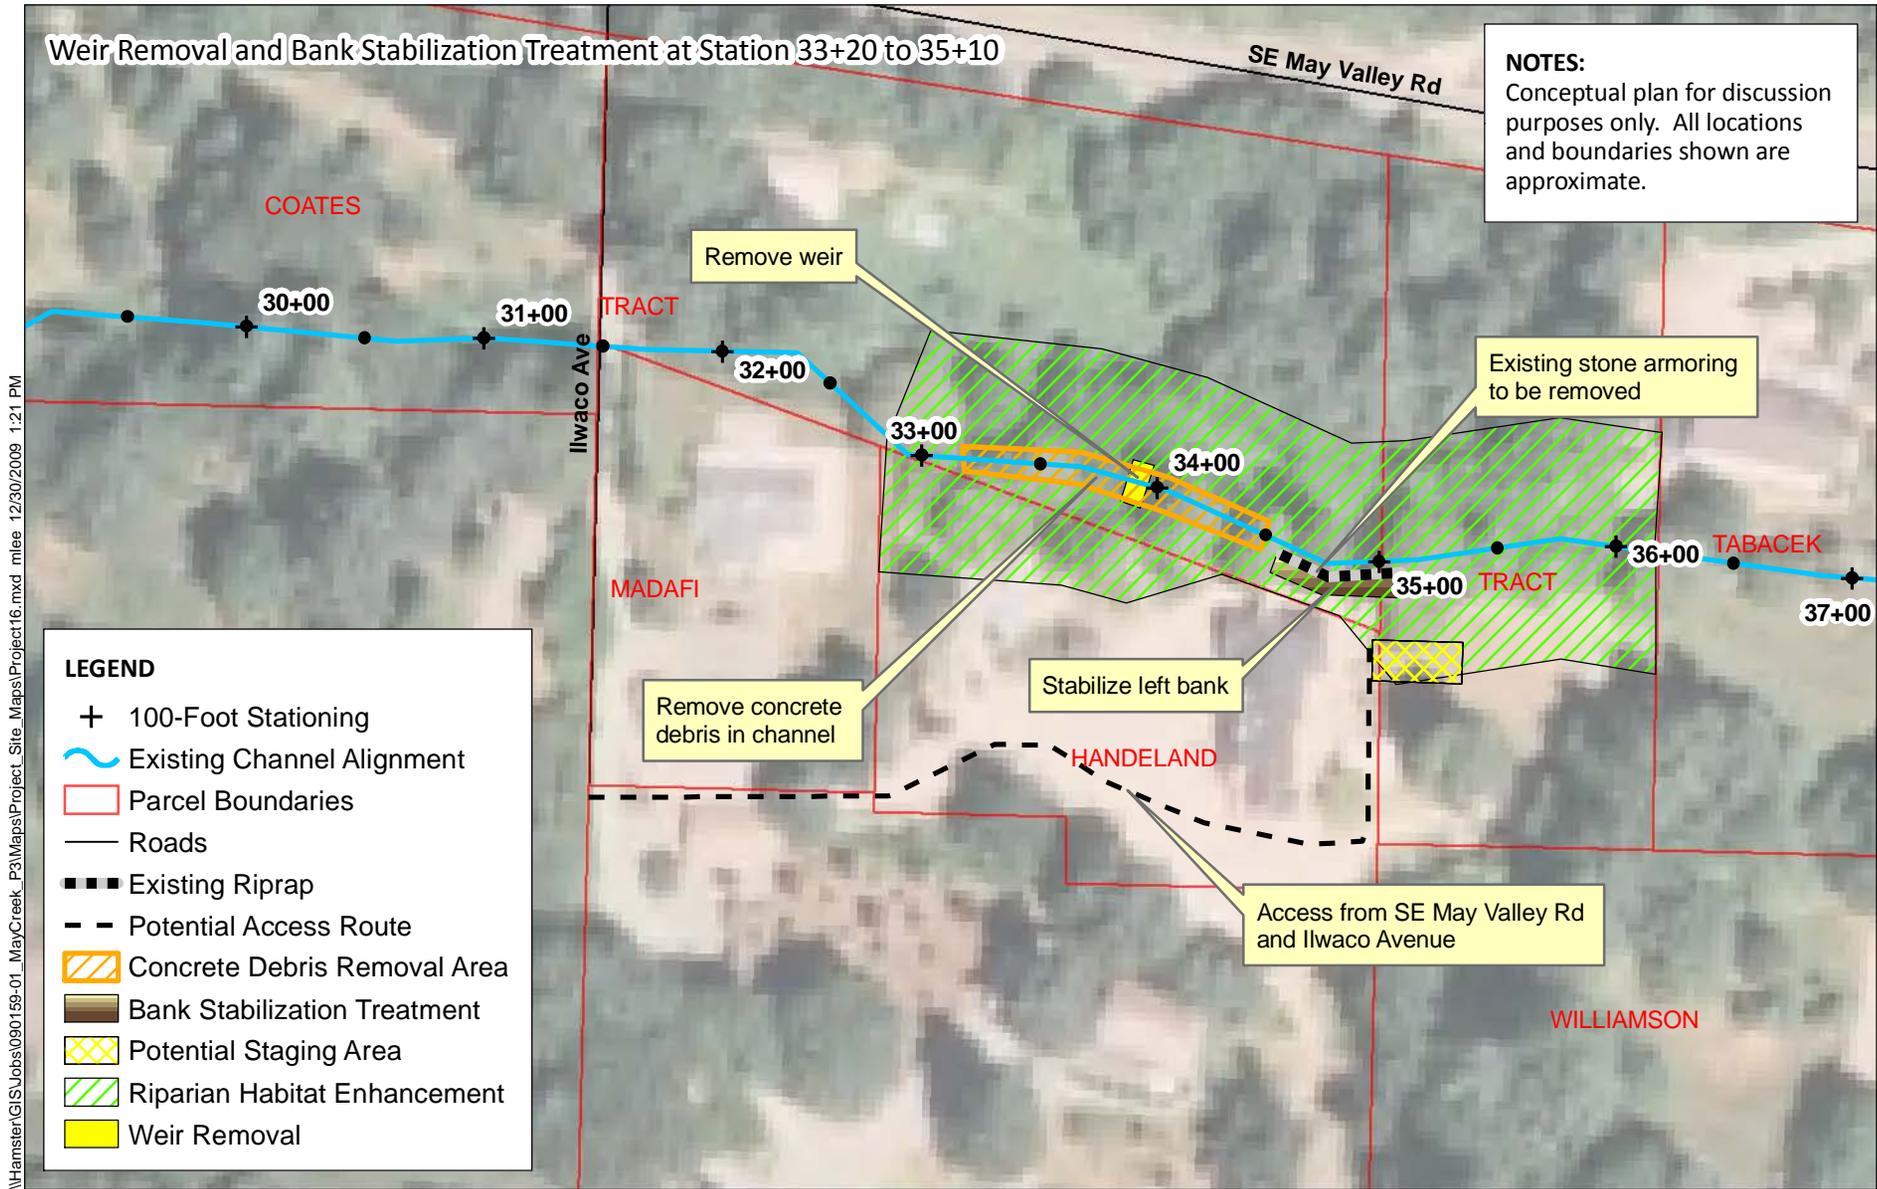
This segment of the channel is characterized as a plane bed section, with local pools forced by the concrete debris and weir. Instream habitat conditions are characterized by gravel and cobble substrate with silt infilling in backwater areas, low to moderate velocities, and moderate water depths at low flow. The upper portion of the site is somewhat constricted by stone armoring protruding into the channel.

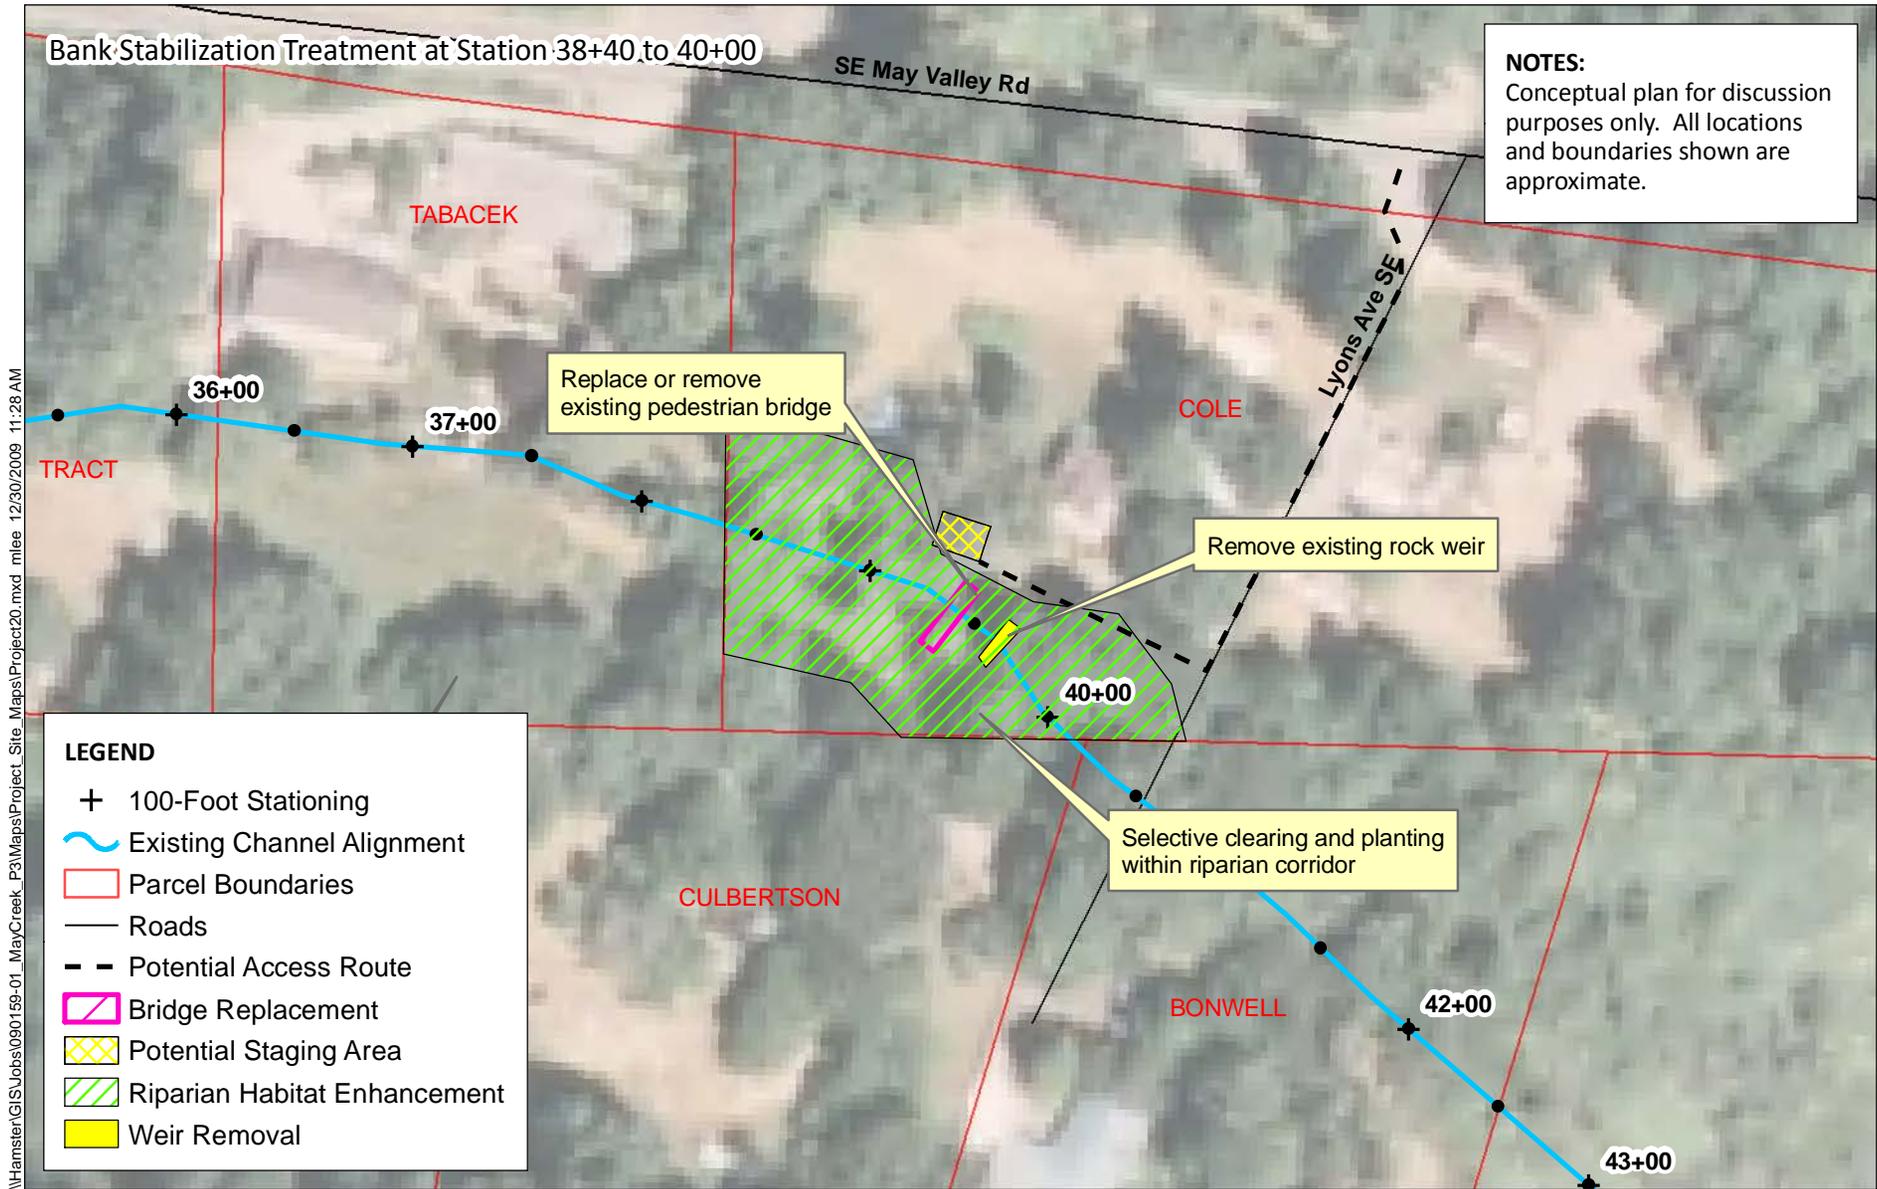
This segment of the stream is characterized as a slow-moving backwater pool created by the weir on the adjacent property downstream and the weir within the project site. This area has a gravel substrate with silt infilling, low velocities, and moderate depths. The upstream extent of the site, outside of the influence of the weir, is a relatively straight run with a gravel and cobble substrate, moderate velocities, and relatively shallow water depth during low flow.
