MAY CREEK EROSION STABILIZATION DRAFT REPORT

MAY CREEK SEDIMENT TRANSPORT STUDY PHASE 3

King County
Department of Natural Resources and Parks
201 Jackson Street, Suite 600
Seattle, Washington 98104

Anchor QEA, LLC
1605 Cornwall Avenue
Bellingham, Washington 98225

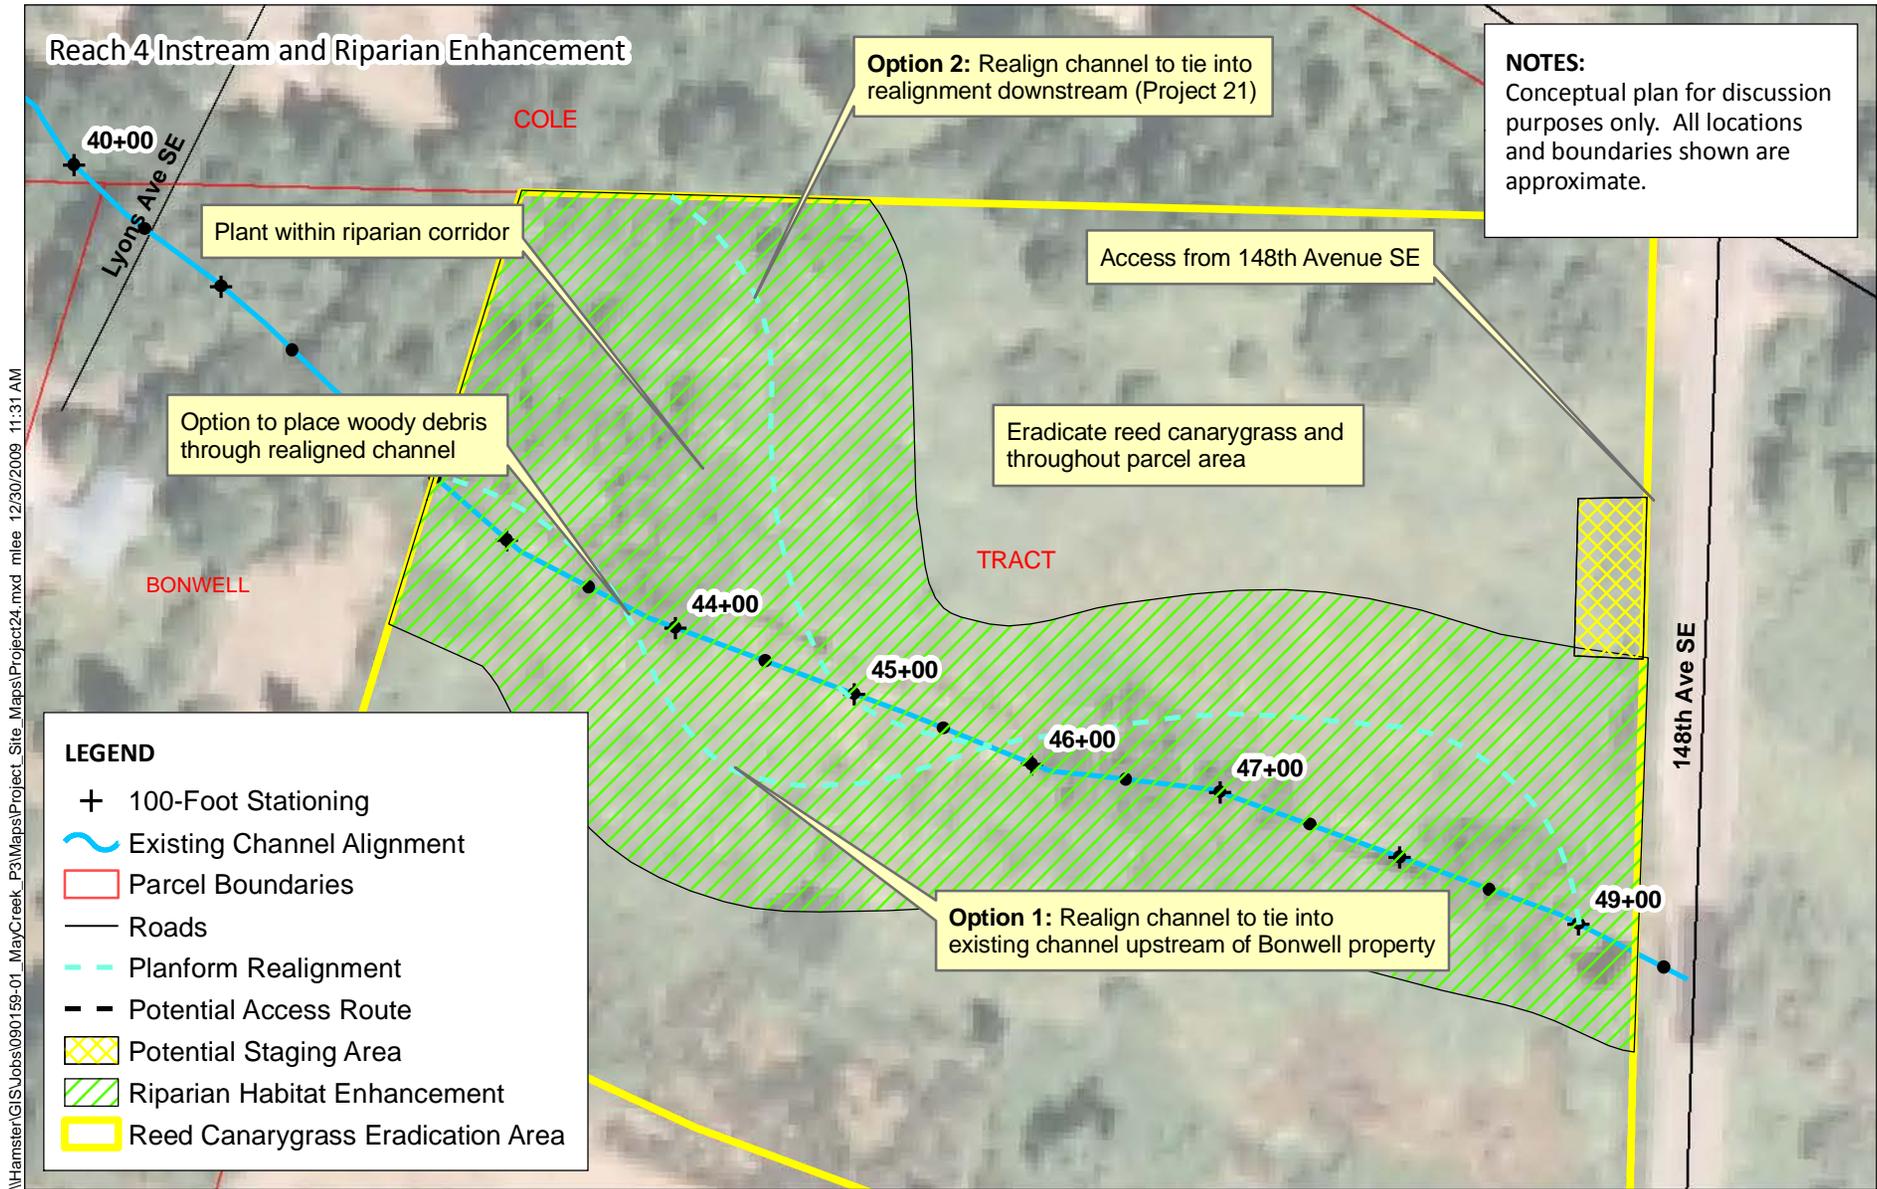
Figure 30

Riparian habitat conditions are severely degraded by thick growth of reed canarygrass throughout the floodplain. There is a lack of mature trees and understory. Some stream shading is provided by the overhanging grasses along the channel margins, otherwise the channel is completely exposed.
