Allen Lake Outlet Stream Reconnaissance

December 10, 2012

1.0 Purpose and Scope

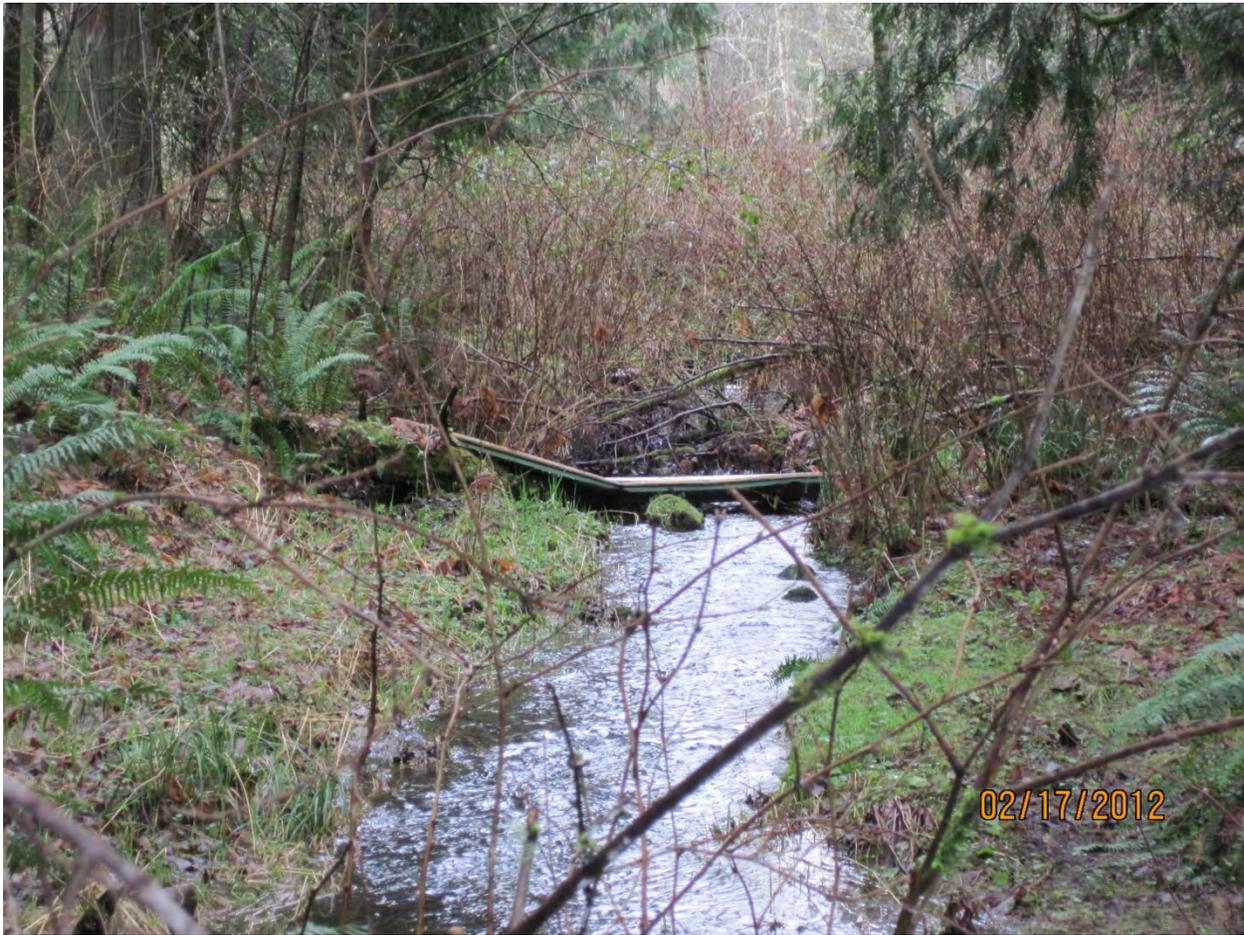
Photo 5. Reach 1 – Small woody debris accumulations at small metal bridges. Fish passable around and through debris.

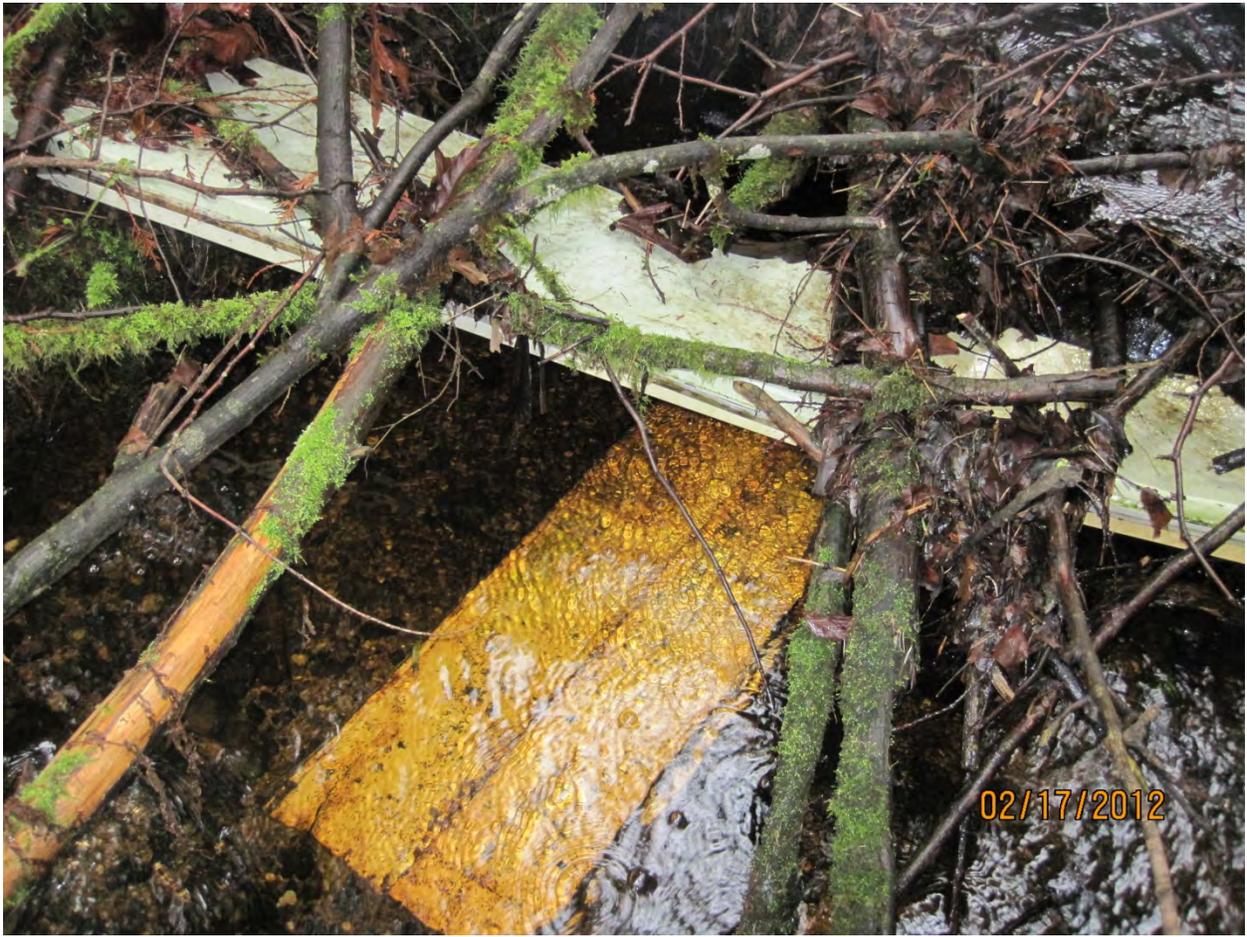
Photo 6. Reach 1 - Close up of upper small metal bridge creating small woody debris accumulation in stream channel.

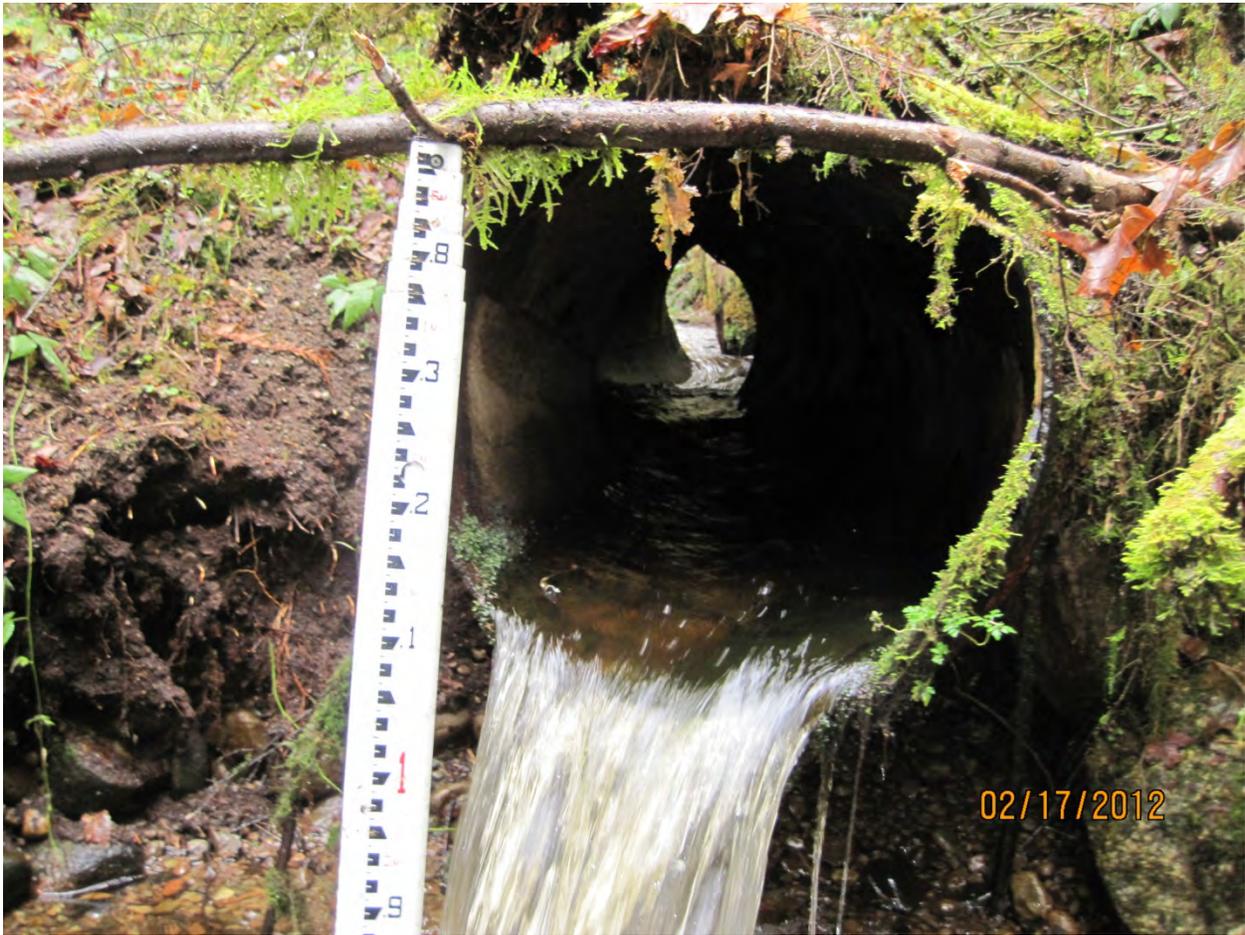
Photo 8. Reach 2 – Downstream end of logging road crossing pipe. Pipe is composed of curved smooth steel segments welded together. Low gradient, fairly low outlet drop, resting areas within pipe, and deep plunge pool make pipe fish passable. Road does not appear to be in use any longer, and fill over pipe is about 1 foot deep.

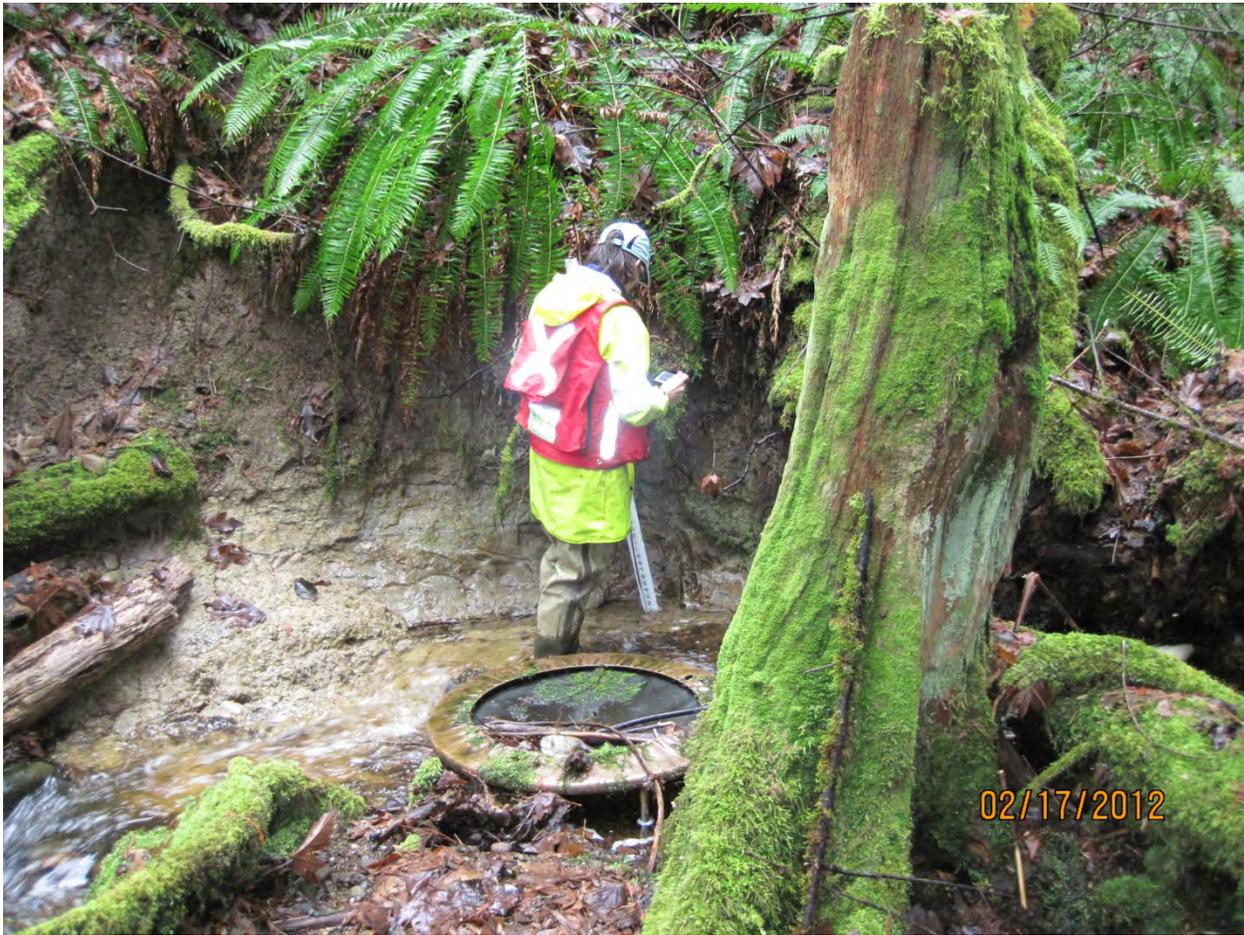
Photo 18. Reach 2 – Ravine reach with area of erosion into hard pan, plus debris.

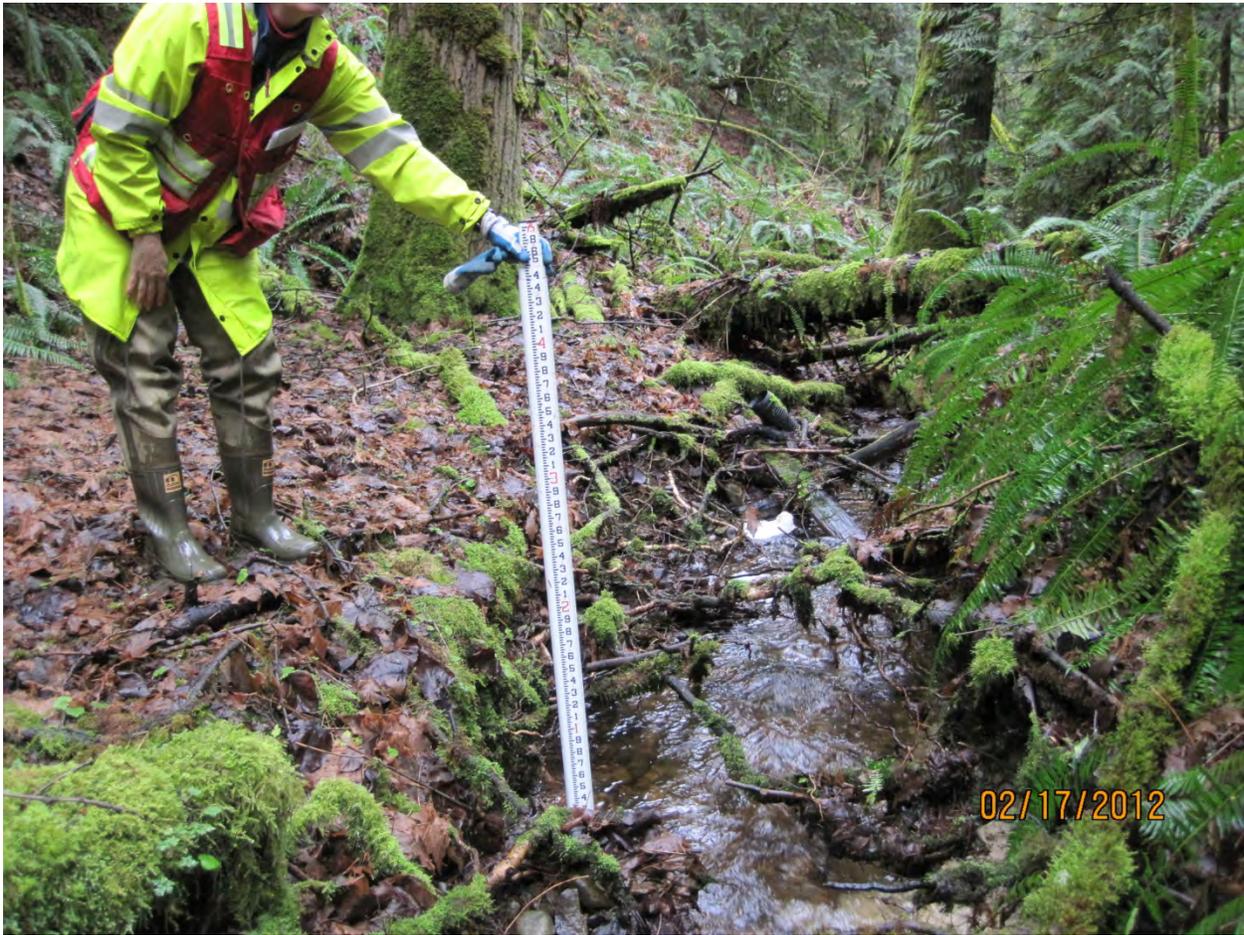
Photo 19. Reach 2 – Short segment of eroded bank in ravine reach.

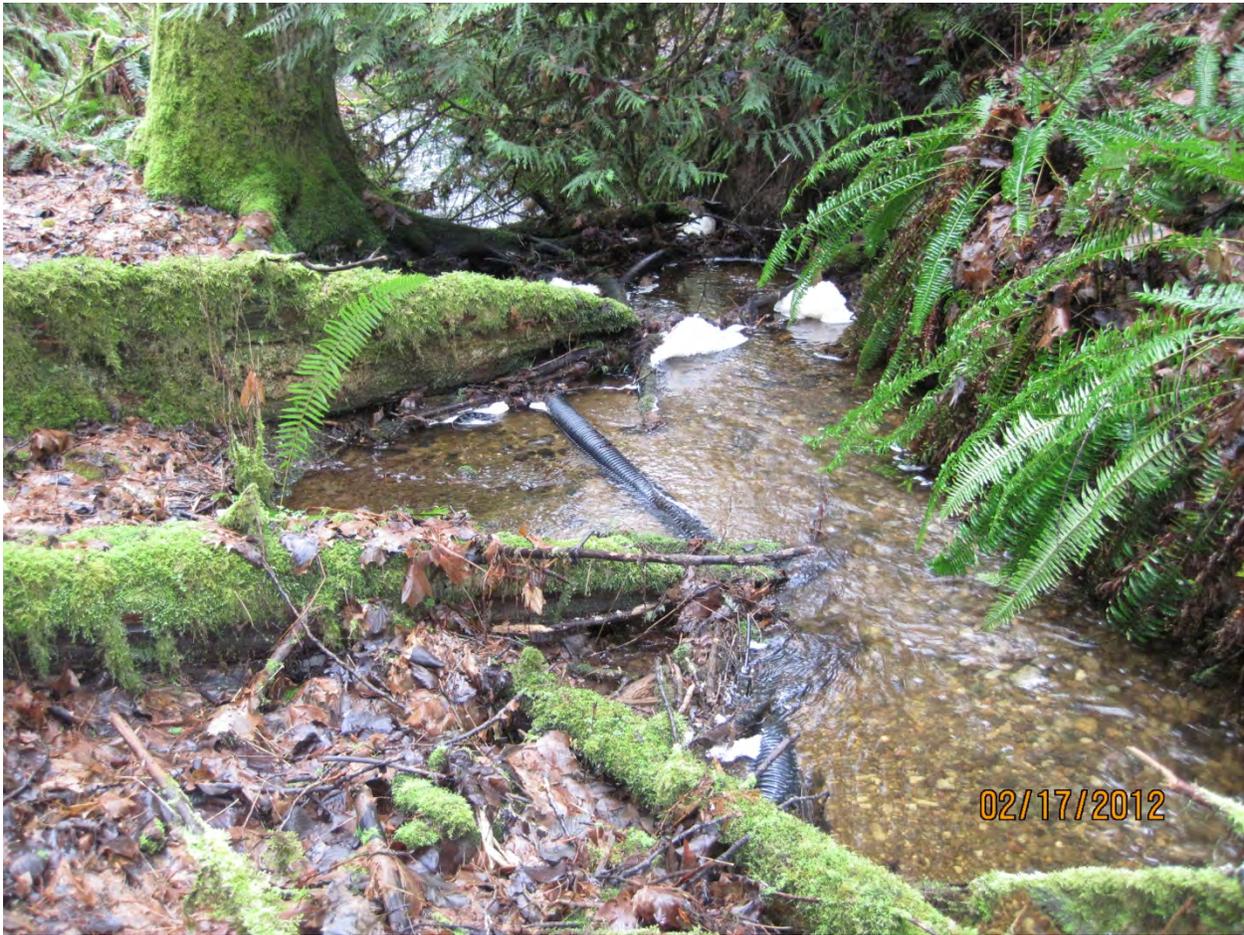
Photo 20. Reach 2 – Slight downcutting of stream bed, with matrix of tree roots intertwining bank.

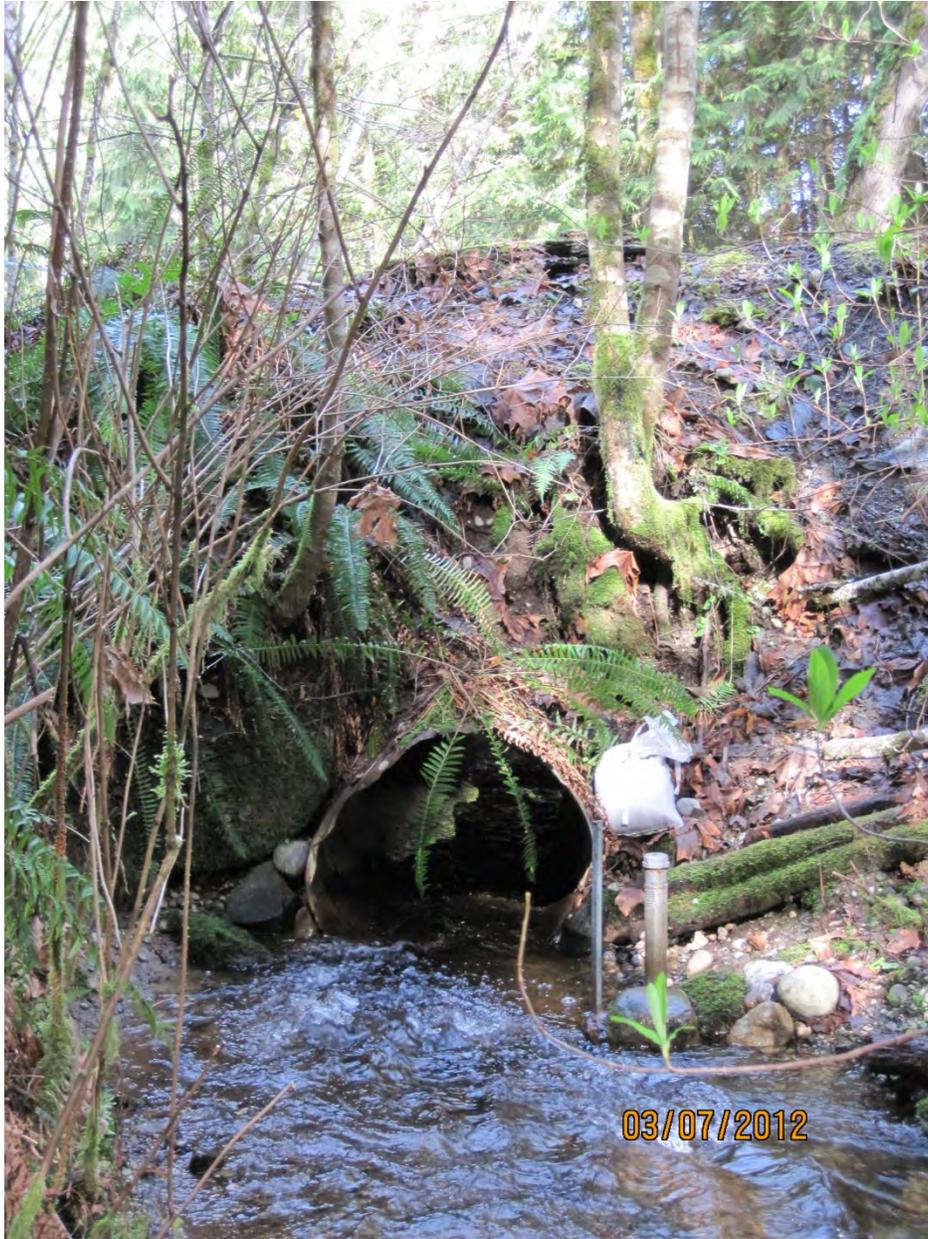
Photo 30. Reach 2 – Downstream end of Reach 2, looking downstream into the 36-inch diameter corrugated metal pipe at NE 25th private residential driveway. The pipe graduates from 36-inch diameter cpm, to 48-inch smooth steel, and then to 54-inch diameter cmp, all within driveway prism. The King County stream flow gauge is on the right, next to pipe. Note partially crushed, rusty, old pipe.

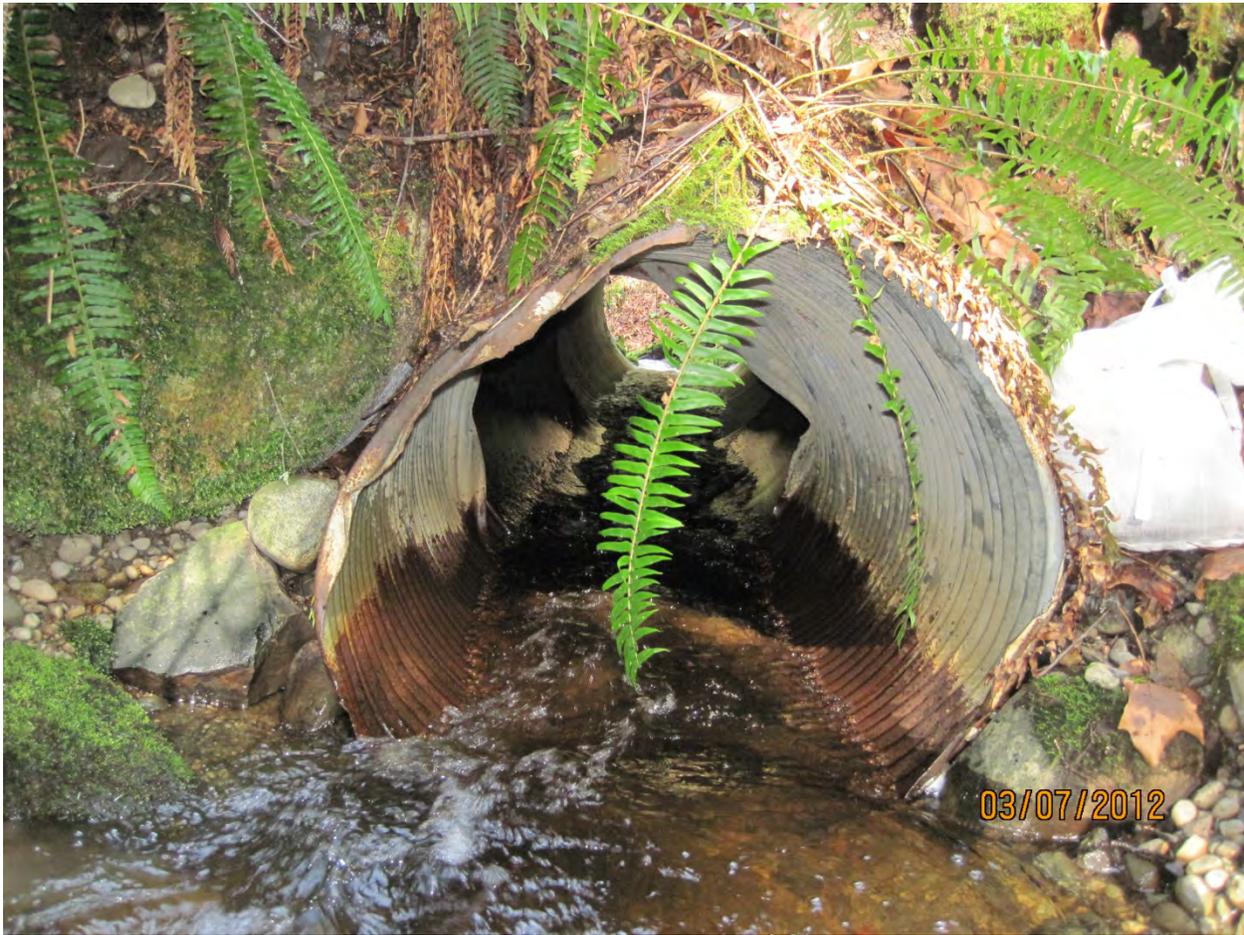
Photo 31. Reach 2 – NE 25th private driveway culvert, upstream end showing height of roadfill prism (about 6 feet above top of 3 foot diameter culvert).

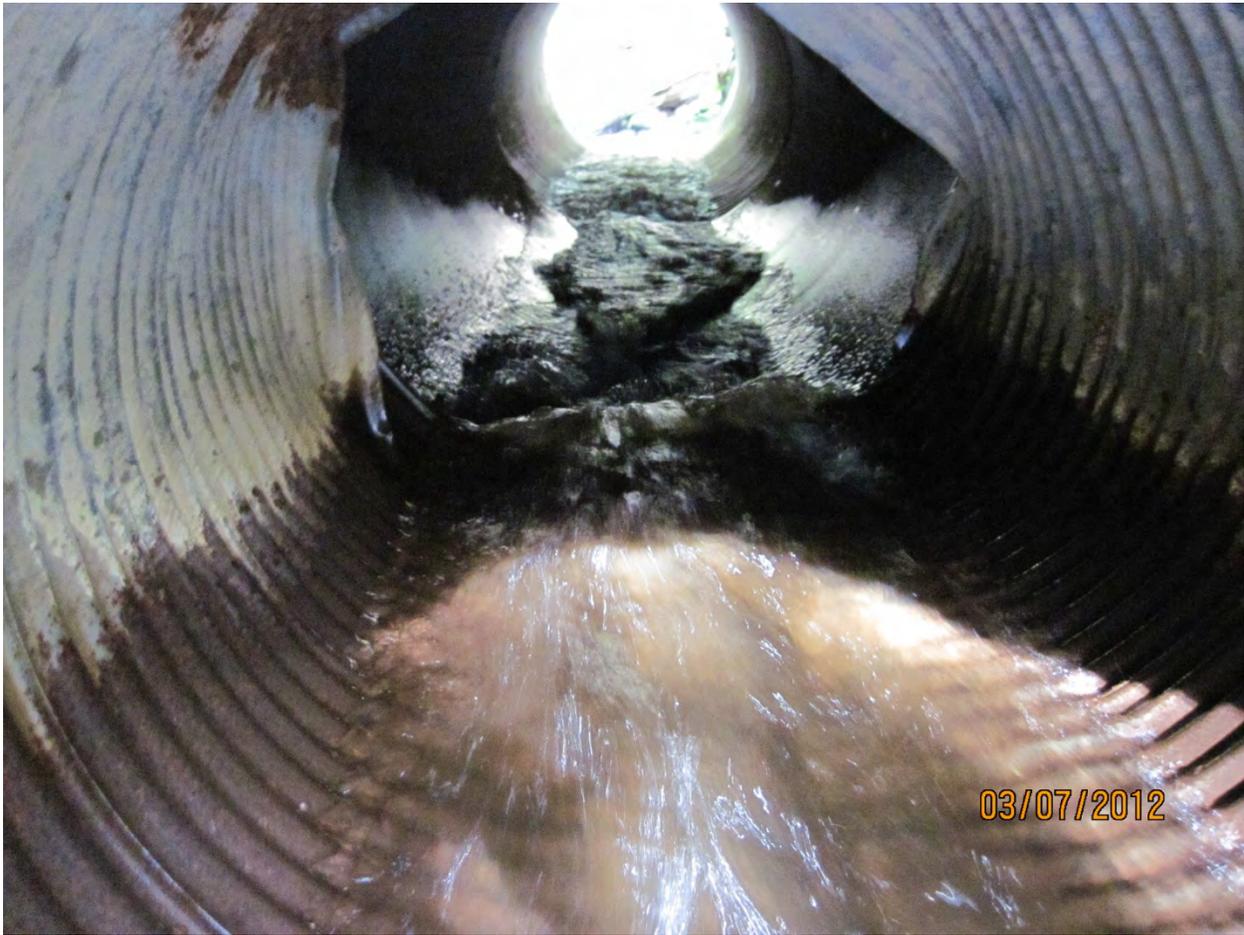
Photo 32. Reach 2 – Close up of NE 25th private driveway culvert (corrugated metal pipe) showing poor condition of upper pipe segment. Pipe is rusty, partially crushed, and appears to have been crimped to fit inside the larger 48-inch diameter smooth steel pipe in the center. There is a one foot drop off the 36-inch pipe segment into the 48-inch pipe that impairs upstream fish passage due to high velocity, turbulence, and no pool.

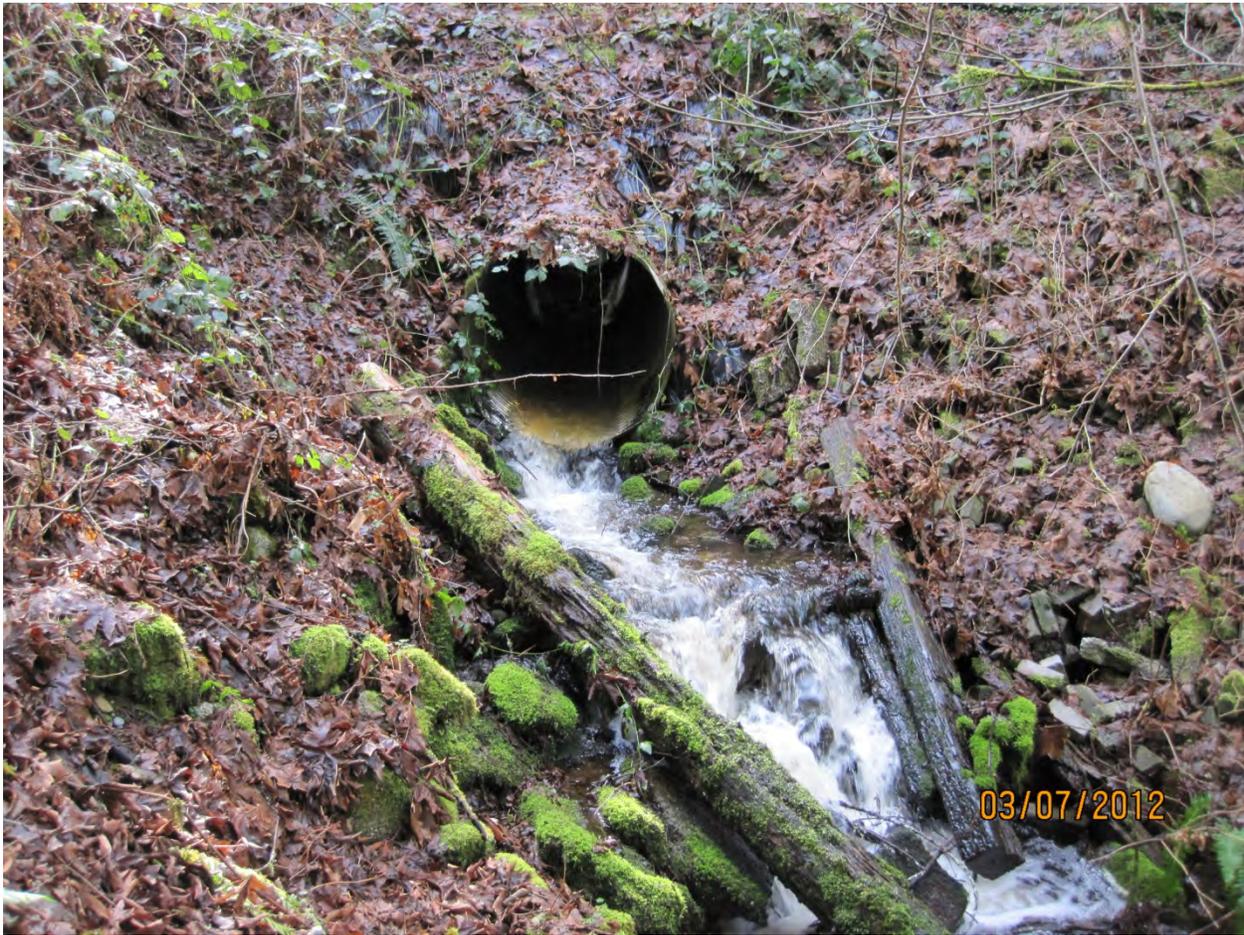
drops, each with poor hydraulics for upstream fish passage. The first internal fish passage problem is a drop at the 48 inch smooth steel pipe connection to the larger (and newer) 54 inch diameter CPM. The second is a drop from the partially crushed 36 inch diameter CMP to the 48 inch smooth steel culvert at the hand grouted connection. This drop creates a reverse wave due to high velocity flow. The third fish passage problem is located at the pipe's upstream entrance at a drop from the aggraded streambed, down into the damaged (partially crushed and rusty) 36 inch diameter CMP (see Photo 32). Additionally, the 12 foot long smooth steel pipe presents velocity challenges due to not only steep gradient, but the smoothness of the pipe provides no hydraulic roughness to facilitate fish passage. The homeowners were surprised and unaware of the fish passage problems at this private driveway culvert, and expressed a desire to remedy the situation. Information on potential grant funding was forwarded from the County to the current owners.

Photo 33. Reach 3 - Upstream end of Reach 3, inside 36-inch diameter pipe at NE 25th, looking downstream. Note the two drops at both connection points of the successively larger diameter pipe segments, and the high velocity flow inside the 5% to 7% steep pipe. These factors impair upstream fish passage.

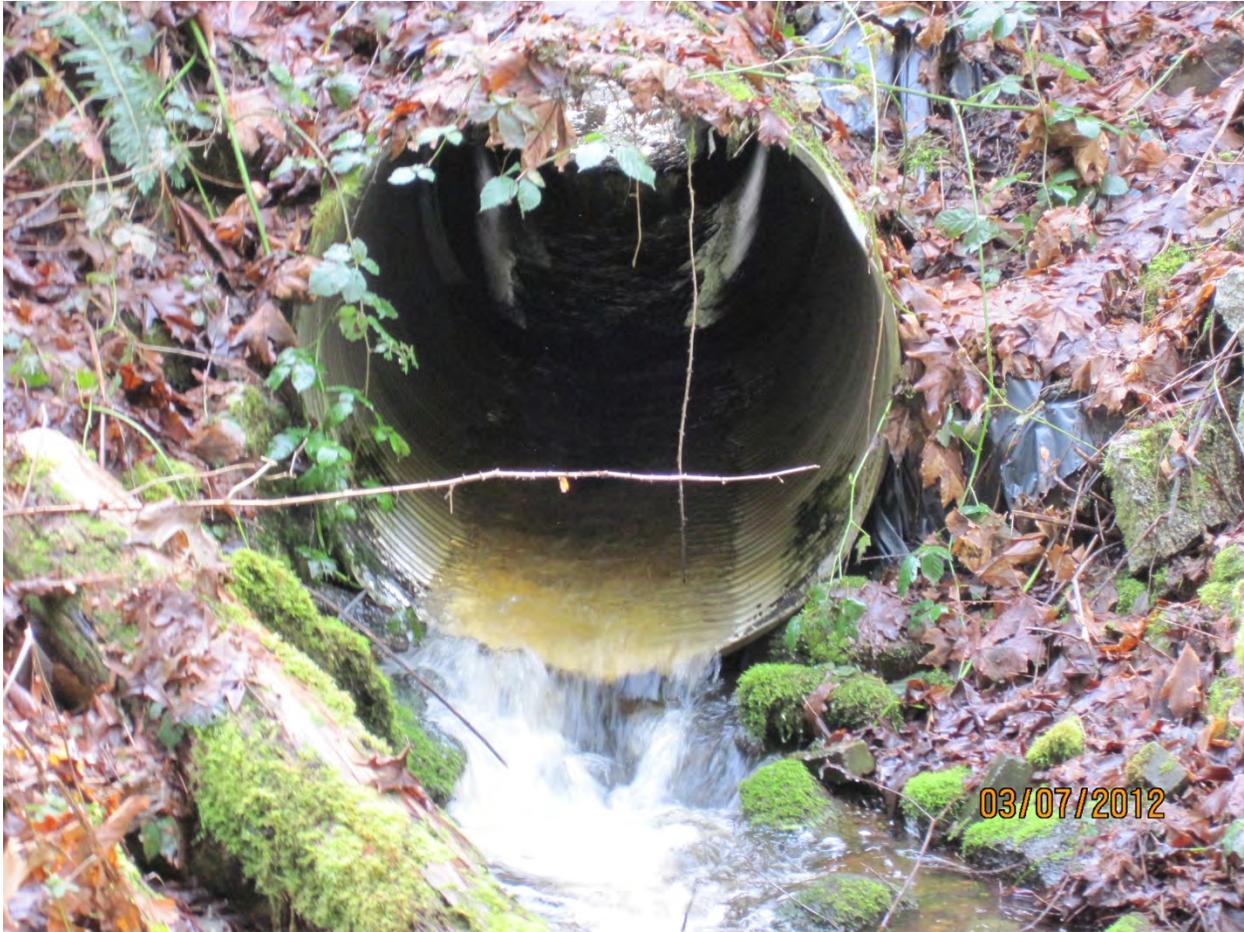
Photo 34. Reach 3 – Downstream outlet of 54 inch diameter corrugated metal pipe at NE 25th private driveway. One foot drop in combination with shallow, small plunge pool, and debris (concrete chunks, brick, railroad timbers) strewn steep cascade do not allow fish passage. The first fish passage barrier on this stream.

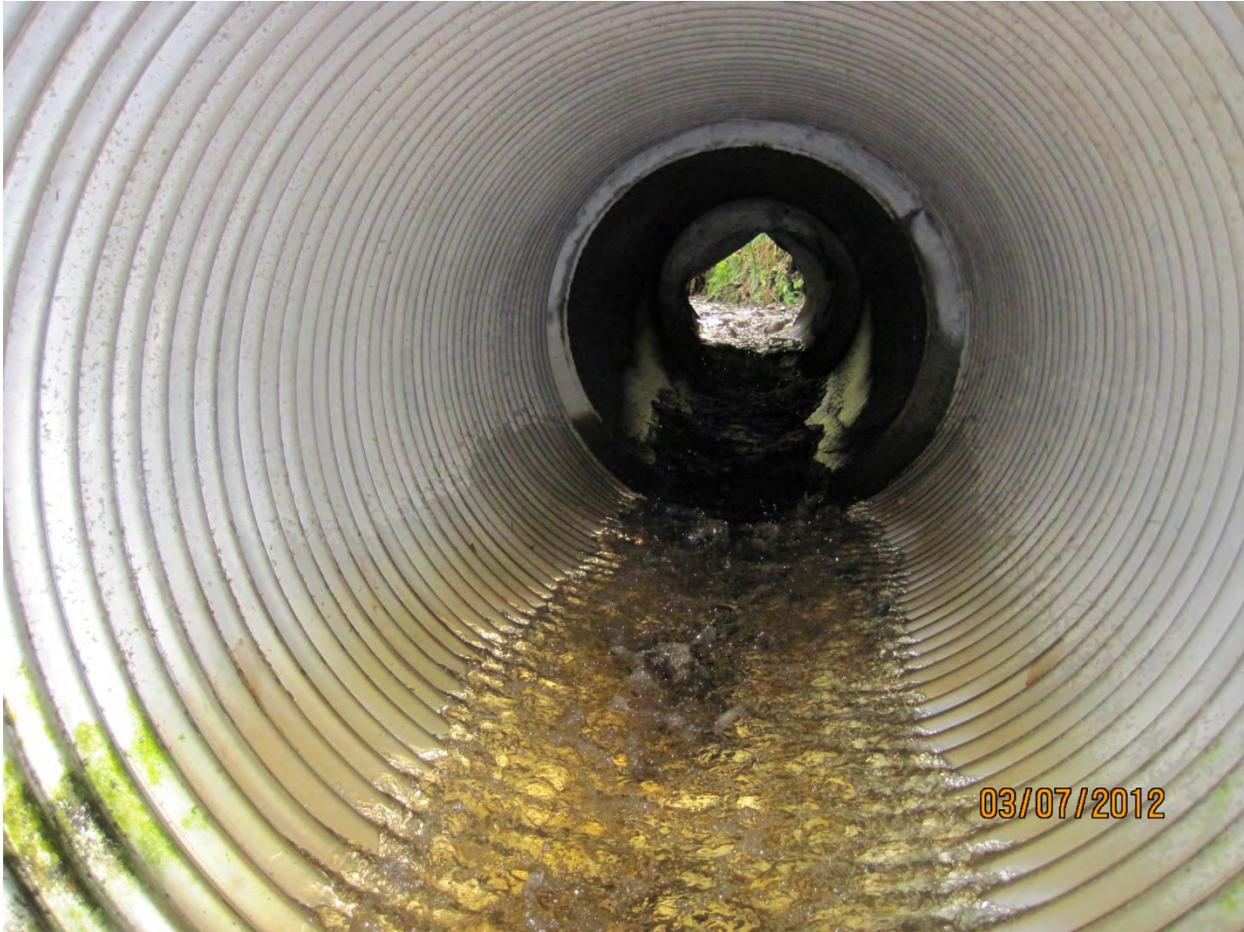
Photo 35. Reach 3 – Close up of poor fish passage conditions at private driveway 54 inch diameter culvert. Steep gradient of culvert produces high water velocities, and one foot drop into shallow, small plunge pool does not allow adequate depth to leap into or navigate through culvert.

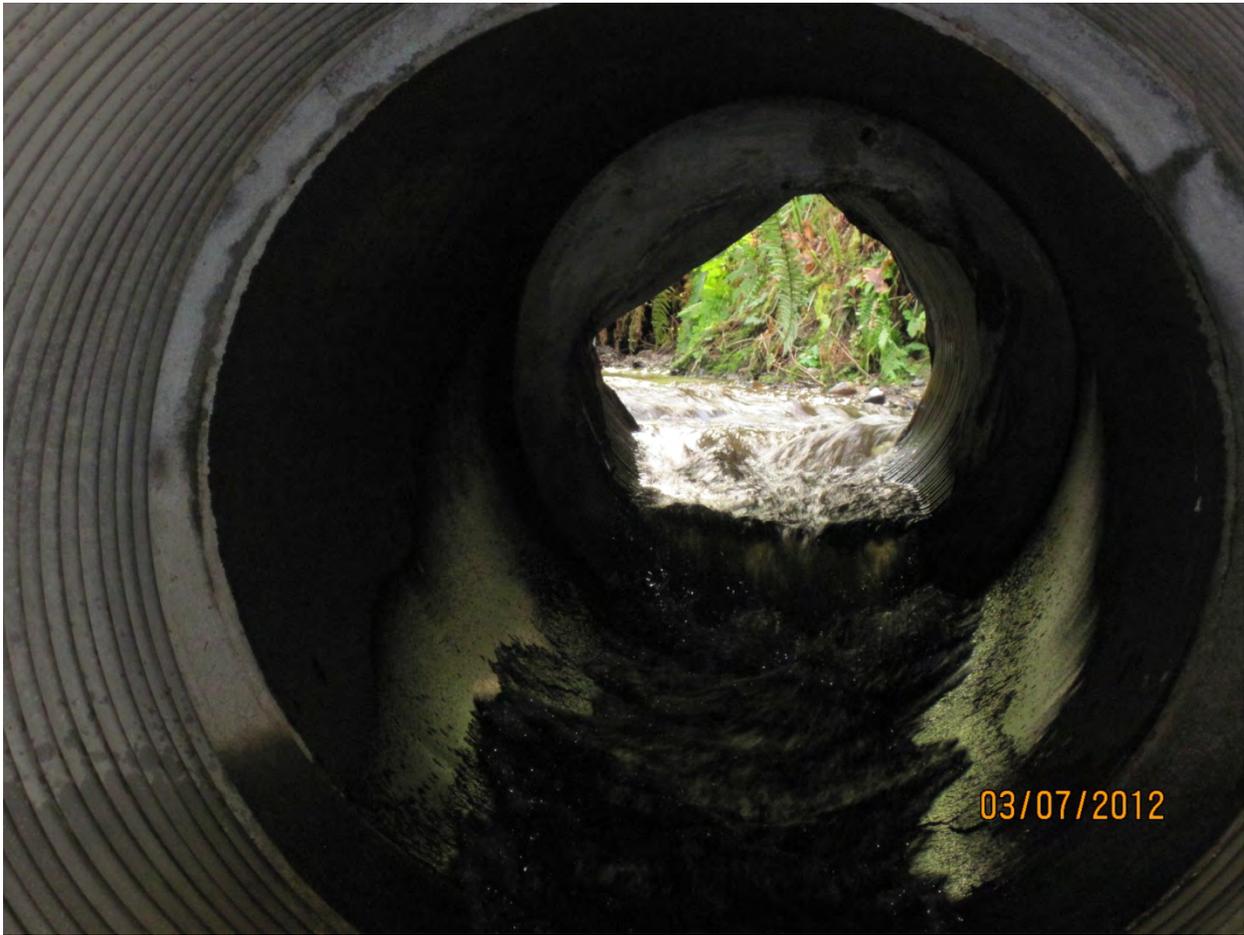
Photo 36. Reach 3 – Upstream end of Reach 3 at impassable culvert at NE 25th private drive. Culvert is composed of 54 inch diameter cmp, 48 inch diameter steel pipe, and 36 inch diameter cmp. Note high velocity flow due to steep 5% to 7% grade.

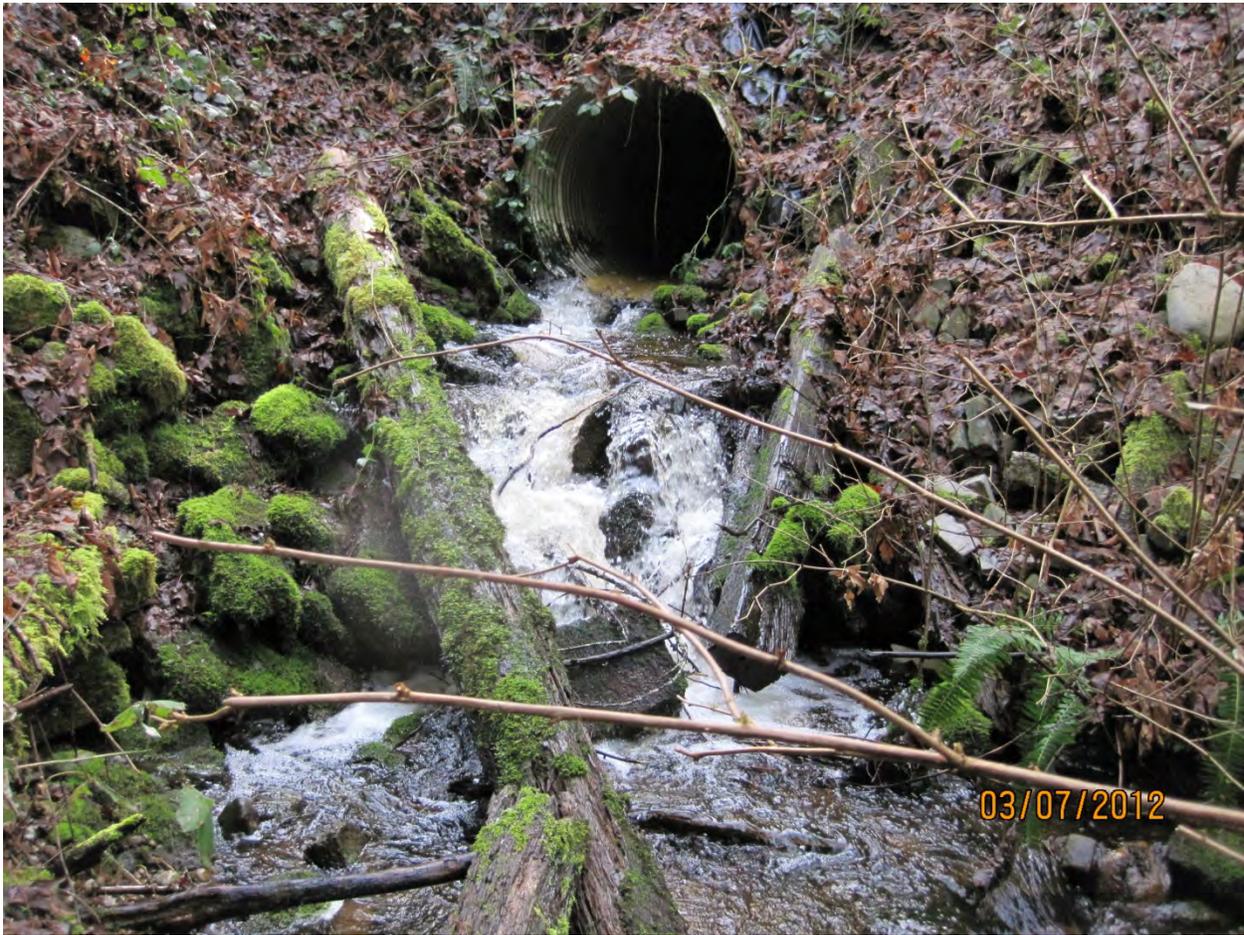
Photo 38. Reach 3 – Fish impassable culvert outlet at NE 25th private driveway. This view looks through pipe, so is slightly different viewpoint than Photo 39.

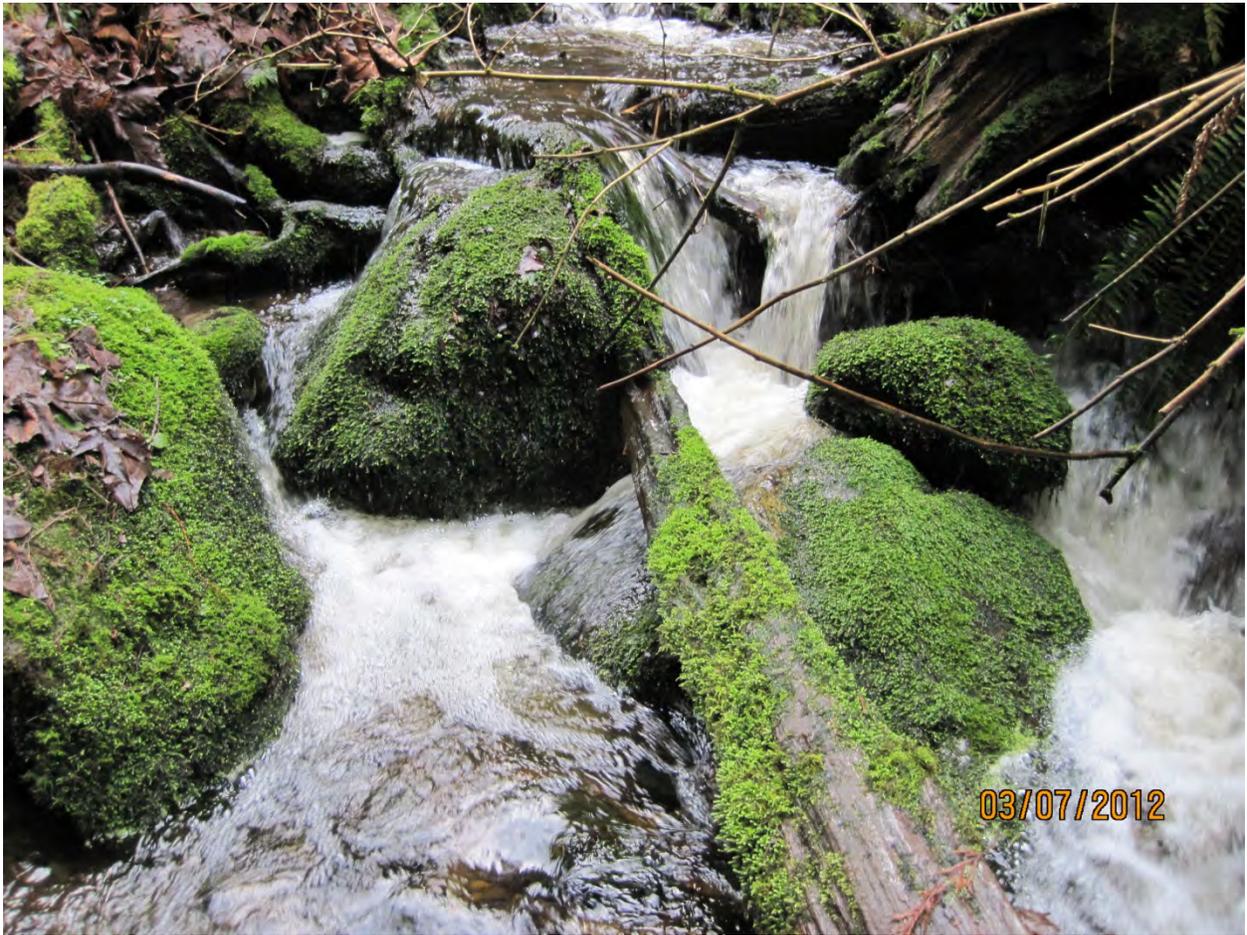
Photo 39. Reach 3 – Downstream end of NE 25th private driveway's 54 inch diameter culvert and steep outfall area of rubble. Determined to be fish impassable. This is the first impassable upstream migration barrier to fish on the Allen Lake outlet stream.

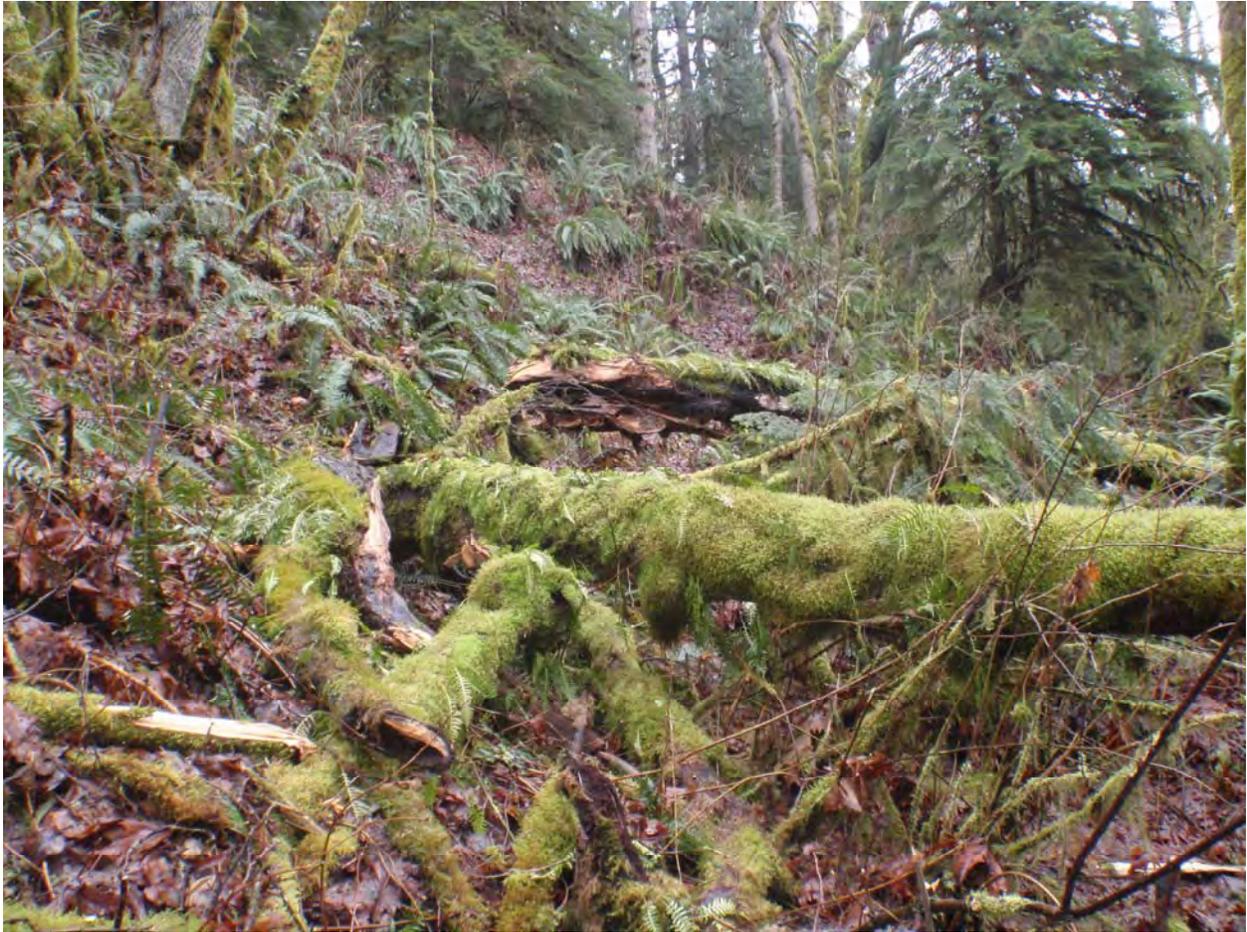
Photo 63. Reach 4 – Olympic interbeds with groundwater seepage from colluvium contact.
