**PHASE II ENVIRONMENTAL SITE
ASSESSMENT REPORT**

South Park Bridge Replacement Project
Seattle, Washington

King County Department of Transportation

September 2009

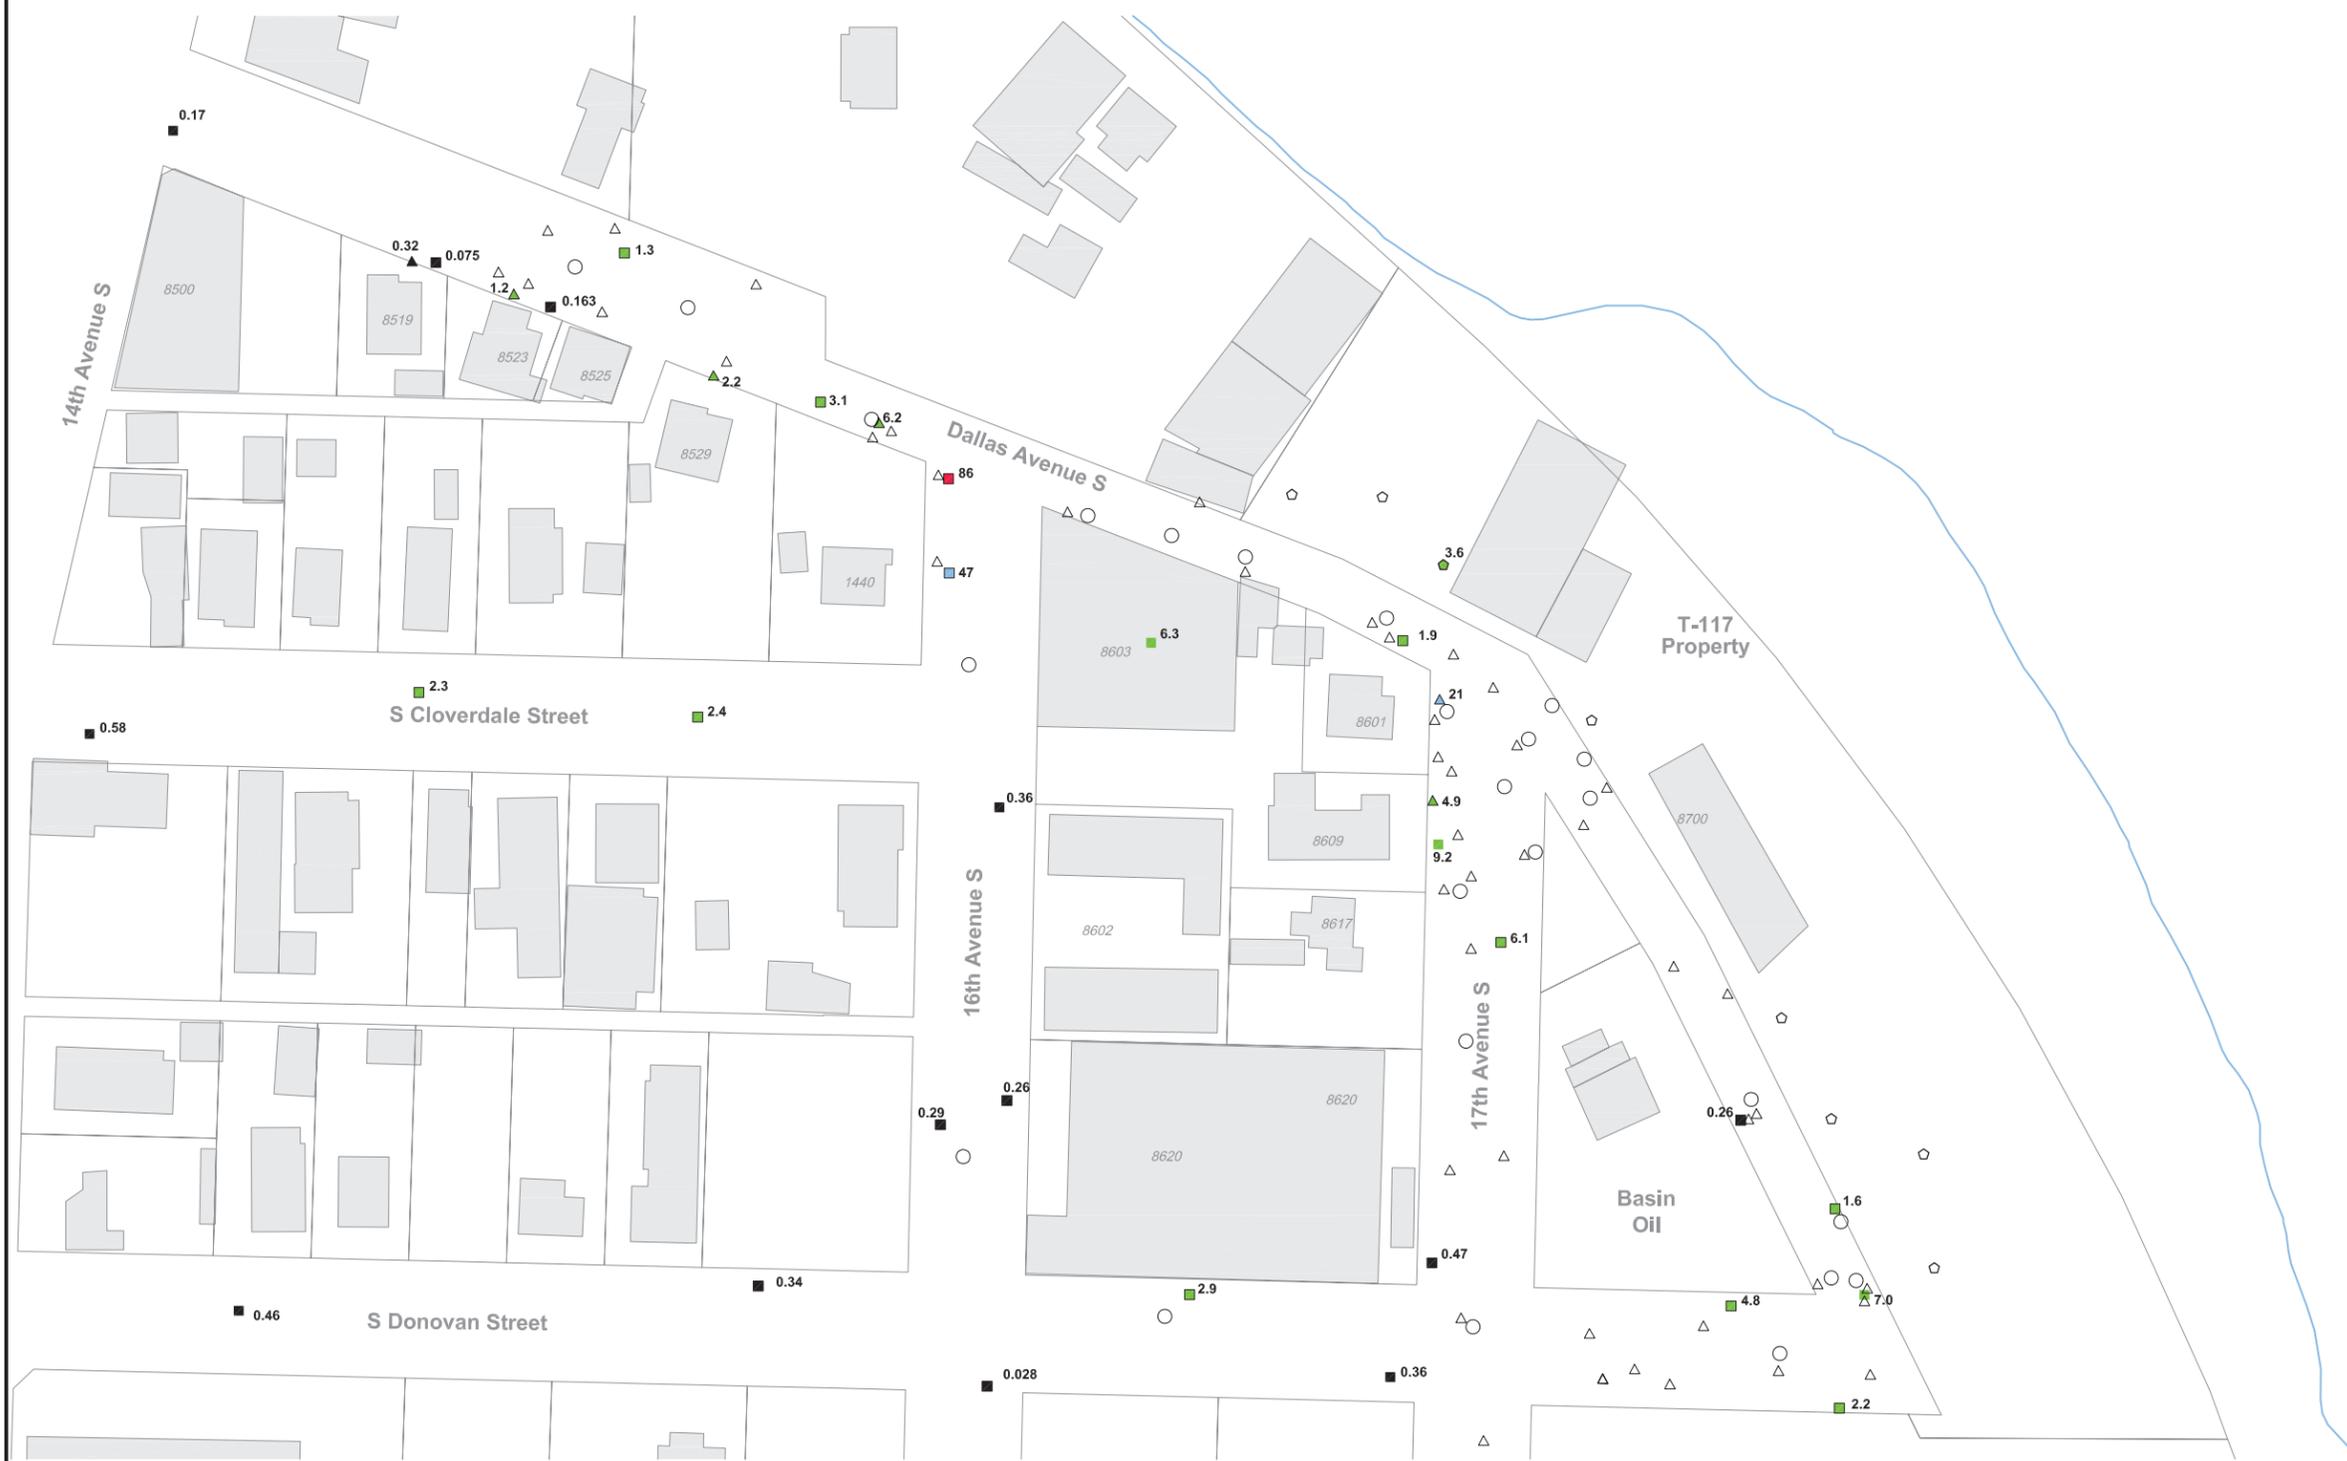
Figure 3.
Surface soil PCB concentrations,
South Park Neighborhood, Seattle

The nearest surface soil samples collected along Dallas Avenue South exceeding the PCB cleanup criterion were found approximately 200 feet east of 14th Avenue South (Figure 3). Composite samples of street dust and sediment from drop inlets inside catch basins were collected further west beyond the main contaminated area at 11 sample locations, including the southeast corner of 14th Avenue South and Dallas Avenue South (PCBs were found at 0.17 mg/kg in a catch basin, below the MCTA Method A cleanup level of 1 mg/kg).

Following the sampling effort in December 2004, SPU implemented extensive interim source control measures that included removing contaminated soil from roadway shoulders and replacement with clean gravel along Dallas Avenue South east of 14th Avenue South; grading and paving Dallas Avenue South, South Donovan Street, and 17th Avenue South roadways; and installing a temporary stormwater collection and treatment system to control stormwater runoff
