South Park Bridge Replacement Offsite Analysis Field Inspection

A field inspection analysis was performed on December 31, 2008 for the South Park Bridge Replacement project. The inspection was conducted with the intent of evaluating one mile upstream and downstream of the proposed project to determine the conditions of the existing drainage patterns and discharge locations. The investigation was conducted keeping in mind how the proposed improvements could potentially impact the existing drainage patterns and conditions. The field visit was performed to meet and exceed the requirements established in the King County Surface Water Design Manual (2005, page 1-21, section 1.2.2). Due to fencing, security barriers, and lack of permission to cross private properties, the shoreline was not walked the full mile up and downstream of the project vicinity. Visual inspection of the shoreline and outfalls were performed from the limited area open for pedestrian access, up on the bridge, and from vantage points across the waterway to the opposite shoreline. Photographs were taken to document field observations and findings. Where access was available adjacent to the waterway, the area was walk

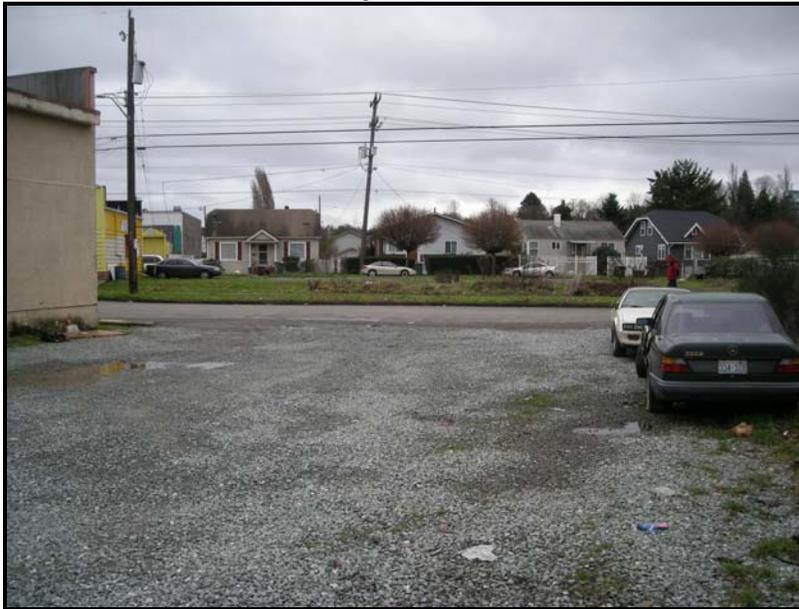
- 1) Photograph of the existing gravel driveway graded to drain toward Dallas Avenue S. on parcel number 2185001045. The existing gravel driveway is graded behind the “bar” to drain from the brick road west around the building and discharge onto Dallas Avenue South. The left corner is the existing “bar” and straight ahead is the elevated parcel 7883607340. The existing bar drains away from the building toward the raised tire stops adjacent to Dallas Avenue South. Dallas Avenue south drains west toward existing catch basins and combined storm/sewer system.

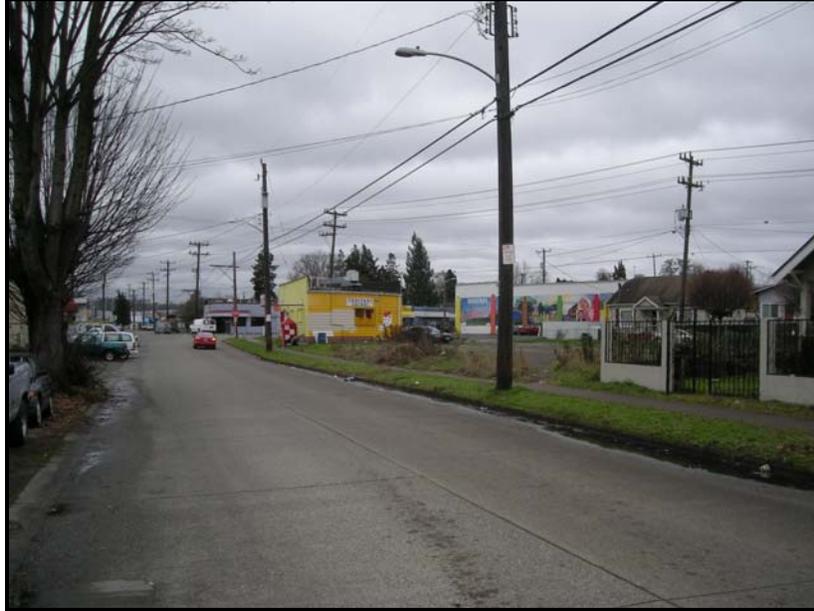
- 2) This photo is looking east up Dallas Avenue S. toward the intersection with 14th Avenue South. To the left of the picture, the existing sidewalk is broken and unusable due to the tree roots. The gutter on the left side of the street is a “thickened edge” gutter one foot wide and raised approximately one tenth of a foot to channel water toward a catch basin. On the right is parcel 7883607340 that is elevated above the existing street and drains mostly toward South Sullivan Street. This photo also represents the wet gutter areas that are not well draining. This location is the approximate location for matching between the existing and proposed construction. The standing water on both sides of the street is indicative of flat gutter grades and an inadequate number/spacing for inlets.

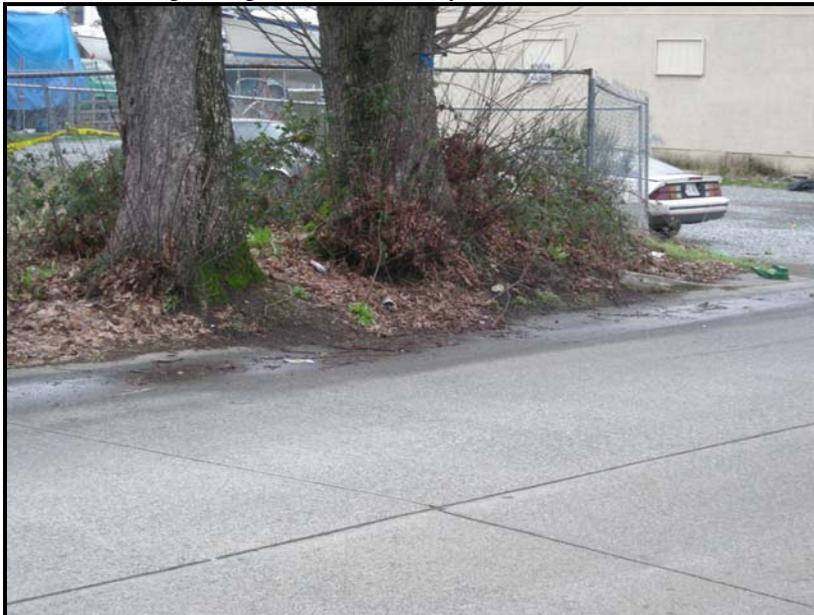
- 3) This photograph is a close-up of the faulted concrete “flat-work” adjacent to the driveway and un-kept flow line. These two trees may need to be removed as part of the project to correct the drainage condition. The roadway is concrete and the panels around these trees may need to be removed due to roots growing under the roadway.

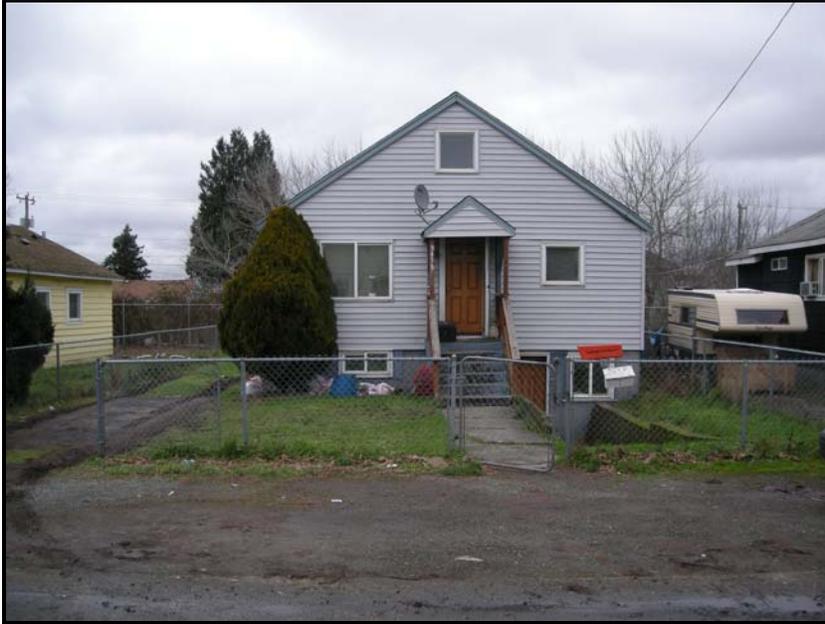
- 4) This photograph was taken two lots west of the “bar.” This parcel does not drain onto the roadway and the thickened edge of pavement is the only barrier separating roadway water from the existing parcel. The existing driveway is muddy and shows signs of saturation due to the lack of on-site drainage. An existing concrete ramp is graded to the basement and is overgrown with moss. The right corner post of the building is showing significant signs of rotting and deterioration on the siding indicating a long term drainage problem with this property. The cracked walkway also indicates long term settlement on the property. We could not determine from a field visit if drainage plays a part in settlement issues on this lot.

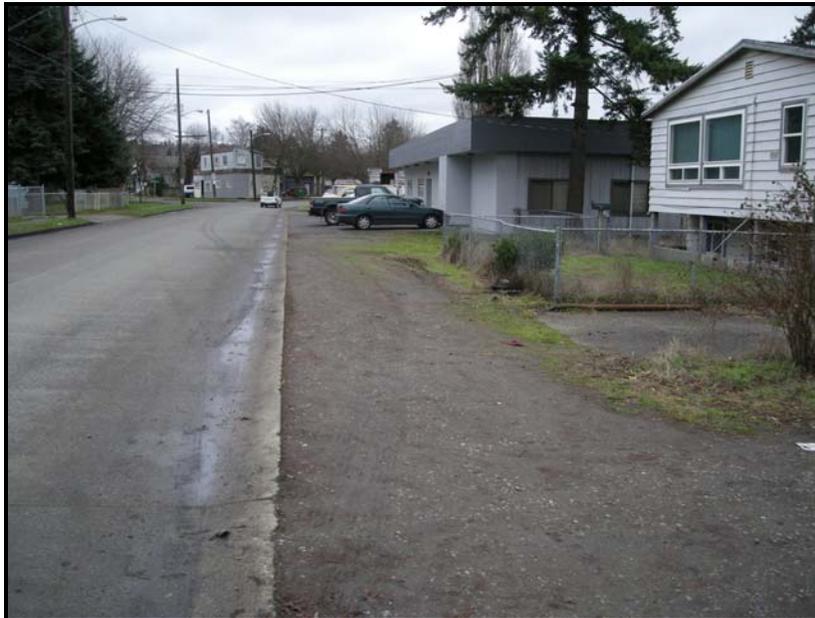
- 5) This photograph shows the thickened edge of the roadway and the slope of the gravel surface away from the road. Since private parcels drain away from the roadway, they will not be included in the tributary areas for the storm drainage design or considered off-site areas for the project. The roadway drainage seems to drain toward the intersection shown in the distance (away from the project).

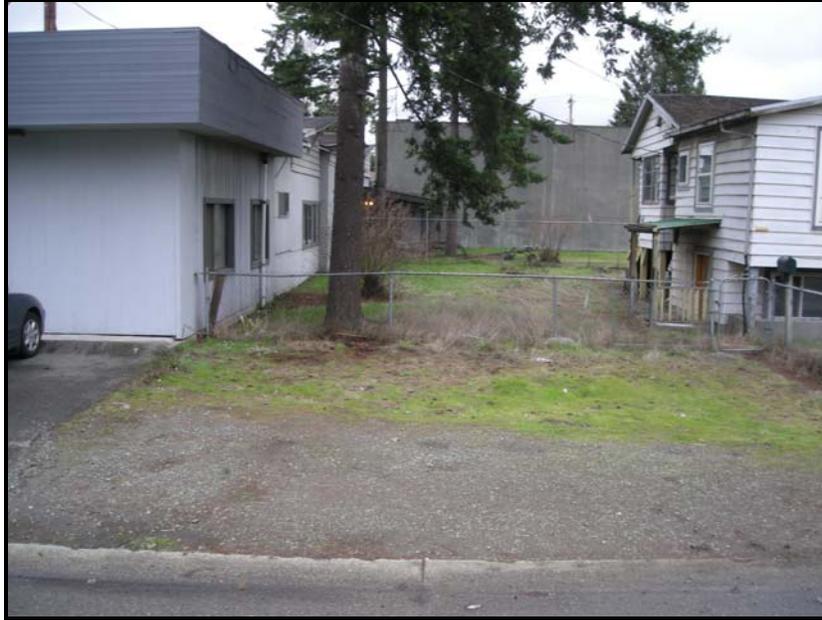
- 6) This photograph shows the relationship between the roadway, property to the left and right. It should be noted, the property to the left is draining directly toward the property on the right. The house on the right shows significant signs of disrepair and damage due to water including rotten posts, siding, and swampy yard area.

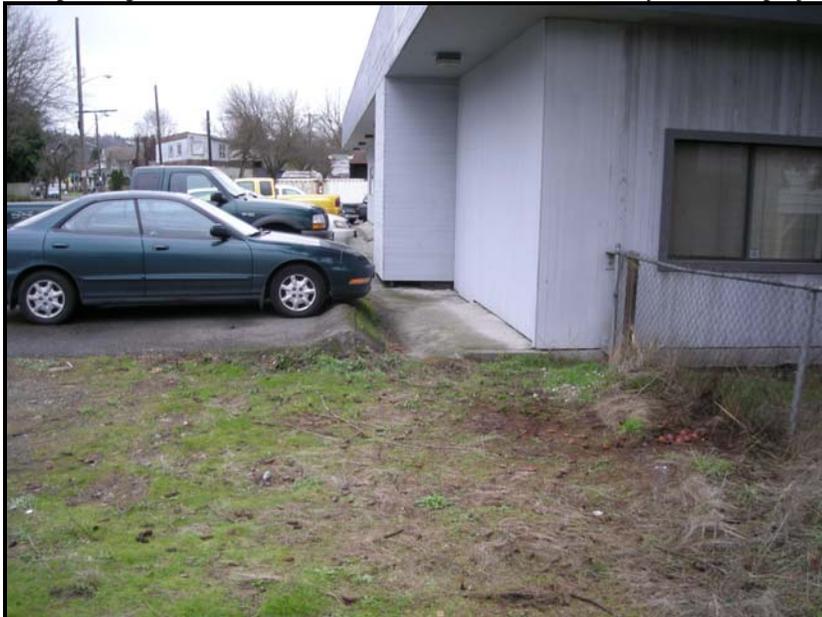
- 7) This photograph is intended to show the formed drainage channel separating the building from the parking lot. This picture shows the formed concrete “V” channel discharging directly toward the adjacent private residence. The grassed area drains directly toward the adjacent properties house. The paved parking area drains toward the street and westward away from the project area.

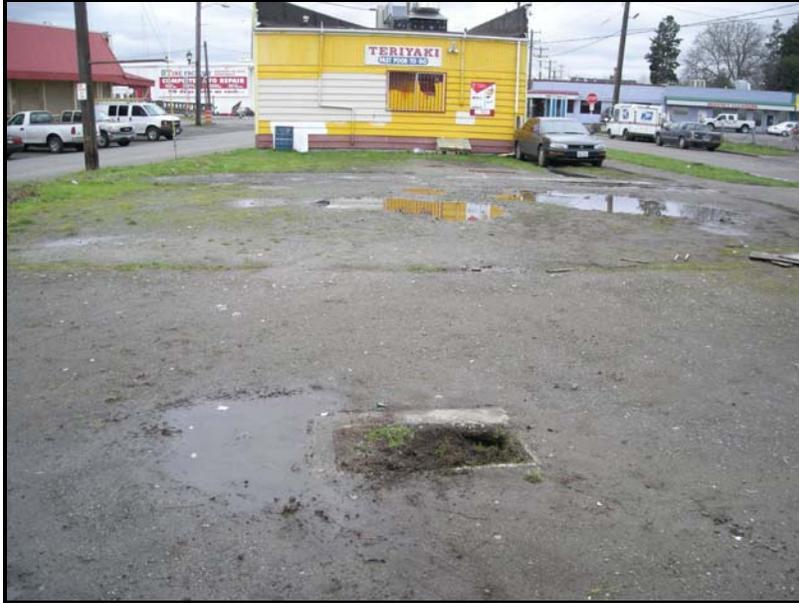
- 8) This photograph shows the cleared lot adjacent to parcel 7883607340. Based on the remaining concrete driveway and wooden buried beam, and drainage structure, this lot used to have a structure in this location. An existing catch basin or cleanout is still in place and a concrete pipe is buried inside the catch basin. The pipe size is approximately 6 inches in diameter and verification of any connection location to an existing system could not be determined.

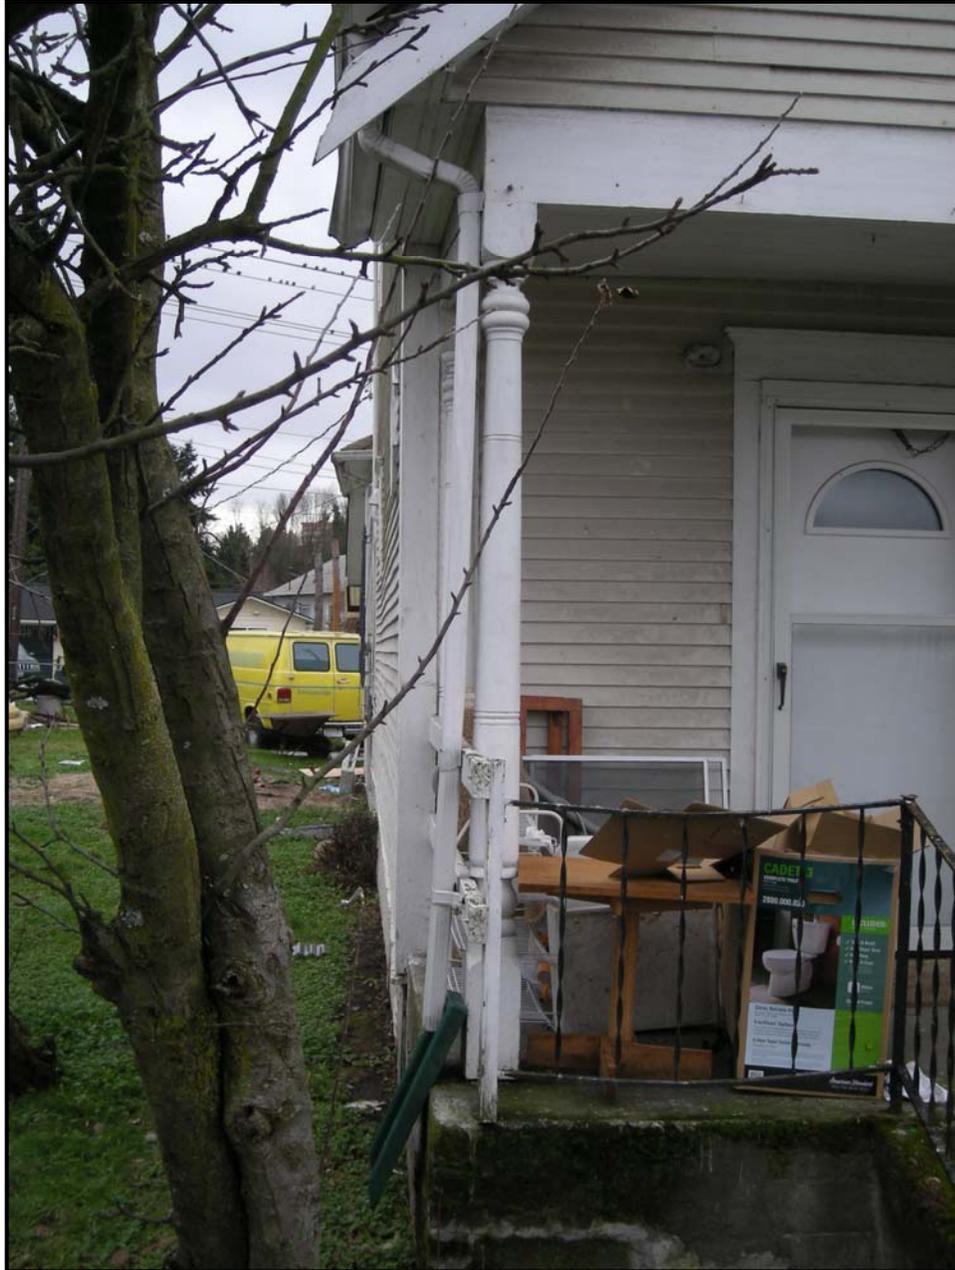
- 9) This photograph shows a general state of disrepair in the project vicinity and the general observed attempt to resolve drainage issues in the neighborhood. Some private residences have downspouts that connect to underground yard drains. We were unable to determine if the yard drains connected to the public system or were infiltration type trenches going to septic systems. In one location (not shown) we were able to identify a 4 inch PVC pipe connecting from a private residence into the public catch basin. Most parcels within the project vicinity are lower than the street or alley and seem to infiltrate runoff.

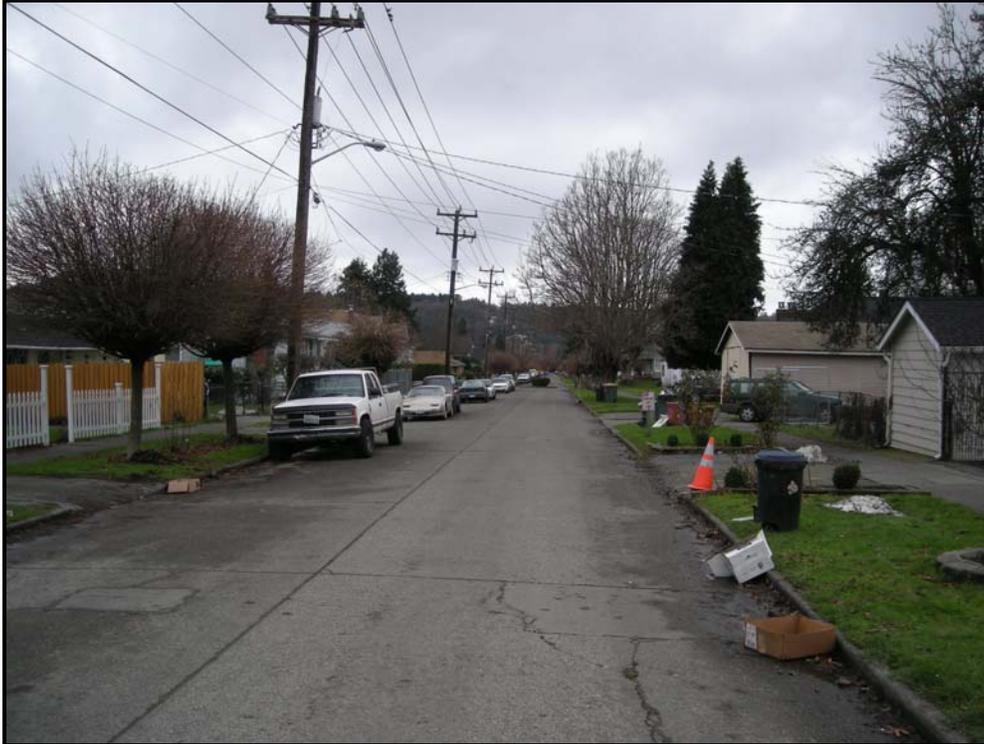
- 10) This is looking west on Sullivan Avenue South showing the curb and gutter condition, the general water ponding and spotting in the flat gutter grades. Some of the driveways on this street drain onto the street from the back of walk. In general, private lots drain from the back of walk into the lot and away from the road. It could not be determined if the water was infiltrating naturally, into french drains, or other underground private drainage systems. A few parking garages have roof drains that discharge onto the sidewalk and into the street. This photograph is at the proposed project limit/ connection location. The street gutters are draining west (away in the picture) and off-site.

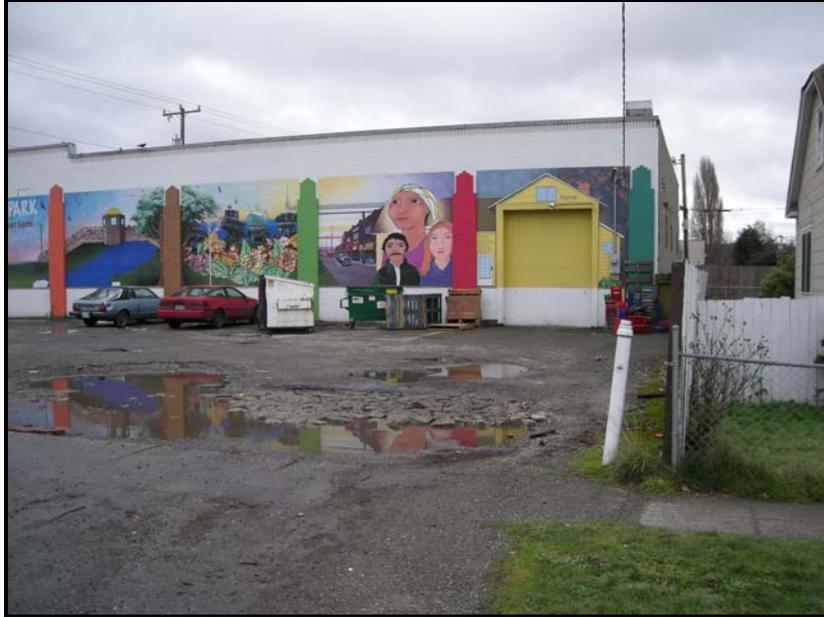
- 11) This is an existing parking lot and driveway access onto Sullivan Avenue South. The parking lot has large potholes that are approximately three to four inches deep. The cause of the significant potholing is unknown and cannot be determined with a field visit. We were unable to determine if the potholing was caused by drainage problems, traffic loading, settling, or other unobserved issues.

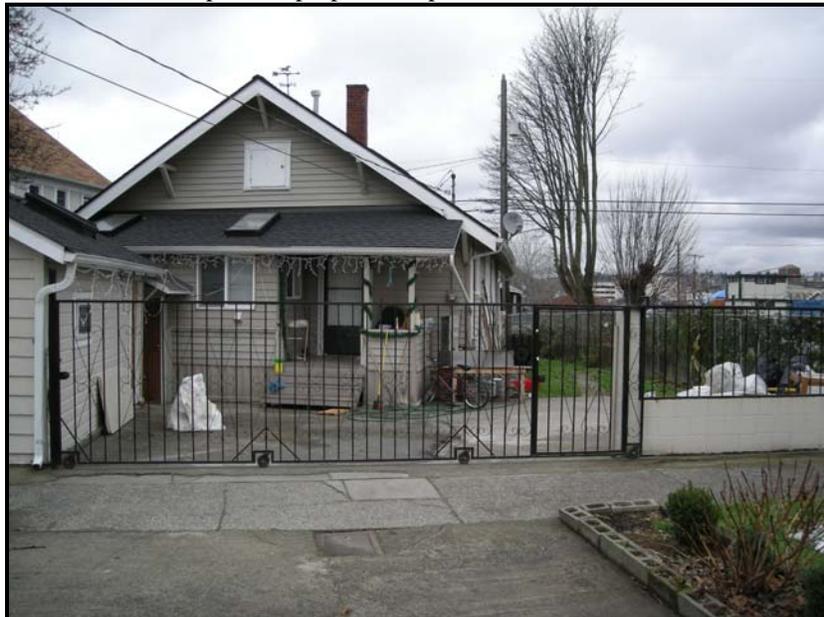
- 12) Photograph from S. Sullivan Street looking north showing the private property grading draining into the lot rather than out onto the South Sullivan Street. The garage downspout is draining into the public right-of-way. However, Sullivan Street drains away from the project limits, and this off-site water will not impact the proposed improvements.

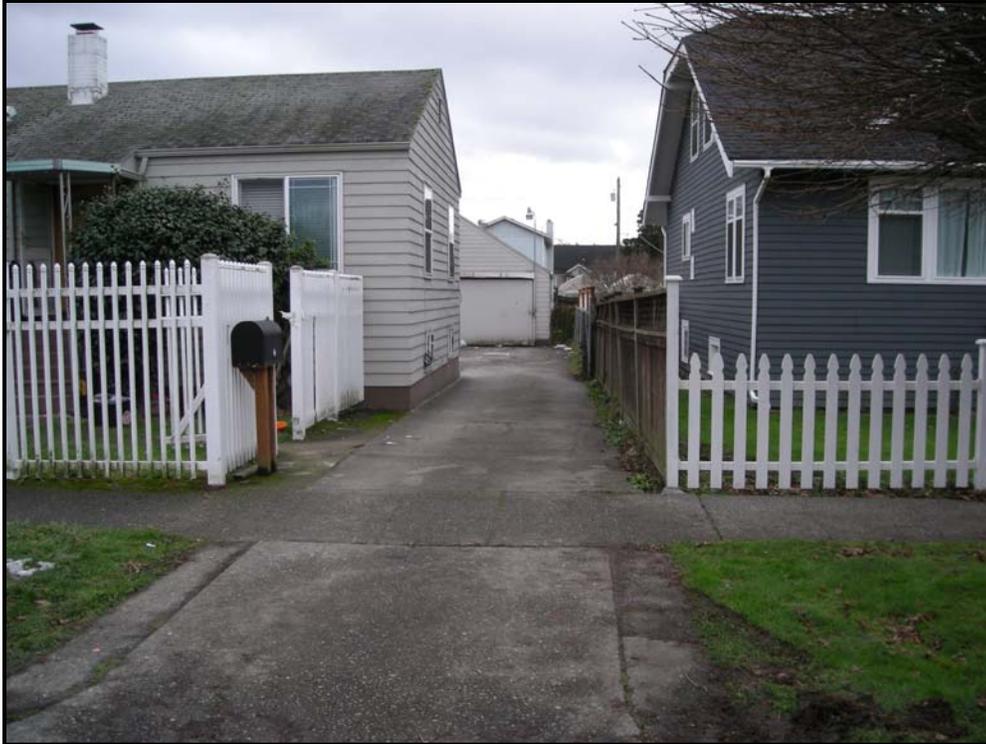
- 13) This photograph is directly across the street from picture number 12 and looking south from S. Sullivan Street. The driveway drains from the house into the driveway, and from the house back into the private lot. No standing water is present, but in the lower right hand corner of the picture the grass planter strip has been damaged by tire ruts. The soil is very wet to saturated with water and was not able to resist rutting under the tire pressure. There does not seem to be any private sprinkler systems in the grass planter areas.

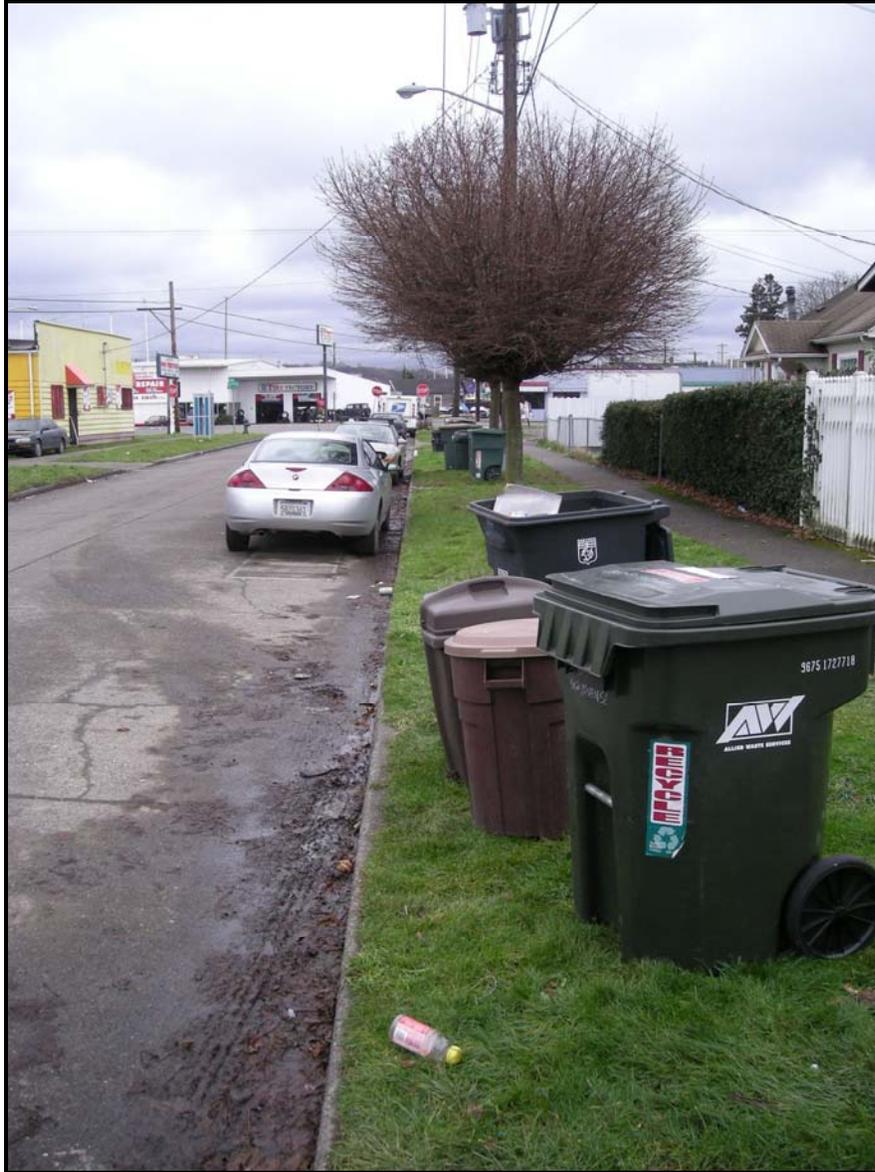
- 14) This is looking east toward 14th Avenue South from S. Sullivan Street. The curb and gutter does not drain very well due to flat grades. The muddy debris and settled particulates in the gutter pan indicates slow moving water and/or standing water allowing settlement in the gutter pan.

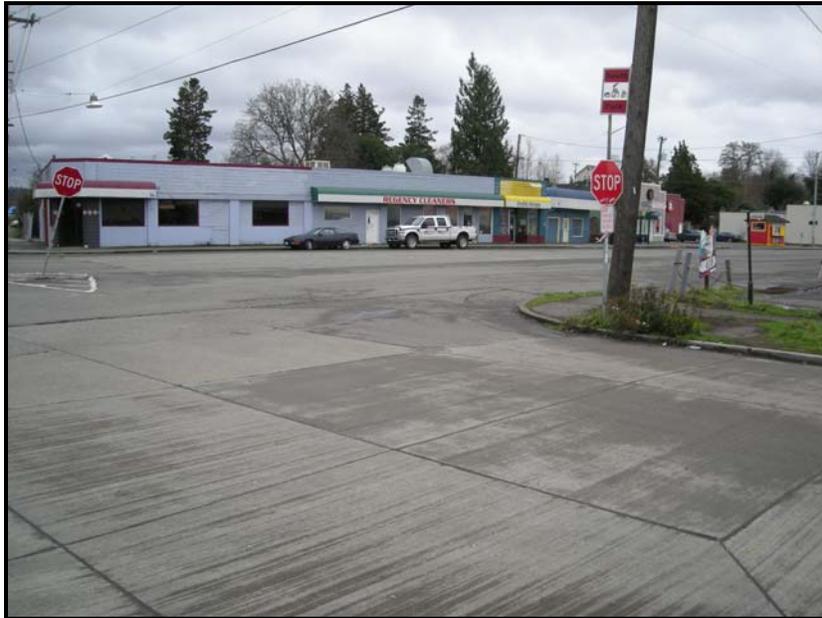
- 15) This is looking east from Dallas Avenue South across the bottom of the bridge approach. The existing roadway is concrete, well sloped and crowned to provide good drainage through the intersections.

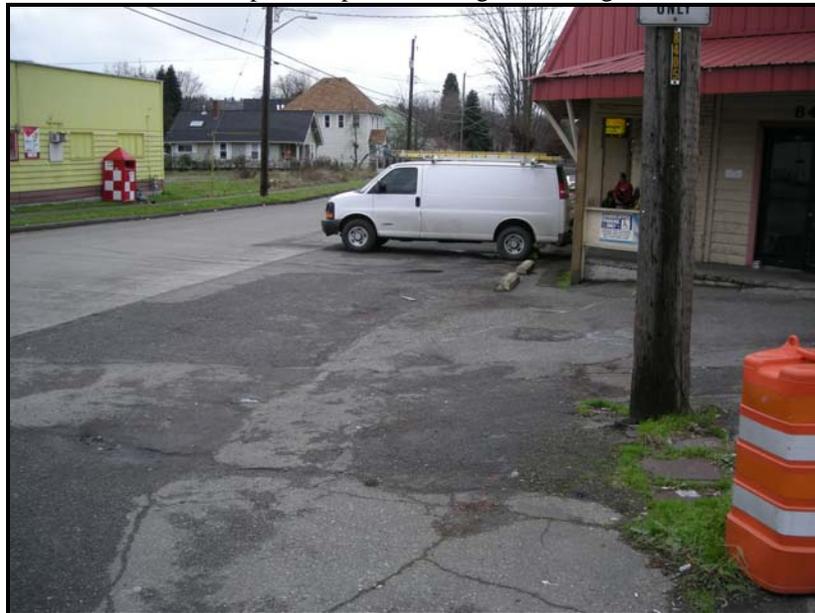
- 16) This picture is looking west toward the County Line Bar. The drainage flow line is under the white van approximately 10 feet from the edge of the building. Existing catch basins collect the water and convey it in the combined storm/sewer system. The existing surface within the project is a combination of concrete, asphalt, exposed earth, gravel, and grass.

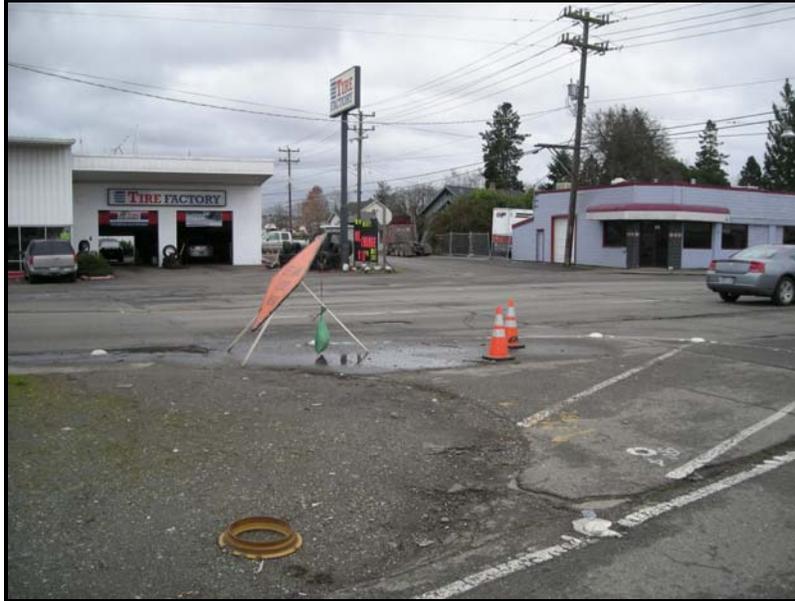
- 17) This is the gore area at the bottom of the bridge that drains into the existing catch basins and combined storm/sewer system. There is not any curb and gutter on the bridge. The walk seems to be cast integral with the roadway and has small 2 inch diameter pipe scuppers. The scuppers were plugged with sand during the field visit. The maintenance program in place for unplugging the scuppers has not been investigated. We are assuming all water from the abutments is draining down into the catch basins located at the bottom of the approaches.

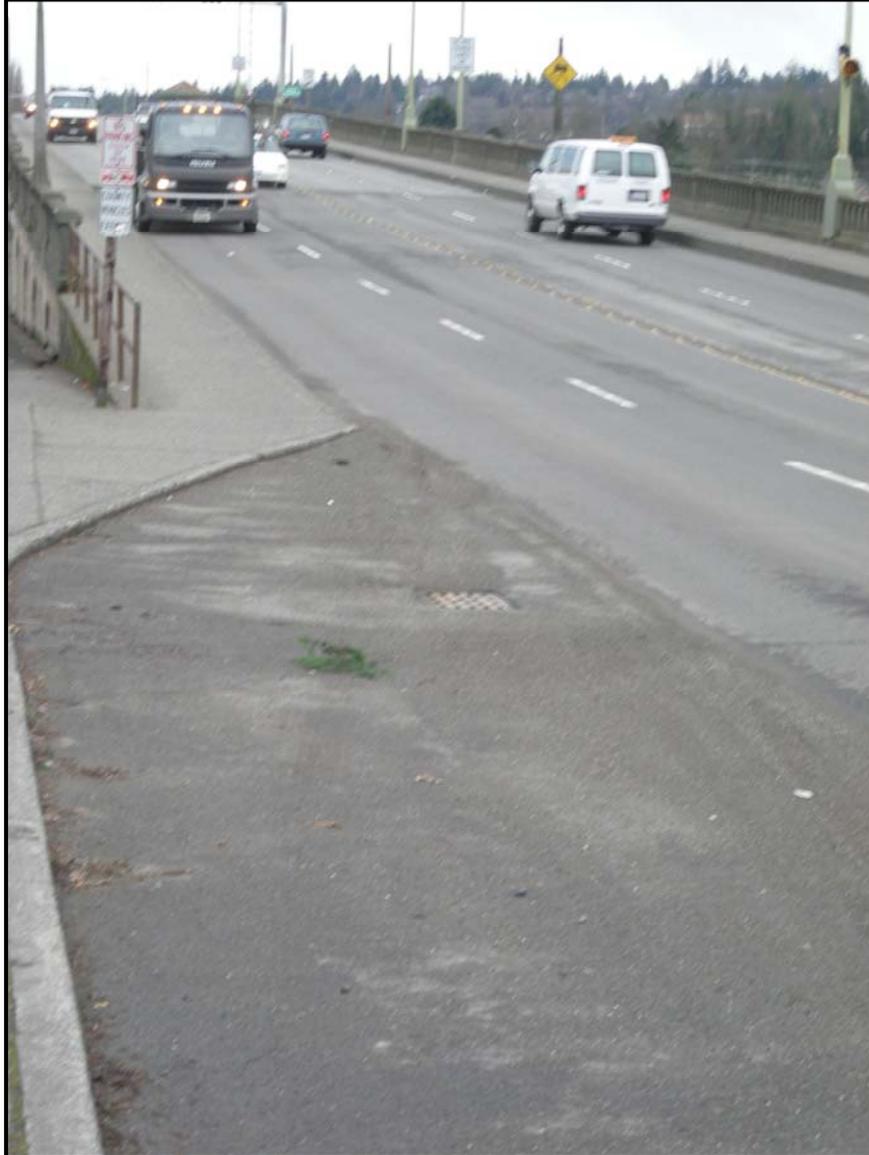
- 18) This is the Boeing side of the bridge looking south. The bridge approaches drain down into the catch basin at the bottom of the grade. The roadway is crowned in the middle of the road and slopes at approximately 2% toward the fog line/ flow line. The curb line is not the flow line and drains away from Boeing toward the catch basin in the street. In a sense the roadway section forms a “W.”

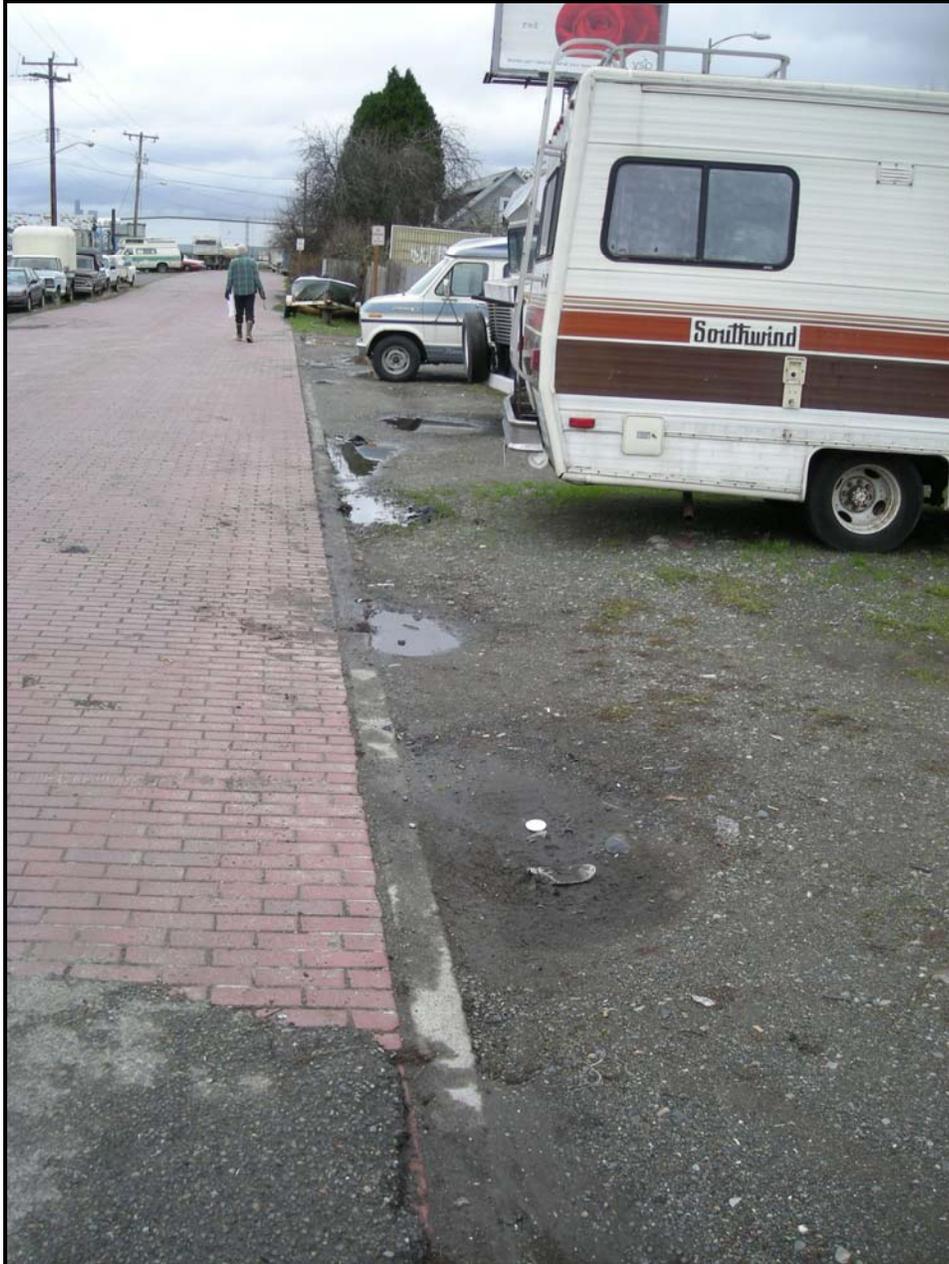
- 19) This photograph of the brick road is looking south toward the river from the south end of the bridge. The existing brick road is crowned to drain to the left and right. On the right (west side of the road), the water drains down into a low hole under the bridge. Standing water was observed under the bridge abutment wall. Two catch basins are located under the bridge. The catch basins have not been surveyed. The pipe connections, direction of flows, and depth of the pipes needs to be determined for the storm drain design.

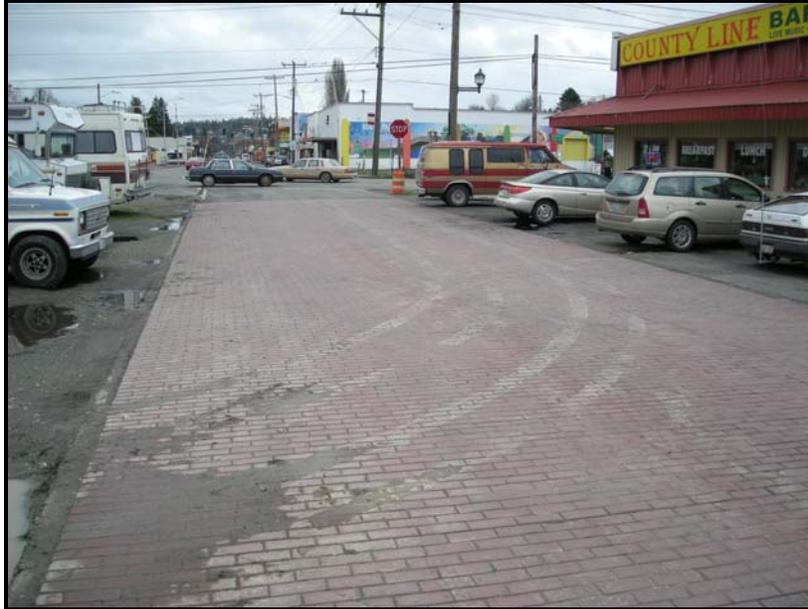
- 20) This photograph is the same location as picture number 19, looking south. The natural drainage pattern is toward the bottom left of the picture and down into the area under the bridge.

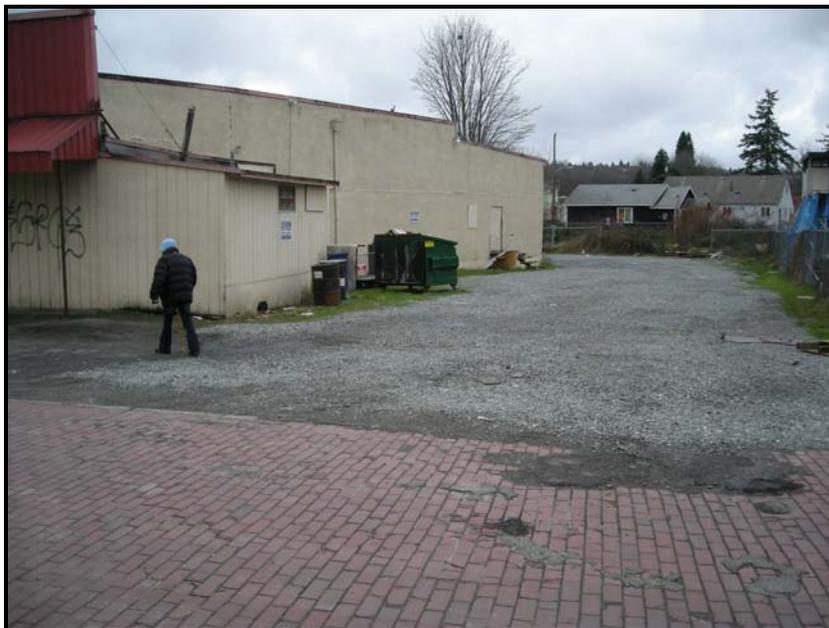
- 21) Photograph of the gravel driveway behind the County Line Bar draining behind the building toward Dallas Avenue South. It is possible some of the water surface drains toward the boat repair yard.

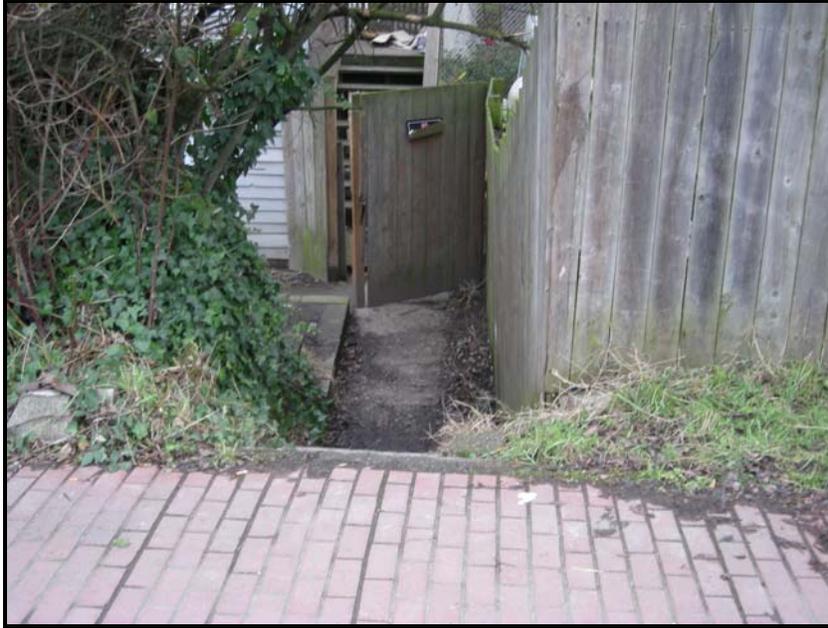
- 22) This picture shows the vertical elevation drop from the brick road down into the private lot adjacent to the bridge and abutment walls where the ponding was observed.

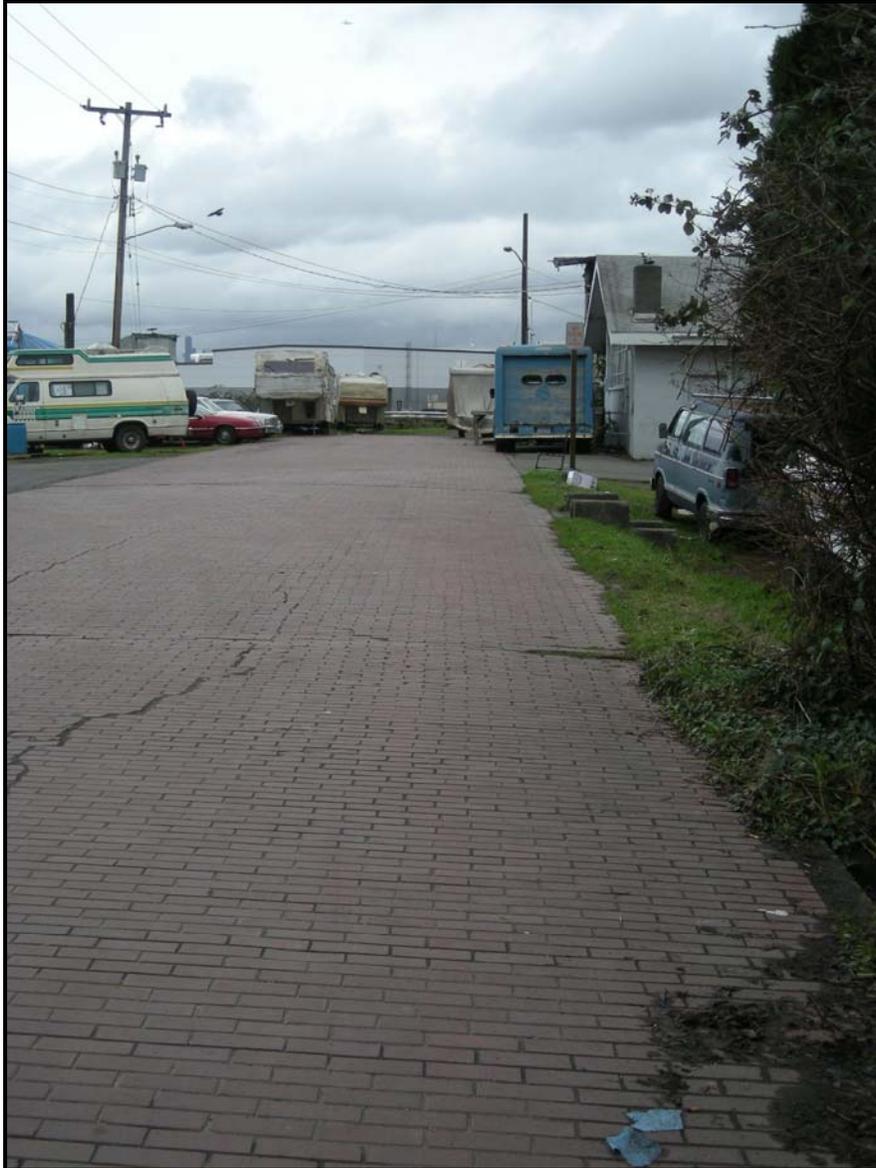
- 23) The brick road looking toward the Duwamish Waterway shows signs of settling. The existing roadway is crowned and even parabolic in some locations. No standing water was observed on the brick.

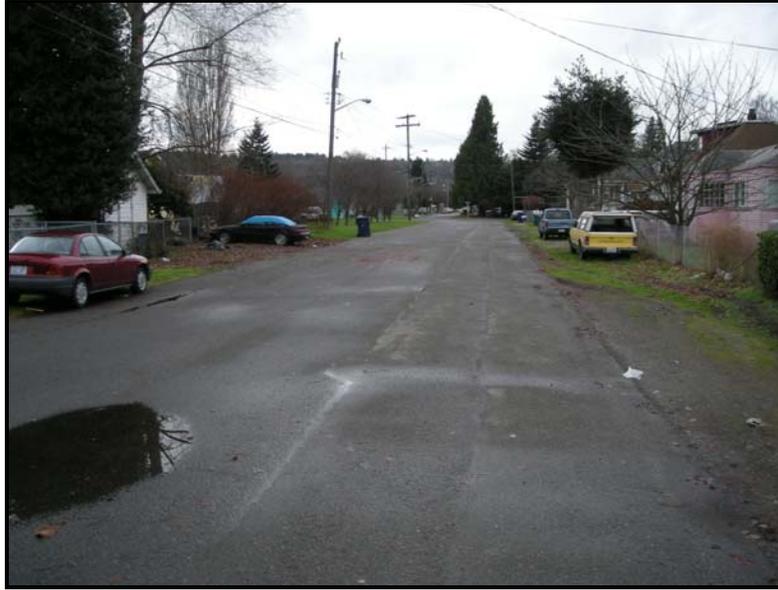
- 24) This is looking west on S. Orr Street. One residence has the yard drain connecting into the public drainage system. This street does not have any curb and gutter or barrier separating surface flows from private and public property. However, most of the properties seem to be lower than the roadway. On the Duwamish Waterway side of the street (right), the properties seem to drain into the Waterway. The roadway is cracked and does have some water ponding on the surface. This road seems to surface drain toward the bridge and the Duwamish Waterway, but the conveyance system drains toward the combined storm/sewer system.

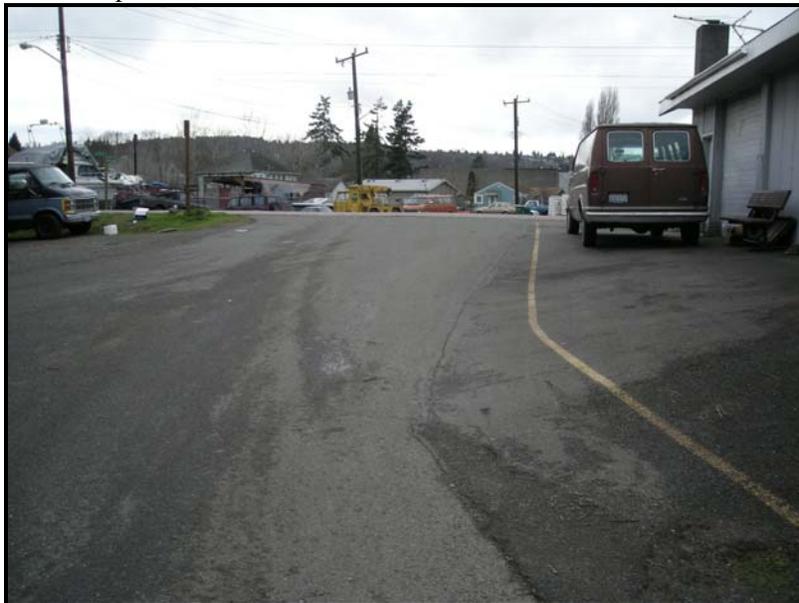
- 25) This picture is looking west on South Thistle Street from under the bridge up toward the brick road and the intersection with South Orr Street. The elevation of the building on the right is significantly higher than the street elevation. The property on the left drains under the bridge toward two catch basins that are in King County right of way under the bridge. Access to the catch basins was blocked by a fence. On the right, the surface water runoff drains into the outfall near the boat ramp.

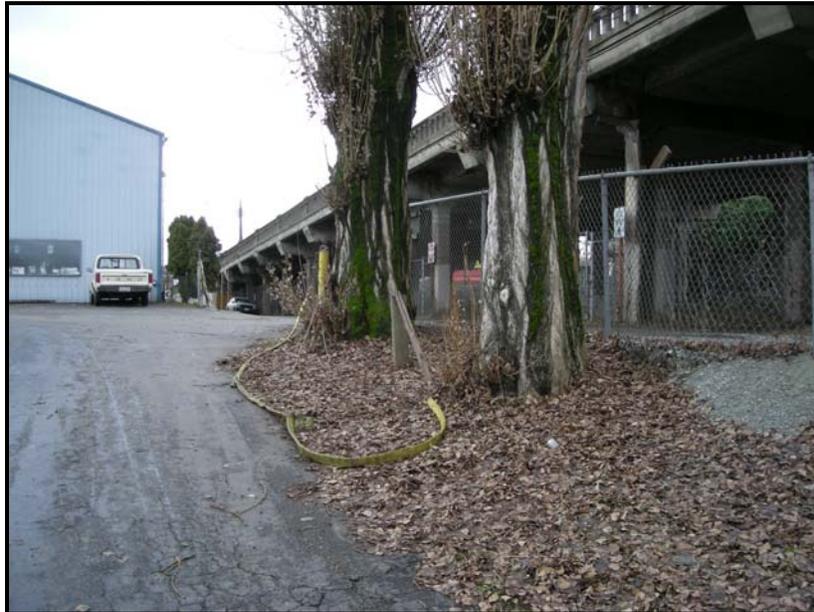
- 26) This is looking up the private boat ramp toward the marina building and intersection with South Thistle Street. The brick catch basin and 24 inch diameter corrugated aluminum pipe outfall is located right of the picture. The fence is King County fencing under the bridge.

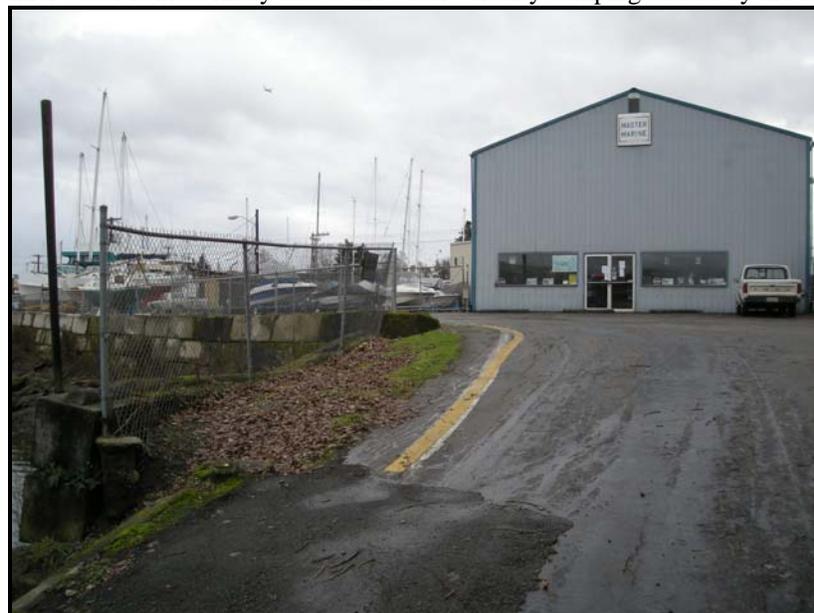
- 27) This is the left side of the private boat ramp looking up toward the marina building and intersection with South Thistle Street. To the left of the boat ramp is an ecology block wall constructed on the marina/channel bank. Much of the bank is unprotected within the marina. Based on visual observations only, the water within the marina was “calmer” than the waterway. The calmer water is most likely due to the water velocity damping caused by the docks and boats.

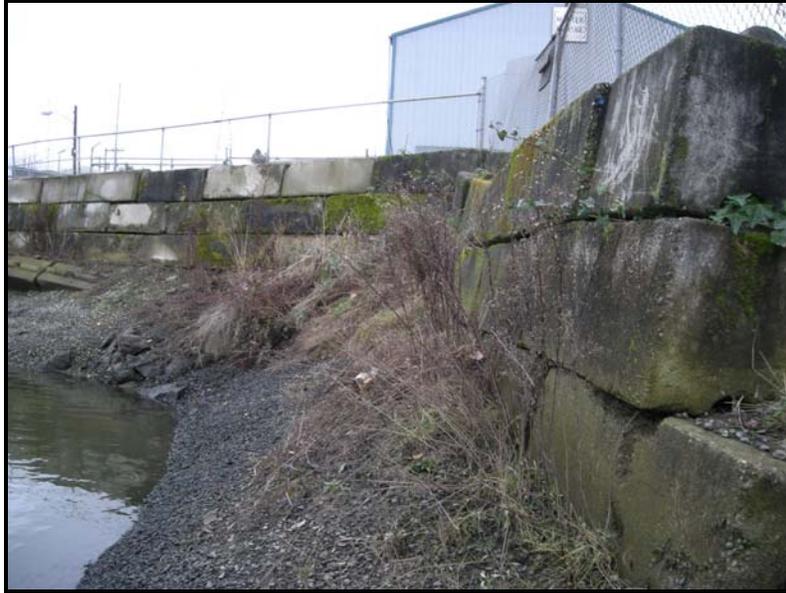
- 28) This is an example of the shoreline within the marina. The ecology blocks are constructed on the waterway slope. The slope is unprotected in some places, and has rock in others. The occurrence of rock and exposed earth is not consistent. The green growth on the blocks indicates constant exposure to water. The moss is present well above the prevailing high water elevation and indicates the presence of water draining through the block wall from under South Thistle Street and the marina boat yard.

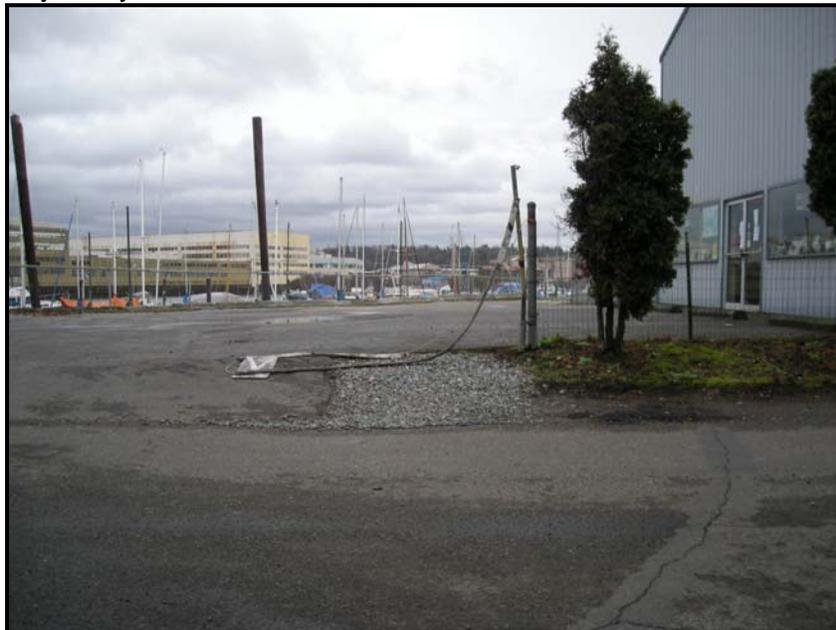
- 29) The boat yard and marina is paved and drains into local catch basins. The catch basins have down-turned elbows to trap oils and sediment from marina boat construction activities. The level of contamination, water quality treatment, and capacity to contain source pollutants was not determined during this field visit. For the purposes of this report and storm drainage design, we will assume off-site water will be treated and clean prior to discharge into the public right of way or conveyance system

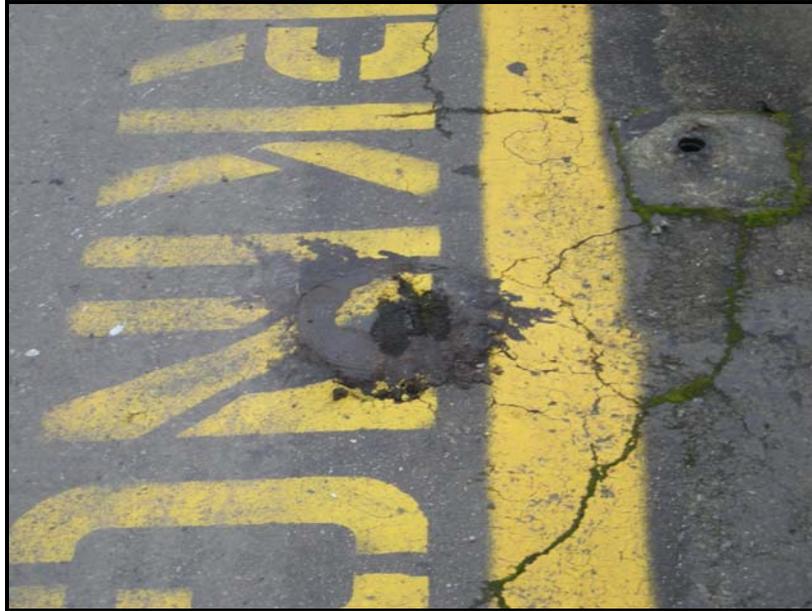
- 30) Within the marina access road, two old pile were observed to be protruding from the pavement. One pile was protruding and one was punching the pavement up. The pile were cut flat on the top and the parking lot/access road was paved over the pile. The extents of the abandoned pile system is unknown.

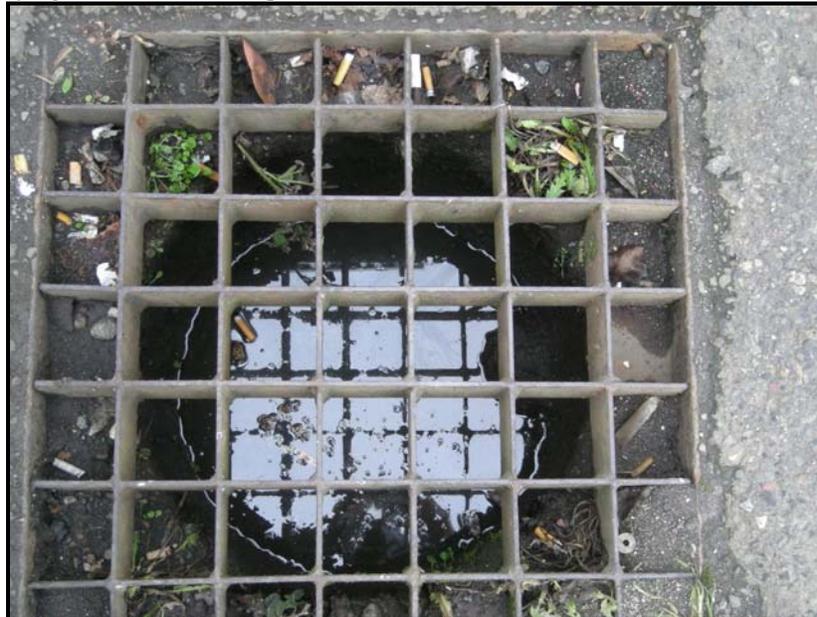
- 31) This is a picture of a private off-site marina catch basin with a down-turned elbow in it. Without quantifying the contamination present, there seems to be a lot of oil and “muck” in the structure.
