South Park Bridge Replacement Offsite Analysis Field Inspection

A field inspection analysis was performed on December 31, 2008 for the South Park Bridge Replacement project. The inspection was conducted with the intent of evaluating one mile upstream and downstream of the proposed project to determine the conditions of the existing drainage patterns and discharge locations. The investigation was conducted keeping in mind how the proposed improvements could potentially impact the existing drainage patterns and conditions. The field visit was performed to meet and exceed the requirements established in the King County Surface Water Design Manual (2005, page 1-21, section 1.2.2). Due to fencing, security barriers, and lack of permission to cross private properties, the shoreline was not walked the full mile up and downstream of the project vicinity. Visual inspection of the shoreline and outfalls were performed from the limited area open for pedestrian access, up on the bridge, and from vantage points across the waterway to the opposite shoreline. Photographs were taken to document field observations and findings. Where access was available adjacent to the waterway, the area was walk

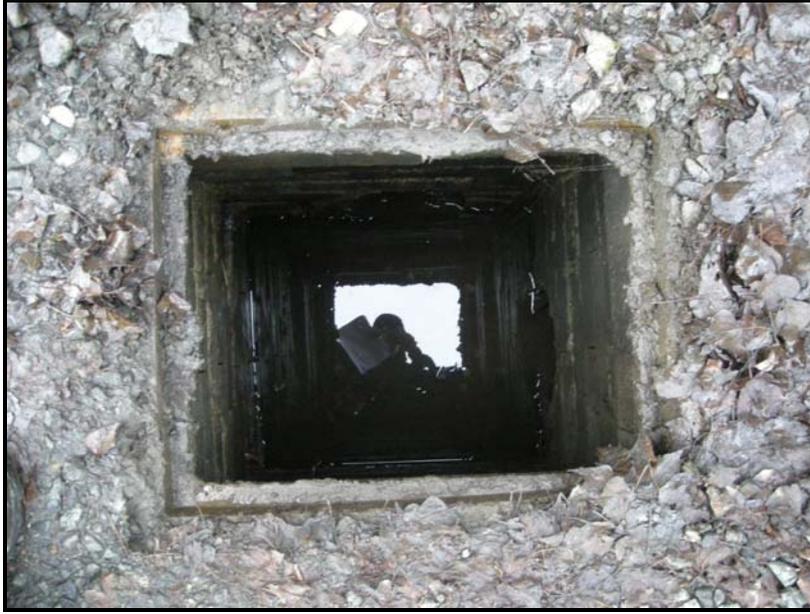
- 32) This is a close up picture of the public outfall catch basin. The outfall is a 12 inch corrugated aluminum pipe in seemingly good condition. A perforation study, soils corrosion testing, and time to perforation study have not been performed for this pipe to determine actual pipe conditions and characteristics. However, the pipe was not bent, oxidized, or deformed in any way and sounded “good” when struck with a hammer leading us to believe it was in “good condition.” When we pulled the lid off of the catch basin we found the entire structure to be constructed of brick and mortar with an inlet pipe pointing toward the brick road, and the same size outlet pipe pointing toward the waterway.

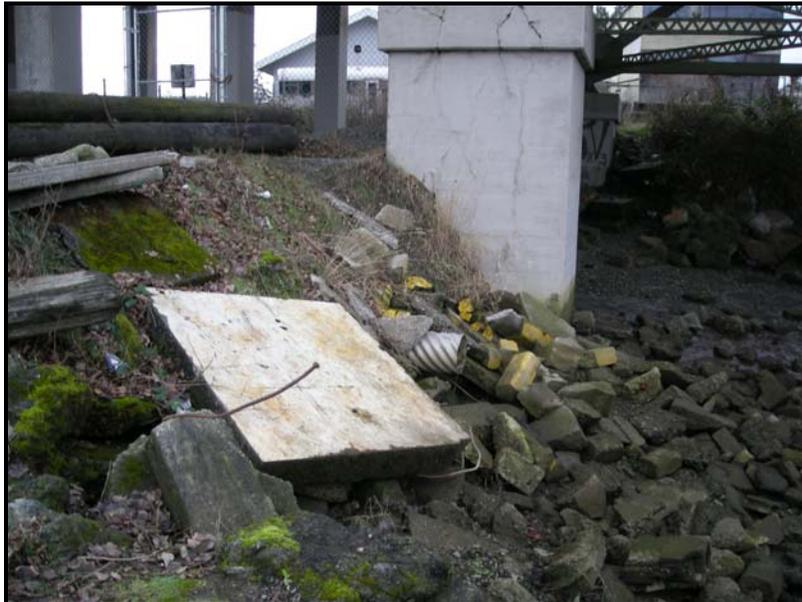
- 33) Picture of the existing south basin outfall, varying slope protection, and bridge pier.

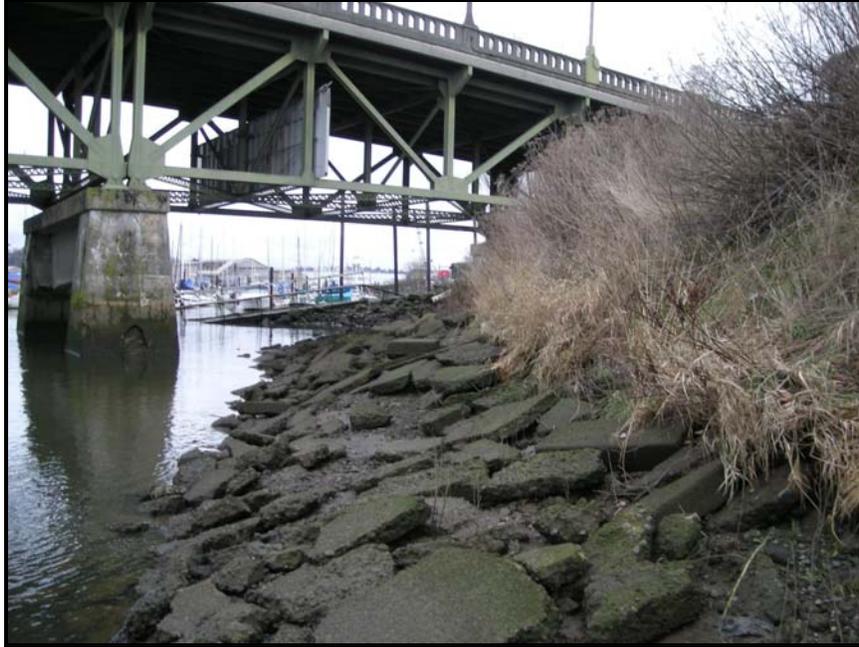
- 34) The shoreline south of the marina boat ramp is grassy in the upland area, and muddy with concrete slope protection. The concrete pieces do not lock together well and leave significant areas of the bank exposed for erosion. The concrete pieces seem to average four to six inches thick and two to three feet in “diameter” (if diameter can be used loosely). The boat ramp can be seen in the middle of the picture under the bridge.

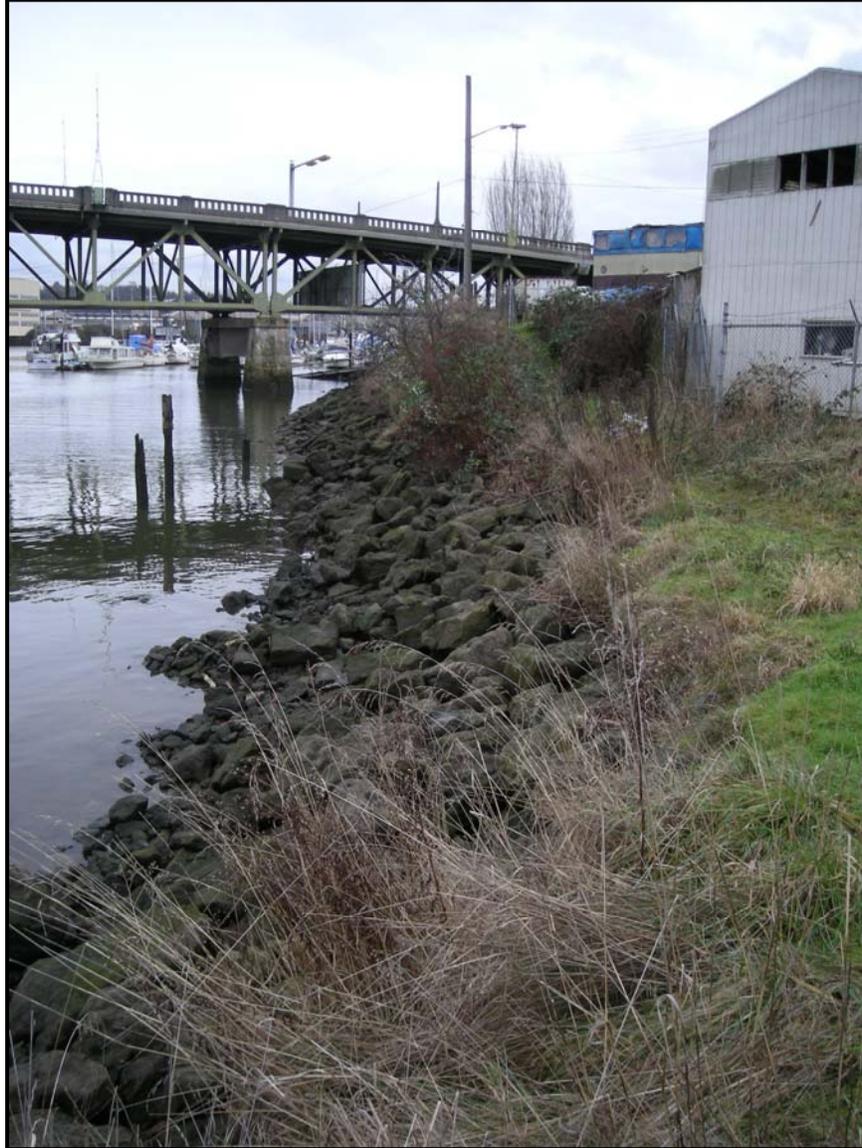
- 35) Further downstream, at the end of the brick road, the shoreline becomes steeper, and rock stabilized. The rock seems to leave less voids exposing earth/mud for erosion.

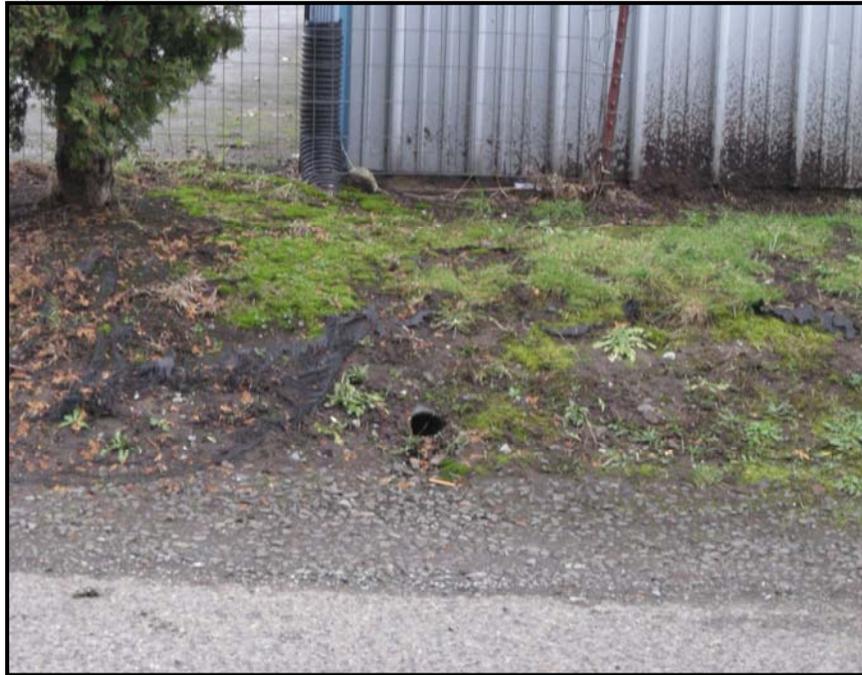
- 36) The existing marina building has roof drains that discharge directly into the “alley/roadway” adjacent to the bridge via 4 inch diameter high density polyethylene pipe. The roof of the entire building will be estimated for off-site flows into the project for the purposes of sizing the conveyance system.

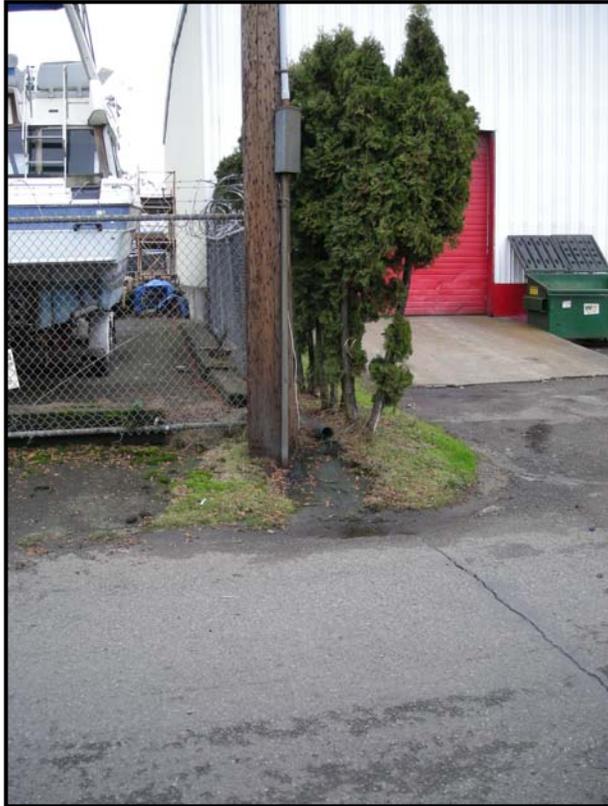
- 37) The Tire Factory building roof drains into the “alley/roadway” via 4 inch diameter high density poly ethylene corrugated black pipe. Note the pavement crack at the discharge location.

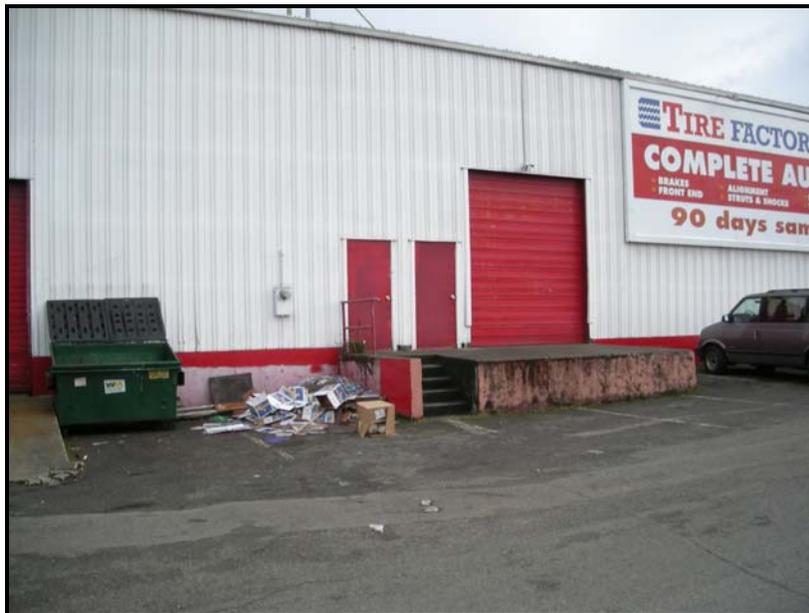
- 38) The Tire Factory building paved loading and parking area as well as roof surface drain into the public right of way. The water seems to drain (north) toward the waterway. This will be treated as off-site water and included for the design of the conveyance system only.

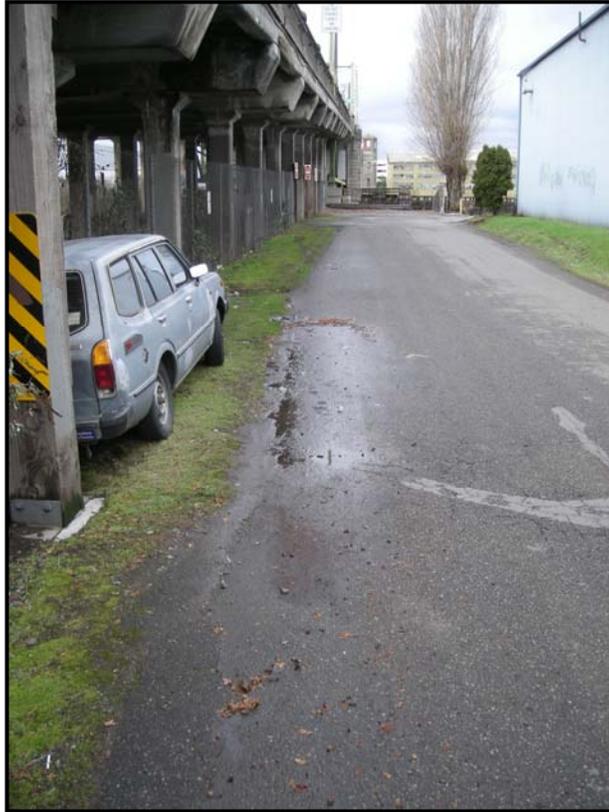
- 39) This is looking north down the ally/roadway toward the marina and public outfall. The alley/roadway drains toward the waterway.

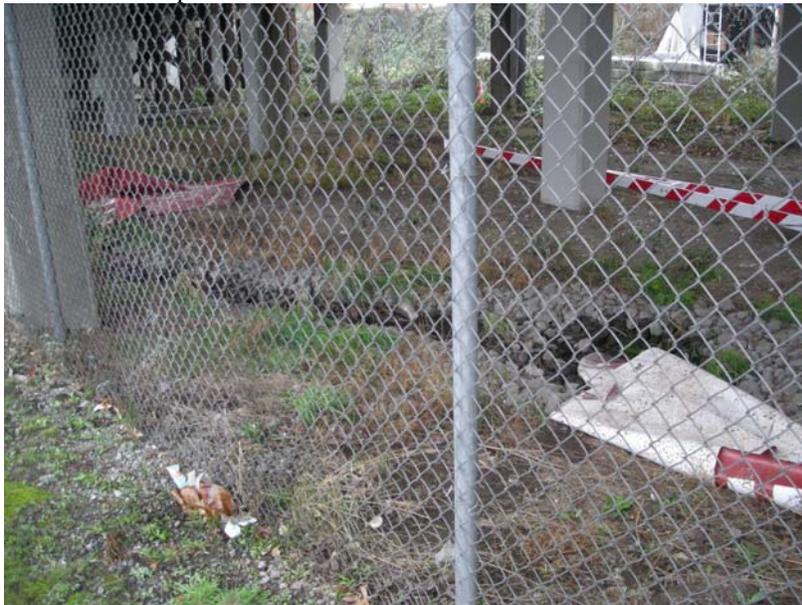
- 40) This is a picture of one of the catch basins under the existing bridge. This is graded in an attempt to drain the low spot at the abutment walls. The catch basin is surrounded with quarry spalls to help stabilize the ditch path.

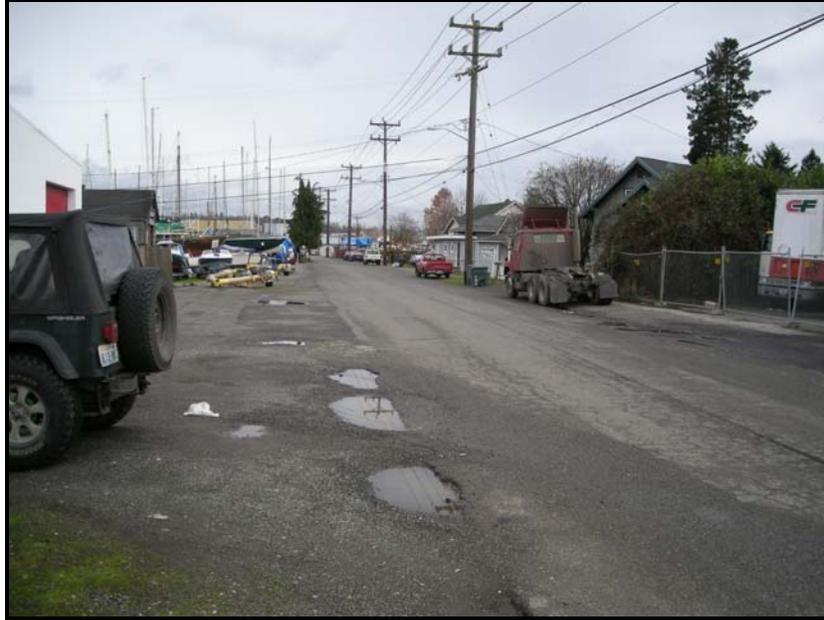
- 41) This is a picture looking west up Dallas Avenue South. The Tire Factory is on the left. The paved loading and parking area seems to drain toward the edge of the roadway and west into the combined storm/sewer system. A catch basin with down-turned elbow was found at the corner of the building indicating water quality treatment prior to connection to the combined storm/sewer system.

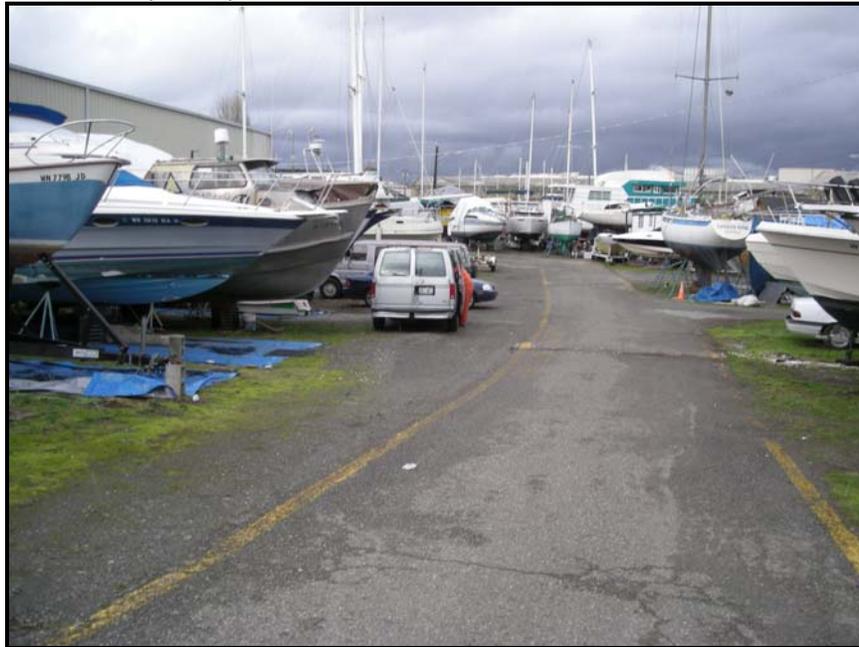
- 42) Continuing east past the Tire Factory on Dallas Avenue South, the marina has a paved driveway access and roadway into a boat yard. During the field visit, we observed on several occasions the movement of materials and equipment from one yard to another. This drains toward the waterway and marina conveyance system.

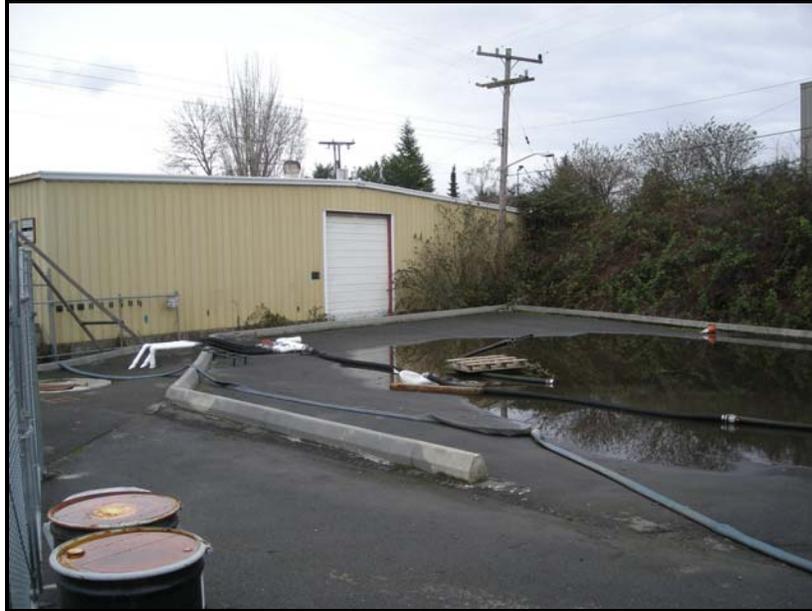
- 43) Further east up Dallas Avenue South, the road “dead ends” at a City of Seattle Public Utilities Treatment Facility. The area is fenced and signed for no admittance, the surrounding area shows significant man-made improvements to protect inlets and provide surface water quality treatment.

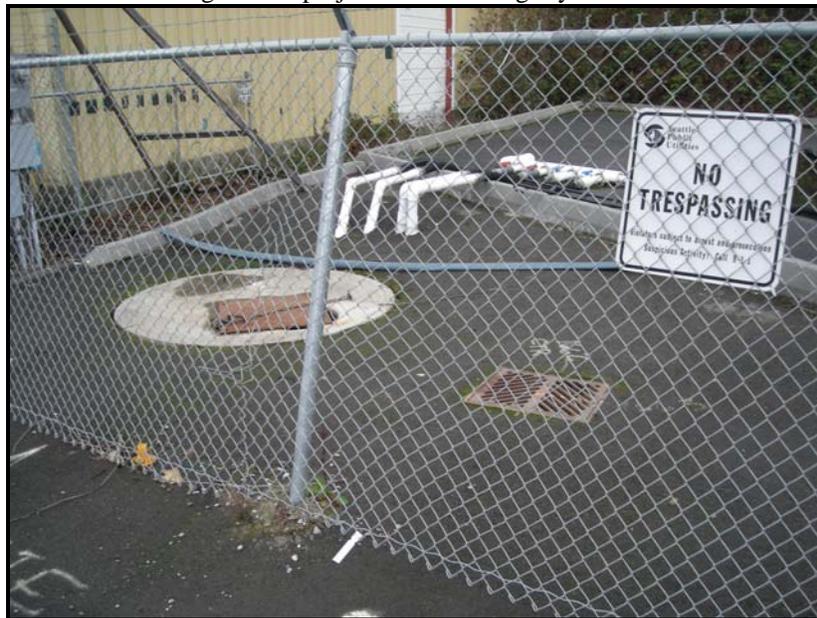
- 44) The site has underground extraction pipes, curbs, catch basins, manholes, control structures, and vaults, material storage areas, and is graded to contain water. The site does not drain into our project and is approximately one-half mile upstream of the project limits. This site will not be accounted for in the design of the project storm drainage system.

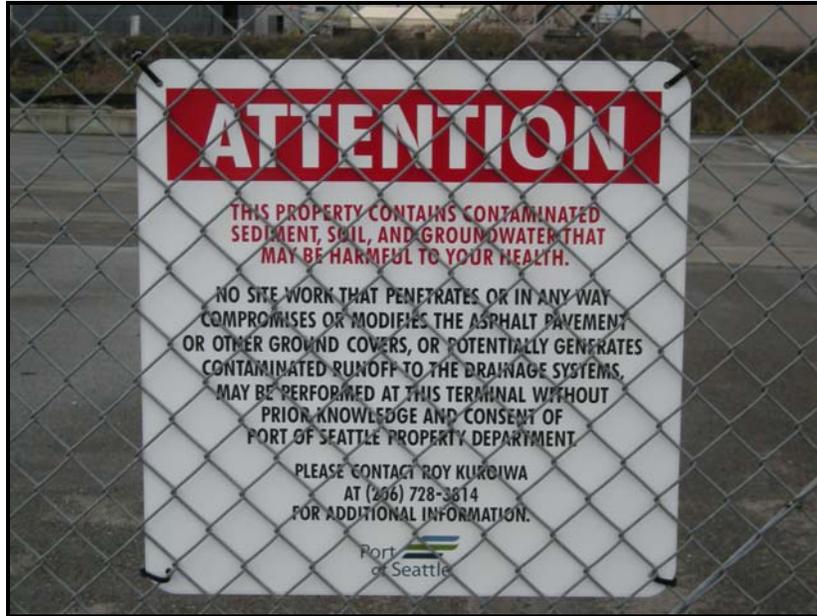
- 45) Between the marina and the City of Seattle treatment facility, the Port of Seattle has a parcel of land that is directly adjacent to the Duwamish Waterway upstream of the project. The site is paved, and seems to drain toward the street and the waterway. Since surface water does not drain into the project vicinity, it will not be accounted for in the design of the project storm drainage or water quality treatment facility. Records of ground water contamination have been provided by King County and do not provide on-site indication of contamination.

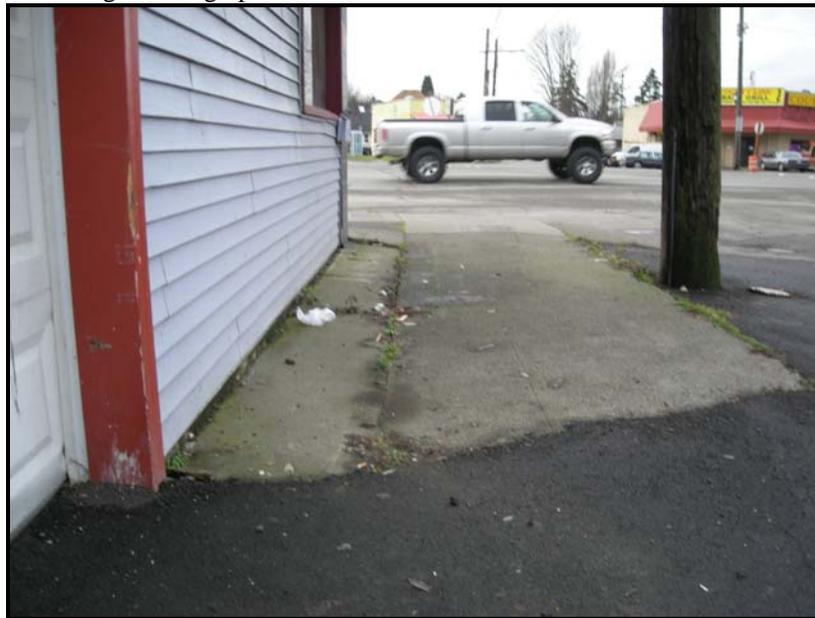
- 46) This is on the left side of the Dallas Avenue South looking west toward the intersection with 14th Avenue South. A two foot piece of concrete drains away from the building and toward the asphalt driveway. The driveway is warped to drain. The street side of the sidewalk is higher than the building side of the walk and water drains from the sidewalk toward the building. This will be evaluated during the design process.

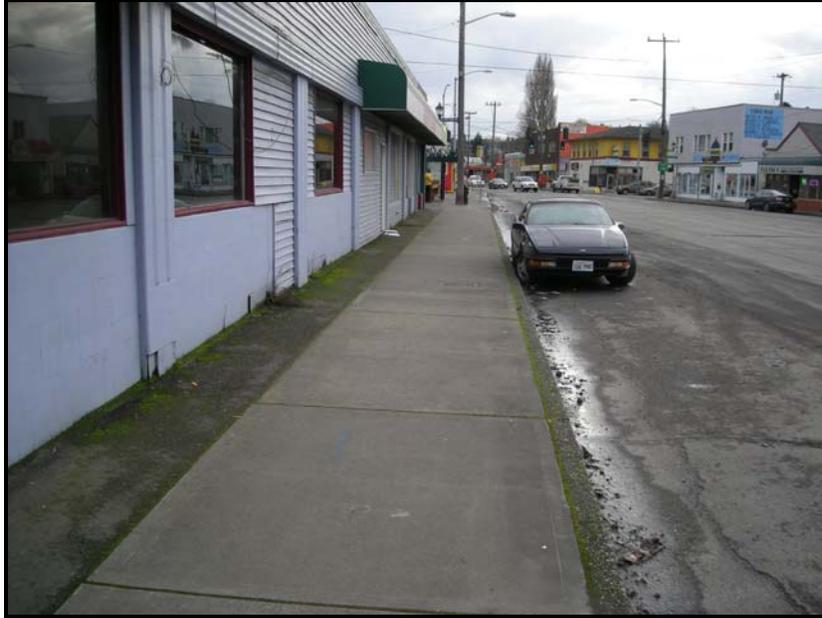
- 47) Turning the corner and looking south along 14th Avenue South, the sidewalk drains toward the street. The buildings do not seem to drain into the street and will not be included as on or off-site area contributing to the drainage system for the proposed project. The existing curb and gutter seems to be “fairly flat” and has water ponding in the gutter pan as well as debris scattered along the flow line. This is indicative of flat grades, and low flowing gutter velocities. Adjacent to the light pole (center of picture) is an alley entrance and bus shelter. We drove the alley and noticed the properties were not draining into the alley and into the street. The drainage characteristics around the bus shelter and further up the street were not investigated due to the type of local wildlife/activities in the area at the time of the field visit. Pictures were not obtained because we ran out of “memory” and did not want to attract additional attention.

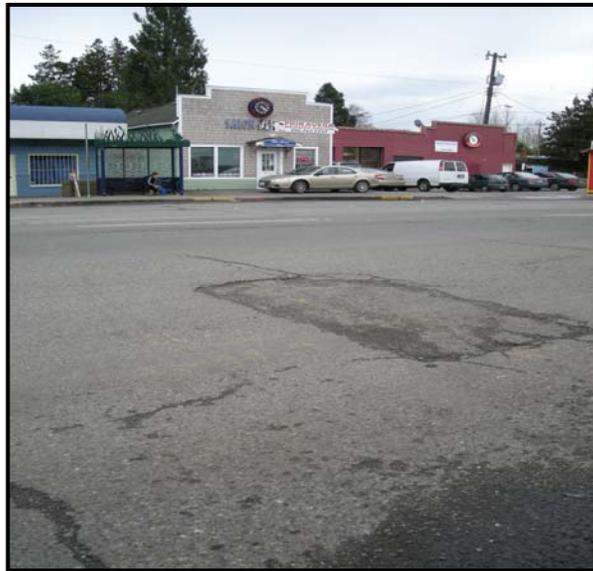
- 48) This is a picture of the area between South Sullivan Street and South Cloverdale Street taken from across the street. The buildings have roof drains and the parcels are graded to drain toward the public right of way from the building face. The drainage boundary will be considered the face of buildings.

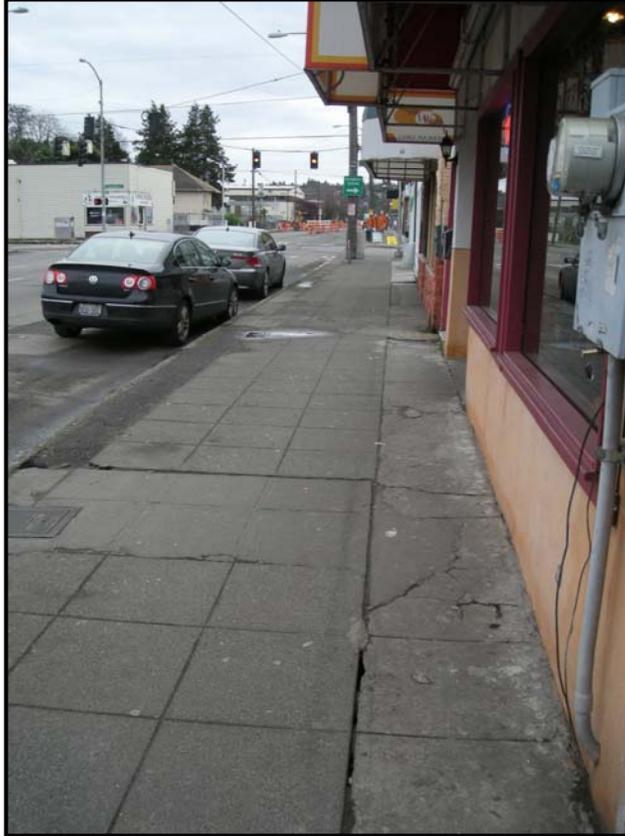
- 49) In front of the building on the southwest corner of the intersection of 14th Avenue South and the alley between South Sullivan Street and South Cloverdale Street, the sidewalk is broken, sinking, and eroding from underneath the surface.

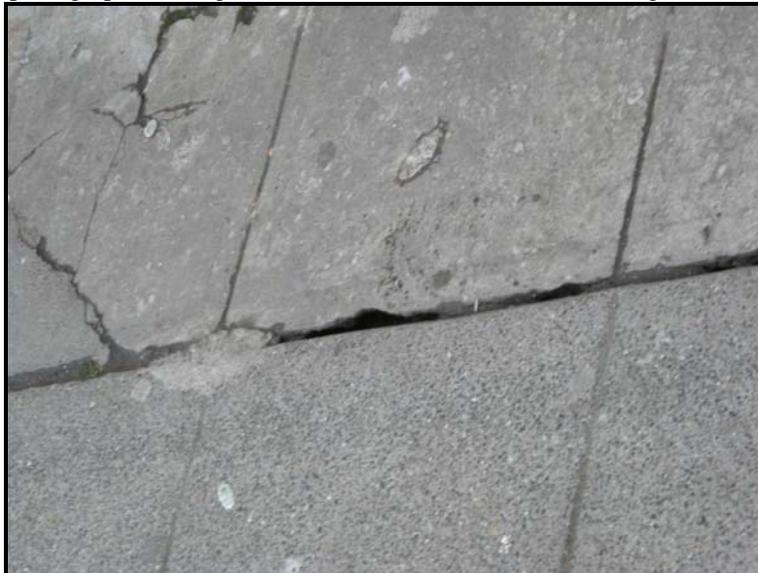
- 50) Close up photograph showing where the surface water is under-cutting the sidewalk.

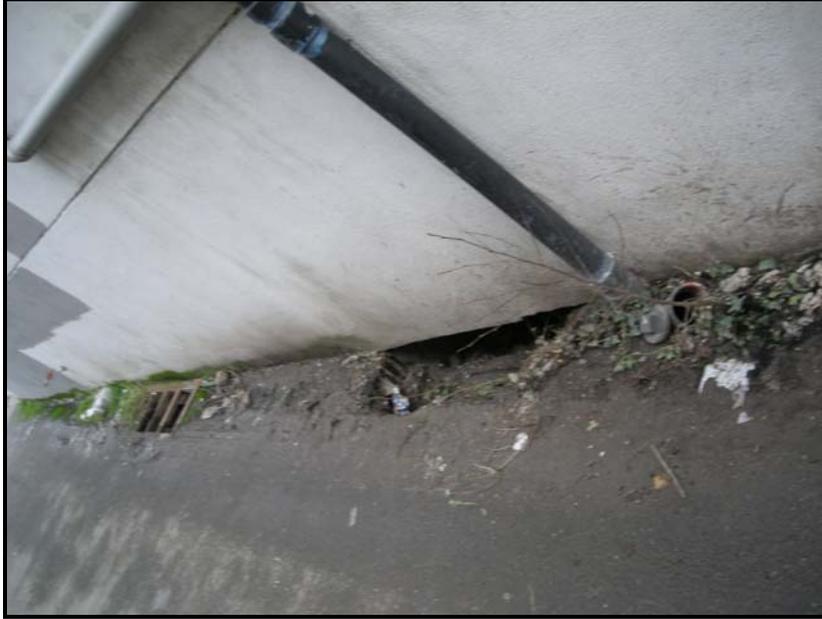
- 51) Approximately fifty feet back into the alley are two storm drainage grate inlets. One of the grates is in place and “solid,” the other is missing. Storm water runoff seems to be draining under the existing building. The hole is approximately 3 feet long and a foot and a half wide. Alcoholic beverage cans and bottles of all shapes and sizes have been stuffed into the hole over a long period of time preventing us from seeing under the building. Based on the visual observation between the two inlets, we believe water is currently draining under the building. Where it goes from there is a mystery. Based on the condition of the existing sewer drain on the outside of the building, the interior has had several remodels, or renovations to the interior. The sewer drain plumbing is not well supported, joints are not well glued, not insulated, and not well maintained.

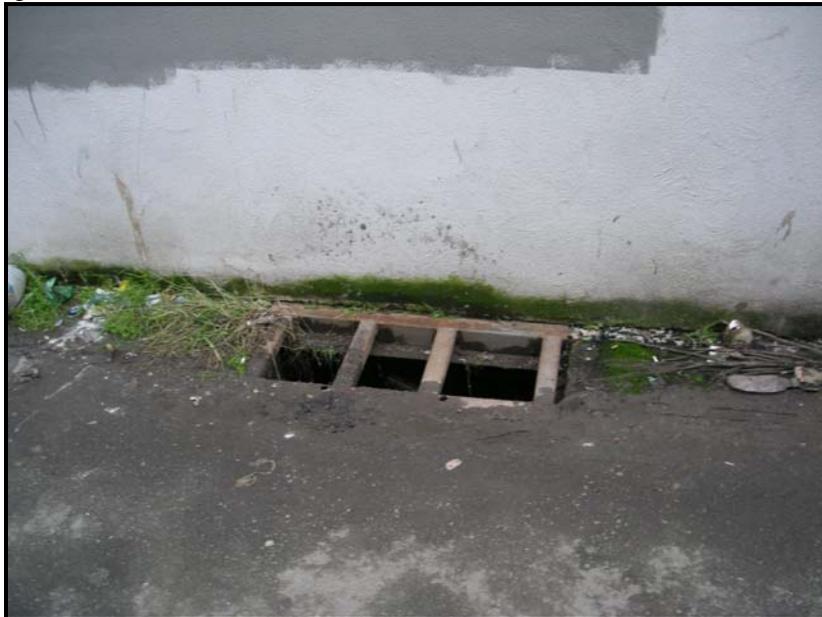
- 52) This is a close-up of the existing storm drain grate seemingly draining under the building. The dark stain and moss on the wall as well as the vegetation indicate water drains along the building wall and alley. The condition of the joists, insulation, studs, and other structural members of the building are unknown.

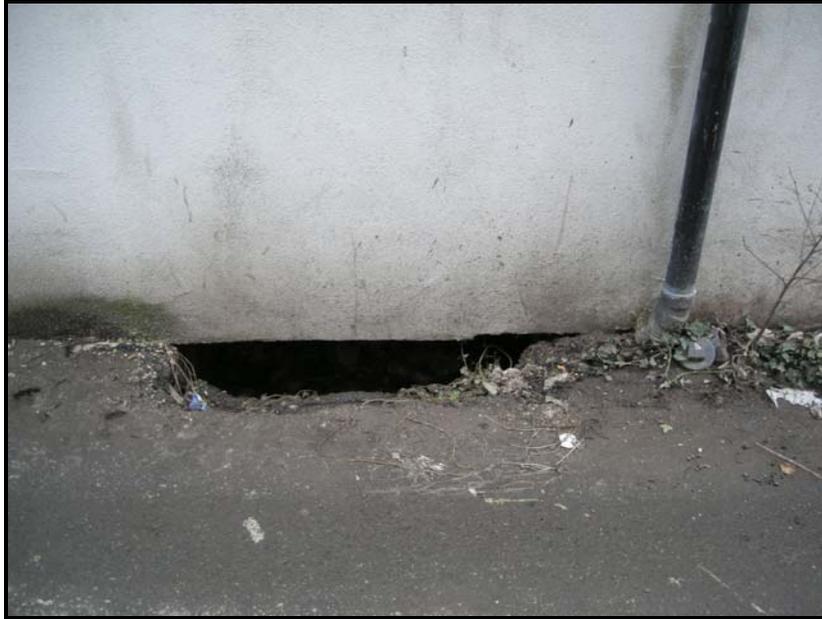
- 53) This is a close-up of the missing grate. The building does not seem to have any supports in this location.

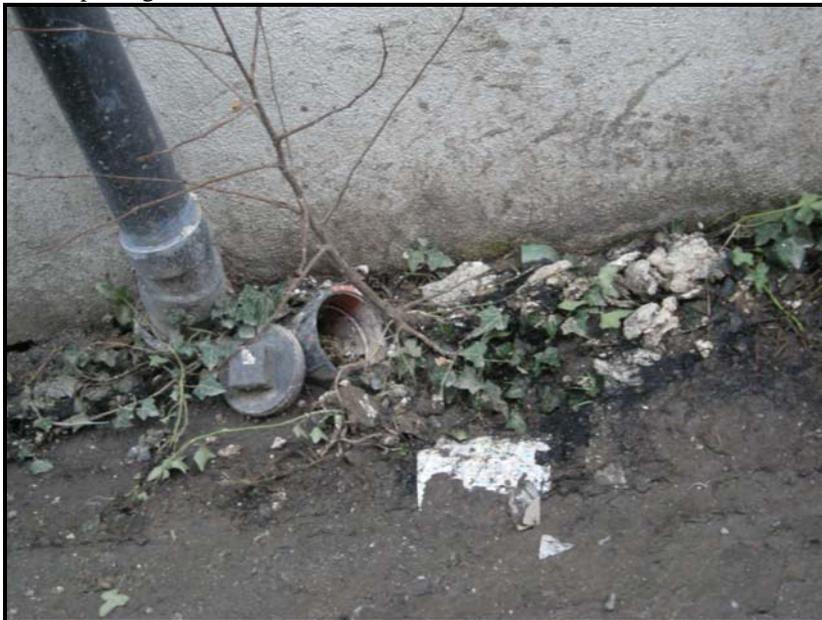
- 54) This is a picture showing the “kinked” sewer cleanout wye fitting connection and the pipe. The cleanout plug was found in the open position and the pipe half full of leaves and debris. The small alder tree growing out of the crack between the wall and pipe indicate this plug has been open for at least one summer. This is a poorly maintained area of the building. We did not touch it or alter this condition in any way. Minimum maintenance responsibility should include capping the cleanout and pulling the tree.

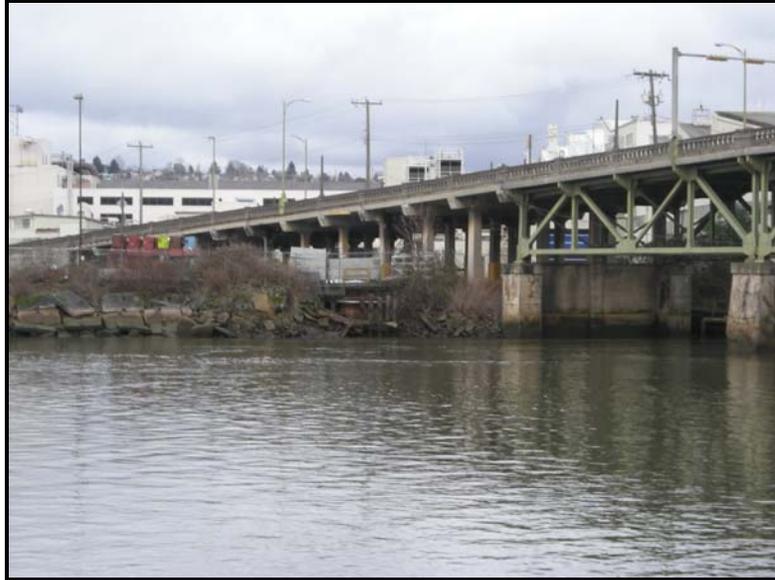
- 55) Access to the Boeing and public outfalls were not possible on the north side of the waterway. This photograph shows the relationship of the slope, slope protection concrete against the existing Standard Oil Dock as well as the steel shoring and public outfall penetrating the shoring. The line of green growth on the concrete indicates the prevailing water elevation affected by the tide. The existing public outfall seems to be above the tide influenced area but has a tide flap on the pipe. The flap does not close all the way and may be blocked or rusted and not functioning properly.

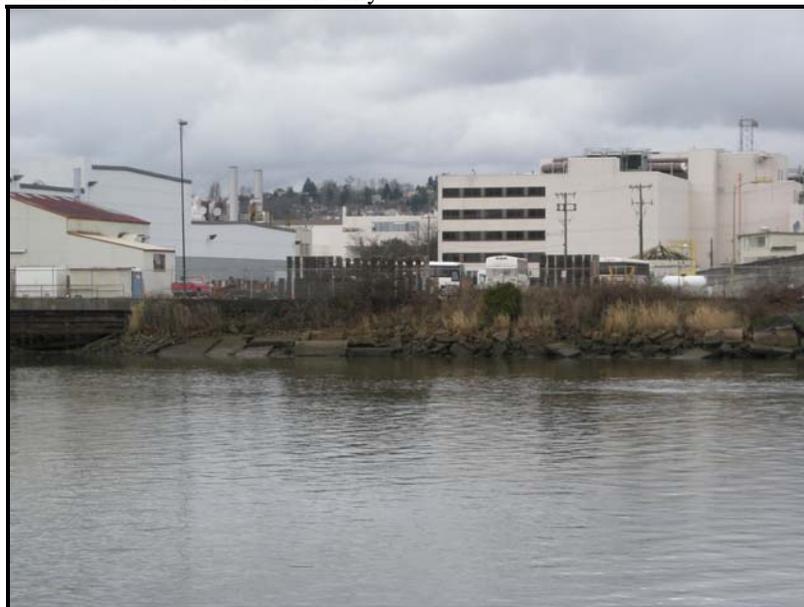
- 56) This photograph shows the end of the earth and concrete shoring against the Standard Oil Dock now used by Boeing. The characteristics of the shore under the Boeing building were not examined due to the lack of access. The discharge locations under the building and from the roof were identified in record information only.

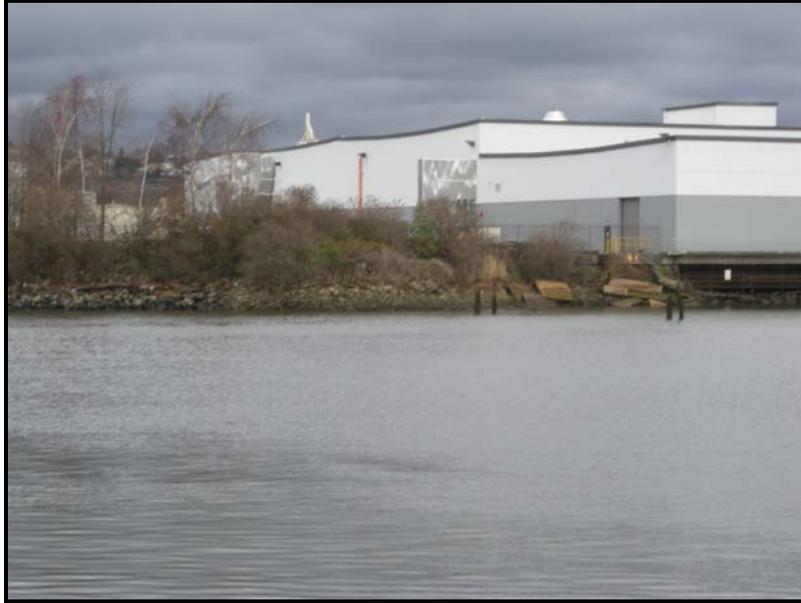
- 57) This photograph is further downstream and shows more of the shoreline that could be observed from the opposite shore. There are remnants of old pile still in the waterway. The use or condition of the pile could not be determined during the field visit. We have no validation for this statement, but the part of piling under the water is usually in better shape than the part exposed to the air. The end of the Boeing building and piling can be seen and the beginning of the concrete and rock shoreline begins.

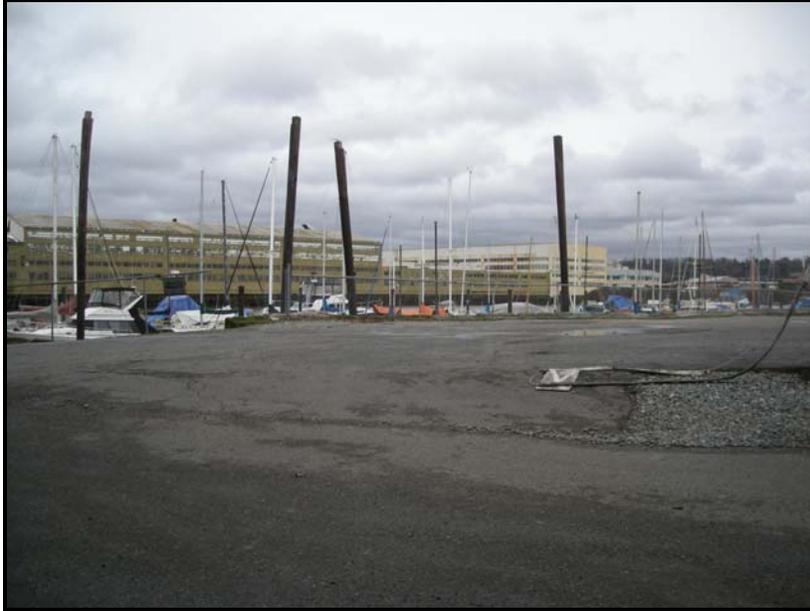
- 58) Looking from the marina, across the waterway, upstream on the northeast side of the waterway, Boeing buildings are directly adjacent to the waterway and roof drain into the waterway. Drainage basin boundaries have been provided by Boeing showing existing conditions. Lots of questions remain regarding the Boeing facilities. A field survey was performed, historic record were examined, and Boeing as-builts were reviewed to piece together the conditions of the existing system. There seem to be inconsistencies between the documented record information and conditions observed in the field. In example, one outfall is documented as a 12 inch diameter concrete pipe and the surveyors found an 18 inch diameter steel pipe. Another outfall is in good condition and controlled with a weir, but the surveyors found an upstream manhole with a plugged hole in the direction of the outfall. Some of these will need to be resolved during construction.

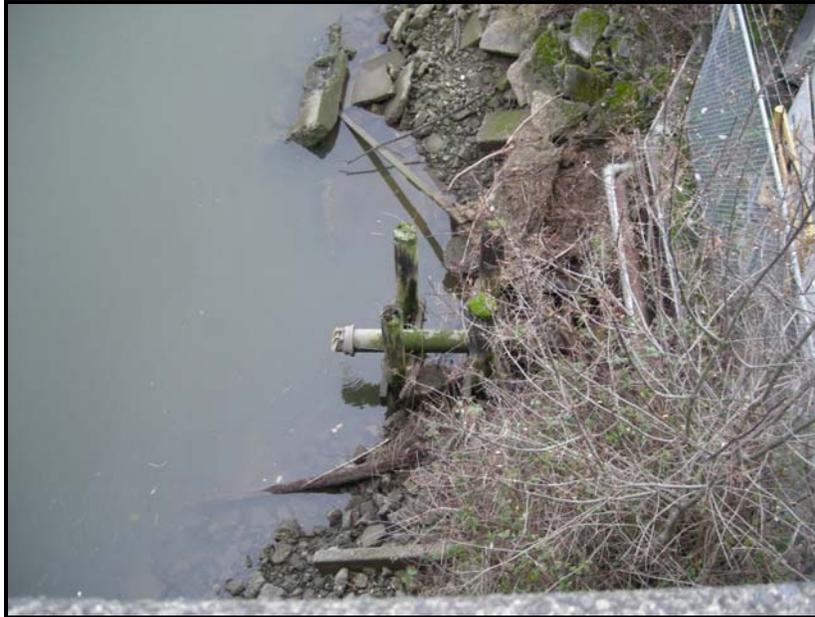
- 59) This is a picture of the existing “18 inch diameter concrete pipe.” The metal tide flap on the end does not close completely. The pipe is supported by braces between four pile. The pipe penetrates and extends well beyond the metal shoring material under the fence line. A smaller service pipe can be seen crossing over the outfall along the top of the metal shoring system. The pipe function is unknown, but is most likely associated with the Boeing parcel.

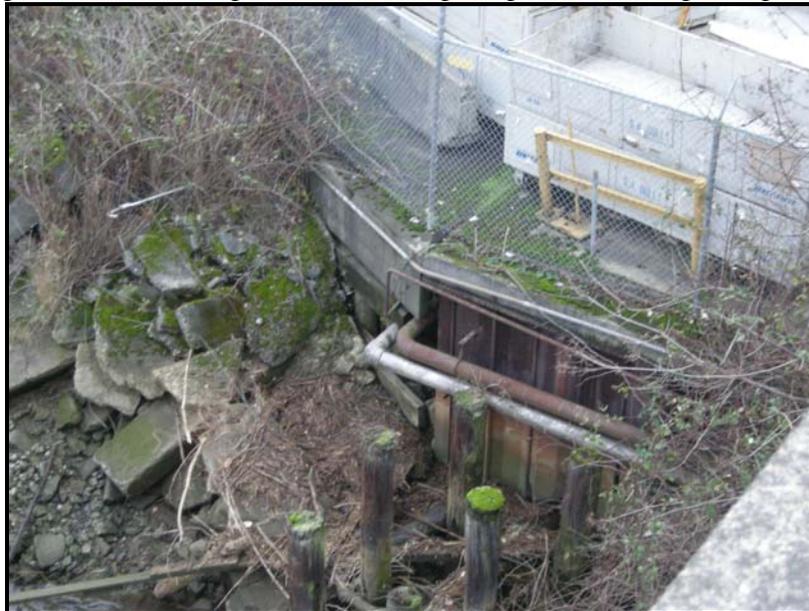
- 60) A better picture angle on the northwest side of the bridge showing the public outfall, pile, metal shoring, un-insulated Boeing service lines, and green growth indicating the high water elevation.

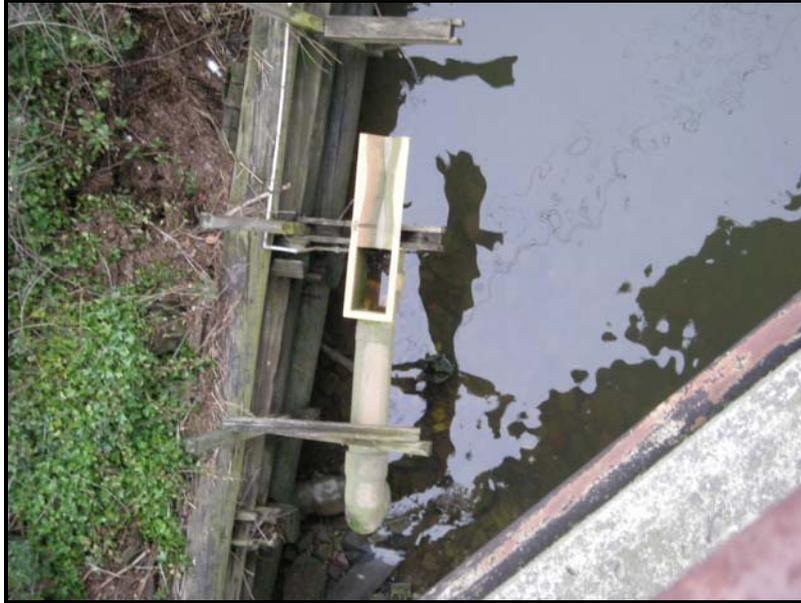
- 61) This is a picture on the northeast side of the bridge of a Boeing outfall. The existing survey information reports an upstream manhole that has been blocked making this line abandoned. Tom Colligan with Floyd-Snider (Boeing consultant) reported in a phone conversation 01/09/09 that the structure on the end is a weir control. The pipe is not thought to be plugged or filled with controlled density fill material and the validity of the system being abandoned is uncertain. A small PVC pipe extends from under the Boeing building and also discharges into the waterway.

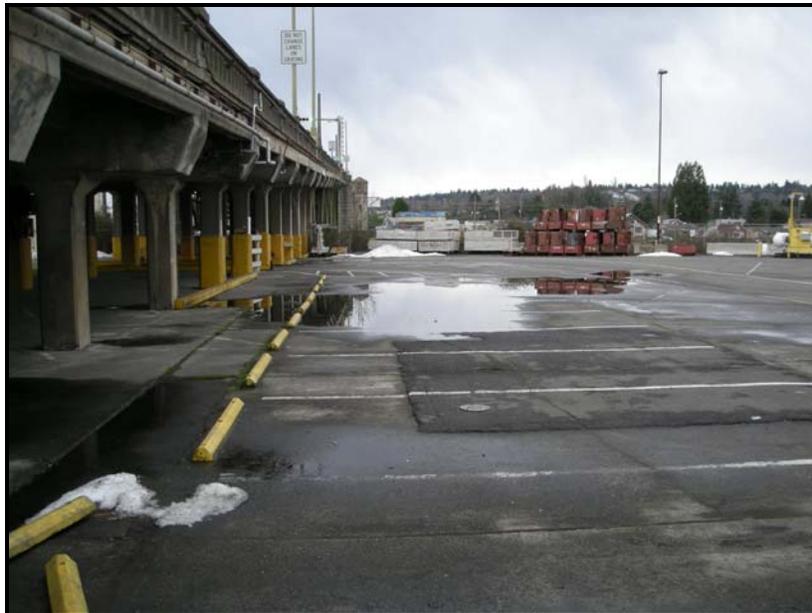
- 62) This picture is on the northwest side of the bridge looking across the Boeing parking area and under-crossing adjacent to the shoreline and waterway. The entire surface is paved and graded toward catch basins. Due to the large flat areas, standing water was observed in many locations across the parking area. This picture is close to the location for the new bridge alignment. Note the small patch of remaining snow in the lower left corner. Plowing may have dislodged the wheel stops.

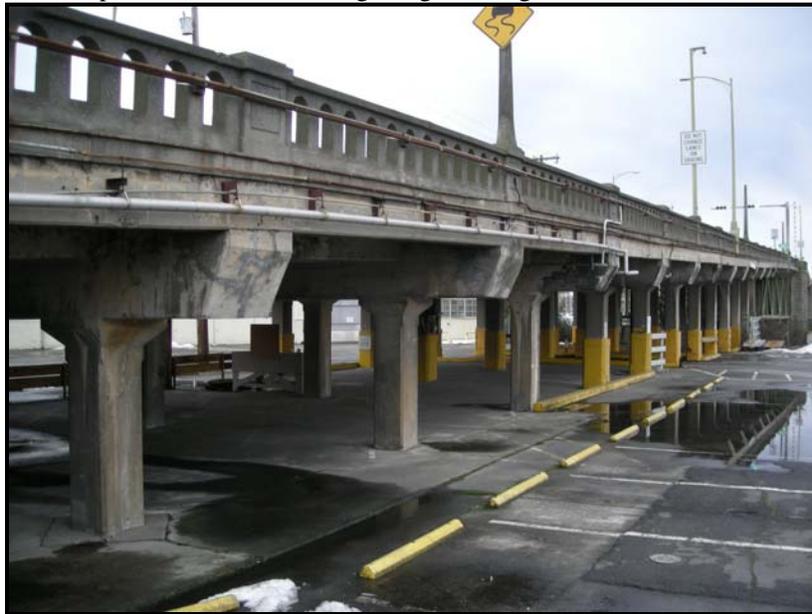
- 63) This is a better picture under the existing bridge looking toward the south side of the project.

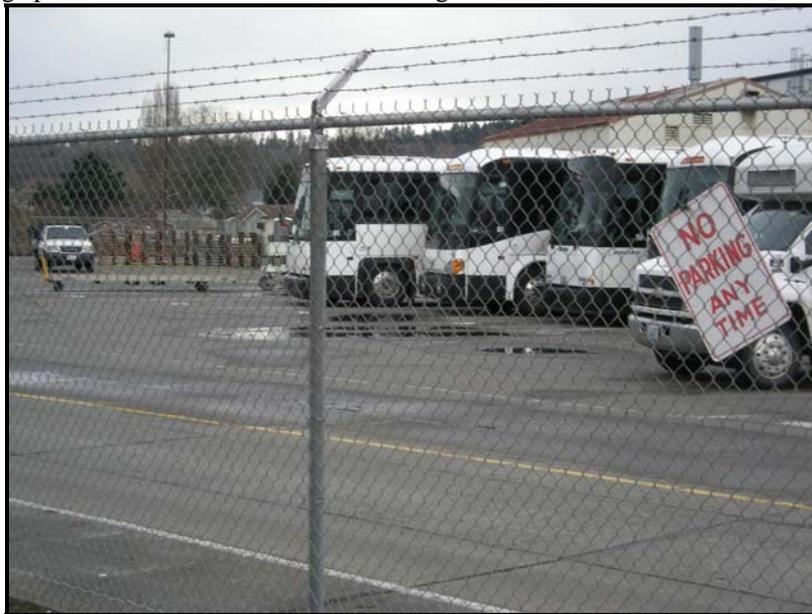
- 64) This picture is an area that may be used for temporary construction staging and storage during the construction of the bridge. Shallow standing water pools indicate flat grades and undefined drainage patterns. Part of the established driving corridor seems to be concrete, not asphalt.

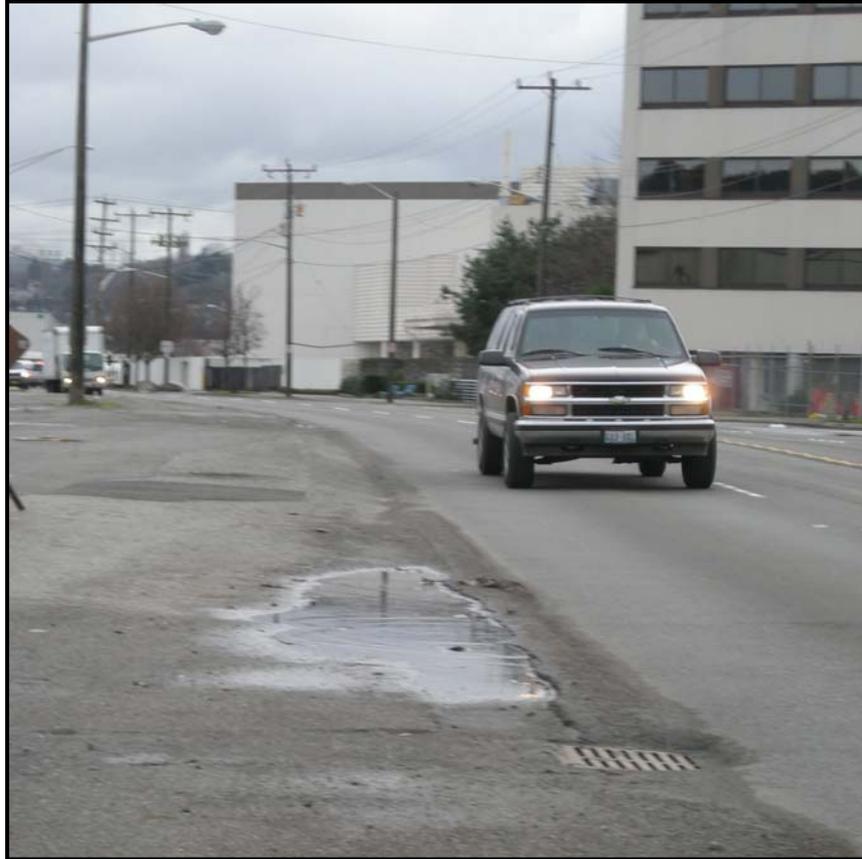
- 65) The surface drainage seems to be from the right of way toward the street on both sides of the road. Public catch basins and conveyance system connected to the public outfall are located along the edge of traveled way.

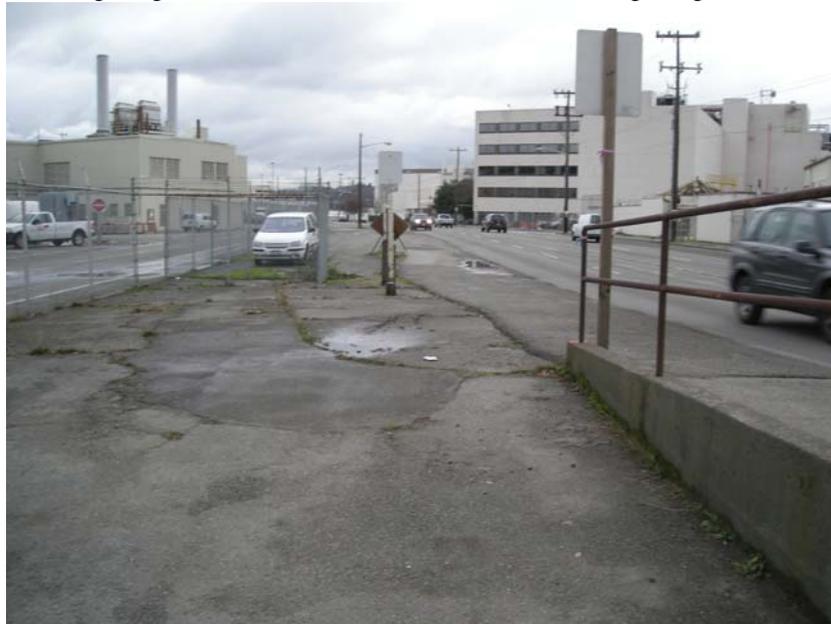
- 66) This is looking from the existing bridge north toward East Marginal Way on/or close to the proposed bridge alignment from the northwest end of the existing bridge.
