King County Green Roof Case Study Report

February 2006

Paladino & Company, Inc.

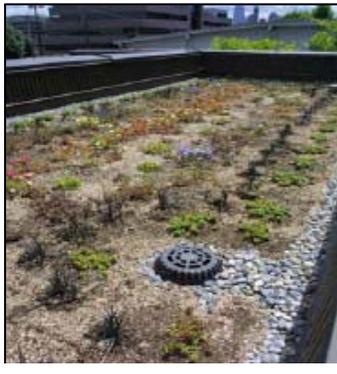
Green Roof in September 2002

The majority of plant material has died. Weeds are now more prevalent than the original species installed. The roof drain is completely clogged. Ivy from the adjoining structure has spread on the green roof damaging the metal flashing. One small area of plantings seems to be thriving. This area is a thin strip of sedums located near the edge of the parapet and is in shade. No fertilizer is used, but a combination of compost and pumice was included in the soil mixture.

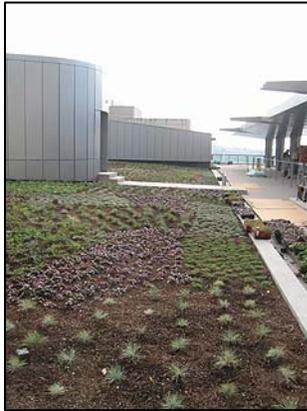
Justice Center Green Roof

The green roof was installed in mid-summer 2004. The roof is green and the plants are thriving. About one third of the plants had to be replaced in the establishment period. The initial design intent was to irrigate the plants during the establishment period only. However, the system was retrofitted later for ongoing summer irrigation.

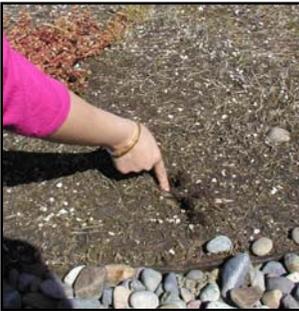
Soil depth less than an inch

- ❑ The inspection on May 25, 2005, indicated a settled depth of 1-1.5". The existing 1-1.5" of soil is minimal for supporting plant growth while providing good drainage and not drying out during summer months. Many installers recommend a minimum of 2" settled depth.

- ❑ When the green roof failed several lab tests were done and the test reports recommended:
 - Avoid excess nitrogen and water
 - Provide adequate drainage or use soil mix containing 50-60% sand.

- Treat the area with disease by applying fungicides OR Remove soil and replace with soils that have been certified free of these pathogens And/Or
 - Replace plants with plantings that are not susceptible to the se pathogens (e.g. Sedums)
