# **Saltwater Intrusion and Infiltration into the King County Wastewater System**

**March 2011**

**King County**

Department of  
Natural Resources and Parks  
**Wastewater Treatment Division**

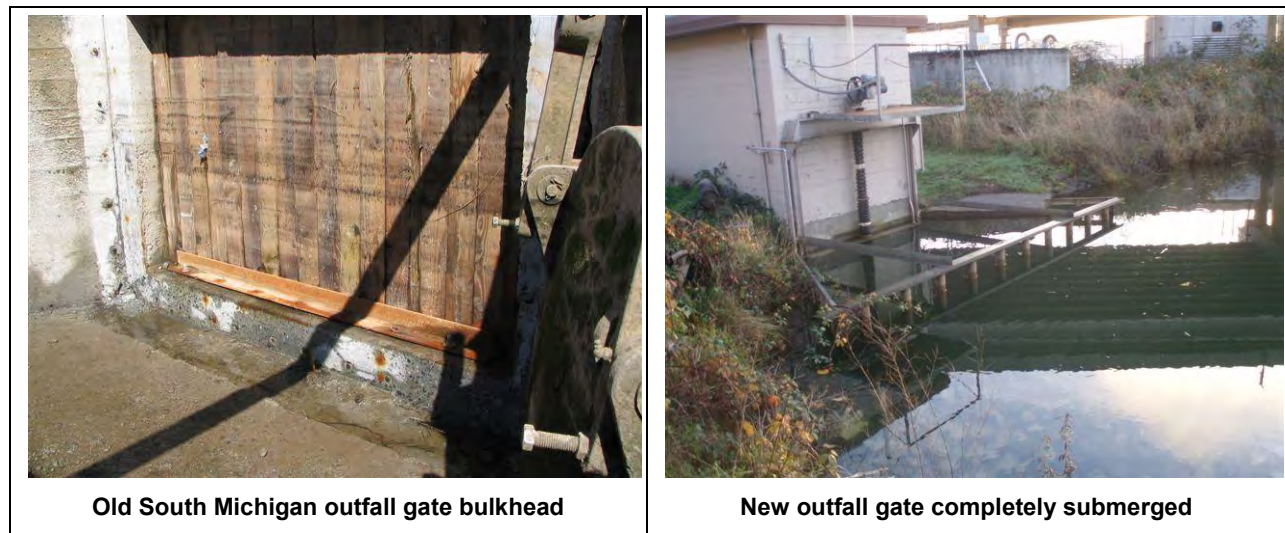
**Figure 7. South Michigan Outfall Gate Before and After Installation**

Further investigation found that several large cracks and fill-portholes inside of the outfall structure were leaking during high tides.<sup>5</sup> These leaks were sealed via grout injection in 2009 through a work-order contract. After completion of these repairs, the average peak conductivity at the outfall dropped to 1.76 mS/cm, almost 95 percent lower than the average peak conductivity measured in 2007 (Figure 8). (The 2009 average peak conductivity shown in Figure 8 for MH 13 is similar to that of 2008 because the monitoring was done before grout injection.)

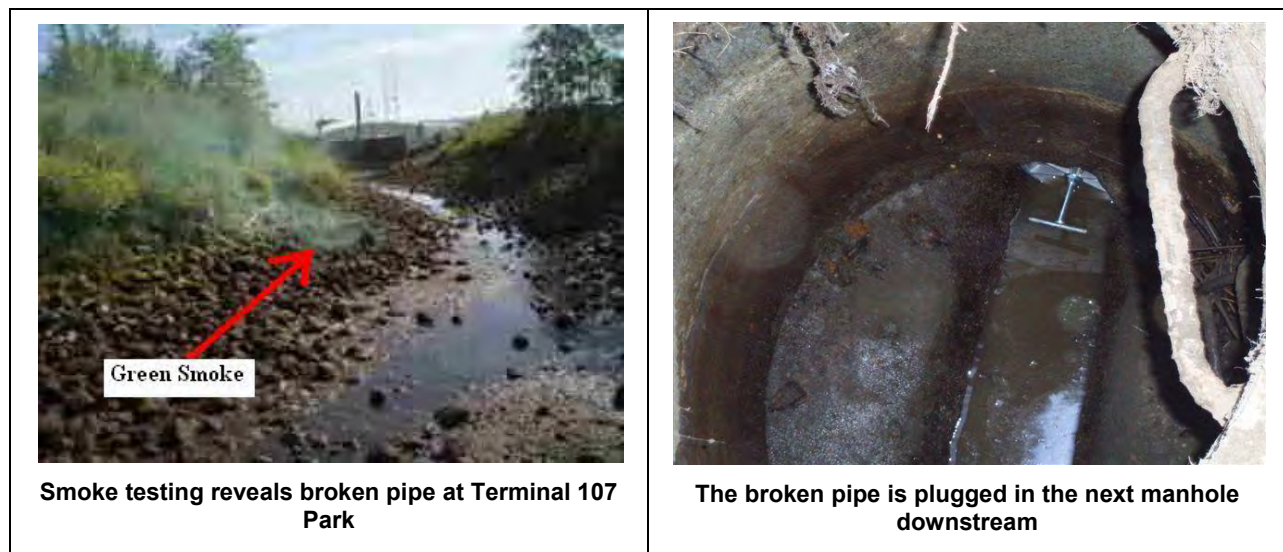
**Figure 9. Discovery and Plugging of Broken Pipe in Terminal 107 Park**

located the breaks in a newly restored estuary habitat at Terminal 107 Park, next to Herring's House Park (Figure 9). The cracks are in an area that is submerged by tidal flows of several feet two times a day. With SPU's assistance, the Facilities Inspection unit installed a mechanical plug at the nearest manhole to the estuary to stop the saltwater intrusion at this location. The work was completed in 2009. The two WDI manholes that were monitored downstream of the Duwamish Siphon near the Duwamish Pump Station registered lower peak conductivities in 2009 than in 2008 before the plugging. Conductivity at the manhole closest to the siphon outlet was reduced from 7.93 mS/cm in 2008 to 1.52 mS/cm in 2009. The manhole closest to the pump station showed a reduction from 4.66 mS/cm in 2008 to 2.24 mS/cm in 2009.

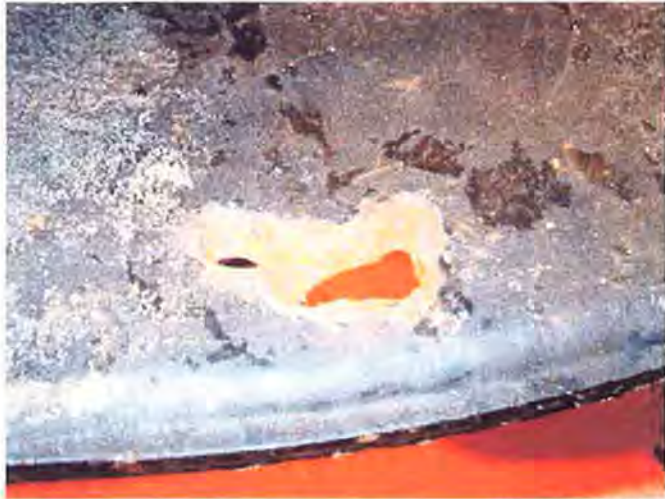
**Figure 2***Photo Sarah White*

Figure 2 shows the penetrating pit that led to the December 2002 inspection. The orange in the background is from an amber lighting system present in the area. The orange in the center of the pit is reflecting from the floor behind and is not rust-colored liquid in the pit. Note that the full thickness penetration is adjacent to coating showing no sign of distress.

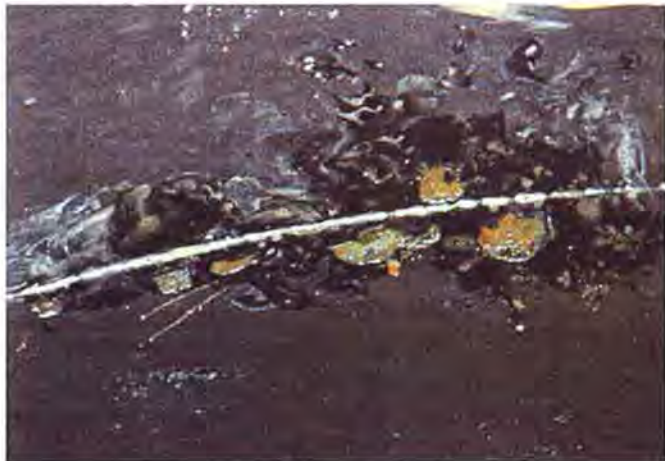
**Figure 3**

Figure 3 shows pitting and blisters along a weld seam. Several of the blisters contained little or no corrosion product. The coating adjacent to this damage appeared to be in excellent condition. The coal tar epoxy tightly adhered to the underlying steel. There were no obvious signs of weld splatter or other clear construction-fabrication defect. During several inspections the coating was examined with 10x magnification. No clear signs of wear, impingement or other operations-based damage were observed.

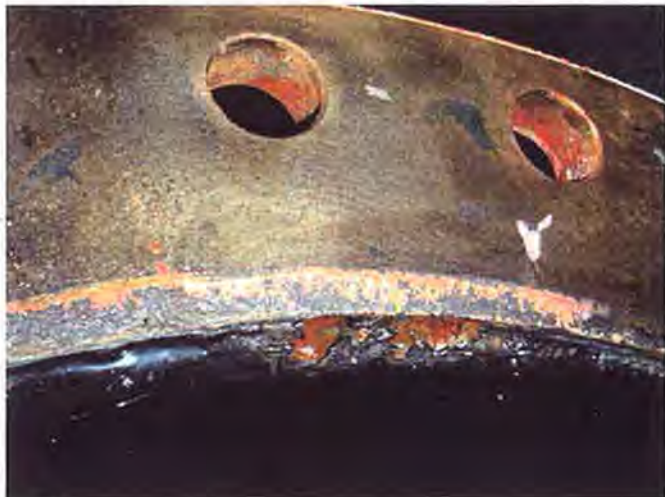
**Figure 4**

Figure 4 shows a flange of one of the inspected elbows. Note the pitting damage at the flange-pipe transition. The deepest pit penetration was 0.16". The pipe-flange face appeared to be in good condition. Potential, resistance and high frequency insulation tests were performed on-line and all joints appeared to be electrically continuous.

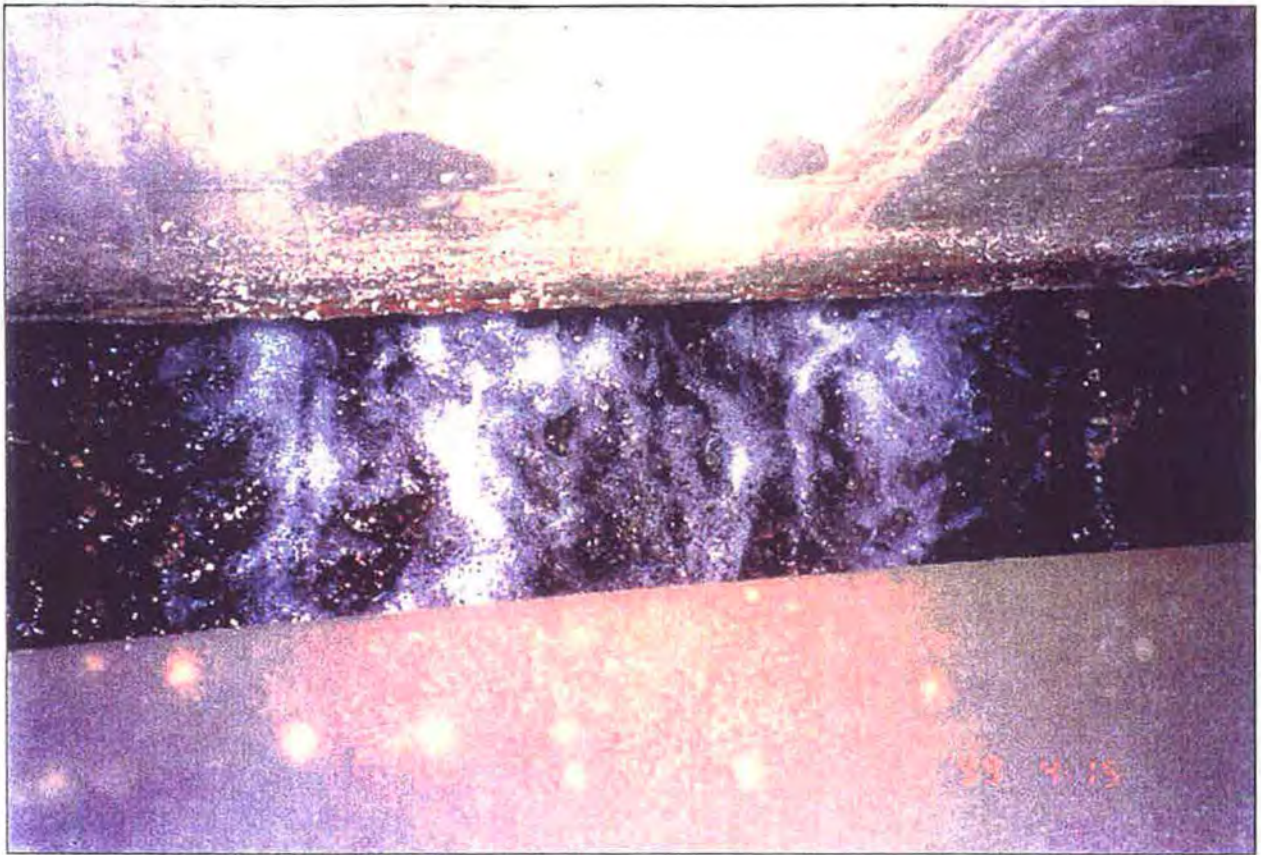
Vine Street Leaking Gate
