Subject: Seattle Metro Final Design Engineering For The Carkeek
Transfer/CSO Facilities Project
North Beach Force Main Inspection Report

Reference: Municipality of Metropolitan Seattle
Final Design Engineering
Carkeek Transfer/CSO Facilities Project
(4359.01/1 and 4359.16/1)

Subject: North Beach Force Main
Excavation and Evaluation - Task 561

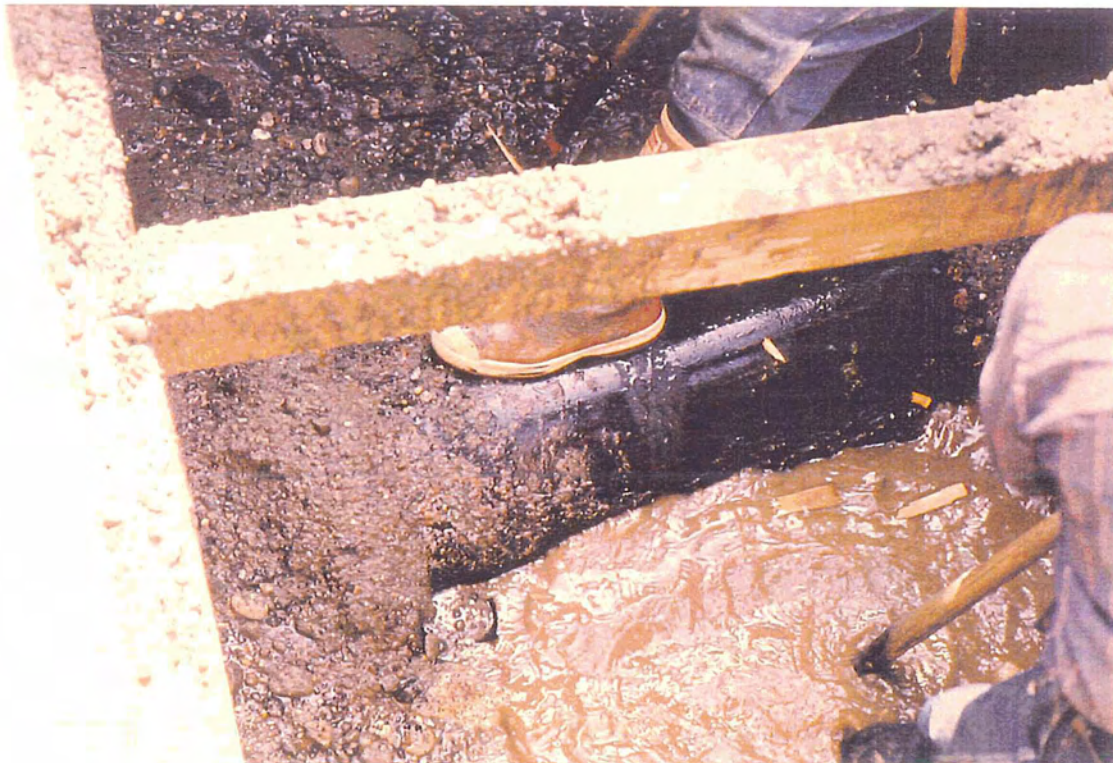
PICTURE NO. 2

North Beach Force Main (14-inch diameter cast iron pipe) exposed at Excavation No. 1 near the North Beach Pumping Station on April 19, 1989. Pipe was encased in a thick layer of graphitization combined with sand and rocks, which was easily removed from the pipe surface (see next three pictures).

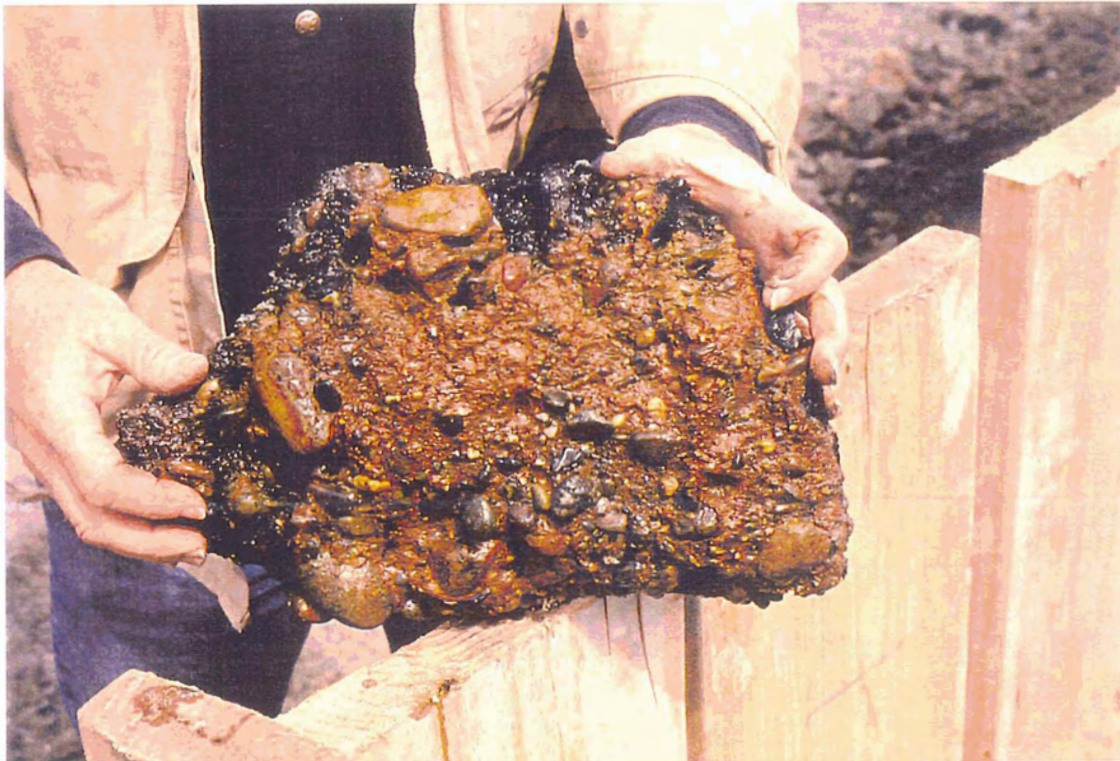
PICTURE NO. 3

At Excavation No. 1, a heavy (thick) layer of graphitization combined with sand and rocks was found adhering to the surface of the pipe. This layer of material, which was up to two inches thick in places, was removed quite easily from the pipe in large pieces. Of the overall thickness of this material, the graphitization was consistently between 1/4 and 3/8-inch thick. One large piece of this material is shown in Pictures Nos. 3, 4, and 5 in Appendix II of this report.

Large piece of thick layer of material removed from the North Beach Force Main at Excavation No. 1 on April 19, 1989. The pipe was encased in this material which consisted of a layer of graphitization, sand, and rocks. This picture shows the soil-side of the material. See next picture for view of the pipe side.

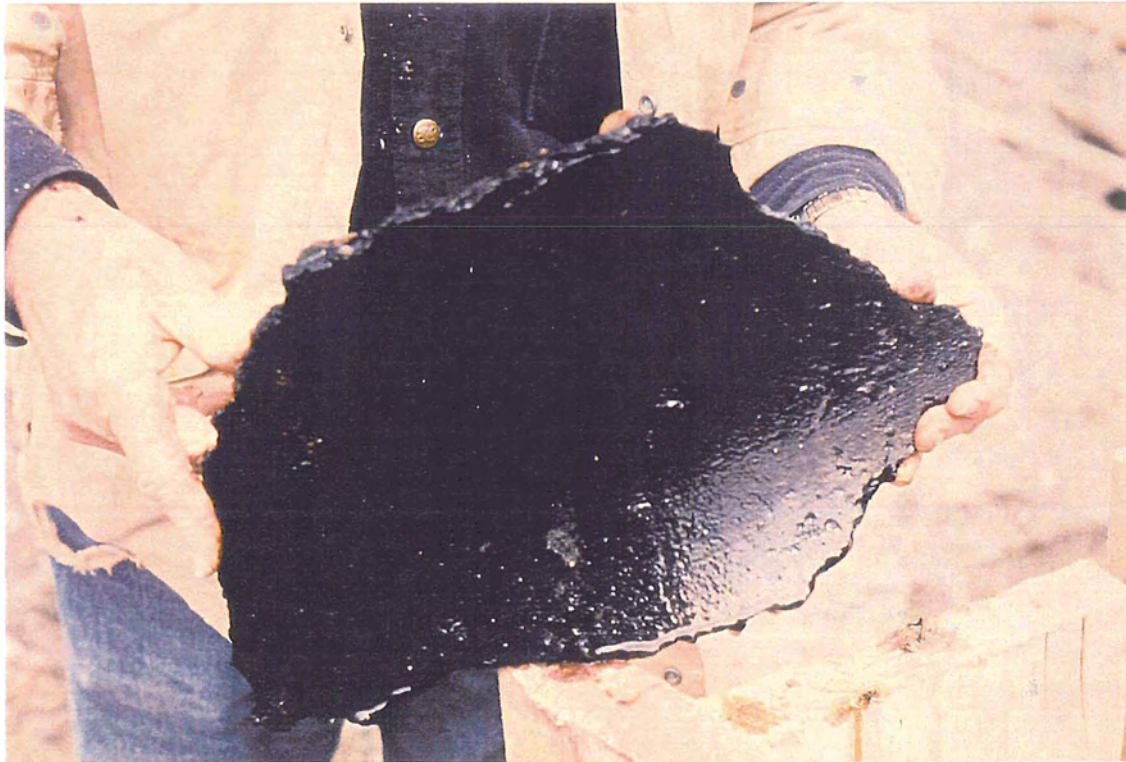
PICTURE NO. 4

Pipe-side of thick layer of material removed from the North Beach Force Main at Excavation No. 1 on April 19, 1989 showing the layer of graphitization (up to 1/4-inch thick) which was easily removed from the pipe.

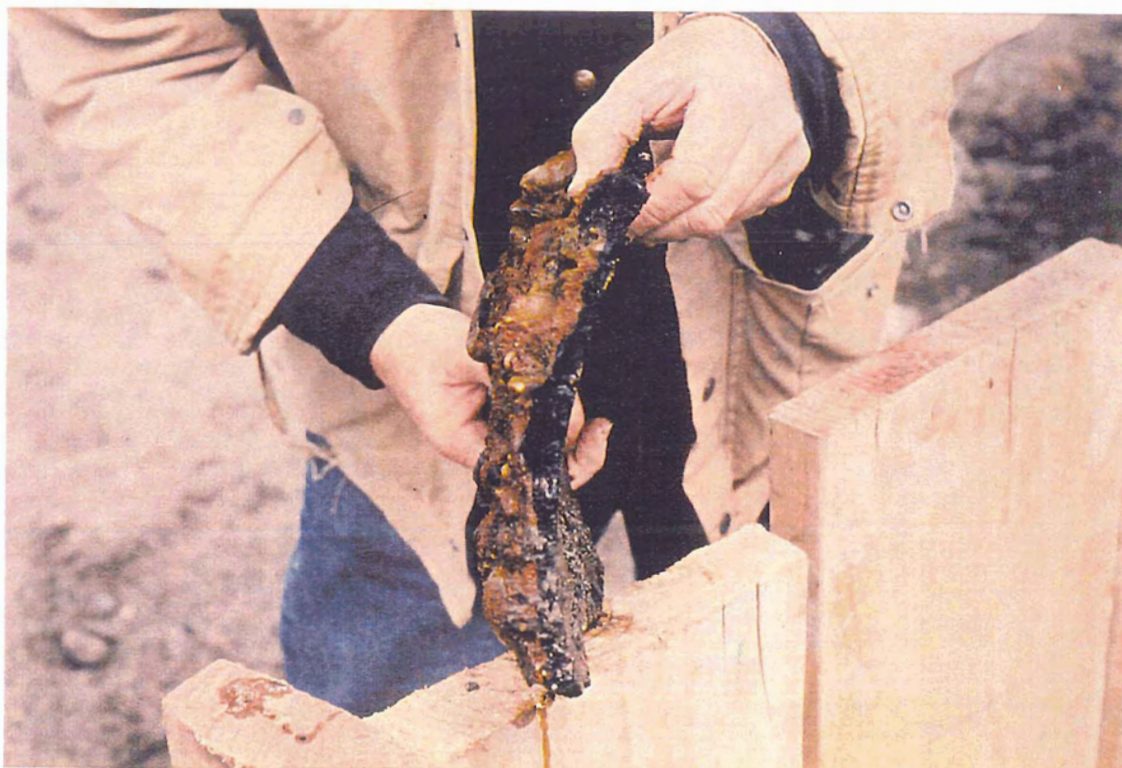
PICTURE NO. 5

Side or end view of piece of material removed from the North Beach Force Main at Excavation No. 1 on April 19, 1989; as shown in the two previous pictures. The total thickness of the material (including graphitization, sand, rocks, etc.) was measured at up to 2 inches, with the thickness of the graphitization layer measured at up to 3/8-inch.

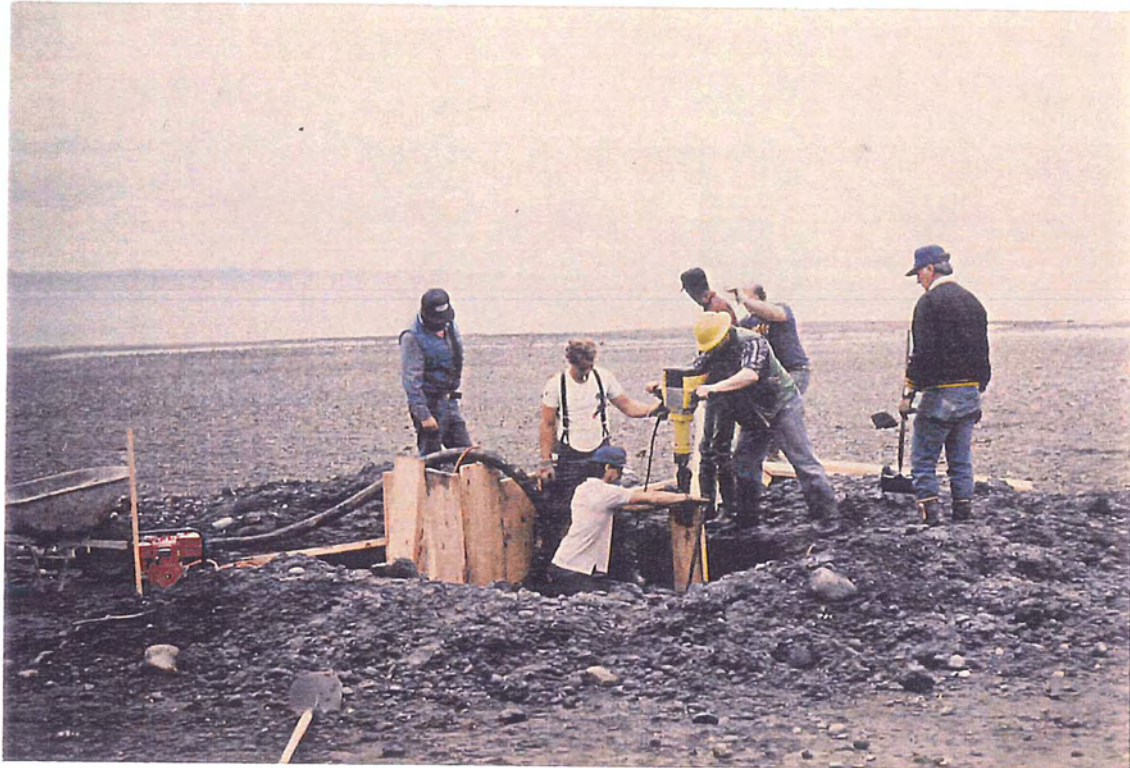
PICTURE NO 12

Excavation No. 2 on the North Beach Force Main on April 20, 1989. Excavation is being shored to prevent caving of the hole. A considerable amount of blue-gray clay was found at the force main depth (six feet deep to the bottom of the pipe) at this location.

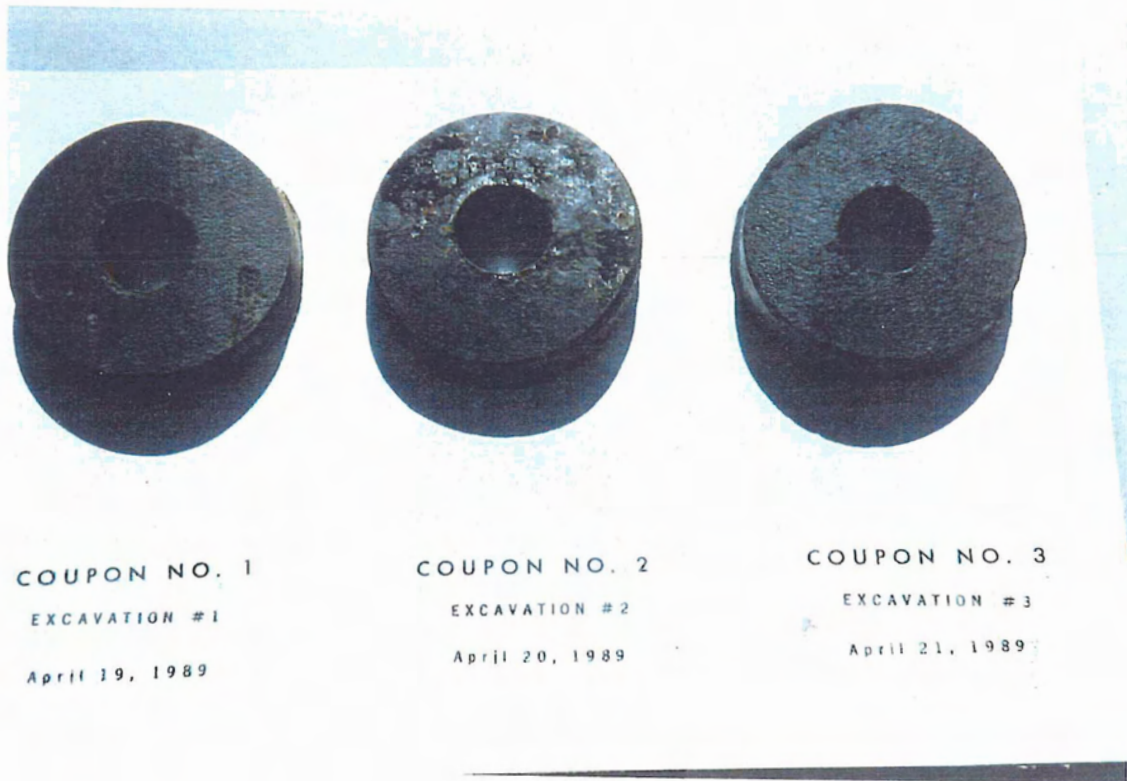
PICTURE NO. 24

The exterior surfaces of Coupons Nos. 1 and 3 (removed from the force main at Excavations Nos. 1 and 3 respectively) appeared to be in very good condition, with a thin film of tightly adhering graphitization and no pitting evident. Coupon No. 2 (removed from Excavation No. 2), however, showed some pitting activity.

Exterior surfaces of 3-inch diameter coupons as removed from the North Beach Force Main, before cleaning. All three coupons had a thin film of graphitization on their surfaces.

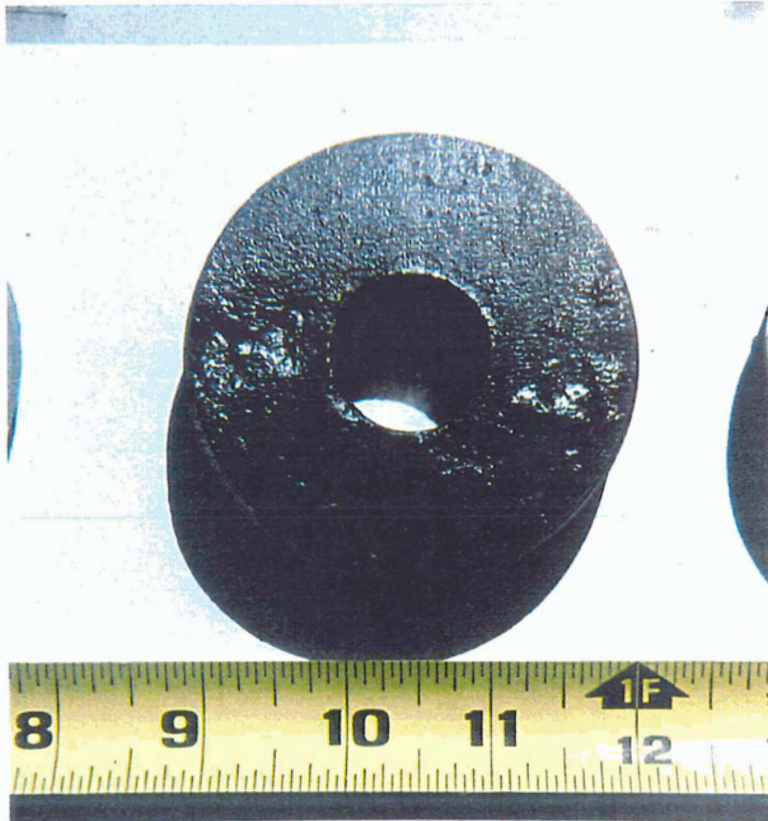
COUPON NO. 2

Close up of exterior surface of Coupon No. 2 as removed from the North Beach Force Main at Excavation No. 2, before cleaning. Some pitting activity is evident.

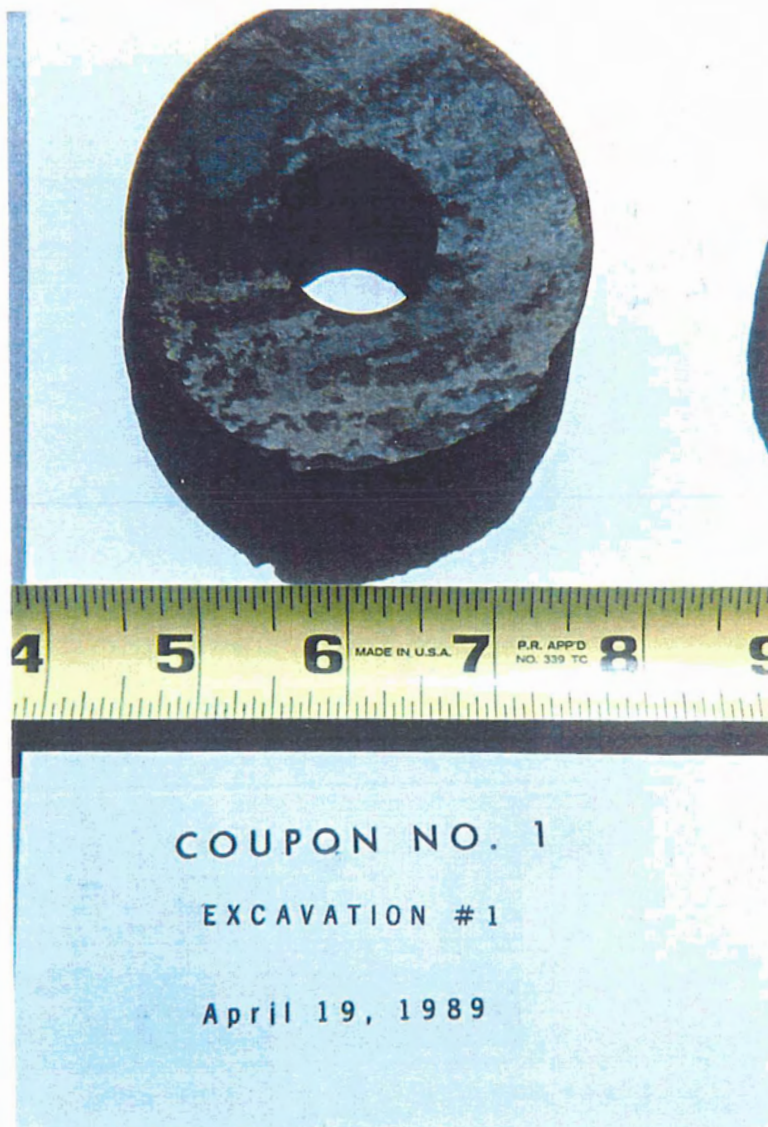
PICTURE NO. 30

Close-up of interior surface of Coupon No. 1 removed from the North Beach Force Main at Excavation No. 1, before cleaning. Note thin coating of cement mortar lining.

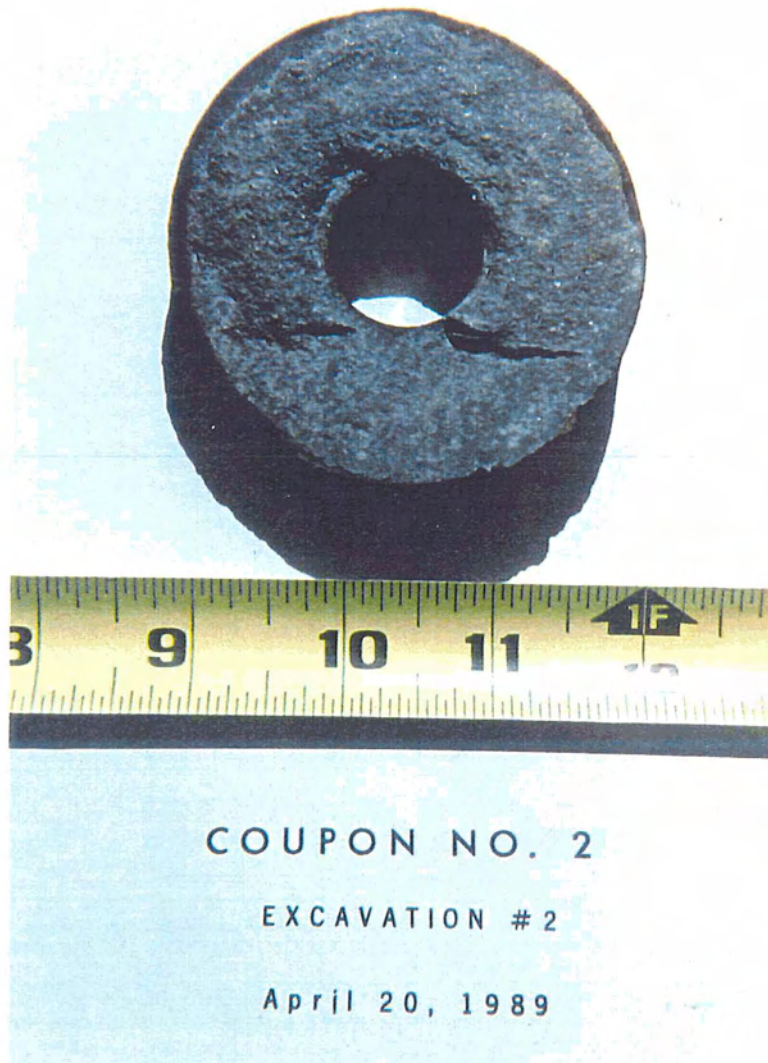
PICTURE NO. 31

Close-up of interior surface of Coupon No. 2 removed from the North Beach Force Main at Excavation No. 2, before cleaning. Note cement mortar lining which measured up to 1/8-inch thick.

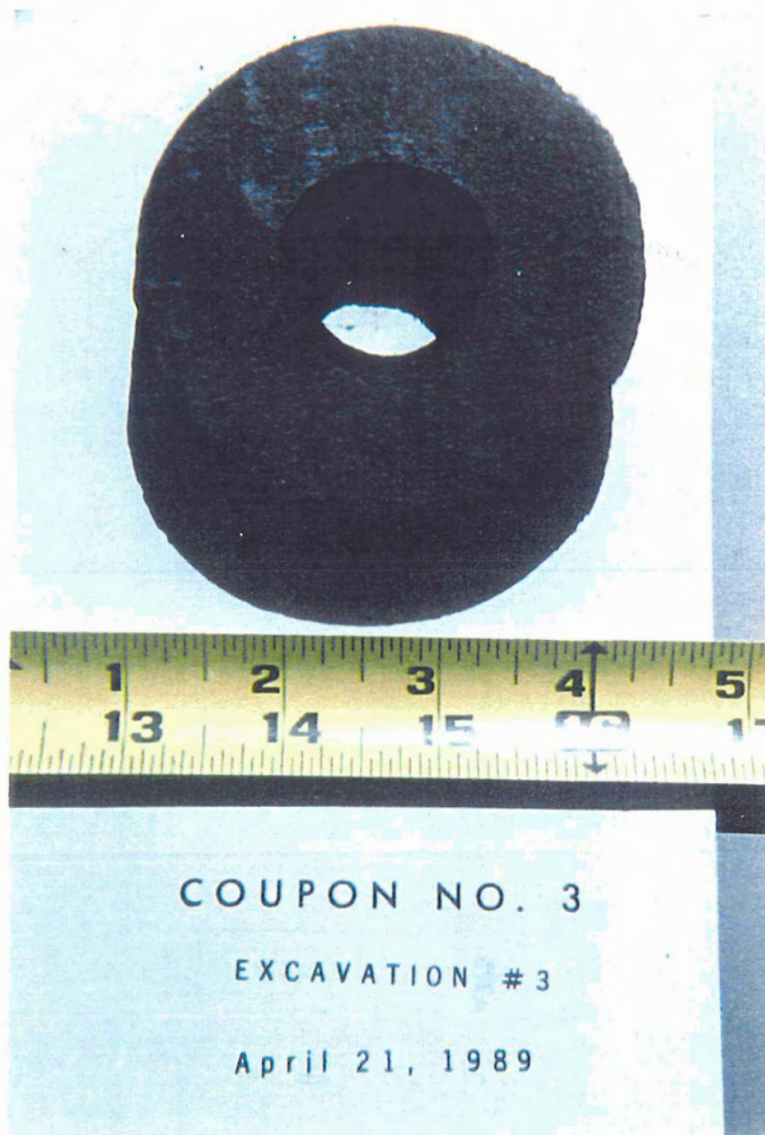
PICTURE NO. 32

Close-up of interior surface of Coupon No. 3 removed from the North Beach Force Main at Excavation No. 3, before cleaning. Only a very thin film of cement mortar lining was noted on small area on this coupon. It is believed that the lining came off during the cutting of the coupon out of the pipe.

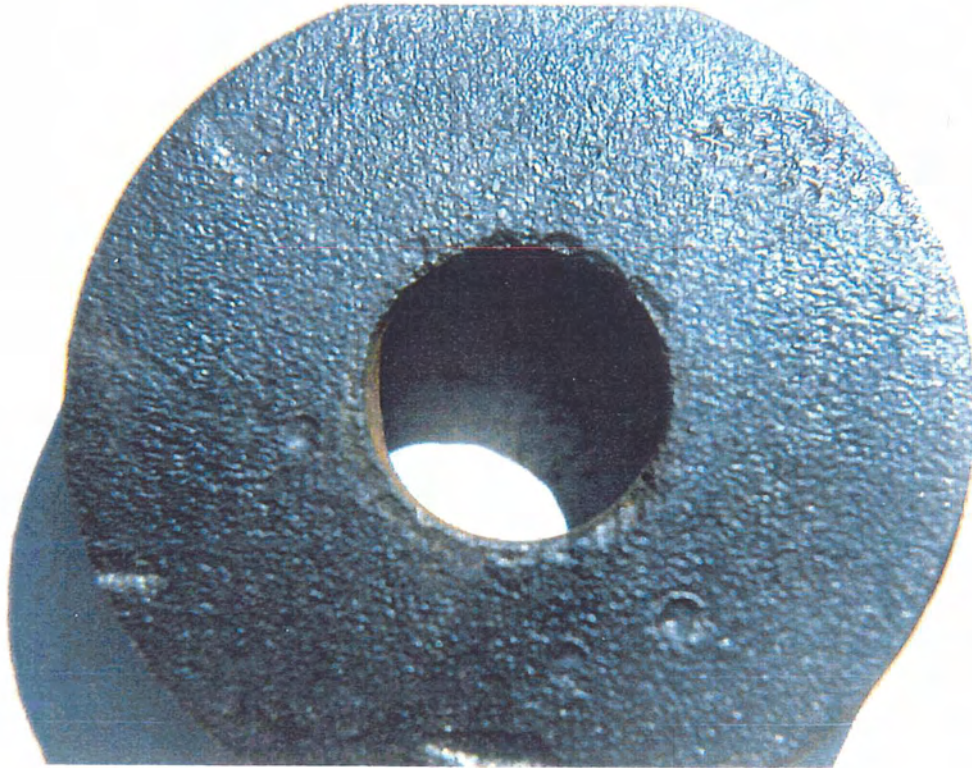
PICTURE NO. 34

Close-up of exterior surface of Coupon No. 1 removed from the North Beach Force Main at Excavation No. 1, after cleaning lightly with a power wire brush. Some very superficial pitting was noticeable on the surface of this coupon.

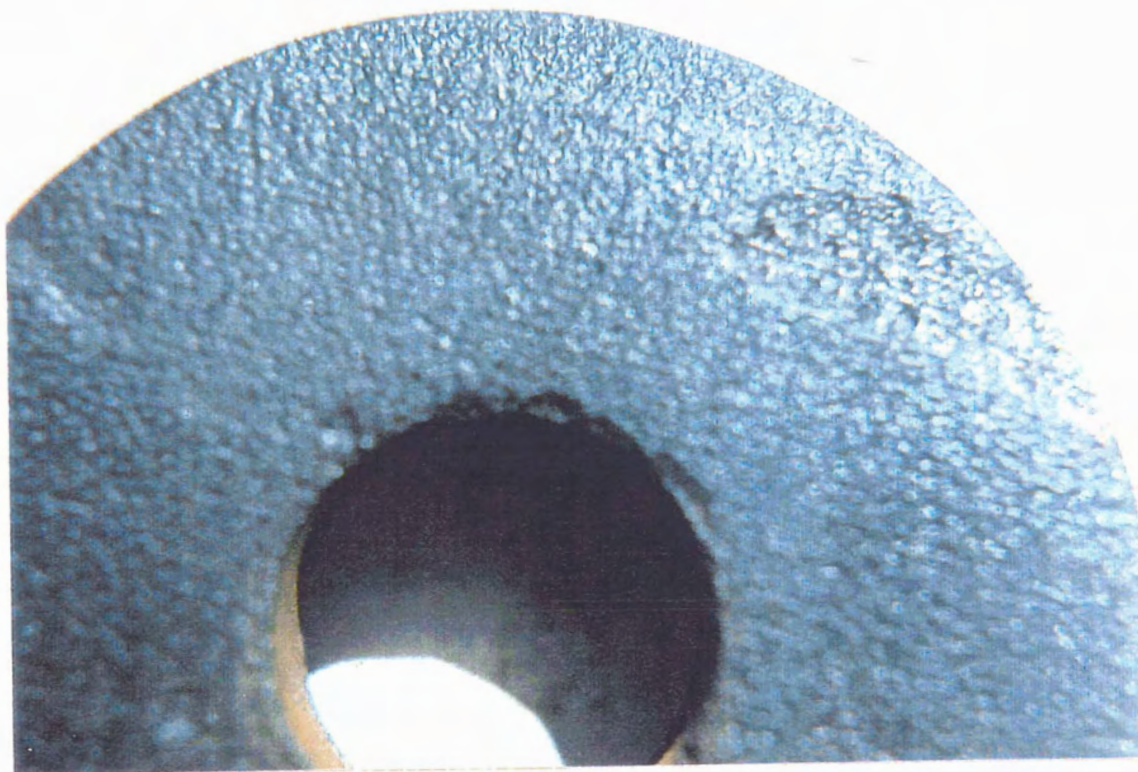
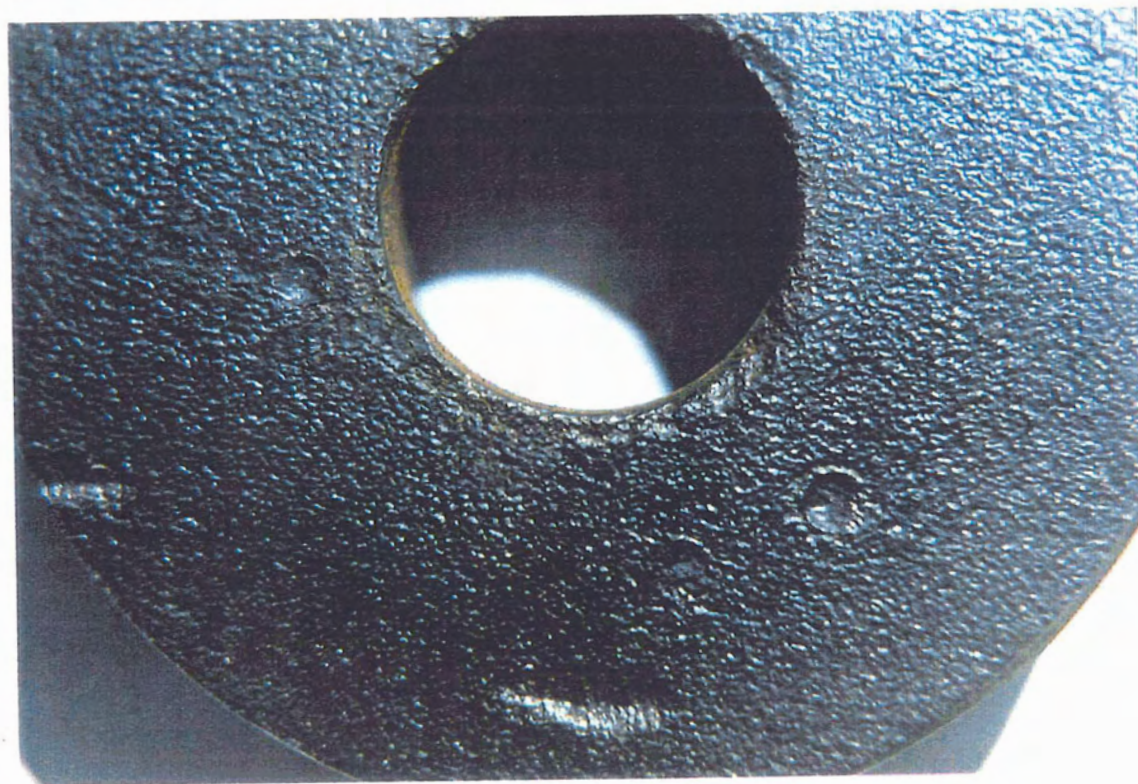
PICTURES NOS. 35 and 36

Enlargements of the exterior surface of Coupon No. 1 removed from the North Beach Force Main at Excavation No. 1, after cleaning. Note the superficial pitting at a few locations on the surface.

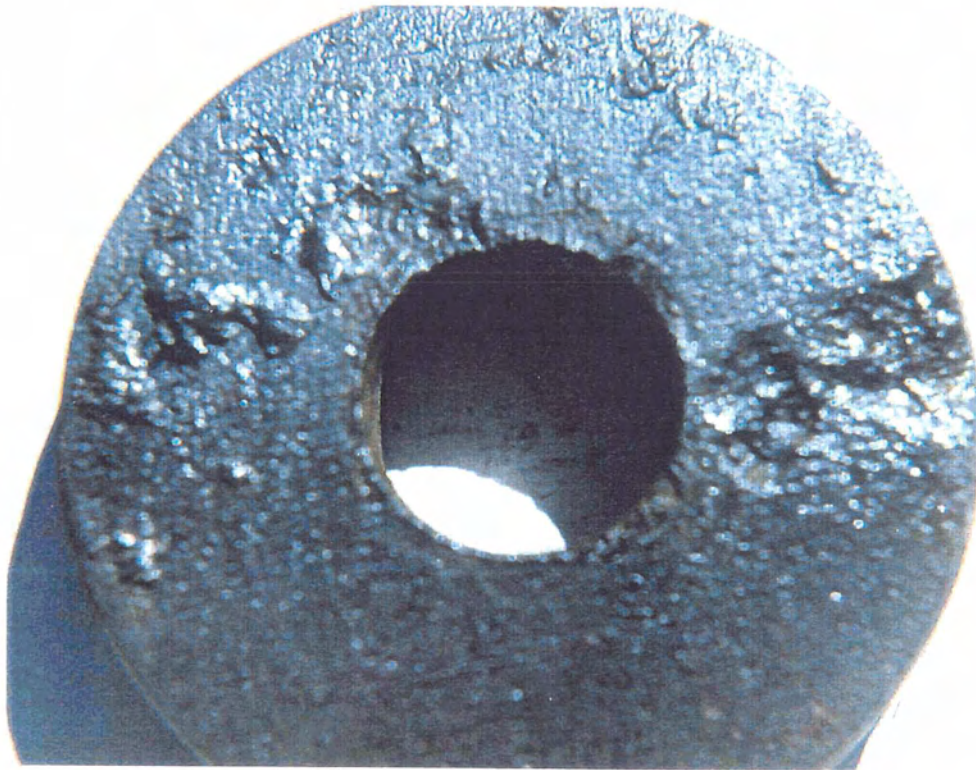
PICTURE NO. 37

Based on the evaluation made of the three coupons removed from the force main, and using the rather deep pitting found in Coupon No. 2 as a "worst case" situation, it has been estimated that the force main could operate for another 31 years before complete penetration of the pipe wall occurs, resulting in a leak.

Close-up of the exterior surface of Coupon No. 2 removed from the North Beach Force Main at Excavation No. 2, after cleaning lightly with power driven wire brush. Note the extensive pitting, which was investigated further as shown shown in Pictures Nos. 56, 57, and 58.

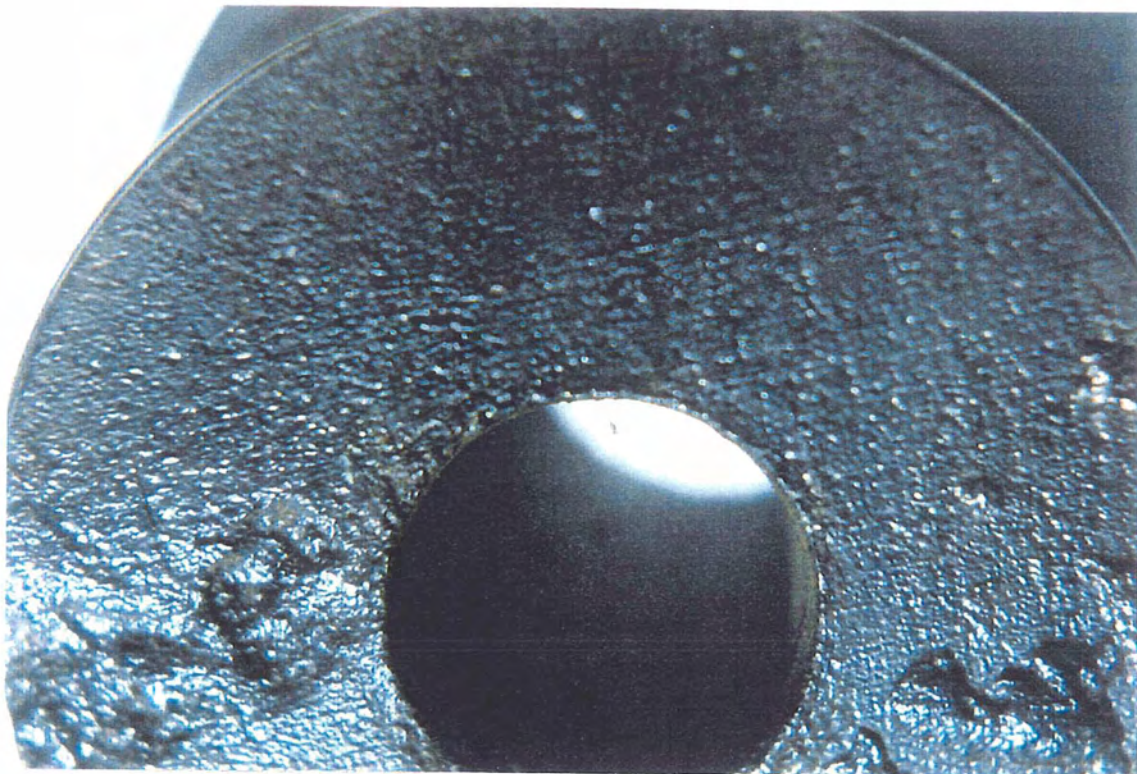
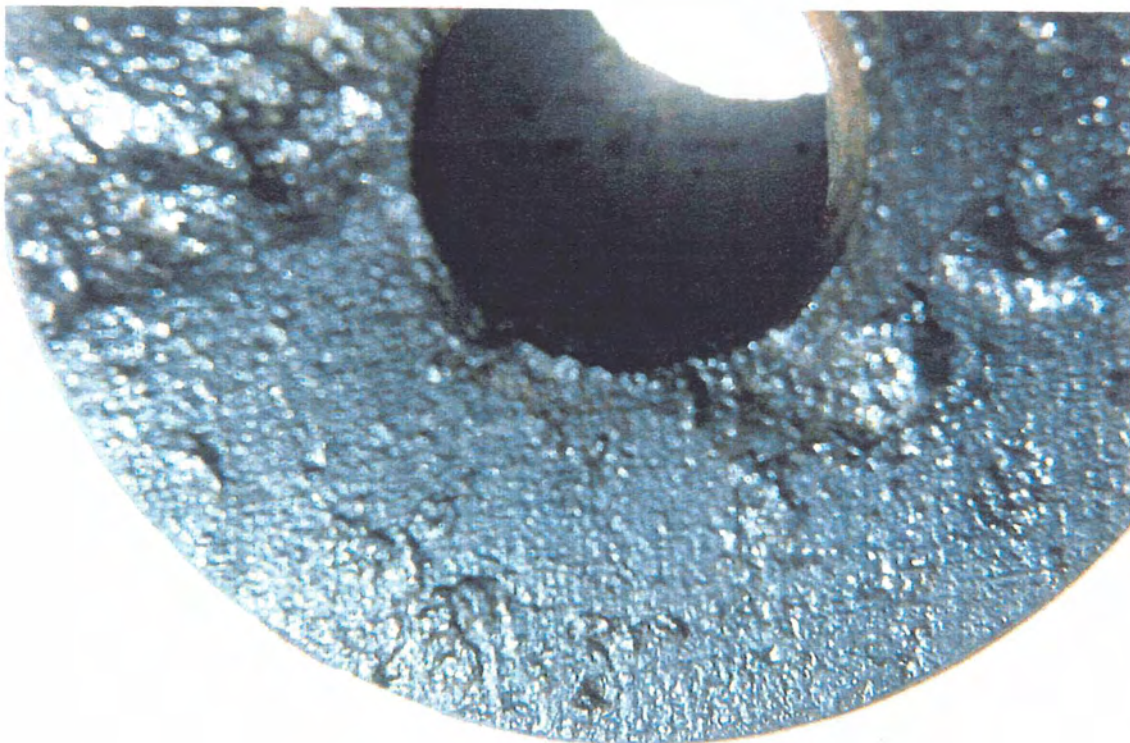
PICTURES NOS. 38 and 39

Enlargements of exterior surface of Coupon No. 2 removed from the North Beach Force Main at Excavation No. 2, after cleaning. Note the extensive pitting on surface, with graphitization build-up directly over pits.

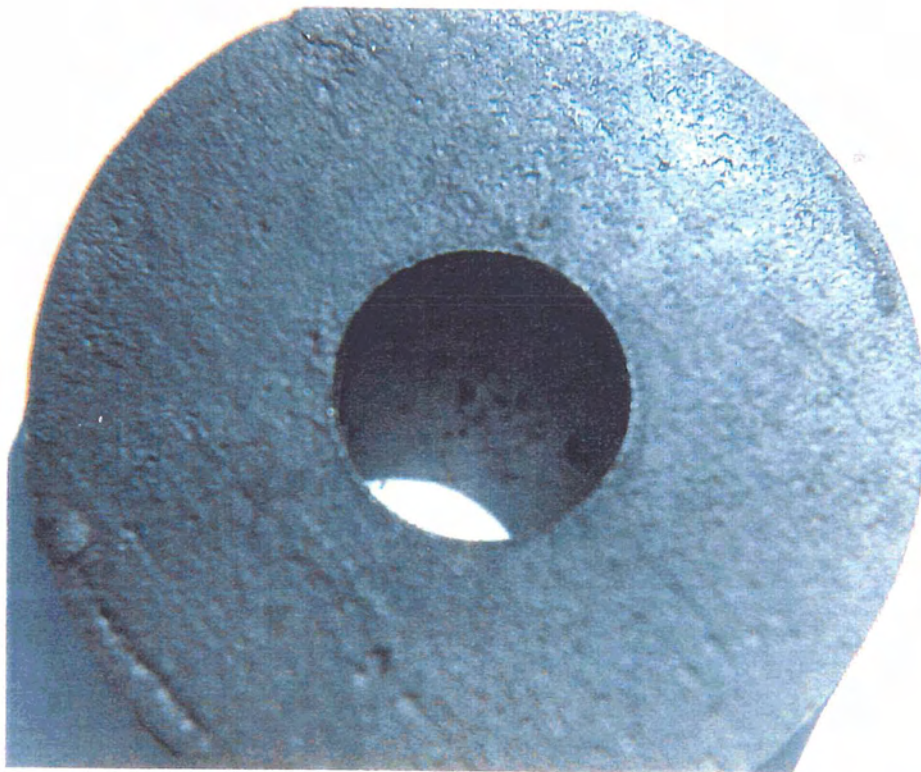
PICTURE NO. 40

Close-up of the exterior surface of Coupon No. 3 removed from the North Beach Force Main at Excavation No. 3, after cleaning lightly with a power driven wire brush. The surface of this coupon was found to be quite smooth, with only a few small minor superficial pits.

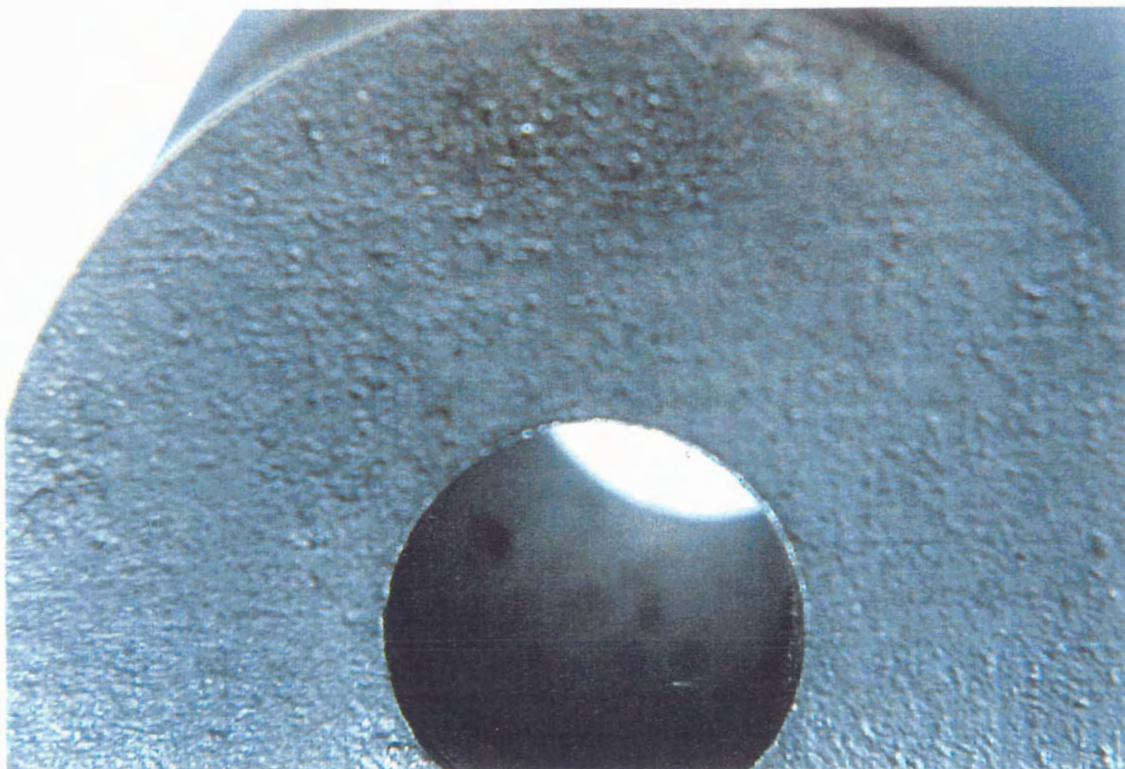
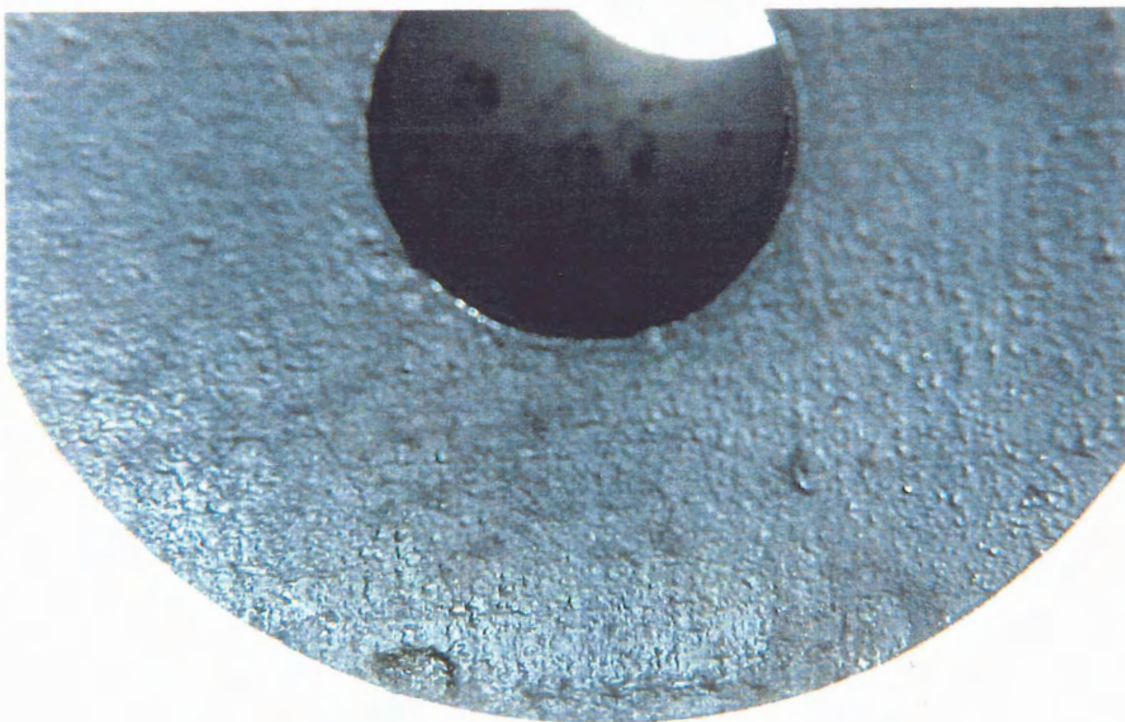
PICTURES NOS. 41 and 42

Enlargements of the exterior surface of Coupon No. 3 removed from the North Beach Force Main at Excavation No. 3, after cleaning. Note the relative smoothness of the surface of this coupon, with only a few minor superficial pits.

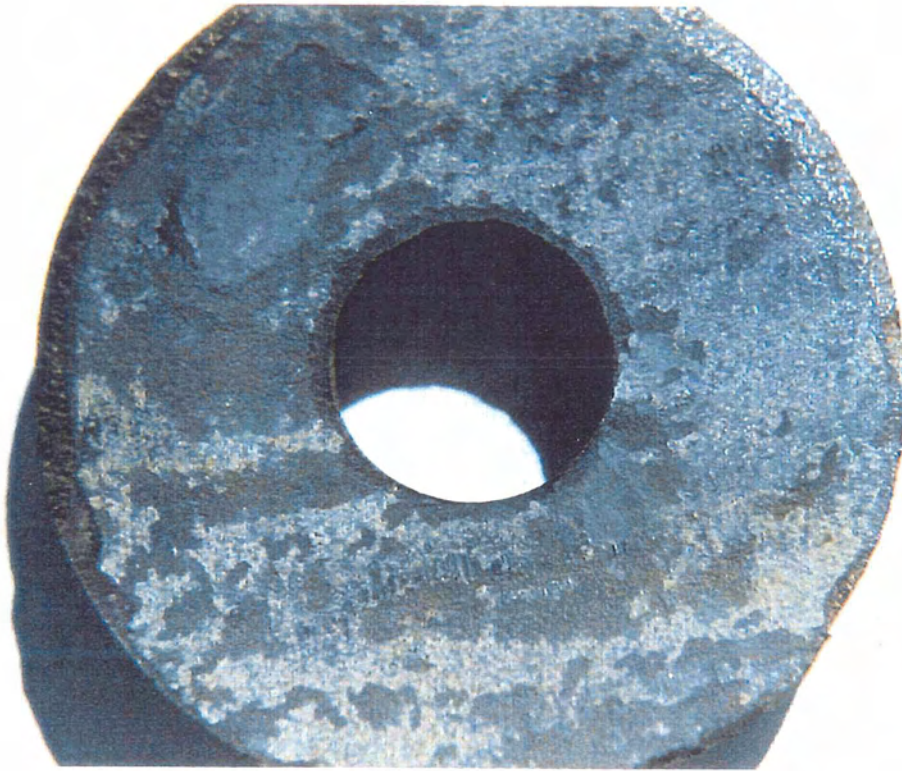
PICTURE NO. 45

Close-up of the interior surface of Coupon No. 1 removed from the North Beach Force Main at Excavation No. 1, after lightly cleaning. Note the thin layer of cement mortar lining still intact on the interior surface.

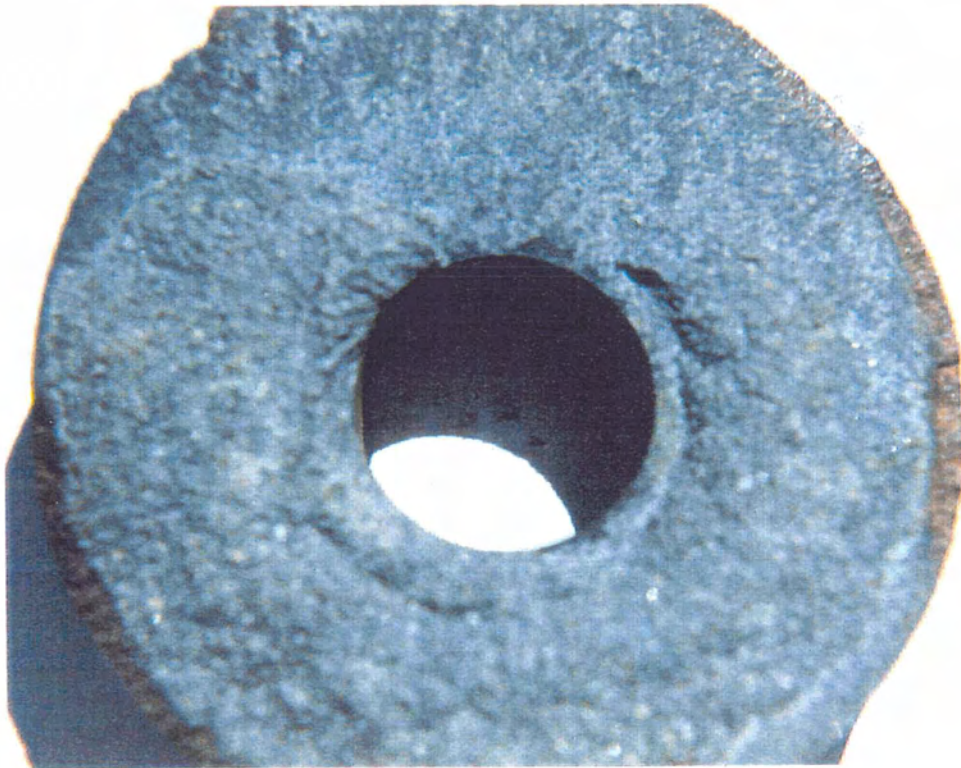
PICTURE NO. 49

Close-up of the interior surface of Coupon No. 2 removed from the North Beach Force Main at Excavation No. 2, after lightly cleaning. Note heavy layer of cement mortar lining still intact on the interior surface of this coupon.

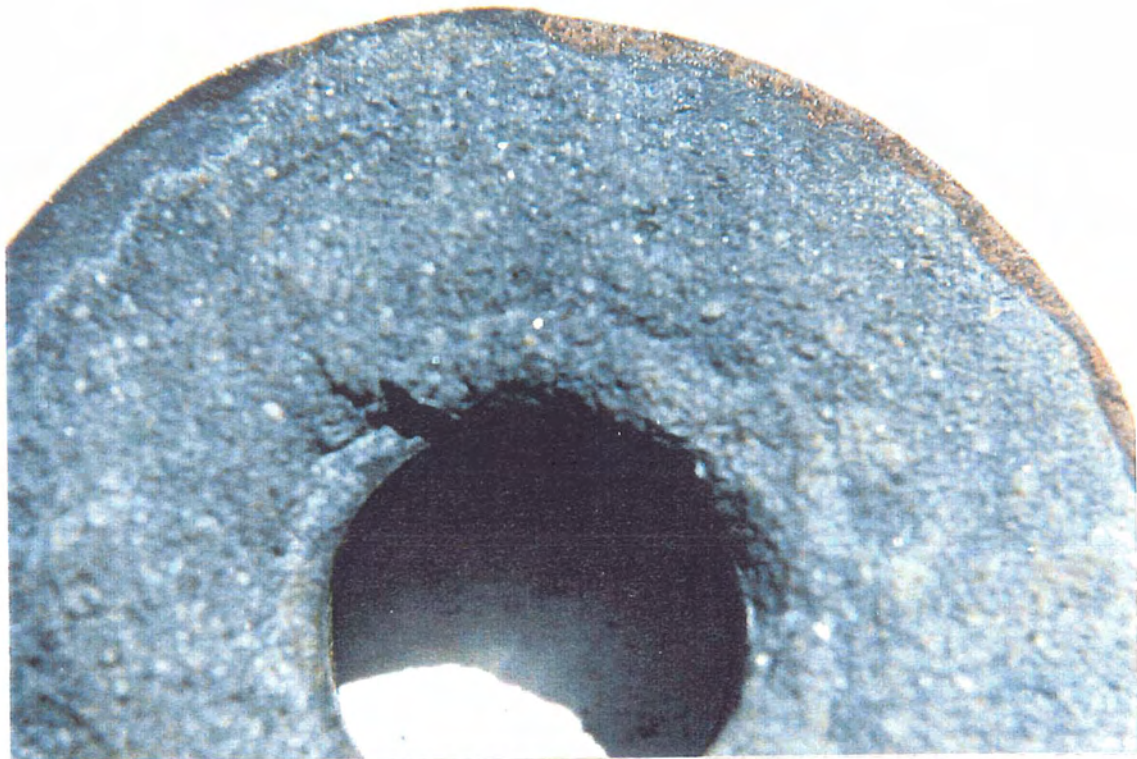
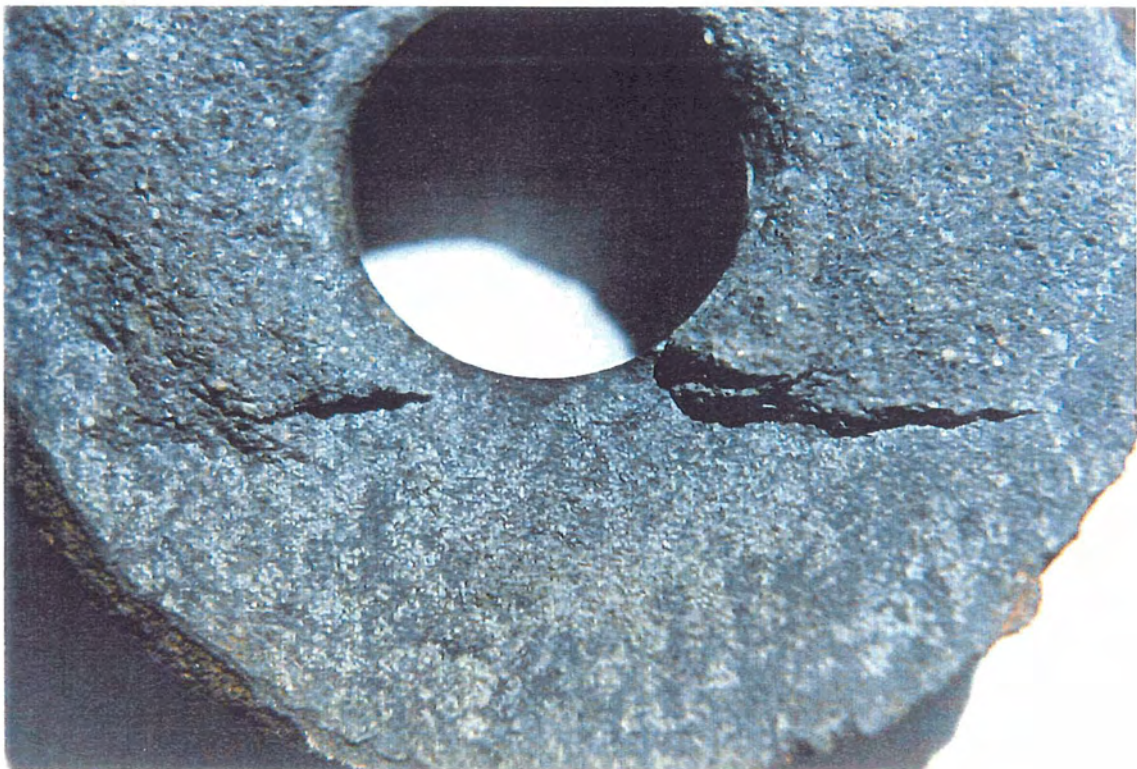
PICTURES NOS. 50 and 51

Enlargements of the interior surface of Coupon No. 2 removed from the North Beach Force Main at Excavation No. 2, after lightly cleaning. The cement mortar lining on the interior surface of this coupon was measured at a thickness of 1/8-inch.

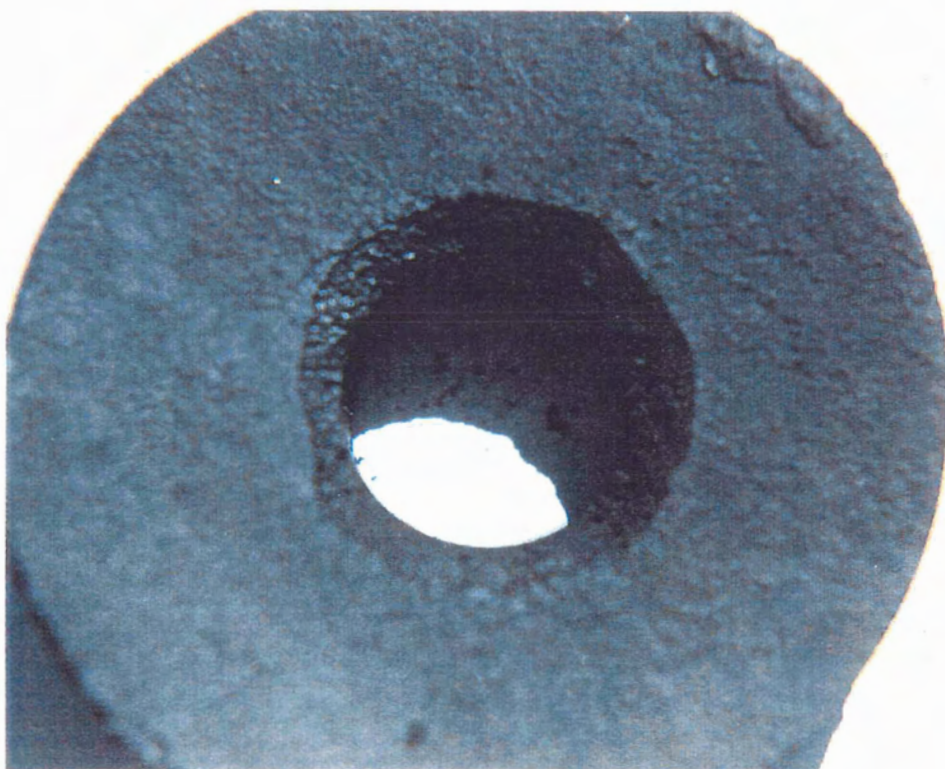
PICTURE NO. 53

Close-up of the interior surface of Coupon No. 3 removed from the North Beach Force Main at Excavation No. 3, after lightly cleaning. The interior surface of this coupon was found to be quite smooth, with only a slight trace of cement mortar lining noted. It is believed that the lining was broken loose from the interior surface of this coupon during the cutting operation.
