## King County

### Water and Land Resources Division

RE: Site Channel Migration Hazard Assessment, Parcel No. 3323069068, Scrivner Property

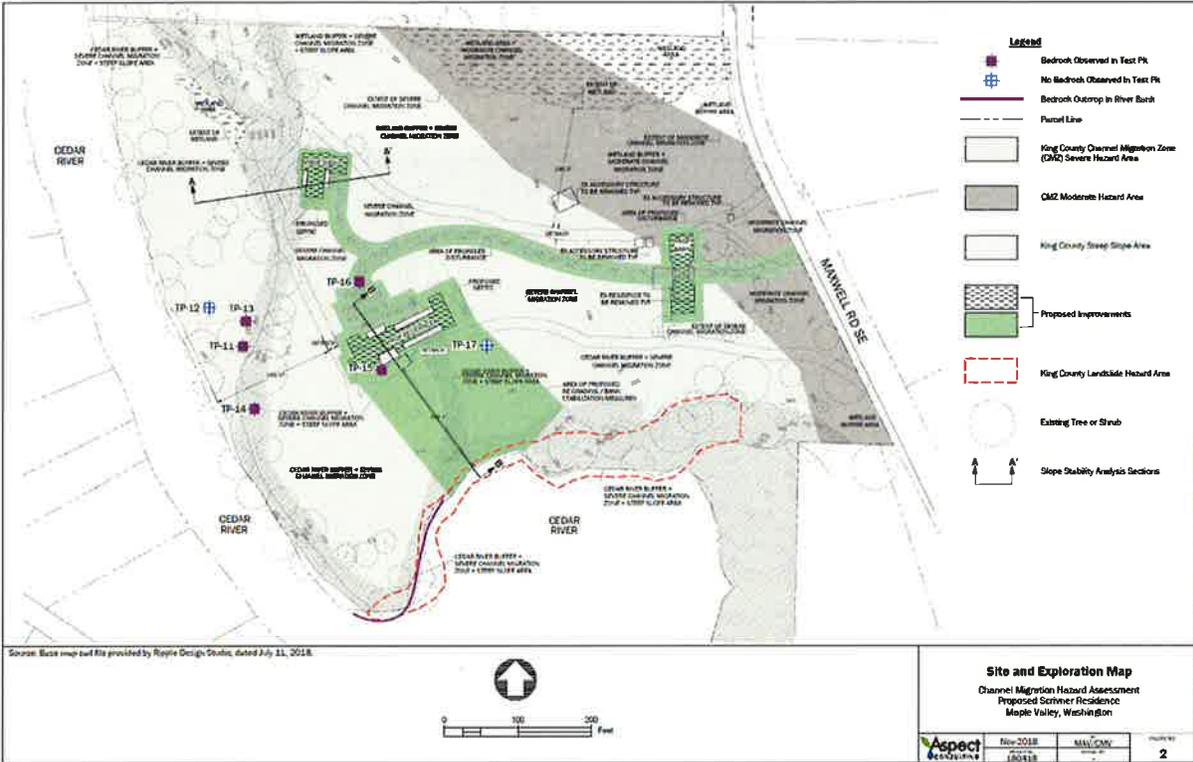
Figure 2. Site Map from geotechnical report (Aspect 2018). Test pits where Aspect identified bedrock are shown in purple.

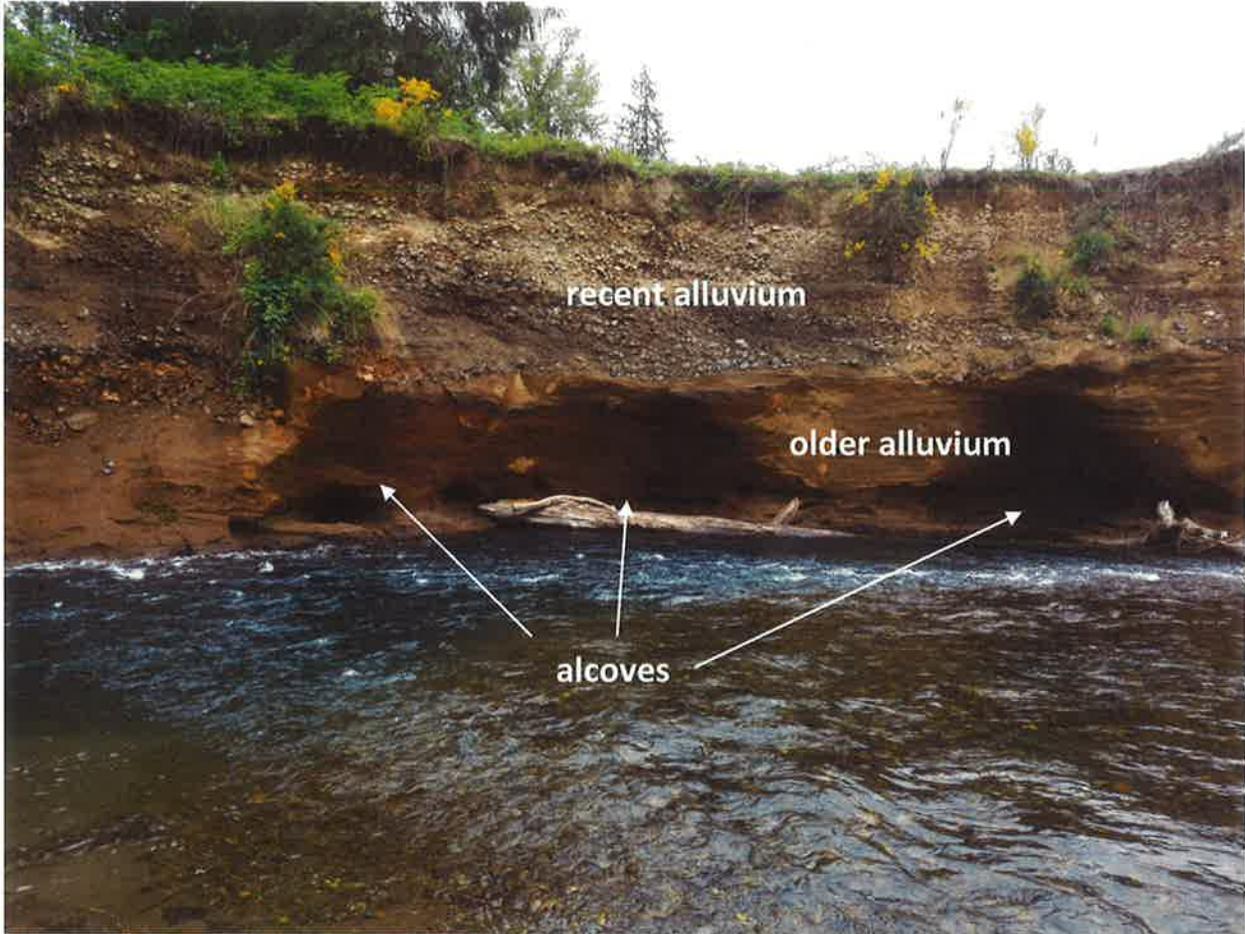
The upper portion of the bank where the assumed bedrock is exposed consists of loose to medium-dense sand and gravel that we interpret as recent (Holocene) alluvium, below which a compacted and relatively competent fine-grained sediment is exposed in the lower river bank. This lower material comprises orange to tan-colored, compacted sand and silt, with visible bedding and intermittent thin gravel layers parallel to bedding planes (Figure 3). The material maintains sub-vertical to overhanging slopes over 10 feet in height, with 5 to 8-foot deep alcoves. Tree-bole diameter pockets were observed in the alcoves, including one with a tree still partially inserted in it, that were scoured into the bank by interaction of river flow and large

wood. At one location graffiti had been scraped into the surface of the material to a depth of approximately 1 inch. We conducted the Pocket Erodrometer Test (PET) for erodibility (Briaud *et al.* 2011) in three locations along the base of the exposed material, the results of which placed it in the “medium erodibility” class.

**Figure 3. Exposure of layered alluvium along actively eroding river bank with tree-gouged alcoves. (Photo taken by RFMS on May 16, 2019).**

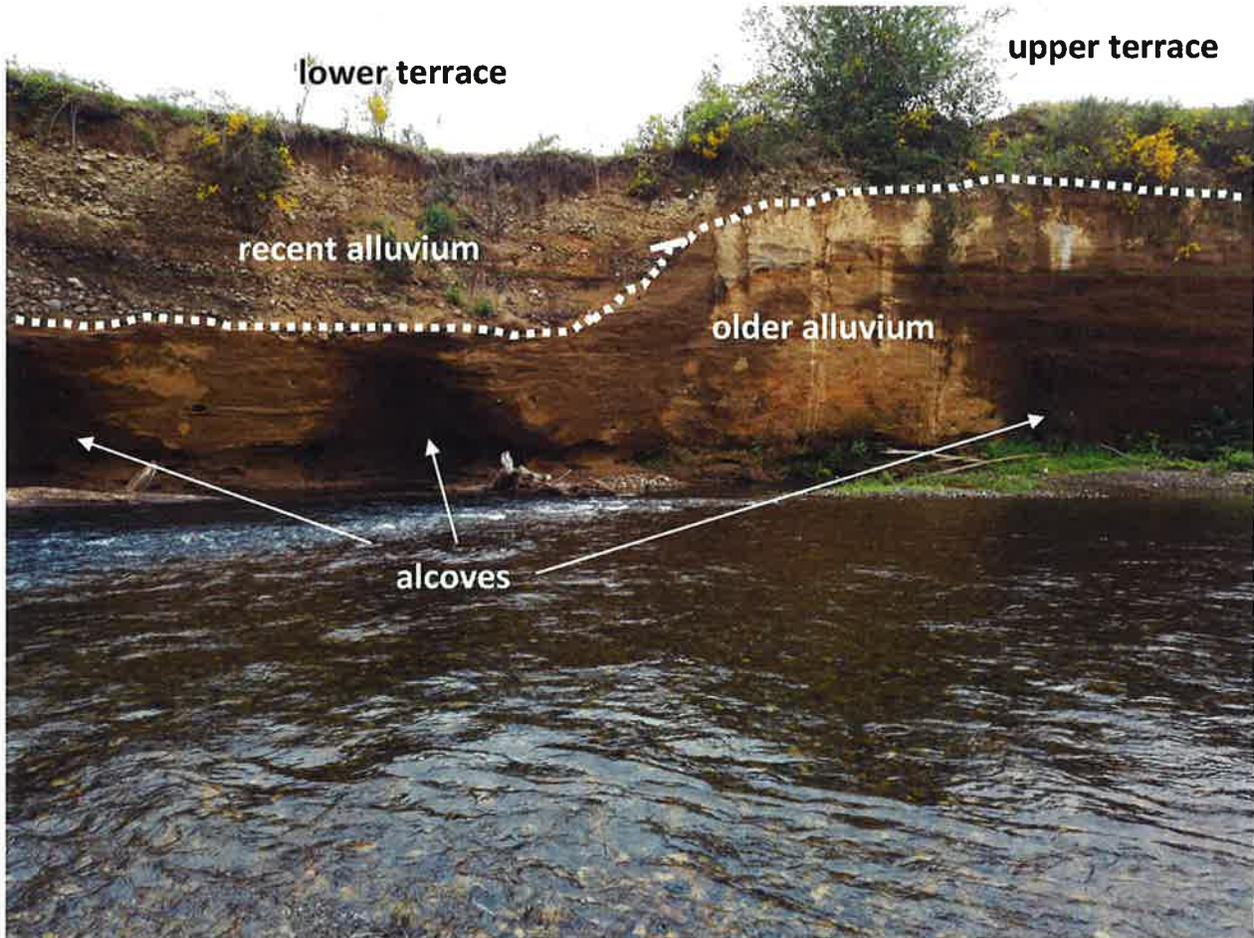
Based on these observations and tests, we concluded that the material exposed on the lower portion of the river bank is likely to be compacted “older alluvium” as mapped and as described by Booth (1995). Given its elevation and extent, this is likely the same material as was encountered in the test pits and described as Renton Formation bedrock by Aspect. Regardless of its origins or proper name, however, the material exposed in the riverbank is not completely resistant to erosion by the river, but it is less erodible than the recent (Holocene) alluvium that overlies it.

**Figure 4. Elevation difference between upper and lower terraces echoes the shape of the contact between older and recent Holocene alluvium layers. (Photo taken by RFMS on May 16, 2019).**

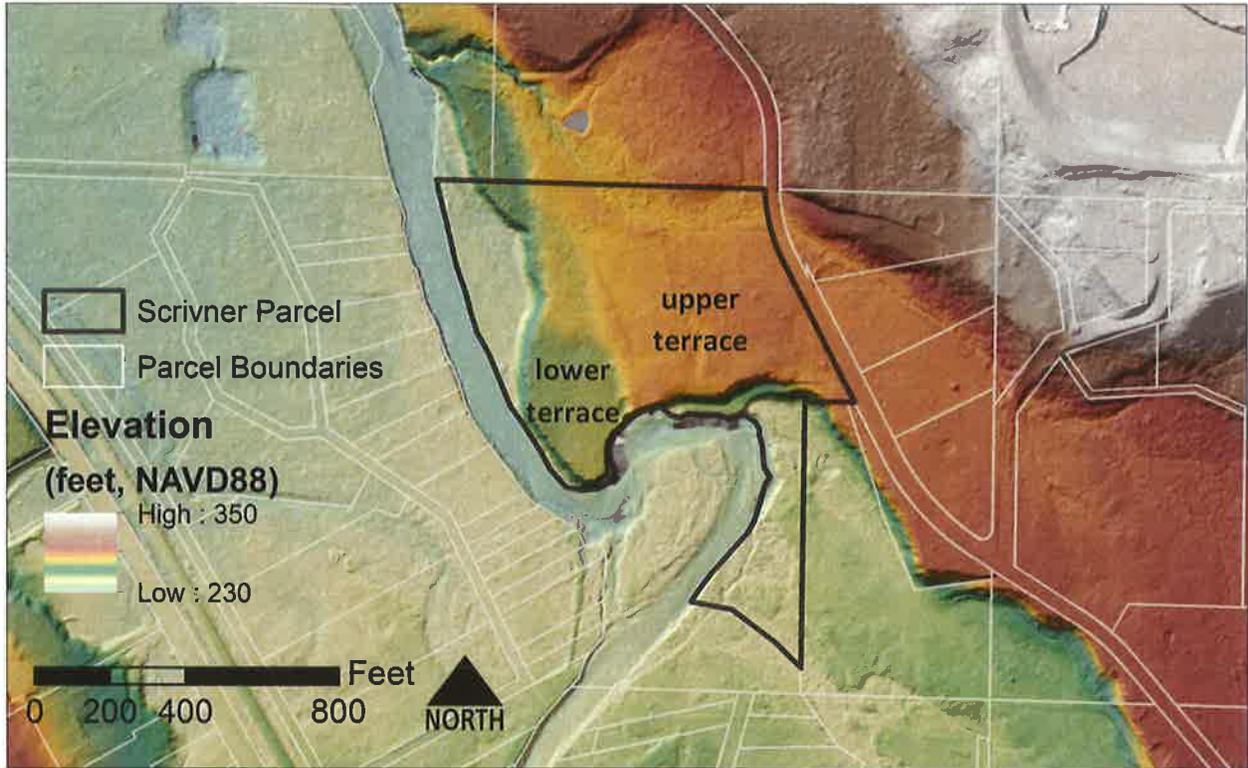
Figure 5: Location of upper and lower terraces. (LiDAR graphic generated by RFMS).

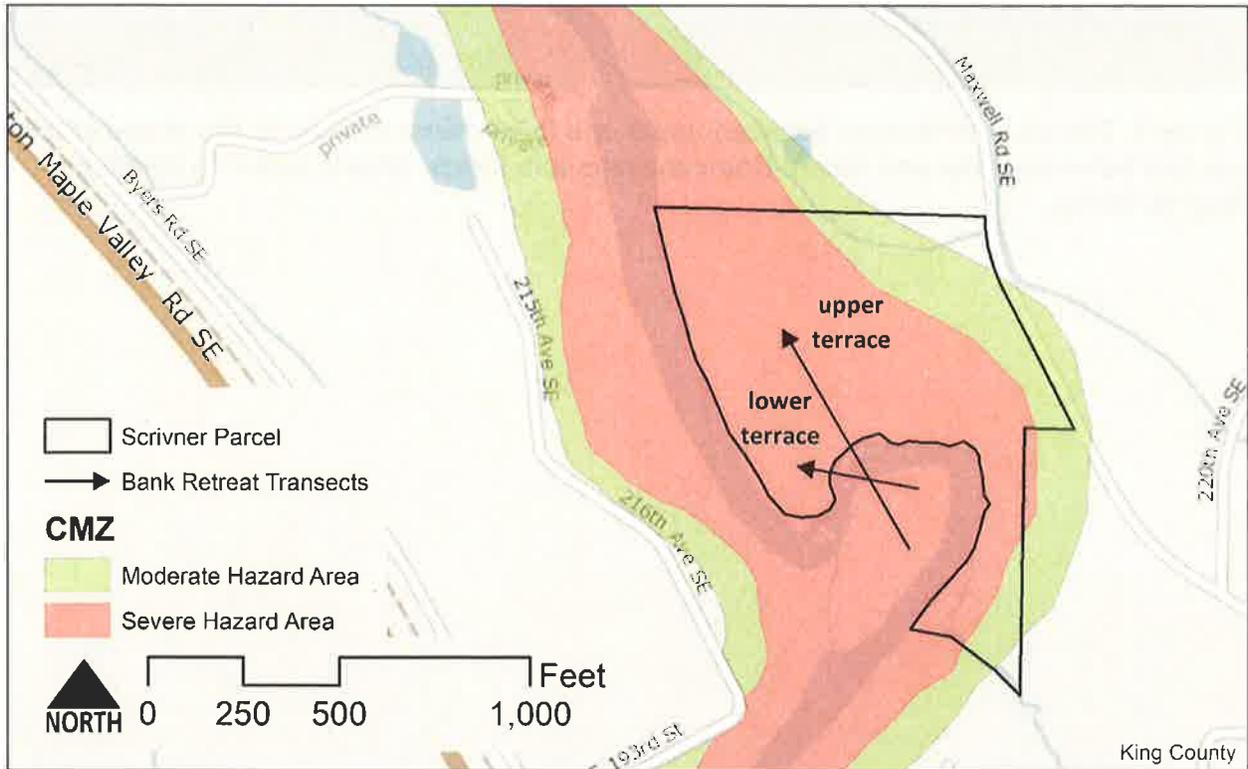
To determine the appropriate erosion rate for this location, RFMS staff used the 1936 to 2018 aerial photograph record to measure bank retreat distances and calculate erosion rates along two transects perpendicular to the river bank where the erosion-resistant material was exposed; one extending into the upper terrace and one into the lower terrace as shown in Figures 4 through 6. Results are presented in Figure 7. The erosion rates measured when the river was eroding into the upper terrace (with a greater thickness of erosion-resistant material) were lower than those measured when the river was eroding into the lower terrace. Based on bank retreat distances measured between 1936 and 2018, we calculated time-weighted average lateral migration rates and compared them with cumulative and interval rates for both upper and lower terraces (Figure 7). These methods for calculating lateral channel migration rates are consistent with Appendix A of the King County Channel Migration Public Rule (King County 2018).

Figure 6. Location of transects used to calculate bank retreat distances and erosion rates. Graphic includes current effective CMZ Severe and Moderate hazard boundaries.

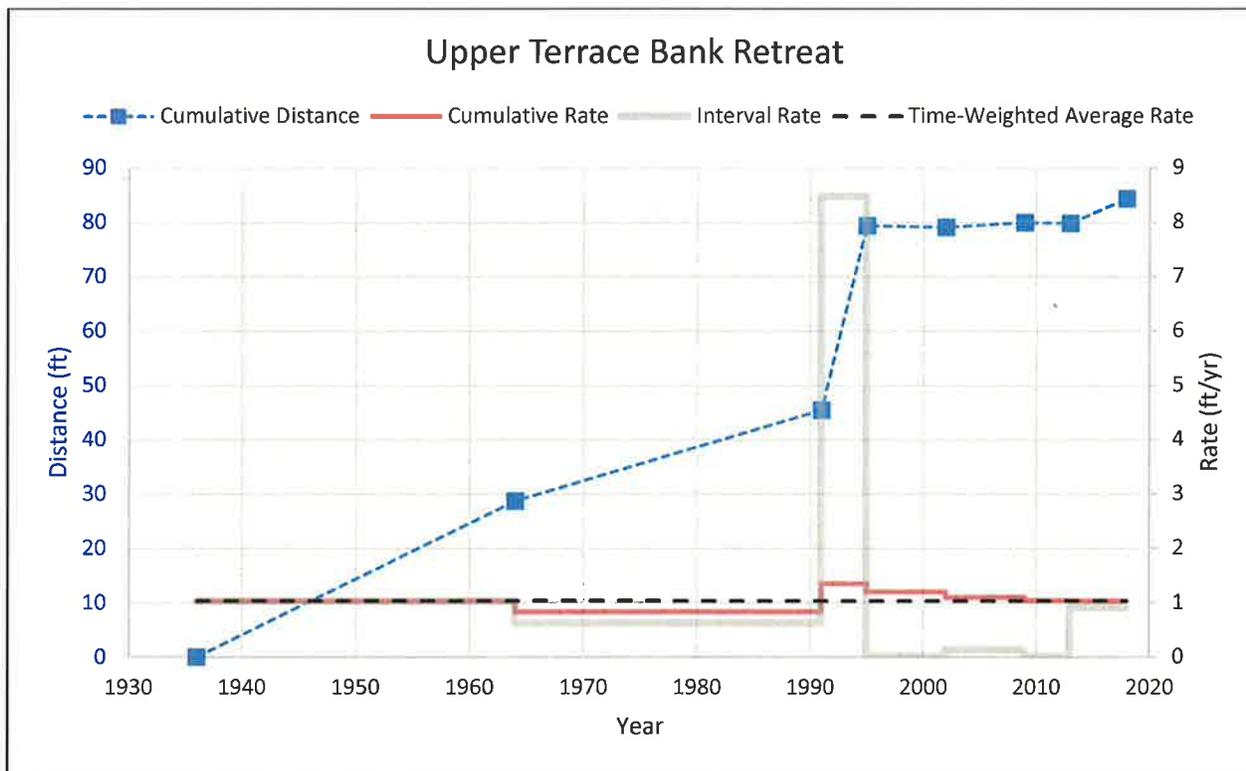
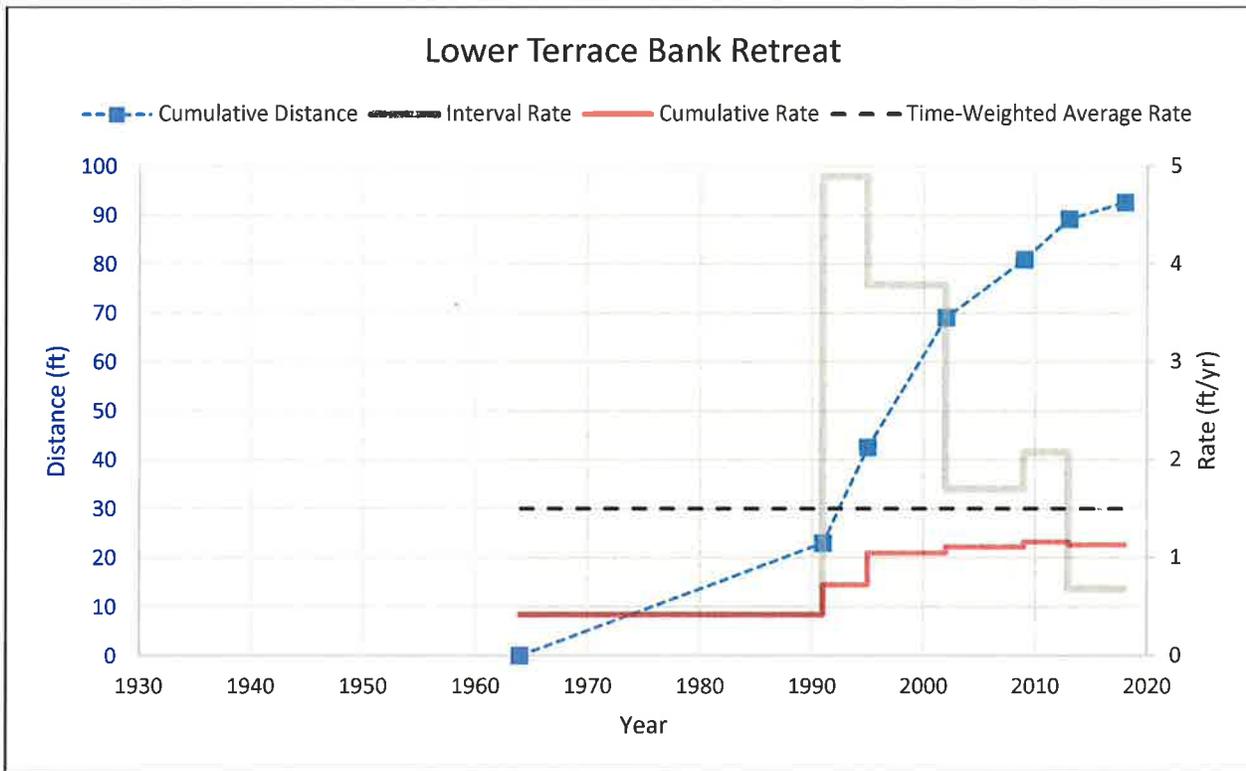
The time-weighted average rate for the upper terrace was calculated to be 1 foot/year, and for the lower terrace 1.5 feet/year. Both rates are close to the cumulative rates at this location over the 81-year historical record, and therefore appropriate for use in determining 25 to 100-year erosion setback distances.

**Figure 7. Upper and lower terrace bank retreat distances and erosion rates as calculated by RFMS.**

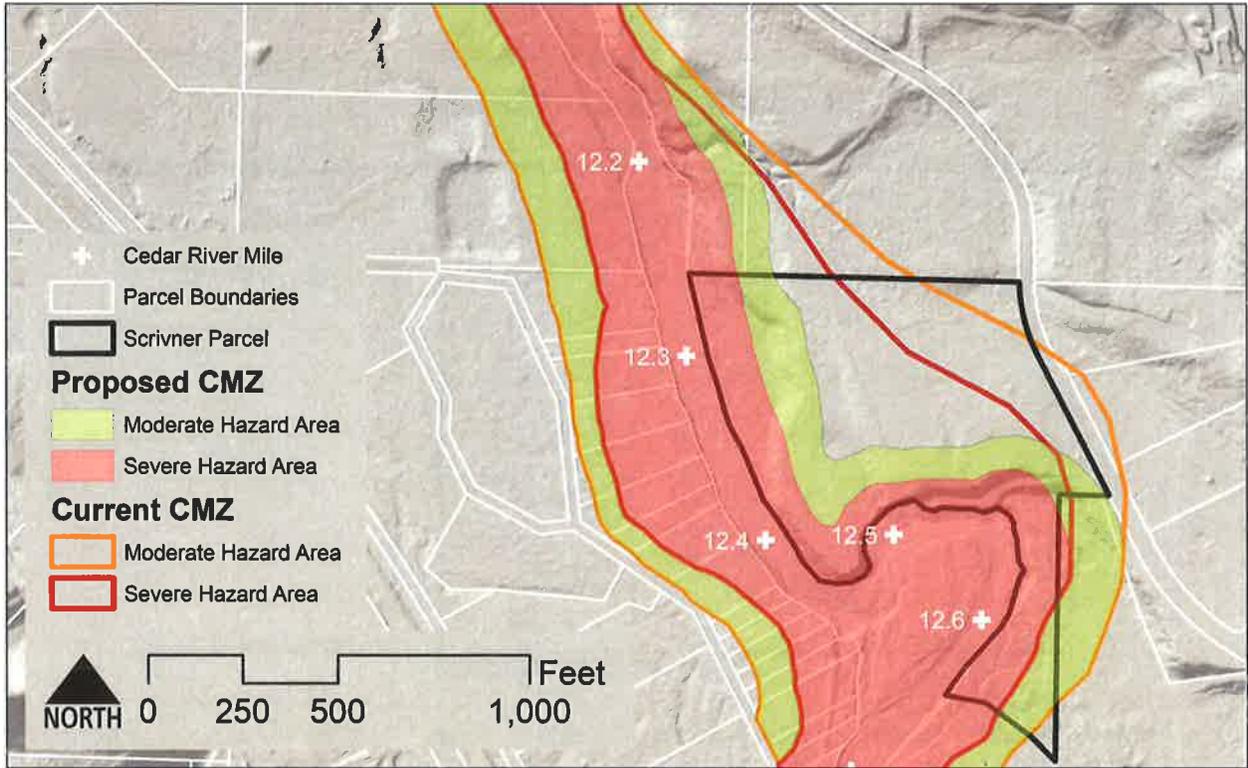
RFMS staff generated proposed revised mapping of the CMZ hazard areas along this portion of the Cedar River to reflect our reassessment of the 2015 adopted CMZ mapping. This proposed mapping was produced using GIS shapefiles to reflect this reassessment per the Public Rule; it also incorporates an enhanced, site-specific understanding of the physical conditions and applies recalculated erosion and geotechnical setbacks to the area on the right bank of the Cedar River where we determined the erosion-resistant material to be present, based on test pit results (Aspect 2018), our site observations, and surface topography. The proposed revised portion of the CMZ extends from RM 12.2 to 12.6 along the right bank of the Cedar River (Figure 8).

Figure 8. Comparison of currently effective CMZ mapping with the proposed revised hazard area boundaries.

In accordance with the procedures set forth in Section 21A-24-279A.B.3 of the King County Channel Migration Public Rule, the RFMS is recommending a revision to the effective Cedar River CMZ hazard area mapping in the vicinity of the Scrivner parcel. The revised mapping would also affect other adjacent parcels along the right bank of the Cedar River as listed in Table 1. RFMS is providing this memorandum and will transmit the appropriate digital version of the proposed revised mapping to DLS in support of DLS's adoption of this reassessment.
