**South Fork Snoqualmie River
Levee Repair and Reconstruction Plan**

**South Fork Snoqualmie River
Levee Characterization Report
River Mile 2.0 – 5.9**

June 2014

Tetra Tech

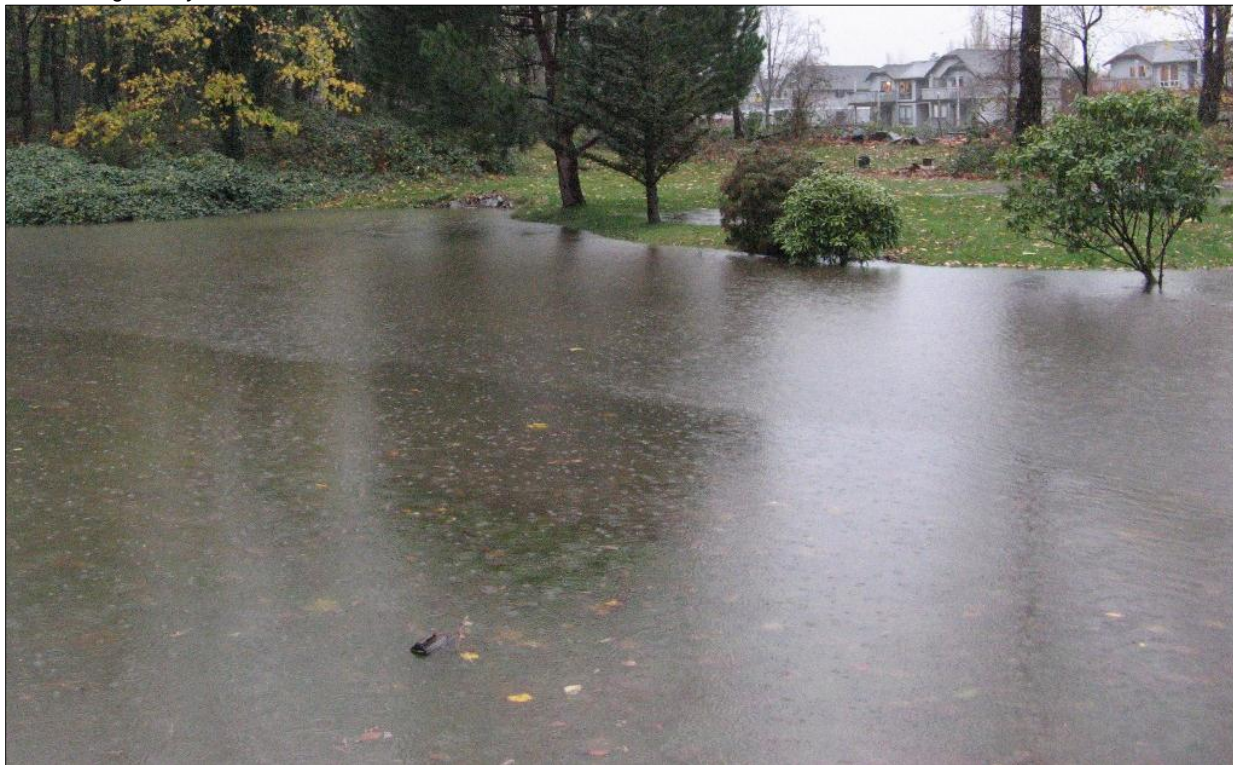
Figure 1-2. Flooding in Shamrock Park, November 12, 2008

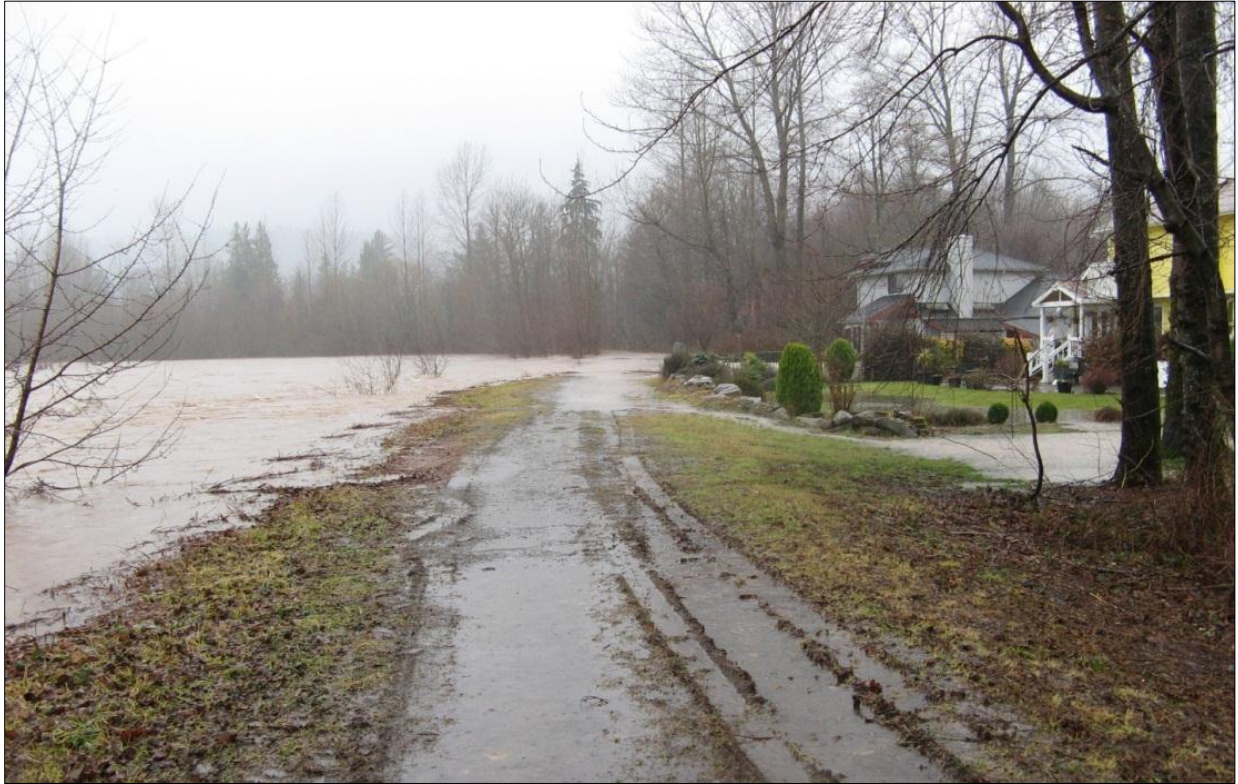
Figure 1-3. South Fork Snoqualmie River Overtopping Left Bank at RM 3.35, January 7, 2009

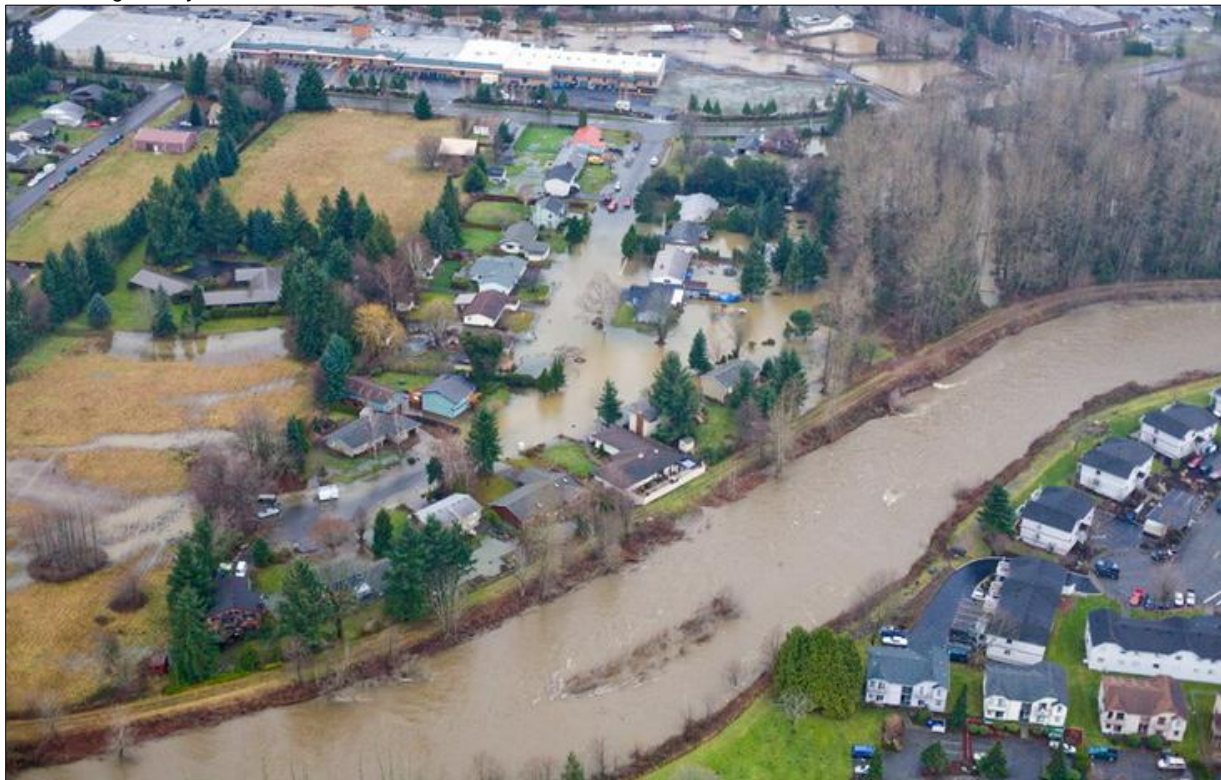
Figure 1-5. Flooding in Shamrock Park, January 10, 2009

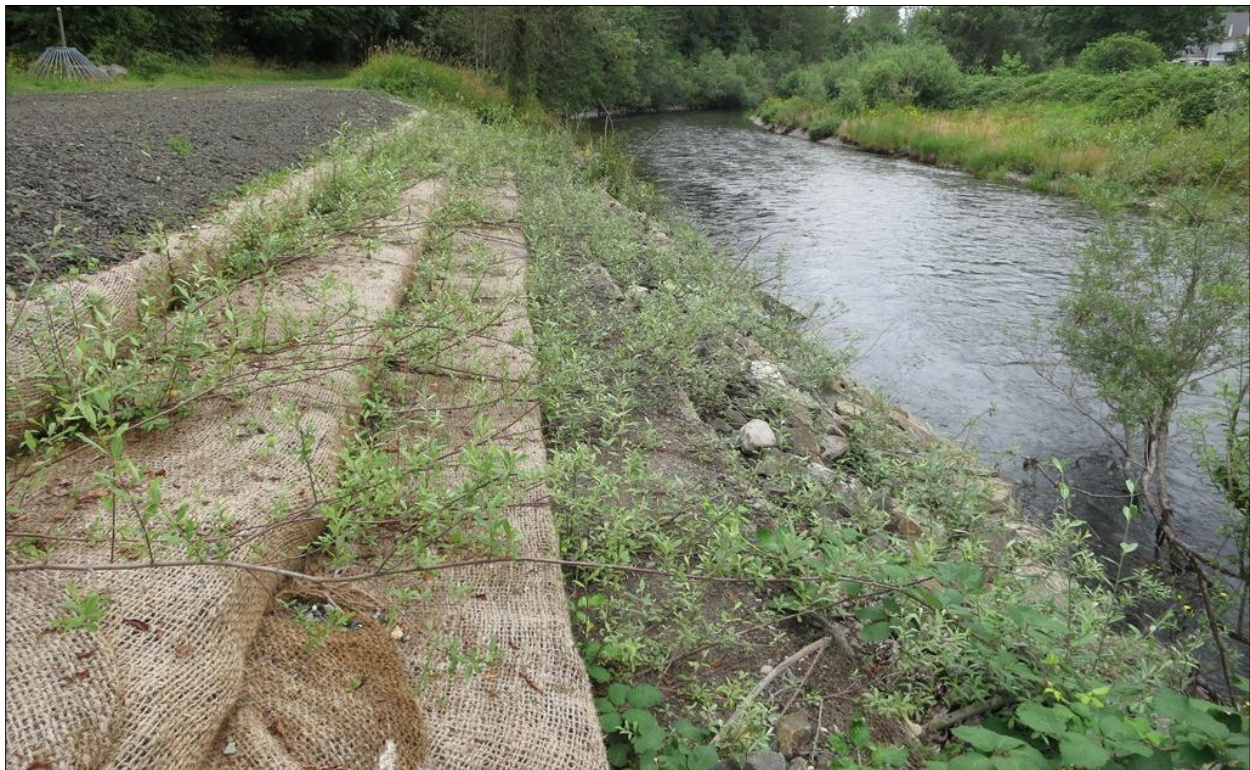
Figure 1-7. Repair to Reif Road Levee at RM 3.05

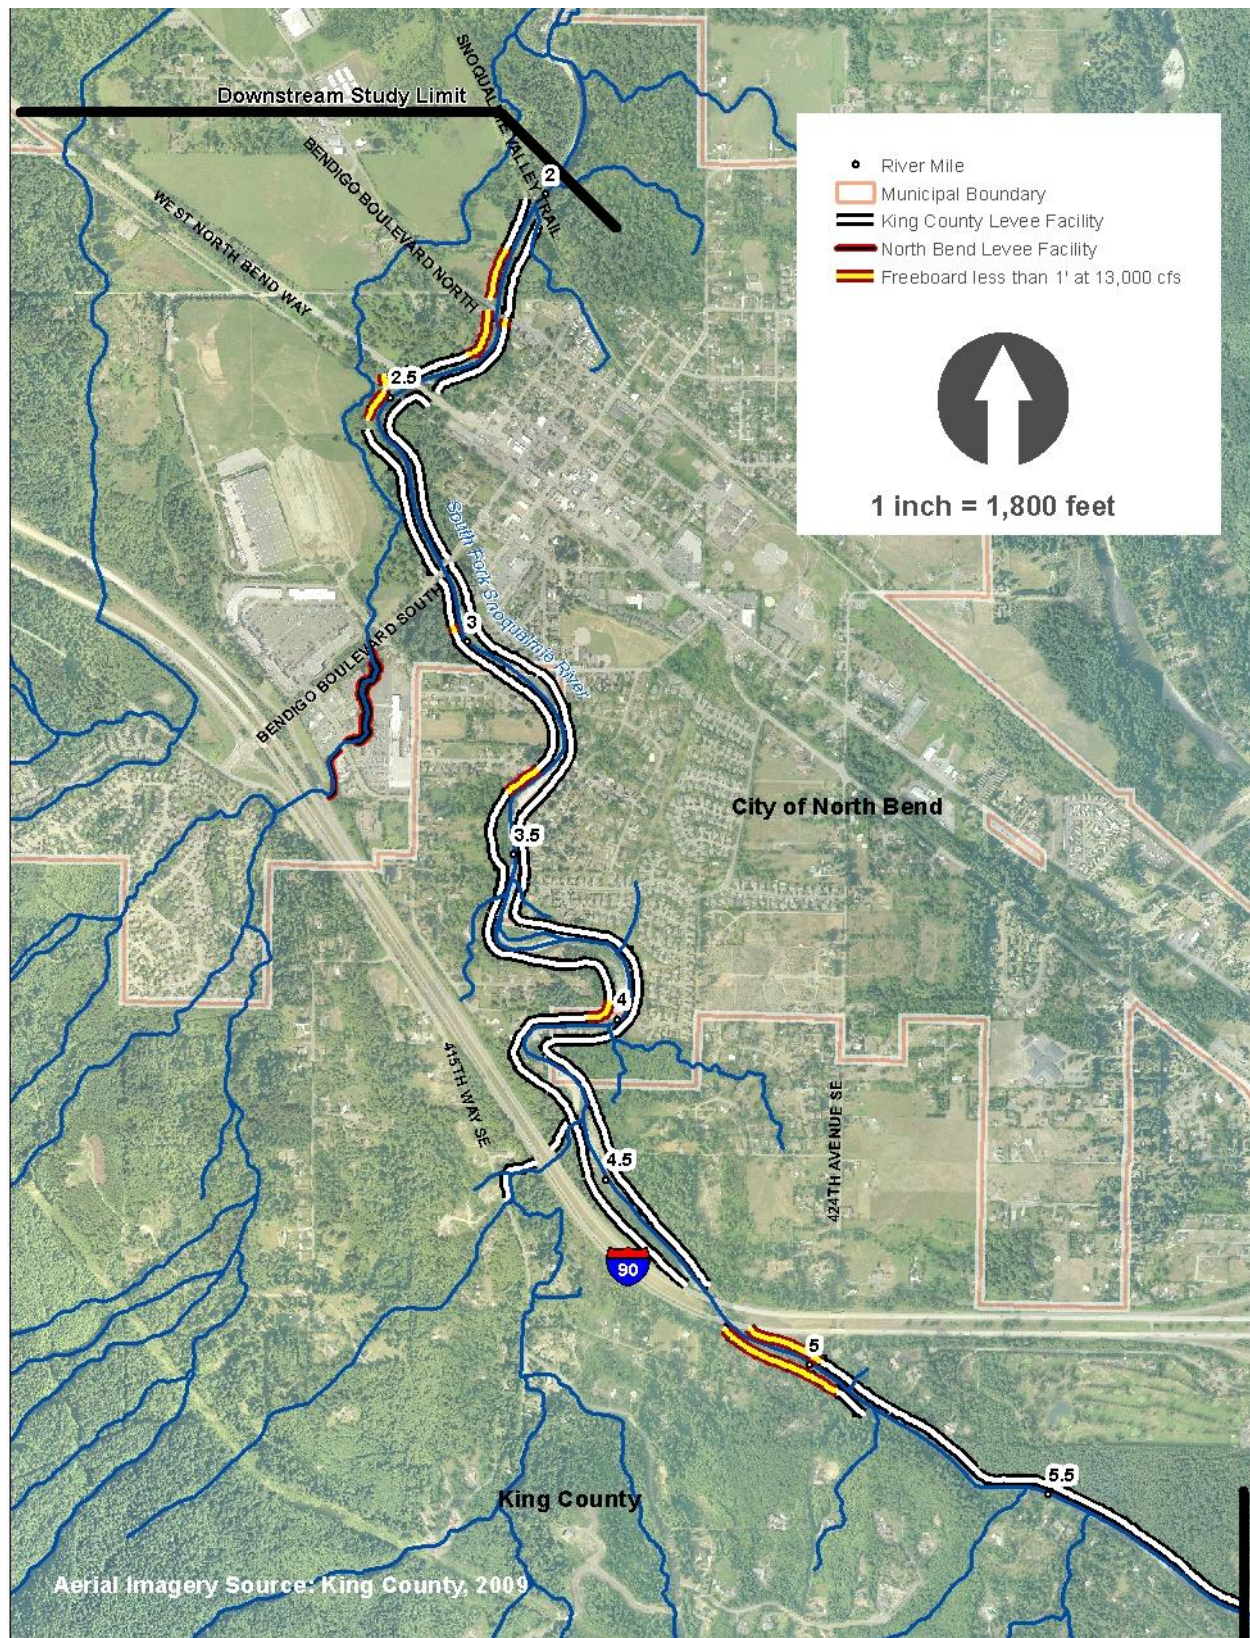
Figure 2-11. Freeboard Less than 1' for 13,000 cfs—Existing Conditions

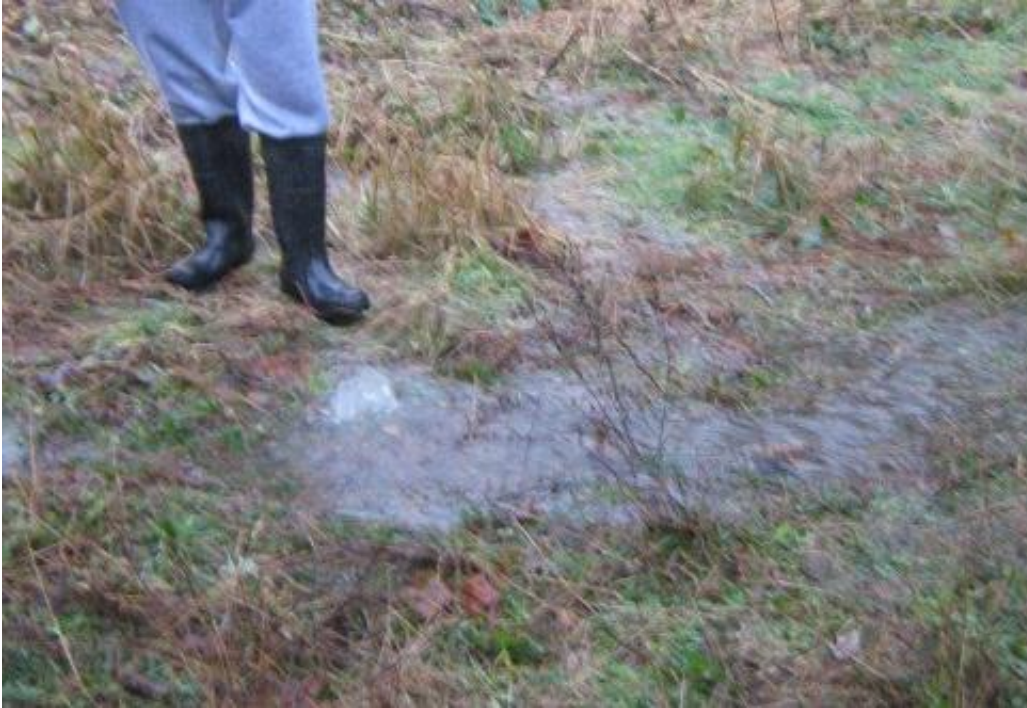
Figure 3-20. Seepage Observed During 2009 Flood Event

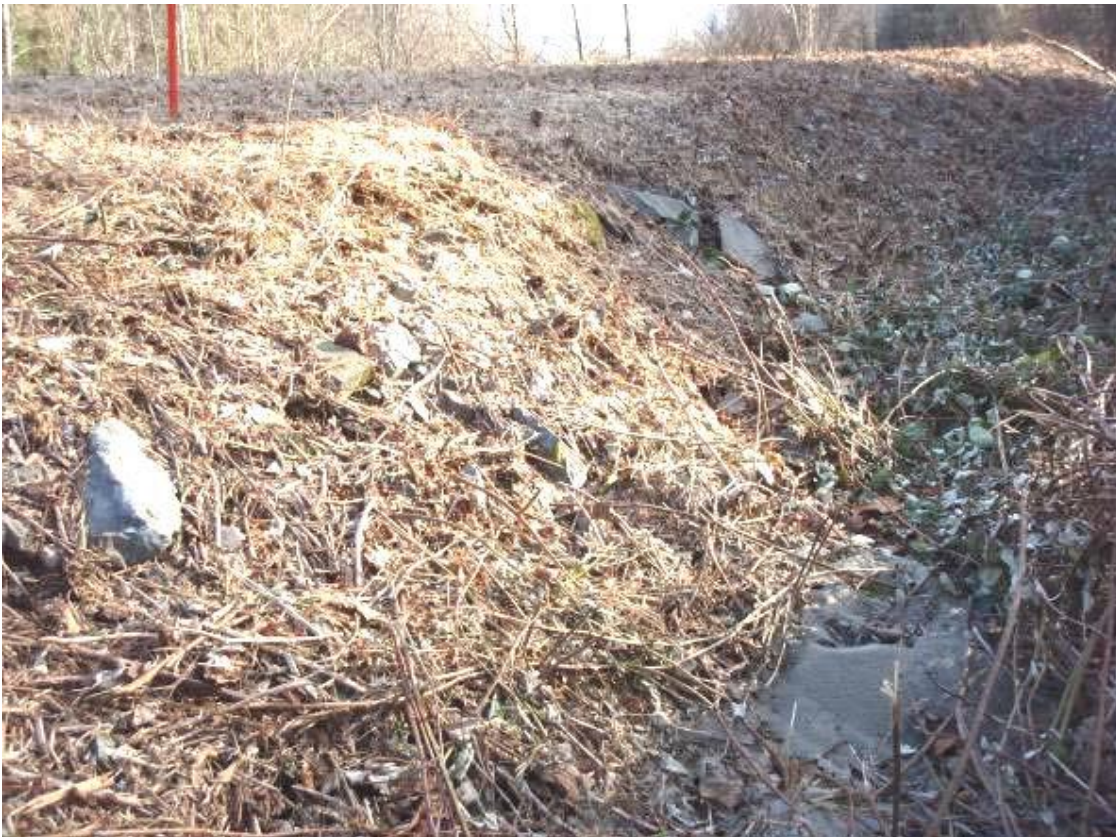
Figure 3-21. Sand Boil Near Problem G-3 Observed During 2009 Flood Event

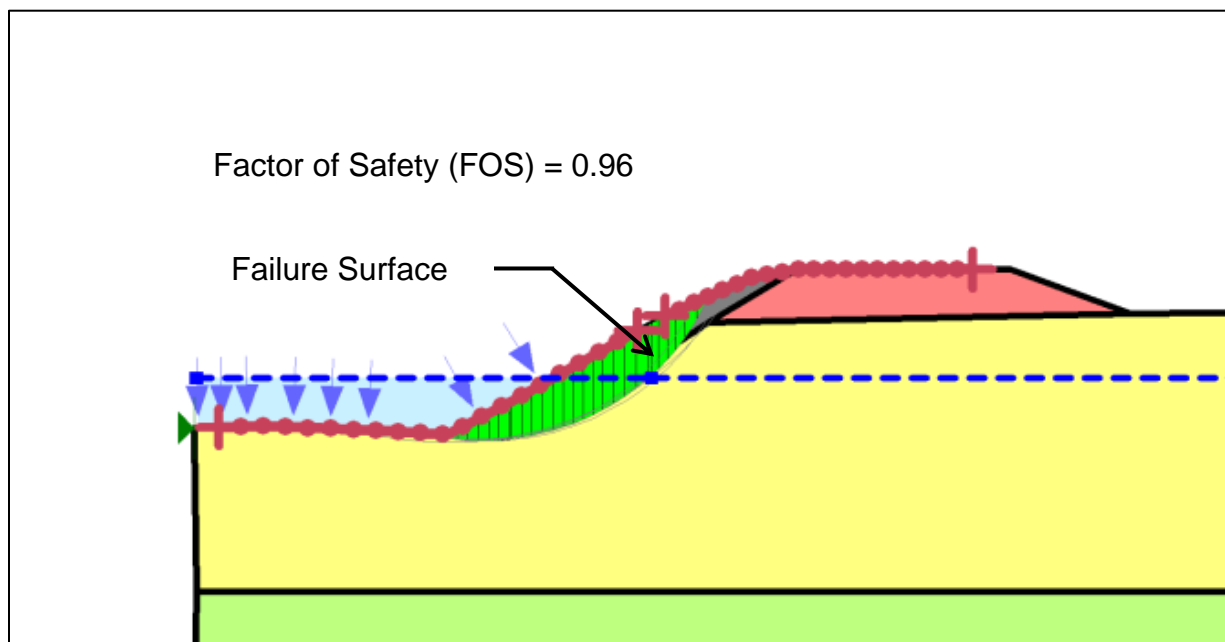
Figure 3-22. Location G-1, Seismic Results for Design Thickness of Riprap, Factor of Safety = 0.96

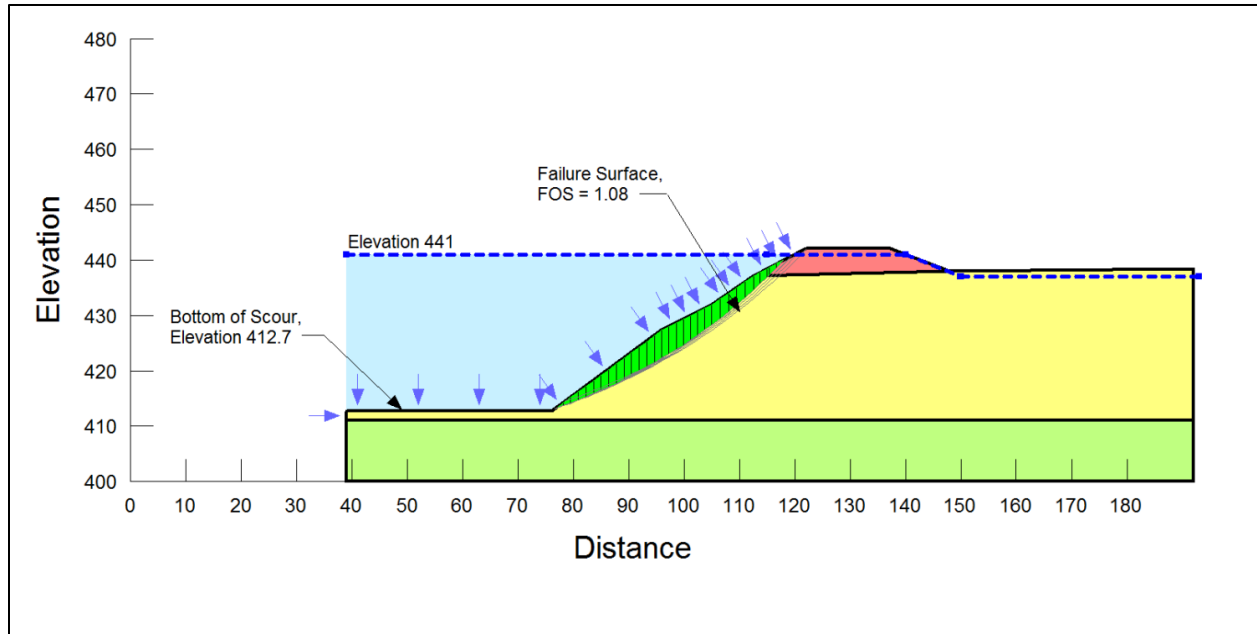
Figure 3-26. Stability Analyses Results, Scour Condition 1 at Location G-1, Water Level at 1 Percent Chance Flood Elevation; Failure Surface Results in Loss of About 5-foot Thick Section of Riverside Slope

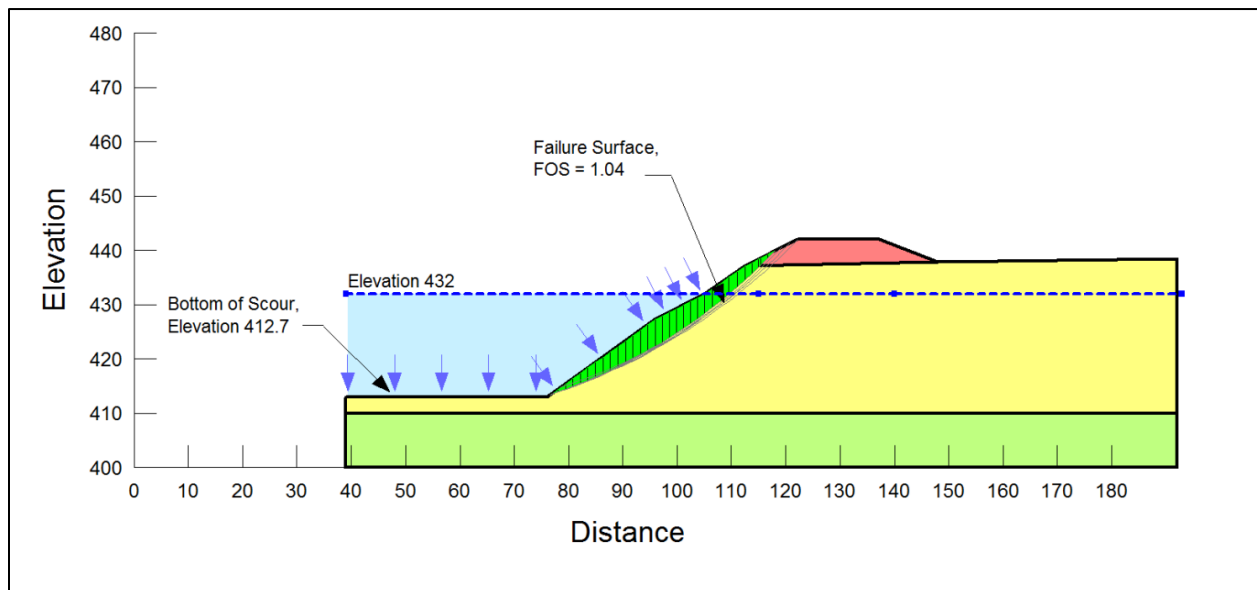
Figure 3-27. Stability Analyses Results, Scour Condition 1 at Location G-1, Low Water Condition (about 2,000 cfs); Failure Surface Results in Loss of about 5-Foot Thick Section of Riverside Slope

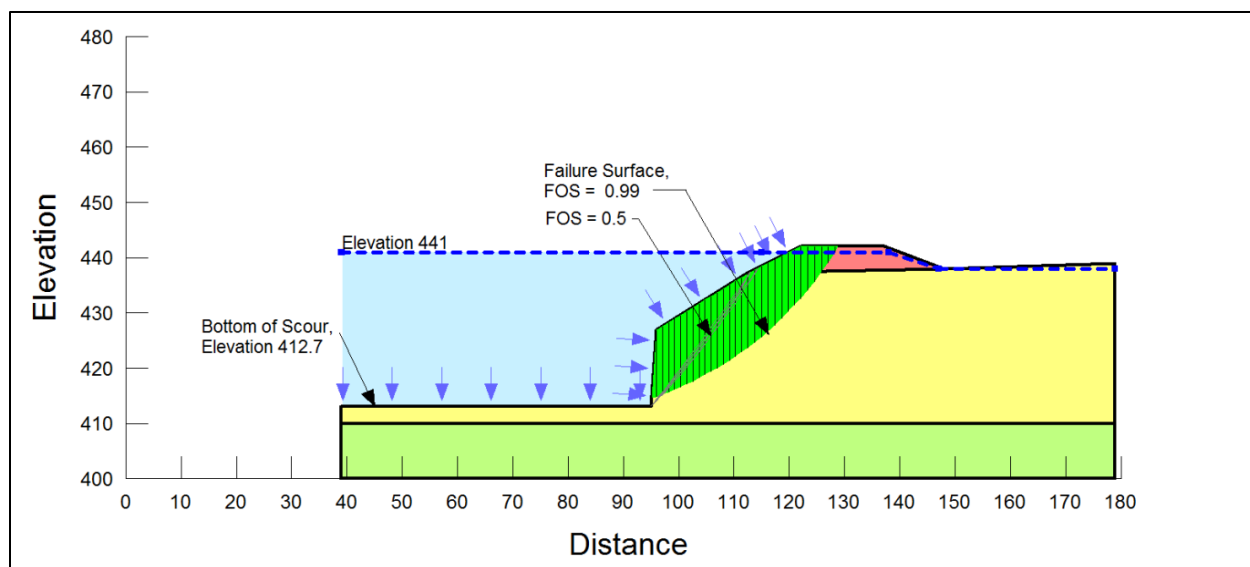
Figure 3-28. Stability Analyses Results, Scour Condition 2 at Location G-1, Water Level at 1 Percent Chance Flood Elevation; Failure Surface Results in Loss of a Portion of the Levee Crest Width

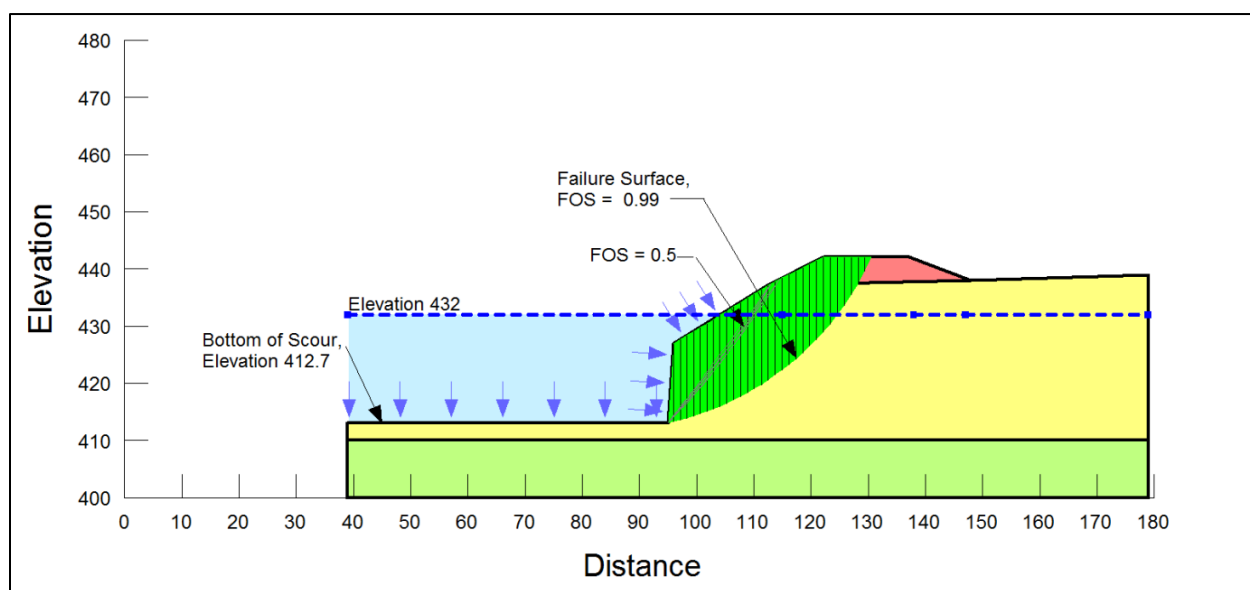
Figure 3-29. Stability Analyses Results, Scour Condition 2 at Location G-1, Low Water Condition (about 2,000 cfs); Failure Surface Results in Loss of a Portion of the Levee Crest Width
