# **2012 Post Construction Monitoring Report King County Multiple Stormwater Facility Retrofits**

**DOE Stormwater Retrofit Grant  
Grant Agreement Number G1100216**

November 30, 2012

2012 Post Construction Monitoring Report  
King County Multiple Stormwater Retrofits

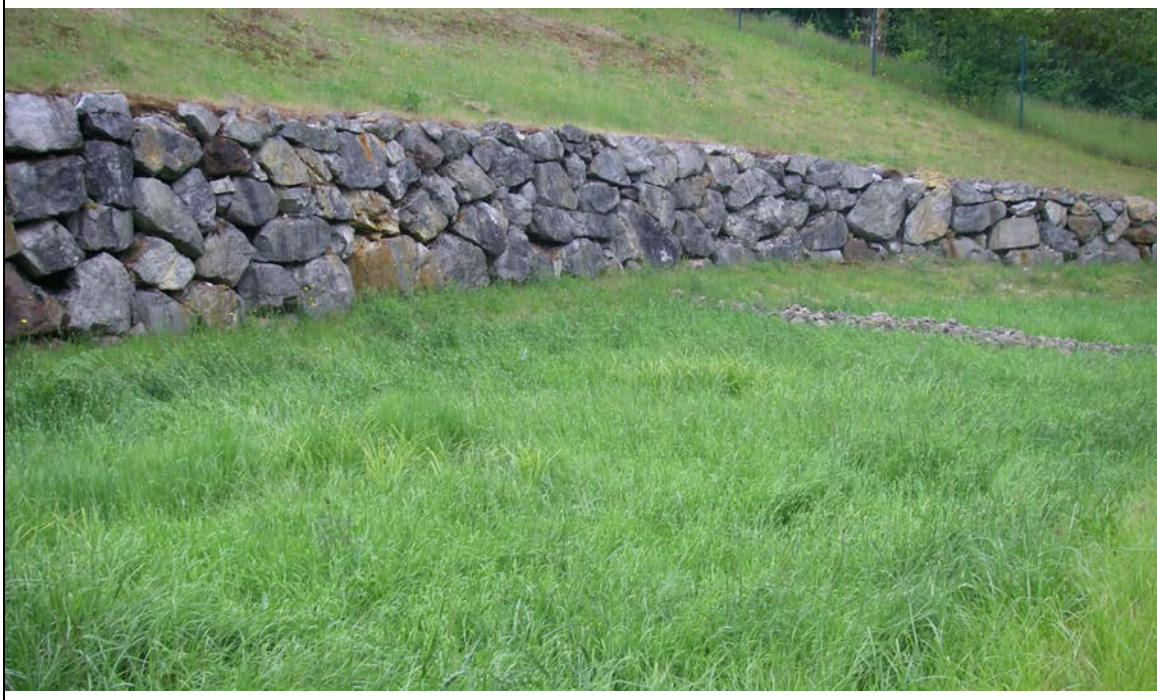
Woodbrook Upper Cells

This bioswale was planted with a total of 4006 emergent plugs including 6 different species. Plant survival is over 85%. In the first two cells closest to inlet, survival and cover is close to 100%. In the 3<sup>rd</sup> and 4<sup>th</sup> cells, survival and cover is not quite as high. The outside of the bends are drier and not as many plants have survived. The plants that have survived in the drier areas have not spread as rapidly. Due to slight imperfections in grading the water tends to hug the inner part of the bends. A few small rivulets have formed channeling the water. These could be fixed with a few yards of compost and the planting of approximately 100 additional emergent plugs. Some clover has moved in and become established in the lower cells. Both inlet and outlet are clear.

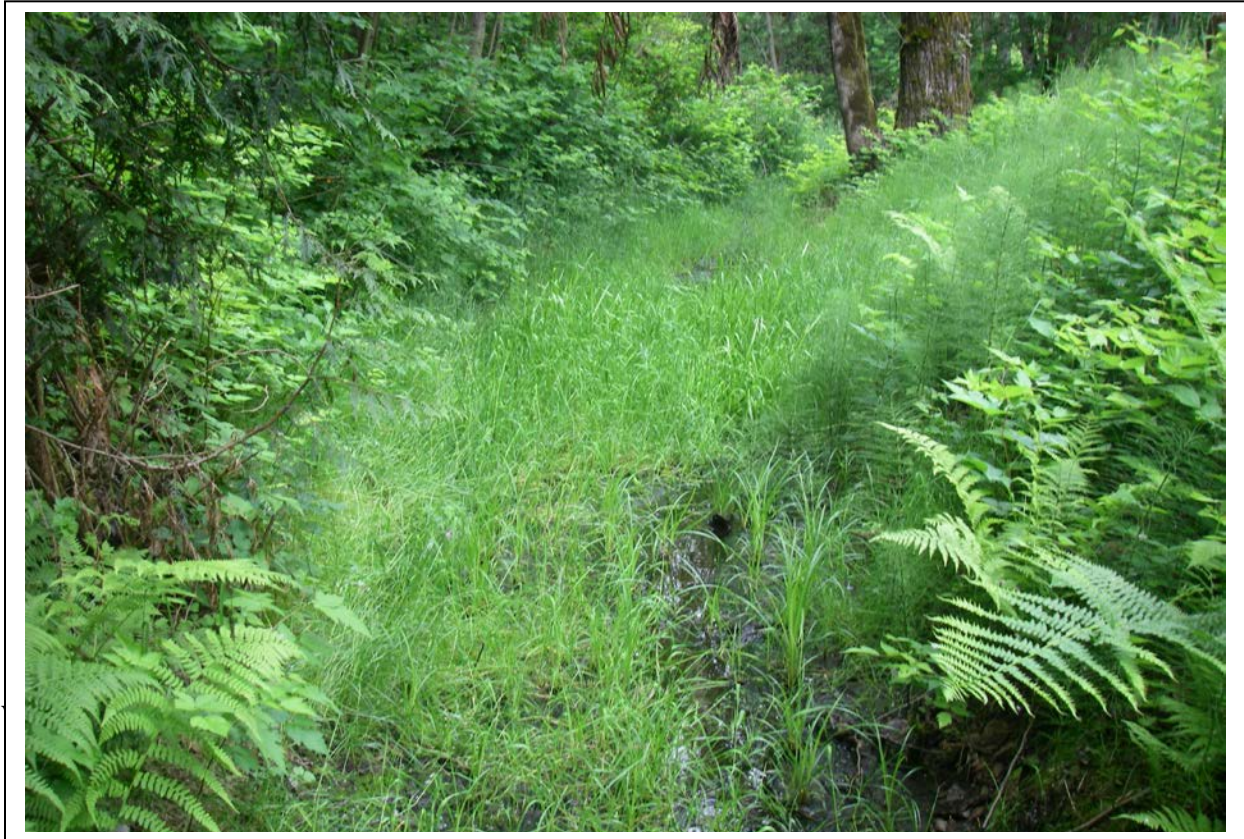
### Woodlands Bioswale

This bioswale was planted with a total of 1250 emergent plugs including 5 different species. Plant survival is over 90% and cover is very good in most areas. A few areas have a small channel path moving through it. These could be fixed by planting approximately 100 additional emergent plugs to fill the channel or it just may fill in on its own. No additional compost would be needed in the supplemental planting. Both inlet and outlet are clear.

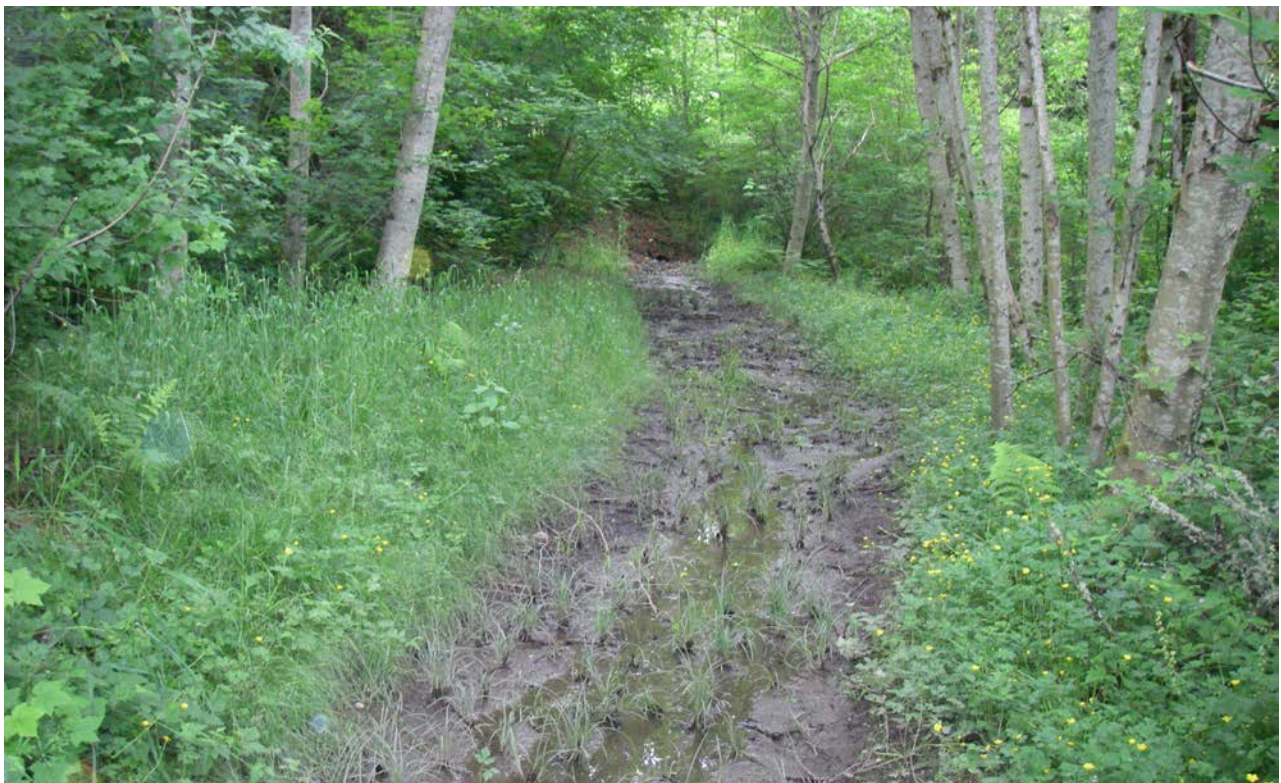
Swan Lake Estates Bioswale 1 Vegetation

This bioswale was planted with a total of 765 emergent plugs including 3 different species. This swale is very shady and it is hard to find species that can tolerate almost 100% shade. Plant survival is over 85% but cover is significantly less than that due to a low rate of growth in the plants. The mannagrass appears to have outperformed the Scirpus and Carex. A few small rivulets have formed but not much water is moving through them due to very low flow in the swale. Cover could be increased by planting approximately 300 additional emergent plugs to fill the channel or it may just slowly fill in on its own. Increased cover will take some time due to shady conditions. No additional compost would be needed in the supplemental planting. Both inlet and outlet are clear.

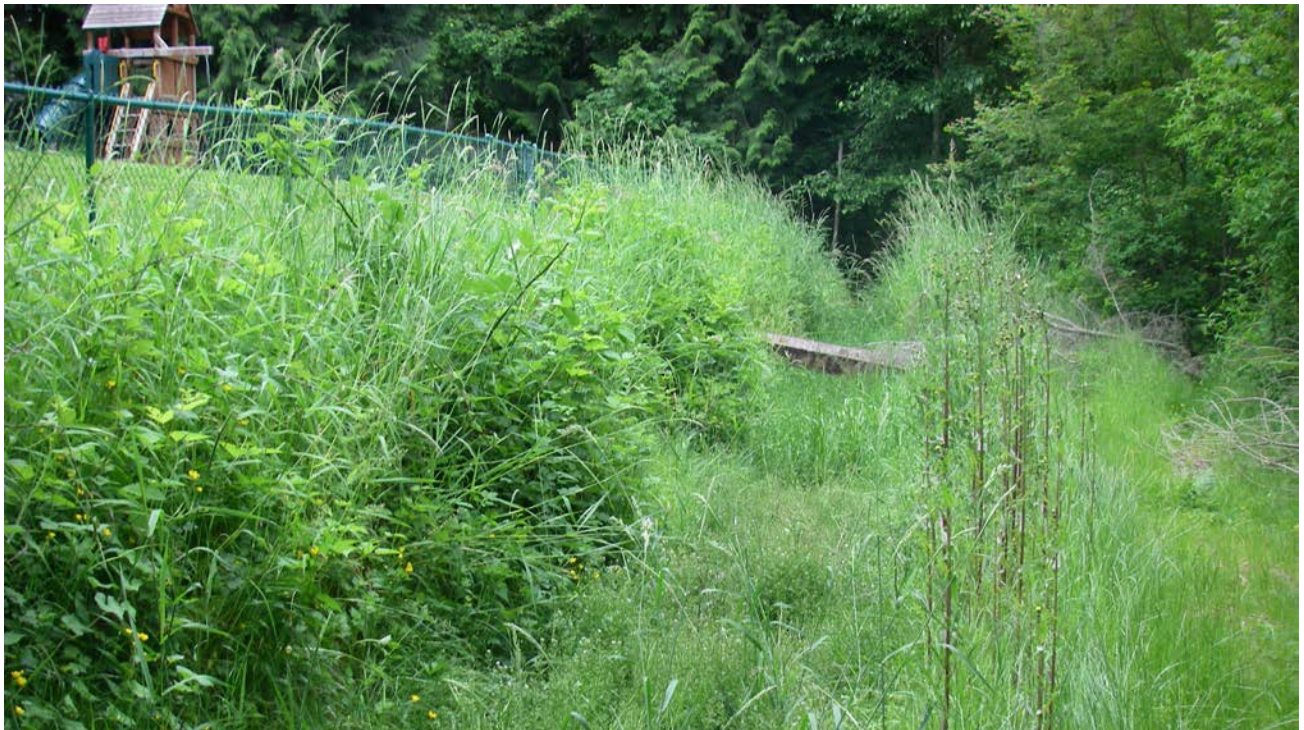
Swan Lake Estates Bioswale 2

This bioswale was planted with a total of 650 emergent plugs including 4 different species. This swale is very sunny. Plant survival and cover is close to 100%. No rivulets formed and water is ponded or very low flow in the swale. No supplemental planting needed. Some watercress has mixed in with the native plants in the swale and there is blackberry, grasses, Salmonberry and other weeds growing around the perimeter that will need to be maintained. Both inlet and outlet are clear.

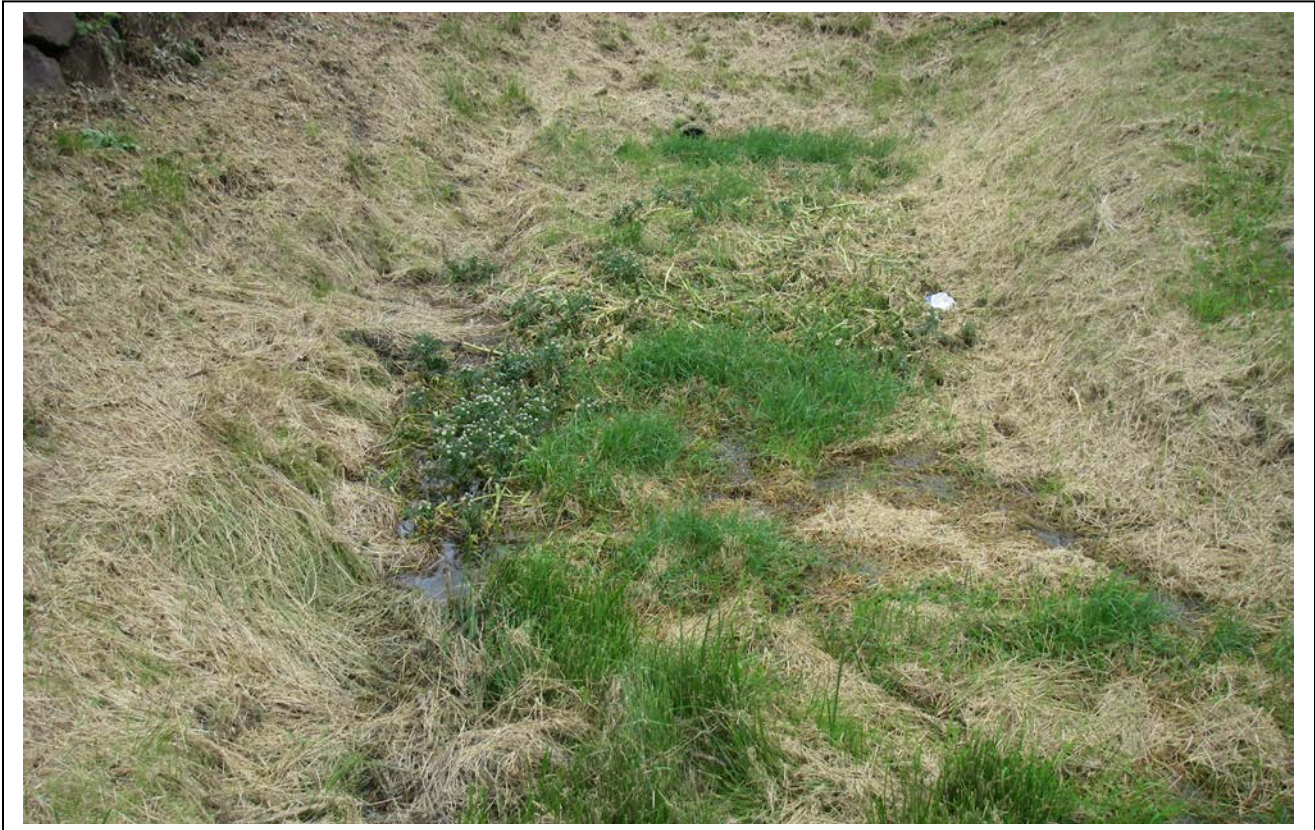
### **Willowbrook Bioswale**

This bioswale was planted with a total of 765 emergent plugs including 5 different species. This swale is in almost full sun. Plant survival and cover is close to 85%. Swale was recently maintained so it is hard to tell exactly how some of the native species are performing. Some watercress and exotic grasses have mixed in with the native plants. Swale appears to be functioning normally. No channelization is occurring and water is at a very low flow in the swale. No supplemental planting needed. Both inlet and outlet are clear.

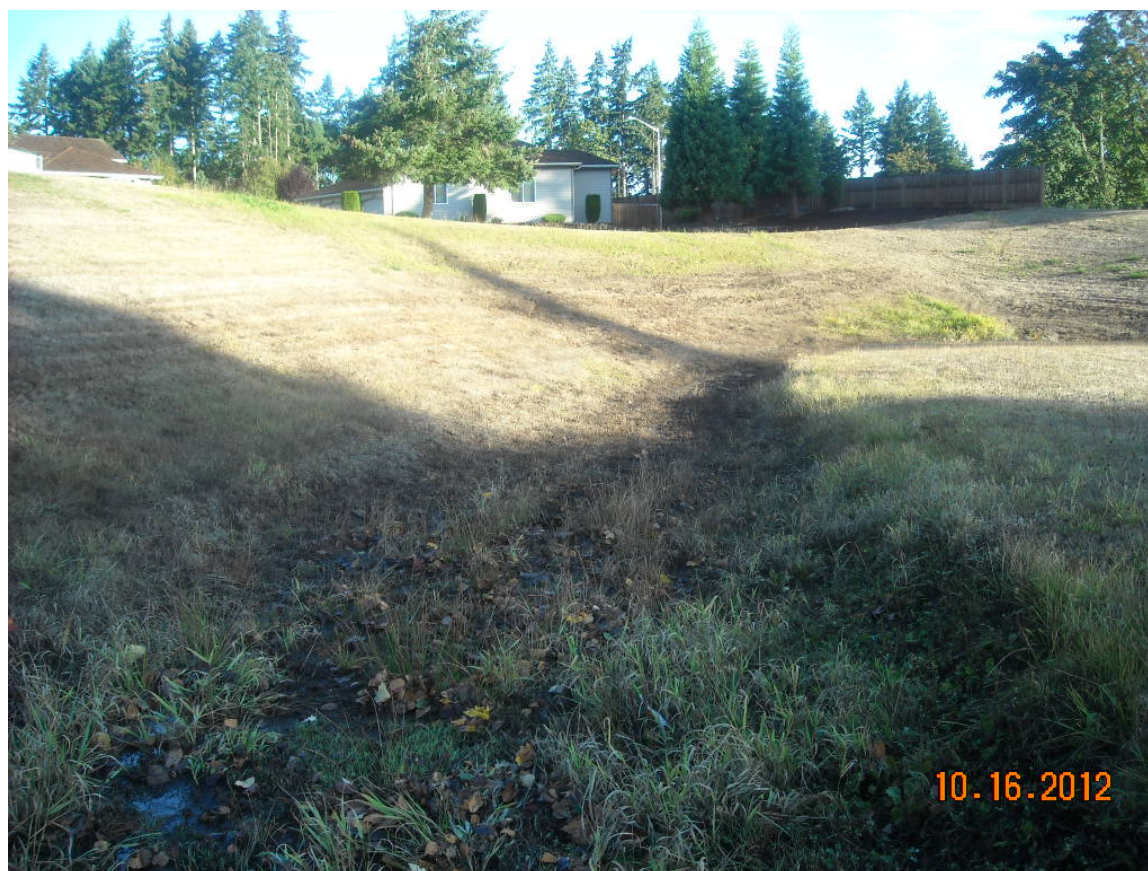
This bioswale was reseeded with bioswale grass seed mixture per Table 6.3.1.C of the 2009 King County Surface Water Design Manual. The bioswale is horseshoe shaped. It appears that a majority of the grass has survived. There were no visible spots where the plastic liner was exposed. There does not appear to be any channelization occurring in the bioswale. Some standing water is present in the bioswale due to the bioswale's shallow slope and accumulated grass clippings. The standing water occurs near the bend in the bioswale. All three inlets and the outlet are clear.

Forest Hills Estates Bioswale – Looking from inlet towards bend.

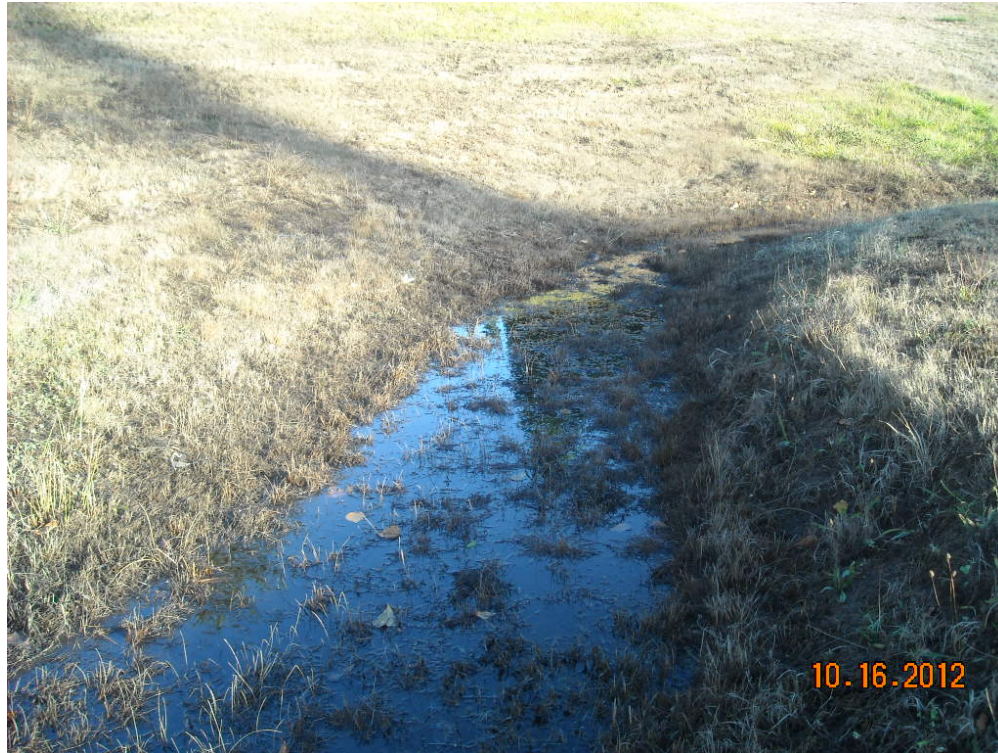
Forest Hills Estates Bioswale – Standing water near bend in bioswale.

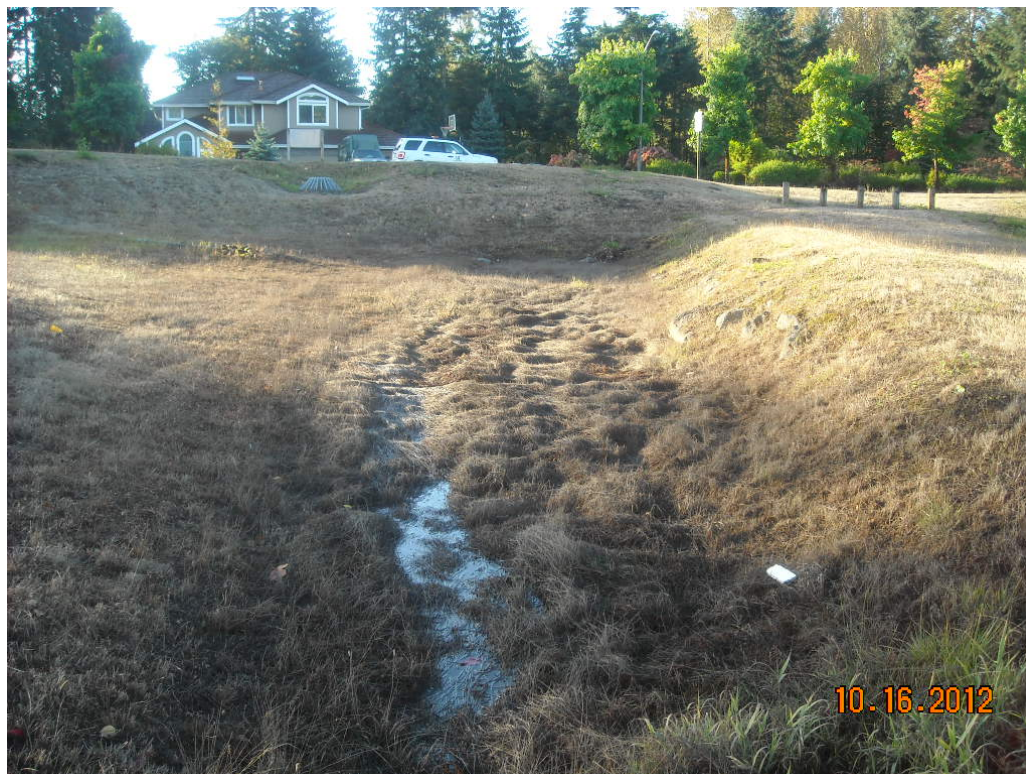
Forest Hills Estates Bioswale – Looking from bend towards outlet.

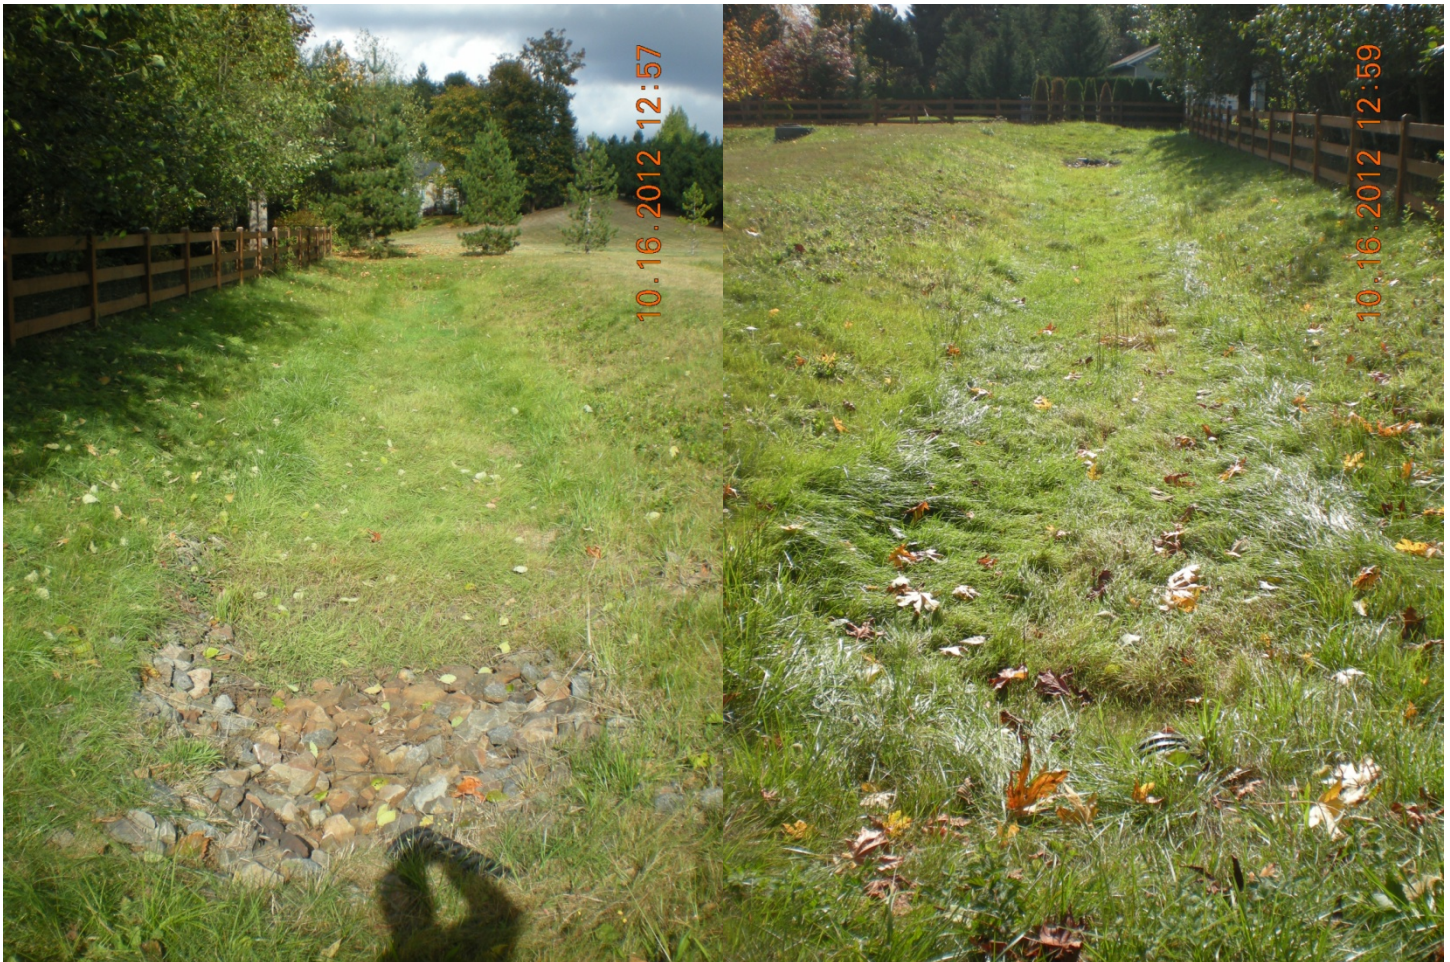
Webster Lake Estates Tract I

The bioswale was planted with bioswale grass seed mixture per Table 6.3.1.C of the 2009 King County Surface Water Design Manual. Plant survival is over 95%. Due to imperfections in the grading water slight pools or goes dry in places. Both inlet and outlet are clear. No modifications or maintenance required.

Vigorous growth can be seen throughout bioswale.

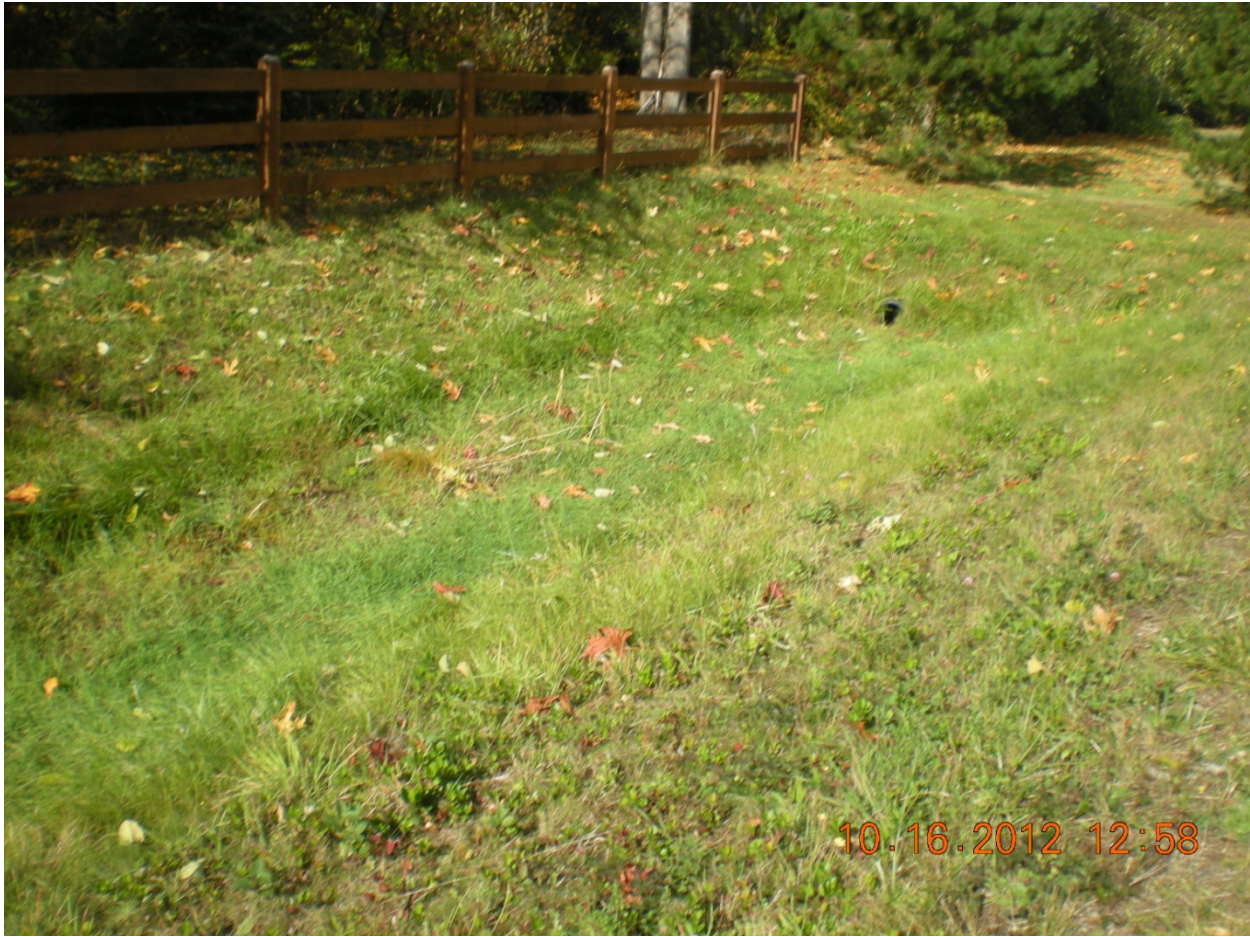
Webster Lake Estates Tract I

Outlet and inlet are clear.

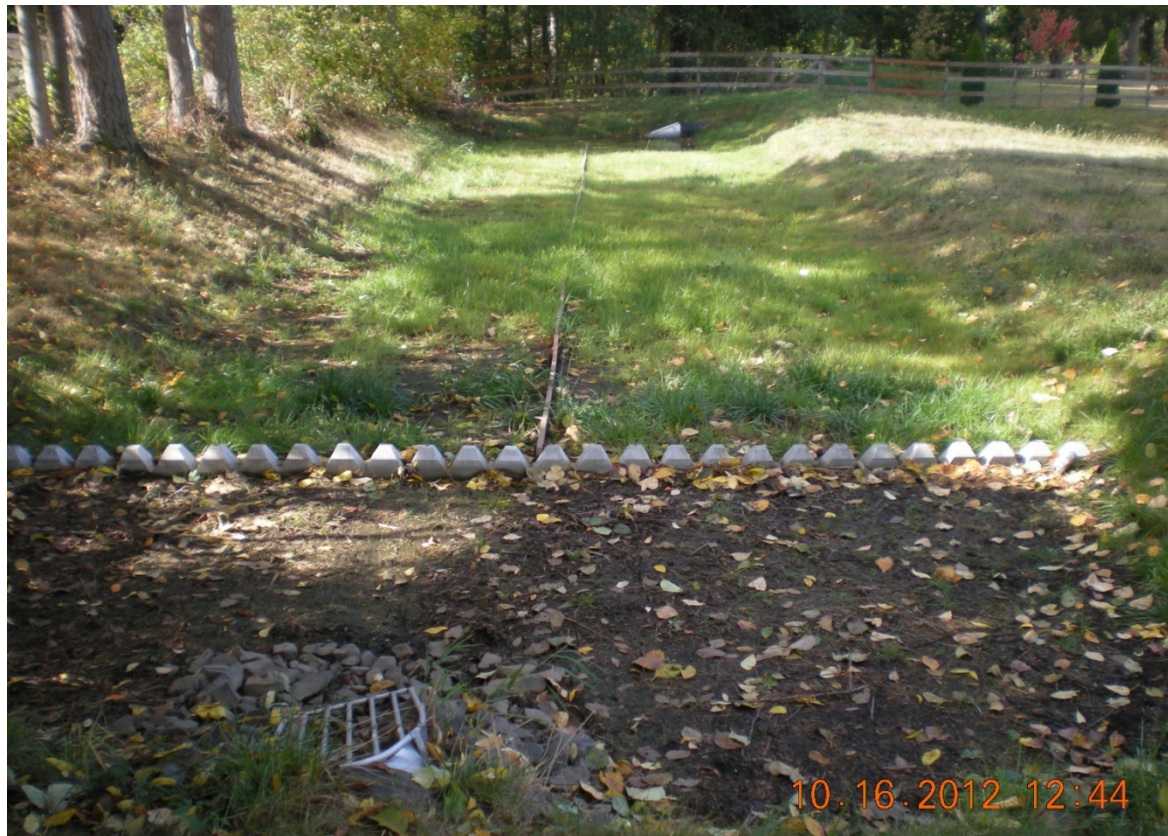
#### **Webster Lake Estates Tract G**

The flow spreader and the flow divider both appear to be functioning as designed. More trimming may be warranted here.

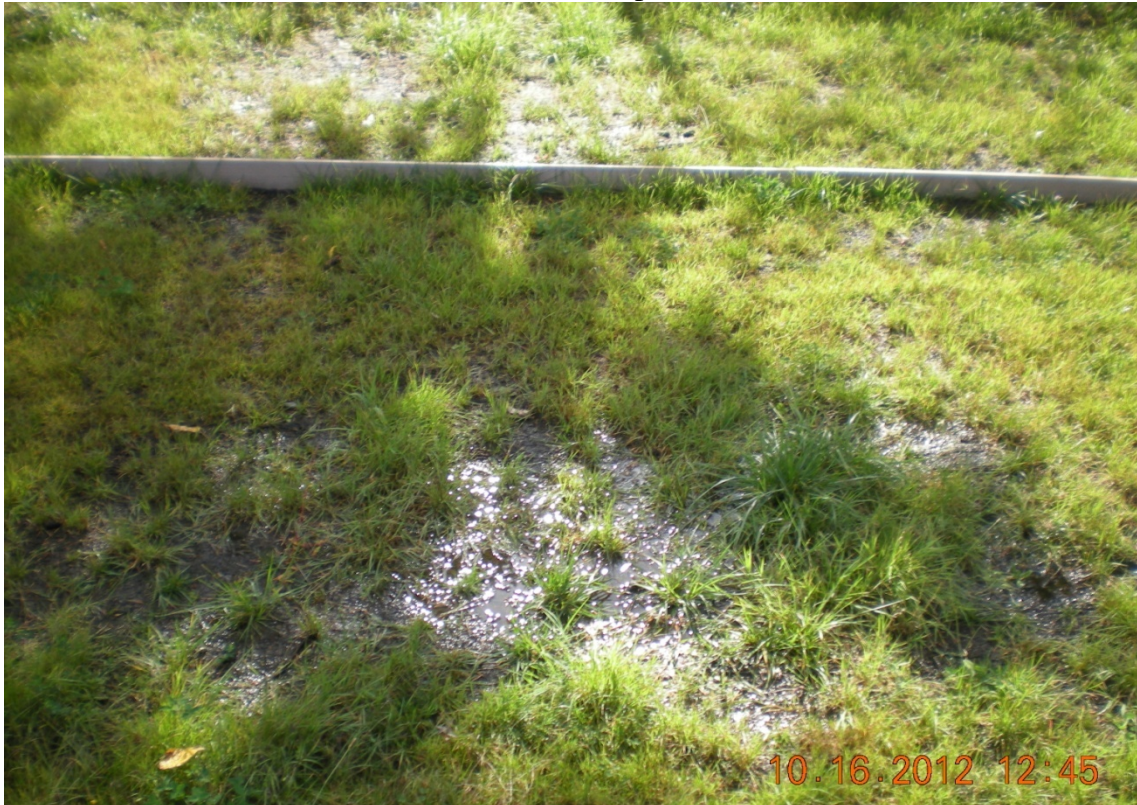
The bioswale was planted with bioswale grass seed mixture per Table 6.3.1.C of the 2009 King County Surface Water Design Manual. Plant survival is over 65%. In the middle third of the bioswale the survival rate and coverage is close to 80%. In the first and last fifths of the bioswale grass survival and cover is less than 10%. The end of the bioswale is under up to four inches of water partial due to a reverse slope in the outlet pipe discovered during construction and some settling of the soils. Due to slight imperfections in the grading water pools or goes dry in places. These could be fixed with a few yards of soil and the planting of similar grass. Both inlet and outlet are clear.

Webster Lake Estates Tract G middle with small pools

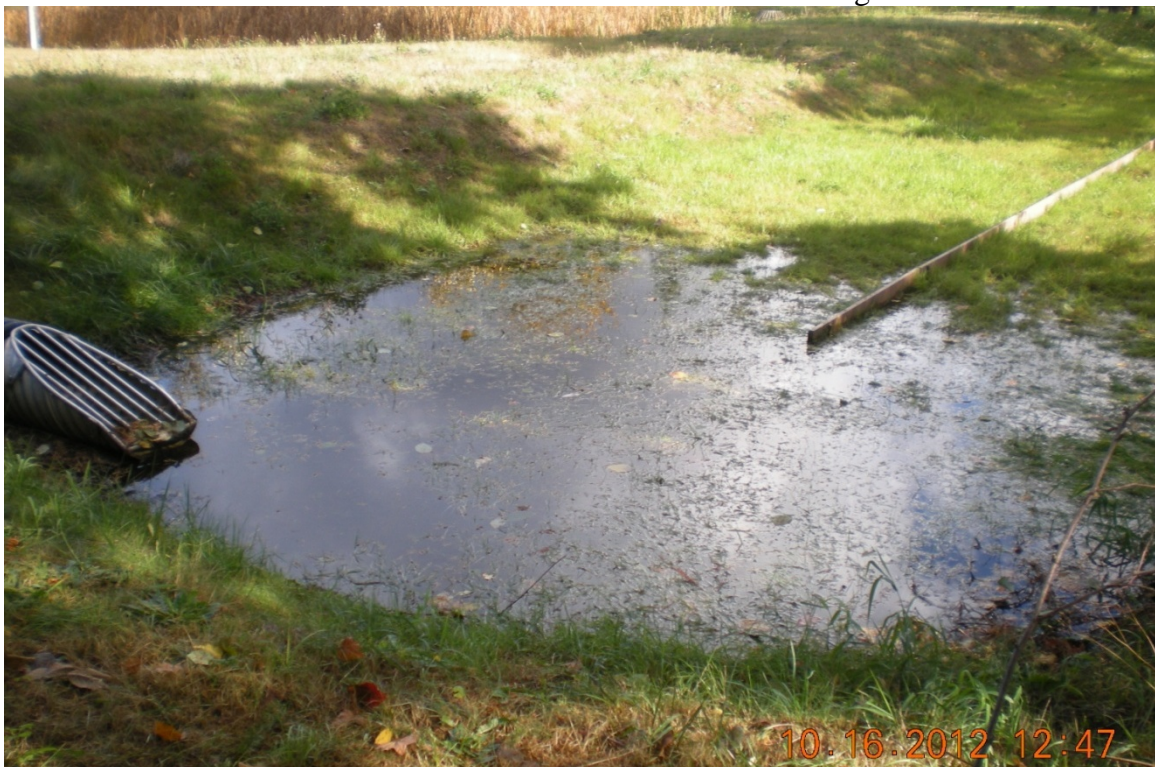
Webster Lake Estates Tract G last fifth with four inches of standing water

As a maintenance item soil should be used to fill this area up to outlet pipe and re-planted

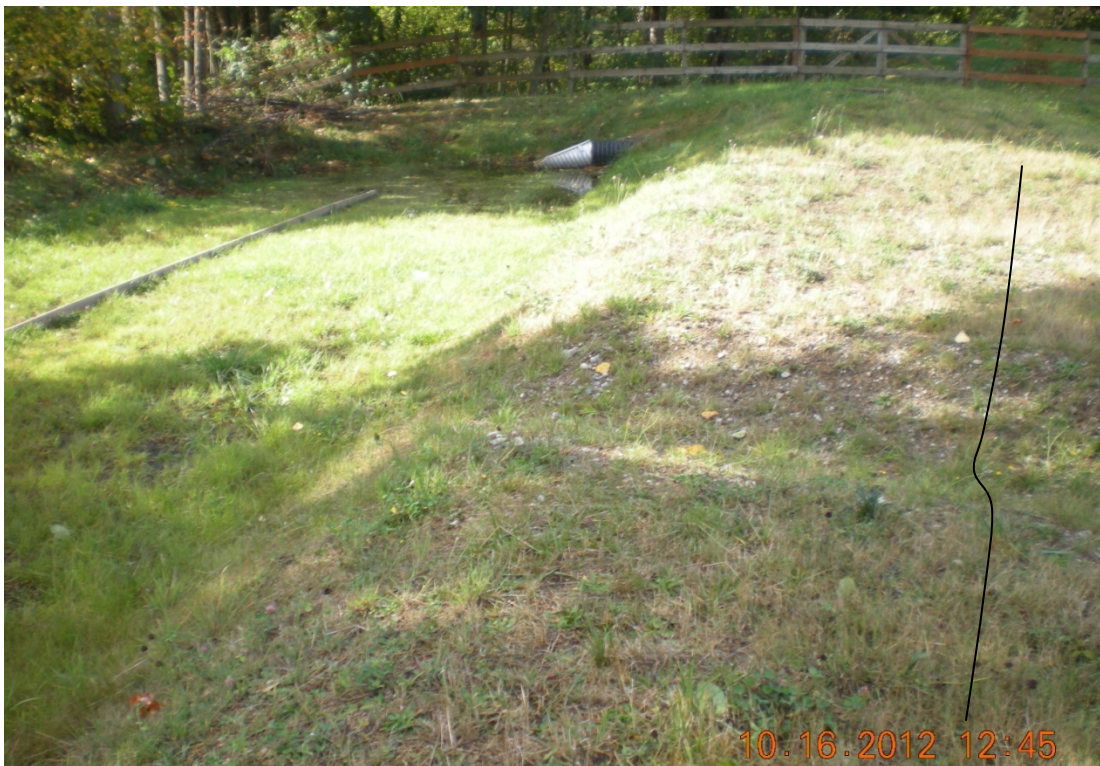
Webster Lake Estates Tract G.

A new overflow was built into the access road to keep a bioswale overflow within the facility.

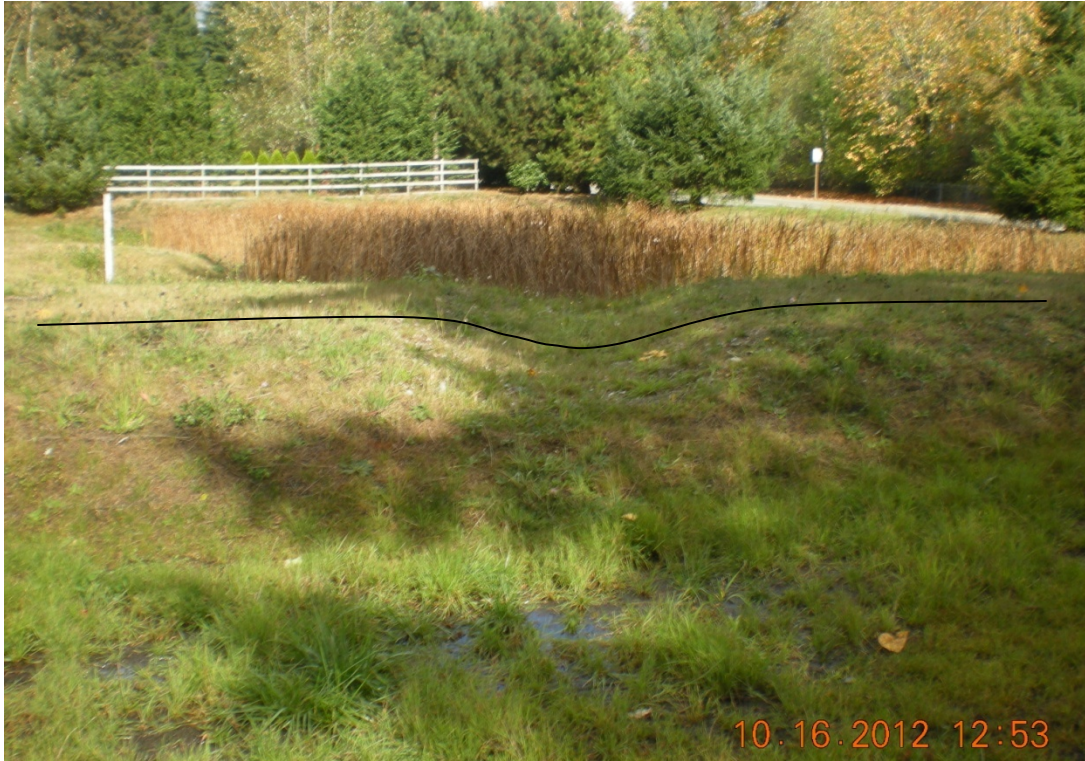
Webster Lake Estates Tract G

The emergency bioswale overflow has not been utilized but appears to be in good shape.

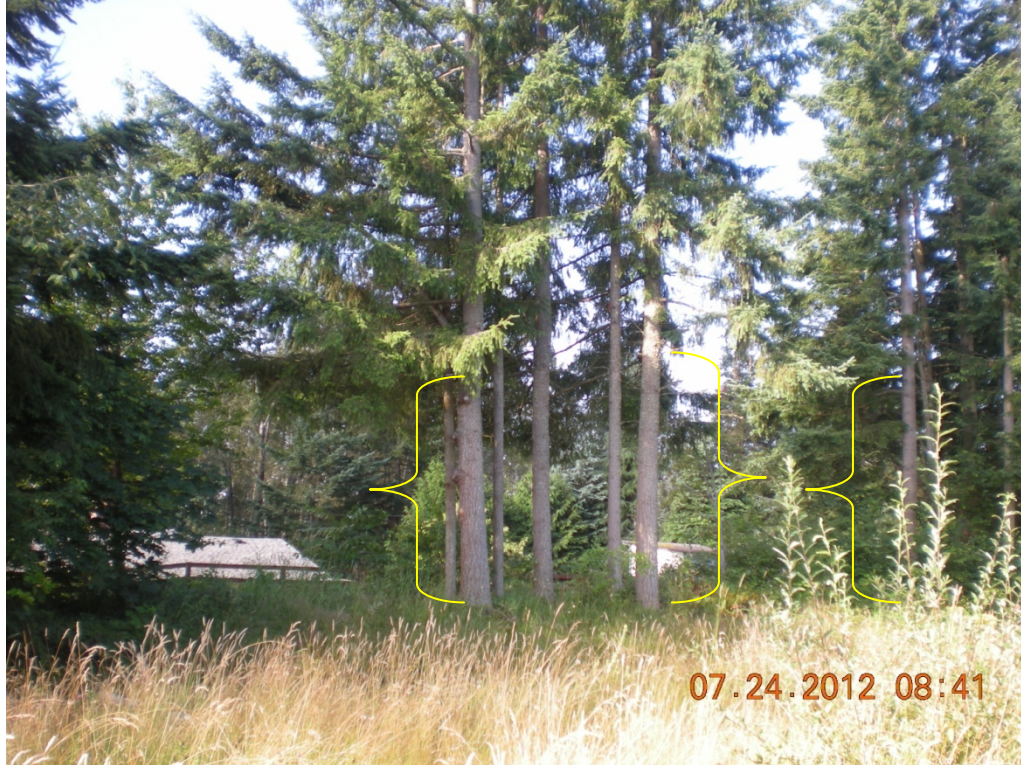
Webster Lake Estates Tract G.

The first 15' of tree branches on conifers were removed. Additional sun on grass can be seen in previous photos.

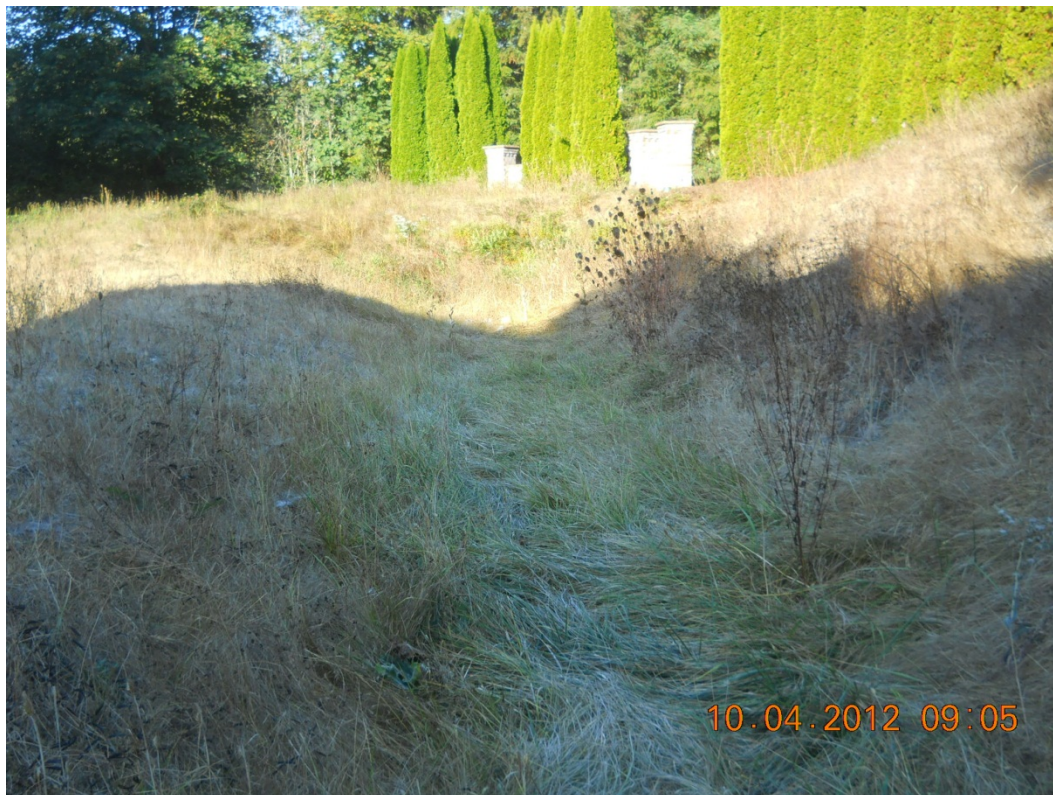
Canterbury South first half of swale. The swale grass cover is very good and close to 100% survival.

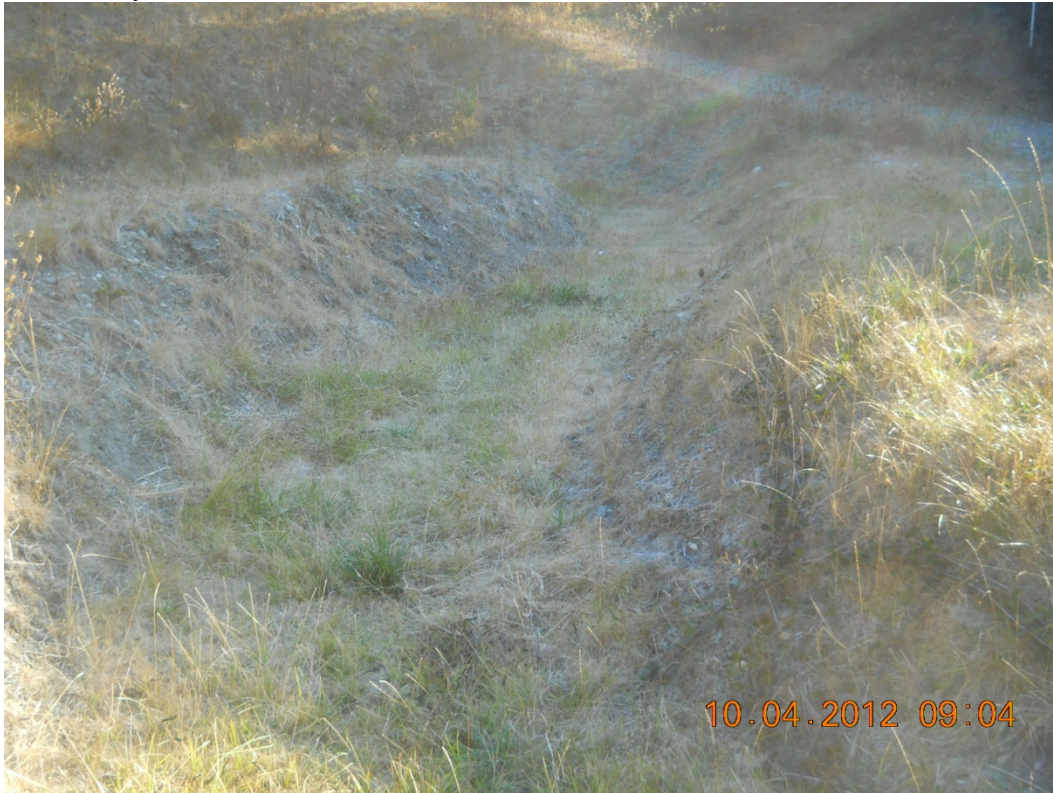
The bioswale was regraded and reseeded with a grass seed mix in Table 6.3.1.C of the 2009 King County Surface Water Design Manual. Plant survival is over 80%. The first half of the swale shows close to a 100% survival rate for bioswale grass and coverage. The final half shows bioswale grass survival and cover of about 70%. No rills or eroded channels were observed in the graded swale channel bottom. It is expected that the swale grass in the final half of the cell will fill in as precipitation increases and the swale experiences more flow. No further action is recommended.

Canterbury South last half of swale.

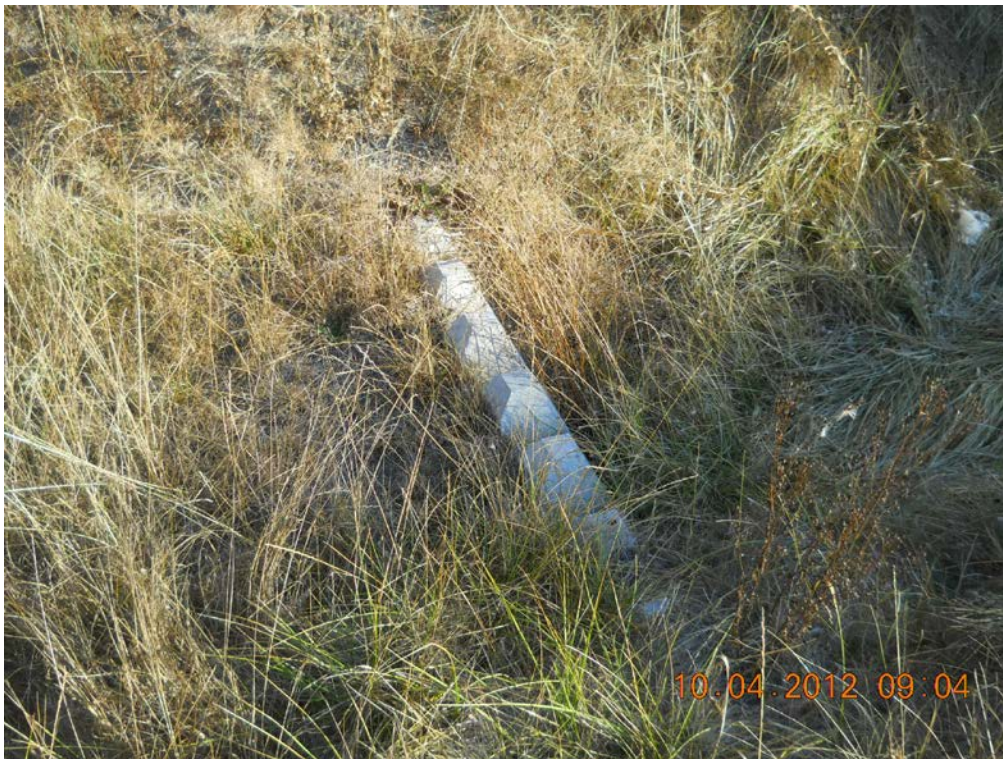
Canterbury South newly-installed flow spreader between the presettling cell and the swale channel.

The presettling cell area was modified by replacing the soils in bottom and sidewalls with low-permeability material. Site visits throughout the year indicated that this appeared effective in retaining water. Overflow over the new flow spreader into the swale channel has not been observed since completing the retrofit. The presettling cell is overgrown with vegetation and the inlet pipe invert is slightly below ground surface. This could be fixed by clearing the vegetation out of the cell and removing a small amount of material from the area of the pipe inlet during standard maintenance activity.

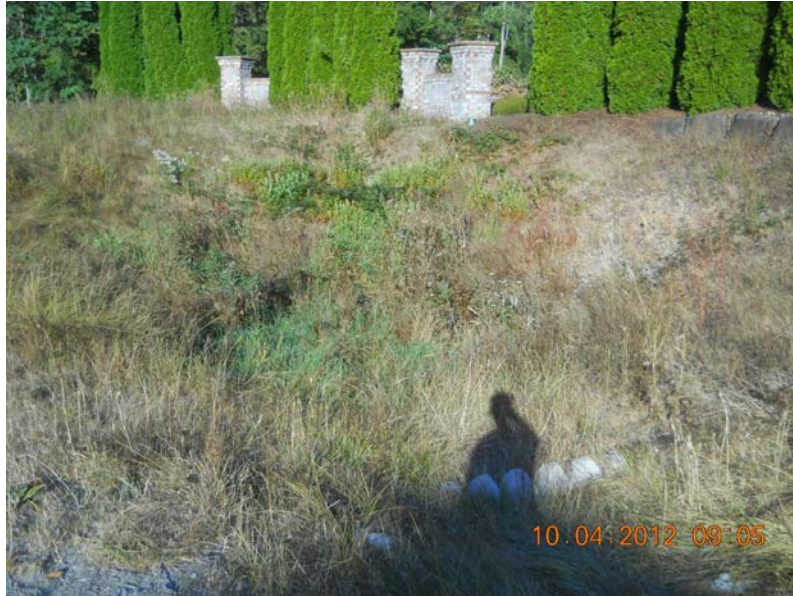
Canterbury South overgrown presettling cell looking toward the inlet pipe. The vegetation and invert clearing can be addressed during standard facility maintenance.

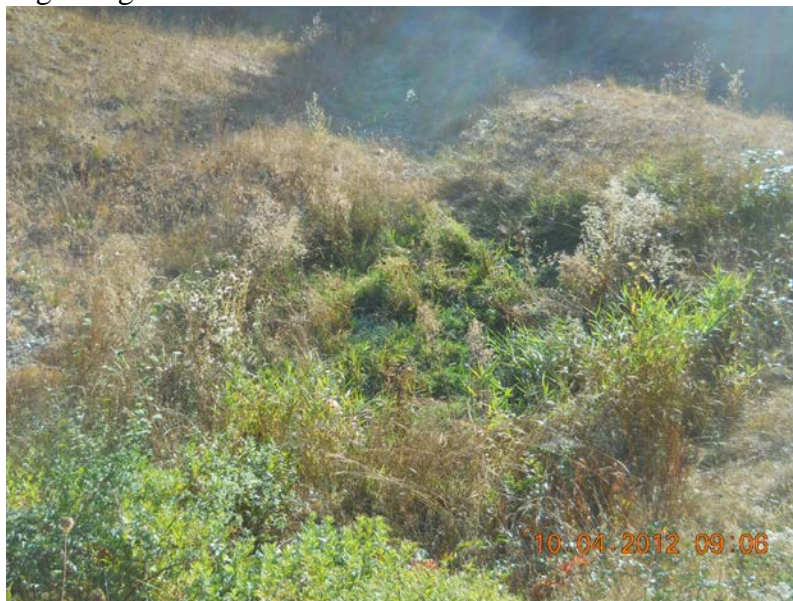
Canterbury South view of the overgrown presettling cell from the inlet pipe looking toward the beginning of the swale.

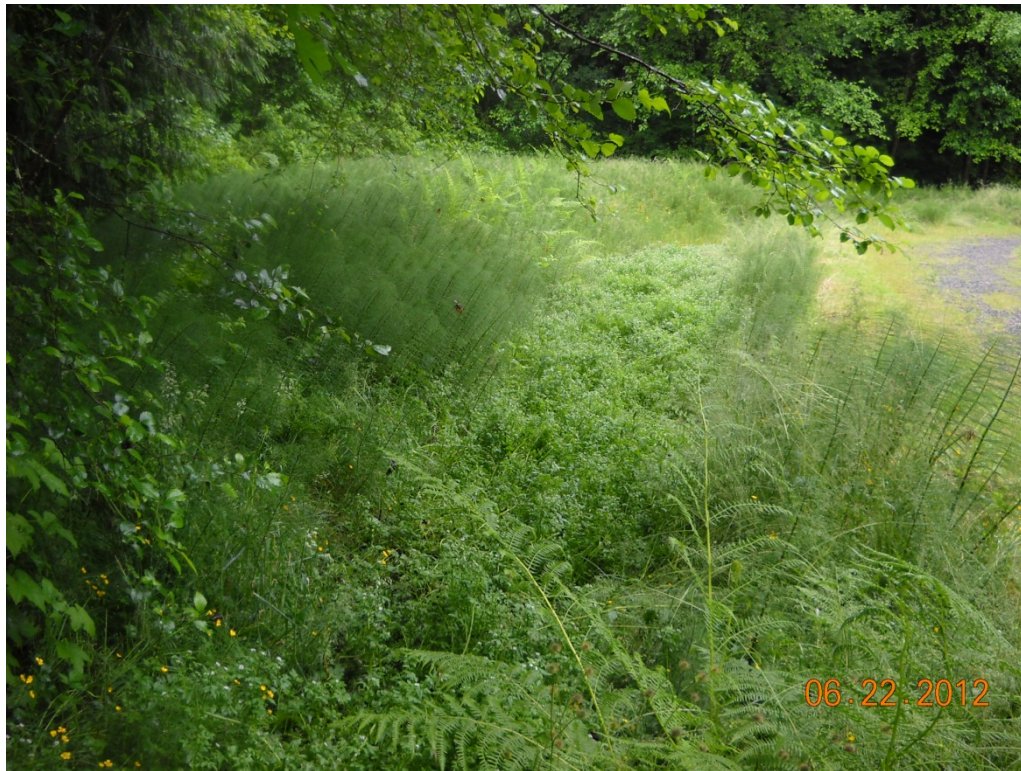
A bioswale seed mix was planted to complete the construction. Grass grew in 2011, and the performance of the bioswale was good. Through the winter, however, watercress became the dominant plant. The watercress has grown between flow spreader notches, concentrating flow more in some places than in others.

Tuscany Tract B Upstream end of bioswale, looking downstream.

This bioswale can be replanted. It appears to be wet enough to plant with wet bioswale plants, despite having a steeper grade than what is specified in the 2009 King County Surface Water Design Manual.

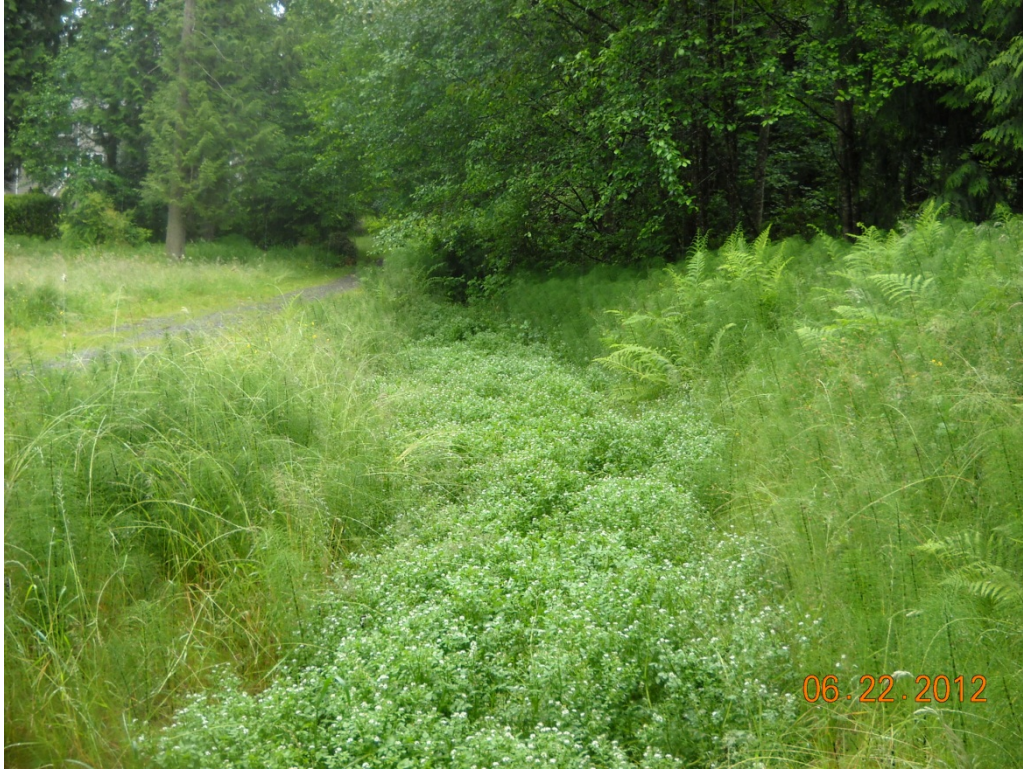
Tuscany Tract B Middle section of bioswale, looking upstream.
