# **2012 Post Construction Monitoring Report King County Multiple Stormwater Facility Retrofits**

**DOE Stormwater Retrofit Grant  
Grant Agreement Number G1100216**

November 30, 2012

2012 Post Construction Monitoring Report  
King County Multiple Stormwater Retrofits

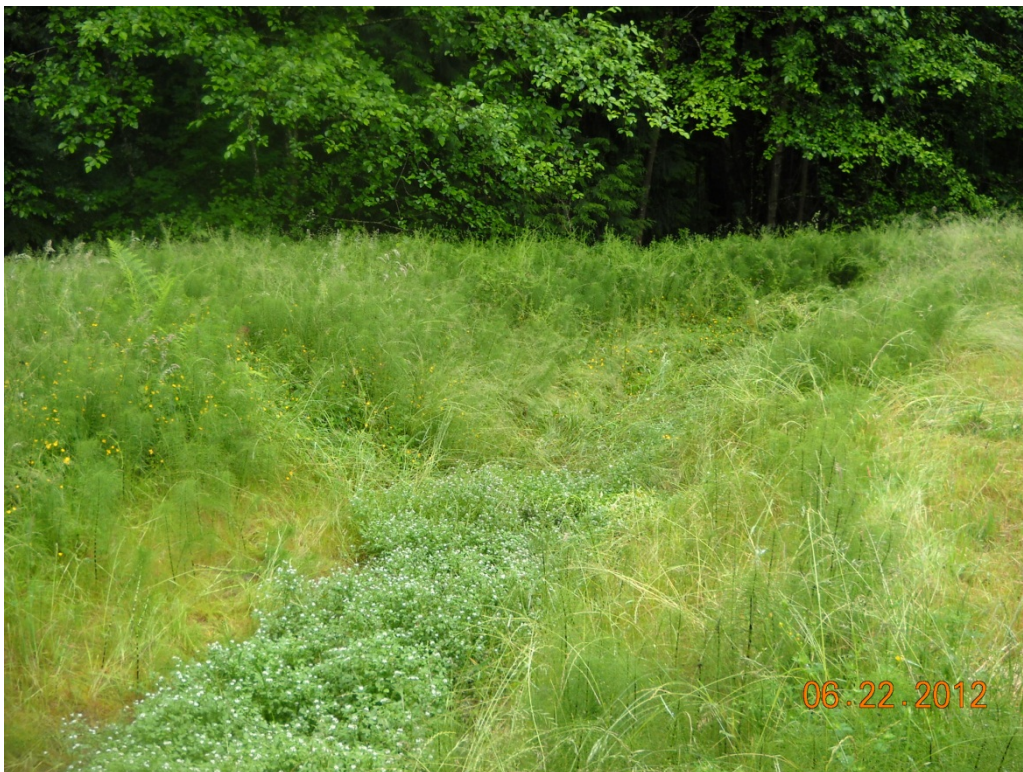
Tuscany Tract B Downstream end of bioswale, looking downstream.

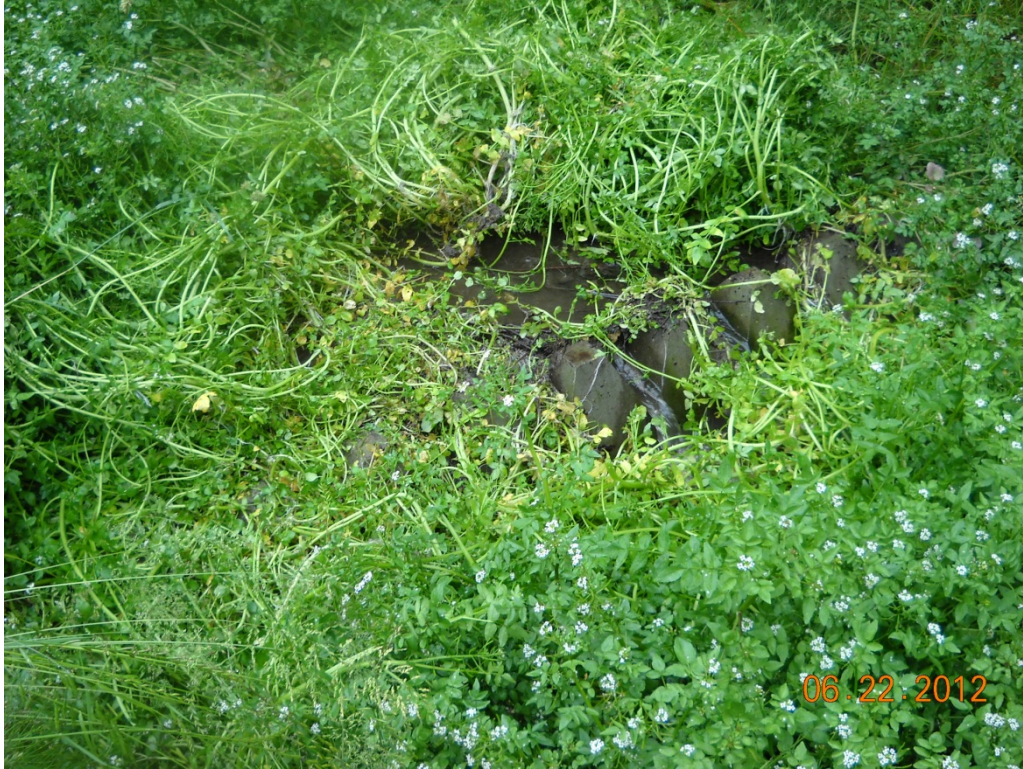
A bioswale seed mix was planted to complete the construction. Grass grew in 2011, and the performance of the bioswale was good. Through the winter, however, watercress became the dominant plant. The watercress has grown between flow spreader notches, concentrating flow more in some places than in others.

Tuscany Tract B Detail of flow spreader notch, watercress pulled back.

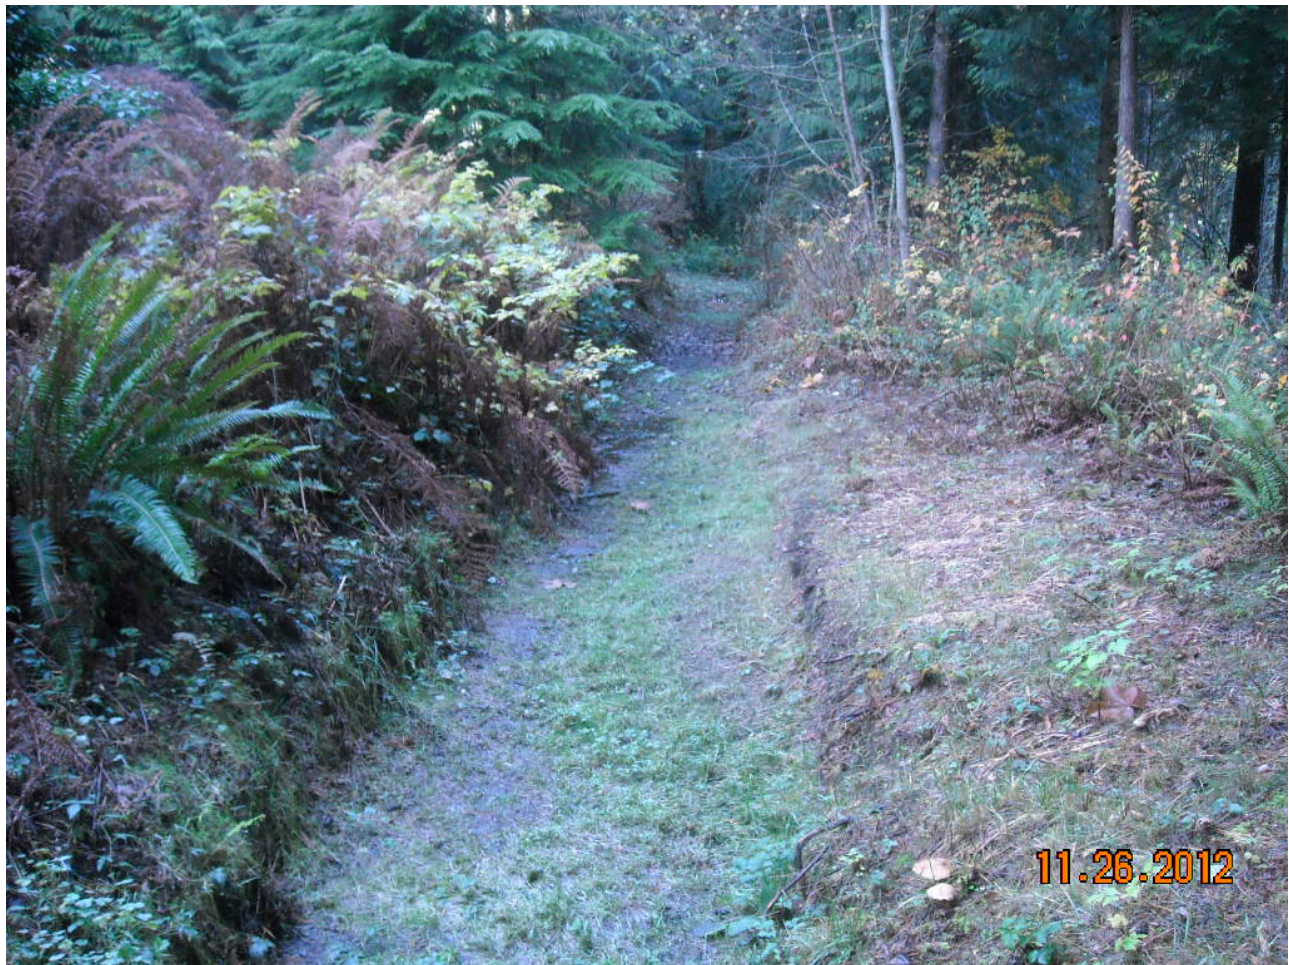
The Swan Lake Estates #3 project was field checked by Chris Gallagher, Engineer, on November 26, 2012. The project is located at 6414 238<sup>th</sup> Avenue Northeast, Redmond, WA. The project removed existing vegetation and sediment in the bioswale and reseeded with bioswale grass seed mixture per Table 6.3.1.C of the 2009 King County Stormwater Design Manual. The bioswale is straight. It appears that a majority of the grass has survived. There does not appear to be any channelization occurring in the bioswale. Some standing water is present in the bioswale due to the bioswale's shallow slope. The inlet and outlets are clear. No modifications or maintenance required.

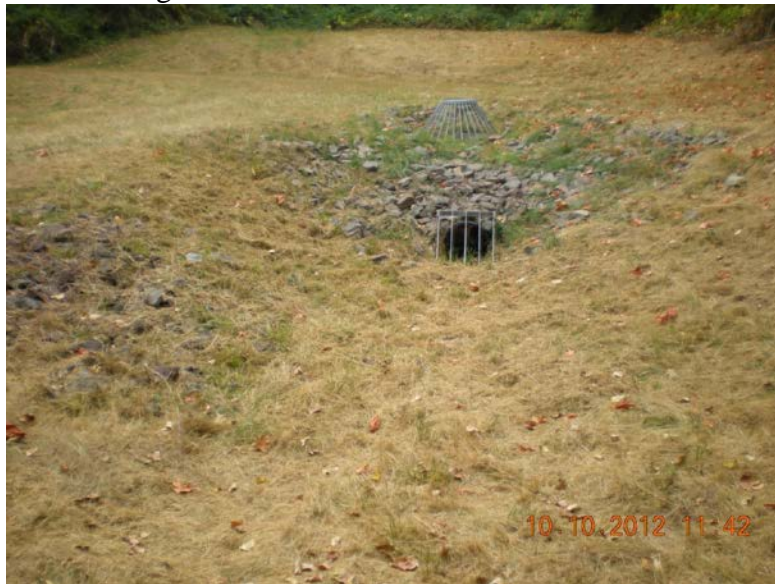
Sunrise Ridge

Vigorous growth can be seen across site, emergency overflow has not yet been utilized.

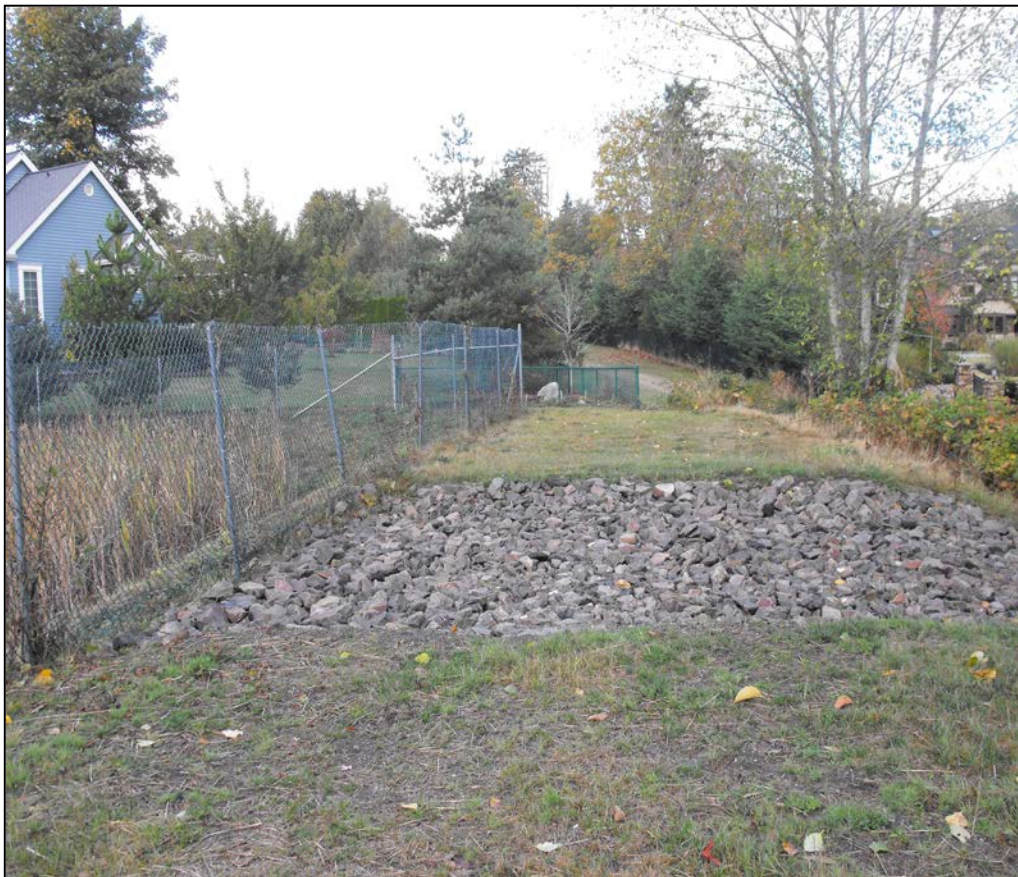
The spillway was built in accordance with the design plans, 0.5 FT depth and 6:1 side slopes and appears to be in good condition (see Picture 1).

Park Avenue Picture 1: Post Construction Spillway

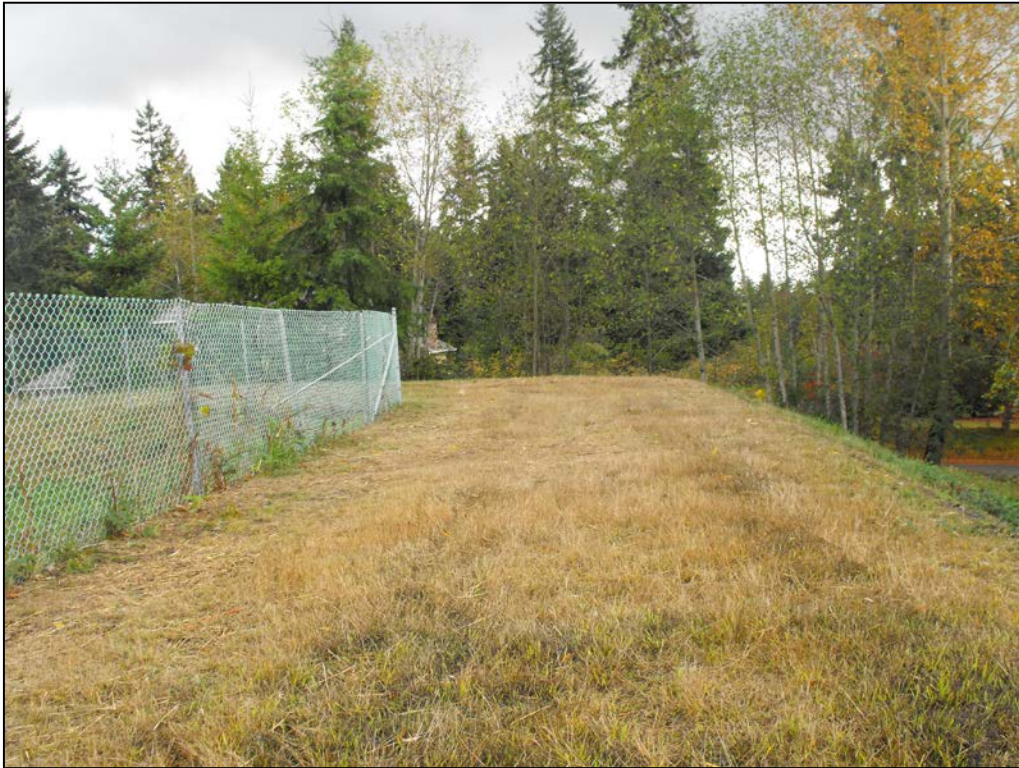
The berm has been raised to the designed elevation, leveled with 1-2" of topsoil and planted with grass. It appears to be in good condition, with no signs of erosion and 100% covered with grass (see Picture 2).

Park Avenue Picture 2: Post Construction Berm

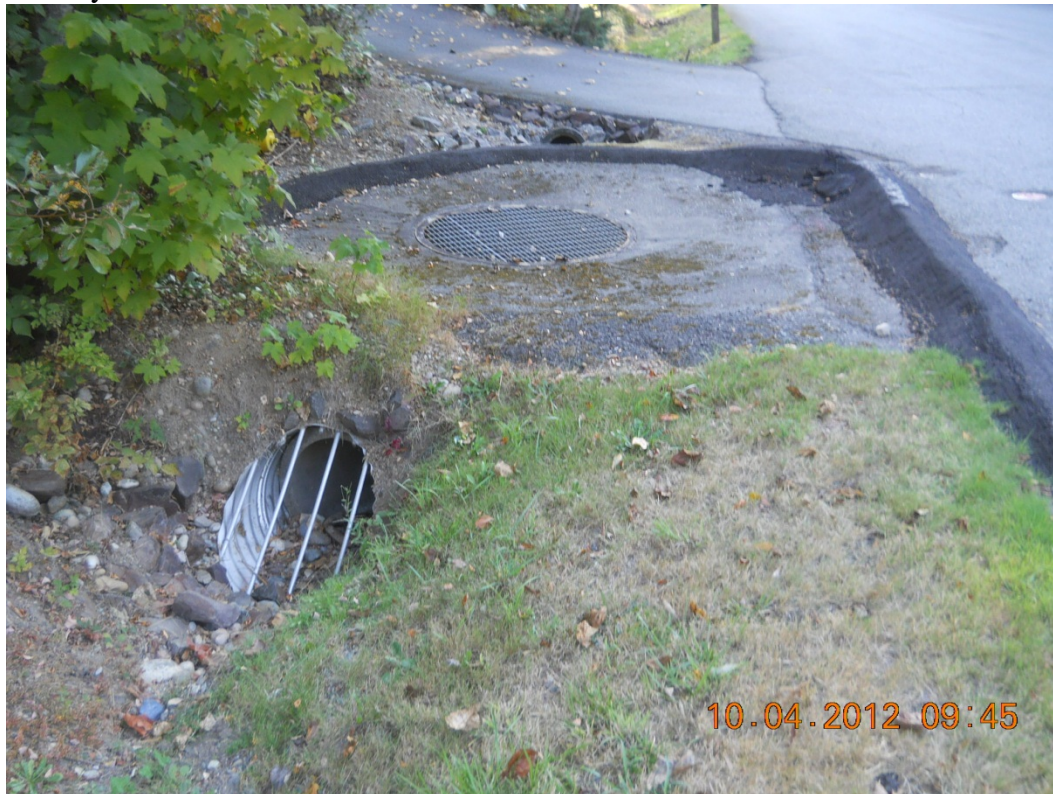
These modifications were intended to reduce the risk of road overflows into a ravine and causing erosion that could impact Paradise Lake. Both the berm and emergency overflow area were in good condition. There was minimal sediment collection and it did not appear that the structure had experienced overflows since the retrofit was performed. No further actions are recommended.

Reintree - Inlet structure with low-profile berm directing emergency overflows to the roadside ditch system.

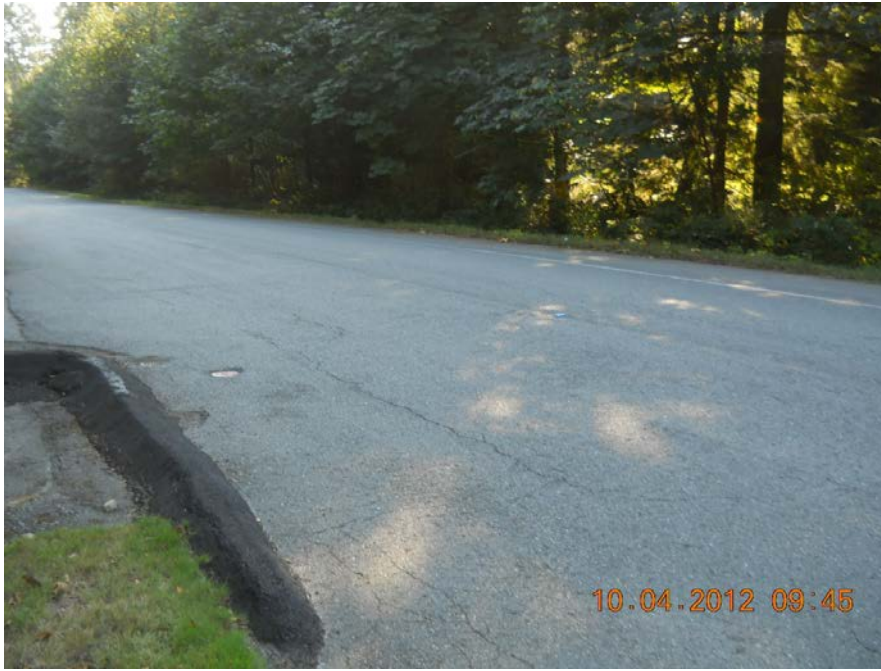
Reintree - Area of previously-reported overflows across the road into a ravine. No recent evidence of overflows.

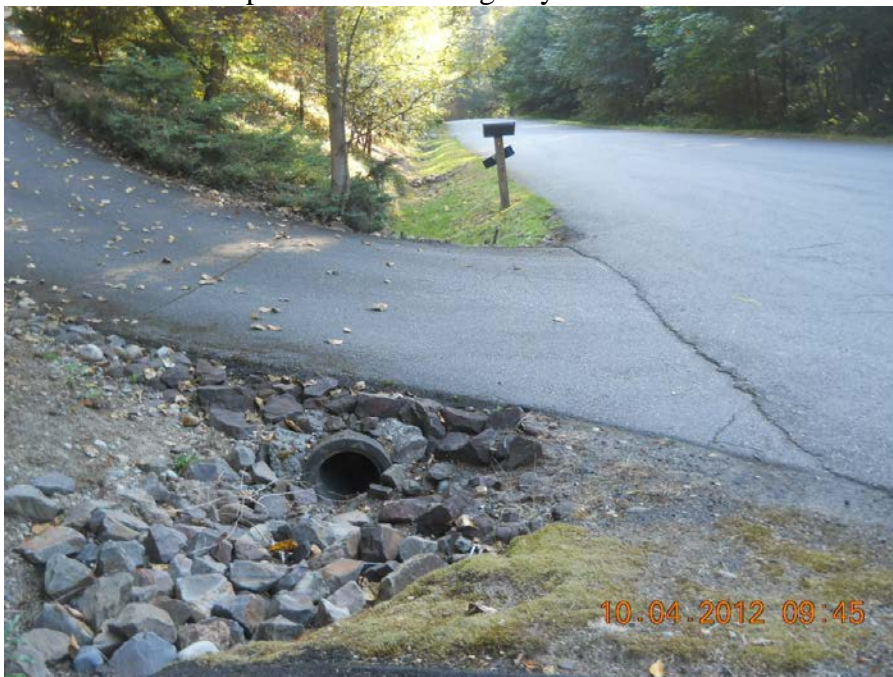
Reintree - Erosion protection at emergency overflow area.

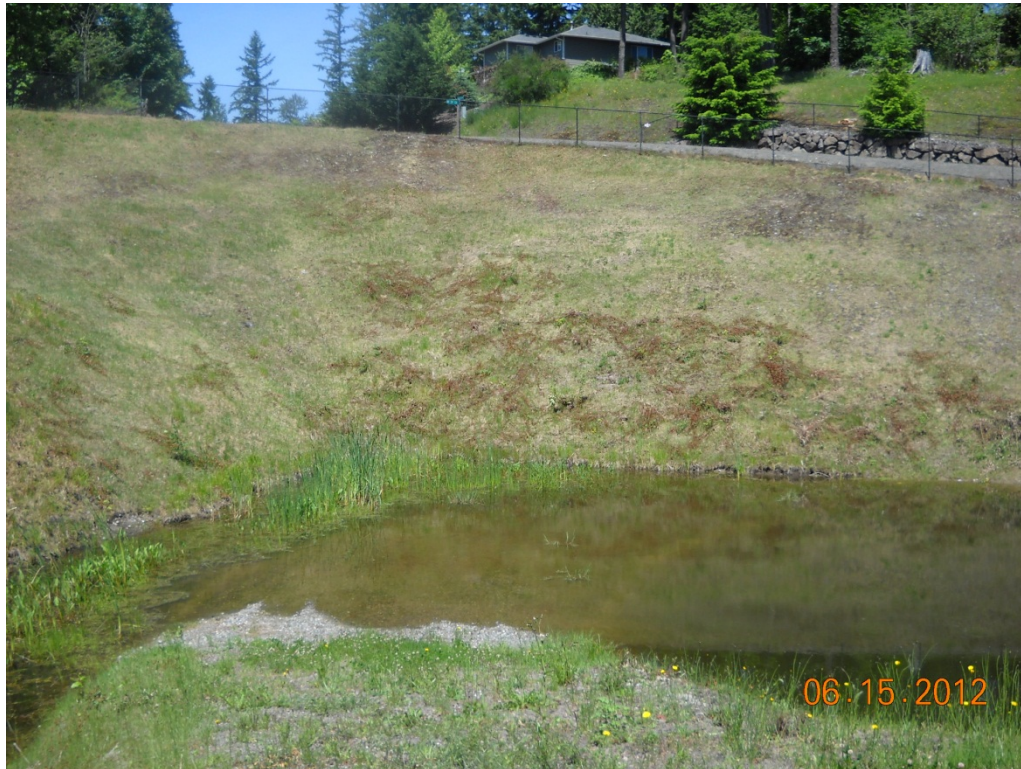
Upon post construction inspection, the dead storage was ponded with low or no flow into it. There was algal growth in the pond, which may have been caused by phosphorous, newly exposed by excavation. This nutrient source may be depleted over time. No further actions are recommended.

Quail Creek No. 2 and 3 View of tail end of pond from south.

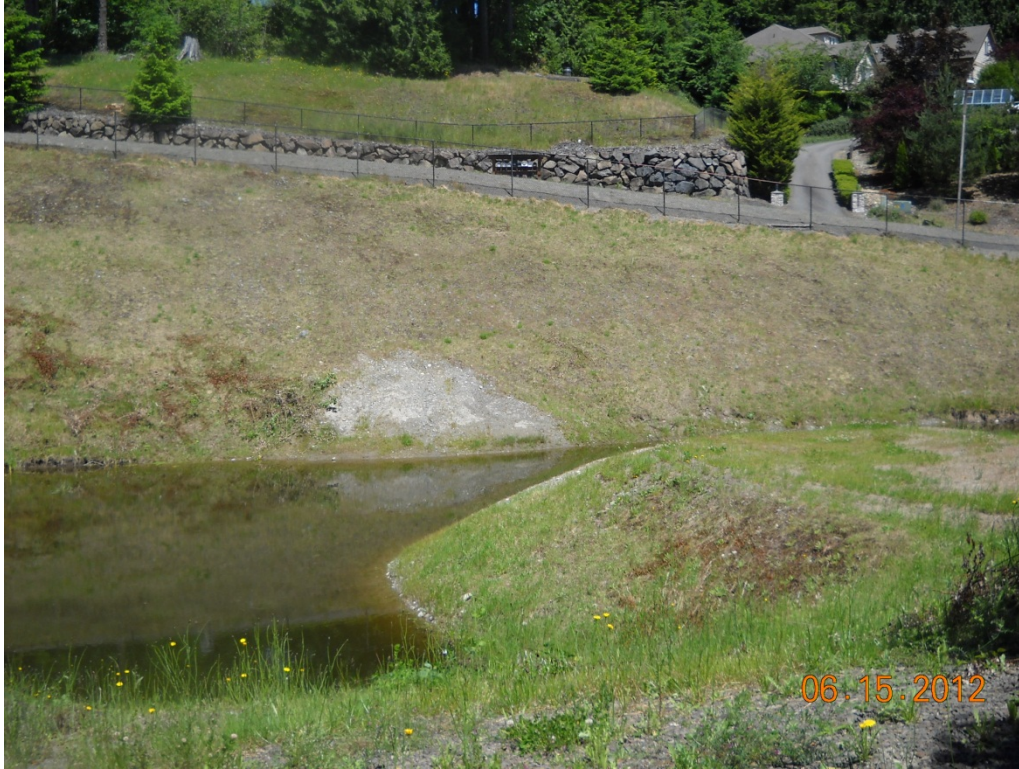
Quail Creek No. 2 and 3 View of middle section of pond, where filter berm was removed, from south.
