PCB Source Control Investigation of the City of Tukwila Stormwater System

Jorgensen Pipe Discharge Area
City of Tukwila, WA

December 2008
Project No. 40407.011

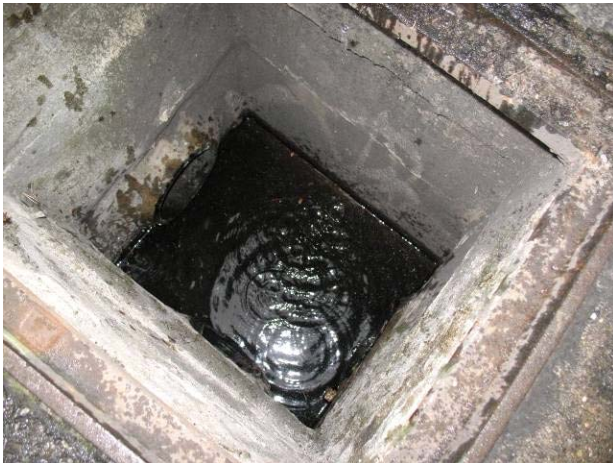
Photo 3. Inside of typical City of Tukwila catch basin in study area

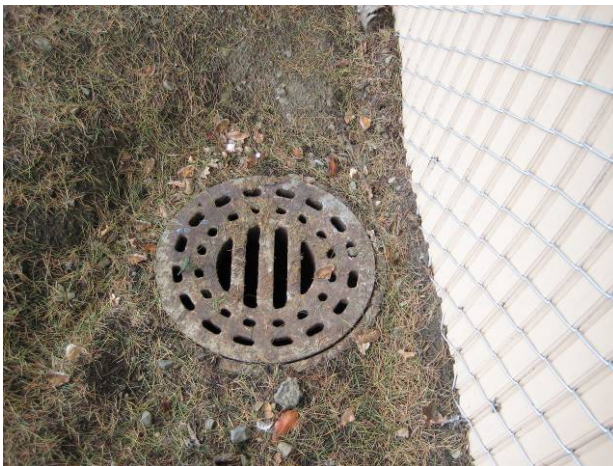
The elevated PCB levels we found in the manhole at the top of the Jorgensen Pipe were consistent with previous measurements at this location and with measurements taken at the KCIA intertie on the opposite side of East Marginal Way. Our sample measured 100 mg/kg, whereas a sample taken in 2005 at the same location had 68 mg/kg. Levels recorded across the street at the King County outfall were 36, 51 and 128 mg/kg dw. During the 2005 sampling effort in the Jorgensen pipe, the recorded level in the manhole at the top of the pipe (68 mg/kg dw) was the lowest level recorded in the pipe. PCB levels further down gradient in the Jorgensen Pipe ranged from 731 to 10,000 mg/kg dw. with the highest level (10,000 mg/kg dw) recorded near the transformer site on Boeing Phase 2 property.

Photo 5. Manhole at top of Jorgensen Pipe along west side of East marginal Way

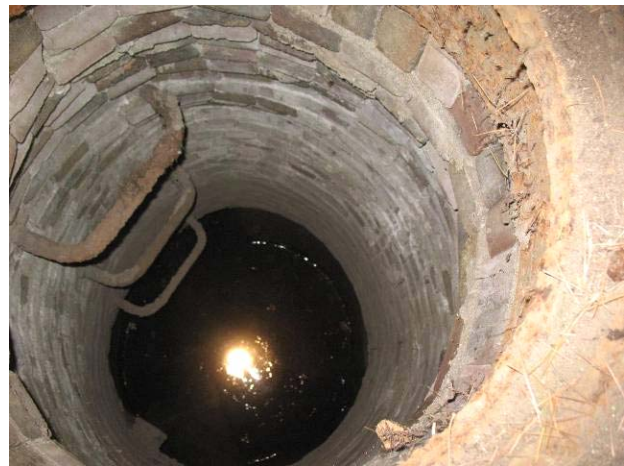
Photo 6. Inside of manhole at top of Jorgensen Forge pipe
