**BRIGHTWATER POST-CONSTRUCTION**

# **Eelgrass Program: 2009 Eelgrass Transplant Report**

**Task 400 – Eelgrass Transplanting**

**December 2009**

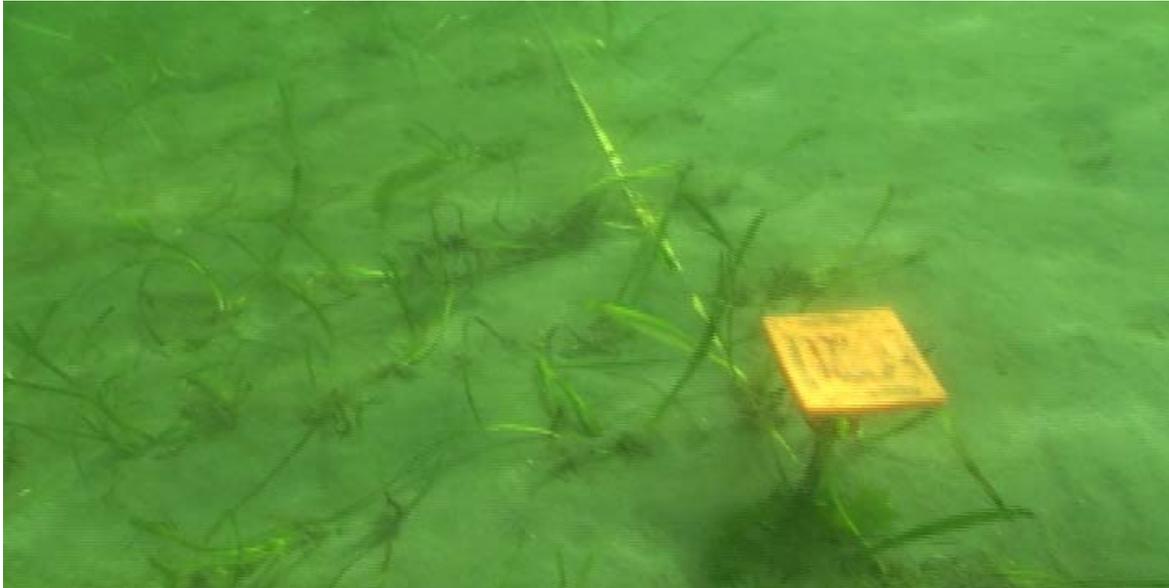
**Photograph 1. Rebar at Transect 1, 120 feet waterward from the start of the transects (1-120; band B). This photograph was taken post-transplant.**

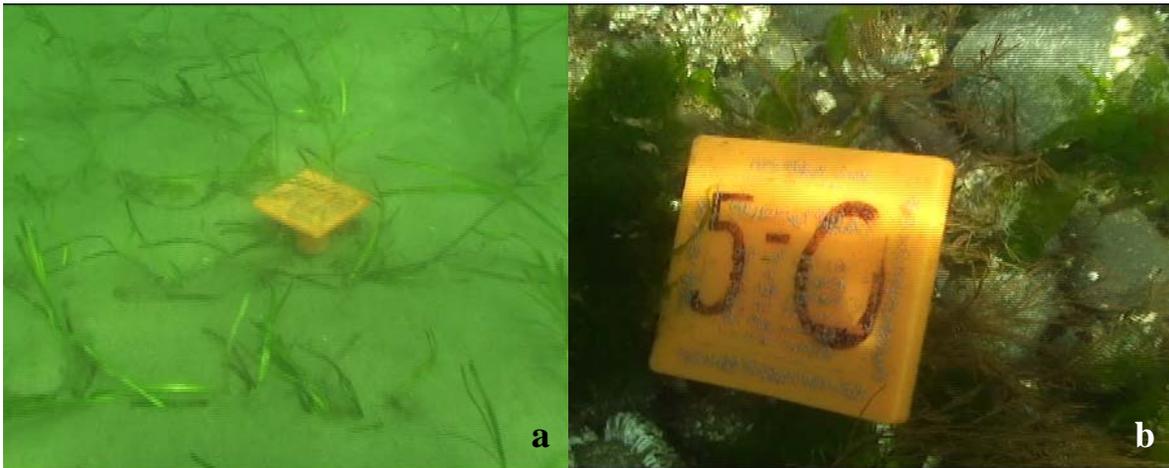
**Photographs 2a and 2b. Rebars 2-120 (band B) and 5-0.**

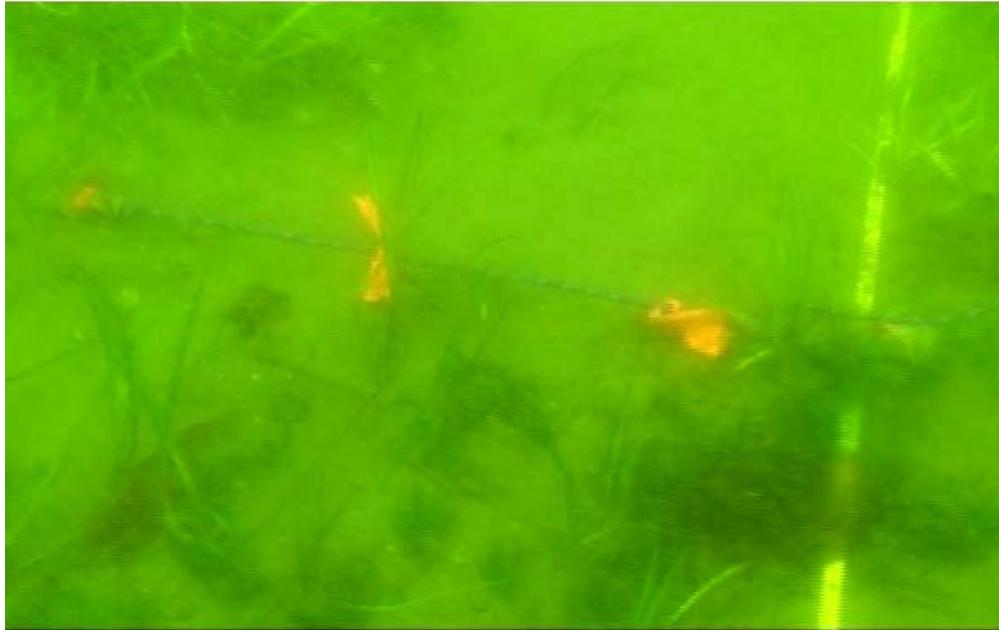
**Photograph 3. Planting rope at band B. The rope, marked every 9 inches with orange survey tape, was laid out perpendicular to the transect tapes. An eelgrass planting unit was placed at each orange mark to achieve the correct density.**

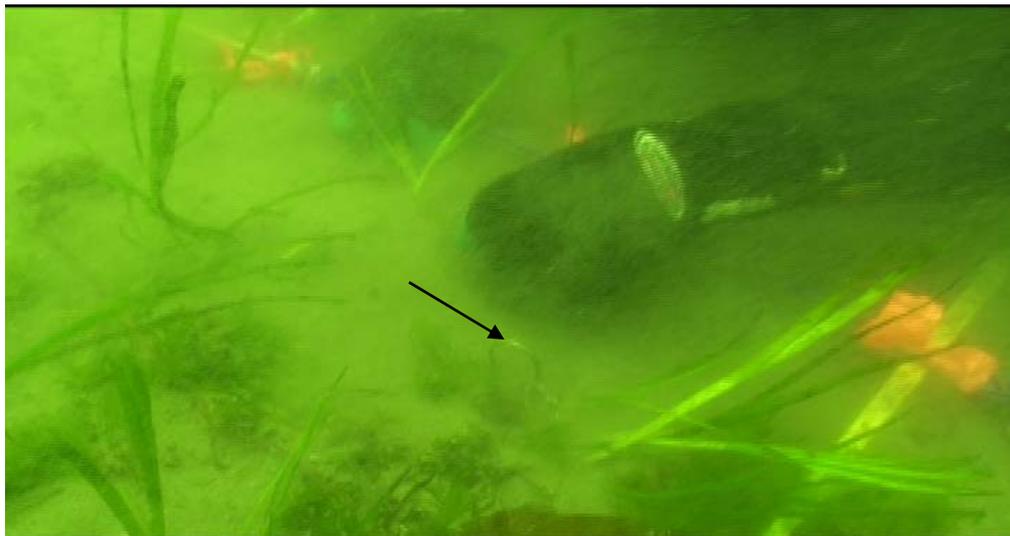
**Photograph 4. Eelgrass planting in band A at Transect 1. The arrow denotes a landscape staple/anchor to which 4 eelgrass shoots were affixed (one planting unit). A furrow was manually created by the diver prior to anchor placement. After insertion the anchor, rhizomes and roots were covered with sediment and the blades pulled free.**

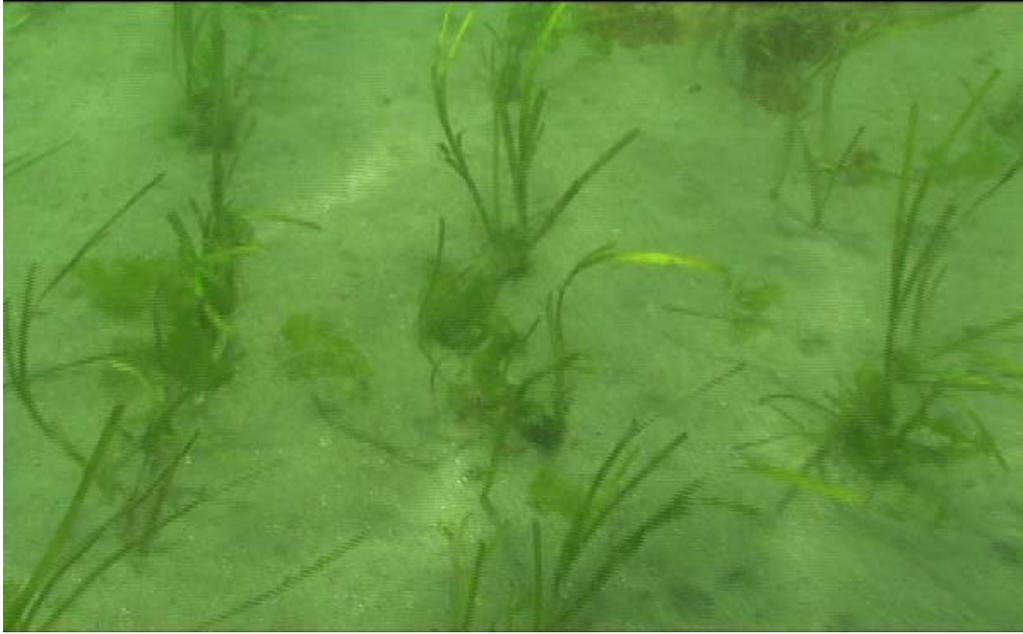
**Photograph 5. A portion of the Outfall Corridor post-transplant.**

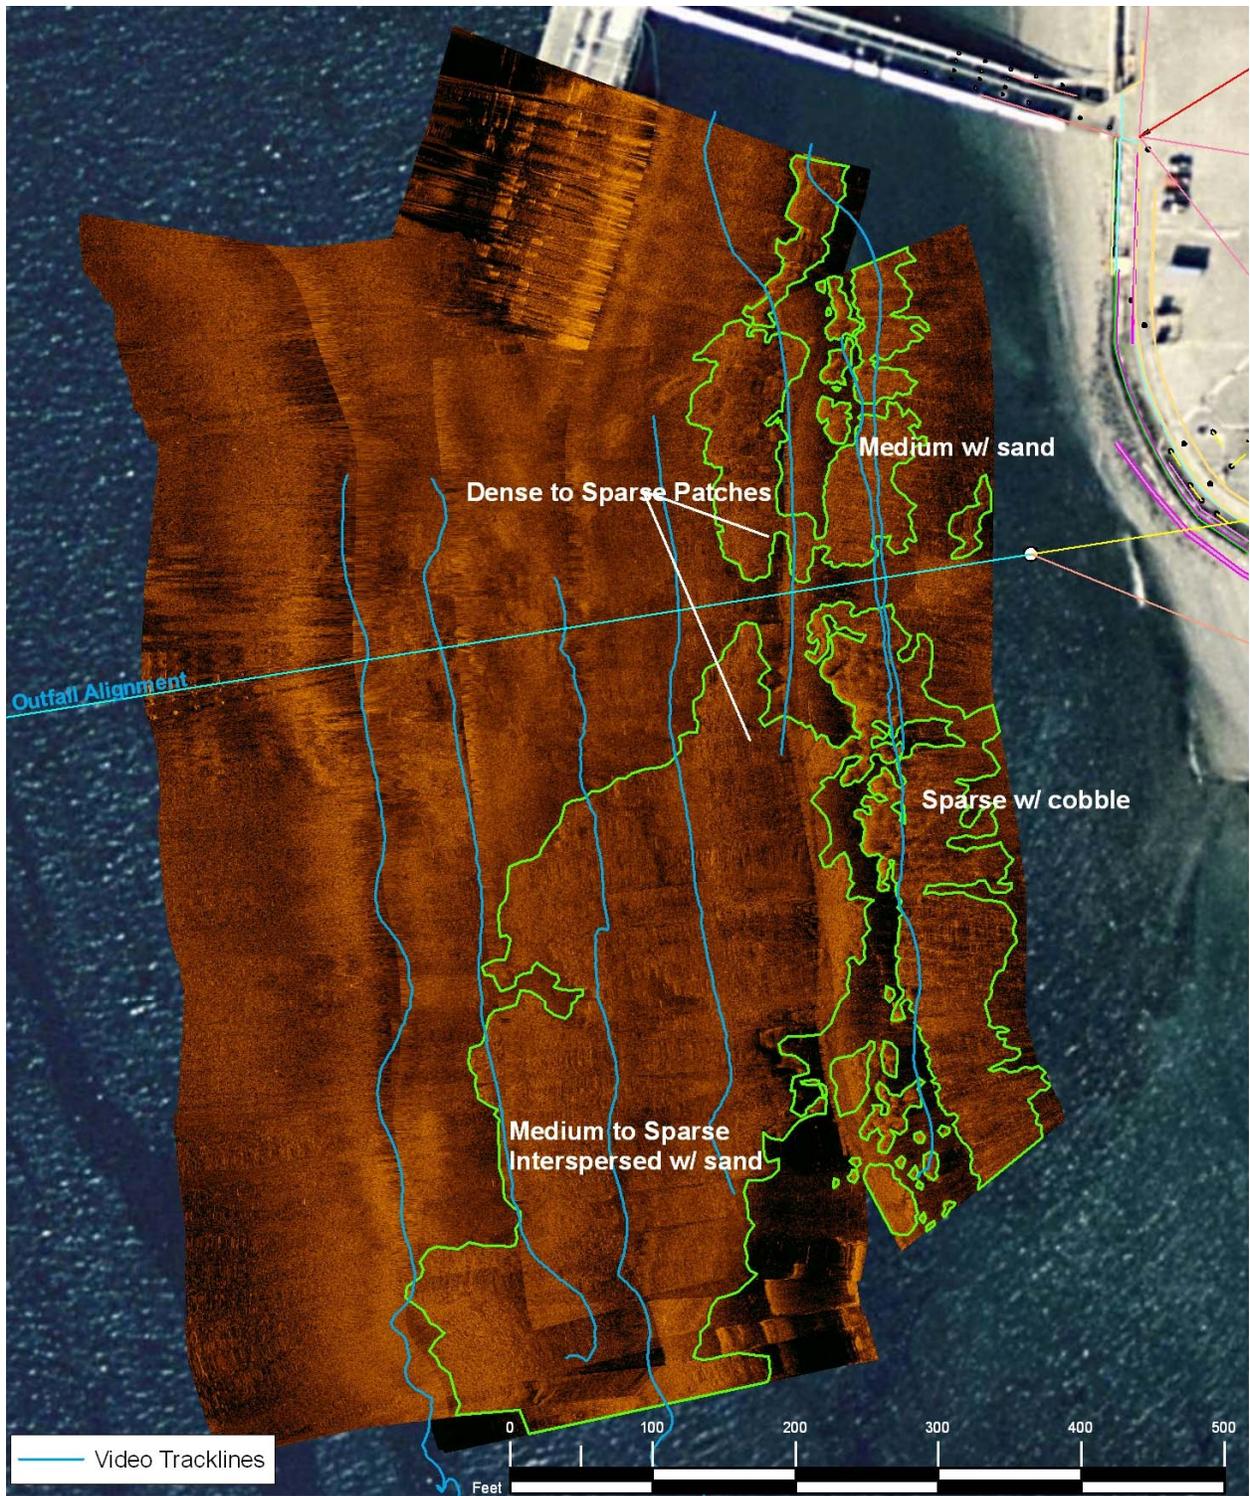
A large contiguous bed of eelgrass occurs to the south of the alignment, becoming more fragmented to the north and shoreward (Figure 7). The fragmentation (absence) of eelgrass to the north and south of the alignment appears to be naturally occurring, as it does not run precisely parallel to the sonar track. The seaward extent of eelgrass around the outfall alignment corridor coincides approximately with the -15 ft contour (Figure 8). The lack of eelgrass directly under the outfall alignment between 0 and -15 ft MLLW depths was expected due to the construction of the pipeline. There are two bright sonar textures in this region, which are likely cobble or turned up sediment following construction (A. Dubois, pers. comm.). There are no similar “gaps” in the eelgrass bed that appear to reflect the pipeline’s location. There are no similar “gaps” of eelgrass coverage that occur along the pipeline alignment.

**Figure 7. 2009 Eelgrass delineation based on groundtruth data and characteristic eelgrass texture signatures. Areas of qualitative density highlighted. The region seaward of the eelgrass area is sand, shoreward is mostly cobble.**

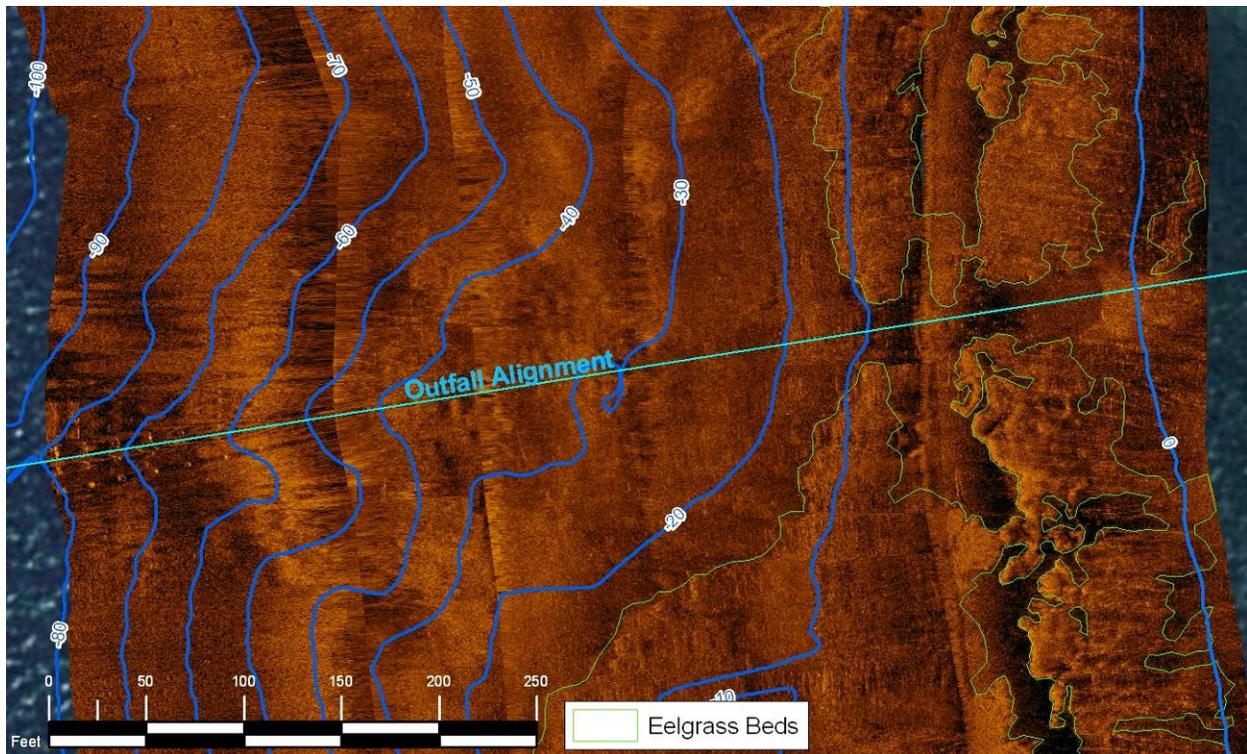
**Figure 8. Close-up of outfall pipeline alignment section. Bathymetry from post-lay and pre-construction (0 ft MLLW contour only) single-beam echosounder surveys conducted by GRS for Triton Marine Construction. Depths in feet.**

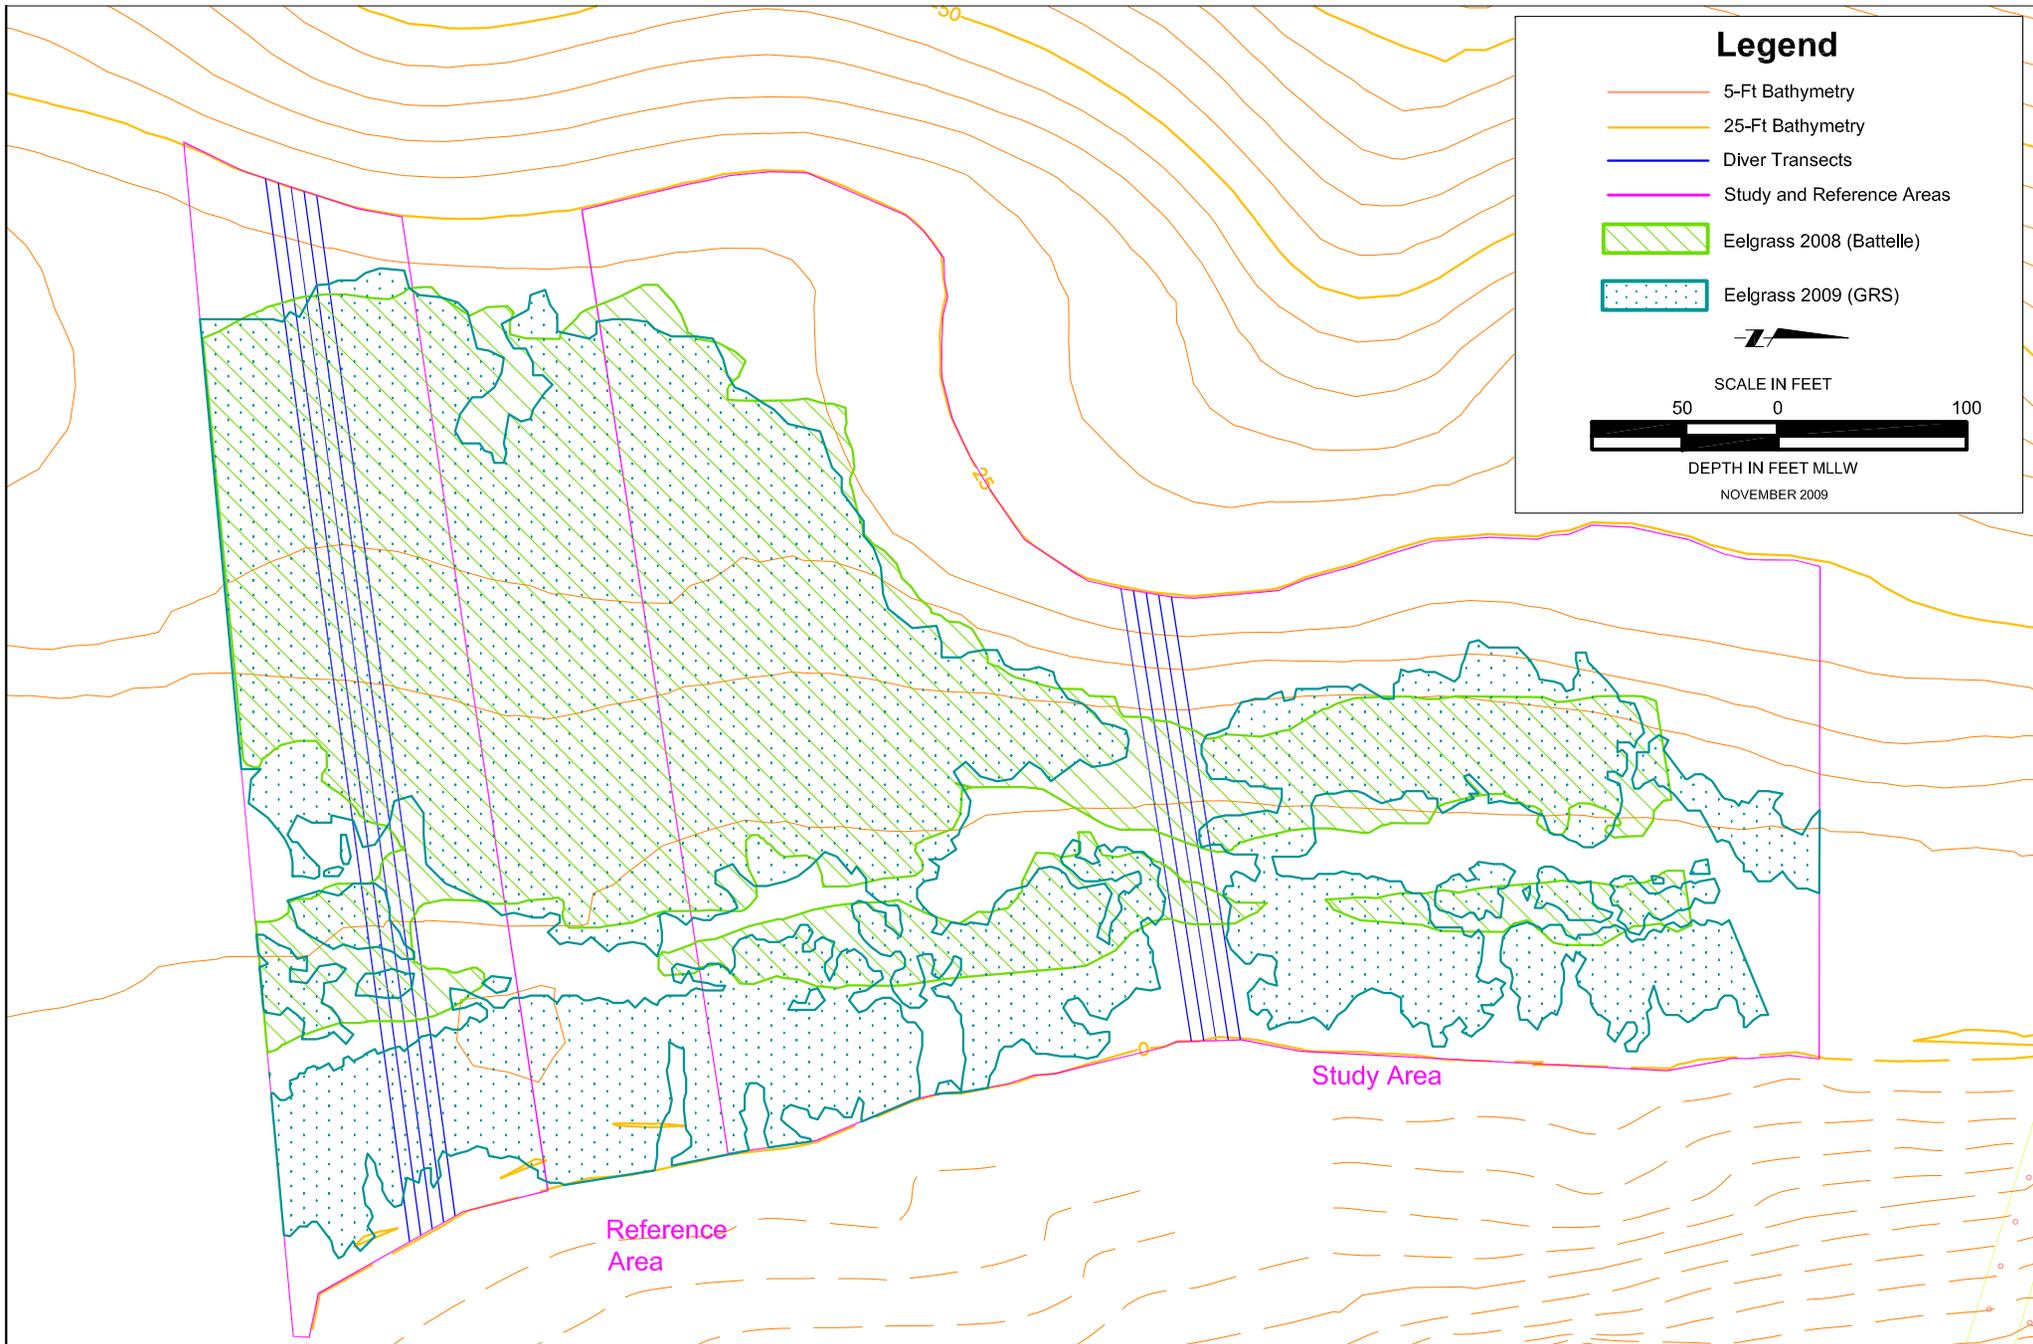
FIGURE 9

Side-scan sonar imagery was collected over the Brightwater Outfall pipeline alignment on 15 May, 2009. The sonar survey was followed by towed video on 21 May, 2009 for the purposes of groundtruthing sonar imagery. Eelgrass extents were delineated from the side-scan sonar image mosaic using ArcGIS and line-segment bottom type information observed in video footage. The eelgrass coverage generally was contained between the 0 and -15 ft MLLW depth contours. The absence of eelgrass immediately around the pipeline alignment was expected due to burial and no visible damage appeared outside of the outfall corridor. A comparison of eelgrass areal coverage between the 2004 pre-construction sonar survey and this 2009 post-construction survey did not reveal large spatial differences in mapping of eelgrass beds at the Marine Outfall Survey Area (Figure 9).

**Brightwater Marine Outfall Eelgrass Presence  
pre- and post-construction survey data**
