RE: May Creek Drainage Improvement Project: SE May Valley Road and 148th Avenue SE – Sediment Assessment

# May Creek Channel Restoration Project

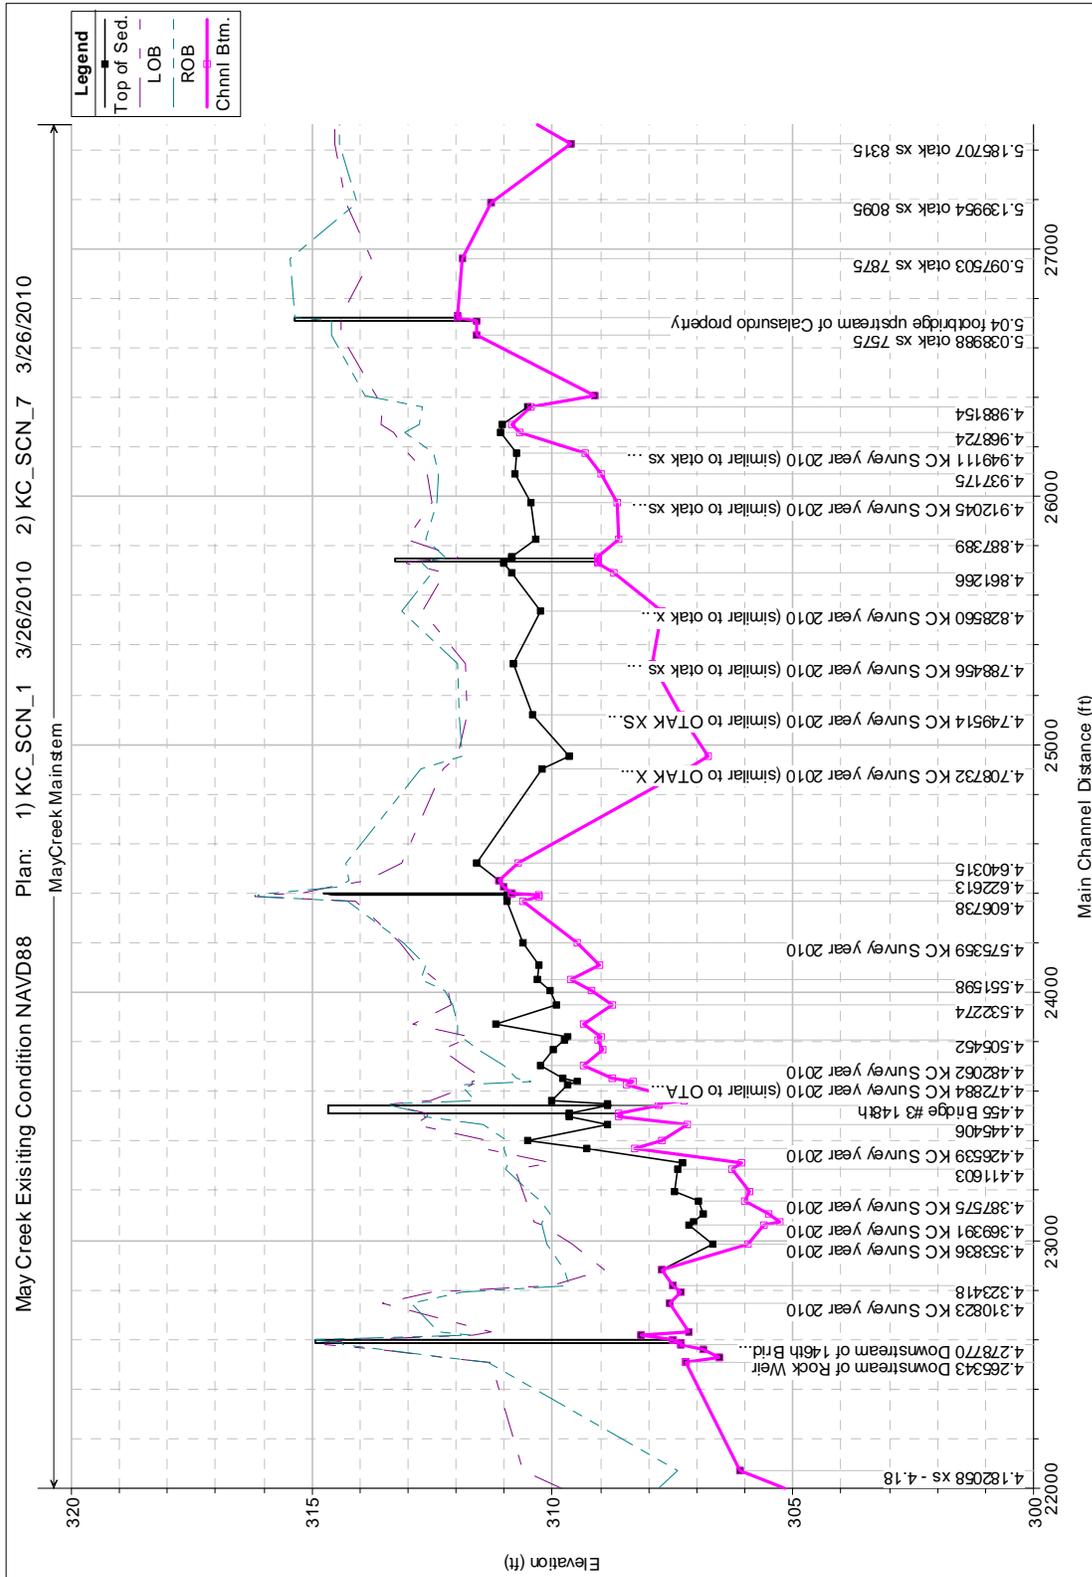
Figure 3 May Creek Profile Showing Channel Bottom Elevation and Open Sediment Thickness in 2010 (From King County, 2010a).

Channel elevation surveys were conducted in 1965, 1979, 1993, 2002 and 2010 (Data is located in Appendix C). A profile of May Creek channel from just below 148<sup>th</sup> Avenue SE to approximately 1,300 feet upstream of the confluence with Long Marsh Creek as shown in Figure 5. The figure compares the 2002 and 2010 survey profiles and gives spot elevations at the 148<sup>th</sup> Avenue road bridge and at the horse-crossing bridge on parcel 0223059091, 15019 SE May Valley Road from 1965, 1979, and 1993. Upstream of Long Marsh, between 2002 and 2010 the hard channel bottom is a foot lower in some areas and a foot to two feet higher in others. At the horse bridge the elevation has varied from 307 feet to 311 feet associated with sediment deposition from Long Marsh Creek. From station 11+00 to 8+00 at 148<sup>th</sup> Avenue, the channel profile has flattened and the channel bottom has shallowed approximately three feet. This area coincides with thick areas of reed canarygrass. Between 1965 and 2010, the 148<sup>th</sup> Avenue road bridge channel profile has stayed relatively consistent at 307 to 308 feet. It appears from the elevation differences that where the muck and vegetation builds up, the channel bottom has also been aggrading. Changes in the bottom elevation should be considered approximate, perhaps within a foot of elevation change. Survey elevations have not been taken at the exact same locations and stationing is different between projects. Stream profiles in 2002 and 2010 (Figures 4 and 5) show thicker areas of muck build up behind higher elevations in the channel. Up to four feet of muck was measured above the Long Marsh Creek confluence in 2002 and three feet in 2010. Stream and elevation survey data indicates that soft muck present in the channel varies in thickness by location and with time. The muck thickness is variable and transitory, building up in the channel until higher flows in May Creek are able to move the sediment downstream.

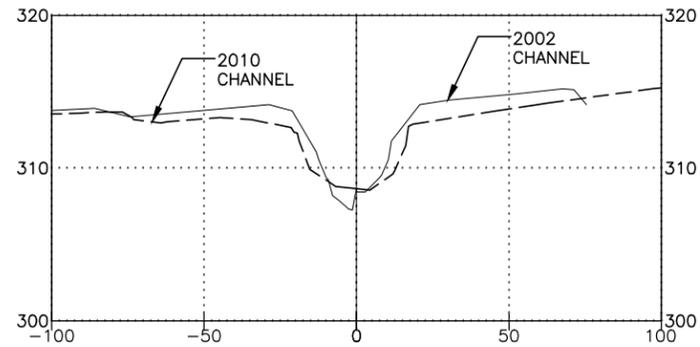
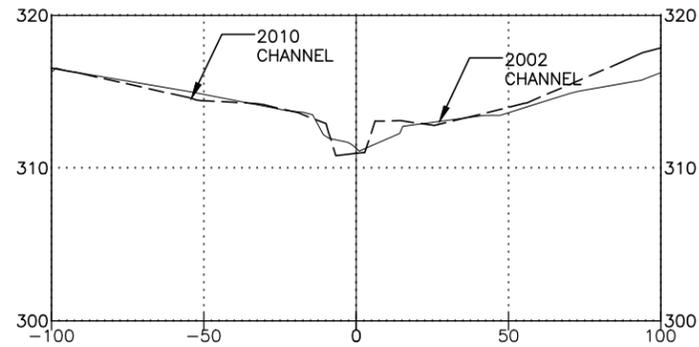
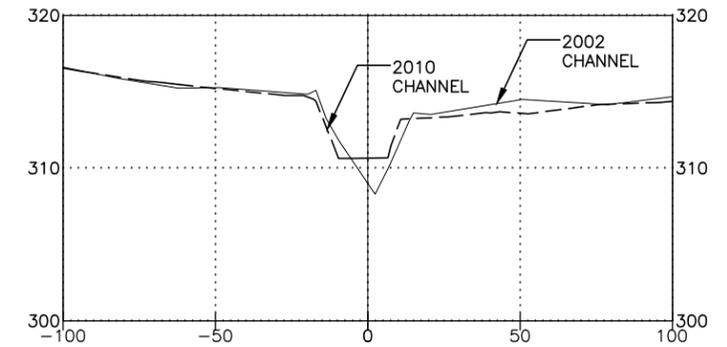
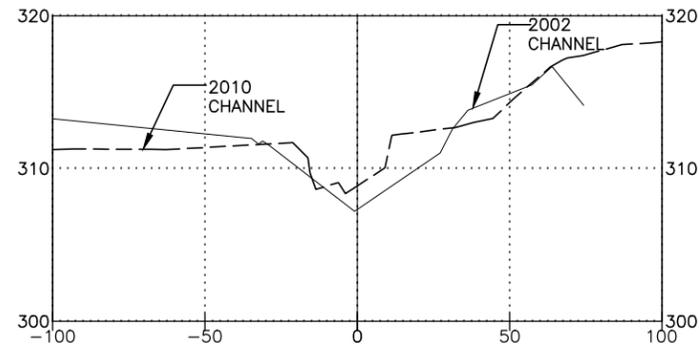
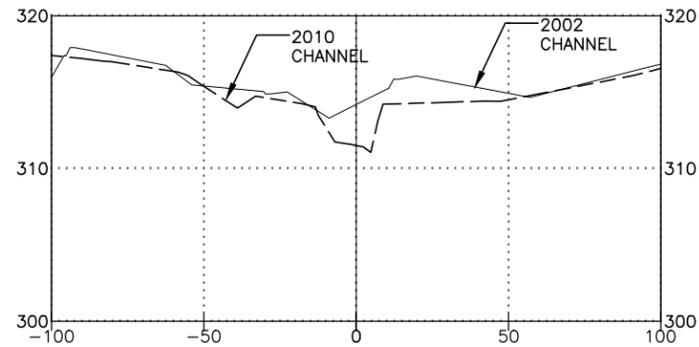
## FIG. 4 CROSS SECTIONS

Survey data from 2002 and 2010 surveys are also available. Cross sections of May Creek are shown in Figure 4 (cross section locations are shown in Figure 5). Five cross sections were chosen to compare the stream channel at relatively fixed locations in the stream. Upstream of the road bridge at 148<sup>th</sup> Avenue SE the channel is narrower and slightly shallower (Section B-B). Downstream of the bridge the channel is wider and more uniform in shape (Section A-A). The cross section at Long Marsh (Section D-D) shows the 2002 bank deposits (right bank) associated with excavating sediment from May Creek (private property owner activity) and the filled-in 2002 channel profile from Long Marsh Creek deposits. During the 2002 pilot excavation project in May Creek at the Long Marsh confluence, sediment was removed to approximately elevation 309. The left bank (looking upstream) has now filled in to 2002 elevations at the confluence but the rectangular channel shape is still present on the right bank. Upstream of Long Marsh Creek, the channel is approximately the same width but shallower. This may be due to where the survey staff was placed and the CAD program interpolating between points. Downstream of Long Marsh Creek the channel has narrowed. Survey locations varied slightly between center line, right bank or left bank and cross section elevations are approximate.

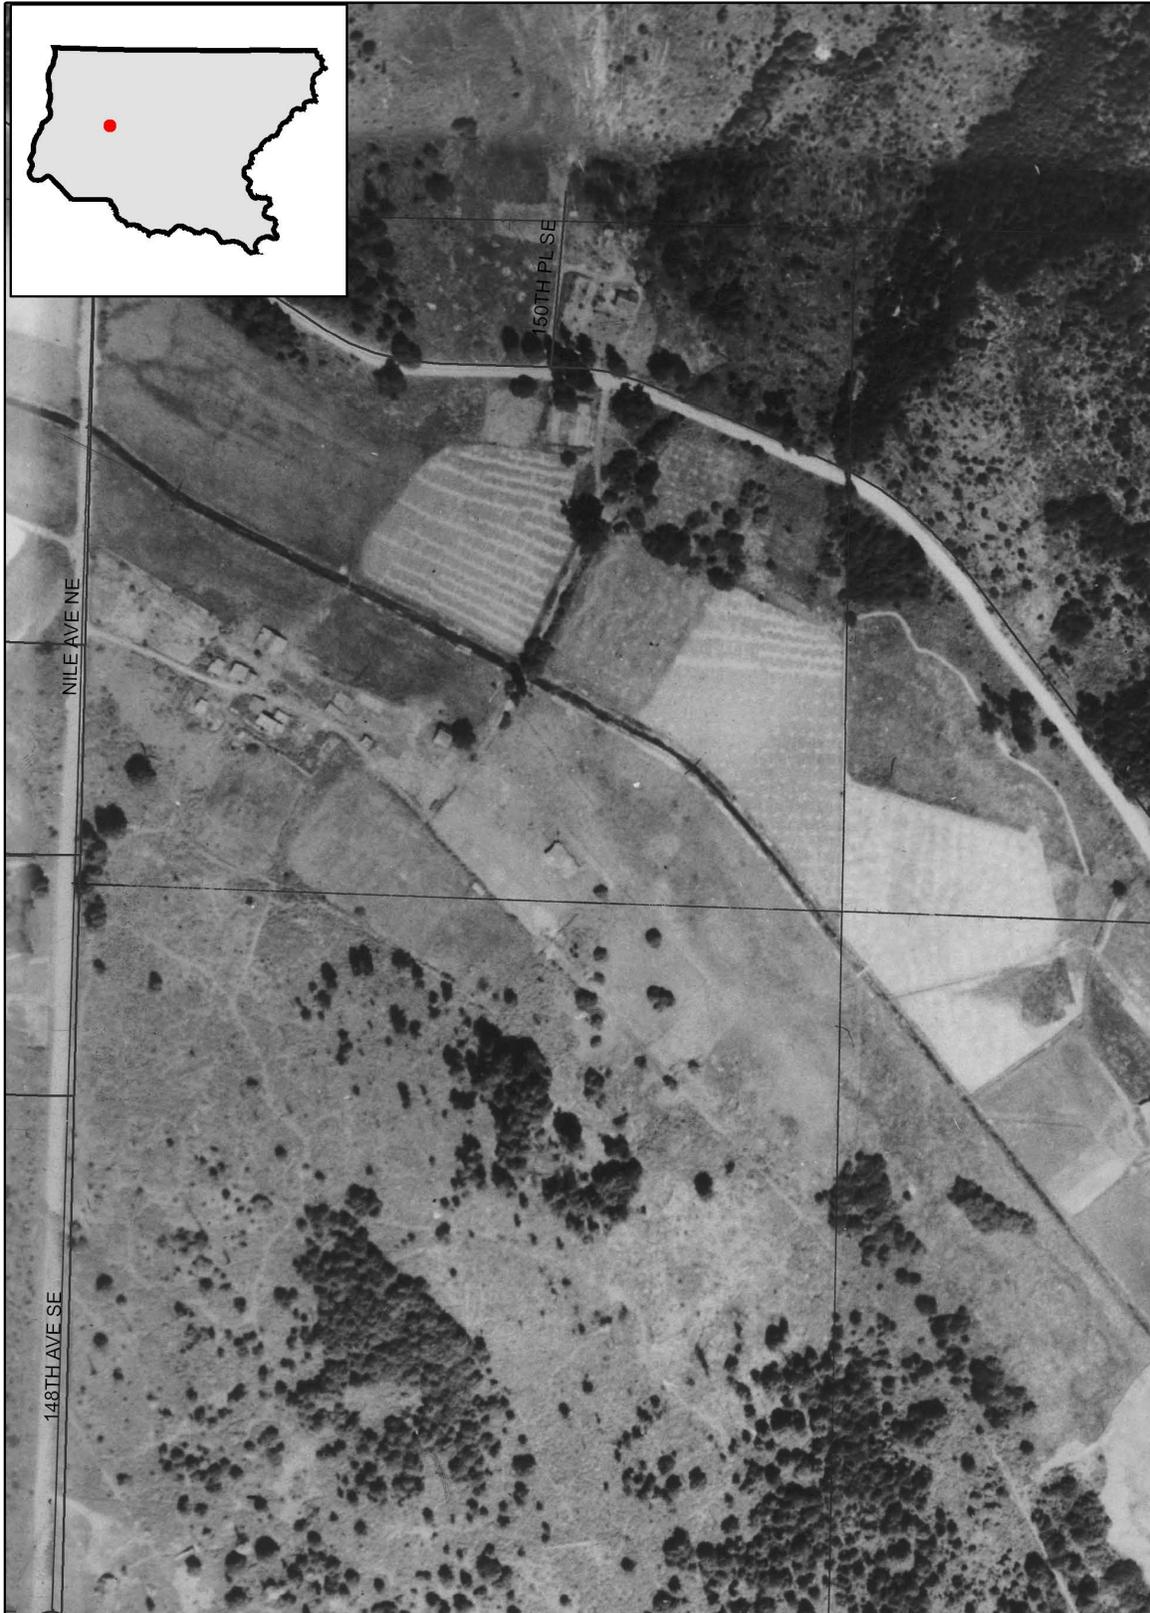
## 1936 Aerial Photo

Aerial photos from 1936 show the May Creek channel cut as approximately 25 to 30 feet wide as measured from the aerial photos. The photos clearly show the channel excavation boundaries. The channel is uniform with limited shrubs or trees. Periodic dredging is reported during the 1940s through 1960s (Foster Wheeler, 1995). Property owners may have removed sediment periodically.

Aerial photos from 1936 show the May Creek channel cut as approximately 25 to 30 feet wide as measured from the aerial photos. The photos clearly show the channel excavation boundaries. The channel is uniform with limited vegetation. Foster Wheeler measured the mean May Valley Creek channel width in 1995 as 20 to 25 feet, with wider sections up to 60 feet at RM 5.6 (Foster Wheeler, 1995). In March of 2002 a stream survey was conducted between 164<sup>th</sup> Avenue SE and 148<sup>th</sup> Avenue SE (O'Rollins, 2002) and measured the average channel width at ten to 14 feet. A stream survey was conducted in 2010 (Thompson and Bauman), and the average wetted width of habitat units was approximately 12.1 feet and the widest wetted width was 23 feet (surveyed reach RM 4.35 to RM 4.87). While no change in average width occurred from 2002 to 2010, there is a possible pattern of channel narrowing between the 1936 and 1995 and comparison between the 2002 and 2010 stream surveys. This is reflected in the available measurements; especially in areas dominated by reed canarygrass. The channel is still a relatively straight excavated ditch but grass, shrubs and trees have encroached into the channel.

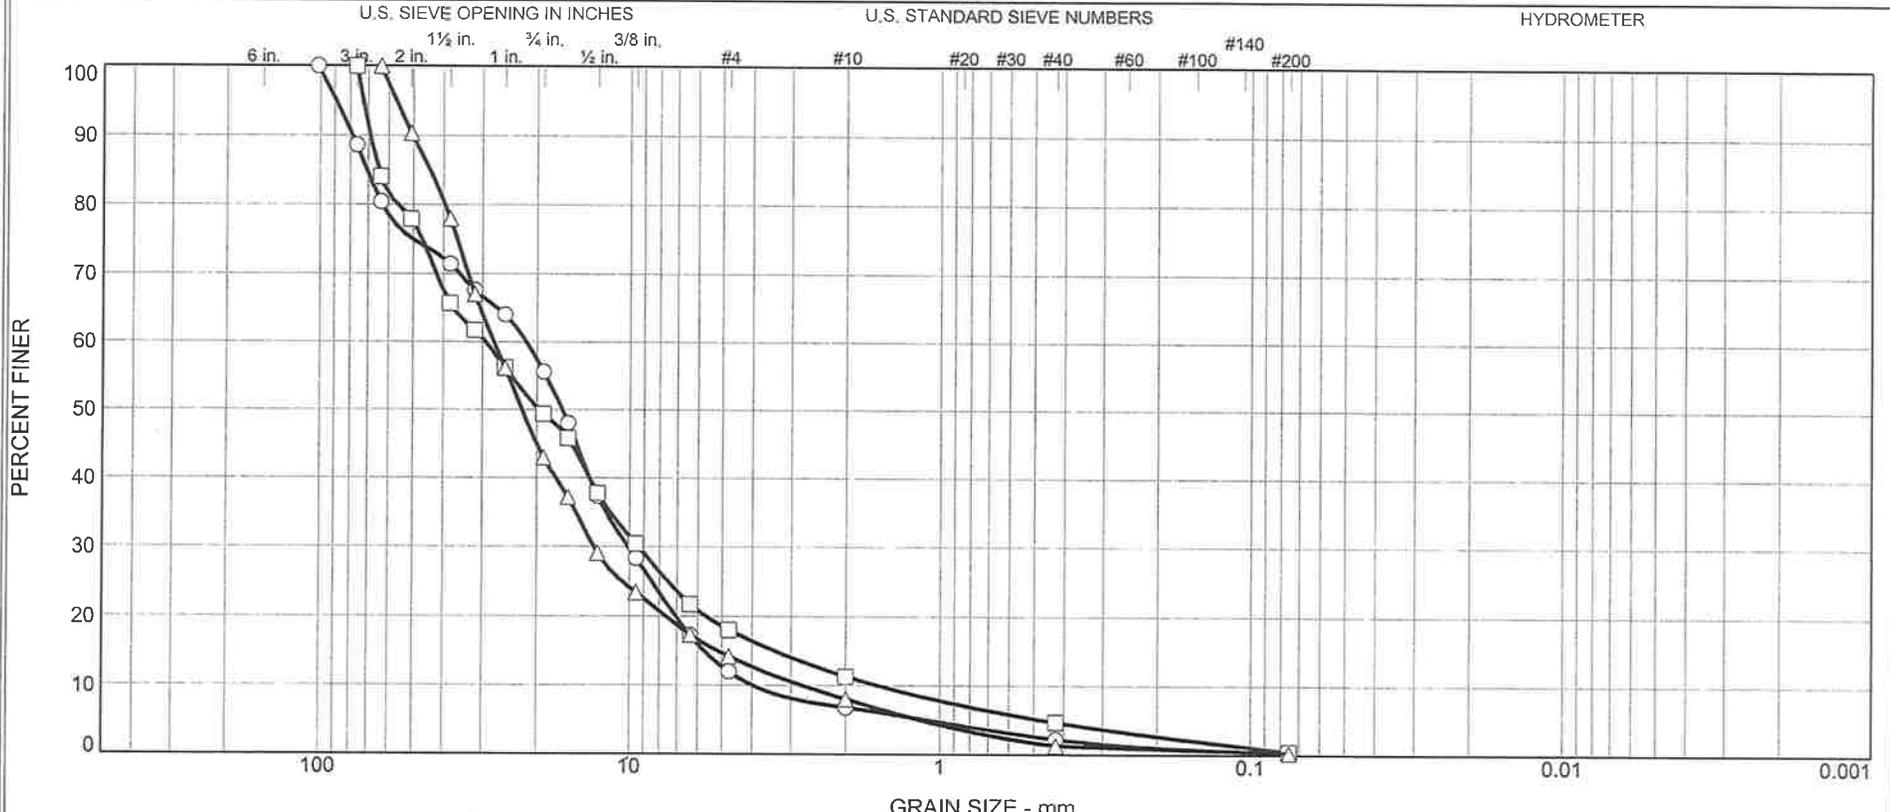
Sample KC-10-426: The sample was obtained at the confluence of a small unnamed stream and May Creek, approximately 30 feet upstream from the bridge. The water depth was approximately 12 inches with moderate flow and the surface of the water channel consisted of clean sand and gravels. This sample represents materials from approximately 0" to 6" below the bottom of the channel. No significant vegetation was noted at the sampling location. A gradation test using conventional screening methods was performed and the USCS classification for this material is well graded gravel (GW).

Source	Sample #	Depth/Elev.	Date Sampled	USCS	Material Description	NM %	LL	PL
○	KC-10-426		4/27/10	GW	Well-graded gravel		NV	NP
□	KC-10-427		4/27/10	GW	Well-graded gravel with sand		NV	NP
△	KC-10-428		4/27/10	GW	Well-graded gravel		NV	NP

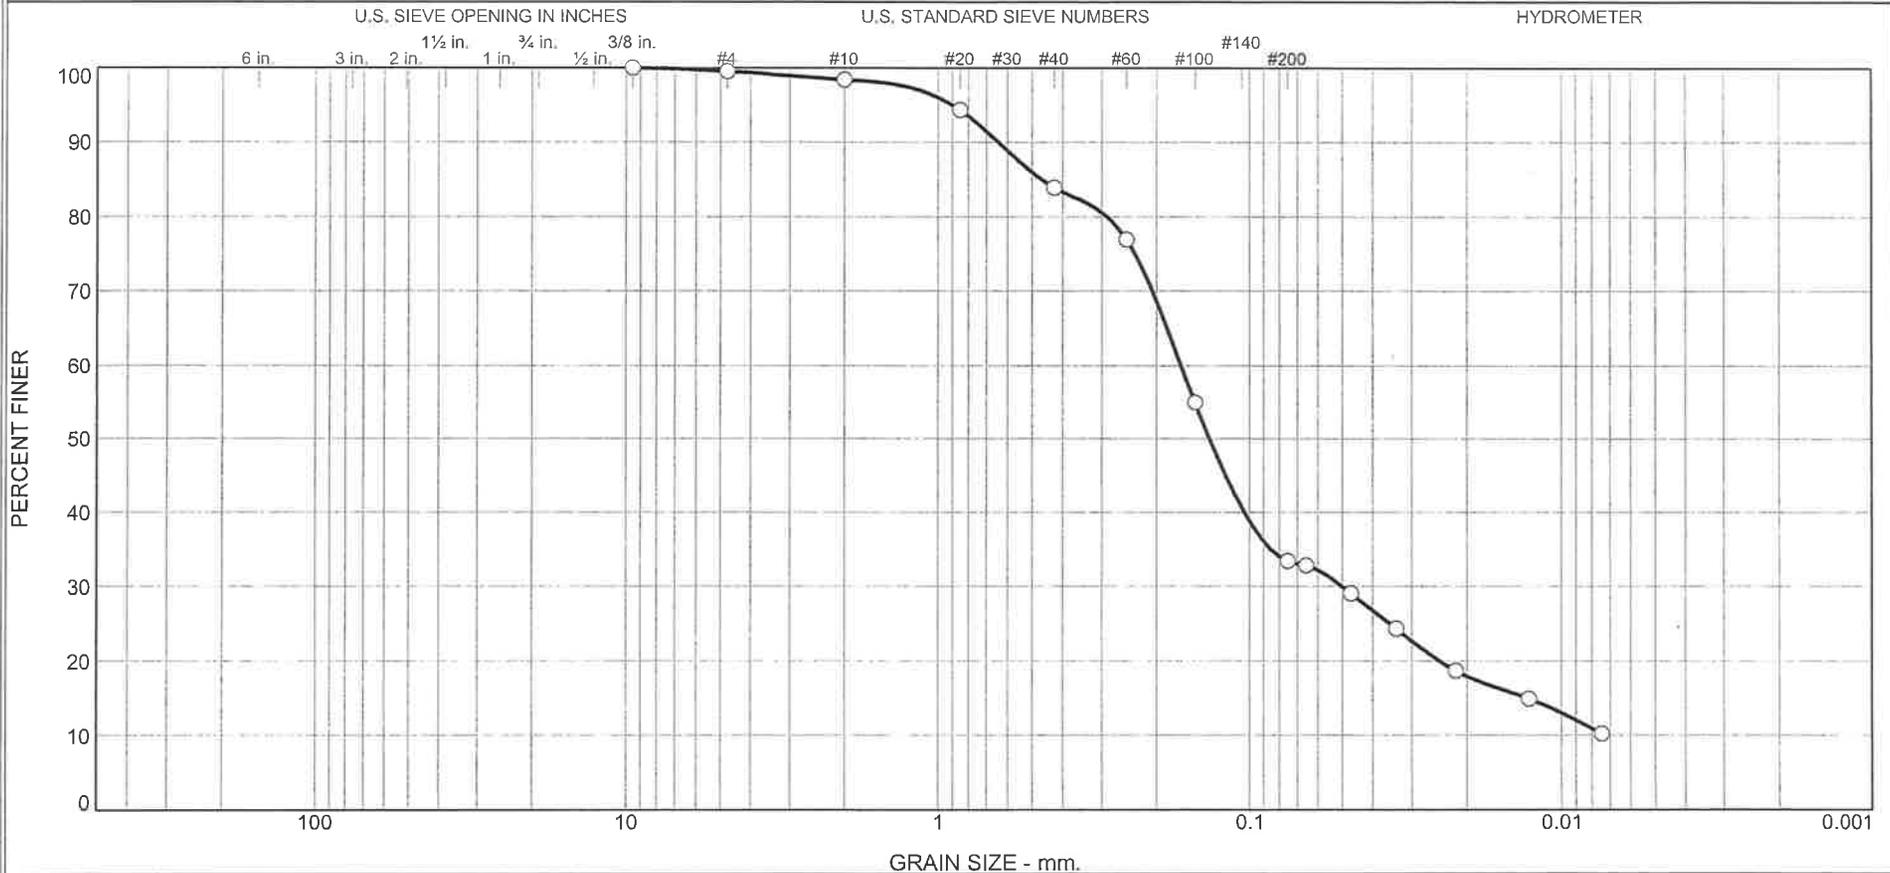
Source	Sample #	Depth/Elev.	Date Sampled	USCS	Material Description	NM %	LL	PL
	KC-10-432	0" - 6"	4/27/10	SM	Silty sand		NV	NP
