RESULTS

CHERRY CREEK (RIVER MILE [RM] 0.0-5.0), JULY 15—17, 2002

HARRIS CREEK (RM 0.0–6.6), AUGUST 1, AND AUGUST 5–7, 2002

TOLT RIVER (RM 0.0–5.9, 7.5–7.9), SEPTEMBER 4, 2002

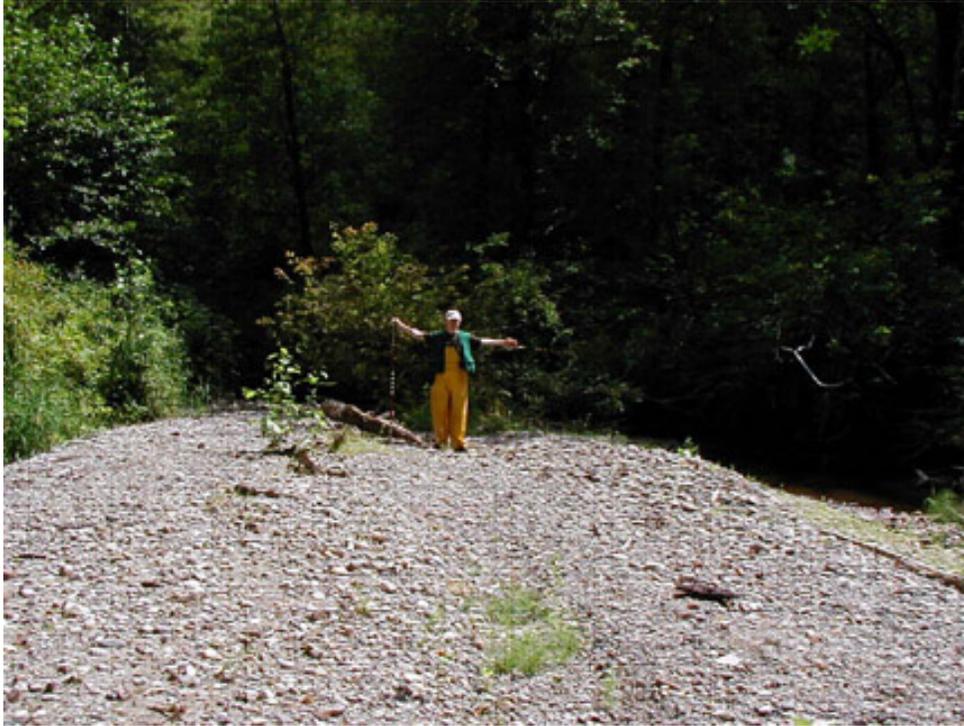
There was a big gravel bar just upstream of the SR 203 Bridge over Harris Creek, indicating that the bridge may back up the creek at higher flows (Photo HA1). Coho fry were abundant in this area.

Photo HA1. Harris Creek. Gravel bar upstream of SR 203 Bridge

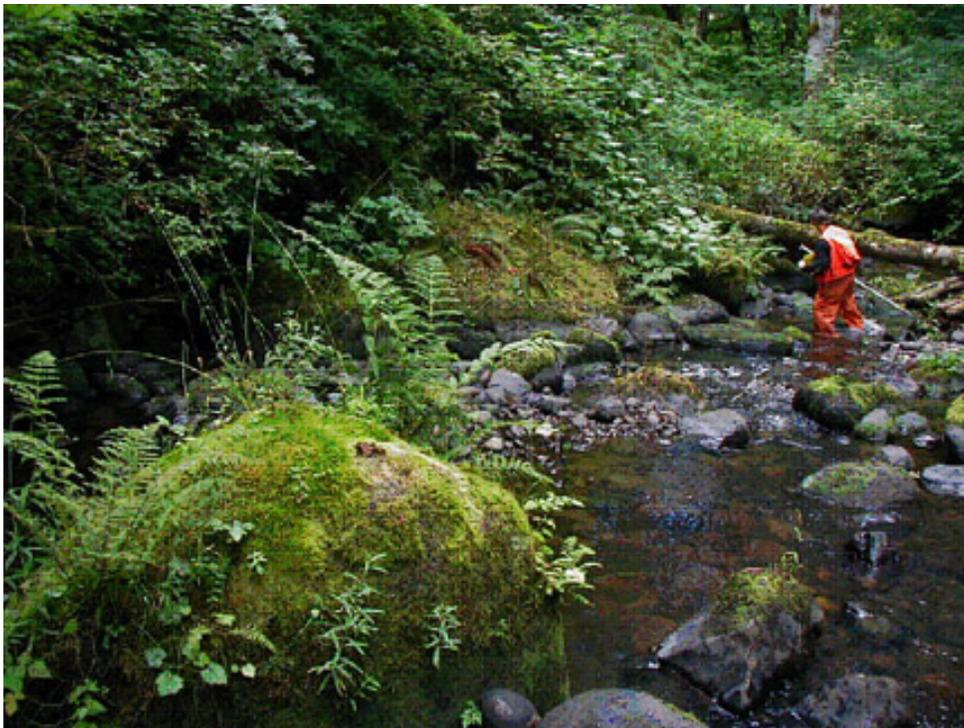
At RM 2.2, the substrate increased in size to gravel and boulder (Photo HA2), with the gradient up to 9%. The dominant riparian shrub was salmonberry. The canopy was still about 40 feet back from the stream, and was composed of alder, maple, and conifers. There was a logjam at RM 2.3 that was 40 feet wide with approximately 60 pieces of wood. Some small caddisflies were present. Many boulders were present at RM 2.3. The wetted width of the channel was 15 to 20 feet and the OHW was 40 feet at this location. Complex habitat with adequate shading and LWD were found at RM 2.5–2.6 (Photos HA3–4).

Photo HA2. Harris Creek. RM 2.2

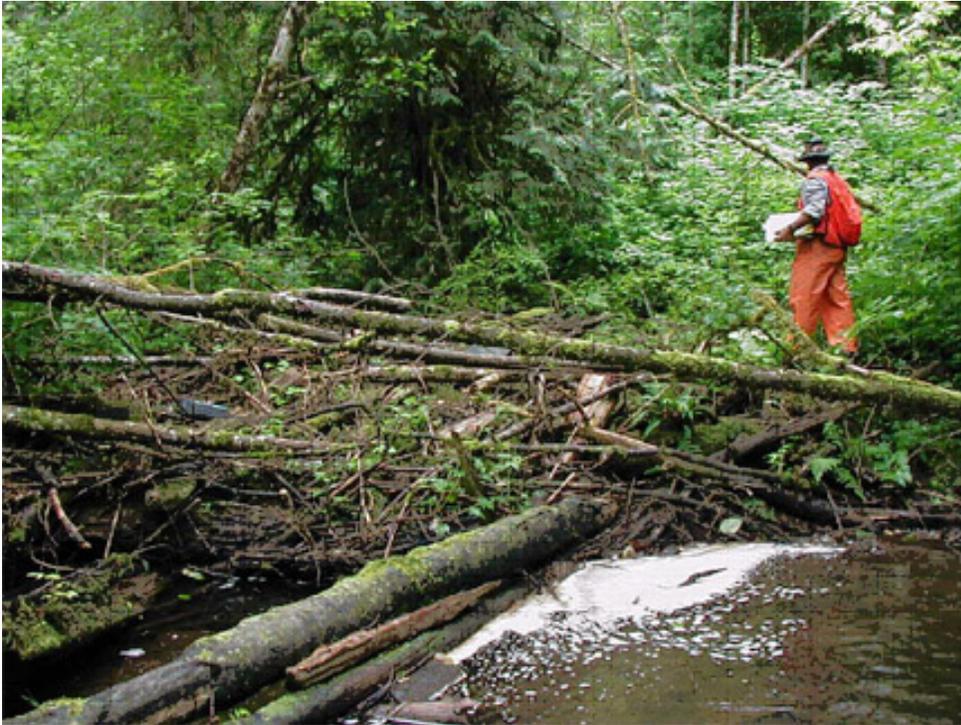
Photo HA3. Harris Creek. RM 2.5

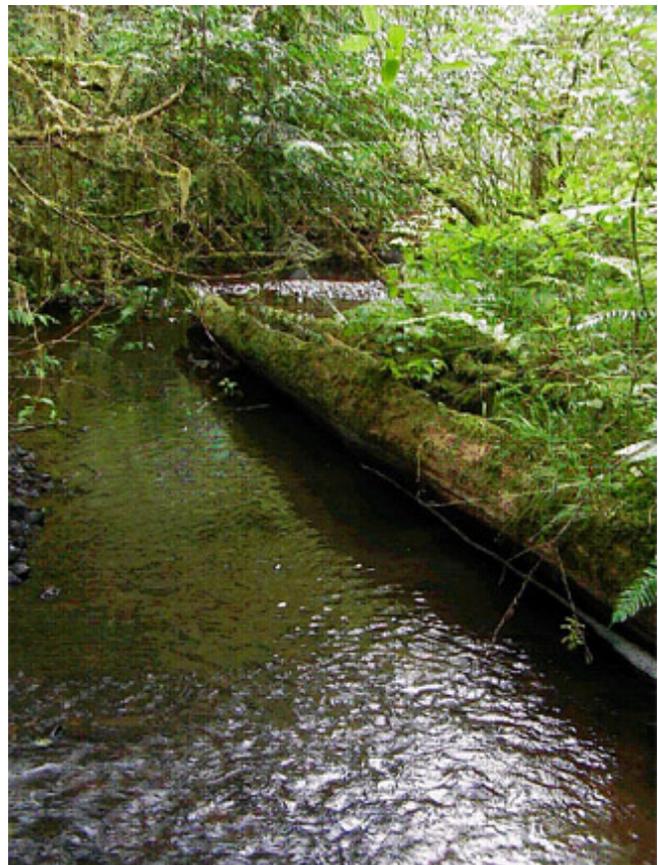
Photo HA4. Harris Creek. RM 2.6

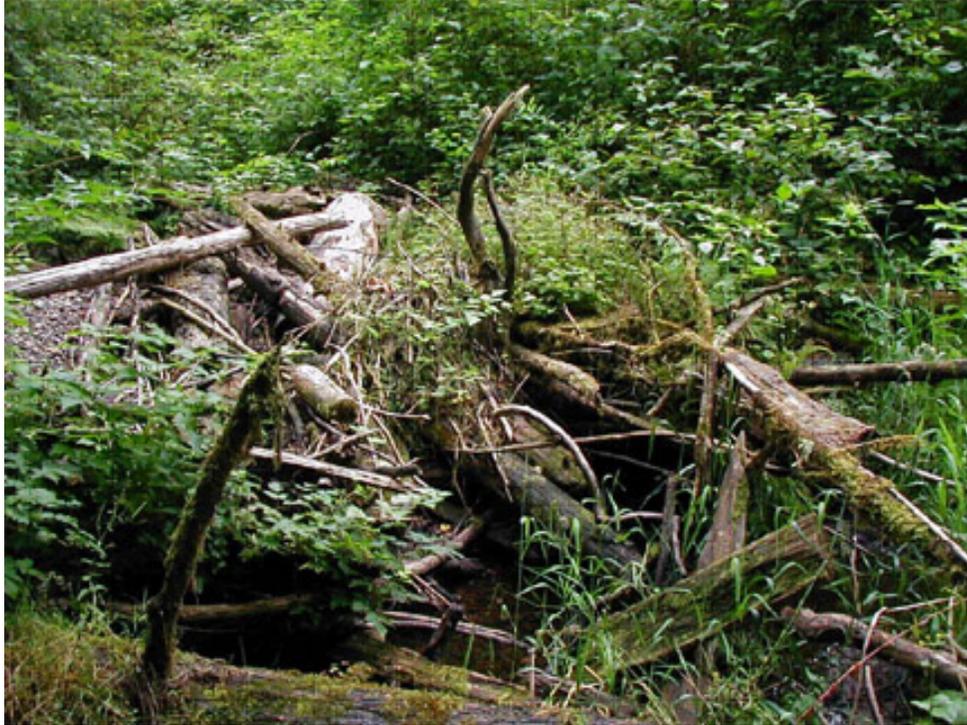
An old, failed bridge at RM 2.6 had backed up a sizeable logjam (Photo HA5). Another logjam was only a few feet upstream of it. Between RM 2.6 and 2.8, the stream was pristine-looking with a healthy riparian canopy. Caddisflies and mayflies were present. These species of macroinvertebrates are associated with good water quality.

Photo HA5. Harris Creek. LWD jam at RM 2.6

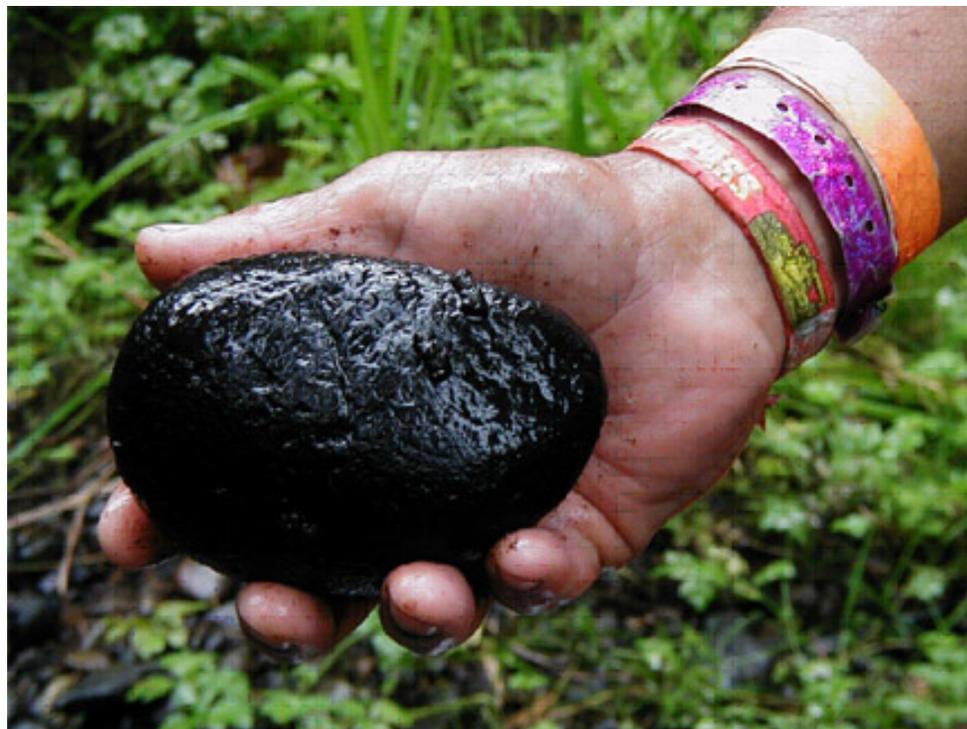
The first house on Harris Creek appeared on the RB at RM 2.9. Exposed clay hardpan was observed on the LB at this location. Freshwater mussels were found at RM 3.0 (Photo HA6), with gravel and pebble substrate. Caddisflies and mayflies were not observed at this location.

Photo HA6. Freshwater mussel

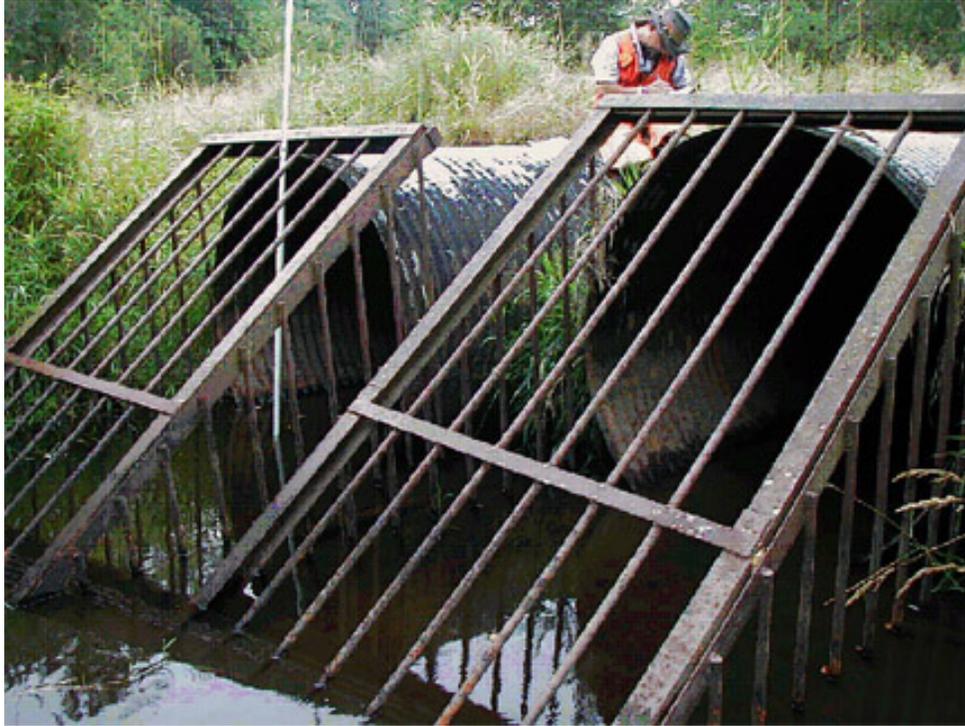
A LB tributary at RM 4.3 was dry. NE Kelly Road crosses Harris Creek at the downstream end of the wetland over two large, grated culverts (Photo HA7).

Photo HA7. NE Kelly Road crossing at RM 4.6

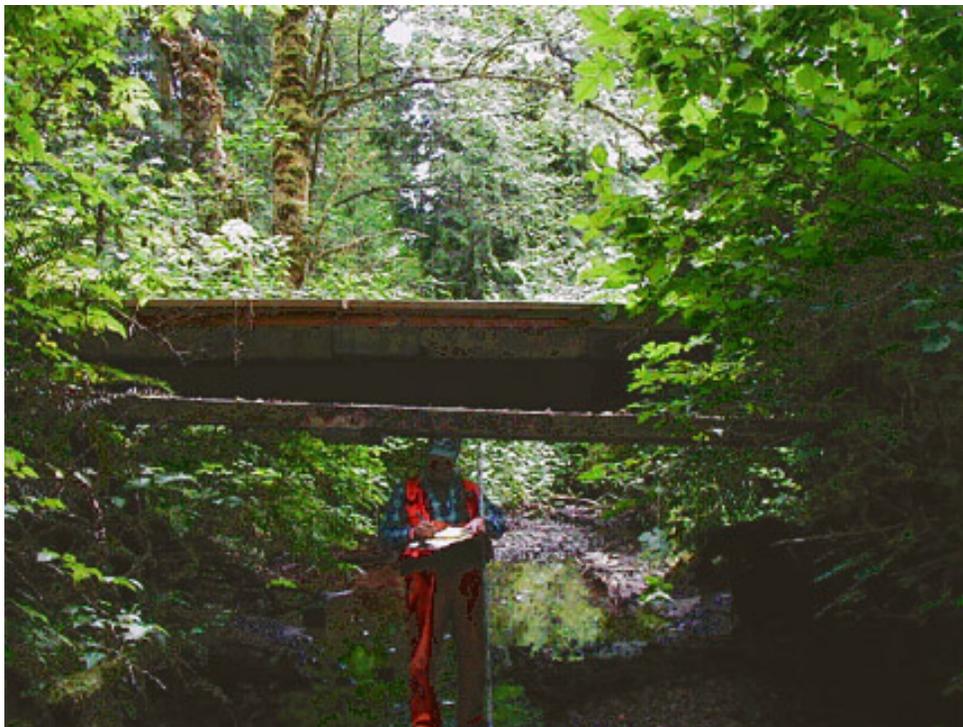
There were not many homes along Harris Creek through this reach, but there were frequent road crossings. NE Stossel Creek Way crosses Harris Creek via culverts at RMs 5.6, 5.9, 6.0, 6.1, and 6.6. The stream also flowed through culverts and under bridges at several small streets and driveways (Photos HA8–11).

Photo HA8. Driveway over Harris Creek at RM 5.7.

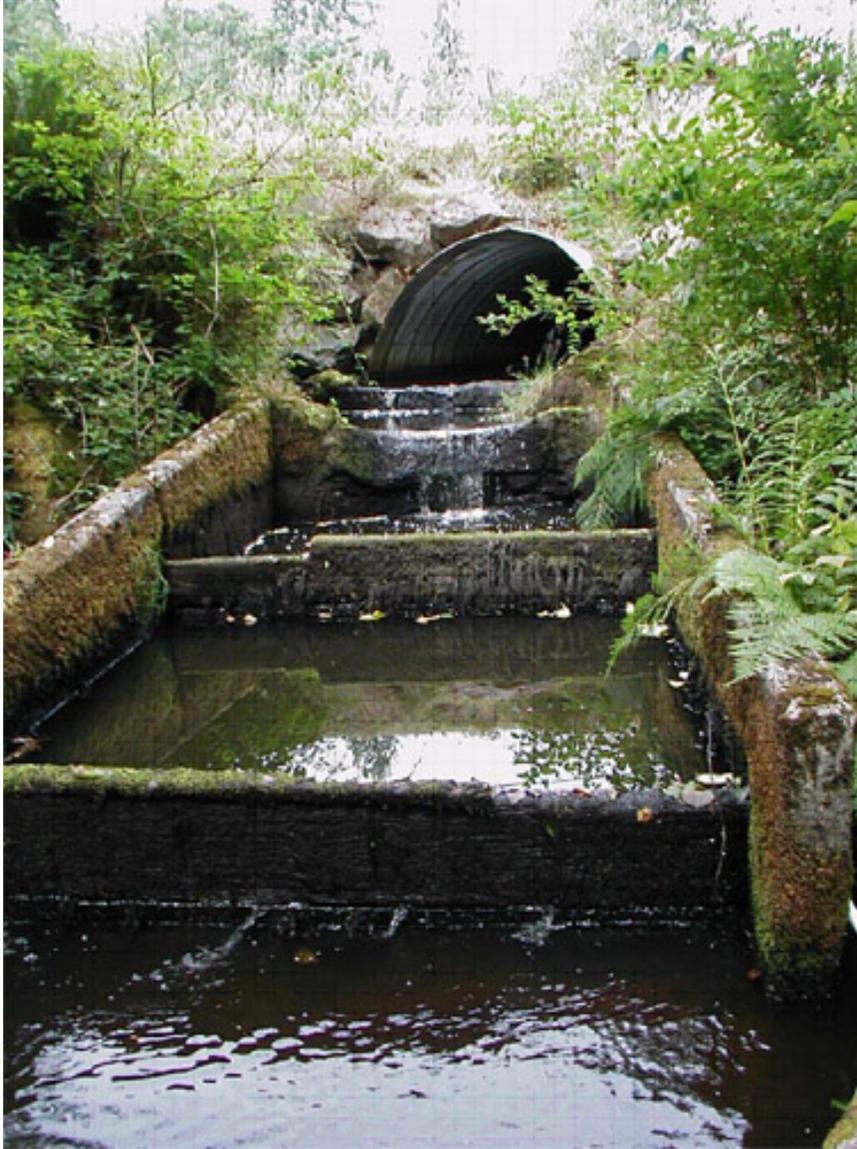
The streambed morphology was riffle/glide between RM 4.6 and 5.1. At RM 5.2, Harris Creek flowed through a culvert that had a fish ladder built into the downstream end (Photo HA13). Above the culvert, between RM 5.2–5.6, the stream was low gradient and the canopy was offset from the stream, indicating that Harris Creek flowed through a broad wetland here. Reed canary grass covered both banks, and alder trees lined the valley. The substrate was silts, and the streambed morphology varied from riffle/glide to low gradient glide with deep, murky water. Another culvert at the NE Stossel Creek Road crossing at RM 5.6 had a fish ladder built into the downstream end.

Photo HA13. Fish ladder at RM 5.2.

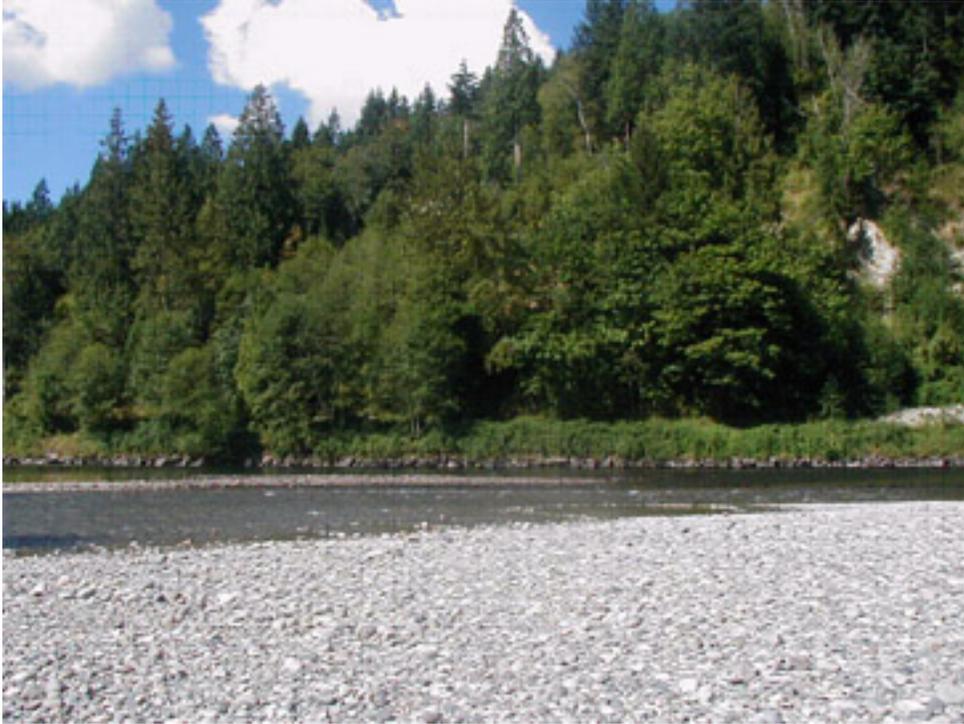
The Tolt River (Map 5) is the largest tributary to the Snoqualmie River, entering the mainstem Snoqualmie at Snoqualmie RM 24.1 (Photo Tolt1). The North and South Forks of the Tolt River are similar in size and meet at Tolt RM 8.2. Seattle Public Utilities operates a water supply dam on the South Fork Tolt River, which alters the hydrology downstream. Aside from RM 0.0–2.0, the Tolt River drains forested lands and has mostly healthy riparian and healthy instream habitat.

Photo Tolt1. Confluence of Tolt River (foreground) and Snoqualmie River (back left)

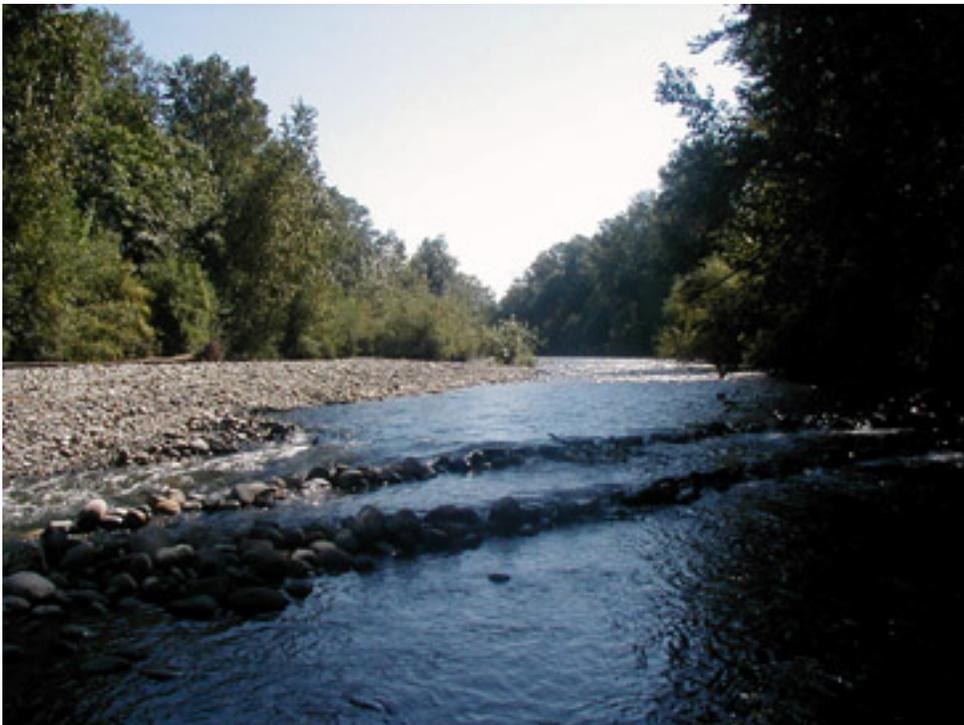
In this lowest reach, the Tolt River was confined between containment levees that protect the City of Carnation; consequently, gravel movement to the Snoqualmie River is disrupted. The substrate in the Tolt River is unsorted gravels embedded with fines. Tall gravel bars have built up within the levees, often confining the river to narrow and fast channels. The channel morphology is mainly riffle/glide with very little available habitat for juvenile fish (Photo Tolt2).

Photo Tolt2. Narrow channel between containment levees, RM 0.2

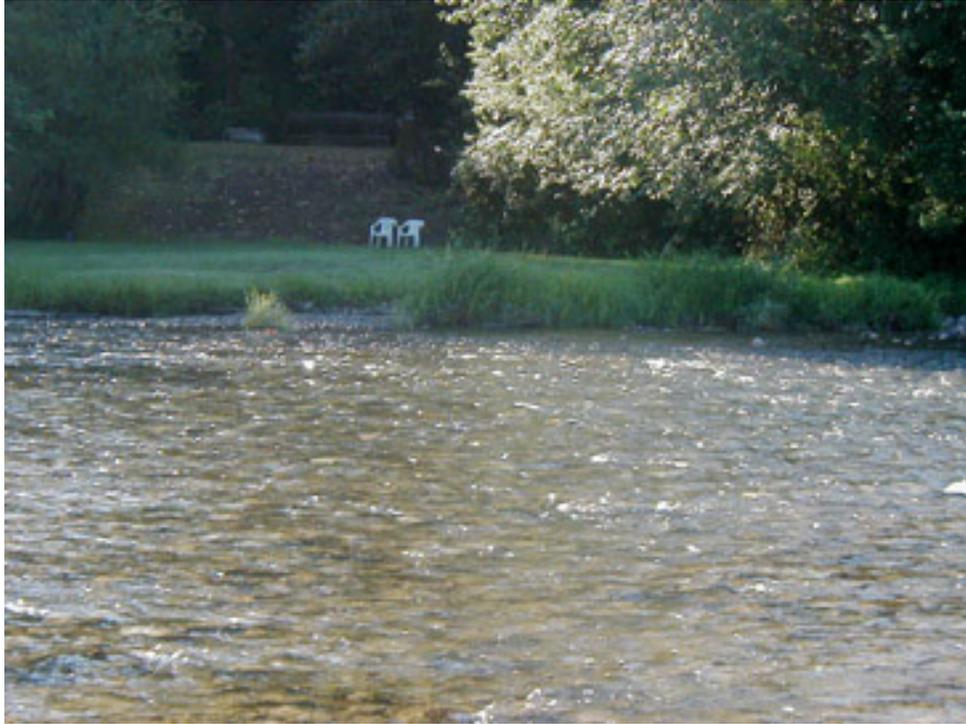
There was consistent but infrequent and well-spaced residential land development on the LB of the Tolt River in this reach. Where houses were present, there was bank hardening and an absence of trees and shrubs (Photo Tolt3).

Photo Tolt3. Residential property with cleared riparian vegetation.

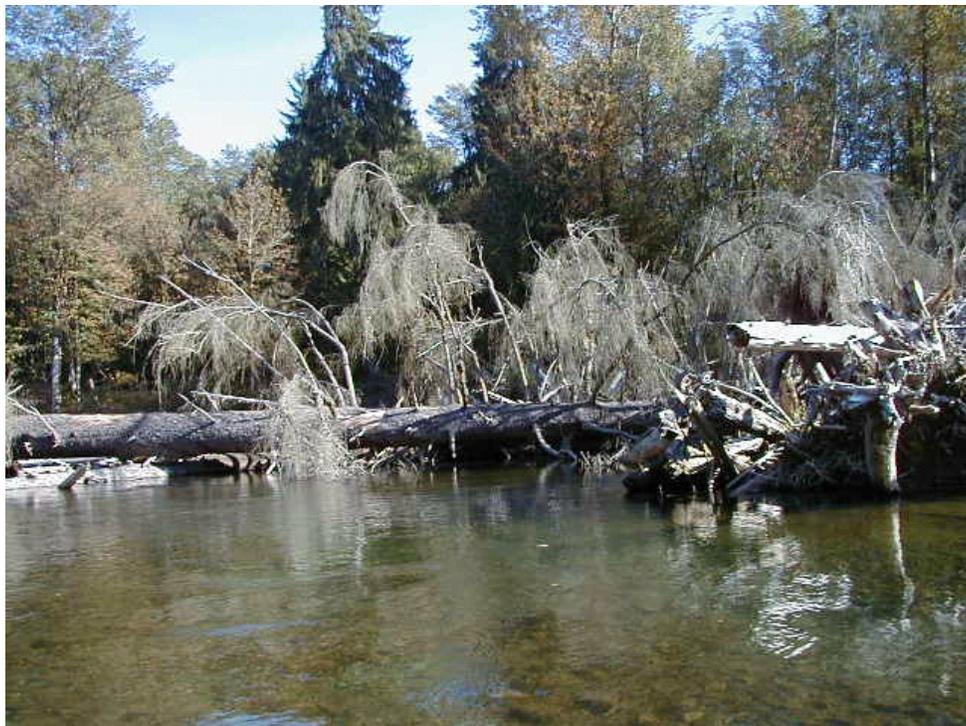
The channel substrate was cobble and gravel with localized reaches of cobble and boulder. Fines embedded the gravels throughout the reach. LWD was prevalent, and there were a few logjams with some excellent salmon habitat (Photo Tolt4).

Photo Tolt4. LWD scoured pool at RM 3.2.

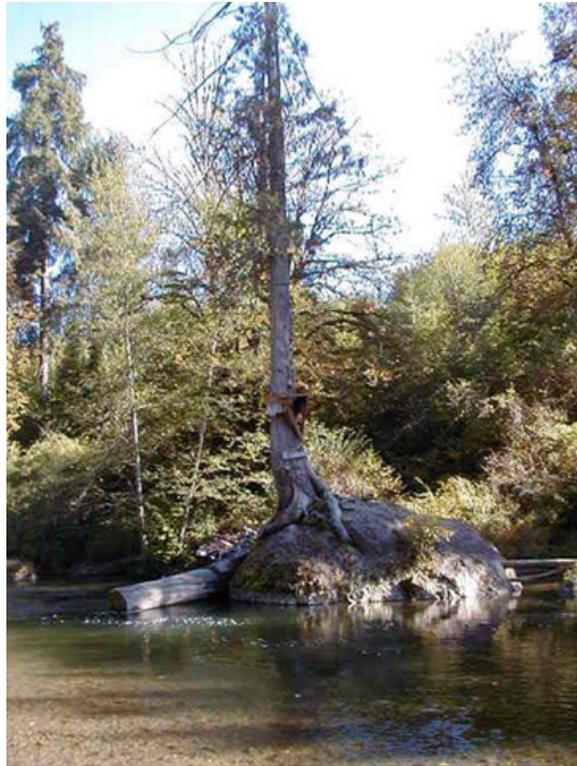
Photo Tolt5. Pool scoured by boulder at RM 4.0

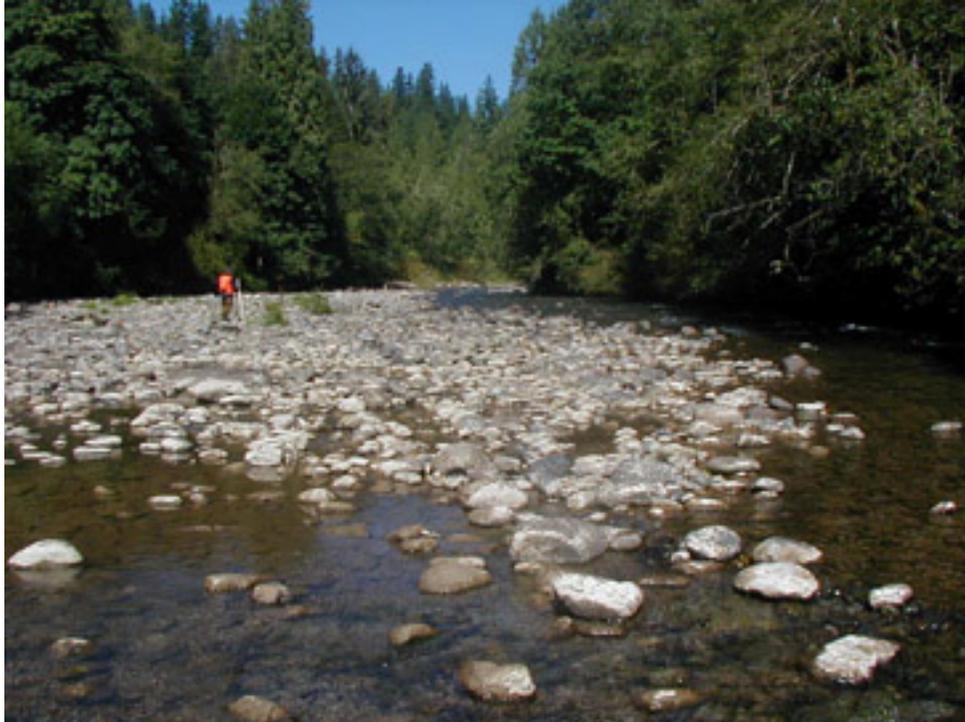
The riparian trees were mature and dense in this reach, but the river was so wide that the trees did not form a complete canopy (Photo Tolt6). The trees were cottonwood, big leaf maple, and conifers. The shrubs were dense and primarily native species, although budlea continued to occur throughout this reach.

Photo Tolt6. Riparian vegetation, RM 6.9

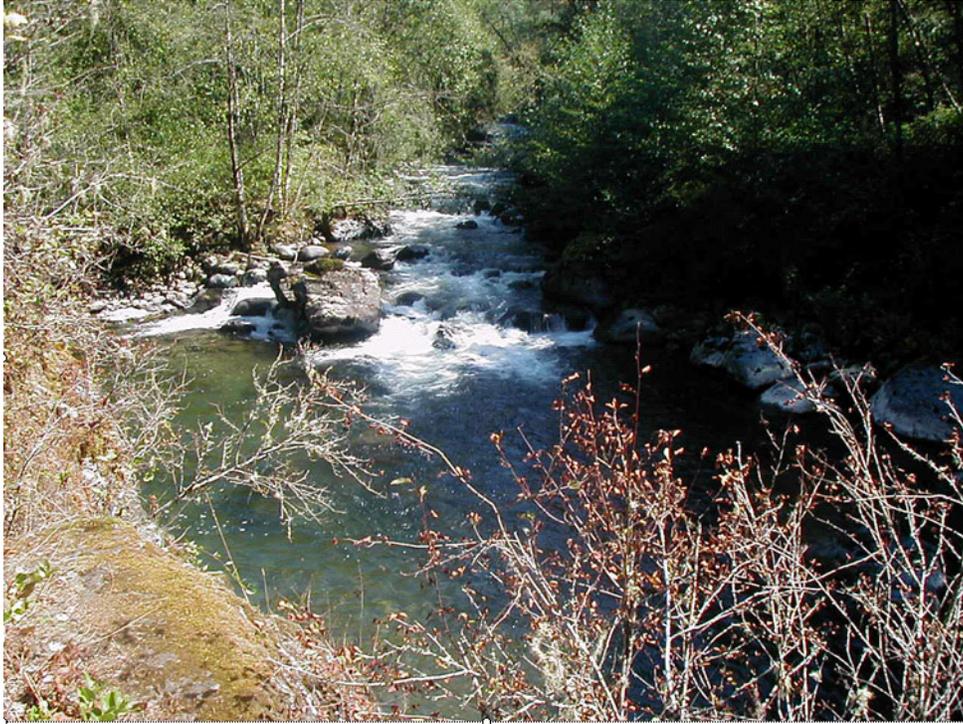
The channel morphology was 2 to 5% gradient riffle at RM 7.5, and then increased to 10% gradient with a step-pool morphology (Photo Tolt7). At RM 7.6, the banks steepened, confining the river in a canyon

Photo Tol7. High gradient channel at RM 7.5.

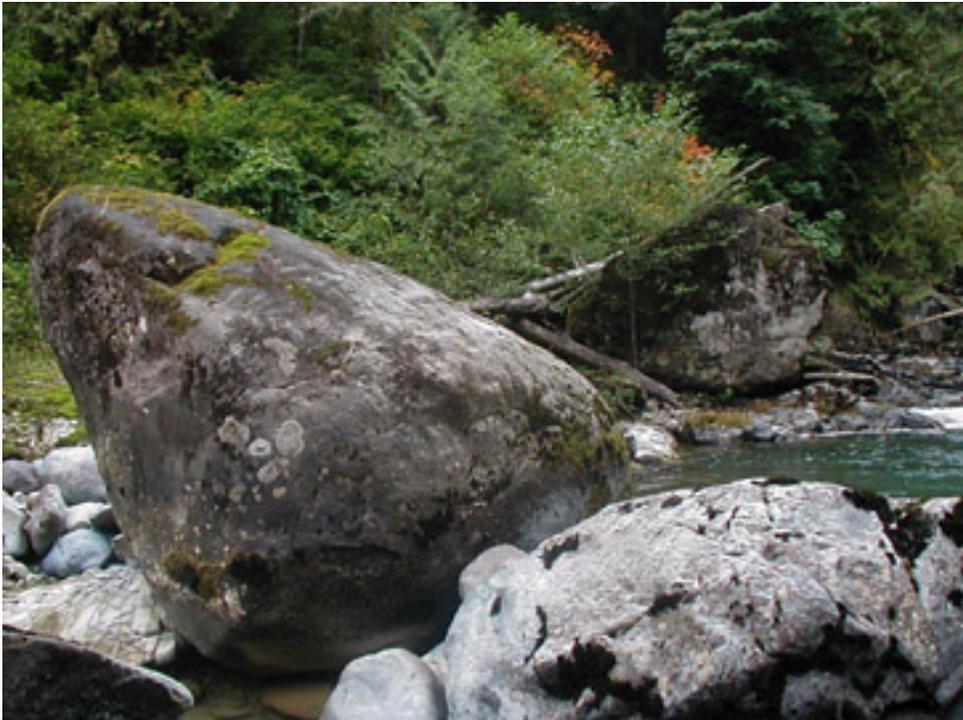
for the remainder of the reach. At RM 7.9, the combination of rocky banks and swift, deep water made it impossible to continue walking upstream (Photo Tolt8).

Photo Tol8. Step-pool channel with boulder substrate, RM 7.7.
