STOSSEL CREEK (RM 0–5.0), JULY 24, 30–31, AUGUST 28, AND SEPTEMBER 11, 2002

LANGLOIS CREEK (RM 0.0–2.2), AUGUST 12, 2002

GRIFFIN CREEK (RM 0.0–3.0), JULY 10 AND SEPTEMBER 23–24, 2002

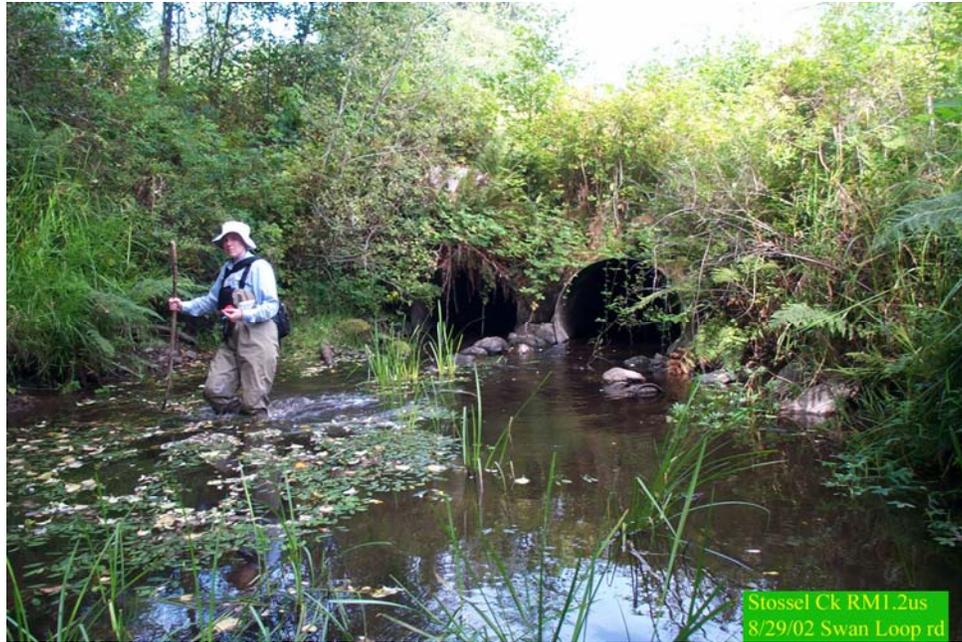
Photo ST3. Swan Lake Road crossing, RM 1.2.

The Swan Loop Road crossing had two culverts across the Stossel Creek valley. The larger of the two was gated and resembled the snow plow on a train. Freshwater sponges were observed below these culverts. The valley upstream of the Swan Loop Road crossing was characterized as a “sea of spirea” turning into a “sea of cattails.” The LB riparian vegetation along the edge of this valley was excellent with dense 40- to 50-year-old conifers, and alder, big leaf maple and willow. The RB riparian vegetation was sparse, but mature.

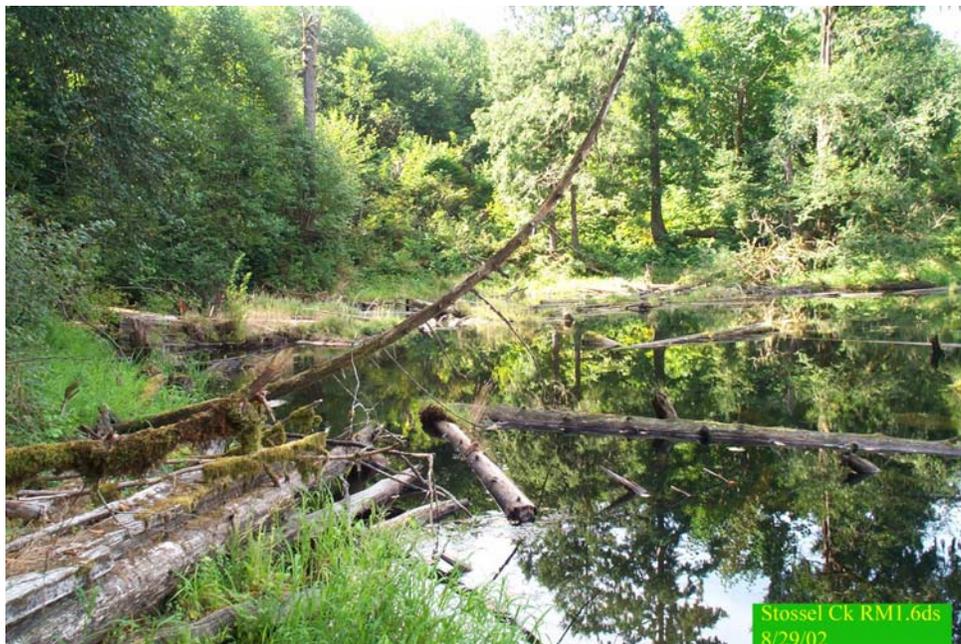
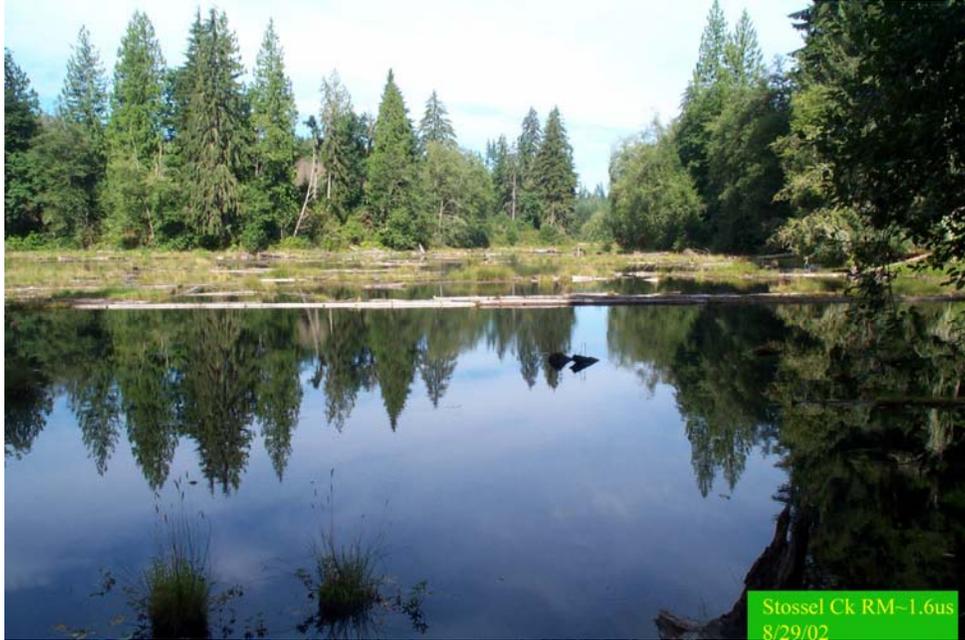
A large lake between RM 1.5 and 1.8 had been dammed by an abandoned logging road that stretches north-south along the base of the lake (Photos ST4-5). The current outlet of the lake was located in a bedrock outcrop on the RB side of the valley. An enormous logjam was built up at the outlet of the lake. Mussels, crawfish, and green freshwater sponges were observed near the outlet. The lake appeared to be very productive with ducks, jumping fish (unidentified species), and many midges, dragonflies and damselflies. There was a lot of wood in the lake, including submerged old growth stumps. All of the wood was debris from logging operations, and appeared to be very old.

Photo ST4. Lake at RM 1.6, looking downstream.

Photo ST5. Lake at RM 1.6, looking upstream.

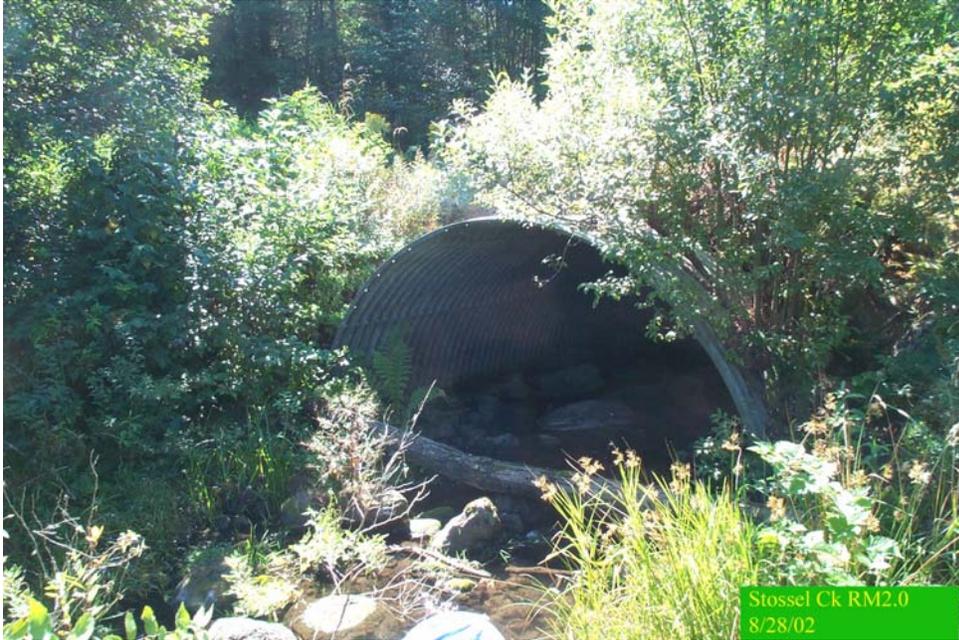
Photo ST7. Culvert at RM 2.0

This was a steep wooded reach below a culvert and road crossing at RM 2.0 (Photo ST7). Mussels were present here, but were less abundant than in the reach from RM 2.5–3 (see description below). For 100 feet below the road crossing, the stream tumbled down a boulder cascade overgrown with salmonberry, willow, Pacific ninebark, and dogwood. Below the cascade, the riparian shrubs were cascara, fern, nettle, Pacific ninebark, and rush. Wetted width was 8–12 feet.

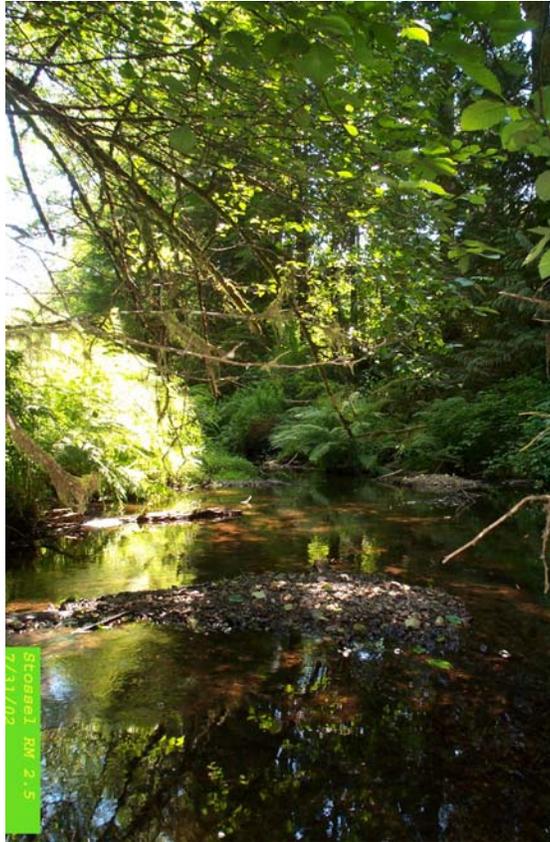
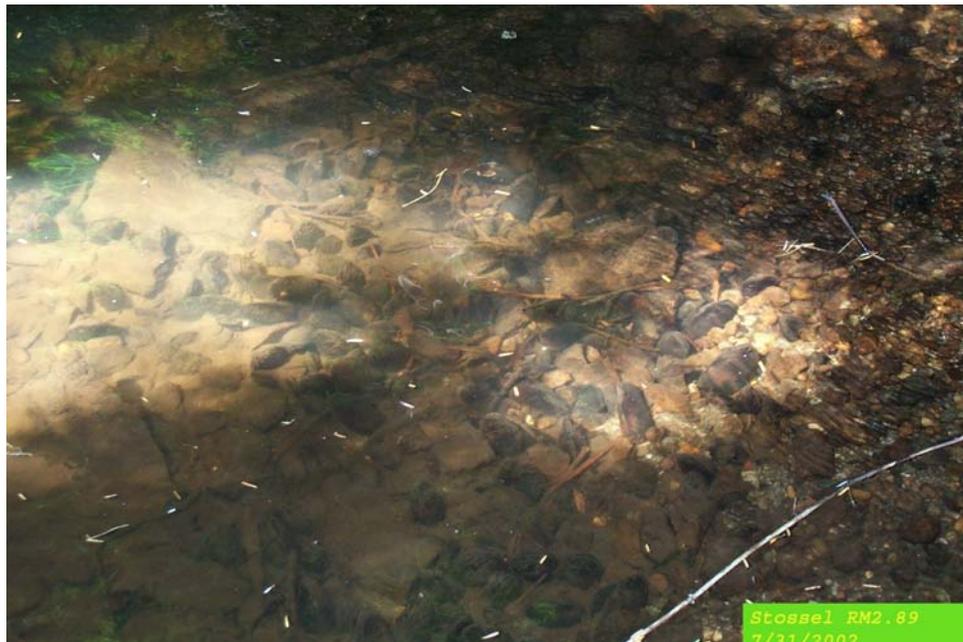
This is a non-wetland, wooded reach of Stossel Creek that was described as a “mussel hot bed” because there was a ubiquitous and dense population of mussels (Photos ST9–10). Some of the mussels were located in riffles.

Photo ST9. Wooded reach with dense freshwater mussels

Photo ST10. Freshwater mussels

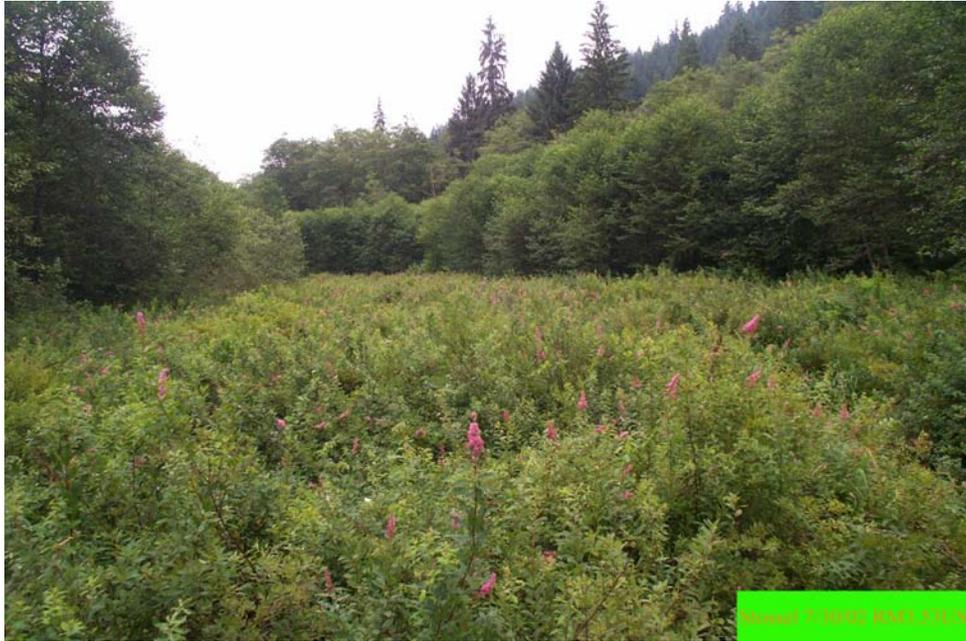
In this reach, Stossel Creek flowed through a narrow wetland valley with standing water. The valley was 200–500 feet wide with dense growth of spirea (Photo ST11). Localized swampy regions had skunk cabbage, fern, and rush (Photo ST12). The riparian vegetation on both banks was sparse but mature. Several valley-spanning beaver dams had created large pools. Coho and trout were observed in these pools. One blown-out beaver dam had bear tracks that appeared to belong to an adult and a juvenile (Photo ST13), and other tracks that may have belonged to a cougar.

Photo ST11. Wetland valley with Spirea

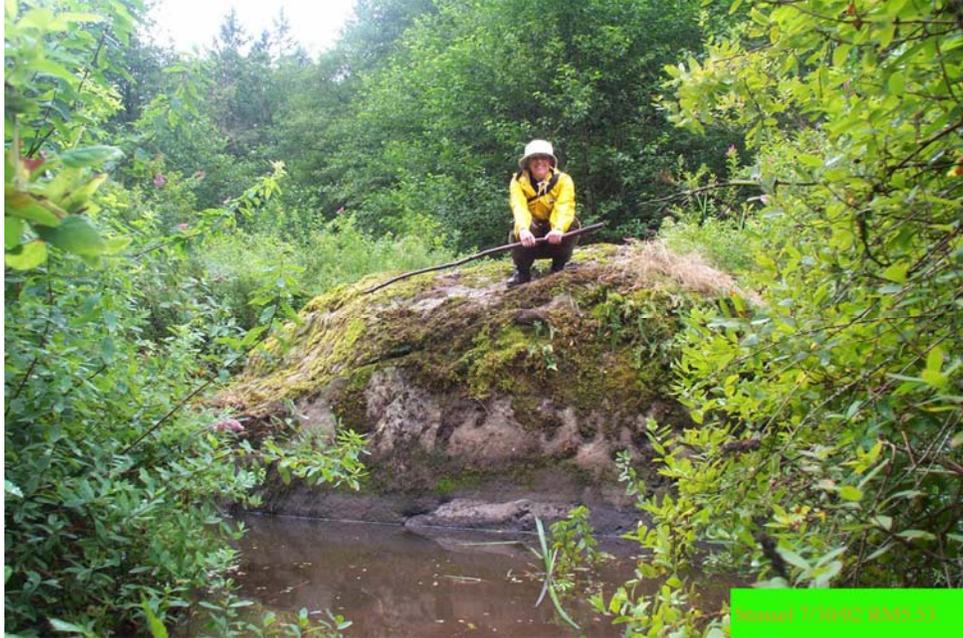
A huge rock in the creek at RM 3.5 might be a glacial erratic (Photo ST14). The stream wrapped around it and was not very deep, indicating that the stream had little scour power at this location. Otter scat on top of the rock was composed almost entirely of crawfish shells.

Photo ST14. Boulder in channel, RM 3.5

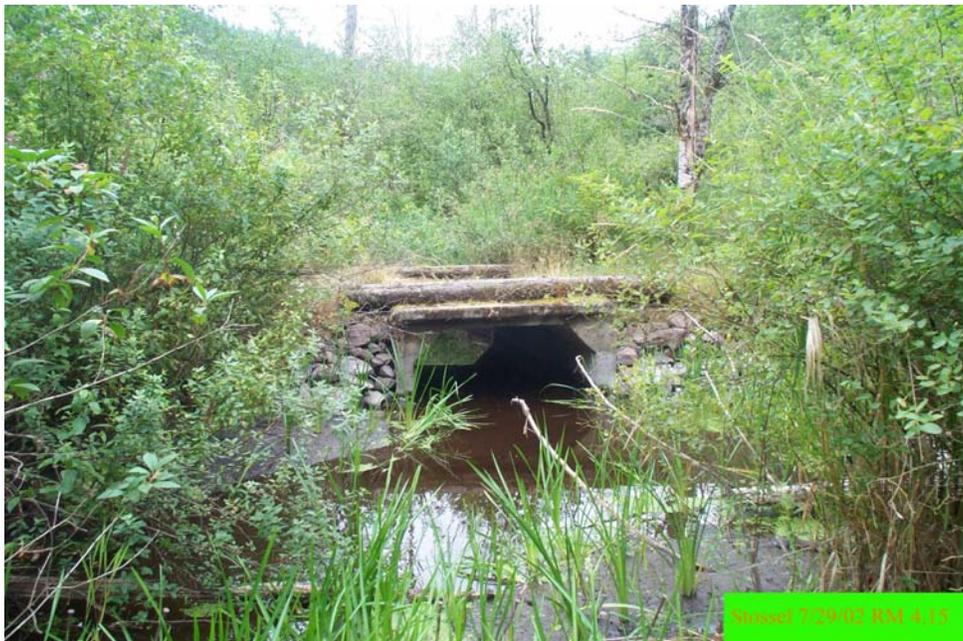
Photo ST15. Road crossing at RM 4.4

This was a densely wooded area with a gradient of 1–3%. Otter scat and deer tracks were observed throughout this reach, and coho were observed near the road crossing at RM 4.4 (Photo ST15). Riparian trees were dense and mature. The shrubs were all native, with only a few patches of reed canary grass and nightshade near the road crossing. The dominant shrubs were salmonberry, twinberry, devils club, and salal. Mussels were not observed in this wooded area.

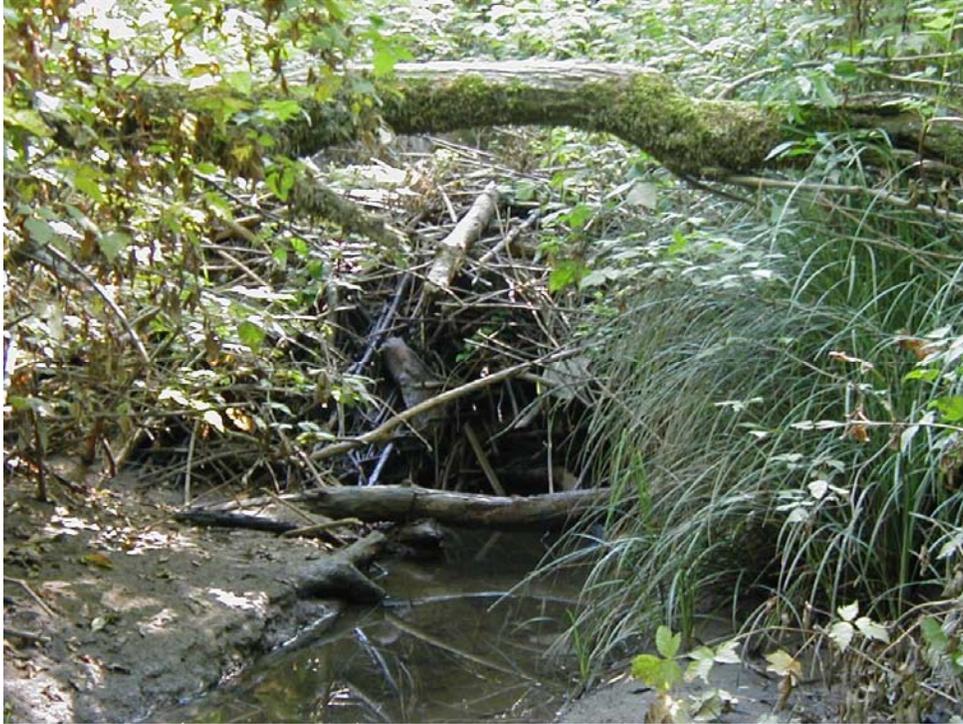
A beaver dam was photographed at RM 0.1 (Photo LA1), and another collection of debris at RM 0.4 may have been created by beavers as well.

Photo LA1. Beaver dam near mouth of Langlois Creek.

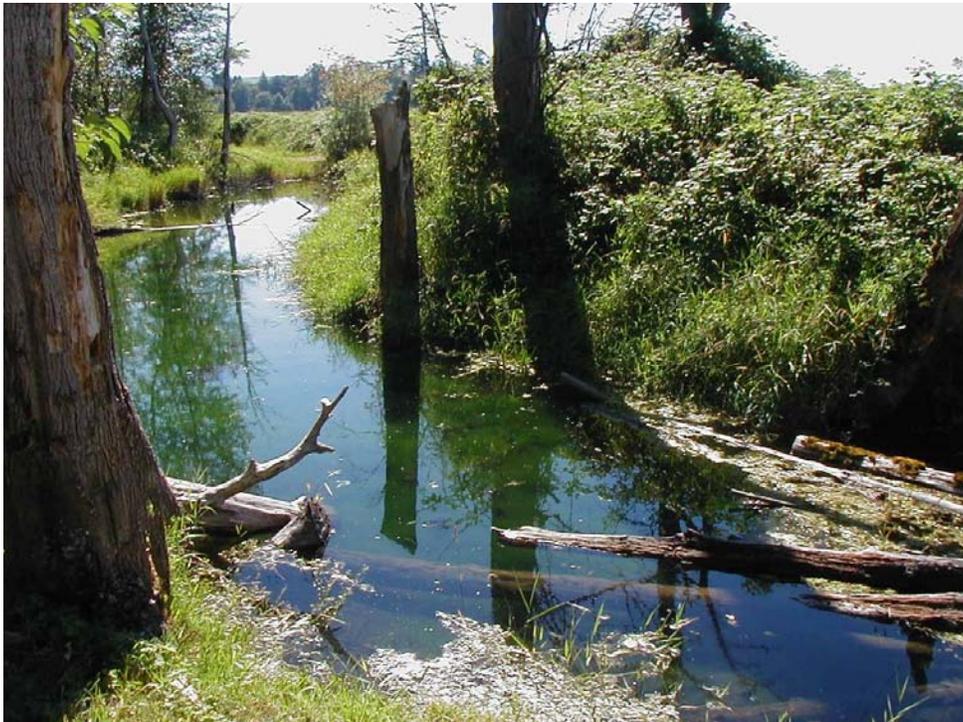
Upstream of the Snoqualmie River riparian zone, the riparian vegetation for Langlois Creek was mostly reed canary grass with very sparse trees. Upstream of SR 203, Langlois Creek entered a broad and deep wetland area that may have been a remnant channel of another river (Photo LA2).

Photo LA2. Wetland area at RM 0.6.

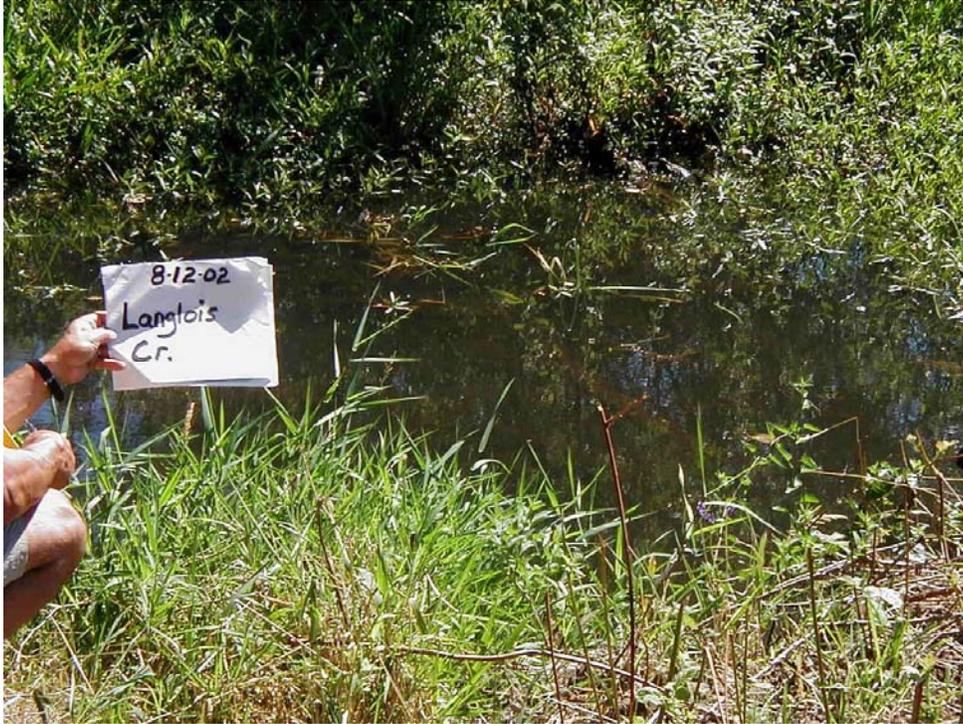
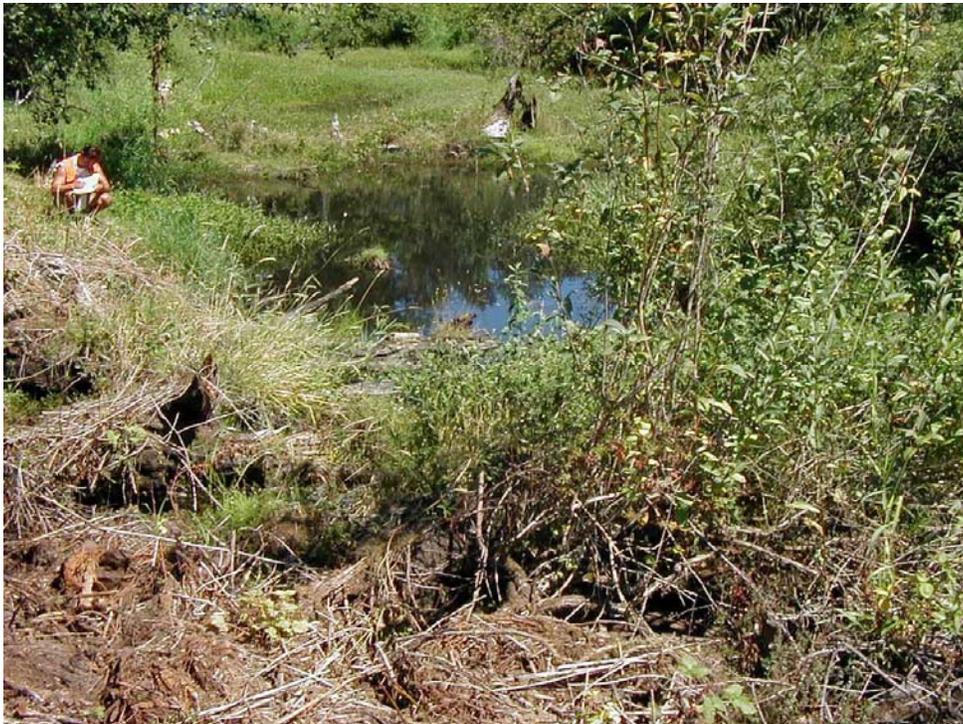
A small road crosses Langlois Creek at RM 0.4; SR 203 crosses at RM 0.6 where the blackberry and reed canary grass are particularly dense. There are two driveway crossings at RM 0.7. At RM 0.9, NE 24th Street crosses Langlois Creek but the culvert was not located. A deep, ponded area (Photo LA3) upstream of this road crossing was filled with threespine stickleback. A broad wetland continued upstream of this pond (Photo LA4).

Photo LA3. Deep section with reed canary grass.

Photo LA4. Wetland area at RM 0.9.

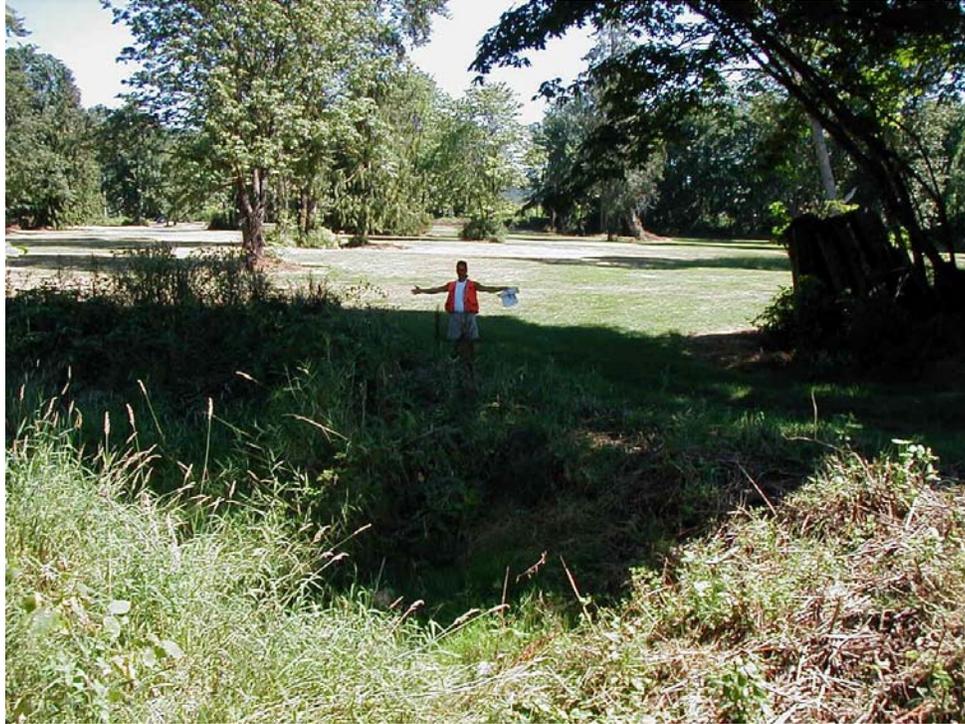
At RM 1.1, Langlois Creek's flow became subsurface and therefore could not be followed any further (Photo LA5). Across this farm field, there was a dry streambed with 20-foot-tall blackberry bushes.

Photo LA5. Where's the creek? RM 1.0

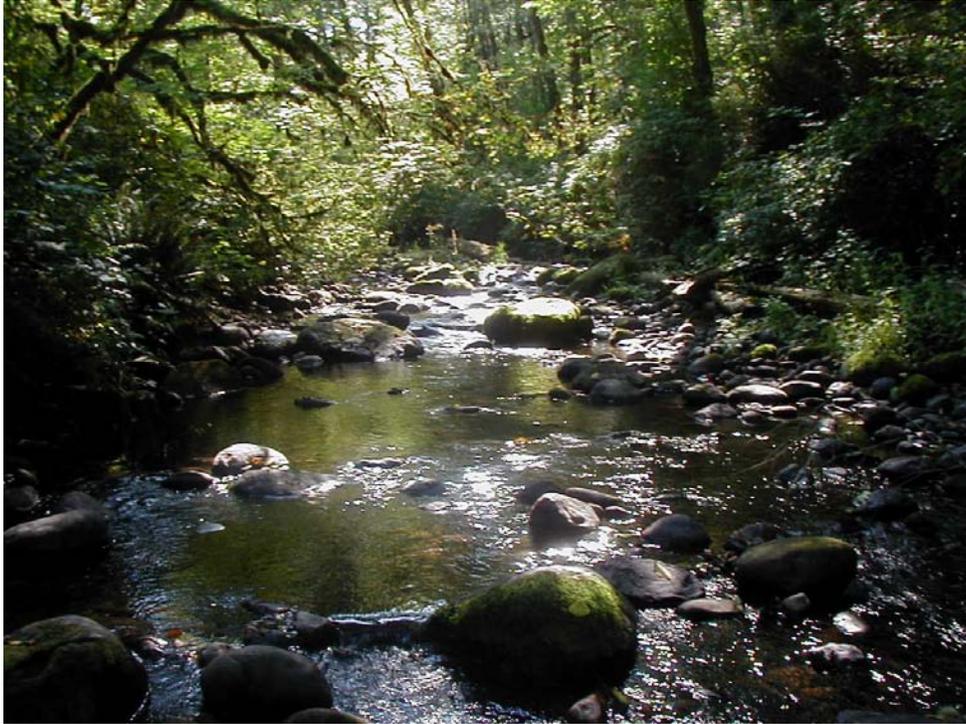
The substrate was gravel and pebble for half of this reach, and gravel and boulder for the other half (Photo GR1) with embedded fine sediments throughout. Additionally, the substrate was covered in algae for most of this reach. The channel morphology was riffle/glide with many pools, some of which were forced by LWD (Photo GR2). It appeared that several LWD placement projects had been implemented in this reach (Photo GR3); the wood in these projects comprised almost all of the LWD that was found

Photo GR1. Wooded reach with boulder substrate, RM 2.2.

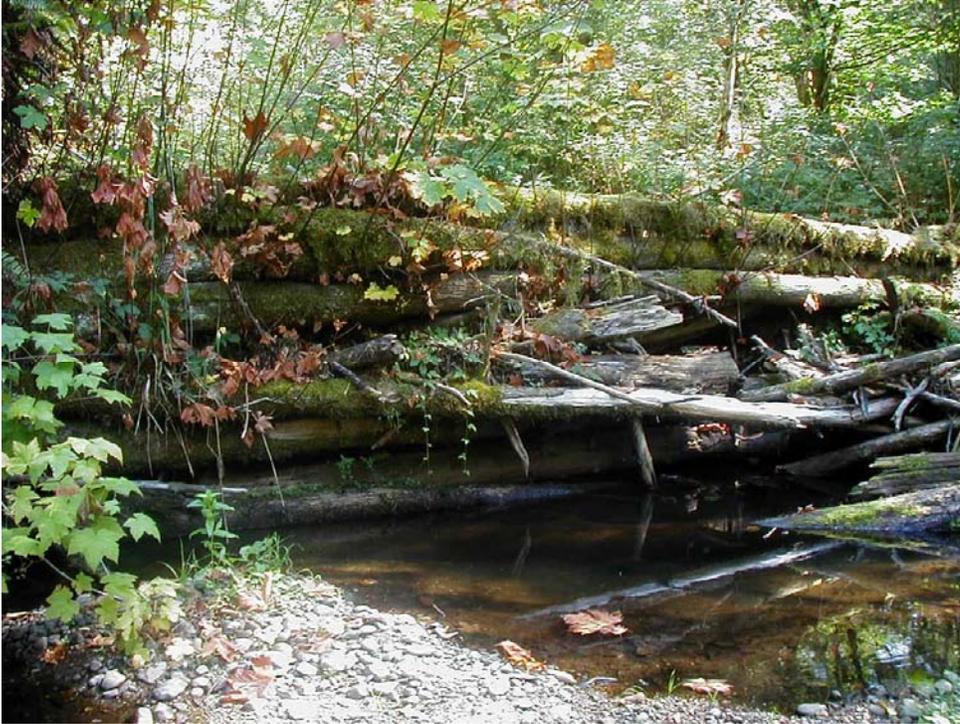
Photo GR3. Engineered LWD jam at RM 2.7.
