# Trilogy and Redmond Ridge Urban Planned Development Final Monitoring Report: Water Years 2008-2010

**King County**

Department of Natural Resources and Parks  
Water and Land Resources Division

April 2011

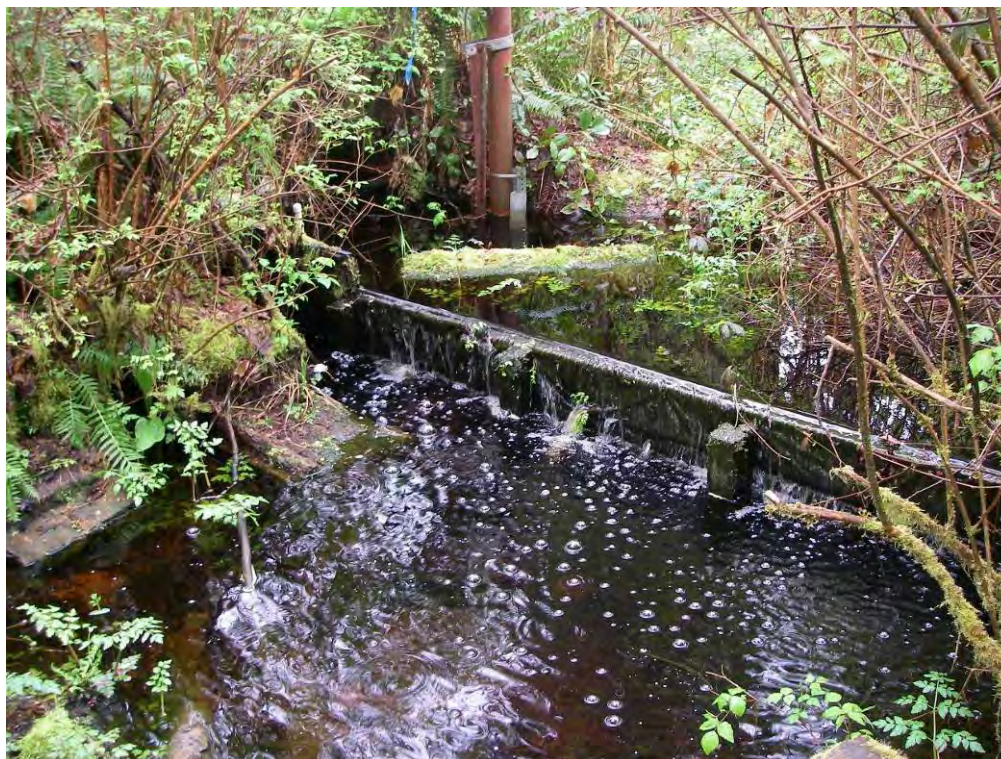
Figure H-2. The south weir.

The south weir, gaging site 18B, separates wetland EC-3 from Evans Creek Central. Water quality samples were collected just downstream of the weir.
