**2010 Monitoring Report
for King County Stormwater
Monitoring Under S8.E of the
NPDES Phase 1 Municipal
Permit WAR04-4501
(Issued February 2007)
Targeted Stormwater
Management Program
Effectiveness Monitoring
Roadside Ditch Water
Quality Treatment**

March 2011

King County

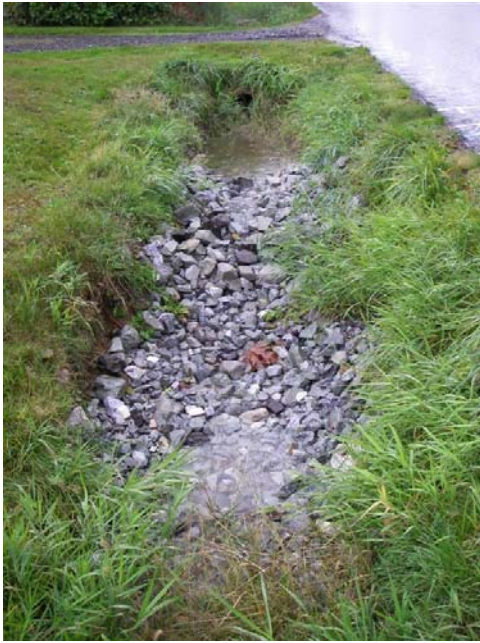
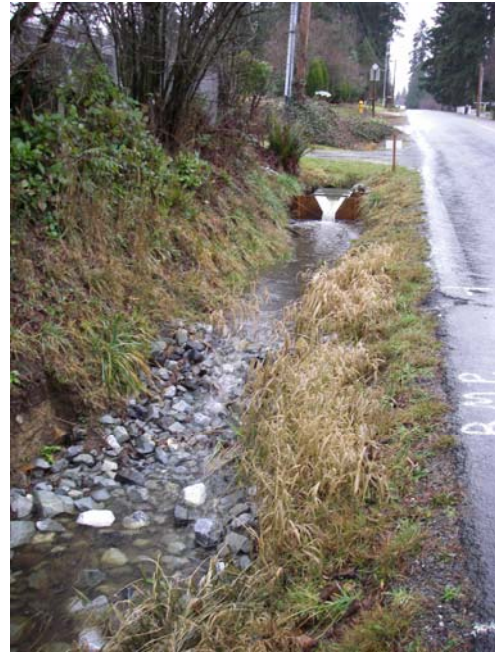
Figure 7. Stormflow Pooling above BMP Structures, 148th Ave SE

These BMP designs function as weirs within the ditch, with the effect of pooling water and taking the scouring energy out of the stormflow. The BMPs are designed to allow stormwater flow-through, so the pooling is temporary. Lower flows are intended to filter through the BMP rock structure and treatment media. Higher flows are intended to overtop the BMPs, and flow into the next downstream pool with less scouring effect, leaving the BMPs intact and preventing scour in the ditch. The monitoring design measures total flow, not velocity. We can demonstrate a delay in flow and changes in total flow from the upstream to downstream monitoring stations, but since the monitoring equipment did not measure velocity directly, this study can not quantify the decrease in energy of the flow. However the pooling effect and lack of fast, scouring water between the BMPs is immediately evident during site visits and is documented in photos.

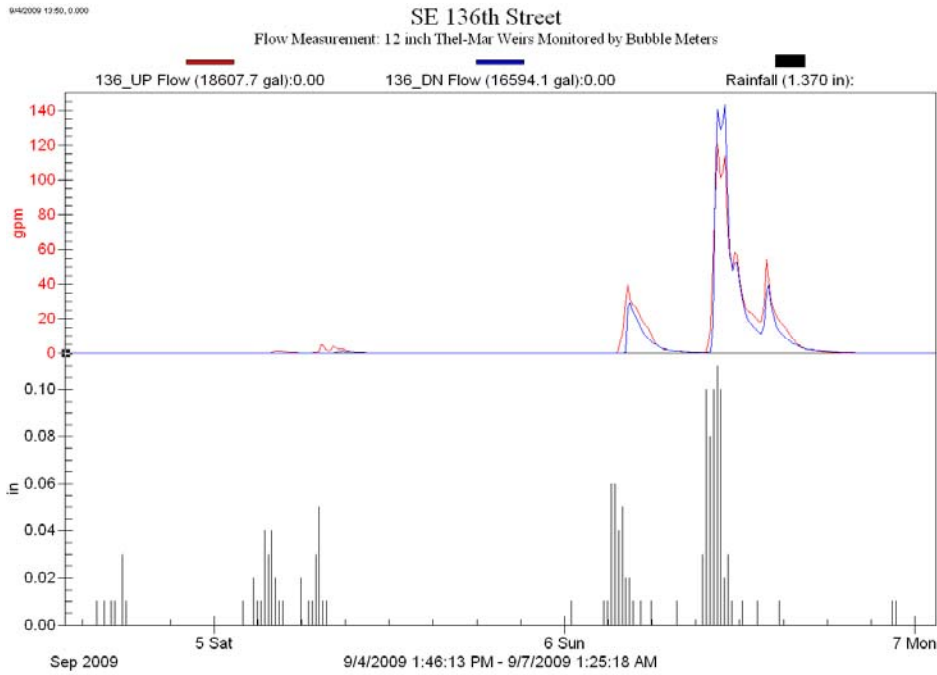
Figure 17 Flow and Rainfall September 5 -7 2009 SE 136th St

Variations in flow modification are presented graphically in Figures 17 to 20 below:
