**DENNY WAY CSO NEARSHORE INTERIM
SEDIMENT CLEANUP PROJECT
CLOSURE REPORT**

**Prepared by the
King County Department of Natural Resources and Parks
Wastewater Treatment Division**

**Prepared by:
Anchor Environmental, L.L.C.**

October 2008

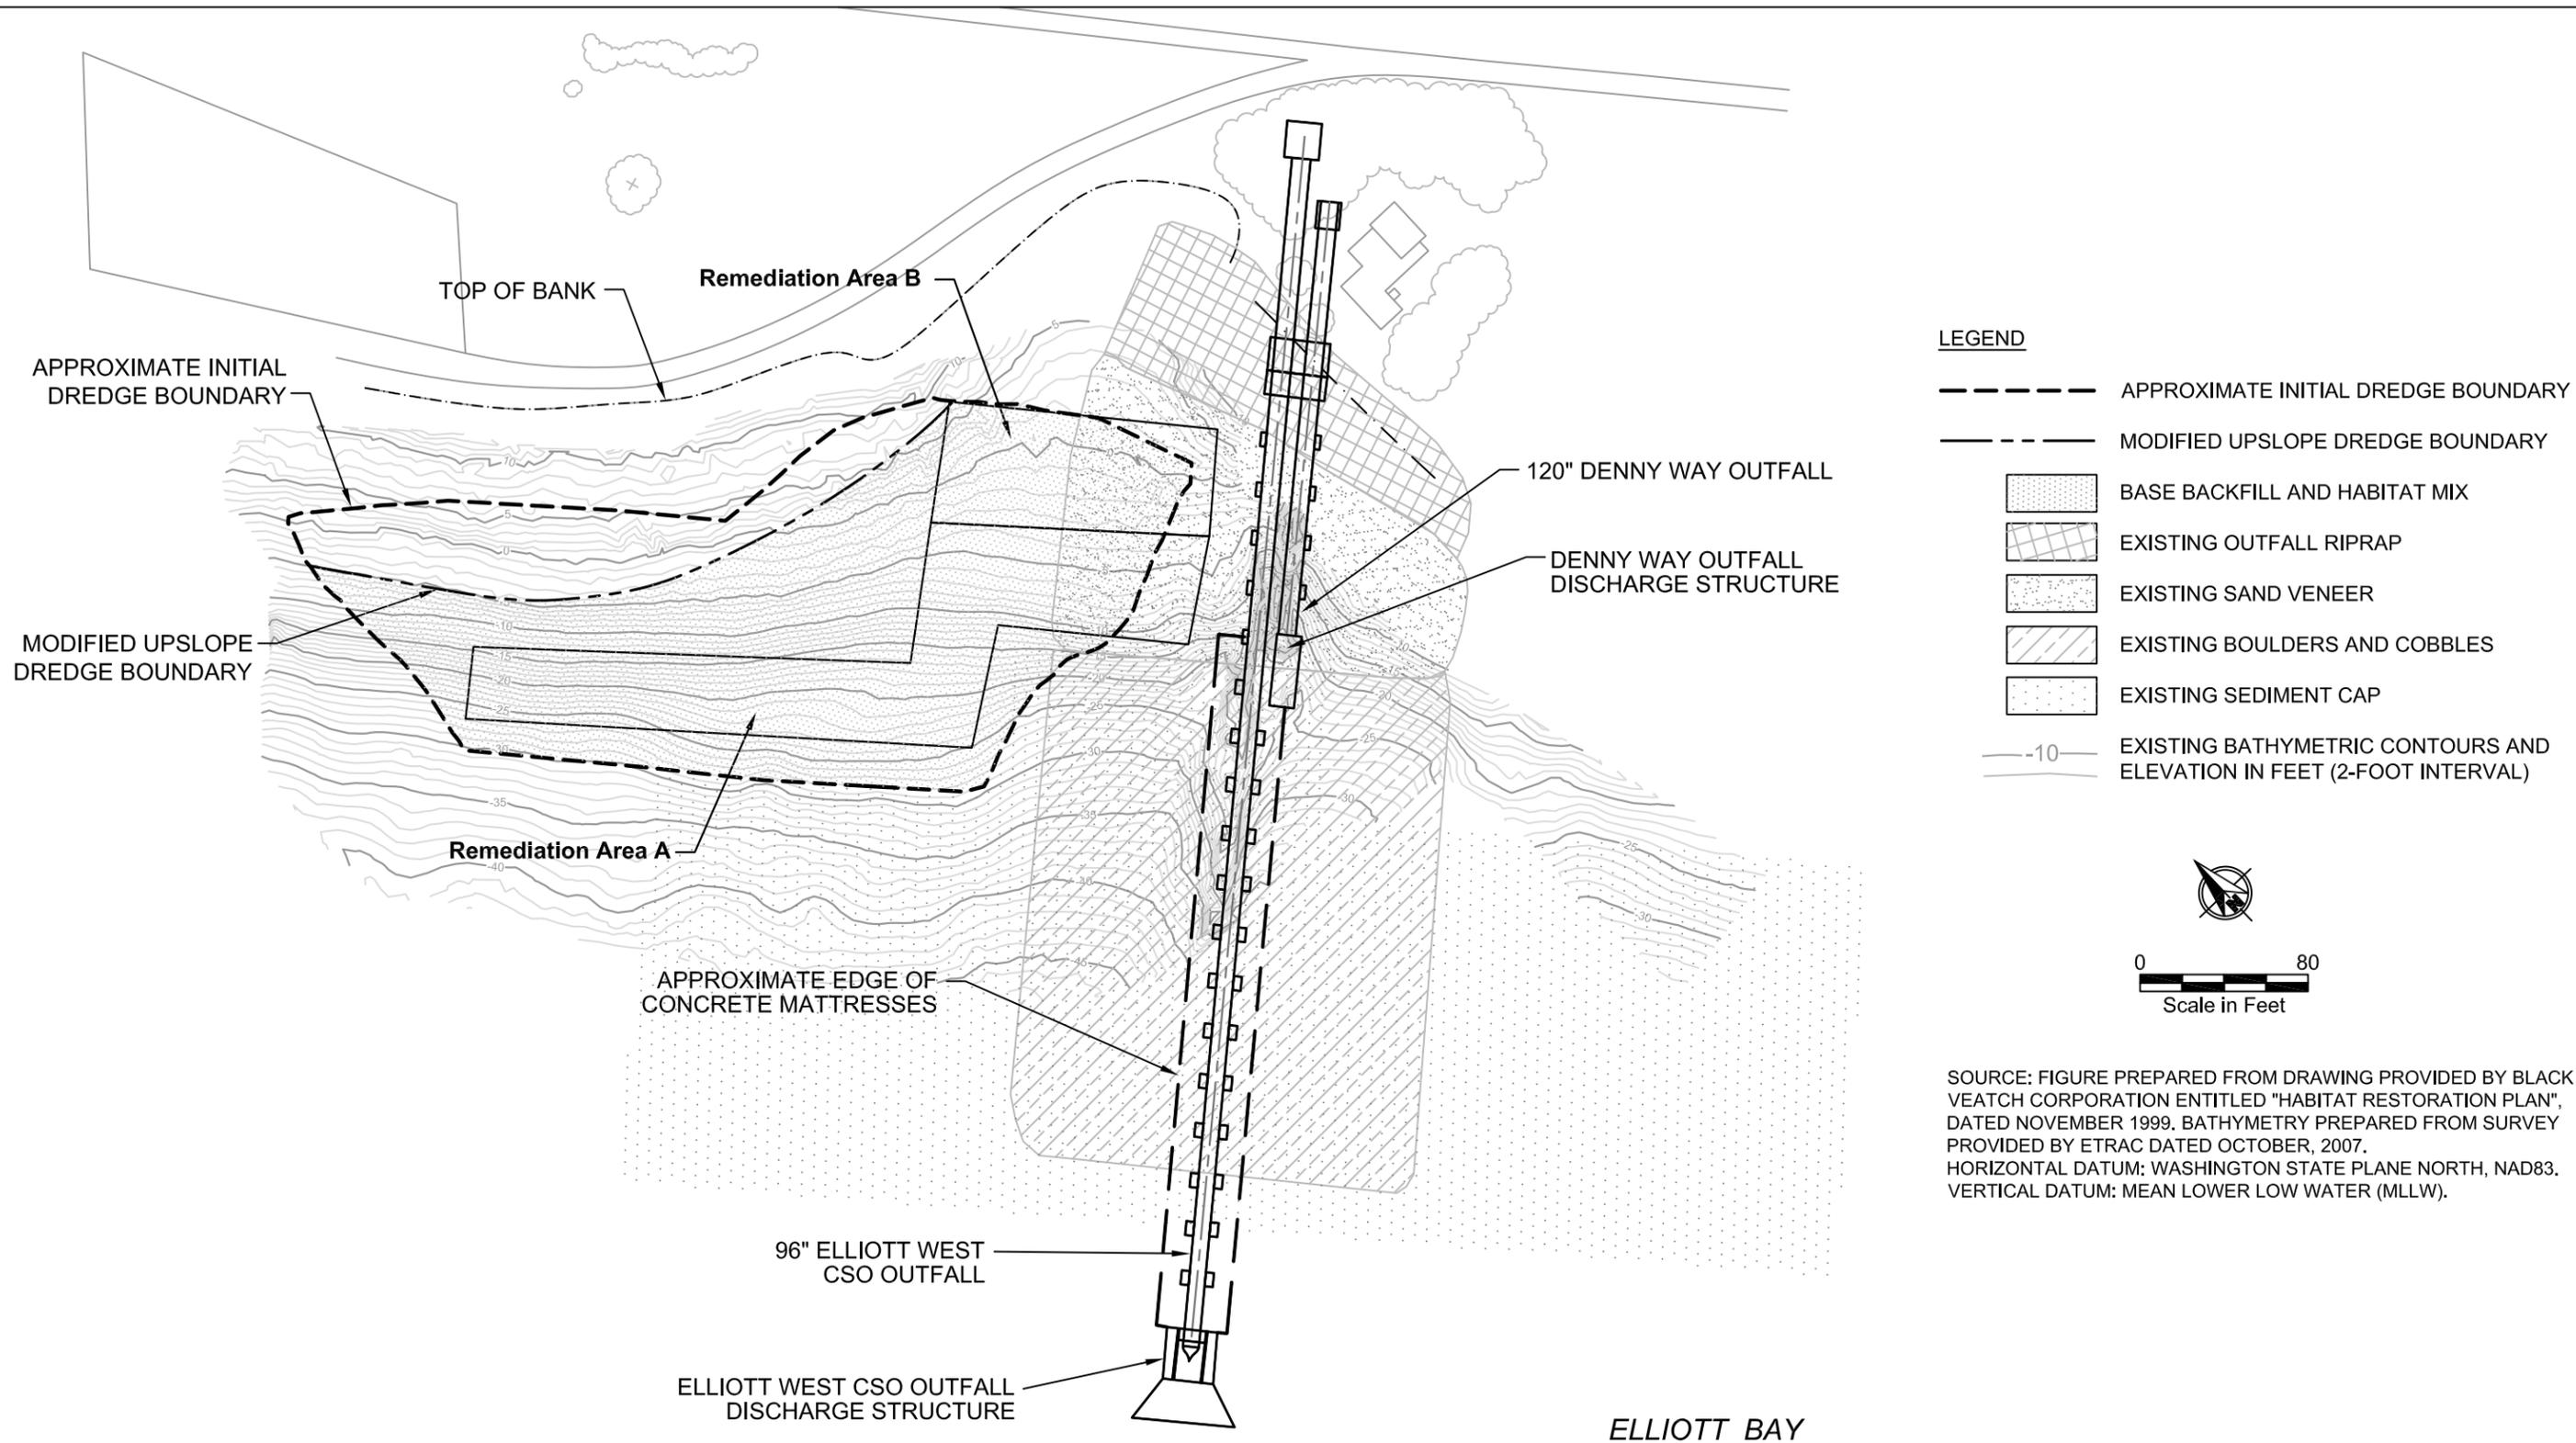
The Denny Way CSO interim action remediated contaminated sediment present in two nearshore areas in the immediate vicinity of the former Denny Way CSO outfall (Areas A and B). A combination of dredging, backfilling, and armoring was employed to remediate the nearshore areas.

The objective of the project was to remediate contaminated sediment in two inshore remediation areas (Areas A and B) in the immediate vicinity of the former Denny Way CSO outfall that exceeded SQS chemical criteria promulgated under the SMS. The two rectangular cleanup areas (Areas A and B) are adjacent to each other and are located immediately offshore of the Denny Way historical CSO as shown in Figure 2. Cleanup Area A is the larger of the two areas at about 0.48 acres, and is located offshore and adjacent to Area B. Cleanup Area B is smaller in size at about 0.16 acres, and is located immediately offshore of the Denny Way historical CSO. Sediments in both cleanup areas had concentrations that exceeded SQS chemical criteria for mercury, silver, cadmium, copper, lead, PCBs, PAHs, bis(2-ethylhexyl)phthalate, and butyl benzyl phthalate. The extent of contaminated sediment removal for the site is shown in Figure 2. As previously discussed, the 1997 sediment characterization study identified contaminants at concentrations above SQS chemical criteria in Areas A and B to a depth of 8 feet below mudline (SEA 1999). More recent characterization (Anchor 2005) indicated that contaminated sediments are present at depths greater than 10 feet.

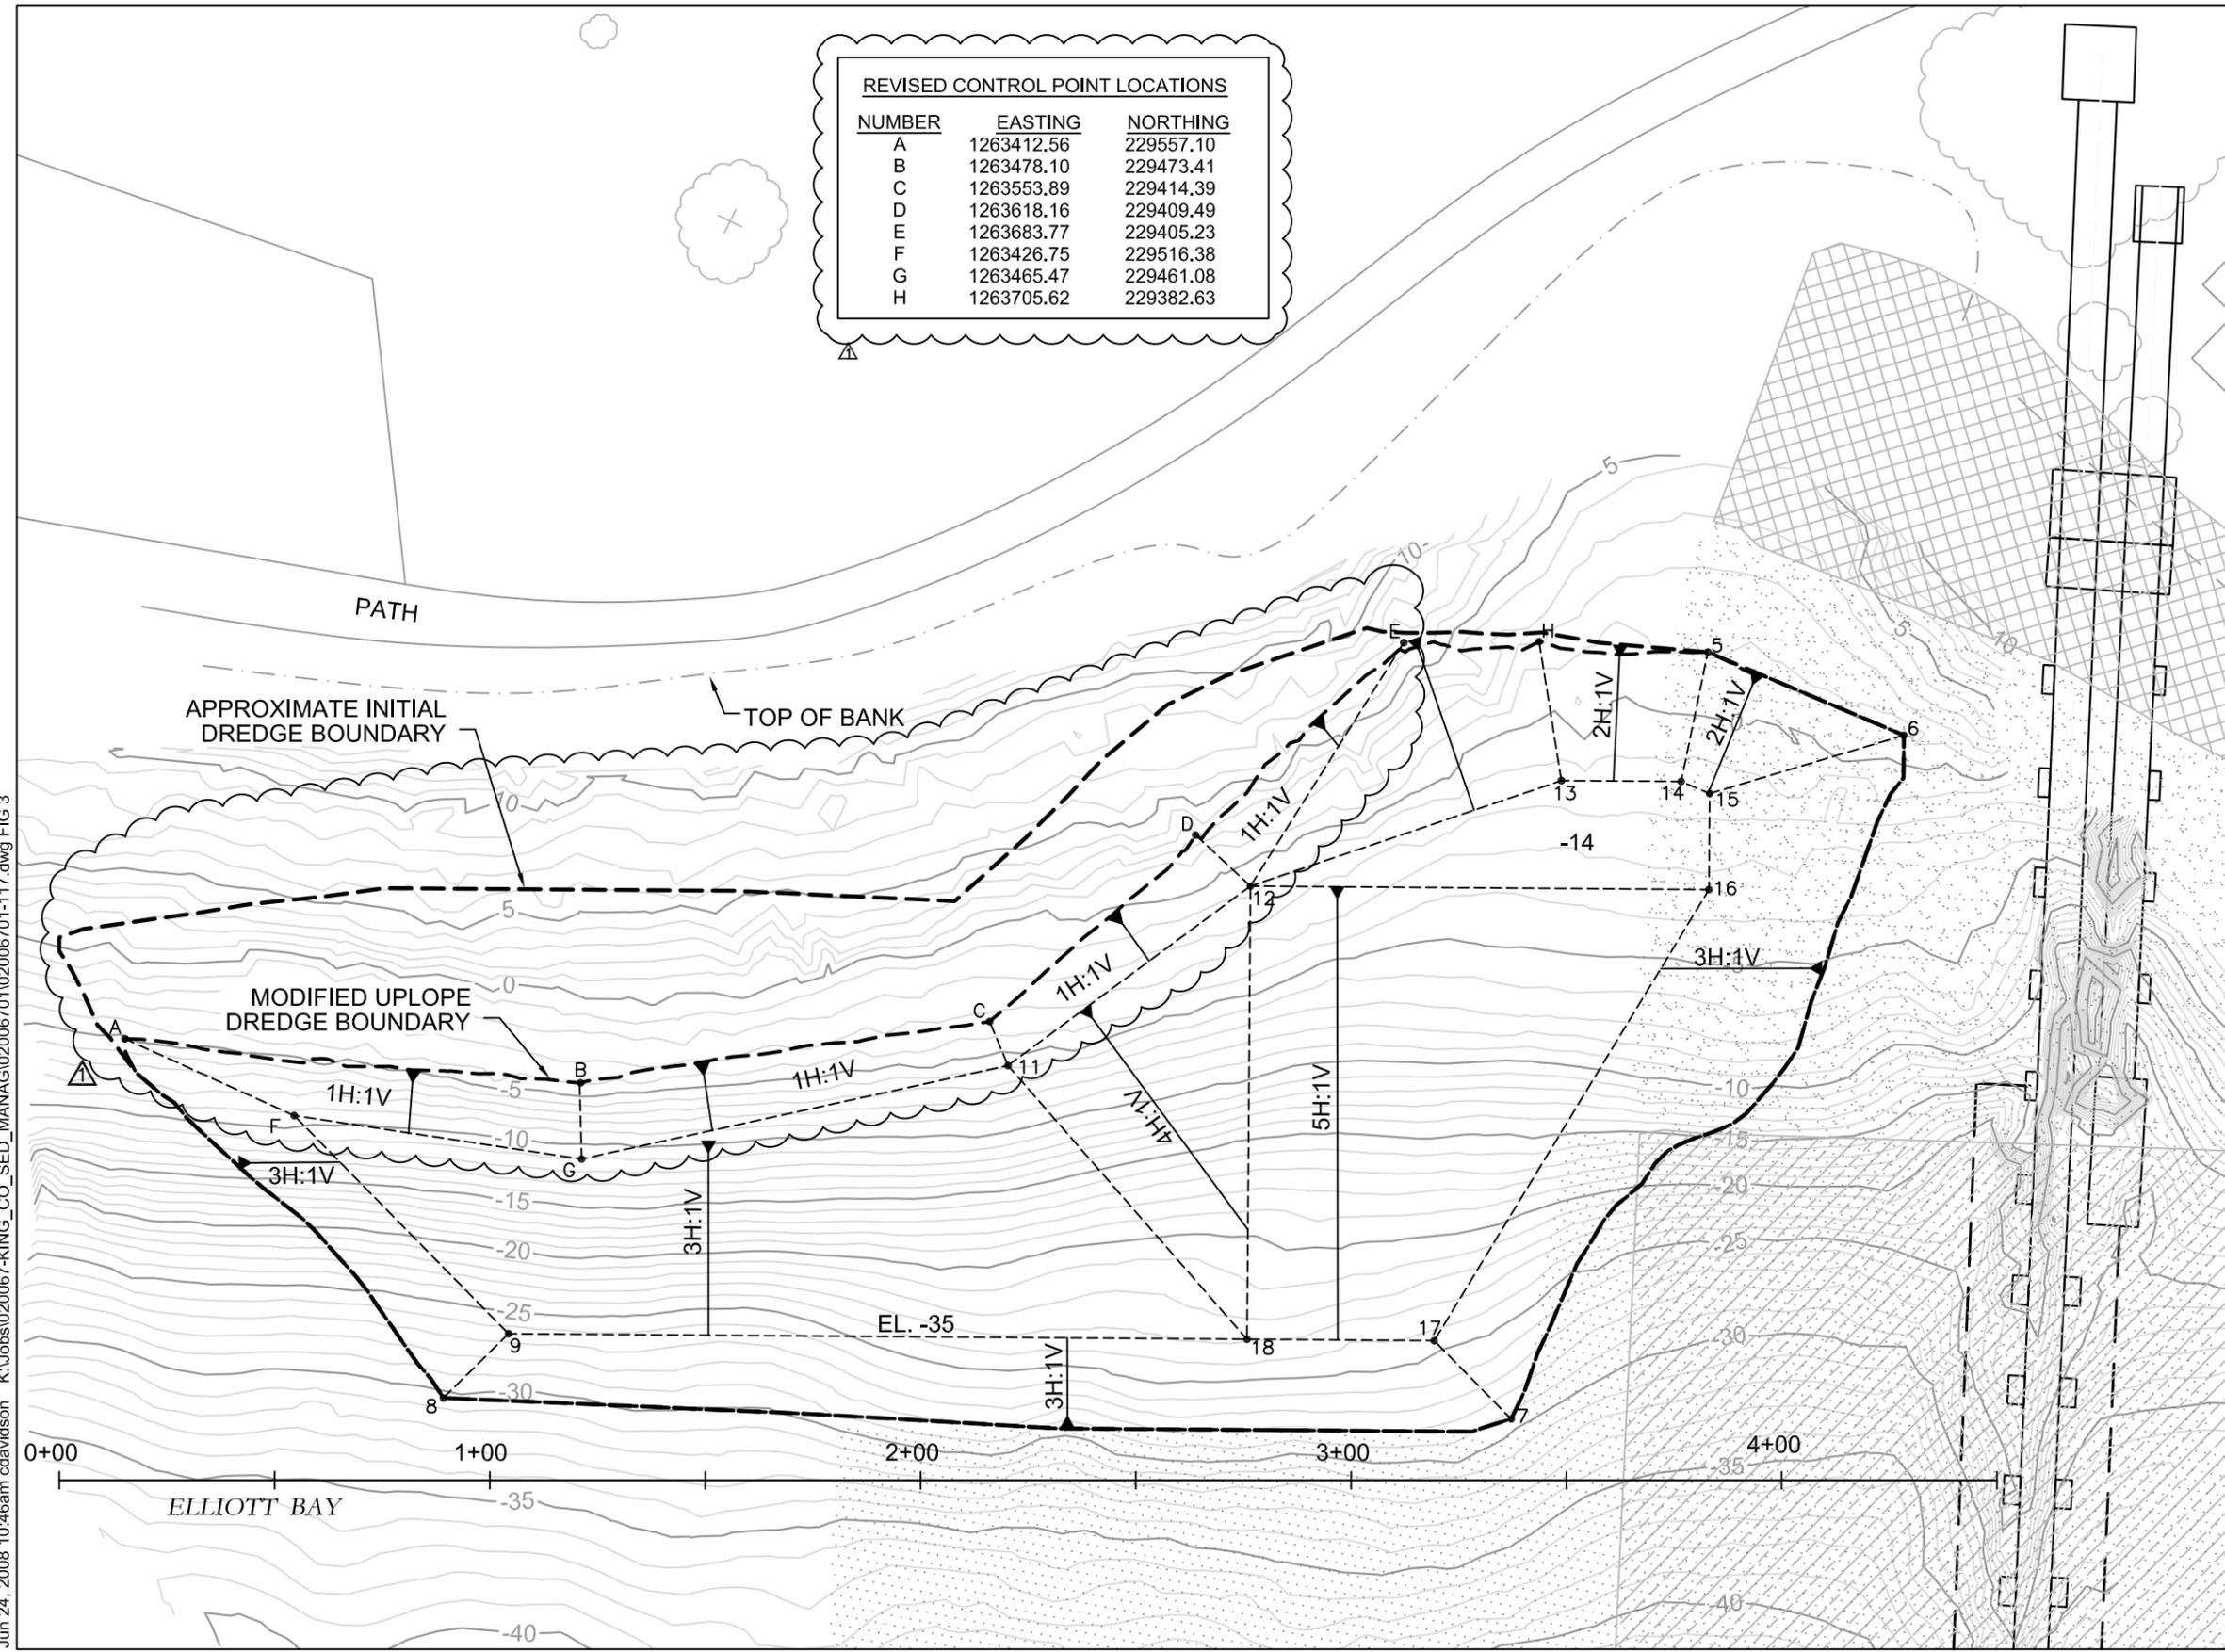
Figure 3
Dredge Plan
Denny Way CSO Nearshore Interim Sediment Cleanup Project

The dredge plan is shown in Figure 3. On November 24, 2007, before dredging work had been initiated, the contractor submitted a letter to King County stating that there was a change of conditions at the site due to a large volume of concrete and debris present on the upslope portion of the dredge prism. At about 12:30 p.m. on November 30, 2007, the contractor began dredging the northern inshore area of the dredge prism between stations 1+00 and 1+75. The contractor identified rock and concrete armor material from the inshore dredge prism boundary at elevation +10 feet MLLW down to elevation -5 feet MLLW. The contractor attempted to remove armor material, but progressed slowly with the 3-cy bucket because the bucket had difficulty picking up the concrete material. The approximate area of rock and concrete armor was previously delineated by contractor surveys and the contractor continued to dredge downslope of the rock and concrete armor area between elevations -5 and -35 feet MLLW. Dredging generally occurred in the upslope to downslope direction to maintain slope stability and moved from north to south within the dredge prism (from stations 0+00 to 4+50). The width of each dredge pass was approximately 50 feet wide and the dredge cut was typically between 2 to 4 feet deep. The time to complete a dredge cycle was, on average, 1 minute 30 seconds for the dredge operator to position the clamshell bucket, lower the bucket to the sediment surface and take a bite of sediment, raise the bucket above the water surface, and release the material onto the flat-deck barge.

On December 18, 2008, King County issued a change order (RCO No. 001) that reduced the dredge prism side slope footprint and minimized the removal of armor rock and concrete on the upslope area by changing the dredge cut from the design 2 horizontal to 1 vertical (2H:1V) slope to a 1H:1V slope cut, which was demonstrated to be stable by the contractor. The change order scope of work also included the replacement of the seawall armoring. On December 28, 2008, the barge-mounted crane was mobilized onto the site to remove armor rock and concrete material within the modified dredge prism. It was anticipated that the excavator would pick up pieces of armor rock and concrete material and stockpile them in a separate barge. The excavator bucket frequently picked up a mixture of sediment and some small debris, and there was noticeable sediment loss from the excavator bucket. The material barge *ITB-166* used to stockpile the armor rock and concrete material had a high perimeter fence, which contributed to sediment loss from the excavator bucket because clearing the high fence increased winnowing of material from the excavator bucket. During the use of the excavator, turbidity was visibly higher and the one turbidity exceedance during dredging activities occurred during its operation (see Section 3.1). The excavator was operated from January 3 to January 8, 2008, and removed approximately 1,636 tons of mixed concrete, rock, and sediment. The *ITB-166* material barge left the site on January 8, 2008, and was loaded with 1,087 tons of mixed material. Armor rock and concrete removal activities continued until January 10, 2008, with the clamshell, and an additional 282 tons of mixed concrete, rock, and sediment were removed. The excavator remained on site until January 15, 2008. A total of 1,918 tons of mixed concrete, rock, and sediment was removed and 414 tons of concrete were recovered and transferred to a concrete recycling facility. The remaining material was transferred to the disposal site.

On January 9, 2008, dredging activities with the 3-cy clamshell bucket resumed between station 2+50 and 4+25 and proceeded to dredge remaining high spots in the dredge prism. The contractor performed a cleanup pass on January 12, 2008. The post-dredge confirmatory survey (see Section 4.1) conducted on January 13, 2008, showed relatively minor high spots above the required dredge line along with relatively minor low spots below the non-paid allowable overdepth line and was accepted as complete by the engineer and Ecology. Photos of the dredging and construction activities, contractor daily reports, and King County Inspector reports are located in Appendices A, B, and C, respectively.

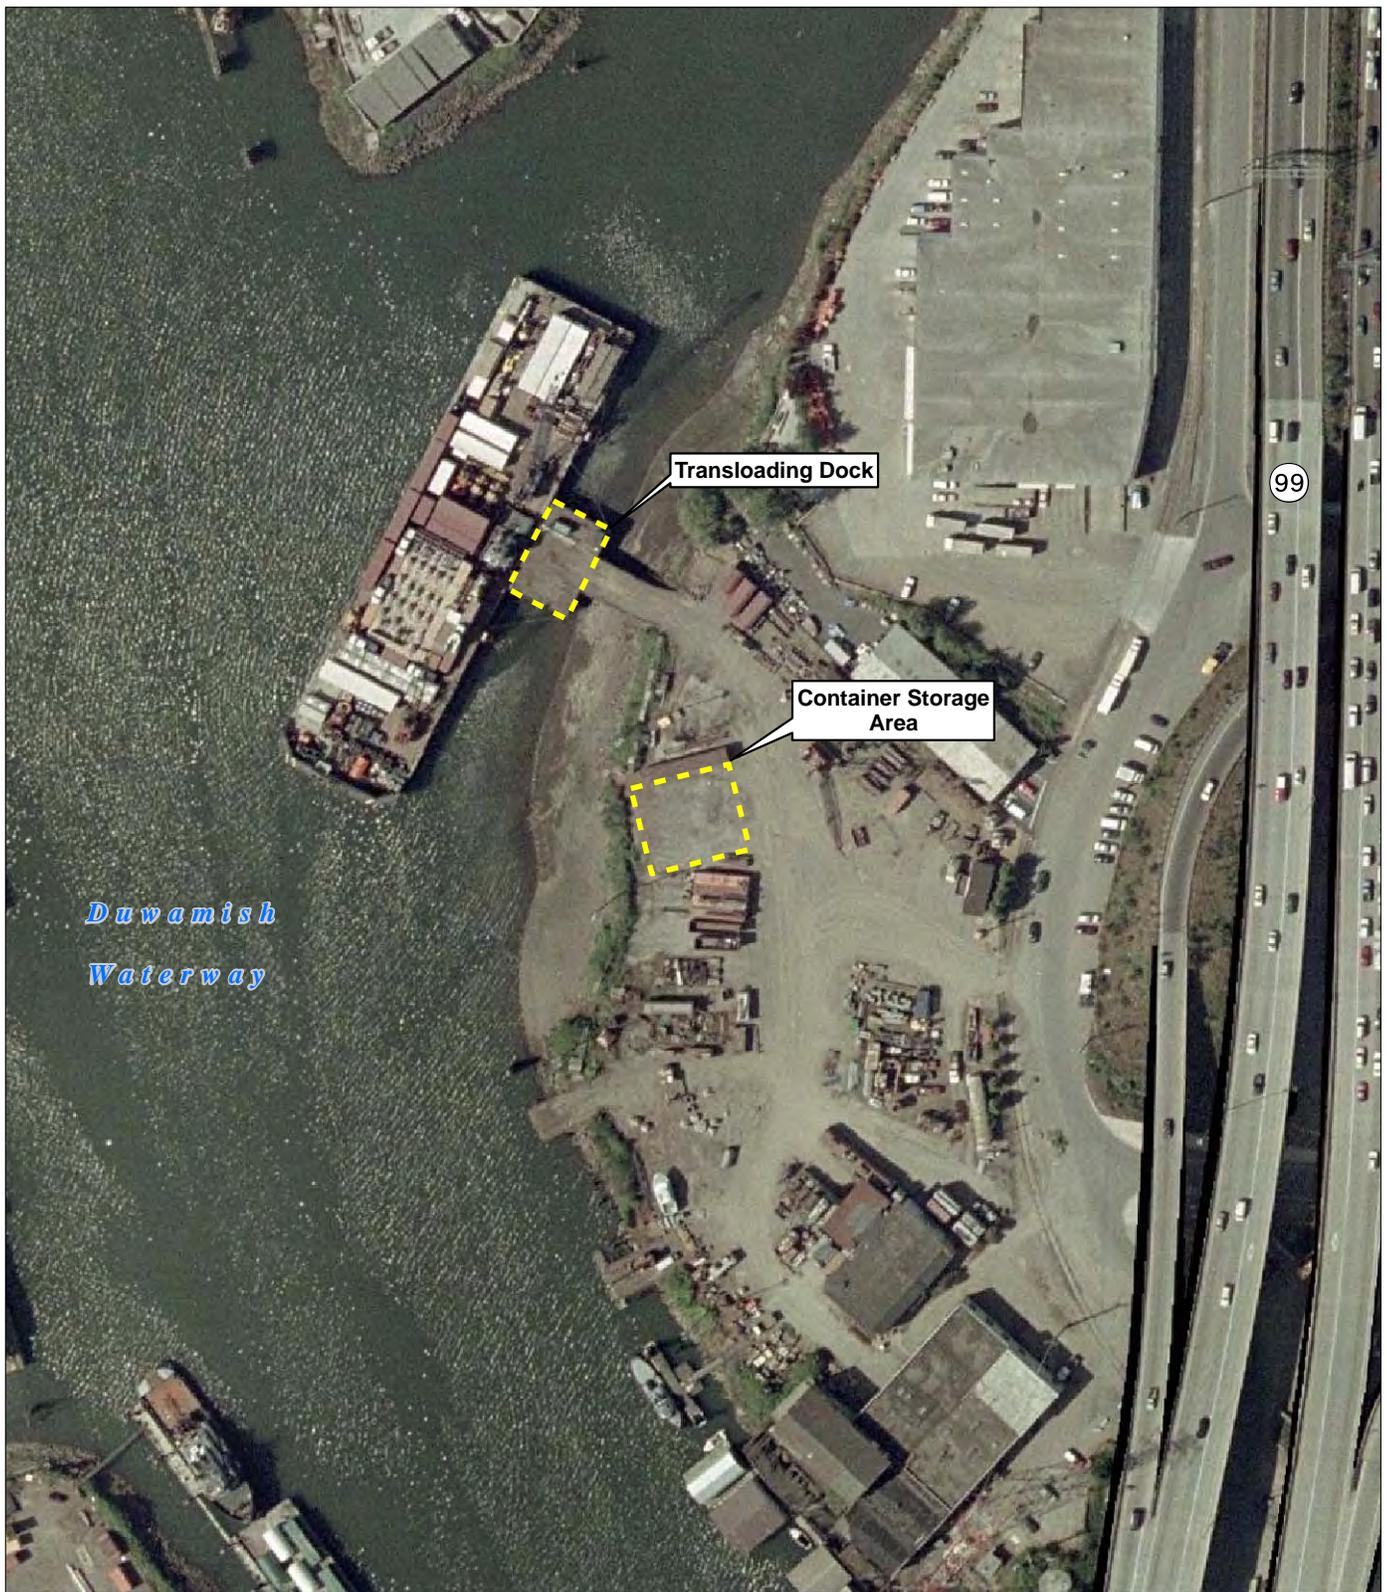
Figure 4
Offloading Facility
Denny Way CSO Nearshore
Interim Sediment Cleanup Project

The offloading and disposal operation was performed by the contractor under a subcontractor agreement with Rabanco. Figure 4 shows the layout of the offloading facility, located at the Duwamish Marine Center located at 16 S. Michigan in Seattle, Washington. The Duwamish Marine Center property is permitted to handle bulk material and contaminated waste and had been used previously to unload dredged material from barges to containers.

Dredged sediments were removed from each barge with a front-end loader, which transferred sediment directly into a lined, 20-foot open-top intermodal shipping container. The front-end loader and container were placed onto the dredge material barge in a small cleared area left open by the dredge operator, and typically positioned in the center of the barge. The liner used to line the shipping container was a 6-mil liner and was secured to the top of each container to prevent leakage. To prevent spillage out of the top, each container was limited to about 30 tons of sediment (approximately two-thirds full) to allow for adequate free board. Once filled, the container was removed from the flat-deck barge by a land-based crawler crane. The crane was positioned over the container and four cables were secured to the corners of the container before lifting the container off the barge and placing it either directly onto a truck or on the ground in the transloading dock area. The process of transferring sediment into a container and offloading the container onto a truck was at an approximate rate of 5 containers per hour.

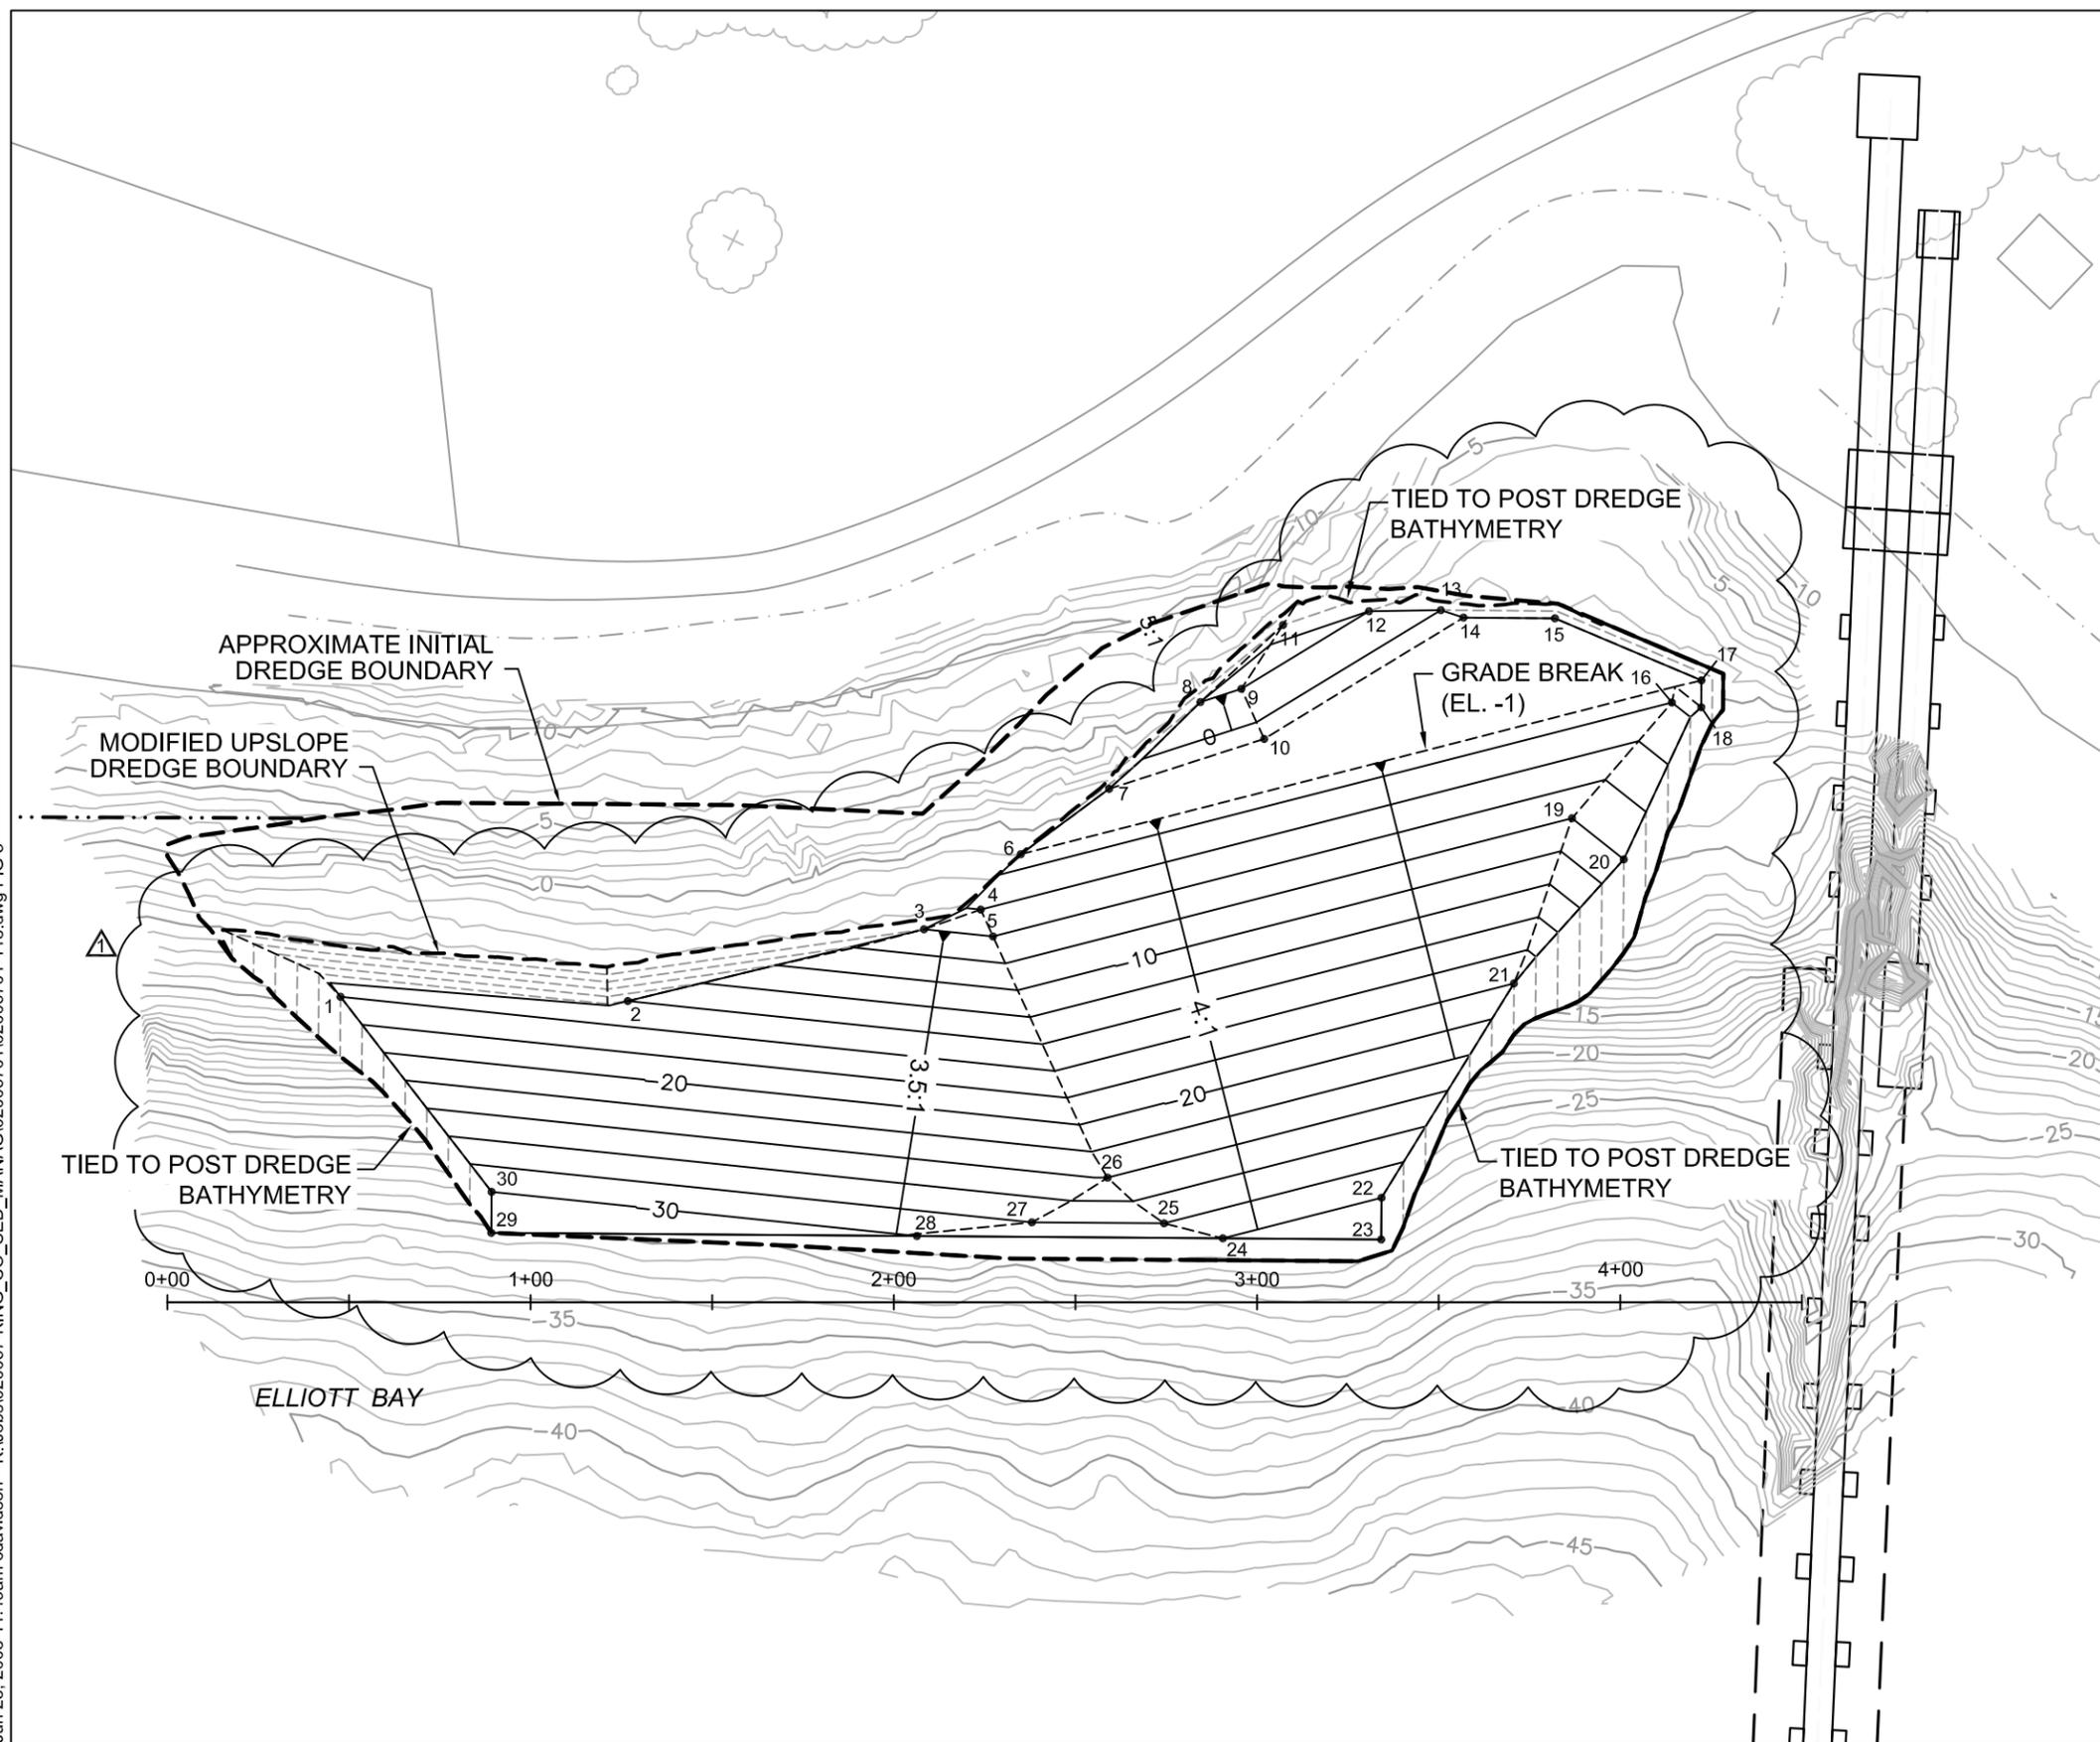
Figure 5
Target Base Backfill Plan
Denny Way CSO Nearshore Interim Sediment Cleanup Project

When dredging operations were complete, the contractor was allowed to begin backfilling operations. The backfill consisted of two different layers. A base backfill layer primarily composed of sand was placed first to cover all remaining sediment contamination. This was followed by a more erosion-resistant surface layer of larger sized habitat mix. Finally, armor rock was placed in areas where it had been removed along the seawall and contingency cover sand was placed in areas where dredge residuals may have migrated outside the dredge prism boundary.

The post-backfill confirmatory survey (see Section 4.0) showed minor low spots. These low spots were corrected by placing additional backfill to grade, and an additional contractor survey was performed and accepted. The contractor placed habitat mix over the base backfill layer, which was confirmed by a post-backfill survey (see Section 4.0) that was also reviewed and accepted. Rock armor was placed on the upslope area to approximate pre-project armoring conditions after the habitat mix layer was complete.

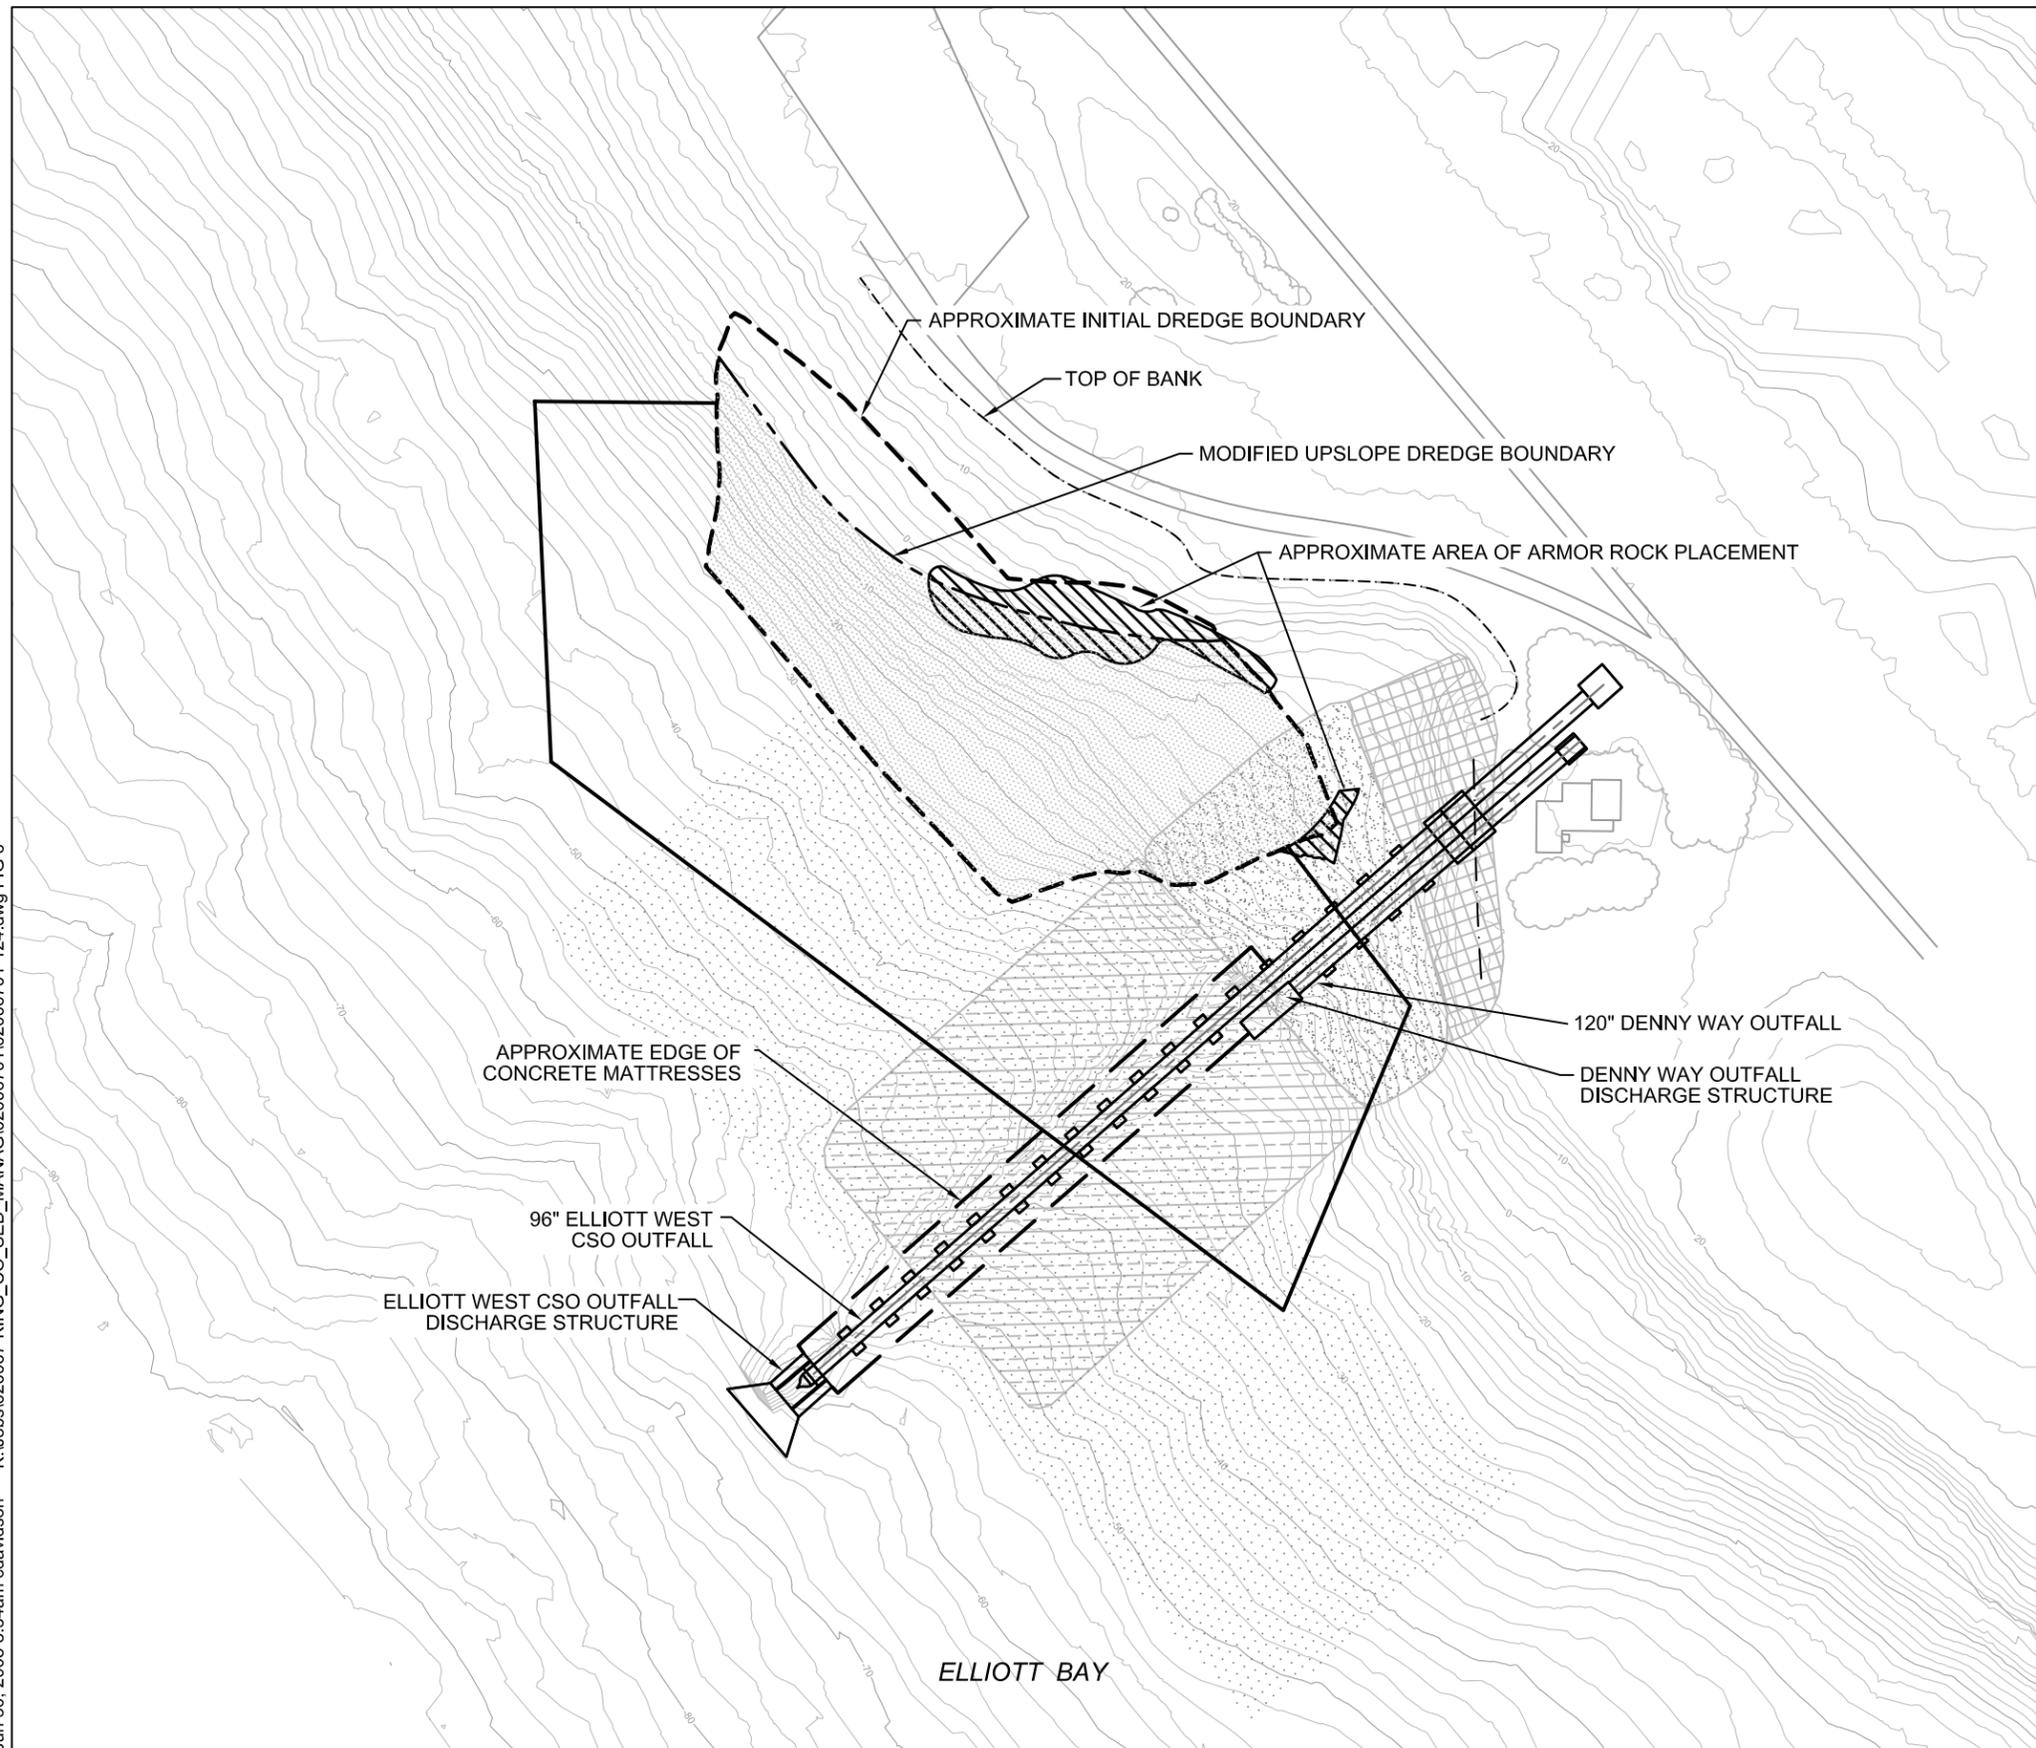
All dredging results in the resuspension of particulate material (USACE 2008) and the backfill design required the evaluation for the need of a contingency cover layer in areas adjacent to and outside the dredge. Post-dredge sampling showed that there was dredge residual outside of the dredge boundary at the closest monitoring station and showed the need for the placement of contingency cover material. A 6-inch contingency cover layer of sand was placed outside the dredge boundary as shown in Figure 6.

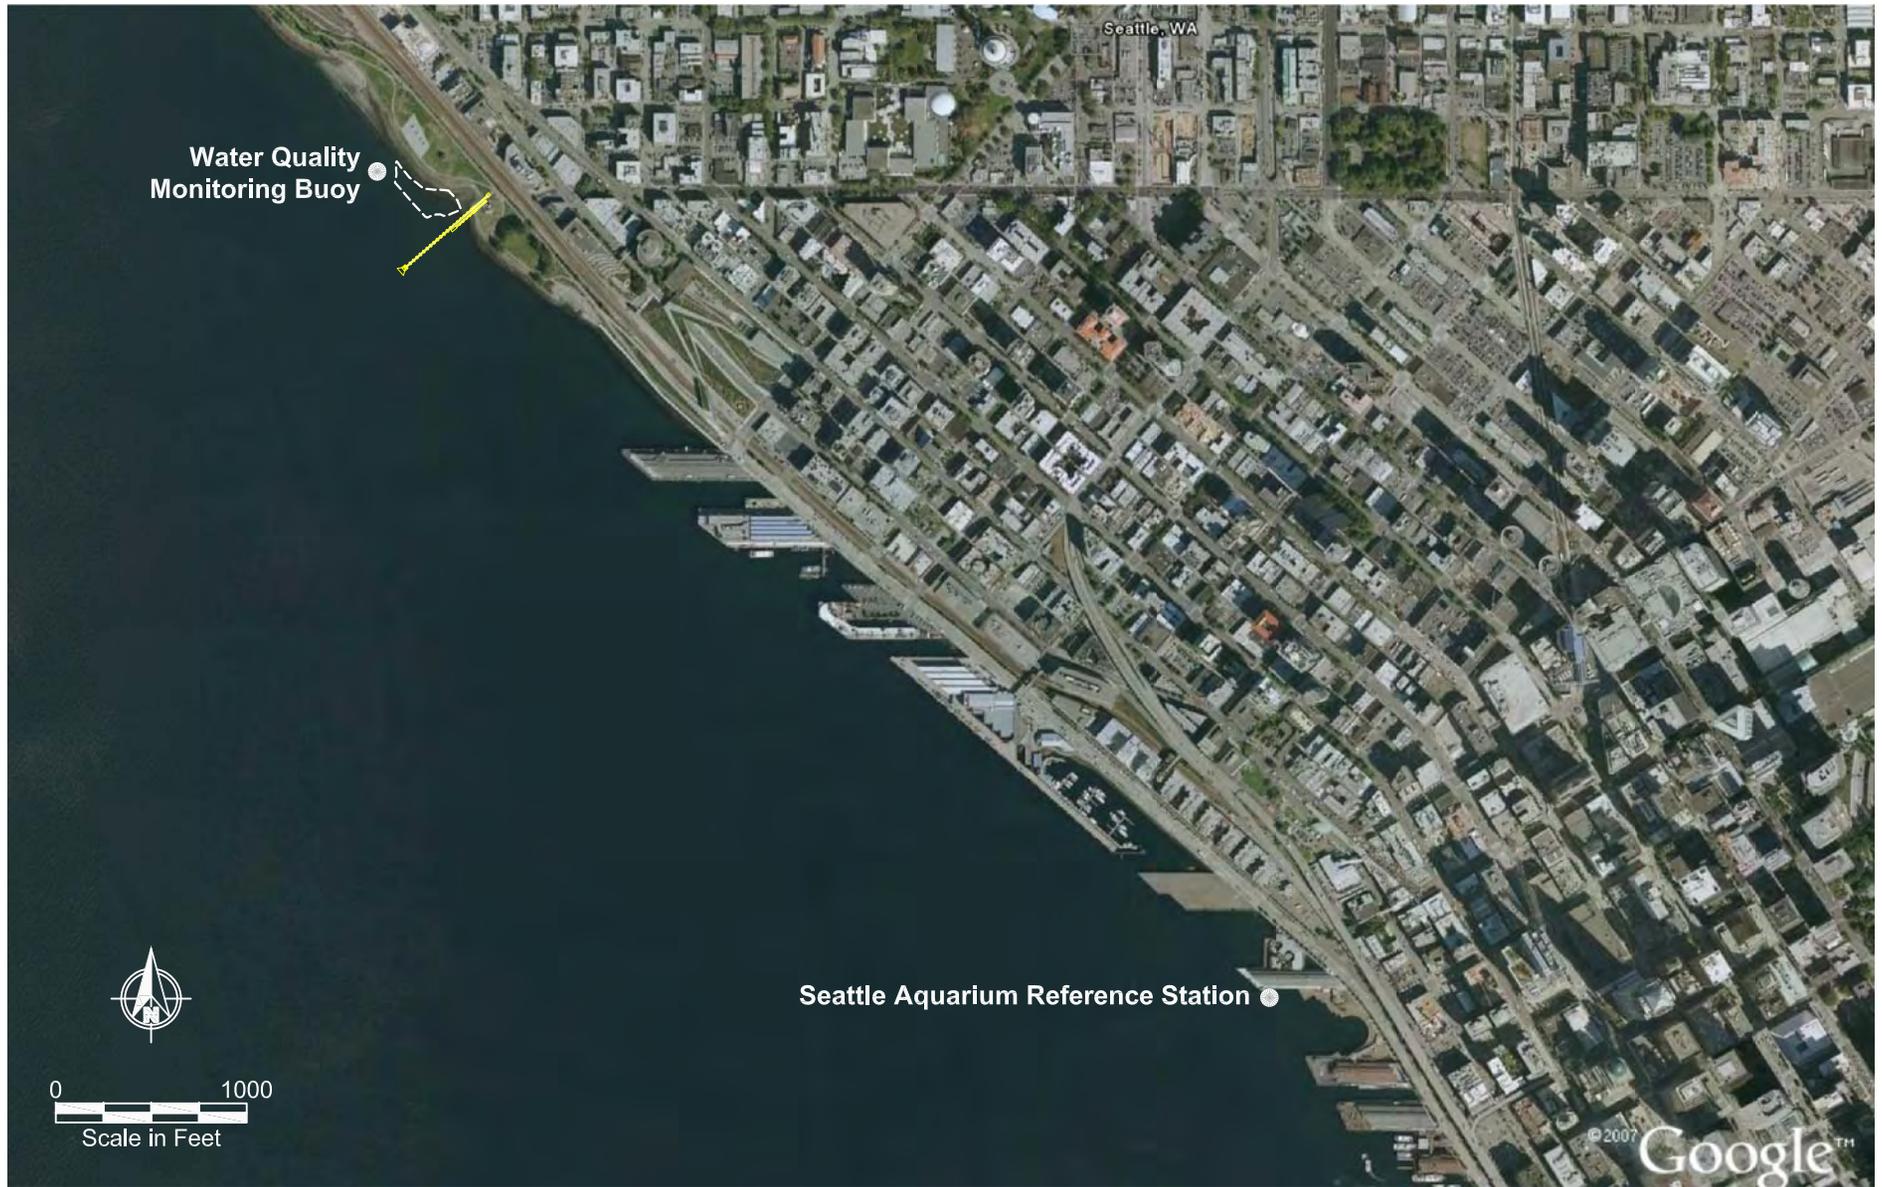
As discussed in the *Dredging and Backfilling Operations Construction Water Quality Monitoring Plan* (KCDNRP 2007a), a turbidity exceedance was recorded if the average turbidity at the site buoy measured over a 1-hour time period was more than 5 Nephelometric Turbidity Units (NTU) higher than the average turbidity measured over the same 1-hour period at the background (Seattle Aquarium) monitoring station when the background turbidity was 50 NTU or less, or if the average turbidity at the site buoy

measured over a 1-hour time period increased more than 10 percent when background turbidity was greater than 50 NTU. Similarly, DO was averaged hourly at the site buoy and compared to applicable DO standards for Elliott Bay.
