**DENNY WAY CSO NEARSHORE INTERIM
SEDIMENT CLEANUP PROJECT
CLOSURE REPORT**

**Prepared by the
King County Department of Natural Resources and Parks
Wastewater Treatment Division**

**Prepared by:
Anchor Environmental, L.L.C.**

October 2008

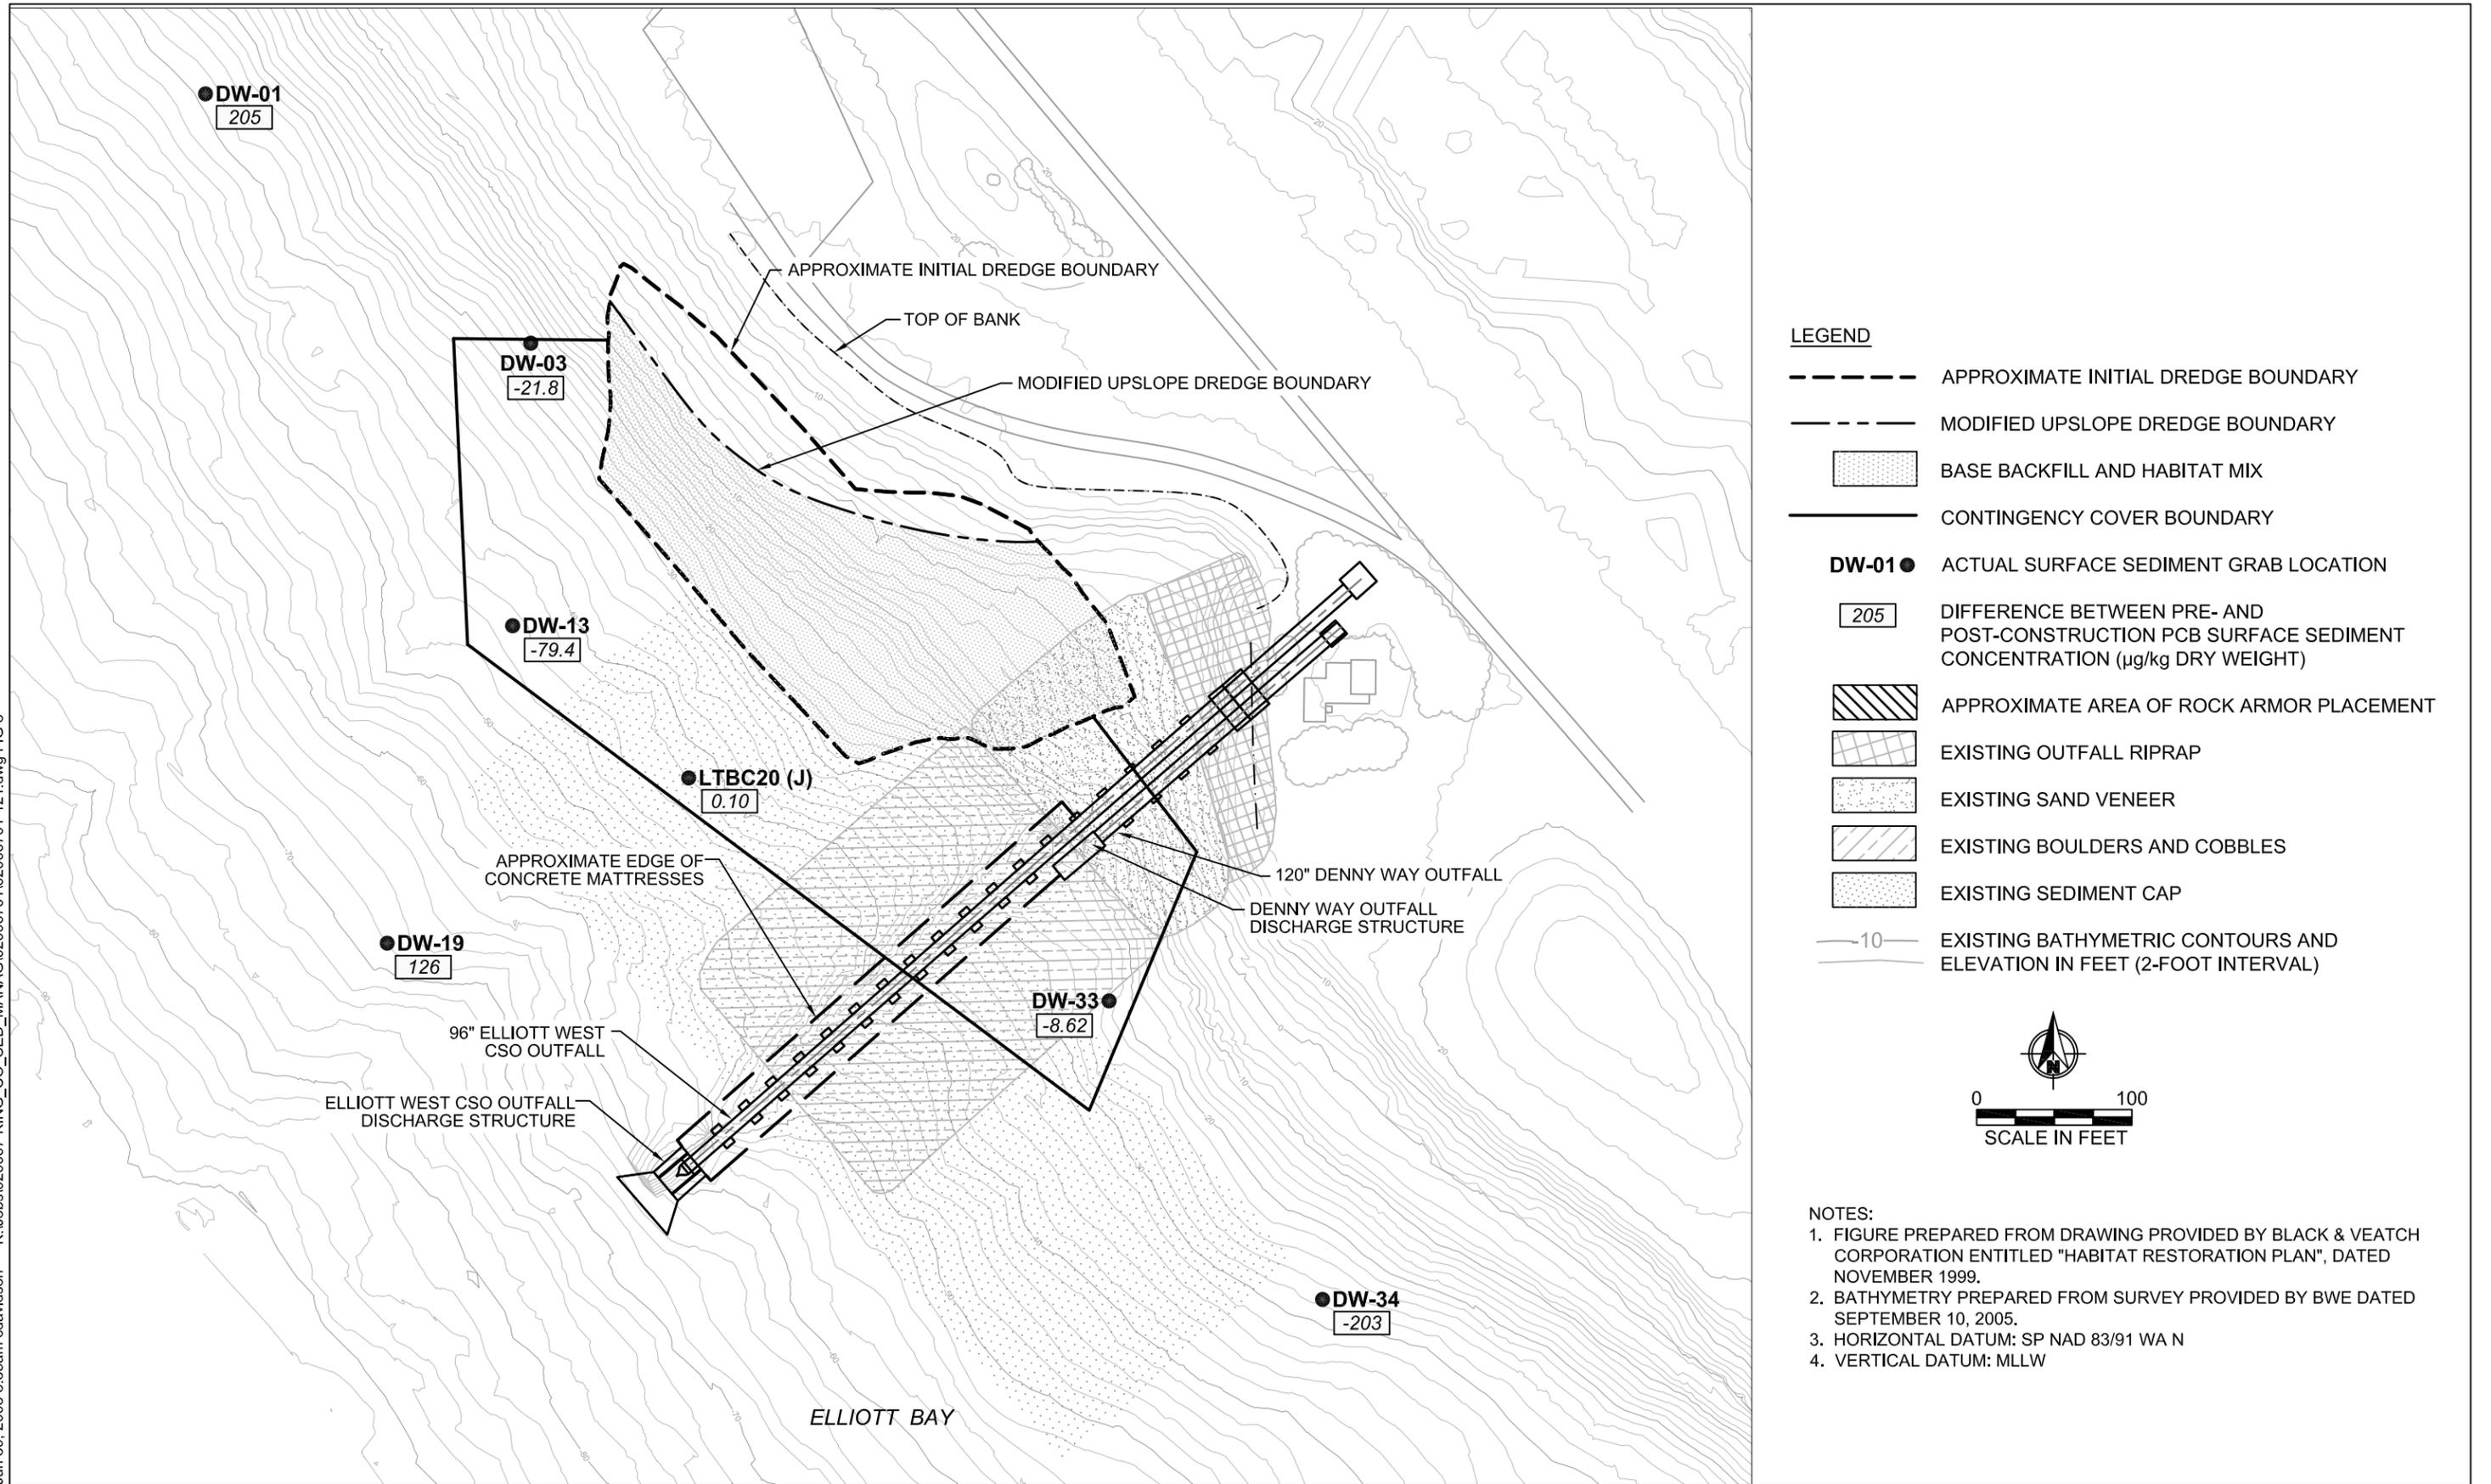
Figure 8
Post-Construction Changes in PCB Dry Weight Concentrations at 7 Stations Beyond Site Boundary
Denny Way CSO Nearshore Interim Sediment Cleanup Project

The most accurate way to identify changes produced by the two transport processes that affect chemical concentrations beyond the site boundary (i.e., dredge sediment transport and backfill sand transport) is to look for spatial differences in the change in dry weight concentrations at each station. To assist in this analysis, the stations in Table 4 were arranged in progressive order starting with the greatest increase and progressing to the largest decrease in PCB dry weight. In Figure 8, the observed changes in PCB dry weight values were plotted next to the station numbers to show the spatial differences. Dry weight concentrations increased at two stations (DW-01 and DW-19), and the increase observed at station LTBC20 (J) is too small (0.1 part per billion [ppb]) to be considered as a change in total PCB concentration. The highest increase (205 ppb) occurred at station DW-01, which is located approximately 350 feet north of the northern edge of the dredge prism boundary and downstream of the site. The second highest increase (126 ppb) occurred at station DW-19, which is located approximately 300 feet west of the western edge of the dredge prism boundary. While these values are potentially within the acceptable error of Aroclor analytical methods, the results indicate some increase likely occurred. The relatively low increases in PCB concentrations show

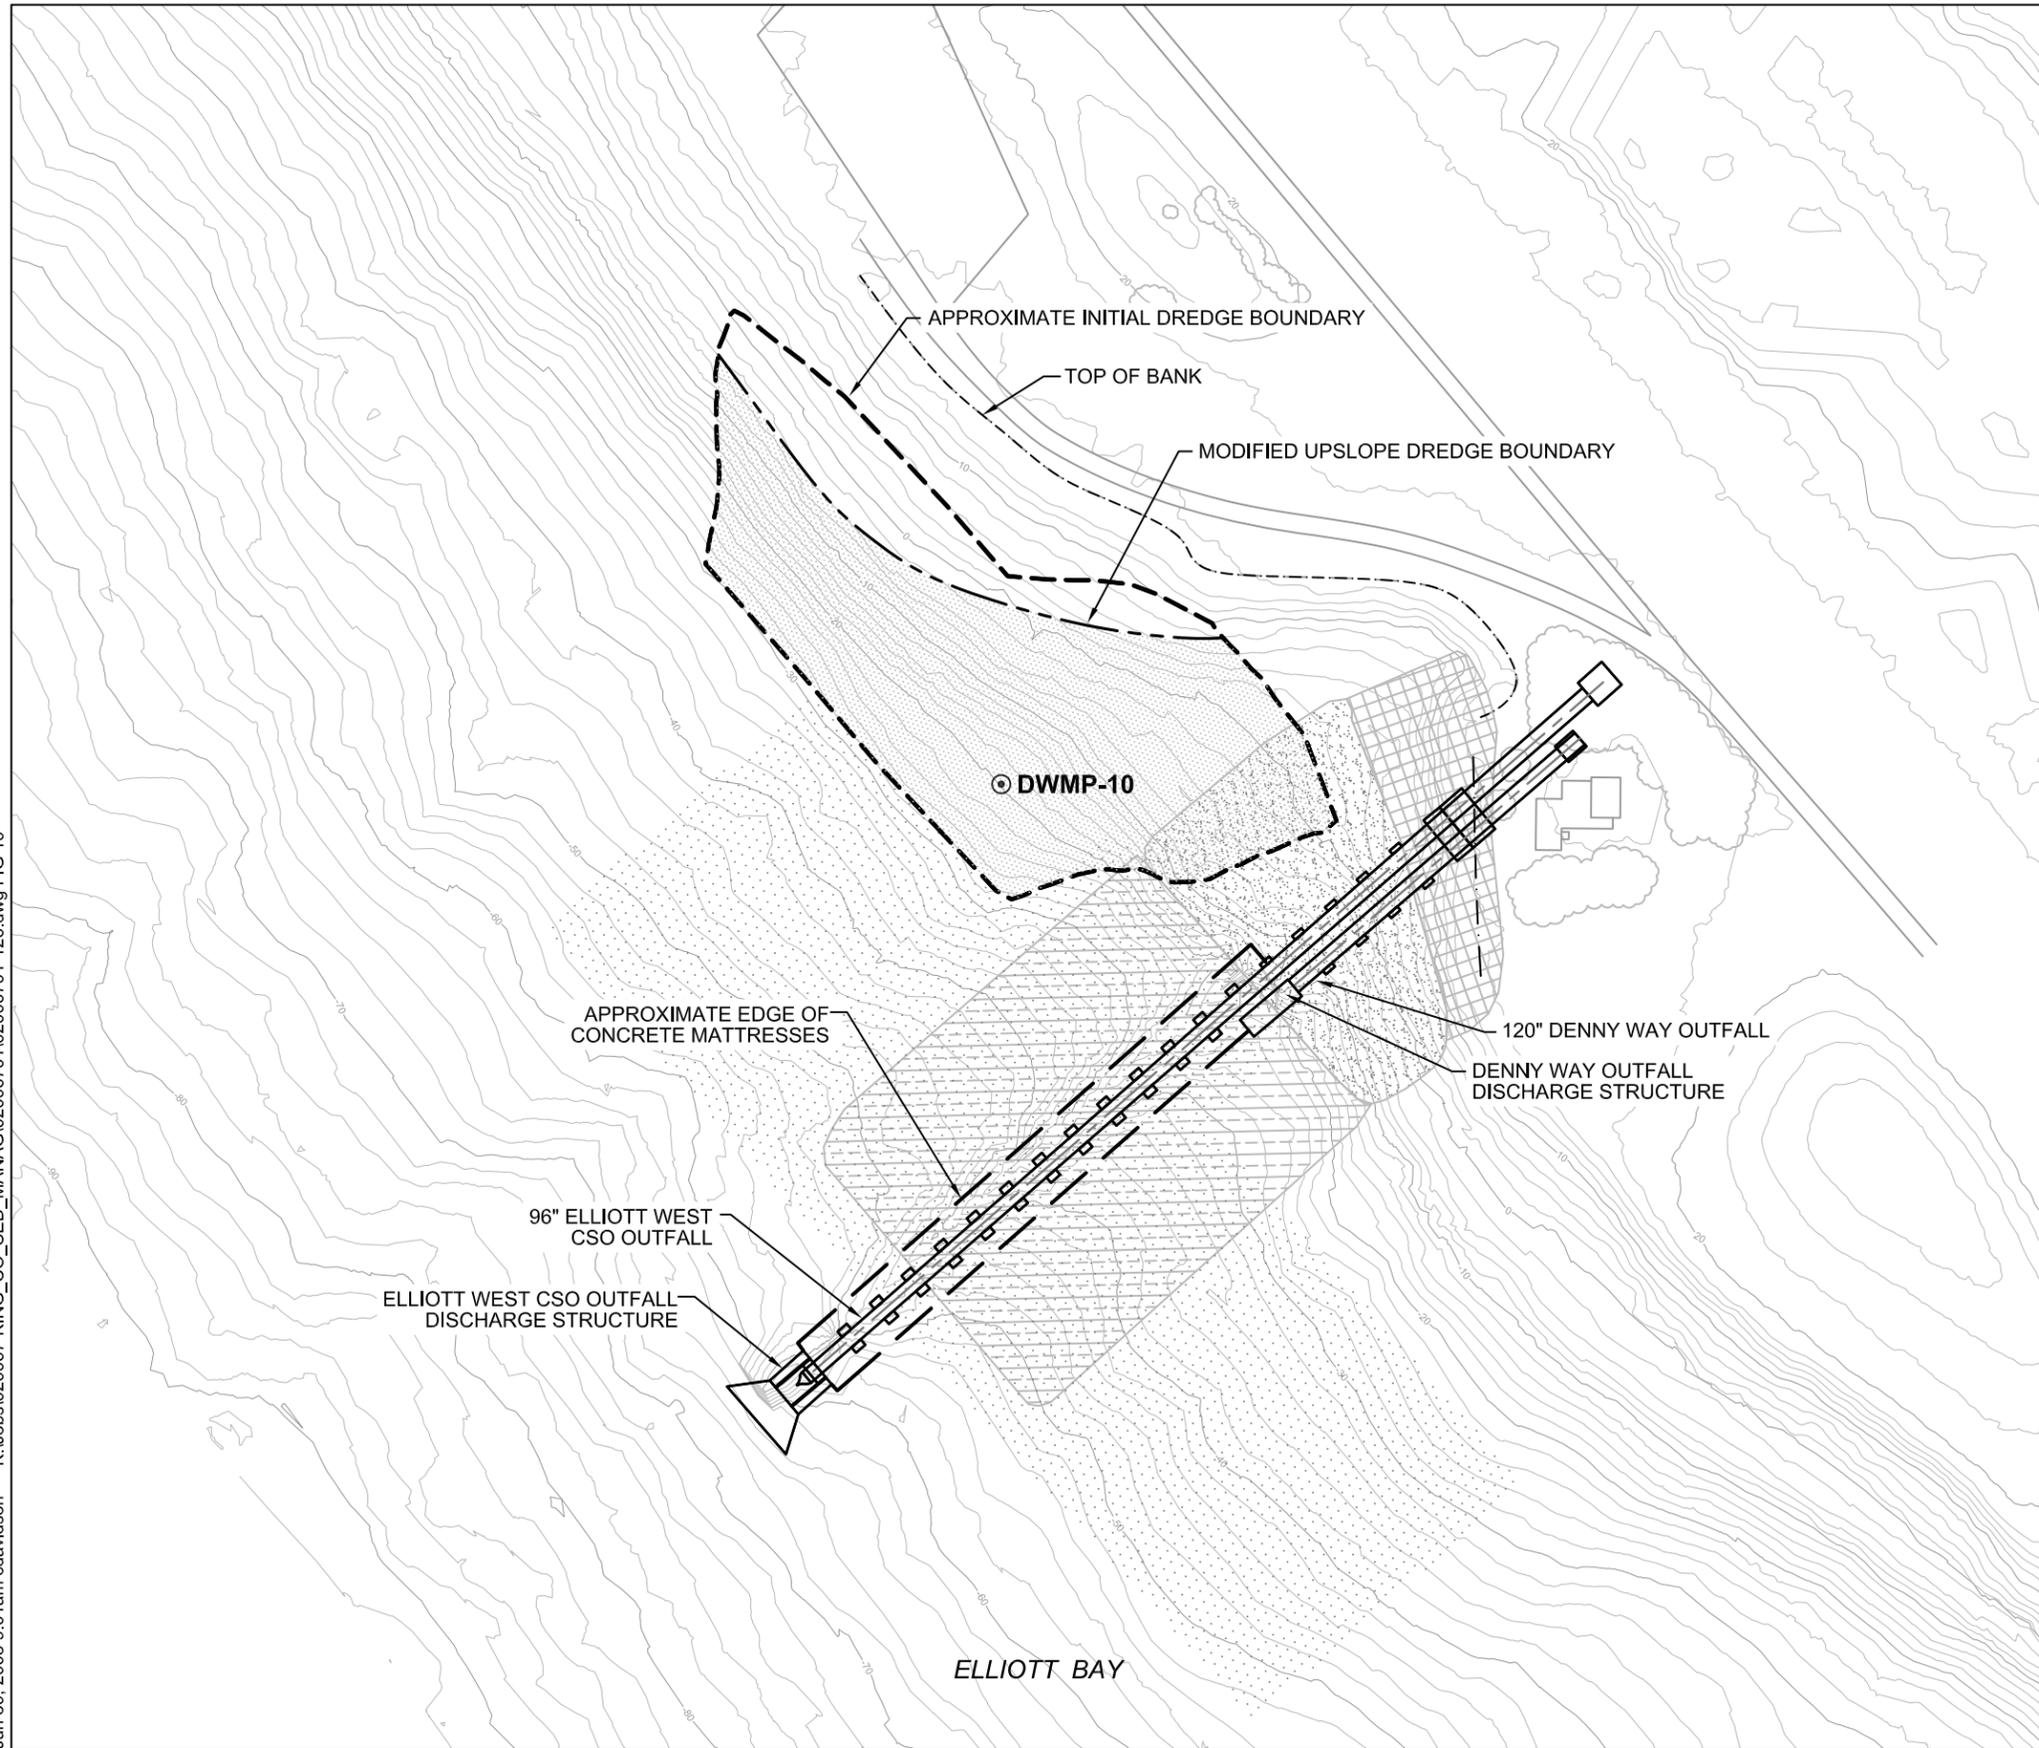
The *Denny Way CSO and Elliott West CSO Treatment Facility, Post Operation Sediment Monitoring, Year 3, Denny Way CSO Areas A and B Nearshore Sediment Remediation Project Post-Construction Sediment Monitoring, Areas C, D, and E Monitoring Sampling and Analysis Plan* (KCDNRP 2008) is included in Appendix G and contains long-term monitoring requirements for changes in the surface sediment chemistry of one station within cleanup Areas A and B to evaluate the potential for recontamination of the backfill over time. Surface samples will be collected from station DWMP-10 annually in April for a 5-year period, from 2008 through 2012. Figure 10 shows the one surface sediment monitoring station located in Area A. An attempt to collect the first-year baseline sample was conducted on April 1, 2008 (Year 0 sampling event). Three casts of the grab sampler that produced only rock and gravel were made at Station DWMP-10, and no collectable sediment was available. Station DWMP-10 is located in an area covered with habitat mix that contains a large amount of gravel and makes it difficult to collect a representative sample. No sample was submitted to the laboratory for this station for this year.
