**Norfolk CSO Sediment Remediation Project
Closure Report**

Elliott Bay/Duwamish Restoration Program

Prepared for the
Elliott Bay/Duwamish Restoration Program Panel
by the
King County Department of Natural Resources

August 1999

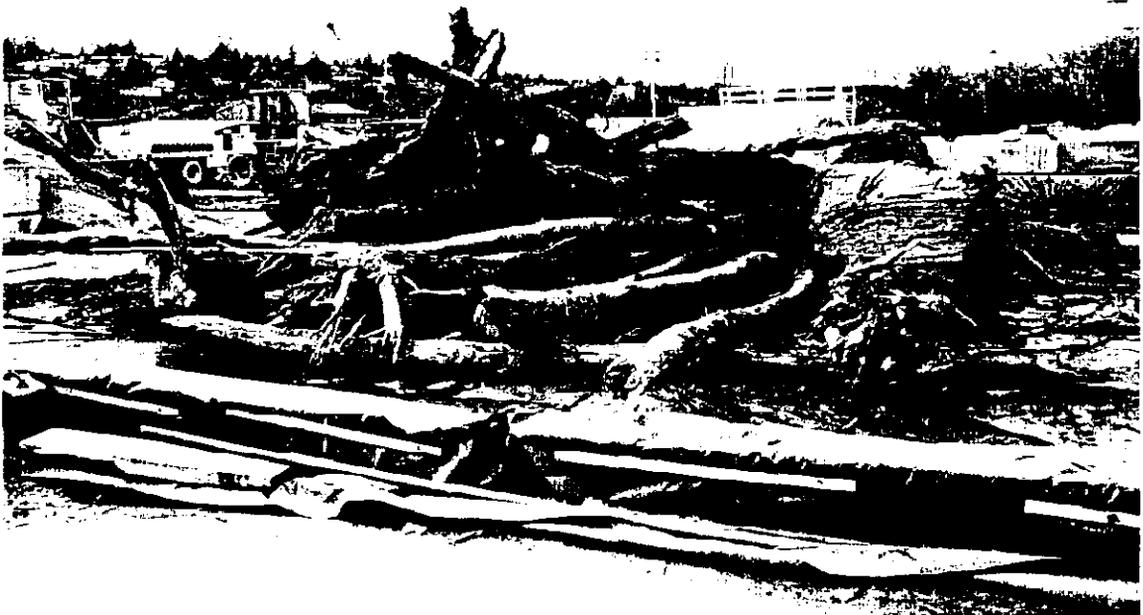
Photo 11 Woody Debris Taken During Dredging. Note 20,000 Gallon Tank In Background.

Woody debris was also brought ashore during the dredging process and stockpiled in the dewatering containment area. Prior to disposal, samples were collected and analyzed for PCBs. Results are provided in Table 2. Samples were collected using a variety of dedicated, pre-cleaned instruments: stainless steel spoons and knives to take "scraping" samples of bark and sediment; and hammers and chisels to collect interior wood. Two samples were collected from mixed sediment and bark to evaluate PCB concentrations on the exposed surface of the woody debris and two samples were collected from interior wood to evaluate the mobility of PCBs through the debris. These samples were analyzed for PCBs and total solids in the manner described above. No samples exceeded TSCA limits so all woody debris was disposed of at the Olympic View Sanitary Landfill.
