CHAPTER 11

Develop Technology to Minimize Sediment Mobilization after Channel Excavation

11.1 Introduction to Sediment Mobilization (Goal 10)

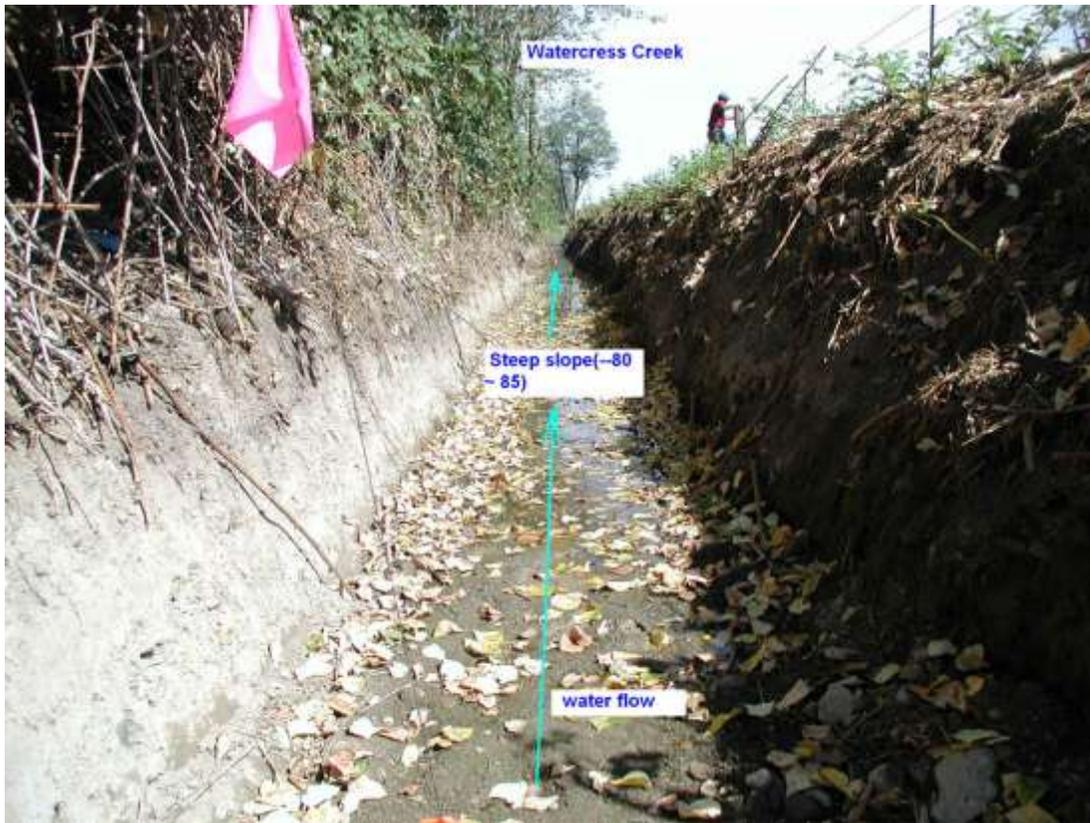
Figure 11-3. Installation of Petri dishes and steel rods at Watercress Creek on August 08, 2004

There were no bank treatments employed at the Watercress Creek site. As previously stated and illustrated in Figure 11-3, the side slopes were too steep for economical erosion control. The total length of the watercourse was 274 m (900 ft) and the effective length for the experiment was

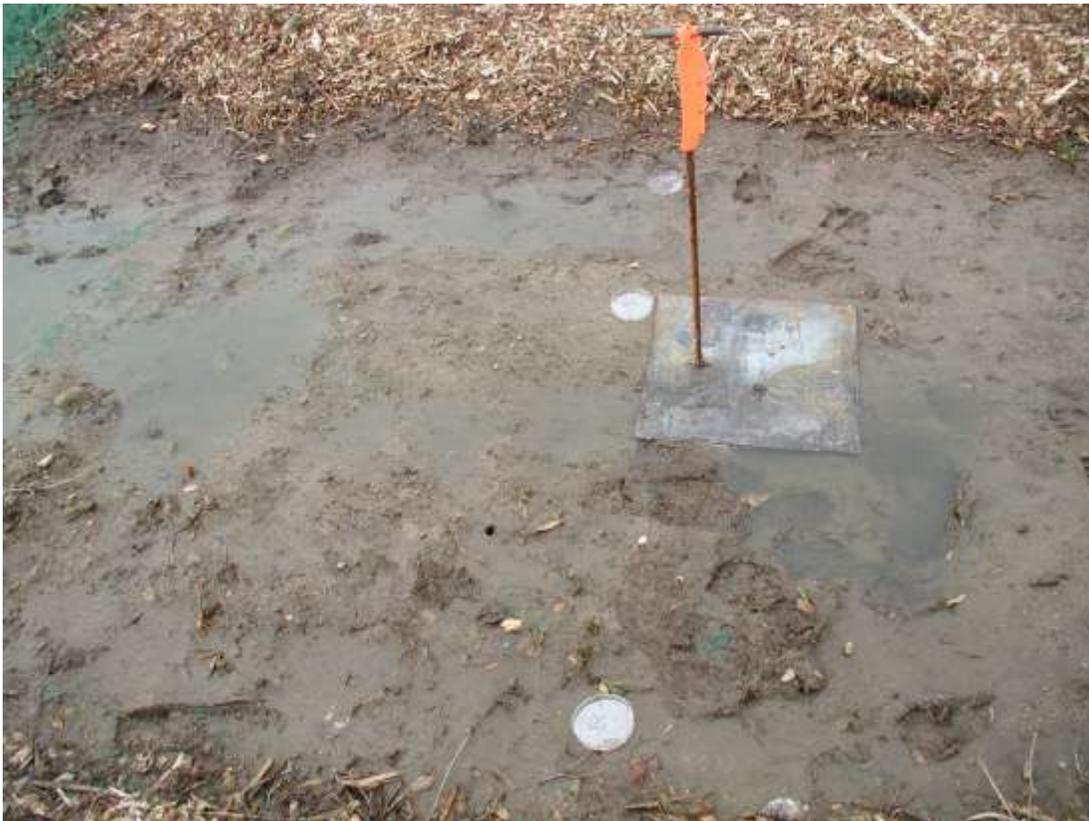
Figure 11-4. Typical installation of Petri dishes and steel rods

The long-term sediment measurements were carried out using circular Petri dishes with diameter of 10.0 cm (4 in) and depth of 1.5 cm (1/2 in). Petri dishes were placed in the watercourse bottoms perpendicular to the flow. One dish was installed in the channel center and one dish on each edge of the channel as illustrated in Figure 11-4. The arrangement of Petri dishes allowed sediment measurements to be conducted at three locations for each TESC sub-treatment. The Petri dishes were secured to the watercourse bottom with fashioned wire hold downs. Total solids in the Petri dishes were collected, dried, and weighted. In addition, site visits and inspections were also performed along with associated photographs to quantify the density and sizes of rills developed on the banks, and determine the sedimentation contribution from channel banks.

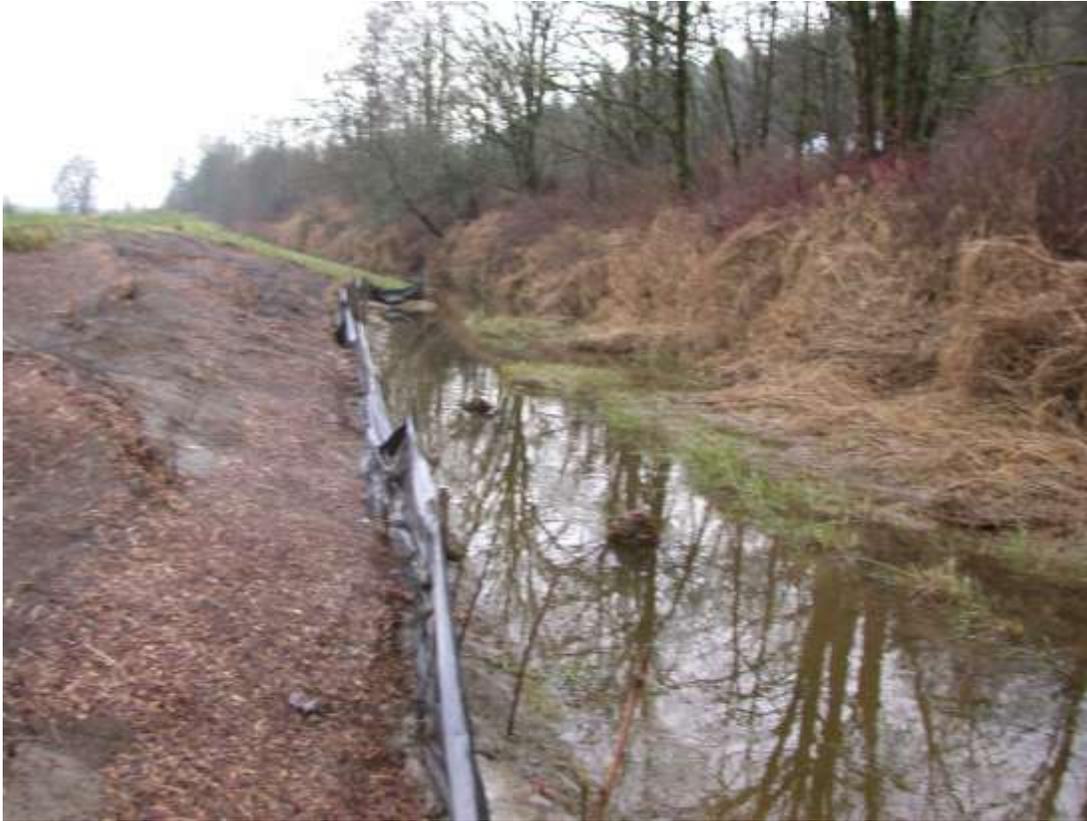
Figure 11-9. Sod (treatment plot #5) was undamaged while woodchips (treatment #4) were washed out at the 124th Street site

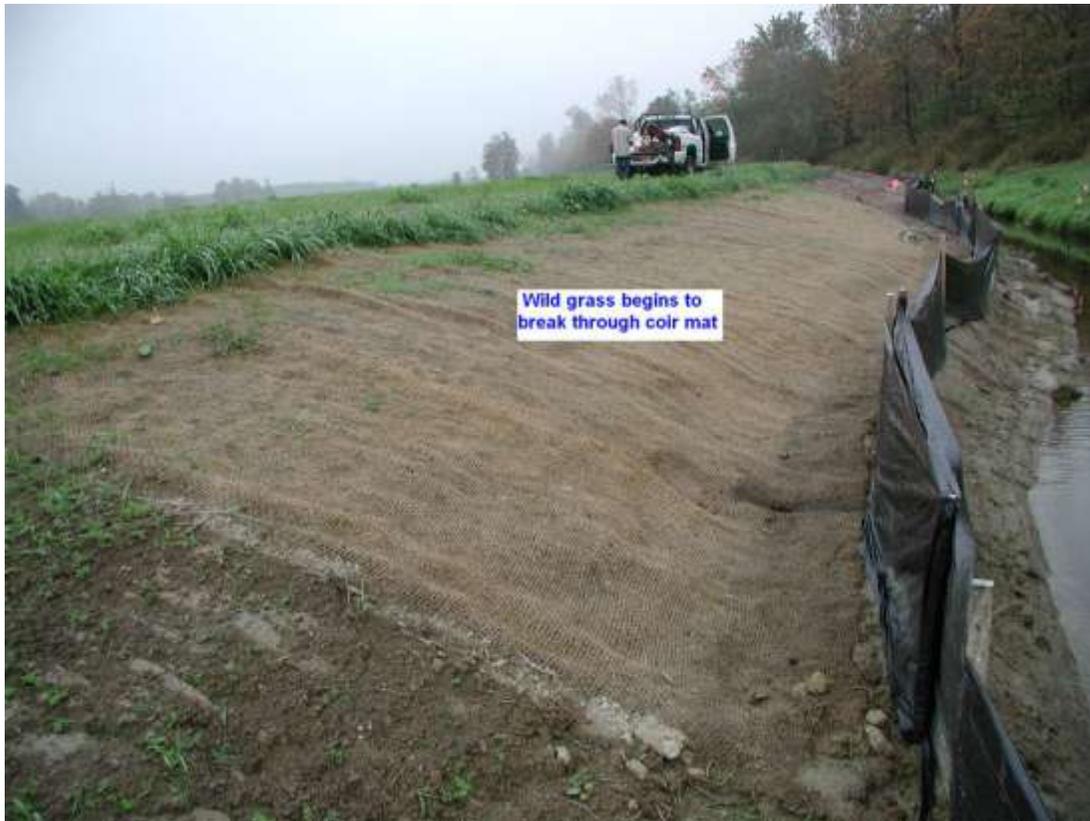
Figure 11-10. RCG breaking through coir mat at the 124th Street site

Petri dishes were installed to measure the long-term sediment resulting from rainfall event after excavation. However, only the experiment at the site of Watercress Creek generated valid measurements. The sediment collected over 66-day period was significantly smaller, compared to the 1-year cumulative sediments. Although there were no valid measurements for the cumulative sediments after excavation at the sites of Ray Ewing and the 124 street, the results of site inspection also indicated that sediment from the treated banks of these watercourses were insignificant and immeasurable, as shown in Figure 11-10 and Figure 11-11.

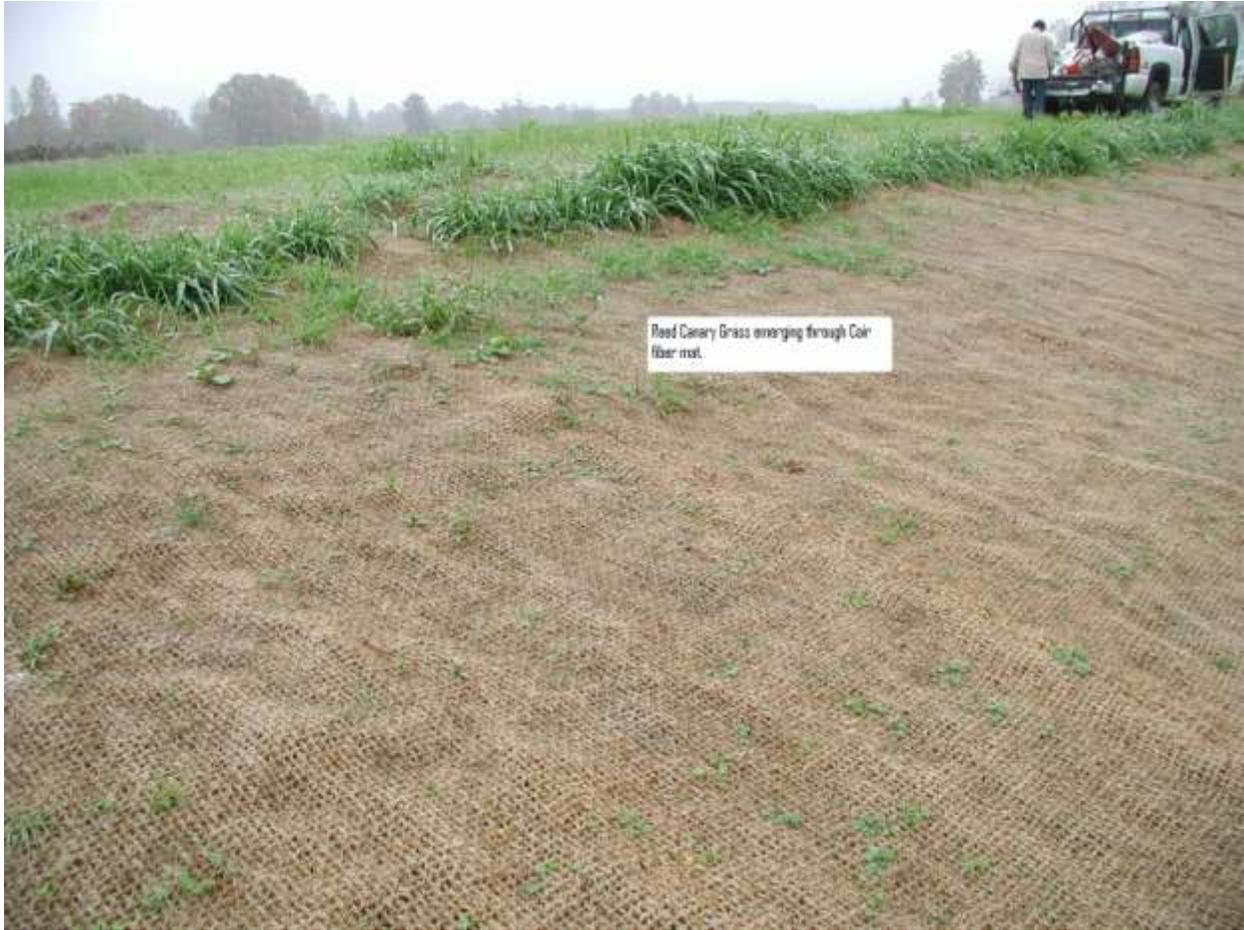
Figure 11-11. No rill formation in the treated bank at the 124th Street site
