# CHAPTER 12

## Evaluation of Techniques to Extend Maintenance Cycles

### 12.1 Introduction to Extended Maintenance Cycles (Goal 11)

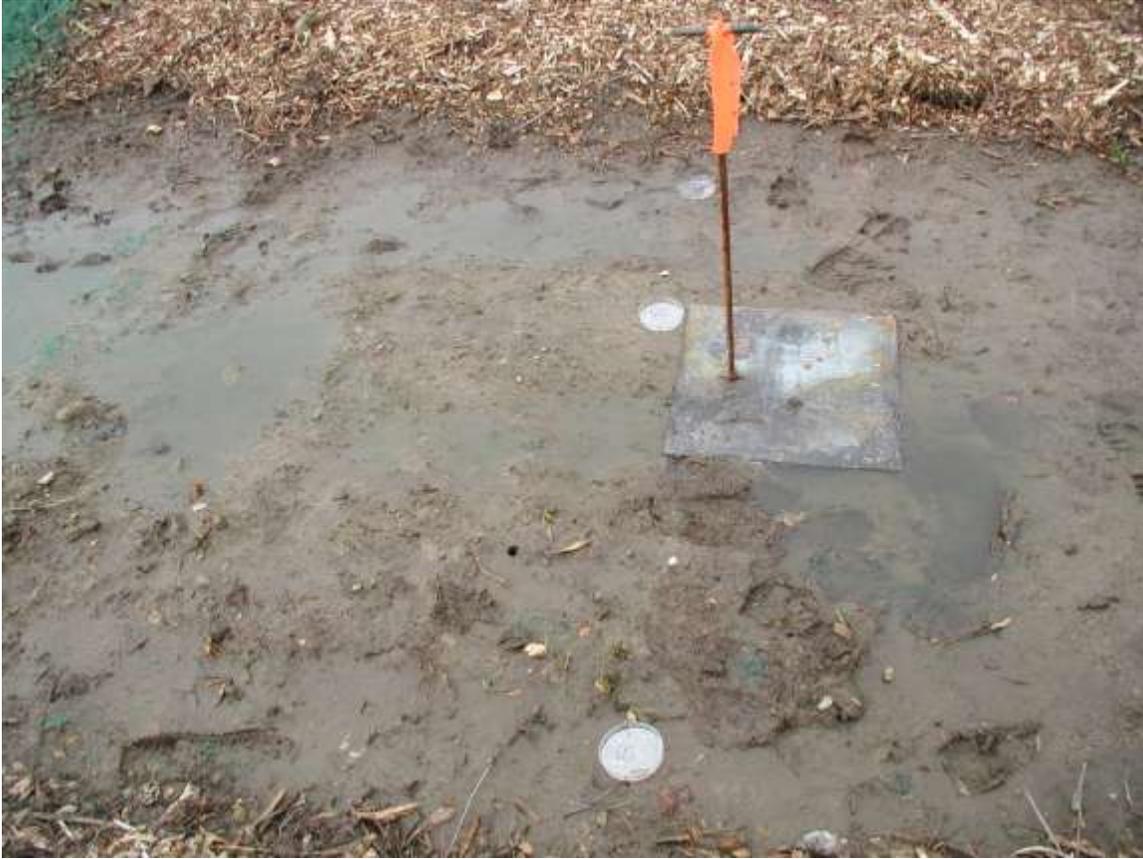
Figure 12-2. Typical installation of Petri dishes and steel rods

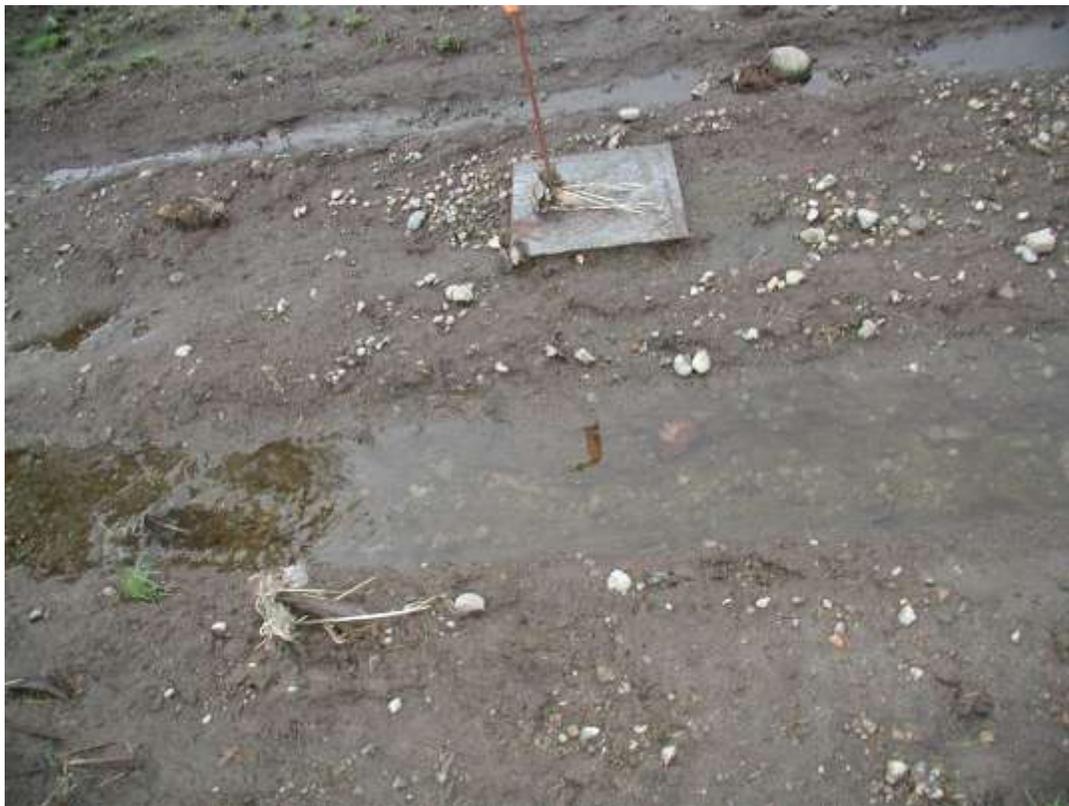
Figure 12-10. High water flow washed away the previously deposited sediment at the 124<sup>th</sup> Street site as depicted in this photograph taken on January 28, 2005

Table 12-4. Based on our observations, the predominate sediment sources were from upstream. The sediment loss from the left bank of this watercourse with treatment was insignificant, and there was no measurable rill formation on the bank as determined by visual inspection (Figure 12-10). Similarly, there was no visible evidence of rill erosion at the treated sites (Figure 12-14). A close-up of the Coir mat erosion control effectiveness is shown in Figure 12-15.

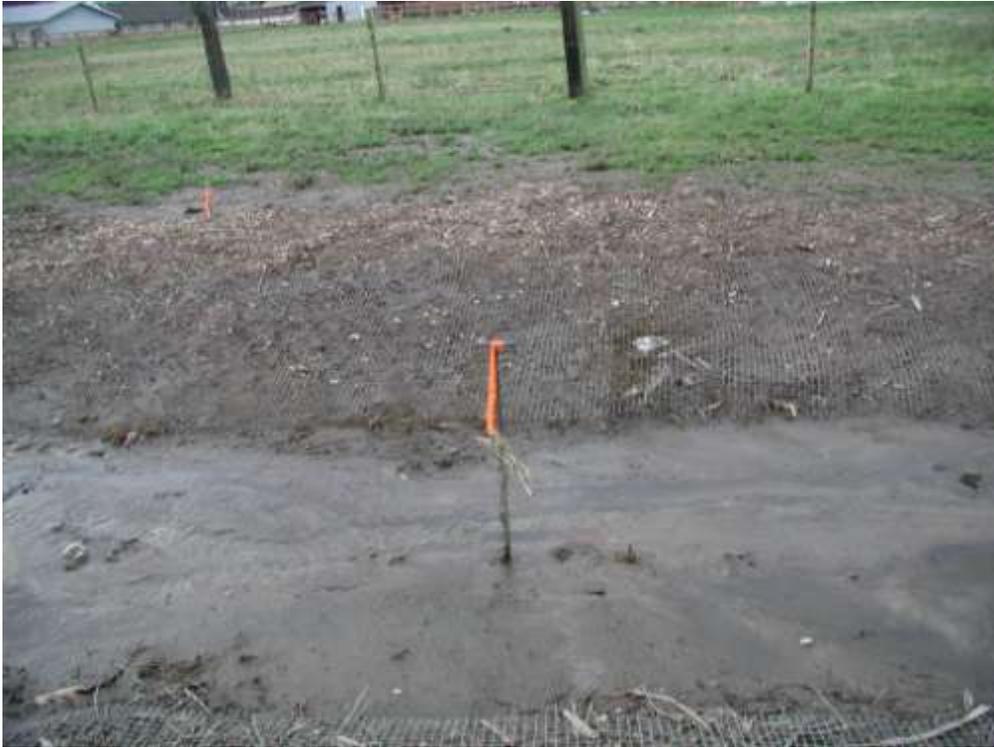
Figure 12-11. Example of sediment deposited near the watercourse outlet at the Ray Ewing property on January 28, 2005

The following are some observations on the results of cumulative sediment measurements at the Ray Ewing property. It is noteworthy that a highway drainage watercourse adjacent to this property inlet was blocked by mud and gravel which resulted in unusually high runoff through the Ray Ewing property. High water flows in December 2004 caused scouring effects on the channel bottom and washed away the previously deposited sediment at this site as illustrated in Figure 12-10. Hog fuel installed in treatments (9) and (10) were also washed out during the flood event. Of the twenty-four steel rods installed, positive cumulative sediment measurements were only observed at the seven rods located from 152.4 m to 182.9 m (500 ft to 600 ft) along the watercourse. This area was about 36.6 m (120 ft) upstream from the watercourse outlet (Figure 12-11). Based on the site inspection conducted by WSU researchers, the stream flow appeared to be impeded by a debris laden fence before the stream exited the property. During large runoff events this blockage created a pond-like area that allowed solids to settle out of suspension (Figure 12-12 and Table 12-3). Therefore, sediment accumulated in the lower section of this watercourse (treatment plot #7). As shown in the photos, a high water table was observed where woody matter (hog fuel) remained.

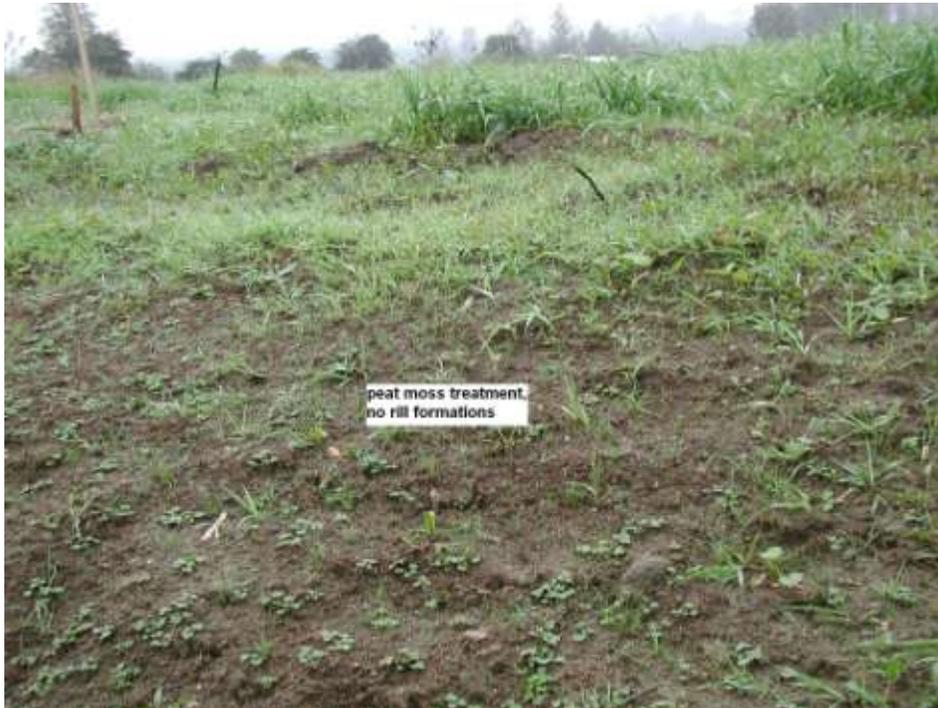
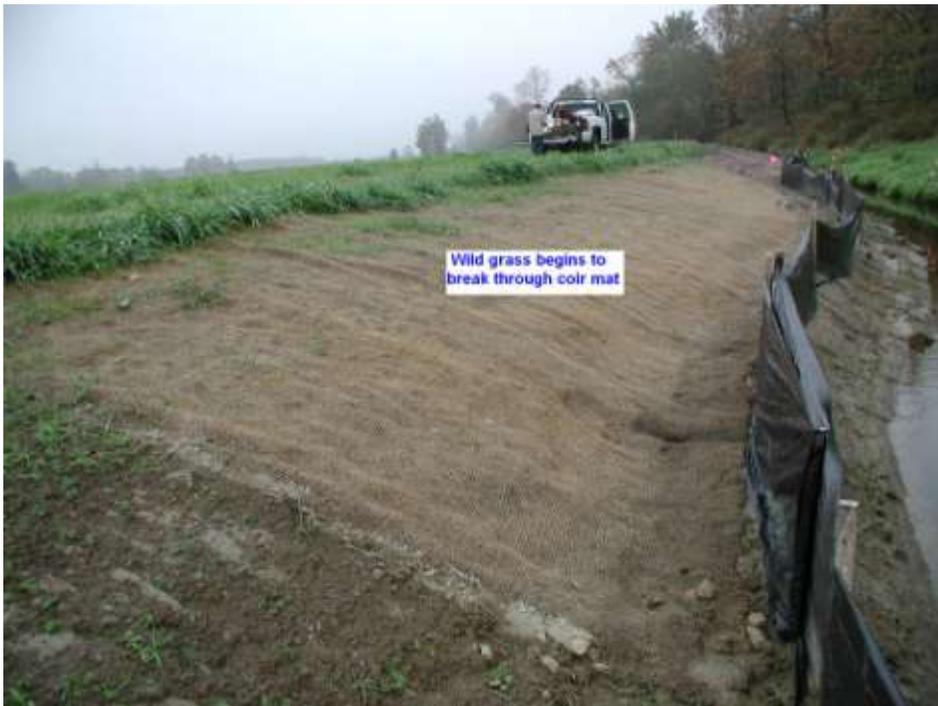
Figure 12-14. No rill formation in the treated bank at the 124th Street site, (a) treatment (1) peat moss, and (b) treatment (2) Coir mat

The first hypothesis was rejected at the 124<sup>th</sup> Street site in Duvall. At this site, the measurement of rill formation indicated that the rills from the treated banks were immeasurable and insignificant as illustrated in Figure 12-14. Upstream erosion sources were the primary contributor of the deposited sediment at this site. Therefore, locations similar to the 124<sup>th</sup> Street site, it is suggested that the most effective practices to extend the maintenance cycle of the watercourse would be to implement effective soil erosion control treatment in the upstream regions. Alternatively, a settling pond could be installed at the beginning of each long watercourse at this site. Sediment from upstream flows would settle out in such ponds due to slower flow velocities and increased hydraulic residence time. Economically, the cost for settling ponds should be much less than the cost of dredging a long watercourse on a frequent basis.

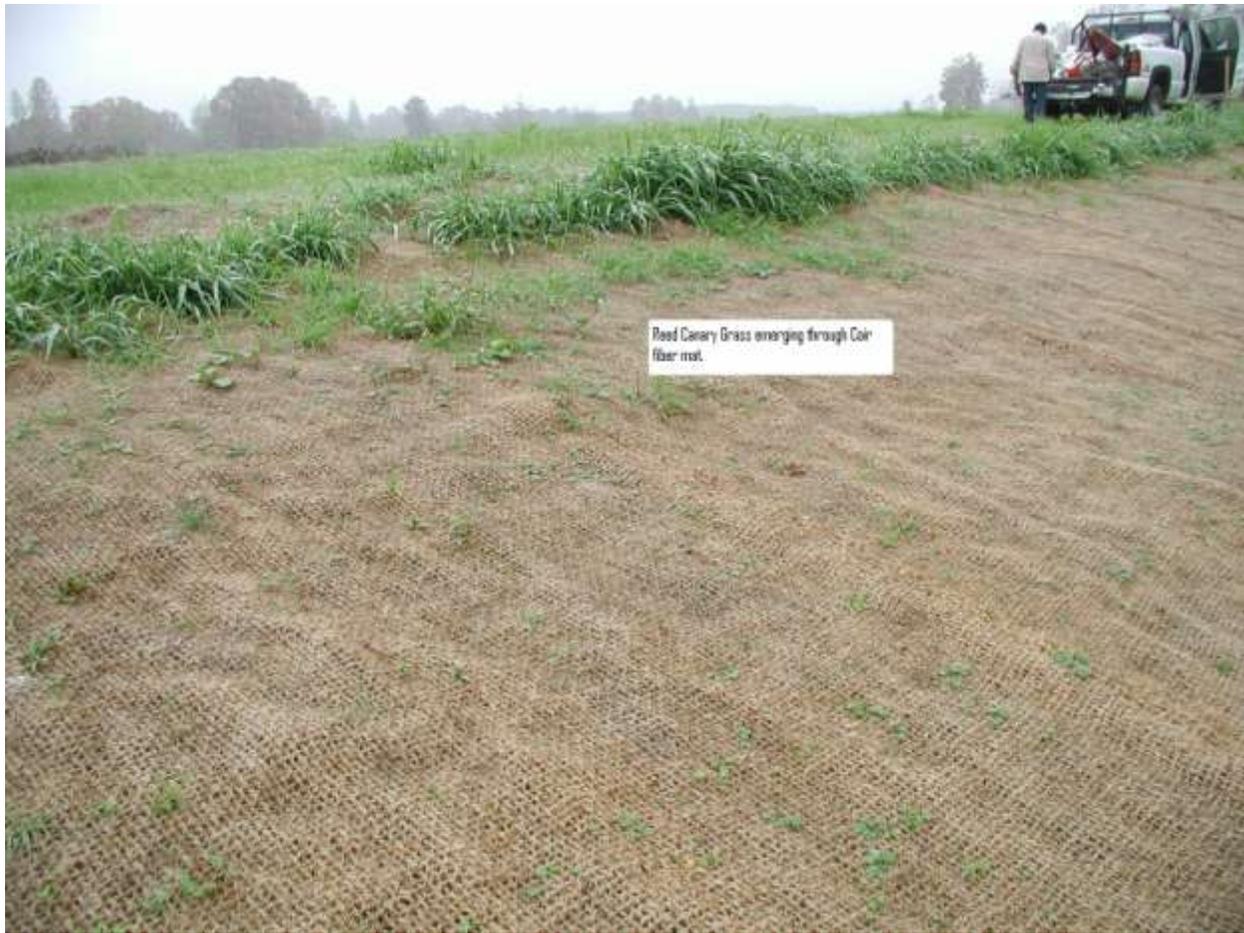
Figure 12-15. Visual evidence of erosion control provided by Coir fiber mat
