CHAPTER 13

Determining Whether Excavation Will Improve Drainage of Adjacent Agricultural Lands

13.1 Introduction to Characteristic Indicators of Improved Drainage after Excavation (Goal 12)

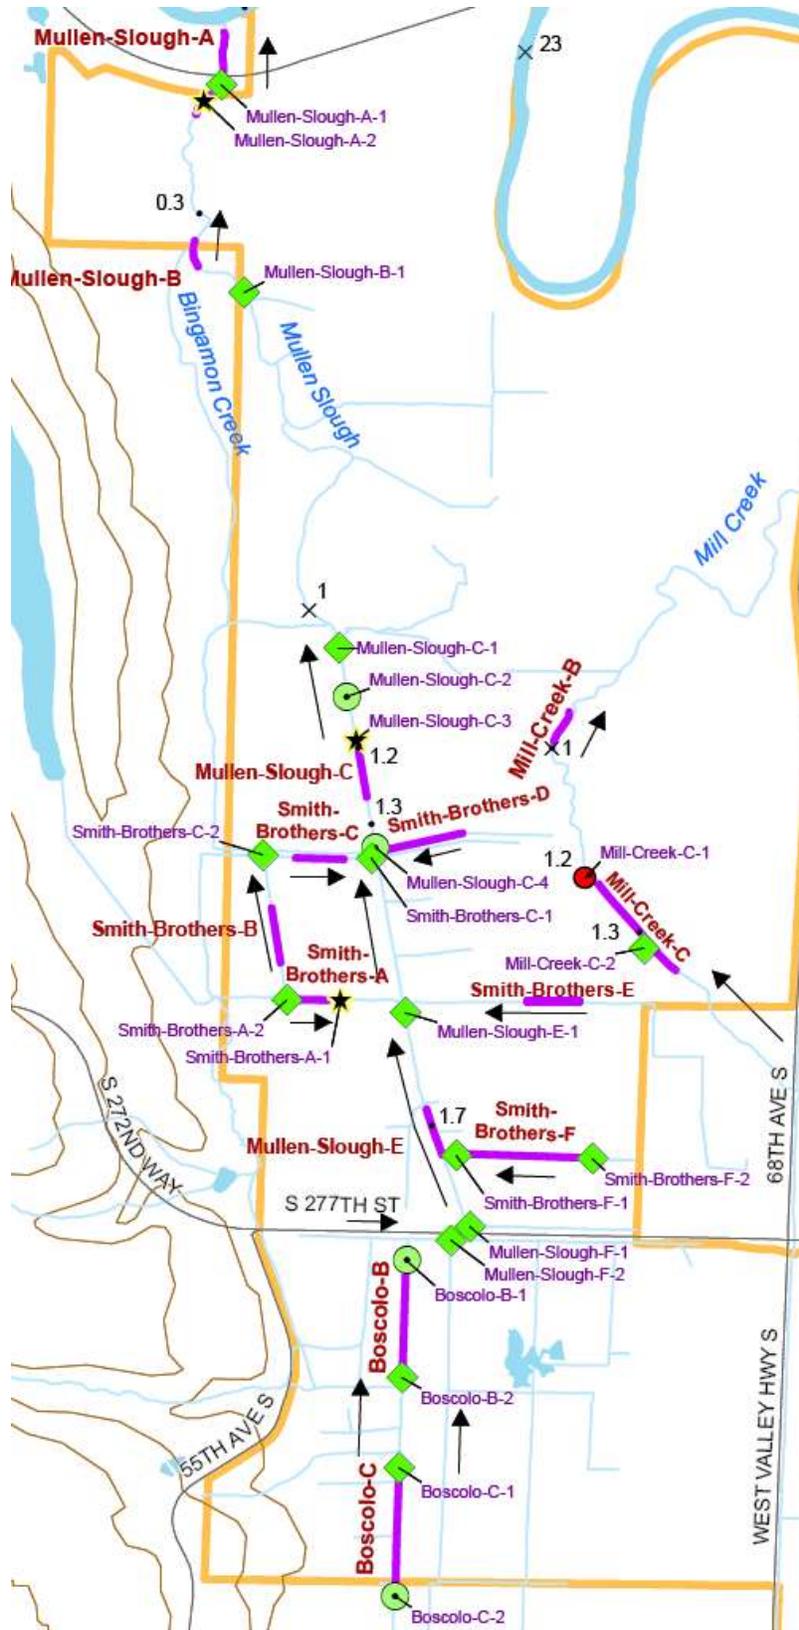
Figure 13-1. Mullen Slough study site location in Lower Green APD

The first site was the portion of Mullen Slough owned/leased by Smith Brothers' Dairy in Kent, Washington (shown in Figure 13-1, E-1 to C-4). A tributary to Mullen Slough is located in unmaintained King County road right of way adjacent to property owned by the Boscolo, Vilog, and Primero families was also used and illustrated as Boscolo B (see Figure 13-1). Both sites are located in the Lower Green River APD. Mullen Slough afforded a unique location from which to observe the effects of agricultural watercourse maintenance on site drainage. During the course of the study maintenance activities were scheduled at Smith Brother's resulting in the site's selection for survey data collection. Prior to maintenance operations Mullen Slough was severely clogged with reed canarygrass which was restricting channel flow and causing local ponding in surrounding agricultural lands. During the sampling at Mullen Slough hand-cleaning operations were underway offering a unique opportunity for direct comparison between un-cleaned and cleaned channel characteristics. Figure 13-2 and Figure 13-3 depict pre-maintained conditions along sections of the Mullen Slough drainage. Field inundation on the dairy property can be clearly seen in Figure 13-3. Alternately, Figure 13-4 shows the same section of waterway after maintenance.

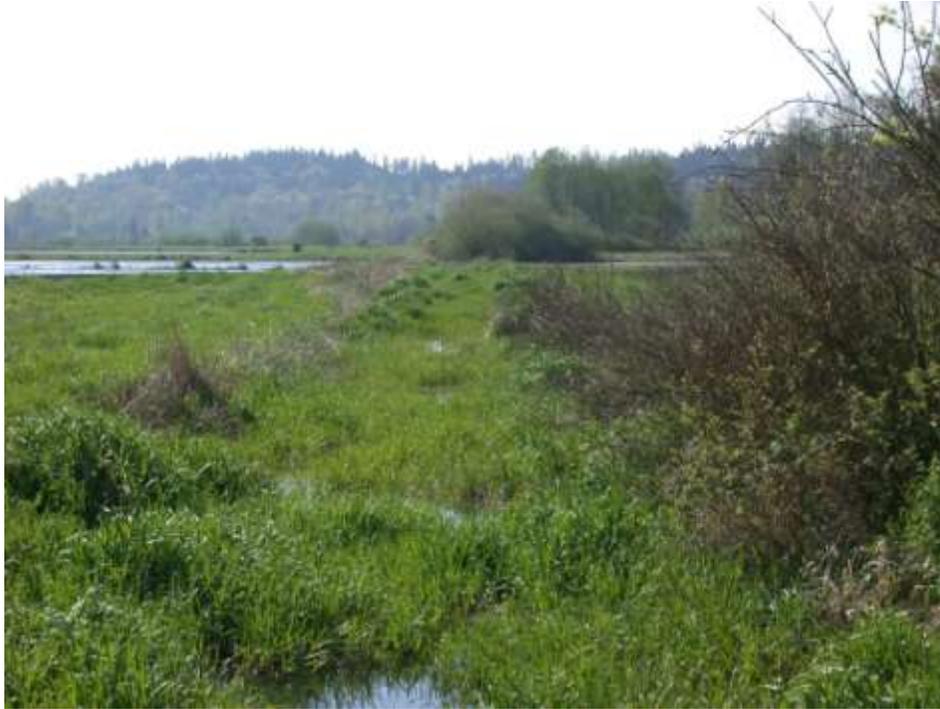
Figure 13-3. Smith Brothers Dairy property April 8, 2004

The reach surveyed for Mullen Slough was a relatively straight, flat section 1,594 ft long with the survey equipment situated at GPS station N47.27.648 W122.15.663 (Mullen Slough E-1 to Mullen Slough C-1 in Figure 13-1) at elevation 31.0 ft above sea level. Figure 13-3 illustrated pre-maintained conditions in the lower segment of Mullen Slough (Mullen Slough C) at the Smith Brothers' Dairy. Figure 13-13 shows the same location after being cleaned.

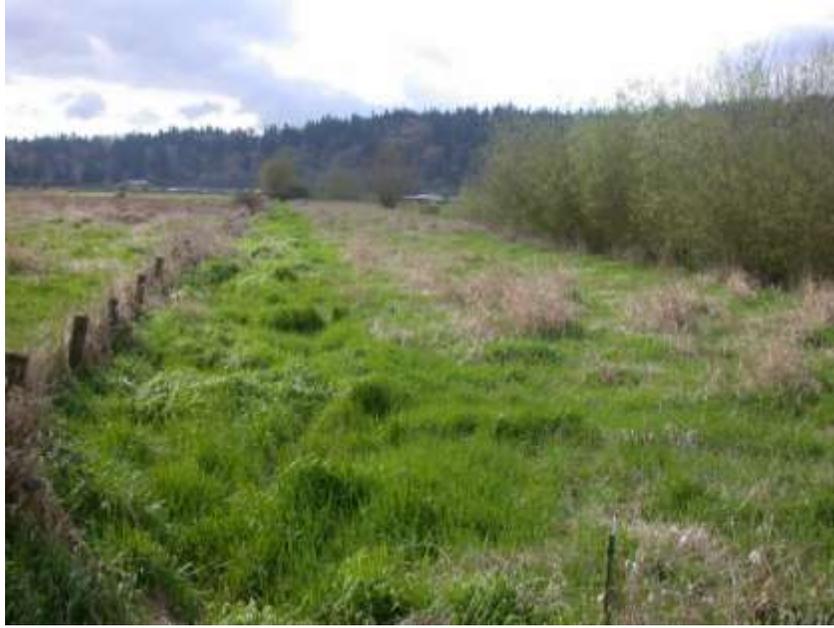
Figure 13-5. Waterway along Boscolo, Vilog, and Primero properties on April 4, 2003

The waterway adjacent to Boscolo, Vilog, and Primero properties was located upstream from the dairy, along a tributary to Mullen Slough. Pre- and post- maintenance photographs are presented in Figure 13-5 and Figure 13-6, respectively. King County performed maintenance activities after survey data was obtained so the reaches included in analysis were still heavily vegetated.

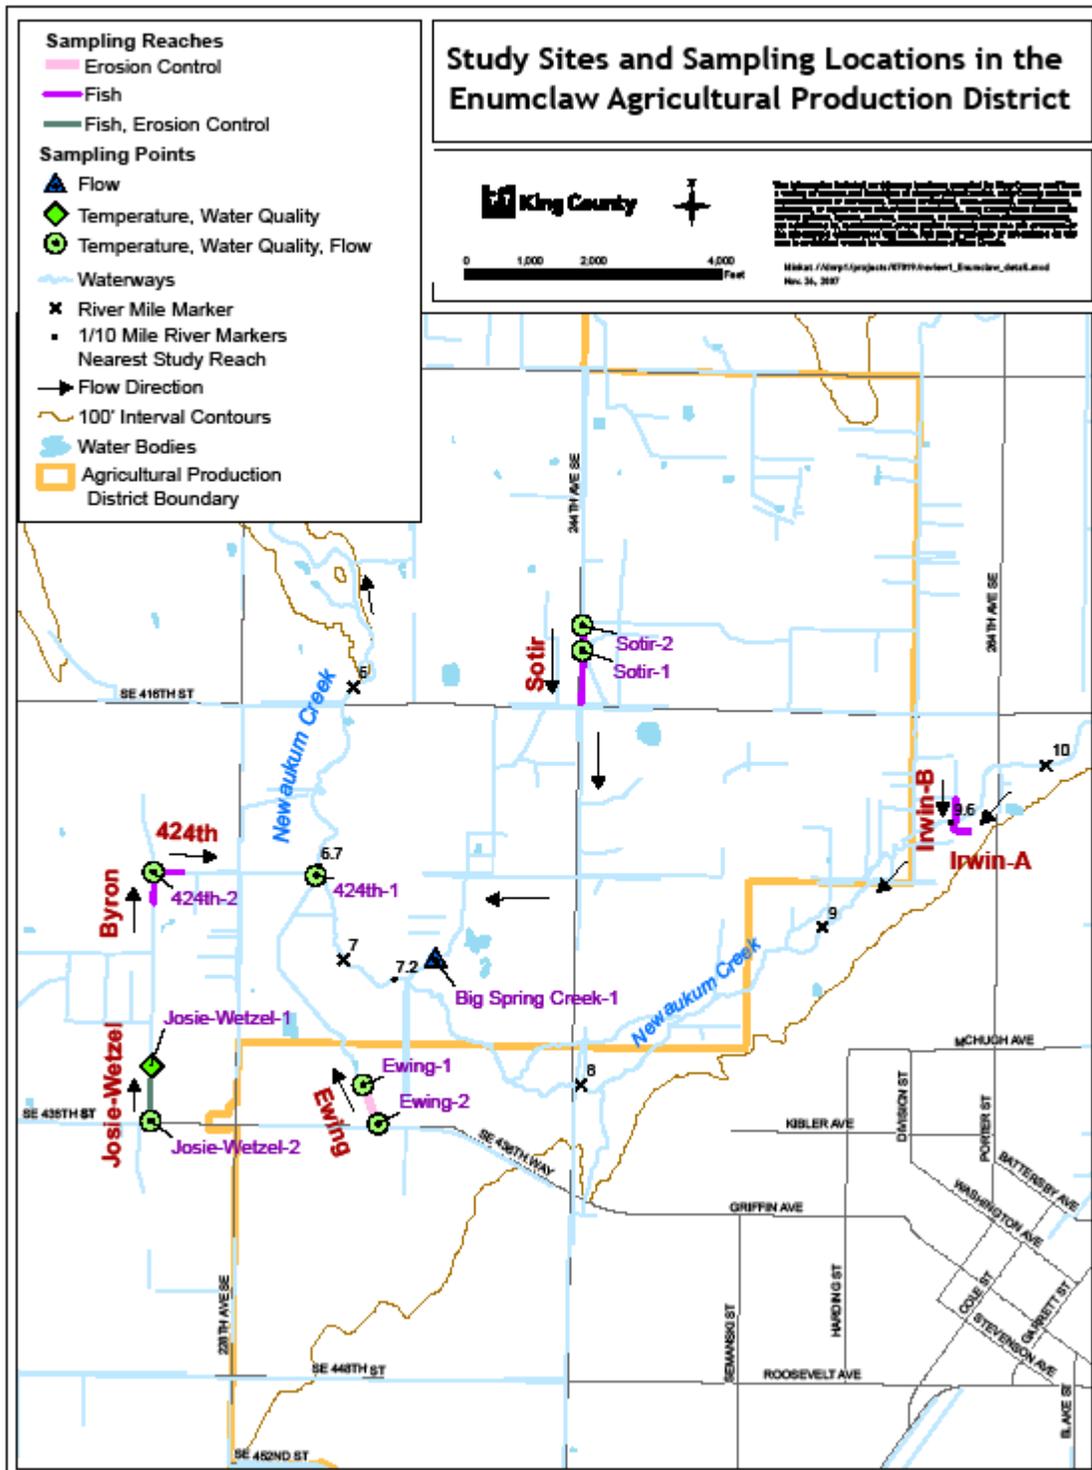
Figure 13-7. Big Spring Creek study site location

A third site was a segment of Big Spring Creek in Enumclaw, Washington at was Engberg/Dryer property as seen in Figure 13-7. This site was selected because its' un-maintained status gave researchers an excellent opportunity to survey and analyze pre-dredge channel characteristics. The Engburg portion of Big Spring Creek flowed through a portion of agricultural land inhabited by a small cattle herd. Other segments were unused at the time of sampling and vegetated primarily by grass species. Figure 13-8 shows a typical section of Big Spring Creek with its high levels of vegetation. Figure 13-9 shows the project post-maintenance.

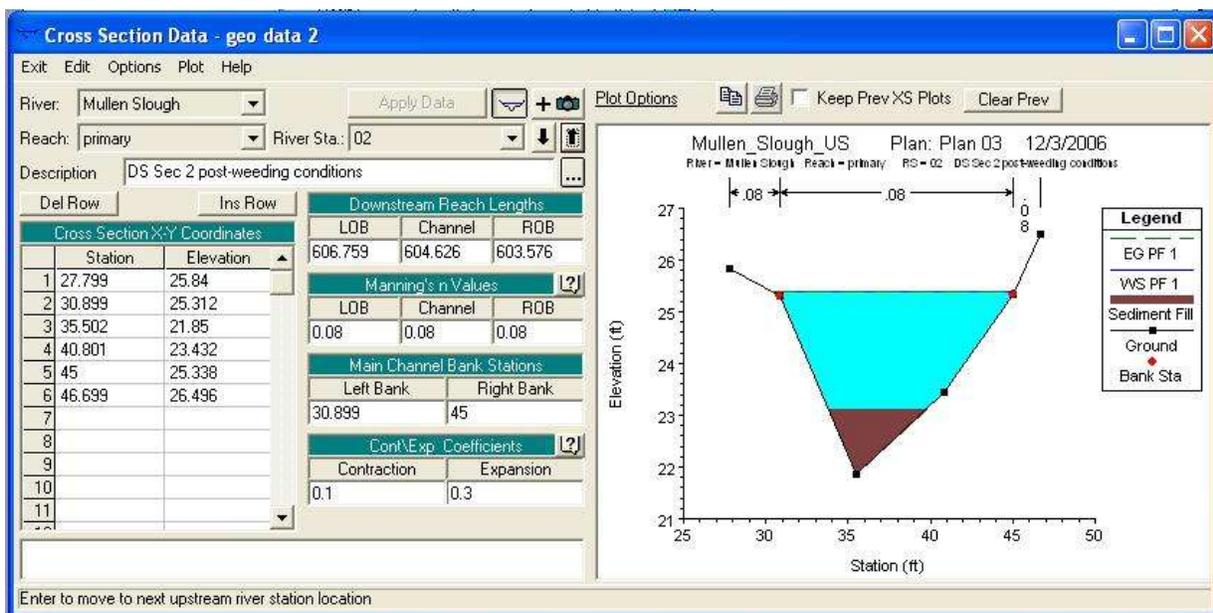
and bed slope. The collected survey and flow data was entered into the program which calculated flow depths based on the variables collected in this study by iterating between different known parameters. When the modeled water depths matched those observed the roughness input from the calibrated model was recorded. In this way a representative roughness value was chosen for both cleaned and vegetated scenarios. The roughness values can then be used in future flood prediction calculations and evaluations of drainage potential as well as a mechanism for estimating flow velocities in water quality models. A typical HEC RAS geometric data entry window is displayed in Figure 13-10. As illustrated, the window contains cross-section characteristics relating station to elevation, Manning's roughness values for the left and right overbanks (flood plains) and main channel, contraction and expansion head loss coefficients, and a graphical depiction of the cross-section.

Figure 13-10. Typical HEC-RAS data frame window

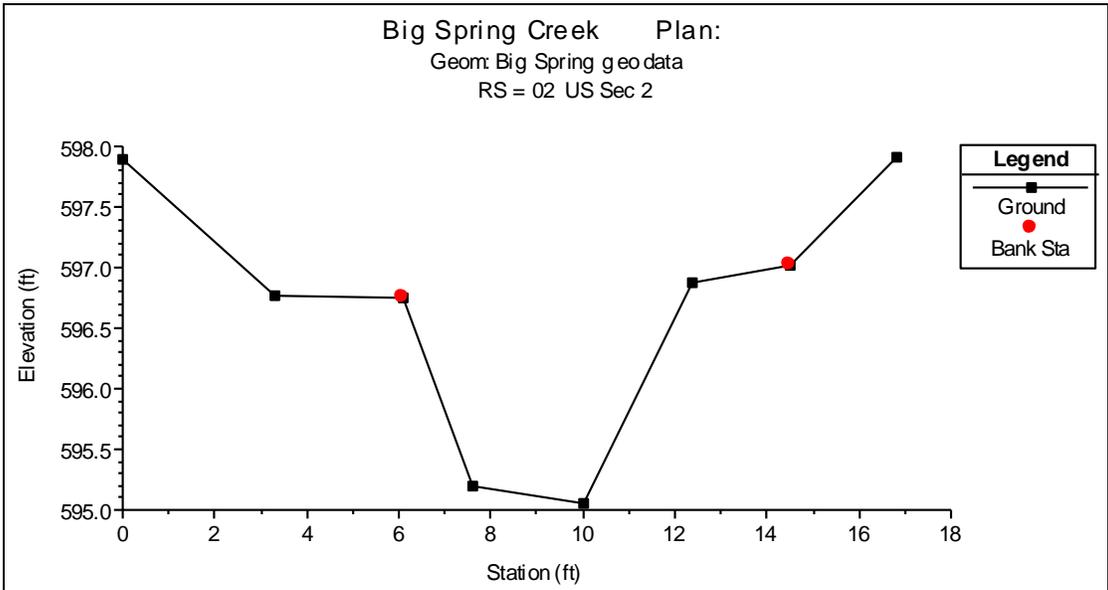
The reach surveyed for Big Spring Creek included a 683 ft long section with the survey equipment situated at GPS station N47° 13.053' W122° 1.511' at elevation 599 ft above sea level. Typical conditions were shown previously in Figure 13-8. The water surface elevation change from the far upstream point to the far downstream point was approximately 1.64 ft for a slope of 0.29 % over the entire 683 ft reach. A typical cross section for the upstream direction can be seen in Figure 13-11 as plotted by HEC-RAS 3.1 modeling software. Similarly, Figure 13-12 shows a typical downstream cross section.

The creek depth varied from approximately 3.0 ft to 1.4 ft upstream to downstream with an average flow depth of 2.1 ft over the entire survey length.

Figure 13-11. Characteristic upstream cross-section of Big Spring Creek

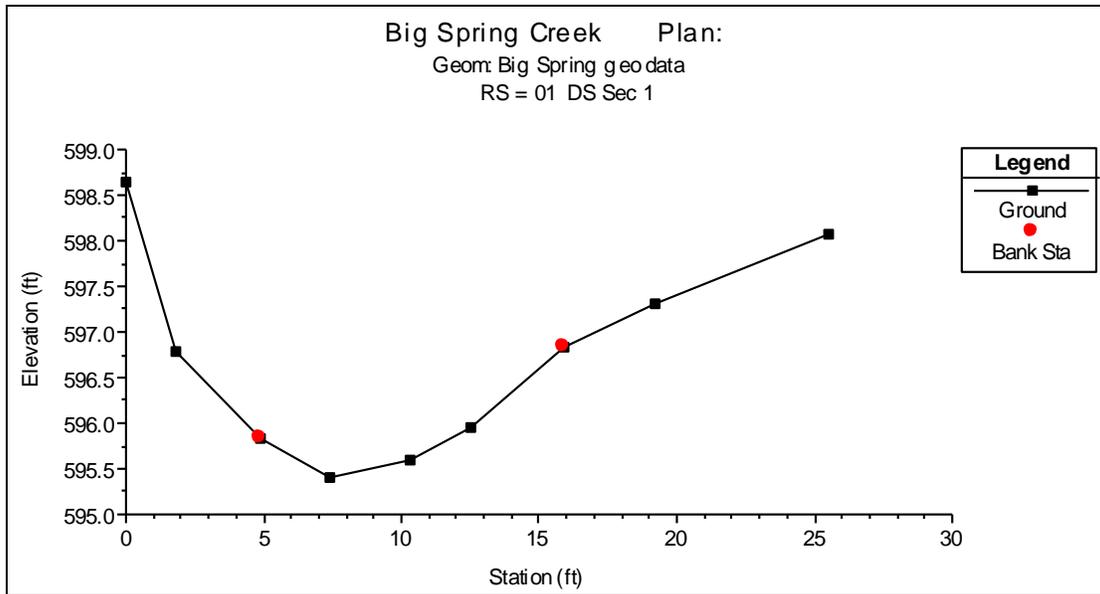
Figure 13-12. Characteristic downstream cross-section of Big Spring Creek
(Big Spring Creek location is seen in Figure 13-7)

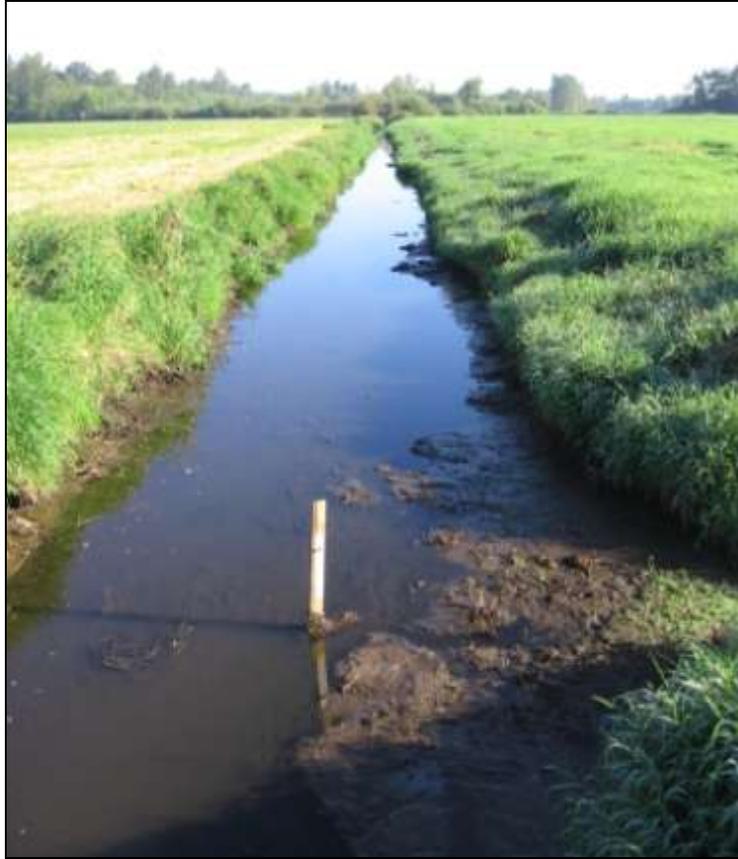
Figure 13-13. Typical post-cleaned conditions at Mullen Slough (Figure 13-1, Mullen Slough C)

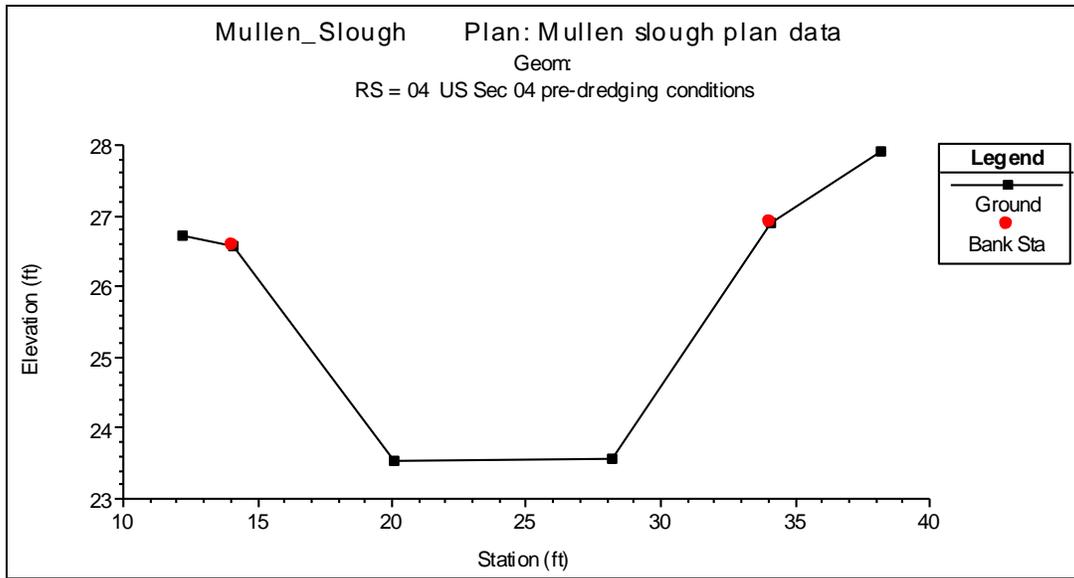
Approximately 184.4 m (604.9 ft) between Mullen C-3 and Mullen C-1 (the most downstream segment) was devoid of vegetation due to ongoing hand cleaning. The remaining 301.5 m (989.1 ft) between the Slough's confluence with Smith Brothers Reach C and Mullen Slough E-1 was clogged with reed canarygrass (RCG). The water surface elevation change of the vegetated portion from the far upstream point to the far downstream point was approximately 0.43 m (1.4 ft) for a slope of 0.14 % over the entire reach. The weeded portion had a water surface elevation change of approximately 0.0012 m (0.004 ft) over the 184.4 m (604.9 ft) length giving a slope of 0.00066 %. Typical cross sections for upstream and downstream directions can be seen in Figure 13-14 and Figure 13-15 respectively.

Mullen Slough's creek depth varied from approximately 1.04 m (3.4 ft) upstream to 1.10 m (3.6 ft) downstream with an average flow depth of 1.05 m (3.4 ft) over the entire survey length.

Figure 13-14. Characteristic pre-cleaned upstream cross-section of Mullen Slough

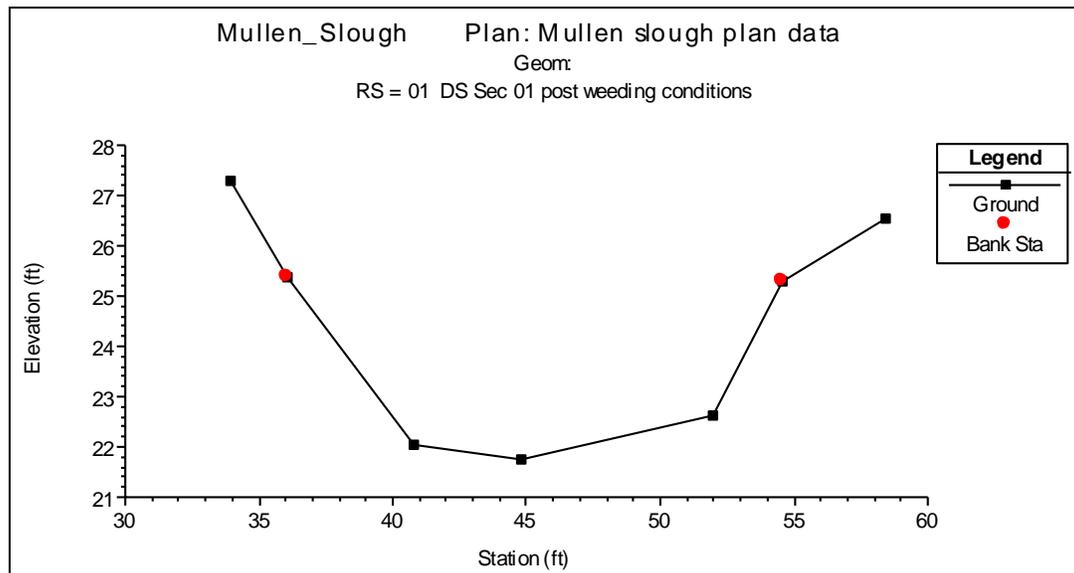
Figure 13-15. Characteristic post-cleaned downstream cross section of Mullen Slough

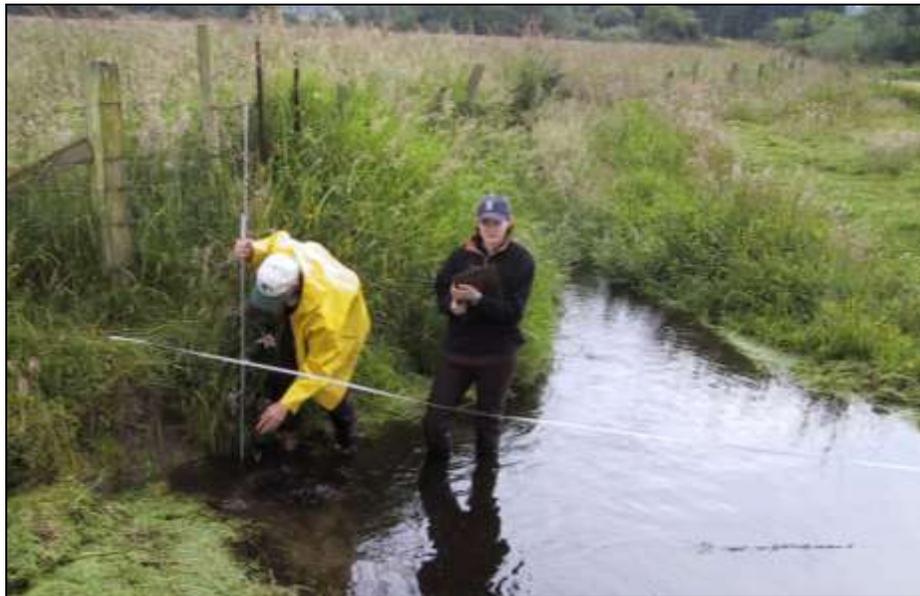
In most areas the creek was clogged with thick vegetation consisting primarily of reed canarygrass. As illustrated in Figure 13-16 in one location, local livestock appeared to have cleared an area downstream from a small bridge. This was the location chosen for flow measurements. Discharge was determined to be $0.058 \text{ m}^3/\text{s}$ ($2.05 \text{ ft}^3/\text{s}$) and the maximum velocity was 0.25 m/s (0.81 ft/sec).

Figure 13-16. Stream gauging location on Big Spring Creek

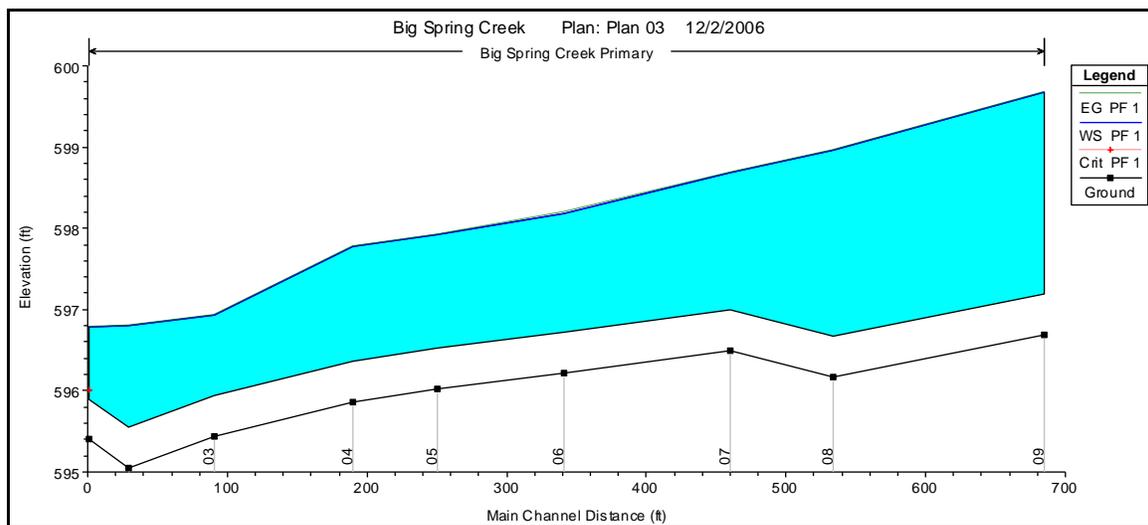
The difference in slopes for both sites can best be illustrated by a longitudinal profile of the reach system. In Figure 13-17 the highly variable slope of the un-maintained Big Spring Creek site is shown. By contrast, in Figure 13-18 the cleaned portion of Mullen Slough has a much lower slope gradient beginning at River Station 03. Note the varied gradient upstream between stations 03 and 07 where cleaning operations had not yet begun.

Figure 13-17. Longitudinal profile of Big Spring Creek showing a highly variable flow gradient throughout the un-maintained reach

Note that the simulations are based on known sediment elevations which appear as a white space between the ground level and the water /sediment interface. The nature of the maintained reach sediment was that of a low-density silty medium with a high degree of decaying organic matter. Due to these characteristics the surveying prism protruded through the sediments resulting in a measurement of the firm watercourse bottom below.

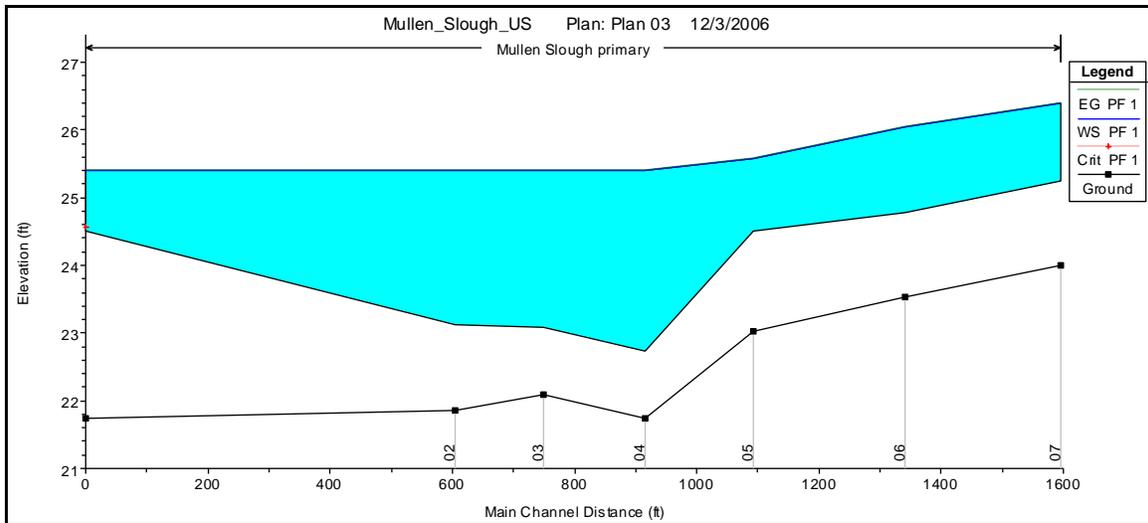
Figure 13-18. Longitudinal profile of Mullen Slough illustrating altered flow gradient as a result of cleaning operations

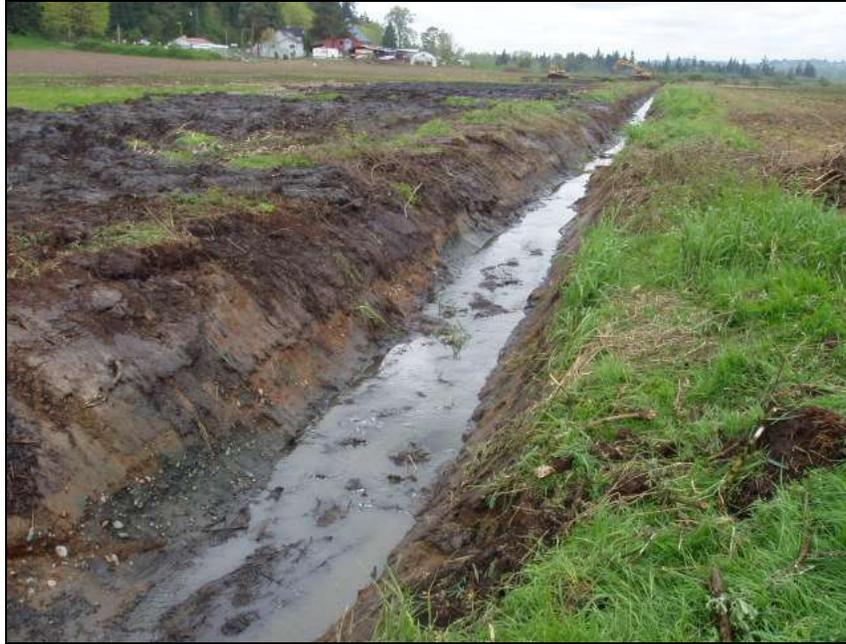
In the first case, heavy equipment is used to remove the reed canarygrass and other unwanted vegetation and tree roots from the watercourse. In this case, most of the sediment is left in place leaving a high dissolved oxygen demand and relatively “soft” bottom. While immediate improvement of the hydraulics is expected, the regrowth of vegetation may be facilitated by the remaining sediments. In the second case, mechanical removal of vegetation and sediment, as depicted in Figure 13-19, results in a cleaner ditch and better overall water quality conditions (DO and BOD are improved) and a firmer bottom which may be beneficial to benthic organisms. The sides of the waterways may be bare and subject to erosion prior to establishment of new vegetation. In general, this is a much more invasive approach that can lead to downstream pulses of sediment if not adequately controlled. However, it is anticipated that this would need to be done less frequently than the other maintenance techniques. In the third case, hand removal of vegetation only produces the same basic conditions as case 1. Hypothetically, it might be easier to be more selective using this approach, even leaving some vegetation if short-term cover is deemed essential, but practically a crew removes most all the vegetation using hand-tools such as rakes and shovels. Because it is a slower process, there is less chance for larger disturbances than with mechanical excavation. The fourth case, hand removal of vegetation and sediment is very labor intensive and would result in conditions similar to case 2. We did not encounter any situations where this was implemented during our study.

Figure 13-19. Typical example of mechanically excavated removal of sediment and vegetation
