# GEOMORPHIC ASSESSMENT

## MIDDLE FORK SNOQUALMIE RIVER TANNER TO THREE FORKS NATURAL AREA

**King County**

June 18, 2013

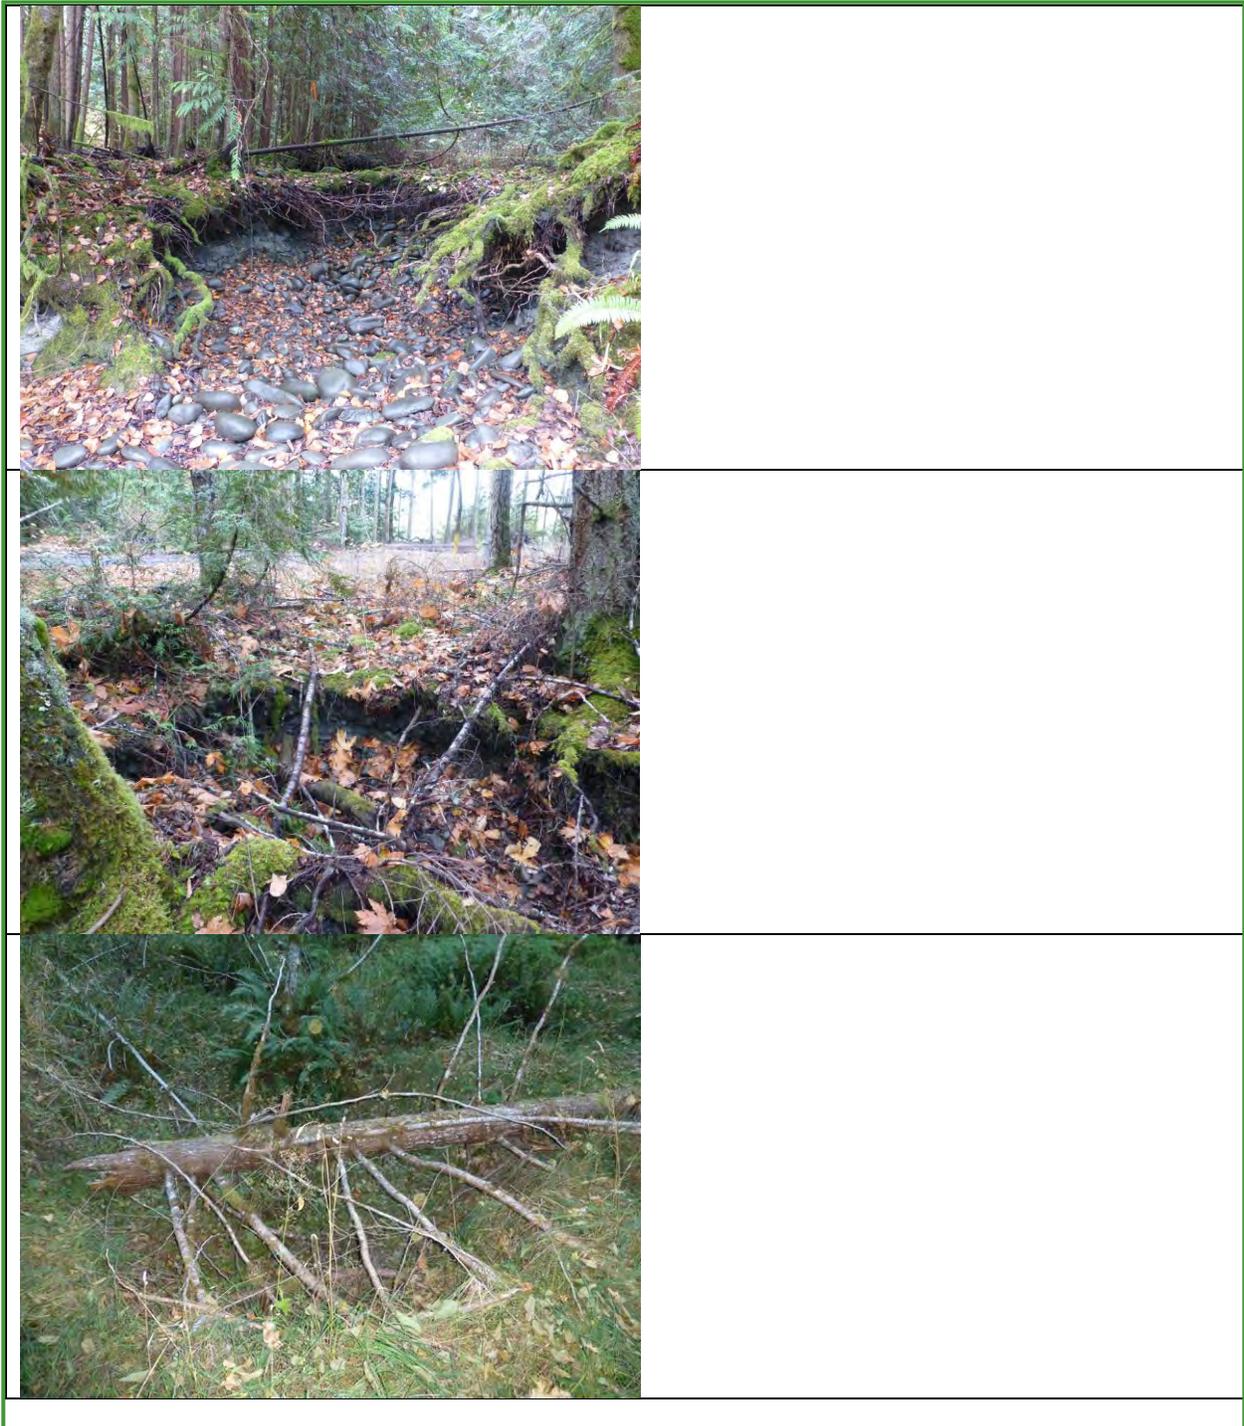
**Figure 14. Headcuts in Vegetated Floodplain Areas, Elwha River, Olympic National Park and Lower Elwha Klallam Indian Reservation, Washington.**

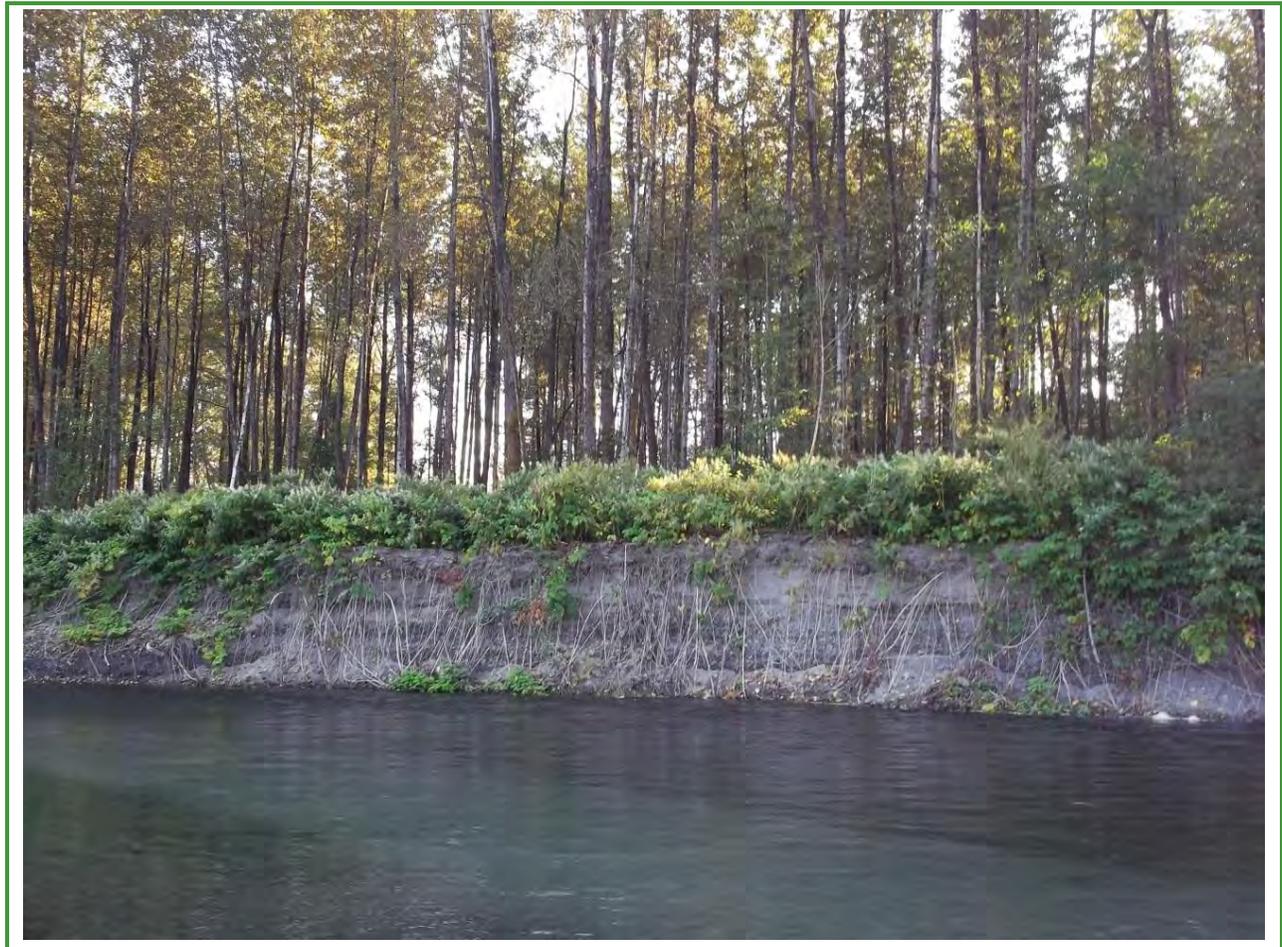
**Figure 15. Typical Cut Bank in Confluence Subreach Showing Relatively High Content of Fine-grained Sand/Silt/Clay at the Top of Bank.**

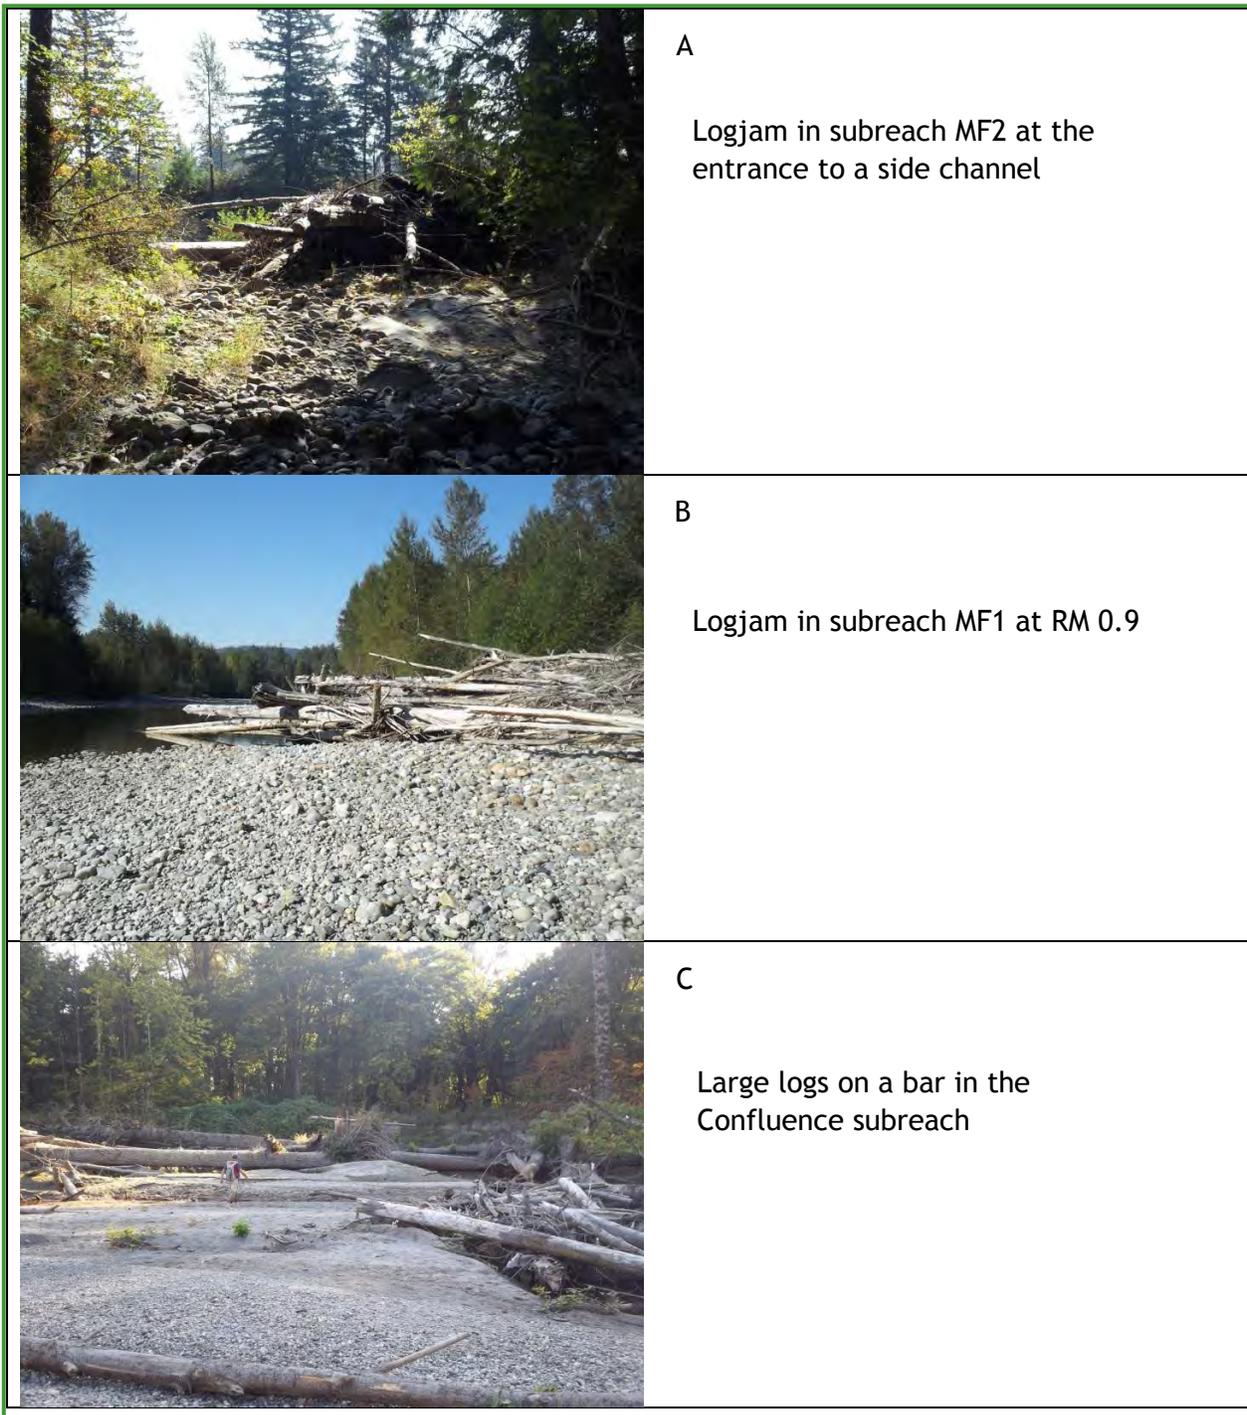
Figure 20. Log Jams in the Study Reach.

Despite the relative paucity of wood recruitment sites upstream of the Confluence subreach, accumulations of wood are present in the channel and on bars at several locations in the study reach. Figure 20 shows photographs of several typical wood accumulations. Wood is present in subreach MF2 at the entrance to several side channels, as shown in Figure 20A. It

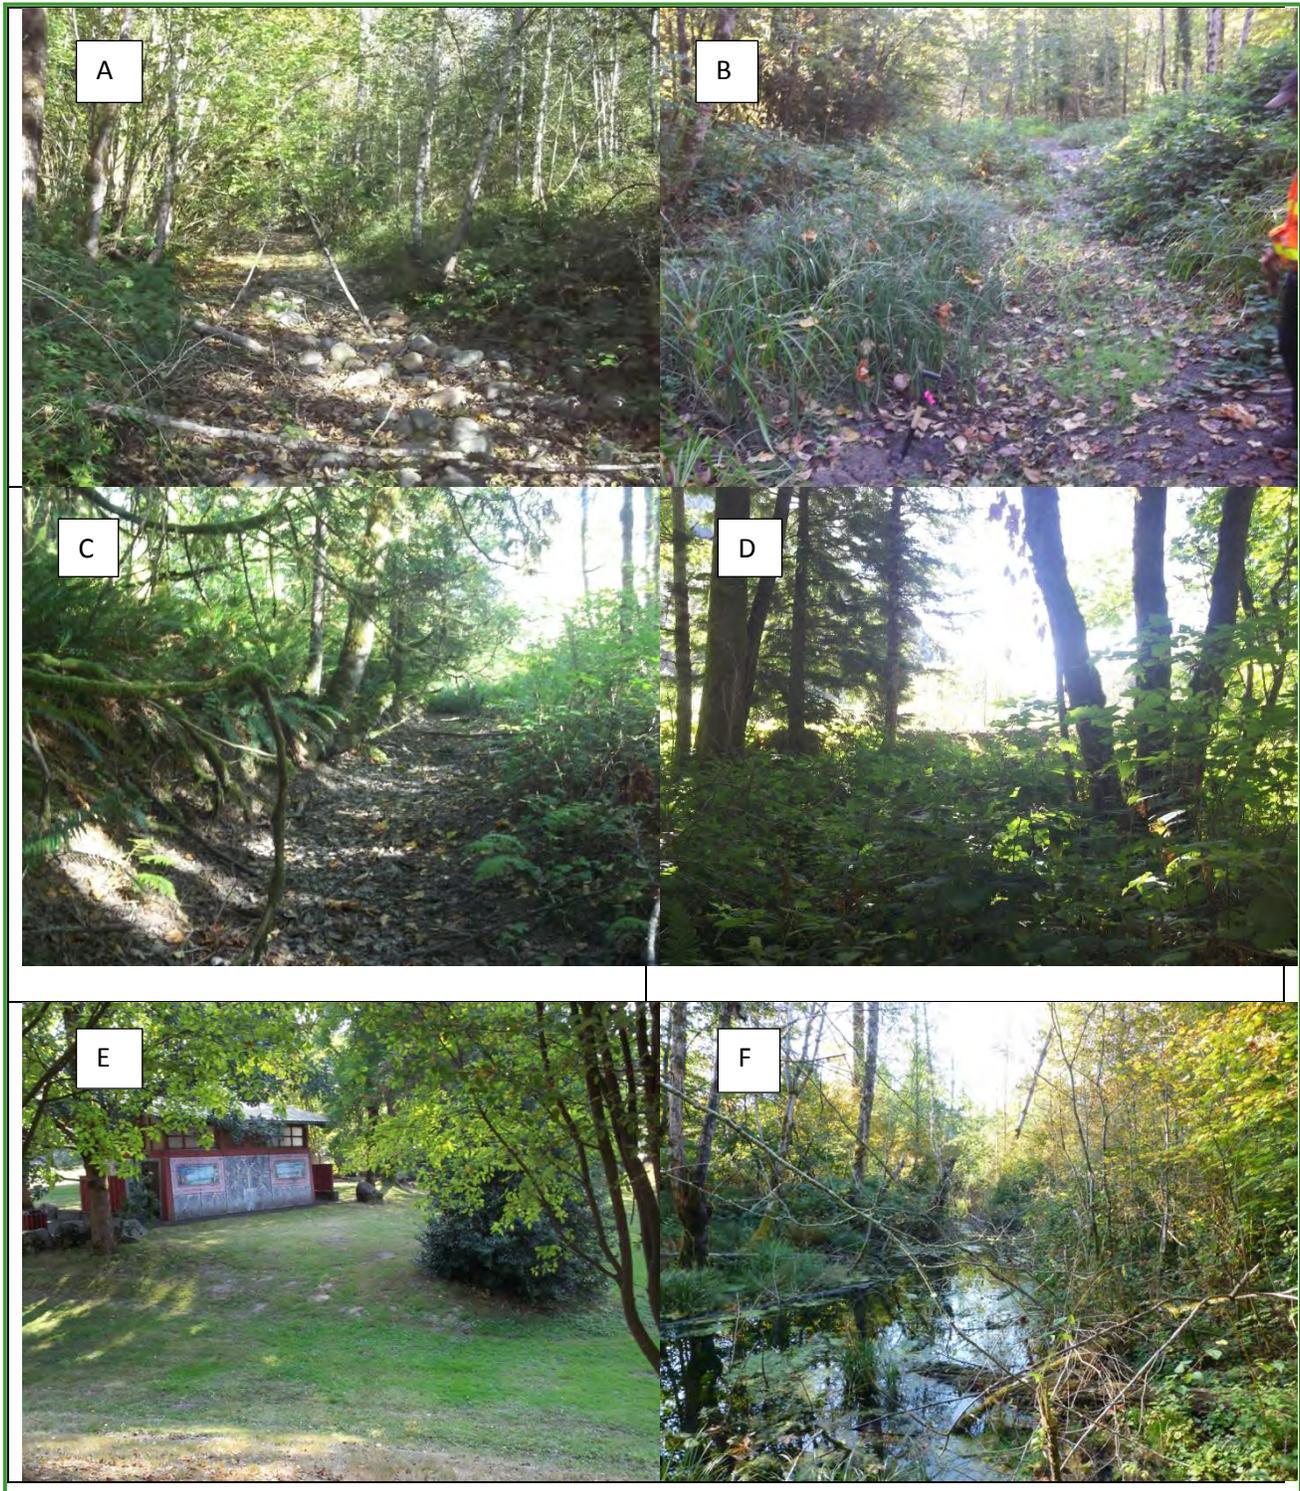
**Figure 24. Side Channels Near RM 1.3 and Relict Floodplain Channels at Various Locations in Floodplain.**

During large floods, flow that bypasses the Mason Thorson Extension Levee could potentially enter a set of relict floodplain channels. The extent of the hydraulic connection is detailed by WSE (2013). Additional erosion of the bank upstream of the levee could provide an additional hydraulic connection to these channels, increasing discharge and associated flood hazards to developed properties in the floodplain. Most of these floodplain channels re-enter the Middle Fork within a mile of the Mason Thorson Extension Levee. However, at least one has the potential to provide flow to the relict channel that connects to Reid Slough. This relict channel was one of the two channels on the floodplain identified by Perkins (1996) as being at risk of enlarging to the point where it could eventually capture the main flow of the Middle Fork in a large-scale channel avulsion.

Figure 24F shows the channel of Silver Creek near radiometric sampling site 5. The obvious backwater in this channel and the fine sediment on the bed and in the hand auger samples collected at this site imply that even during floods, shear stress is not sufficient to mobilize coarse material in the channel. While flow velocities and shear stresses in the cross-floodplain channels that supply flow to this area are certainly higher than in Silver Creek, the presence of multiple road crossings and relatively dense vegetation probably mitigates the risk of rapid enlargement of these channels during a single large flood event.

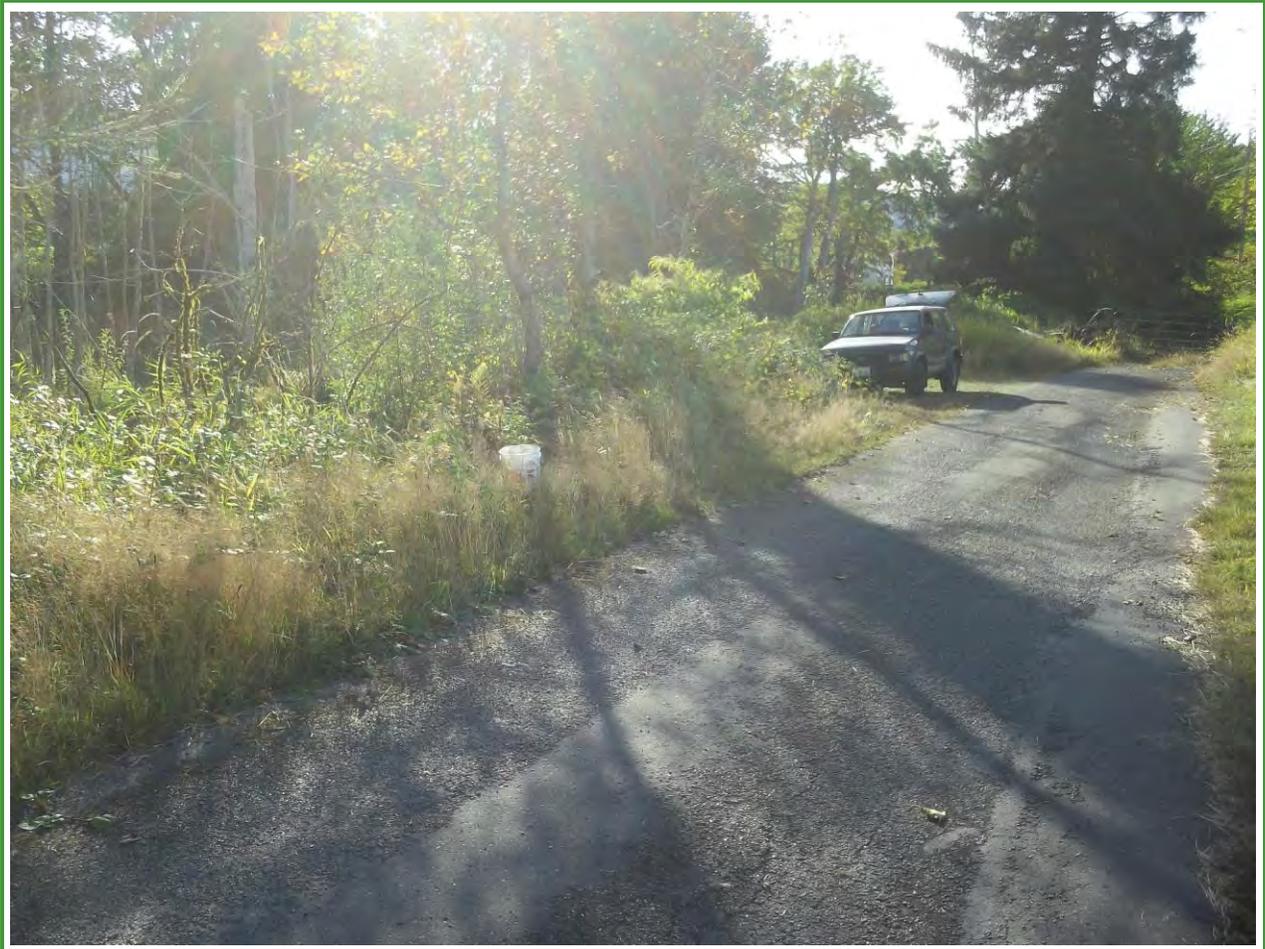
**Figure A2. Sample Site for MFS F2-3.8 we and MFS F2-4.2 we. The Coring Site Was Located Near the White Bucket Shown in the Image. Photo Is Taken Facing West.**

These samples were collected by hand auger from an oxbow lake deposit on the south side of SE 100th Street, approximately 100 feet east of a closed gate, near the bottom of the road prism. A photograph of the site is provided in Figure A2.

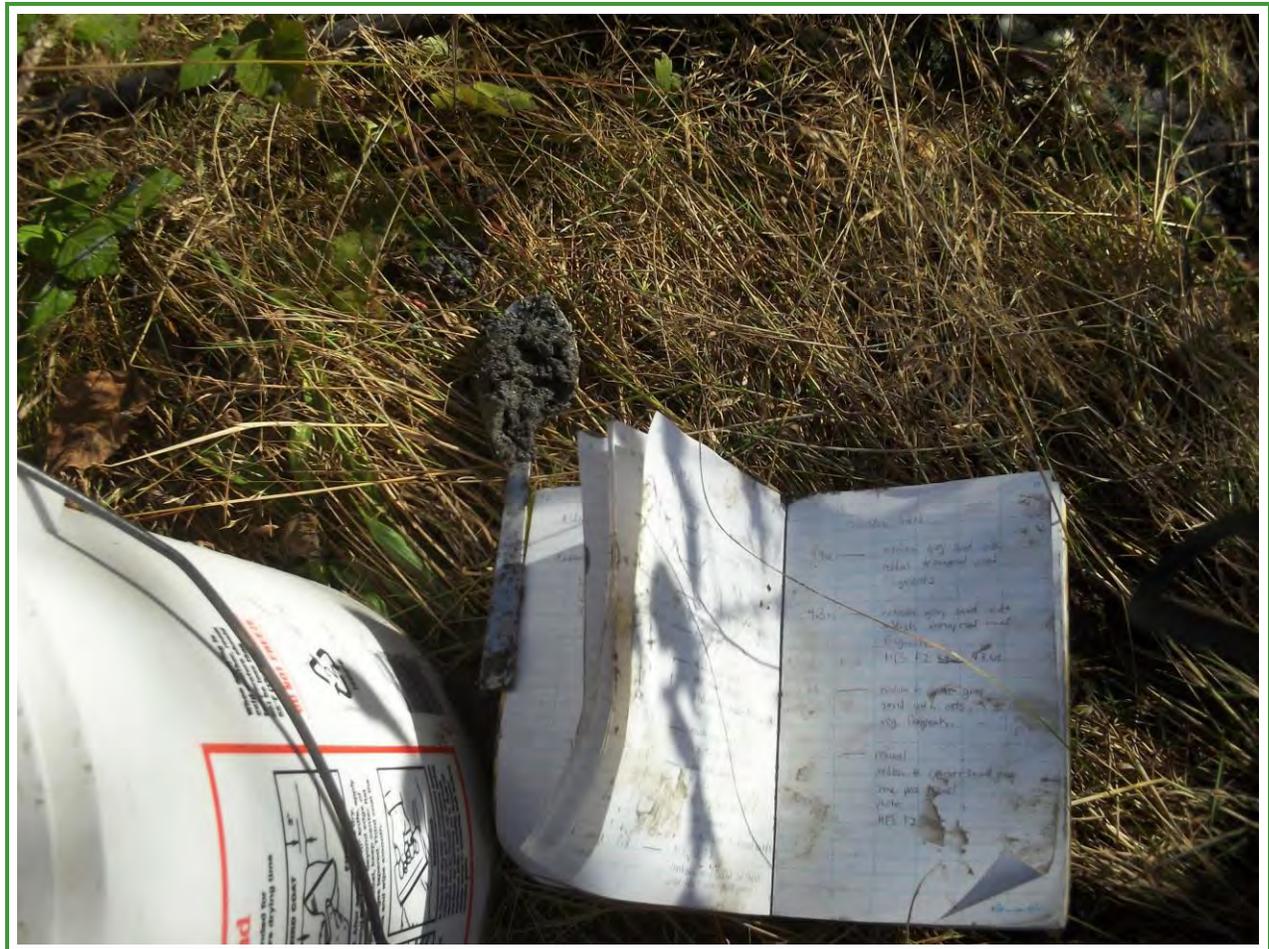
Figure A3. Gray Sand From Which Sample MFS F2-3.8 we Was Sampled.

Samples were collected at depths of 7.1 and 7.5 feet below the ground surface, respectively. A photograph of the soil from which sample MFS F2-3.8 was collected is shown in Figure A3. Both samples at this site were collected from near the base of a massive, 5.9 foot (1.8 m) thick sand layer, approximately 0.5 feet (0.2 m) above gravel that could not be penetrated by the hand auger. The sand deposit exhibited noticeable upward fining. Minimal oxidation was present. The water table on the day the sample was taken was within 2.5 feet of the ground surface. Since the sample was taken after an extended dry period, it is likely that the sampling depth is permanently below the water table.

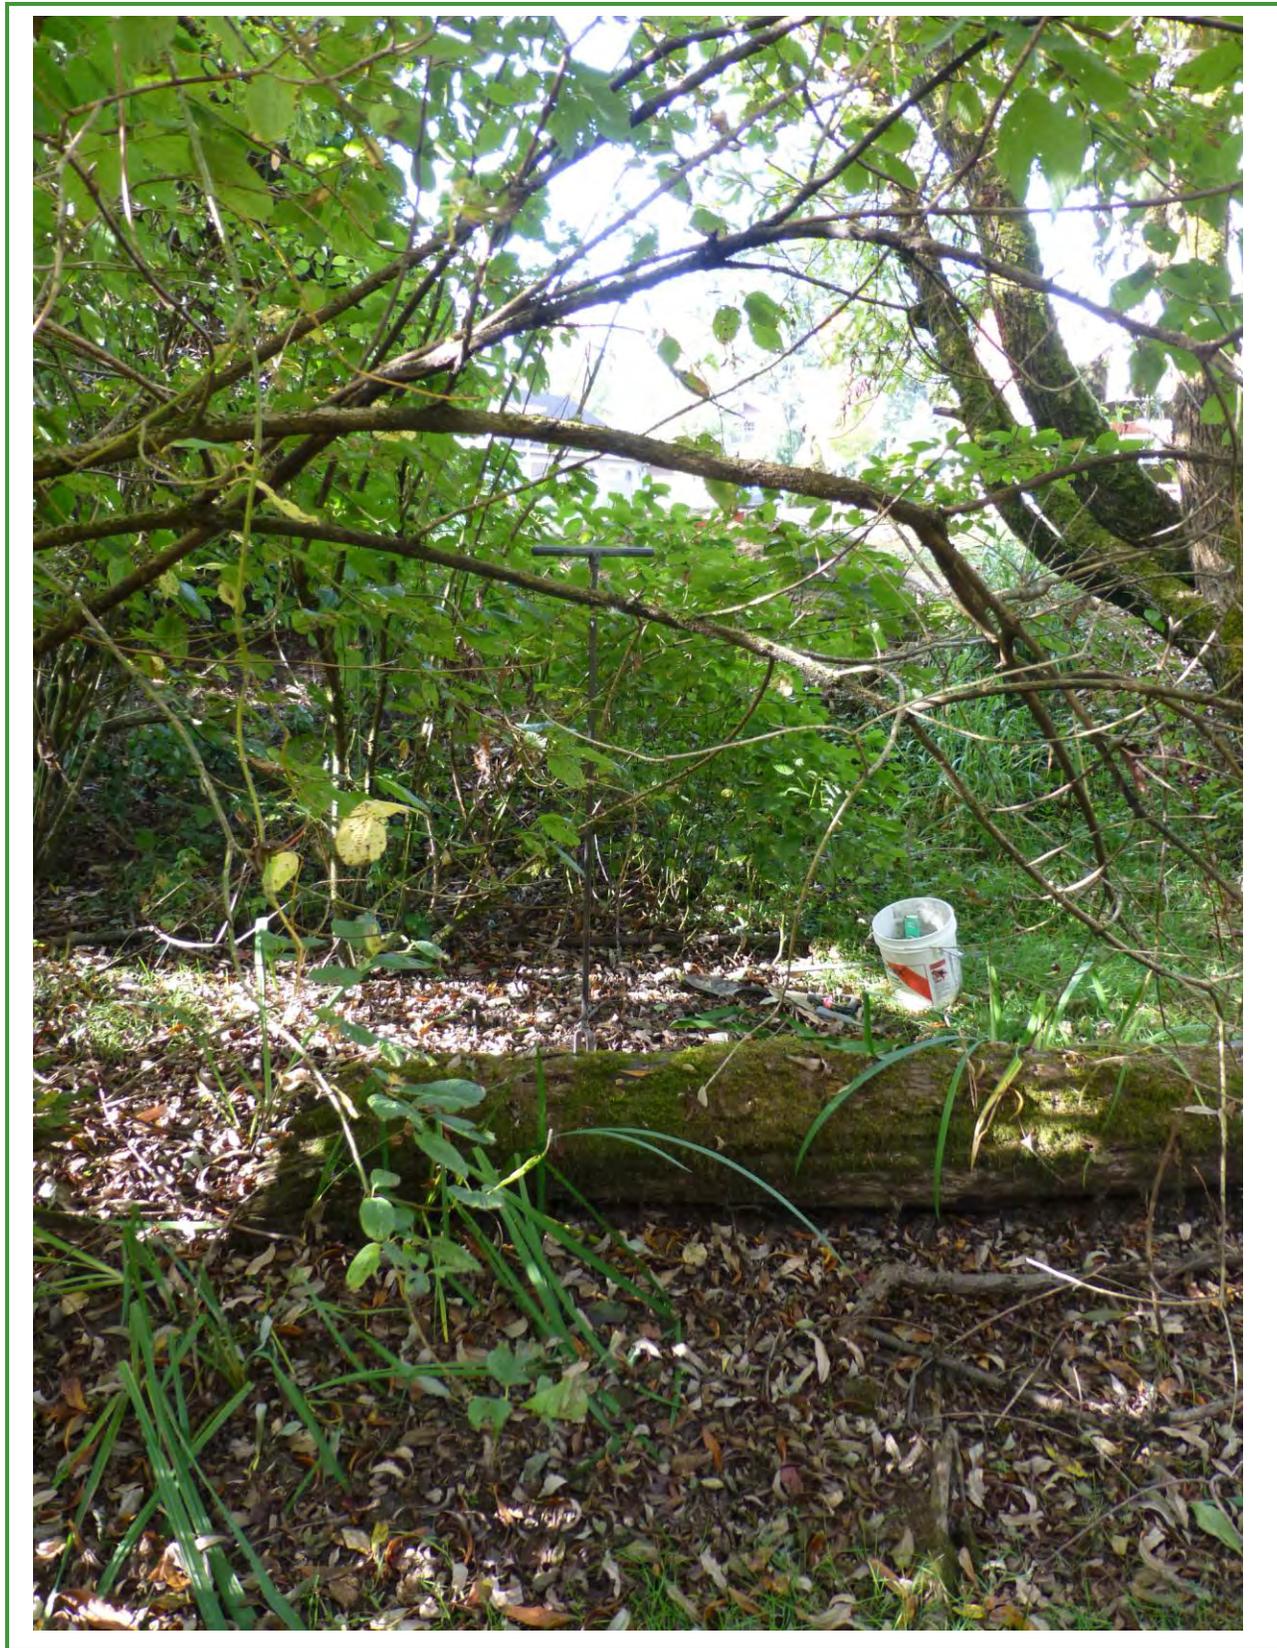
Figure A4. Site 4. The Sample Was Taken at the Location of the Hand Auger.

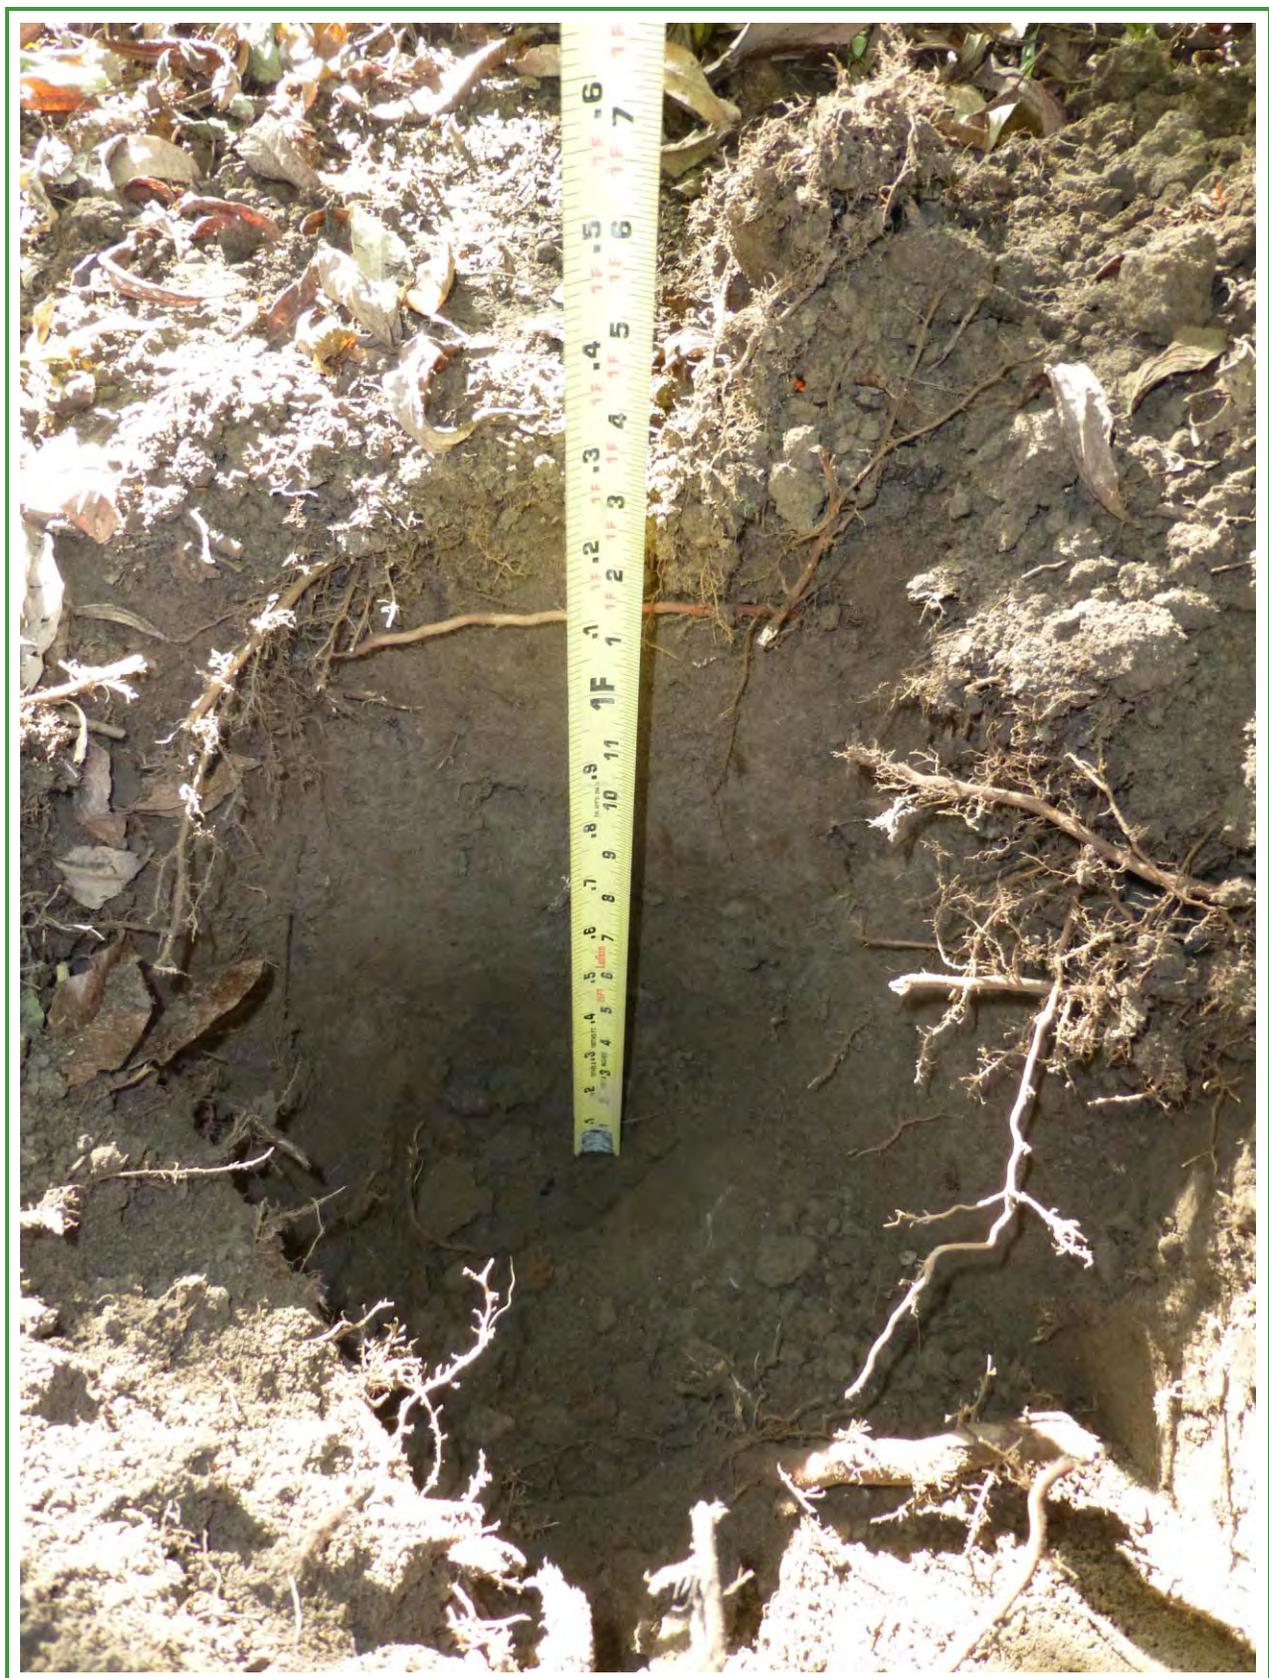
Figure A5. Photograph of Sample MF4-C Prior to Collection.

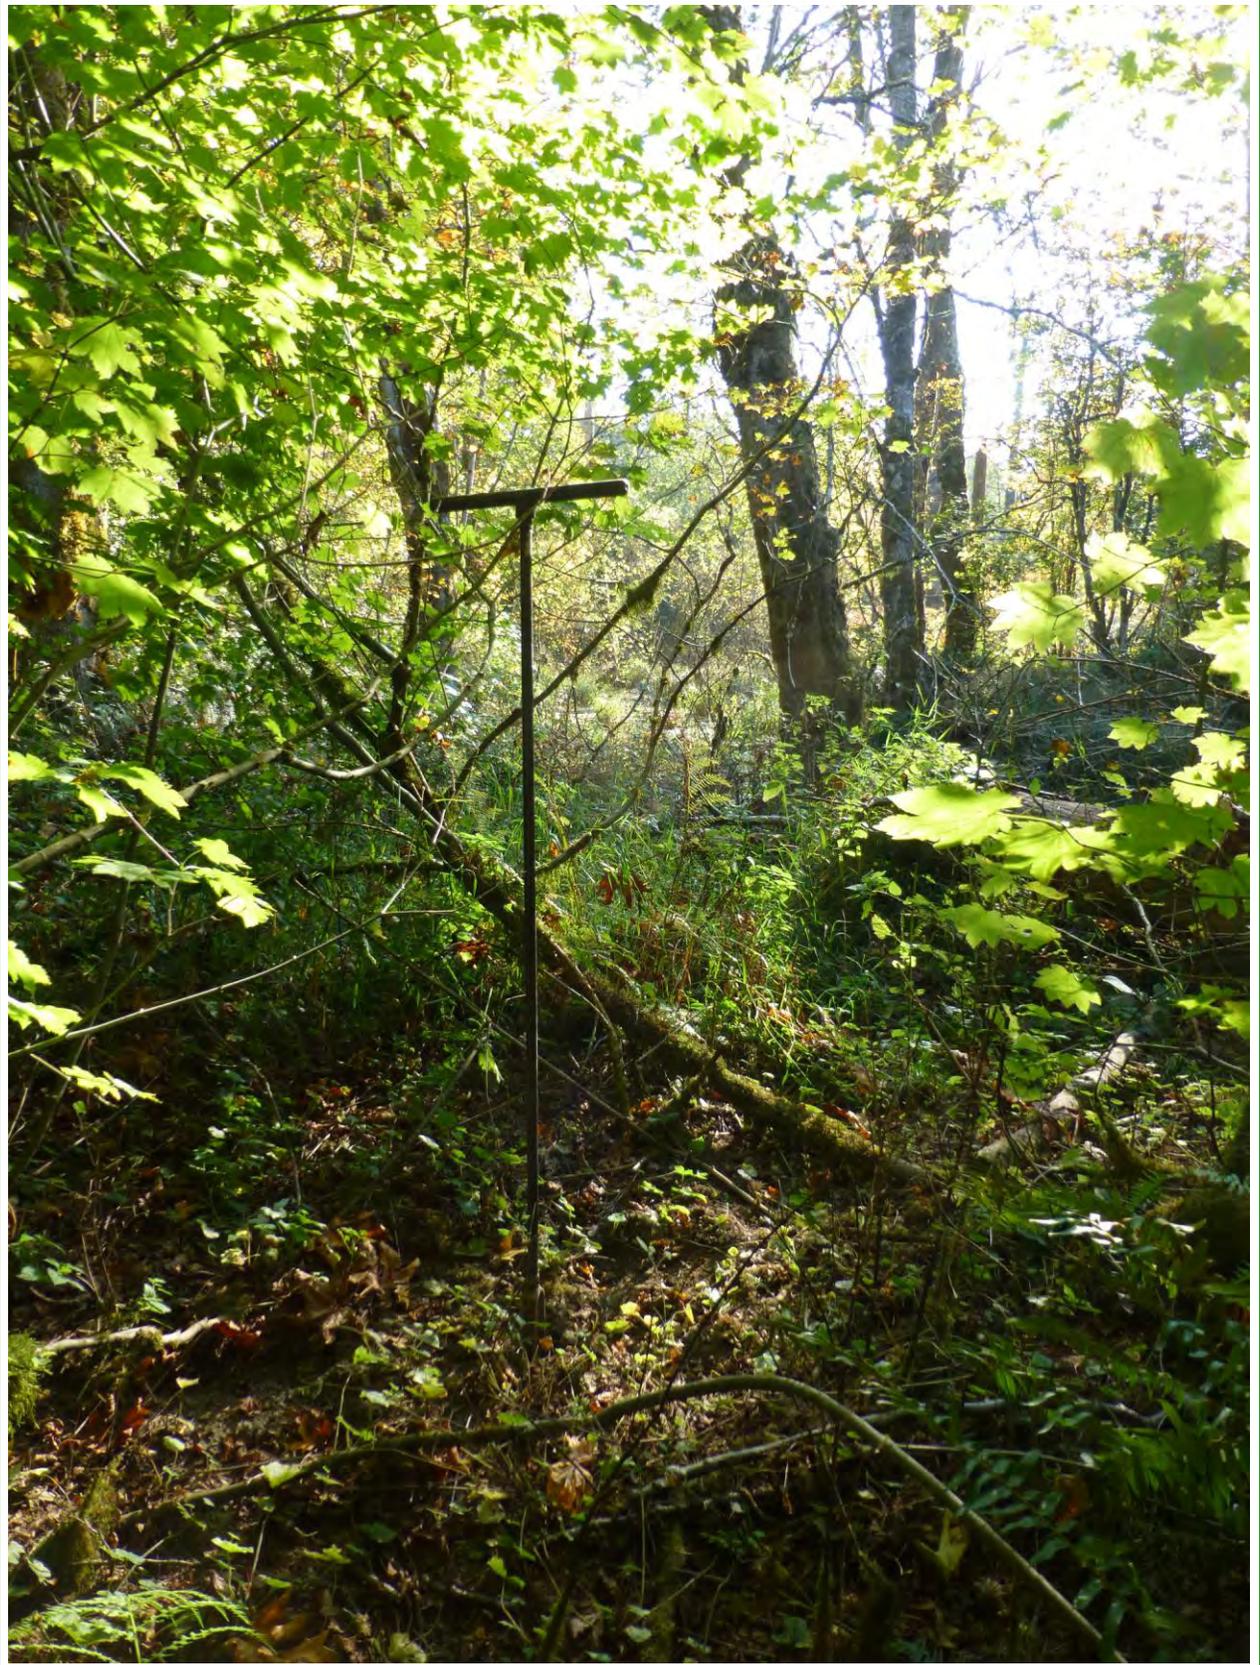
**Figure A7. Site 5. Ponded Water in Silver Creek Is Visible in the Background.**

The sample site is shown in Figure A7. The sample is shown in Figure A8.

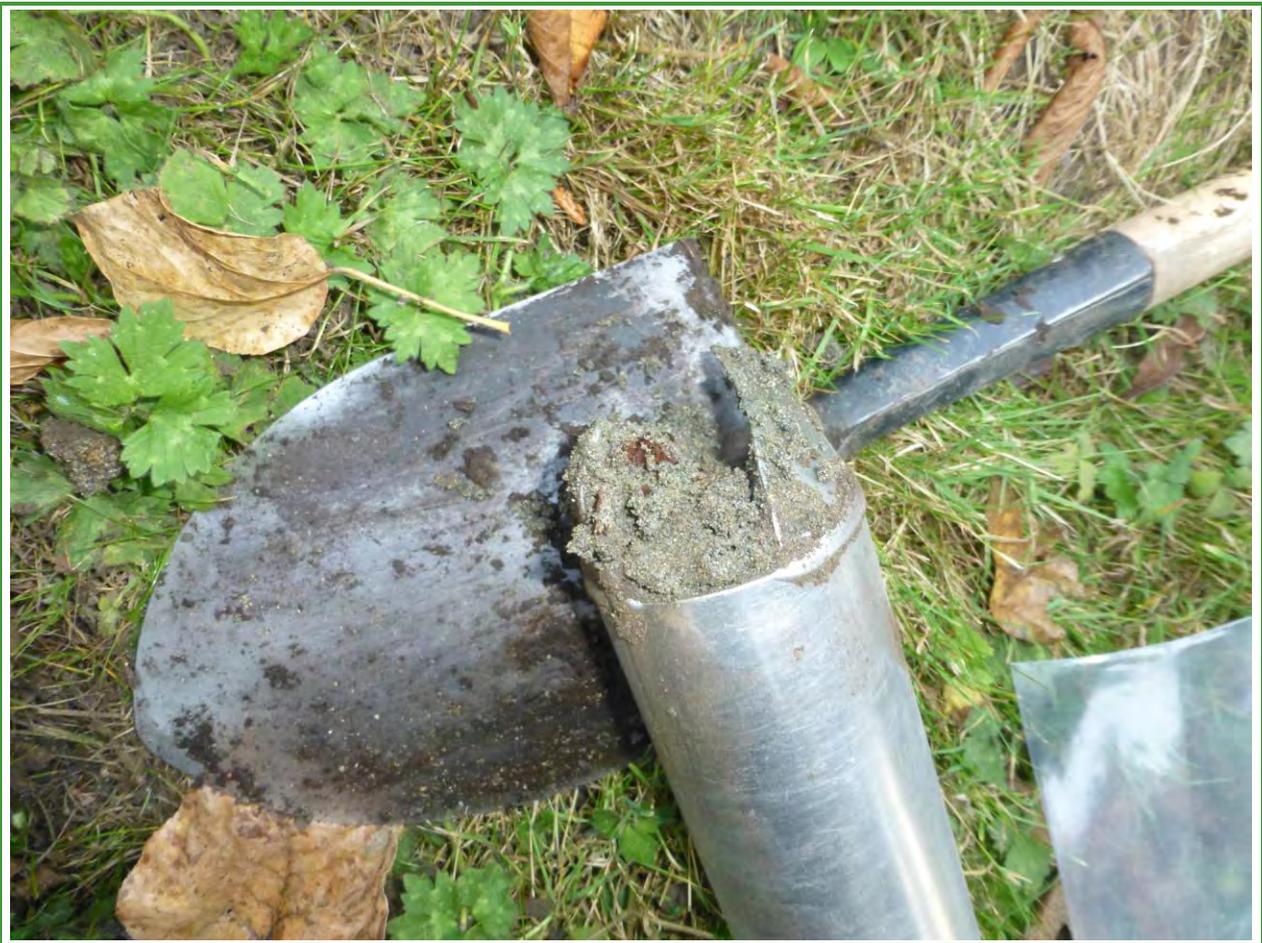
Figure A9. Auger Sample from Which Wood Fragment MF7-A Was Collected.

A photograph of the sample is shown in Figure A9.

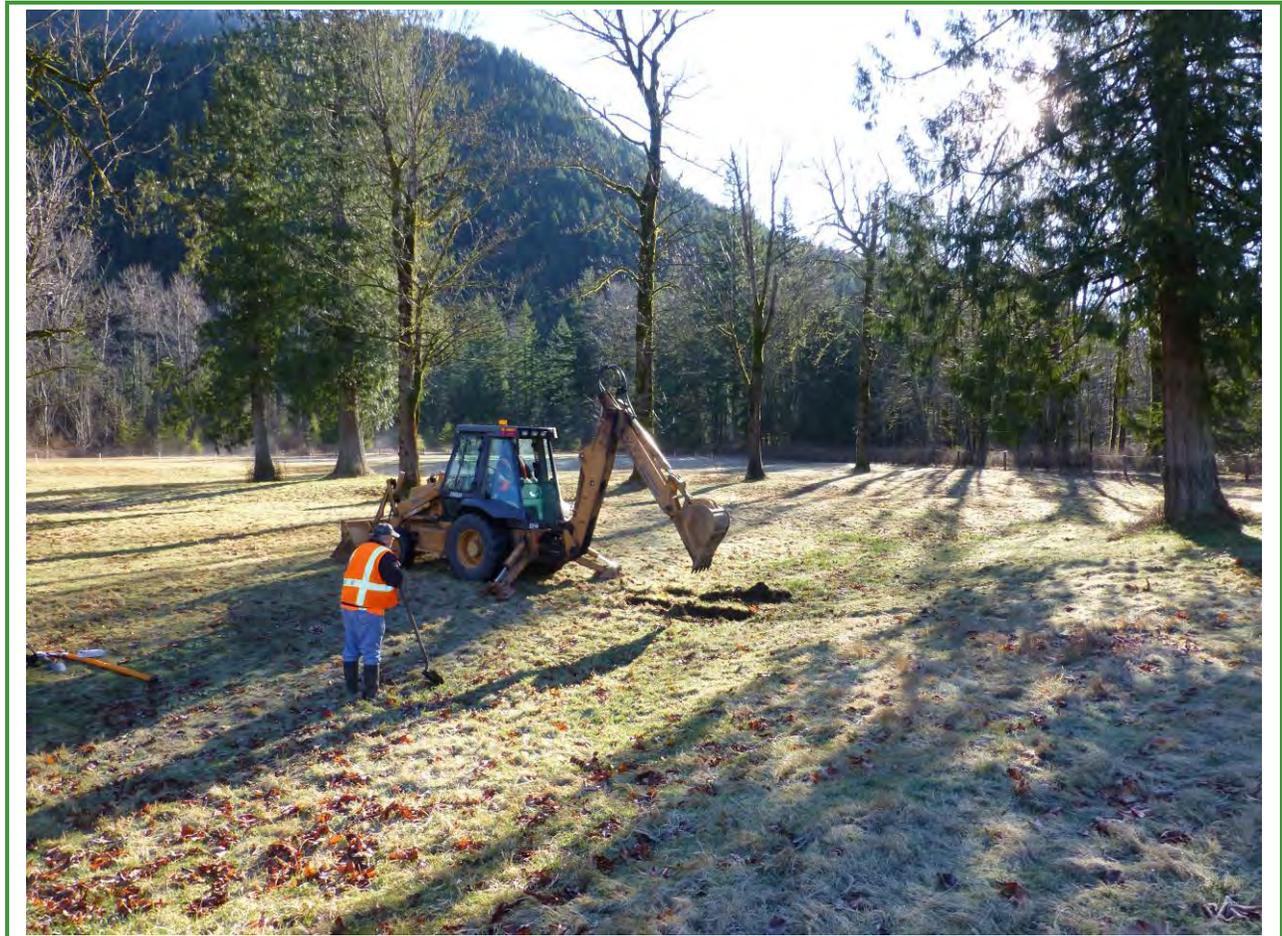
Figure A10. Sample Site 8.

This sample was collected from a pit excavated in an abandoned channel within the wandering river floodplain adjacent to subreach MF1b. Cobble was encountered at a depth of about 3.3 feet below ground surface. Wood was dated from a sample (sample MFP1-0.9) collected from near the silt/cobble interface, at a depth of 3 feet (0.9 m). A photograph of the sample site is shown in Figure A10. A photograph of the pit wall showing the location of the sample is provided in Figure A11. The sample was wrapped in aluminum foil and labeled in the field and then stored for several weeks prior to shipment to Beta Analytic, where final sample preparation was performed.

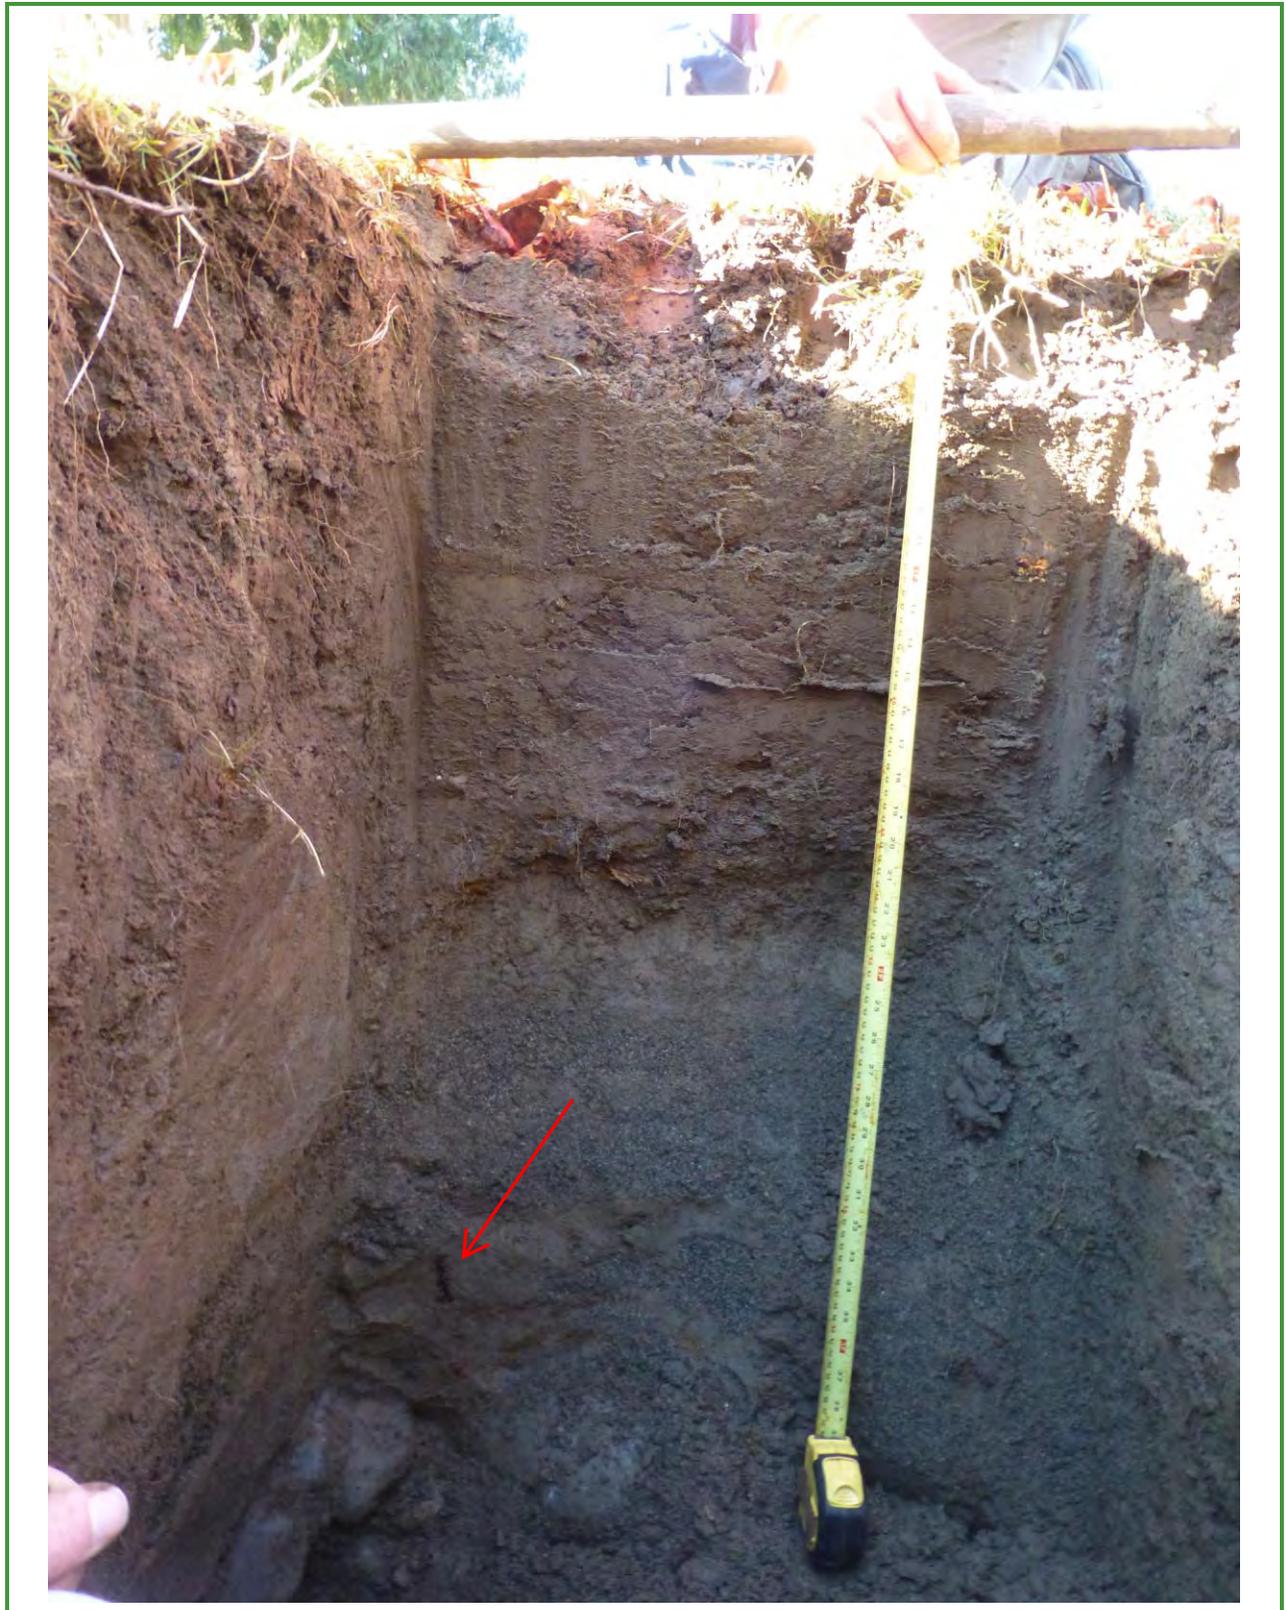
Figure A11. Pit at Sample Site 8. The Arrow Points to Sample MFP1-0.9.

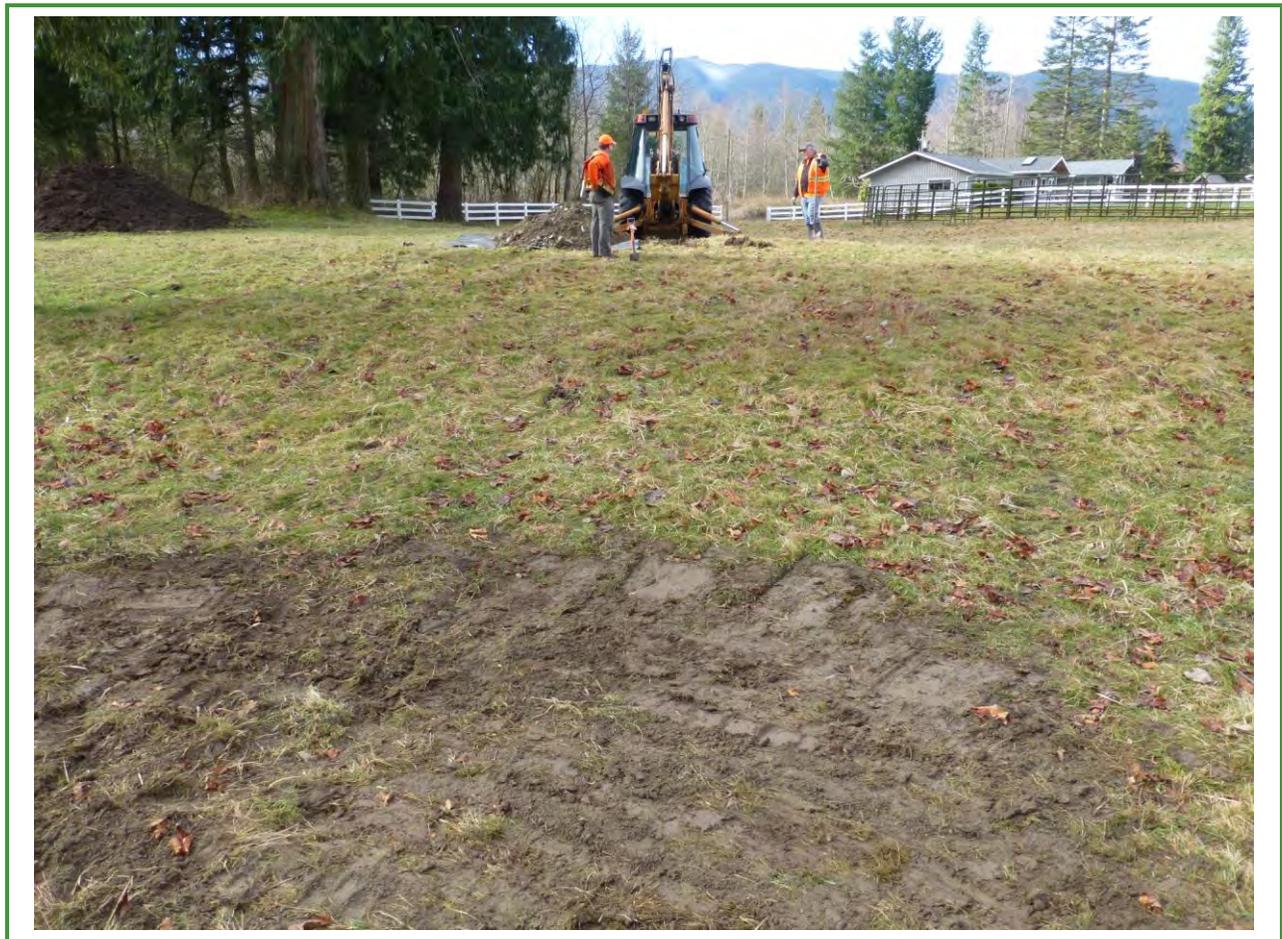
**Figure A12. Sample Site 9 (at the Excavator). The Photograph Was Taken Standing at Site 8.**
