# GEOMORPHIC ASSESSMENT

## MIDDLE FORK SNOQUALMIE RIVER TANNER TO THREE FORKS NATURAL AREA

**King County**

June 18, 2013

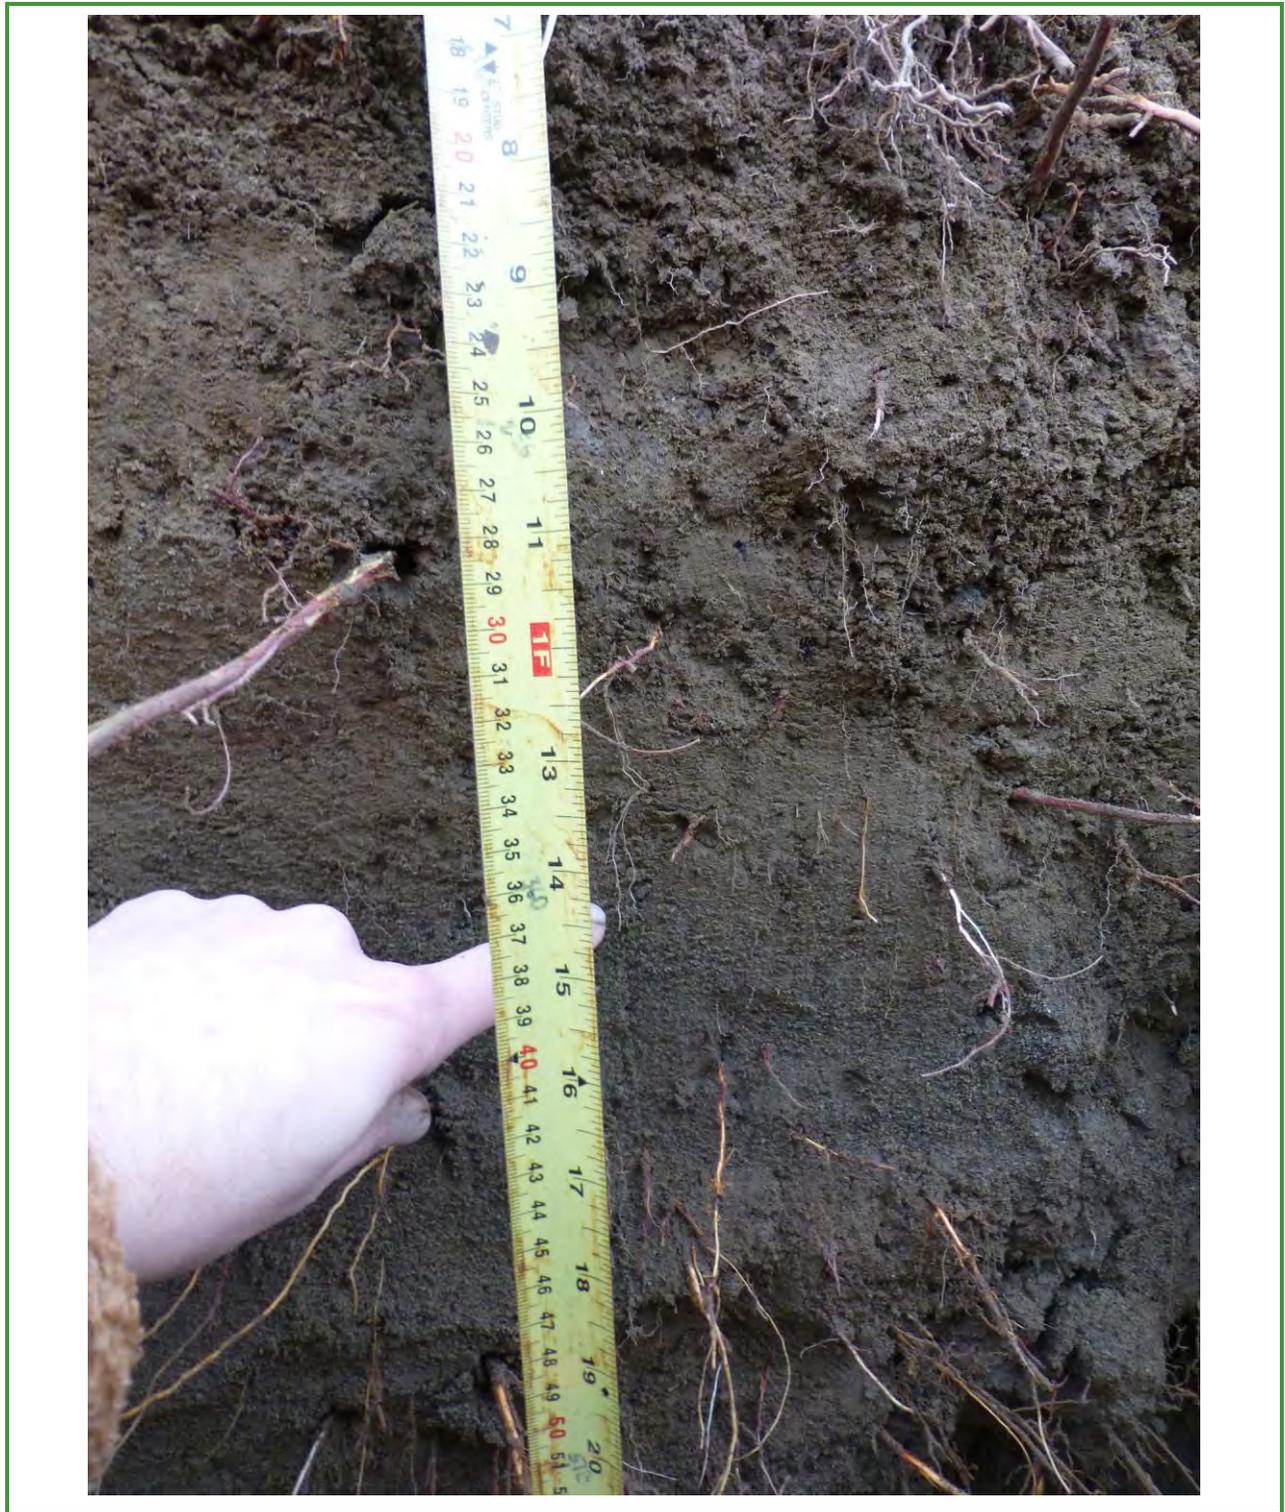
**Figure A14. Charred Material Sampled as MFP2-0.35 From Pit Wall at Site 9. Material Similar to That Sampled Is Visible at the 28 cm Level. Measurement Indicates Depth Below Ground Surface.**

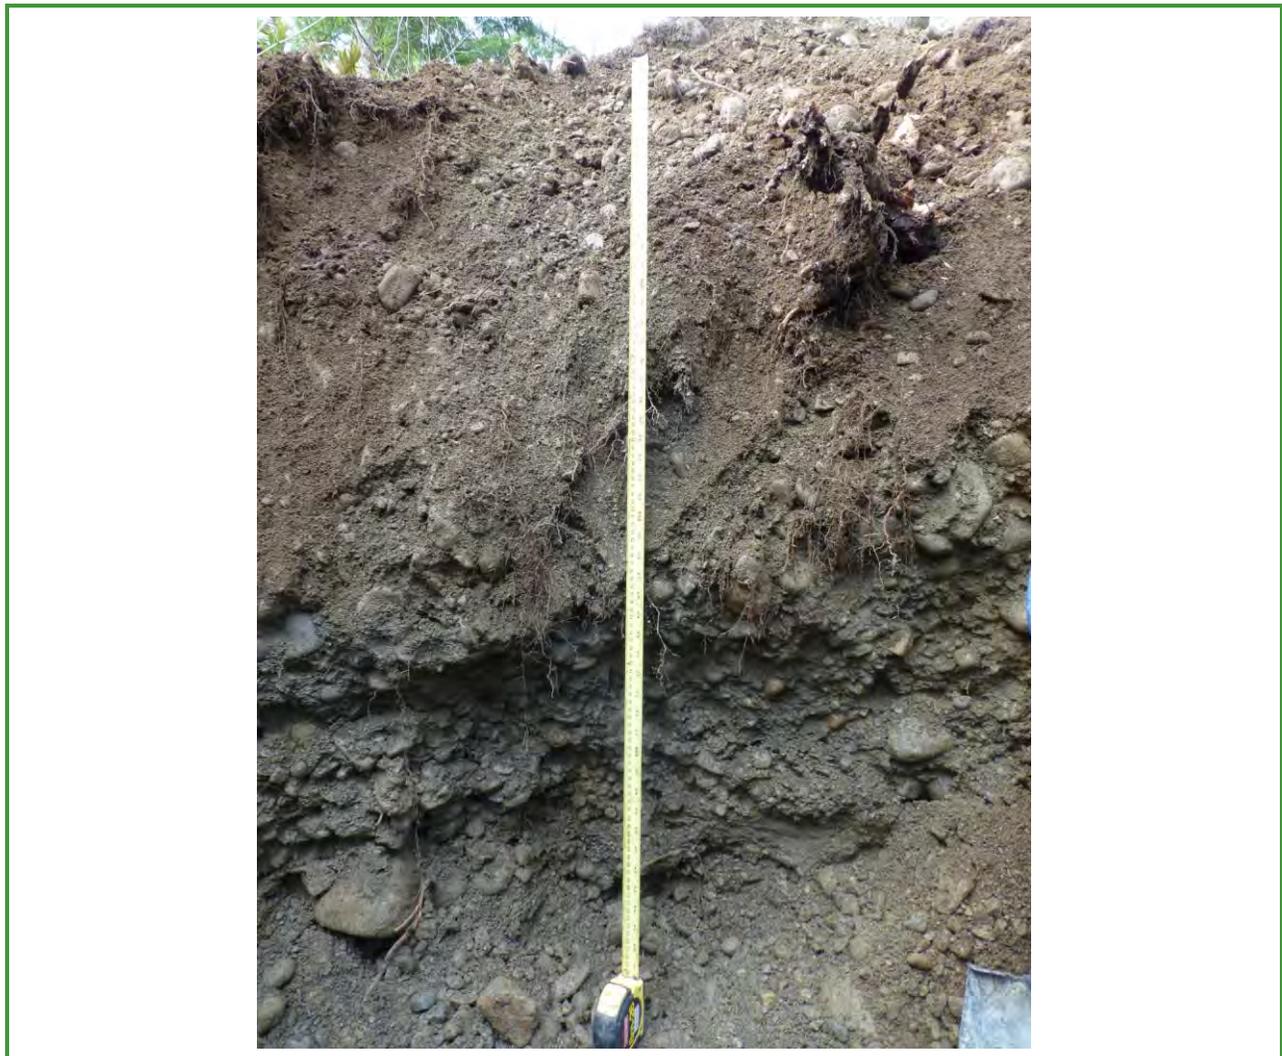
**Figure A15. Pit at Site 10. No Datable Material Was Found In the Pit, But a Bone (Subsequently Dated as Modern) Was Found In The Excavated Spoils.**

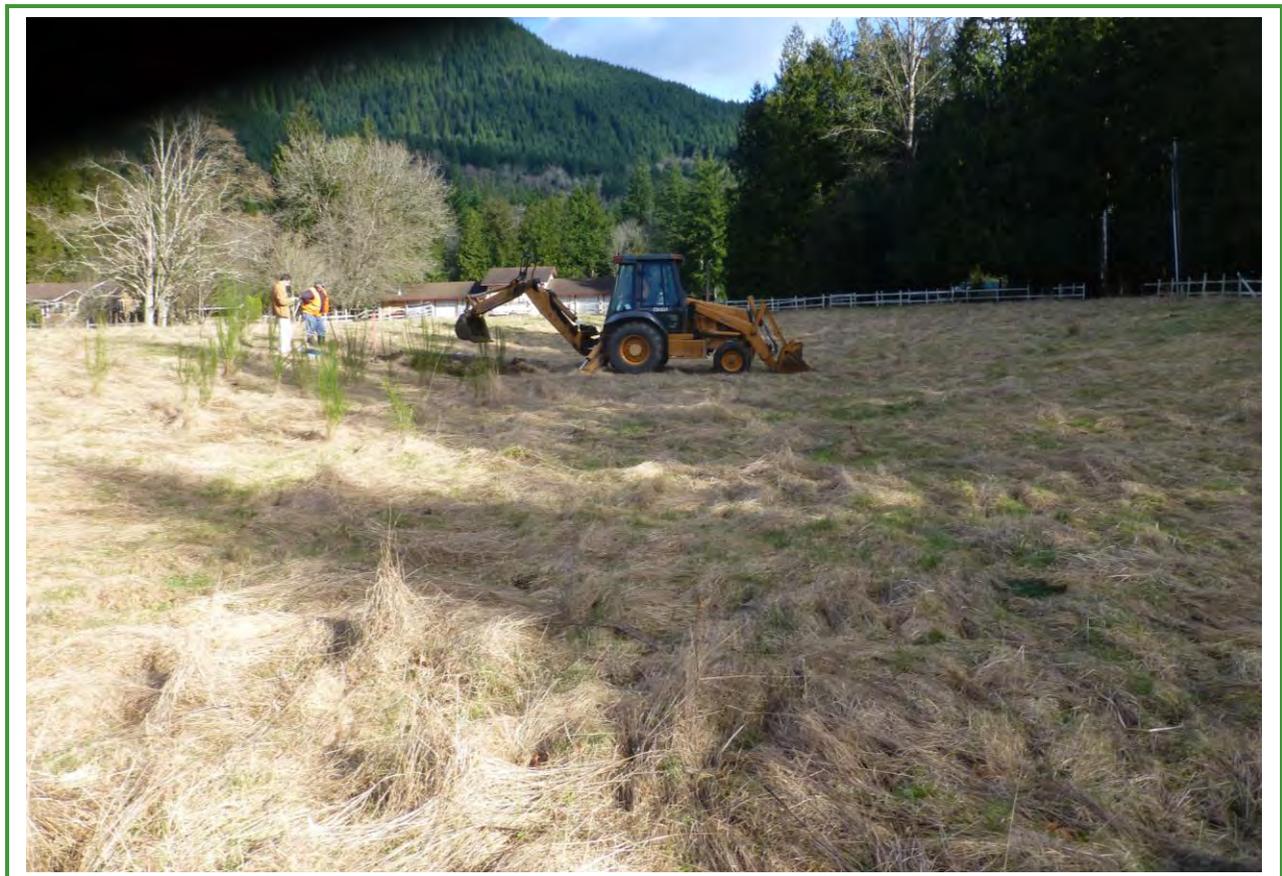
Figure A16. Location of Pit at Site 11. Samples Were Collected on North Side of Pit (Farthest Left from Excavator).

This site is located in a pasture within the northern of two relatively wide floodplain swales that parallel 120th Street. Pit MFP4 was excavated into the northern edge of the channel and included the lower part of the channel bank (Figure A16). The pit was excavated to a depth of approximately 5 feet below ground surface. The stratigraphy of the soil in the pit consisted of a 4.6-foot-thick sequence of sand and silt/clay overlying a cobble substrate (Figure A17). Three samples were collected from the pit: charcoal at depth of 2.0 feet (0.6 m) (sample MFP4-0.6), charcoal at depth of 4.0 feet (1.2 m) (sample MFP4-1.2), and wood fragments/soil collected at the interface between clay and sand immediately above the cobble substrate (reported by Beta Analytic as soil carbon) at depth of 4.6 feet (1.4 m) (sample MFP4-1.4). Photographs of the pit wall where each sample was collected are shown in Figures A18 to A20.

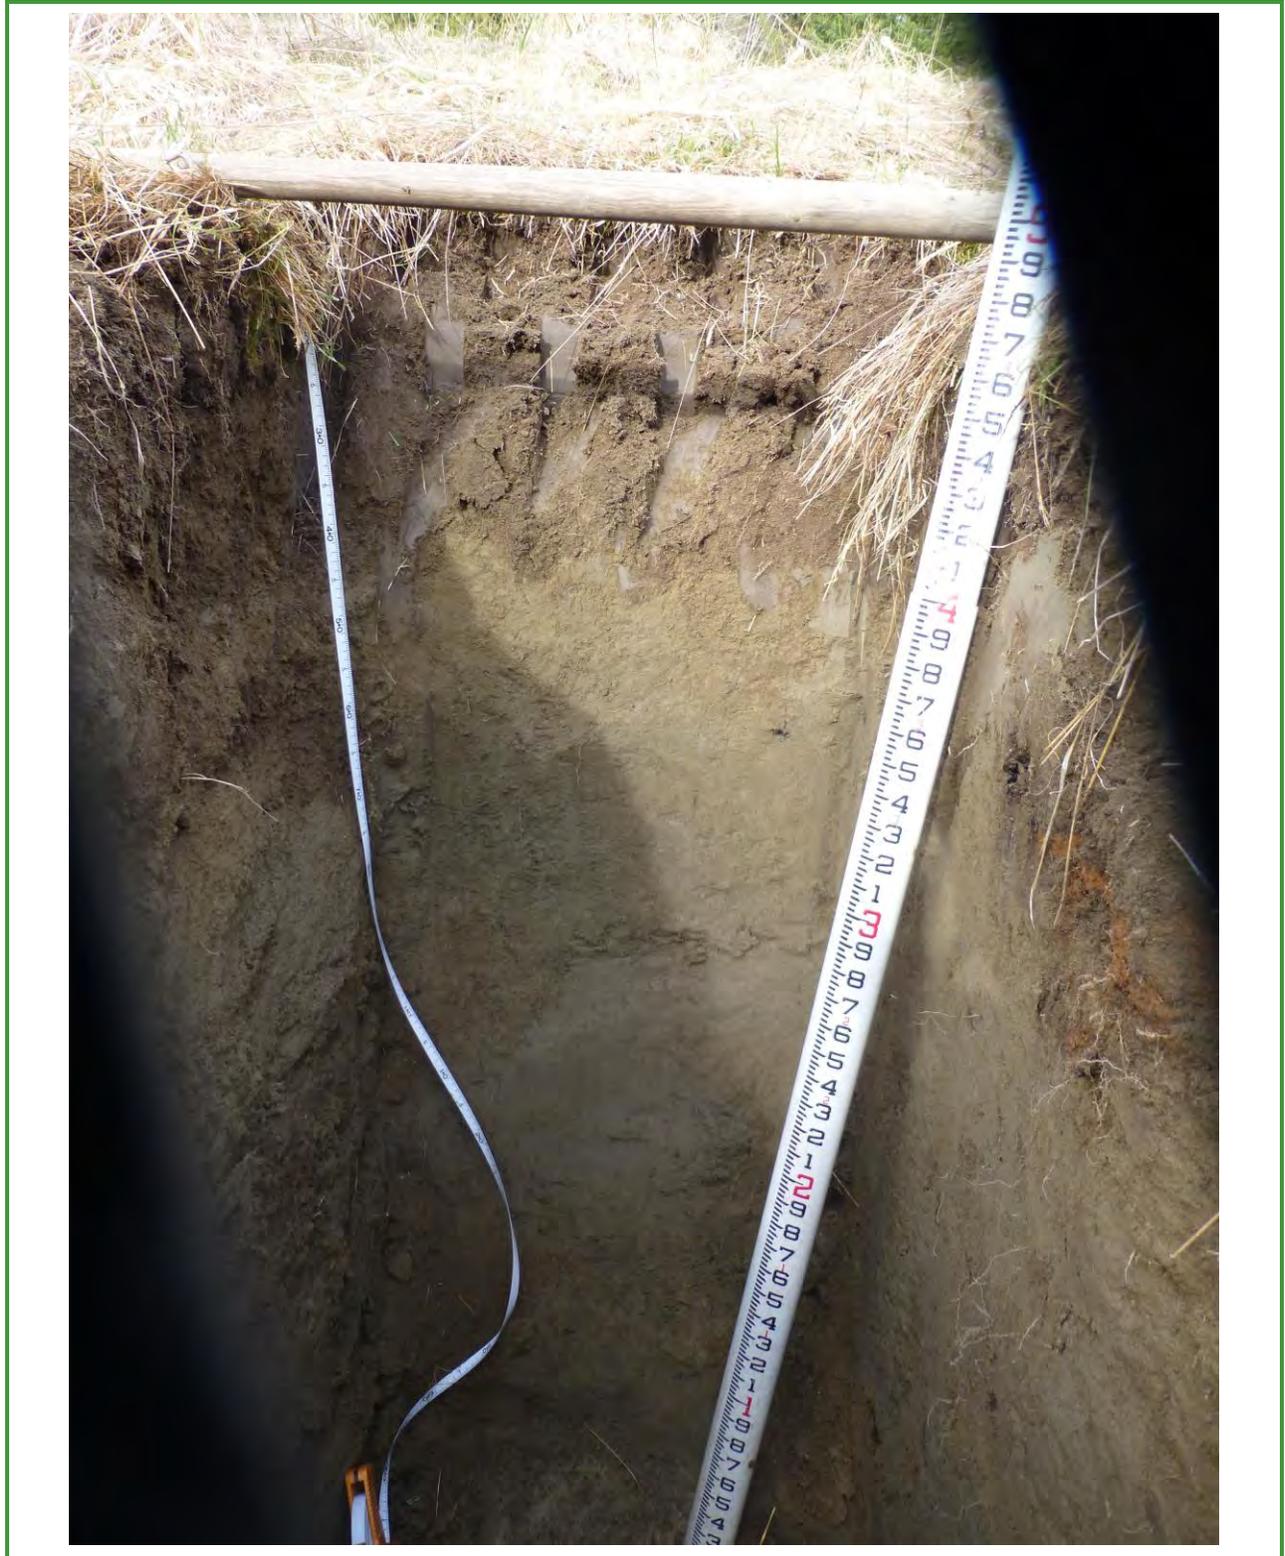
**Figure A17. Northern Wall of Pit at Site 11. Cobbles (Not Shown) Were Present At Bottom of the Pit. The Dark Portions of the Image Resulted From Grit Preventing the Camera Lens Cover From Fully Opening. The Scale on the Surveying Rod Is In Tenths of a Foot.**

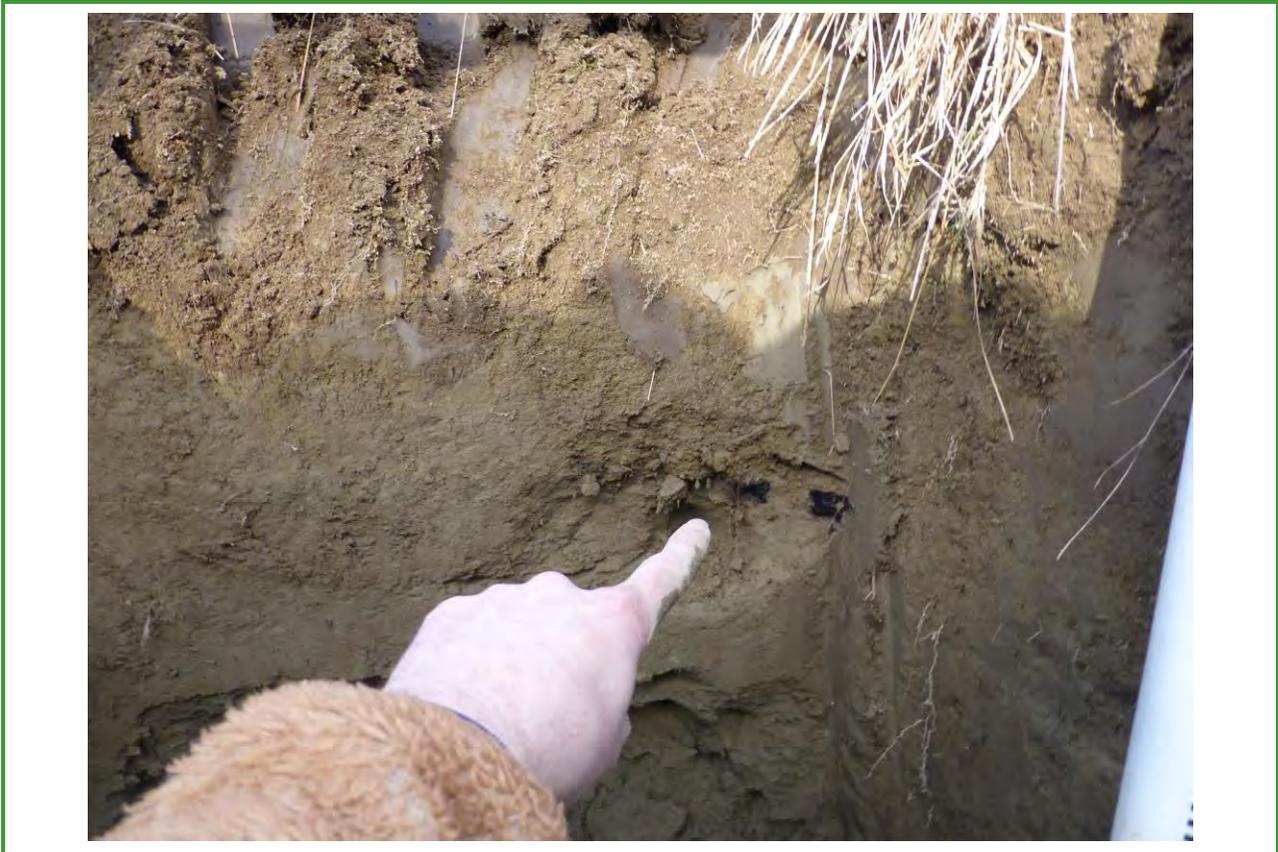
Figure A18. Charred Material in Pit Wall at Site 11 Collected as Sample MFP4-0.6.
