***Tolt and Raging Rivers  
Channel Migration Study  
King County, Washington***

*April 1991*

***King County Surface Water  
Management Division  
710 2nd Avenue, Suite 730  
Seattle, WA 98104***

**SHANNON & WILSON, INC.**

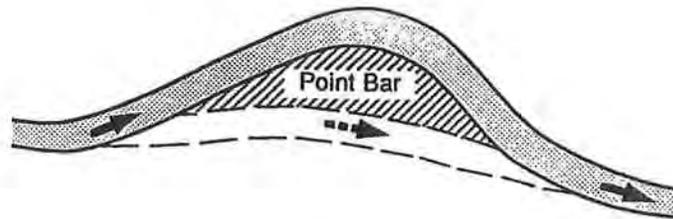
**Lateral Migration**

**Cutoff**

**Avulsion**

King County SWM Tolt & Raging River Channel Migration Study	
<b>TYPES OF CHANNEL MIGRATION</b>	
March 1991	W-5666-01
SHANNON & WILSON, INC. Geotechnical Consultants	<b>FIG. 8</b>

Chute cutoffs occur when a river abandons a bend and switches to a straighter, steeper path across the back of a point bar (Figure 8). As a meander bend develops (radius of curvature decreases), the water slope decreases upstream of the bend, promoting deposition in the channel and diversion of flow over the point bar and a consequent cutoff. Well-developed back-bar channels were observed on almost all gravel bars on the Tolt River, and less commonly on the Raging River. These channels provide easy paths along which chute cutoffs can occur. Once a cutoff occurs, erosion of the outside of the bend stops, and the area between the two channels may eventually become vegetated. Cutoffs can trigger rapid lateral erosion downstream, by causing the river to impinge on the opposite bank at a sharp angle.
