Lower Boise Creek Channel Restoration Project

2013 MONITORING REPORT

Monitoring Year 3 of 5

Lower Boise Creek Channel Restoration 2013 Monitoring Report

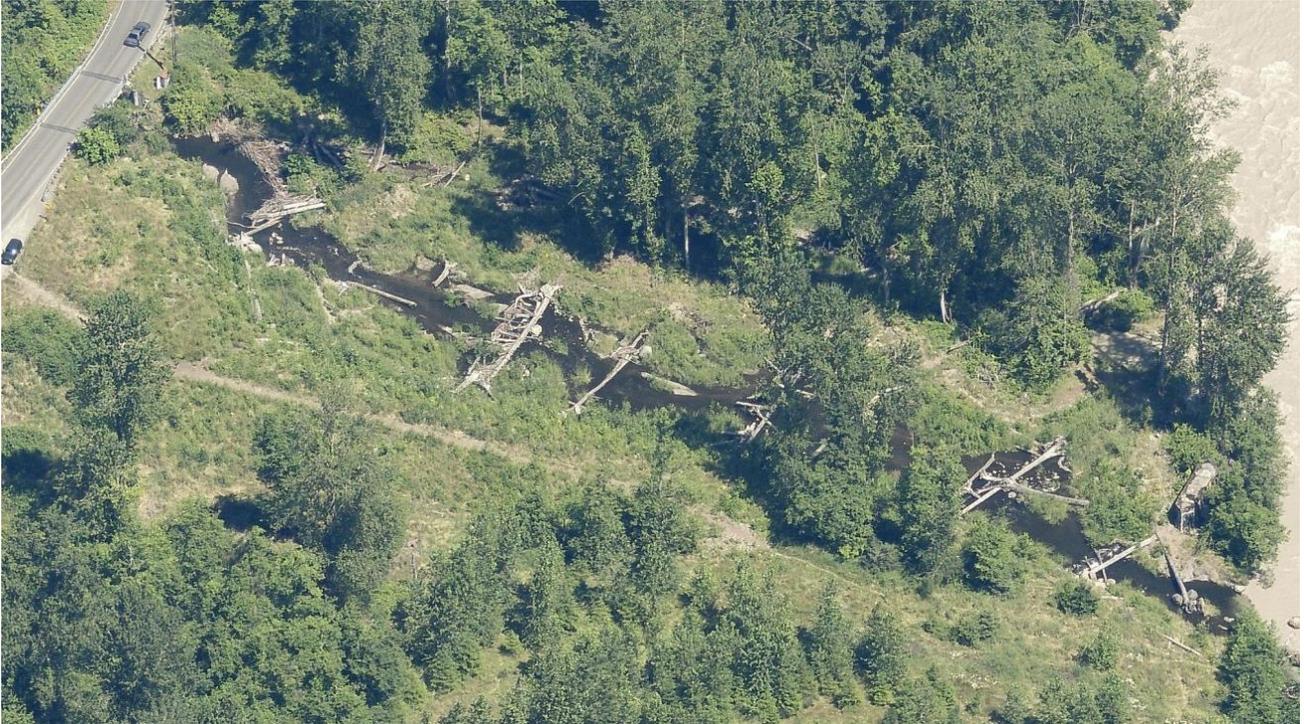
Figure 1. Aerial view of the project site in May 2013. Mud Mountain Road is on the left. White River is on right. The new channel is in the foreground. The old channel is in the background, mostly behind the trees. The upstream control reach is to the left of the bridge.

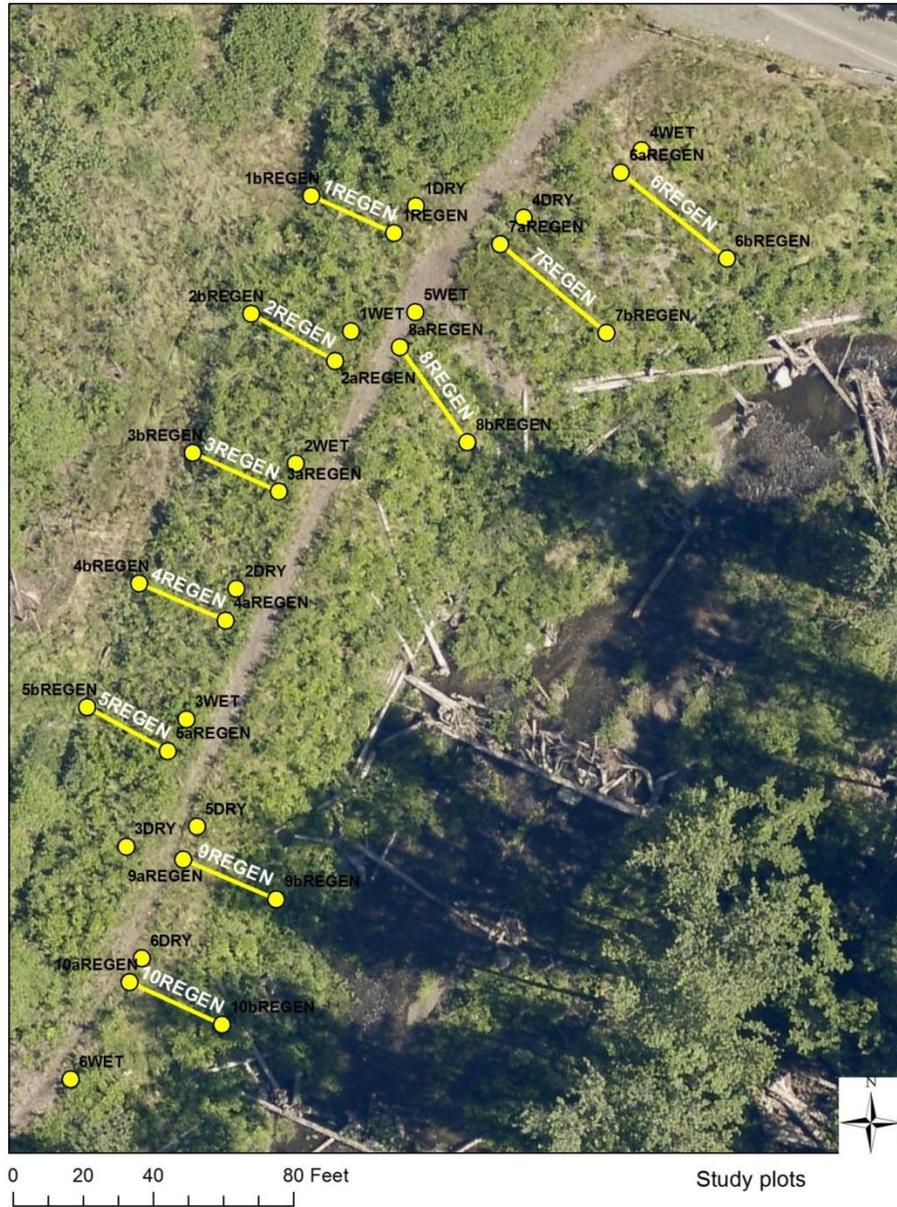
Figure 4. Vegetation study plot locations. Photo is from 2013.

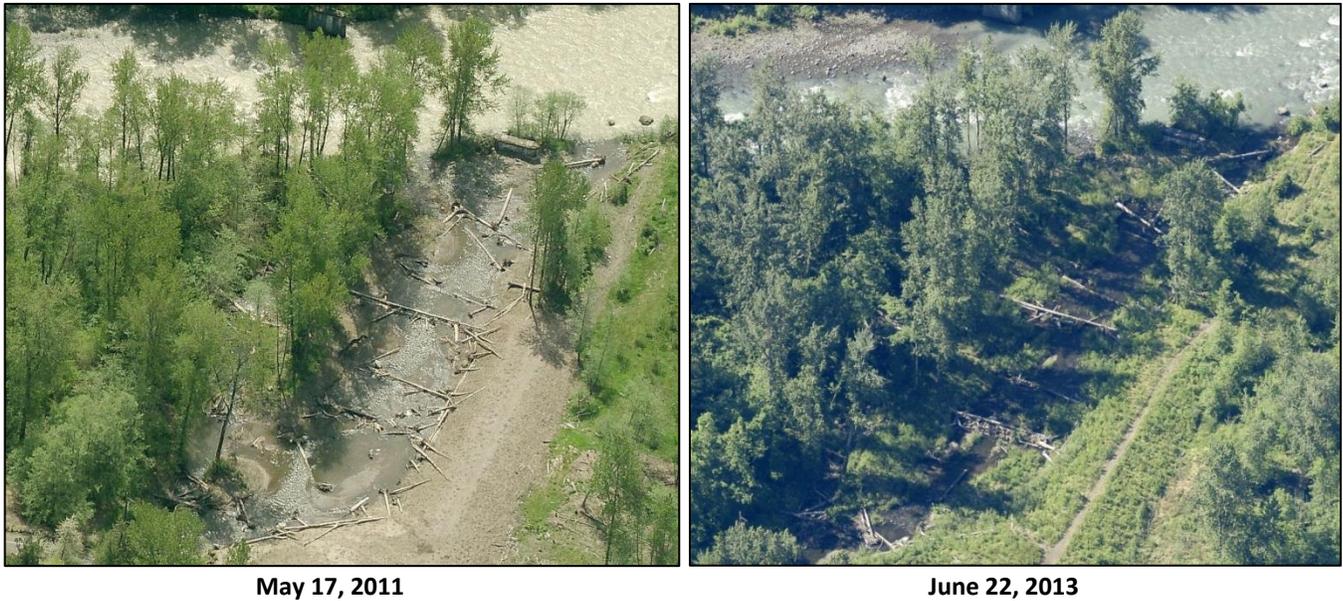
In general, riparian forests are re-establishing across the site, the channel is evolving, habitat has improved, and fish use has increased (Fig. 5).

Figure 5. Aerial oblique photos of the project site, looking downstream, in 2011 and 2013. The old channel is on the left behind the trees. The new channel is on the right. The control reach is not visible.

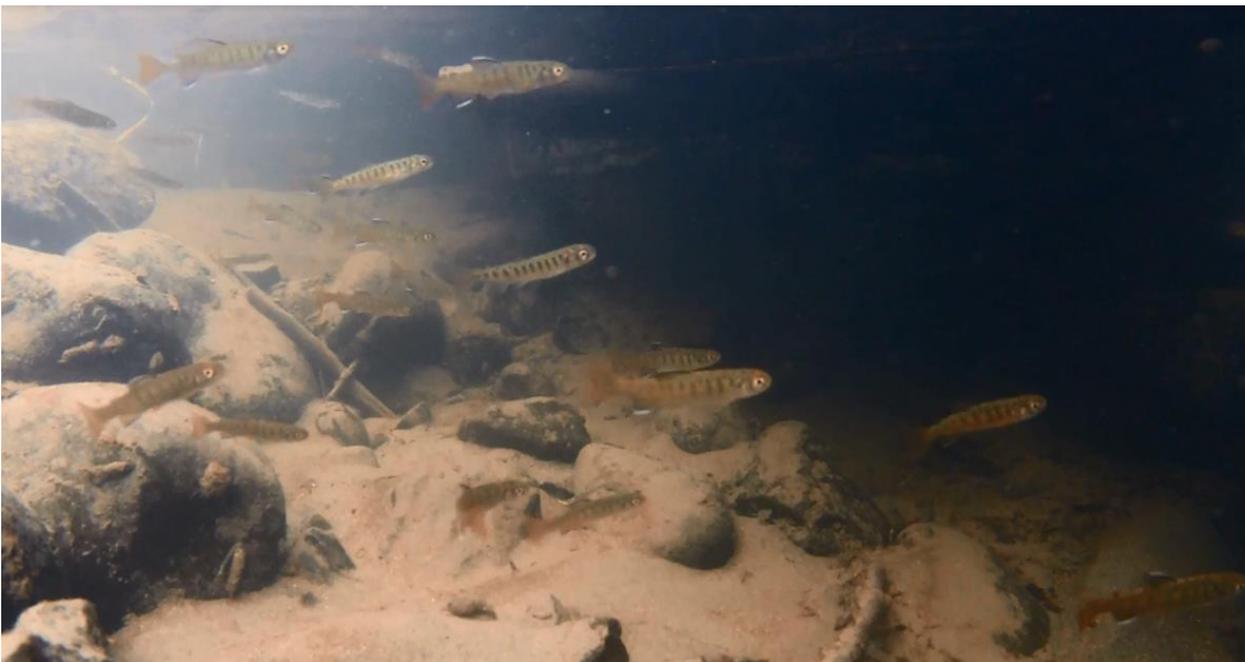
Photo 1. Juvenile salmonids (coho and Chinook salmon) using the new channel at the Lower Boise Project site (April 4, 2014).

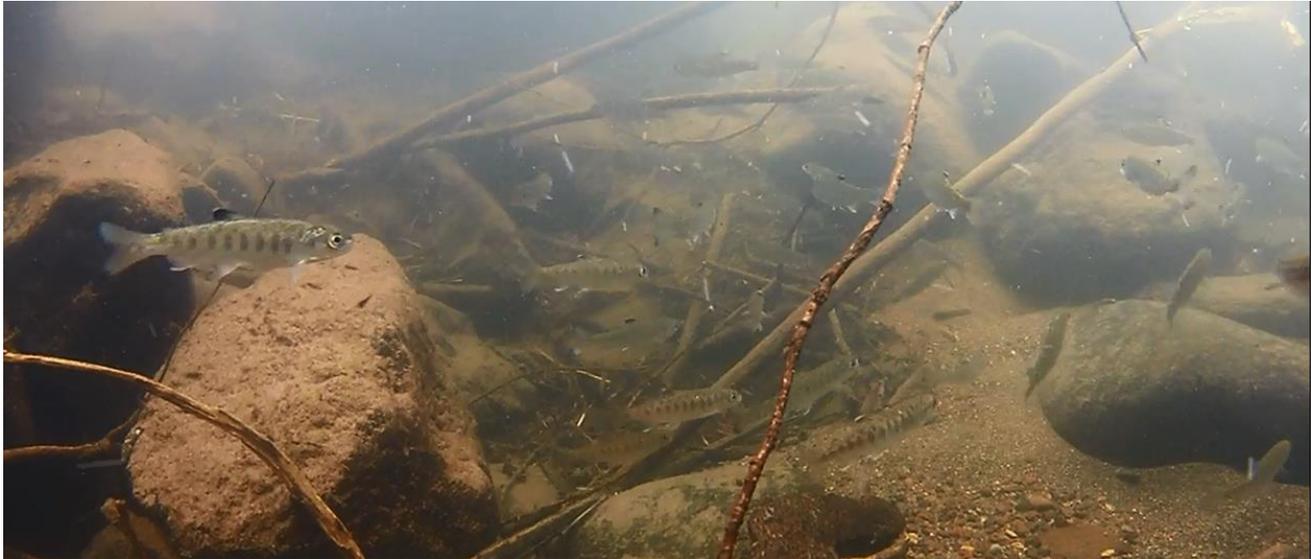
Photo 2. Juvenile coho (fry and smolt) and trout at the Lower Boise project site on May 15 2013.

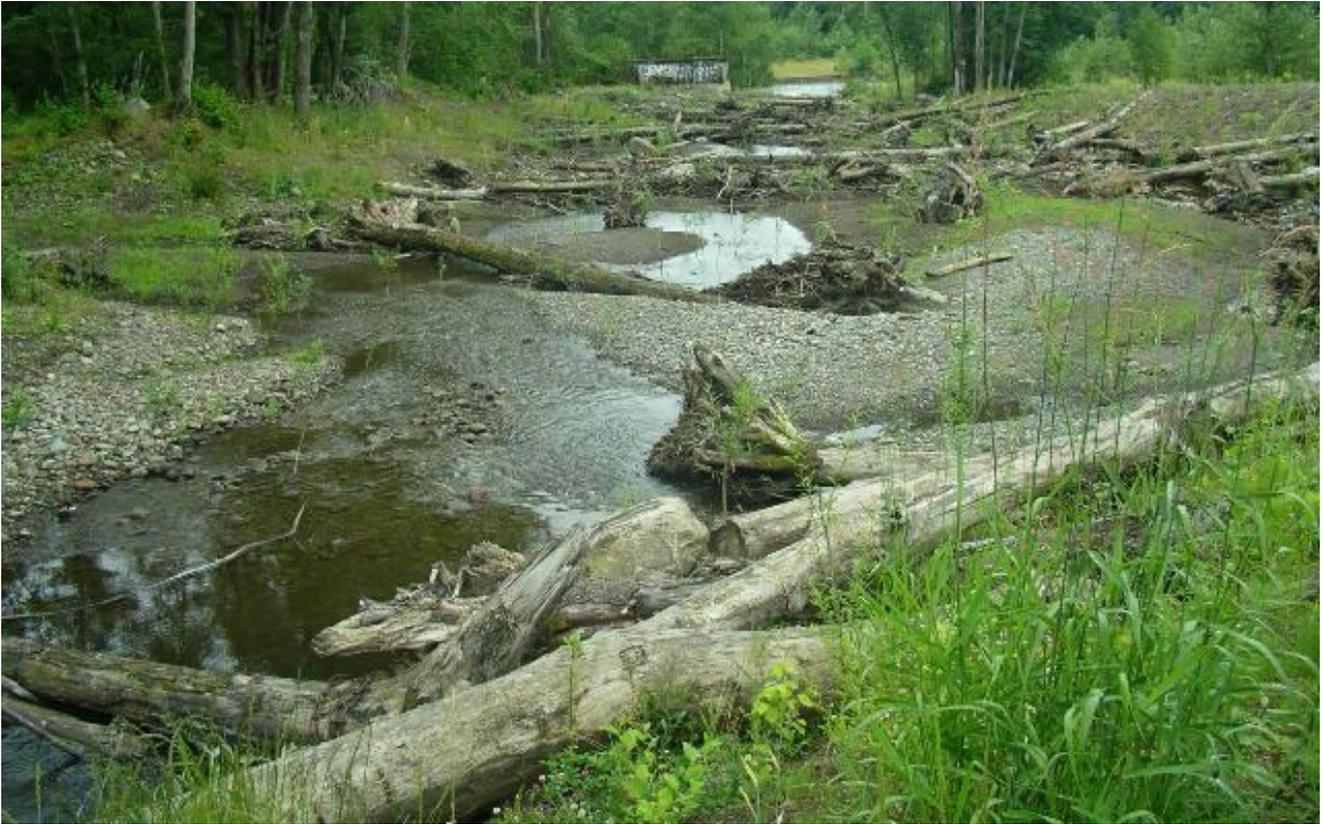
On or around July 5, 2011, water stopped flowing into the new channel; the elevation at the inlet to the old channel was lower and so it captured all of the discharge (Photo 3). Flows at that time were 16 to 17 cfs at Buckley (USGS 112099600). Many residual pools remained in the new channel, but temporarily became very warm and exceeded acute levels for steelhead fry and parr. As a consequence some steelhead redds were likely de-watered and juvenile salmonids that could not disperse and evacuate unsuitable habitats may have died.

Photo 3. View looking downstream in the new channel on July 14, 2011, approximately one week after a small diversion had restored some flow to the channel.

- July 6 KC excavated a small channel to allow some flow into the new channel.
- July 12/13, this channel was enlarged by PTF.
- July 27/August 11 PTF filled burlap sandbags provided by KC with stream gravels and placed them across the inlet to the old channel, forming an emergency flow diversion (Photo 4).
- August 23, KC relocated one to three cubic yards of gravel from the new channel into the old channel behind the upper logjam and placed brush and branches in front of the jam, in hopes of sealing off the jam during winter floods.

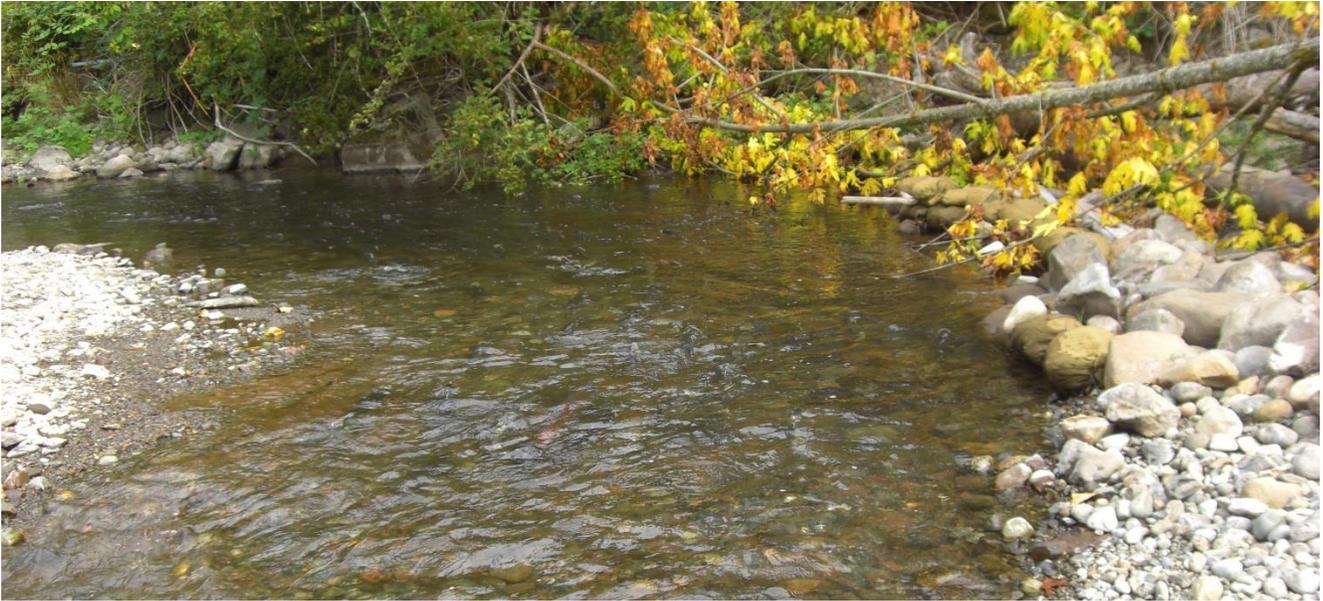
Photo 4. Flow diversion structure built by Puyallup Tribal Fisheries, with KC support. Photo taken September 12, 2011. Flow is moving from left to right, then toward the bottom of the picture. Diversion is visible on the right.

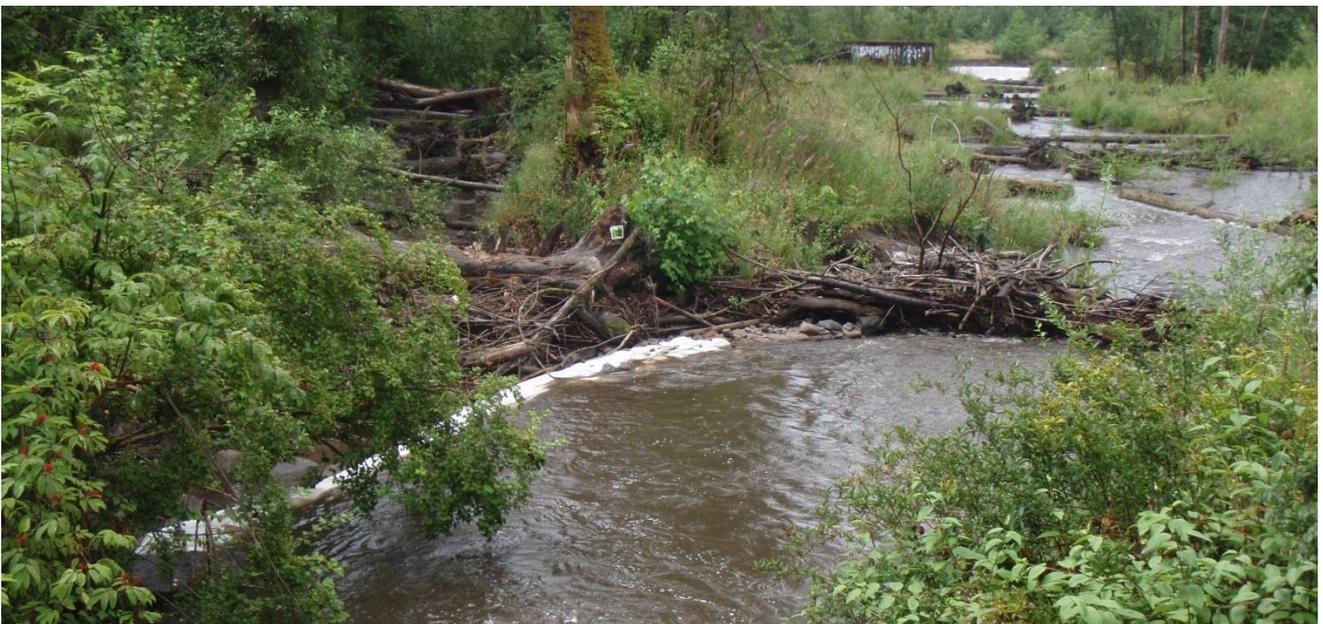
In 2012, the old channel thalweg remained lower in elevation than the new channel by approximately 0.5 m, so on June 26, a new flow diversion was installed after consultation with stakeholders and the KC design team (Photo 5). This diversion was more robust than in 2011, built from five hundred burlap sacks filled with pea gravel and covered with 6-mil plastic. It was effective at channeling the majority of flow into the new channel without de-watering the old channel, so that both areas provided optimal habitat value. The plastic was removed prior to winter floods, the burlap sacks disintegrated, and gravel was released into Boise Creek.

Photo 5. The 2012 flow diversion (left) routing discharge into the new channel (right).

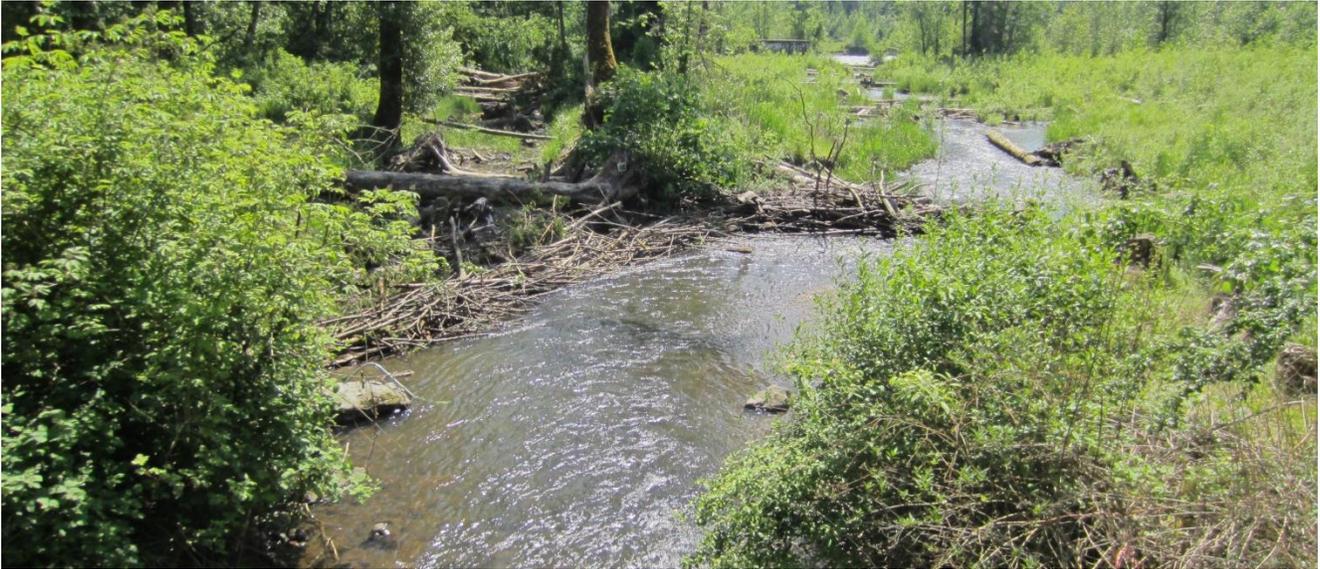
In 2013, the old channel was still lower in elevation, so the flow diversion was re-installed, again after extensive consultation (Photo 6). This diversion was built in a similar fashion (on June 5, 2013) as in 2012, except that 700 bags were used and no plastic covering was applied. In addition, the entire structure was

covered with branches and small woody material to provide camouflage, improved habitat value, and to prevent vandalism. Once again, it was effective and aquatic habitat in both channels was sustained.

Photo 6. The 2013 flow diversion (left) covered in woody material. The image was taken on June 5.

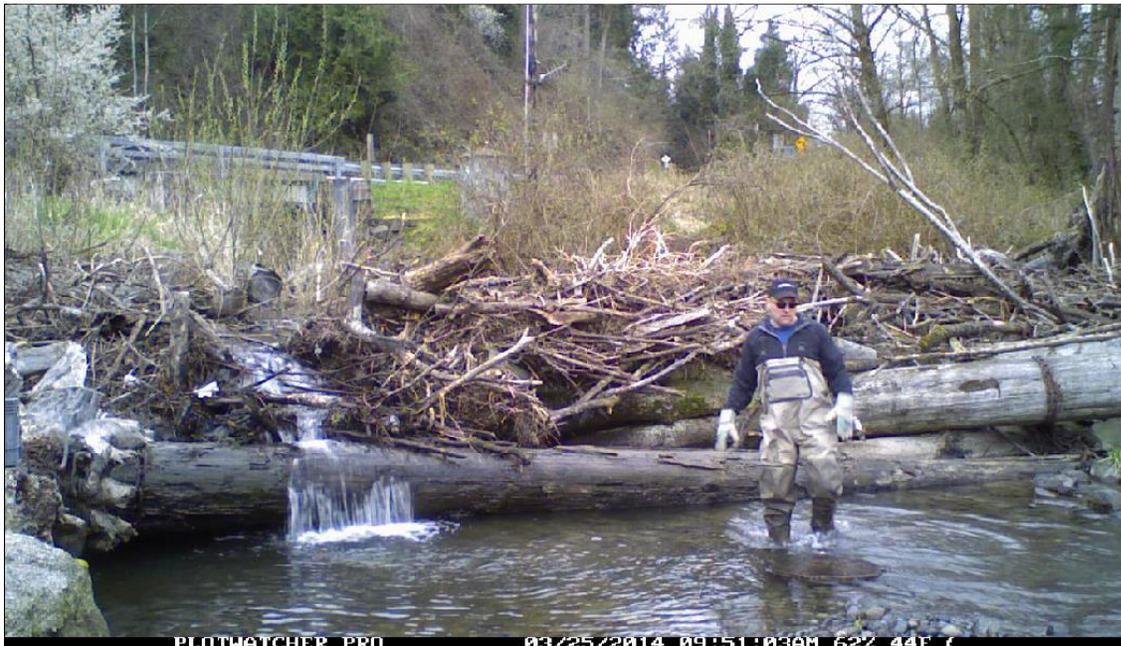
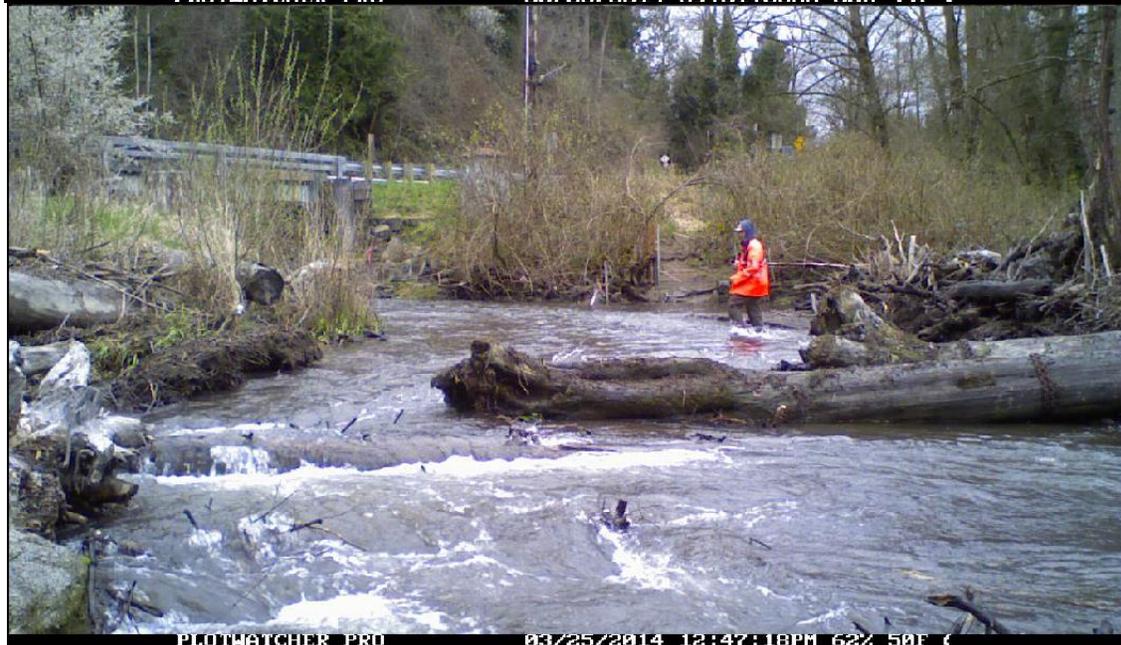
Photo 7. Channel-spanning logjam shown before and after modification to improve passage for adult steelhead and salmon, as unanimously directed by co-managers (WDFW, PIT, MIT).

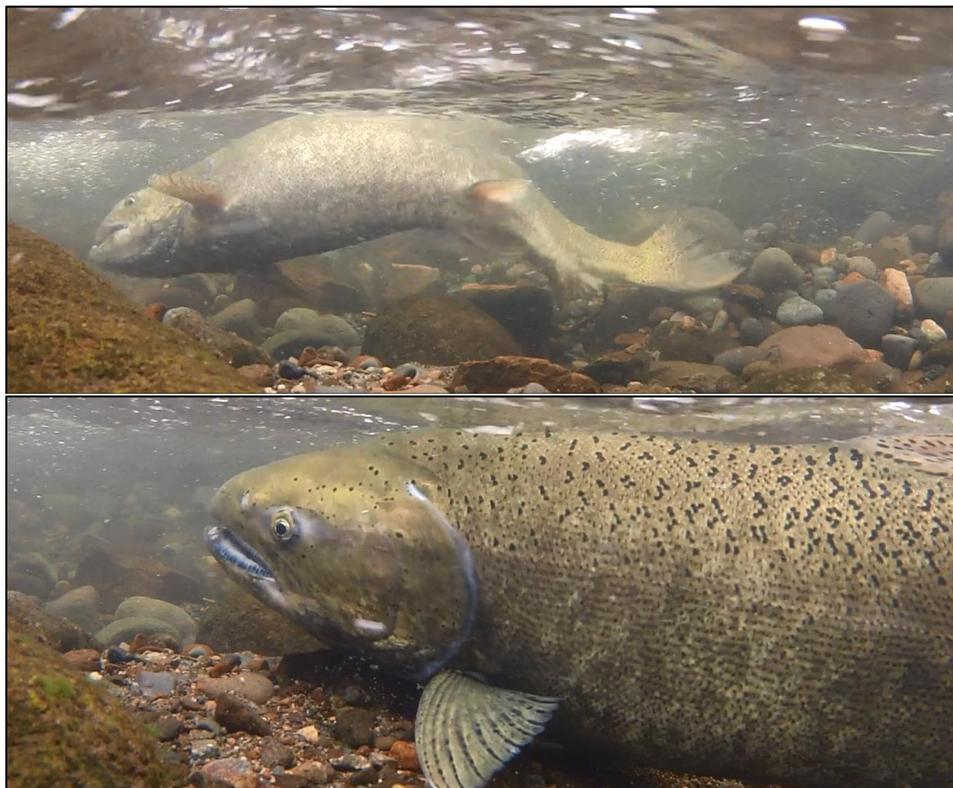
Photo 8. Female Chinook salmon digging a redd at Lower Boise project site on Sept 25, 2012. In total, 12 Chinook redds were established at the project site in that year.

- Prior to the project, salmon and steelhead redds were not documented⁵ in the project reach, but now Chinook salmon (Photo 8), steelhead trout (Photo 9), coho salmon, and pink salmon (Photo 10) consistently spawn at the project site (Table 18).
- In 2010 and 2012, three to 20% of the Chinook redds in Boise Creek occurred at the project site.
- Most of the Chinook redds had been constructed by September 20th.

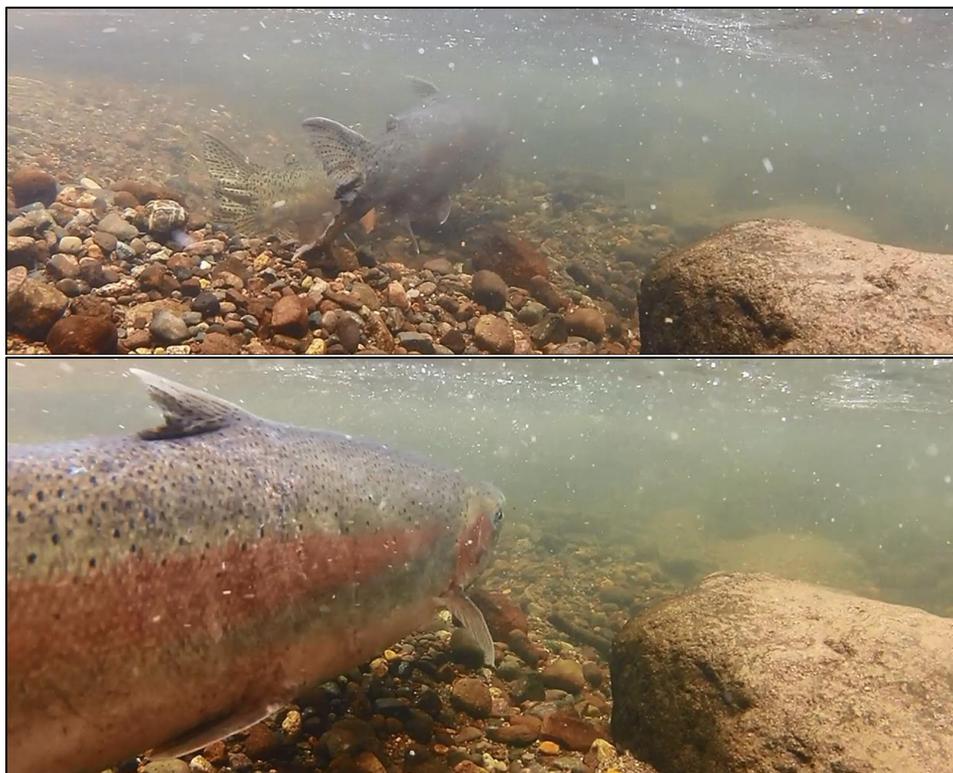
Photo 9. Pair of adult steelhead on a freshly-constructed redd in the Lower Boise Project site on May 15, 2013; one of two created at the project site in that year.

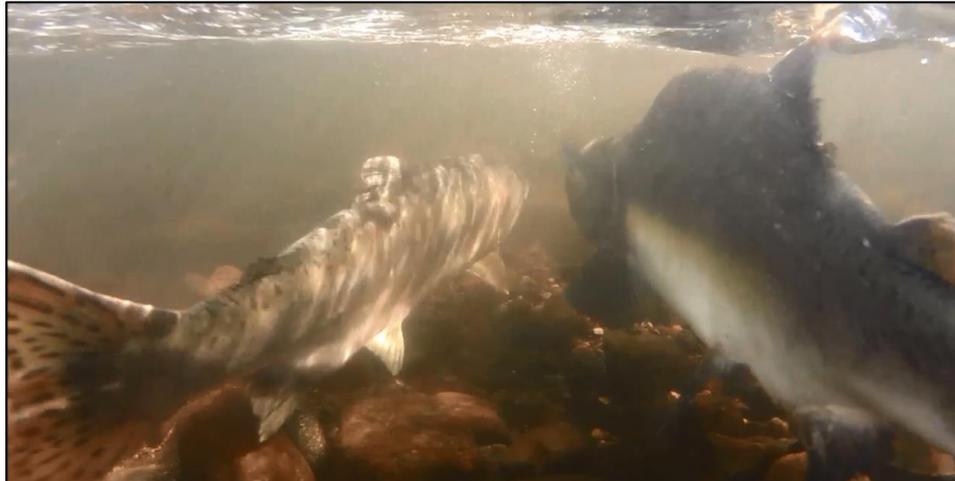
Photo 10. Spawning pink salmon pair at the Lower Boise Project site on September 9, 2013. The number of pink salmon redds has not been estimated for Boise Creek in any years, though they numbered over 100,000 in Boise Creek in 2009 (280,000 were counted; over 6200 per mile; just over one fish per linear foot of stream). Fewer were seen in 2011 and 2013.

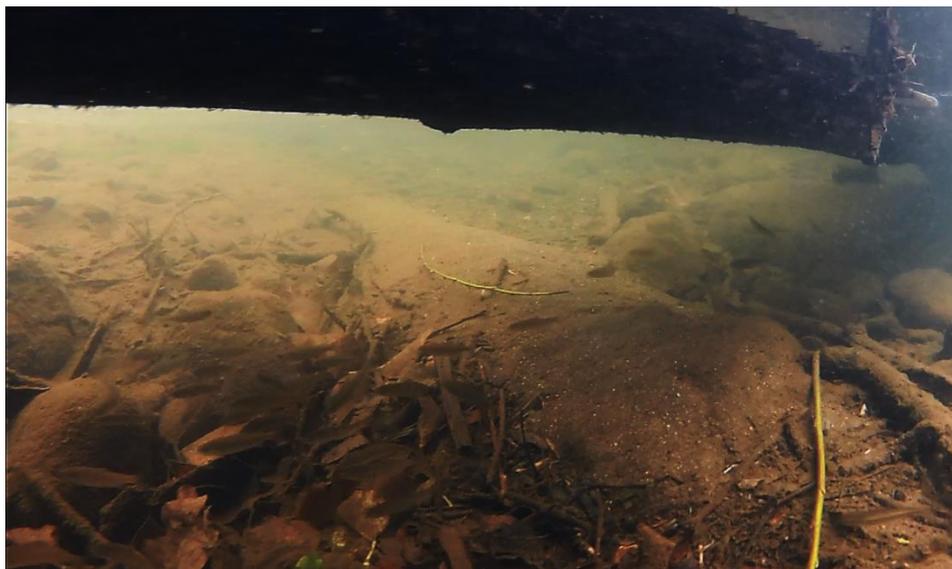
Photo 3. Juvenile salmonids (mostly coho – darks shapes below the log near the streambed) using Structure 6.

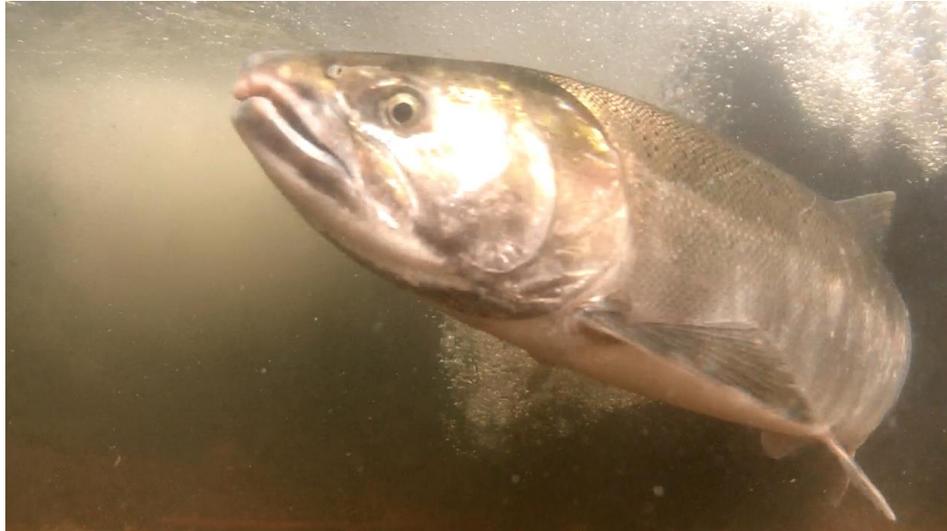
Photo 4. Adult coho salmon holding in pool habitat created by Structure 5.

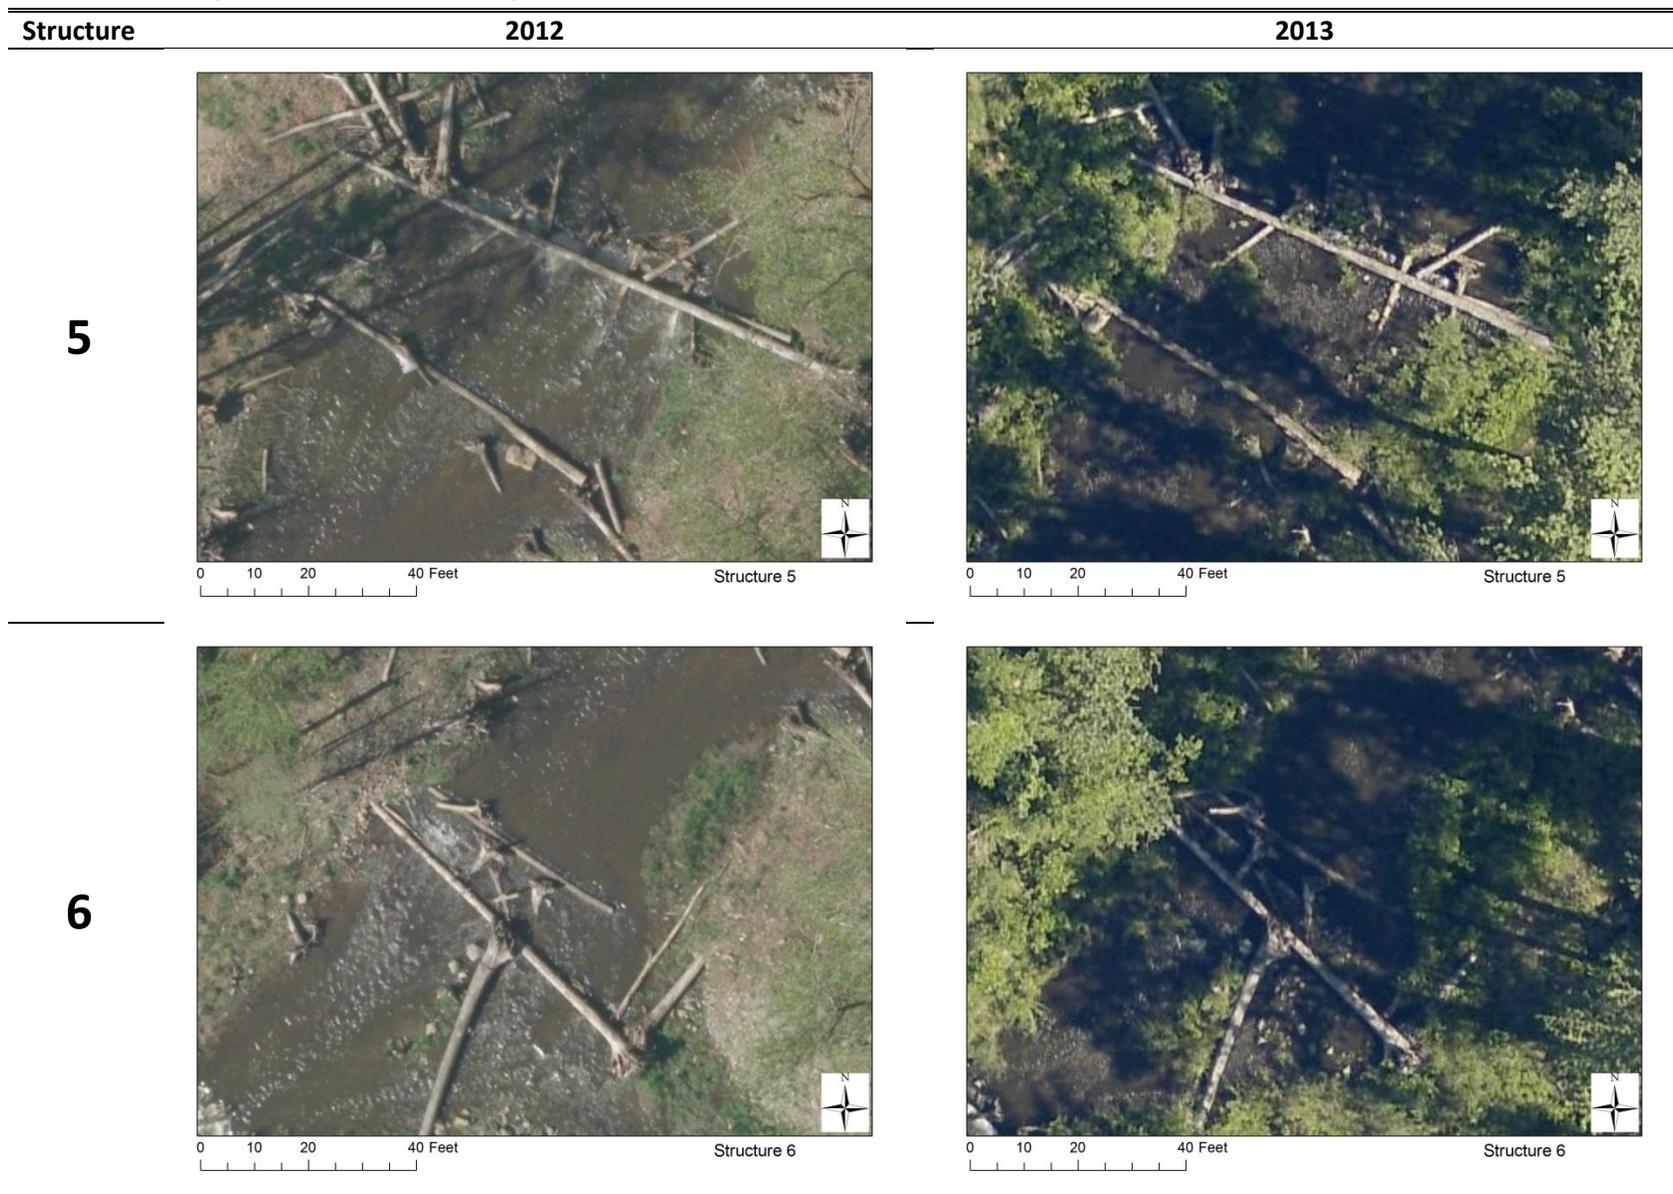
Figure 15. Aerial photo reference points for Structures 5 and 6, showing conditions in 2012 and 2013.
