**Subject: Summary of technical information and identification of data needs  
(Final Deliverable for Task 2.1)**

The project site is located near RM 20.35 on the Green River in the City of Kent at the former Rosso and Teufel nursery site. The site was acquired by King County in 2011 as part of a long-term habitat enhancement and flood mitigation strategy for the Green River. The site is located on the west bank and is currently vacant... The Green River at this location is entrenched with steep banks covered in shrubs and grasses, primarily blackberry, alder, and willow (Figure 1). Several large cottonwood trees are located -near the top of the bank on the upstream edge of the project area with the southern tree supporting an active bald eagle nest this year (2016). In compliance with the US Fish and Wildlife guidelines, activities will be restricted within 330 feet of the nest during nesting season (February through August 31).

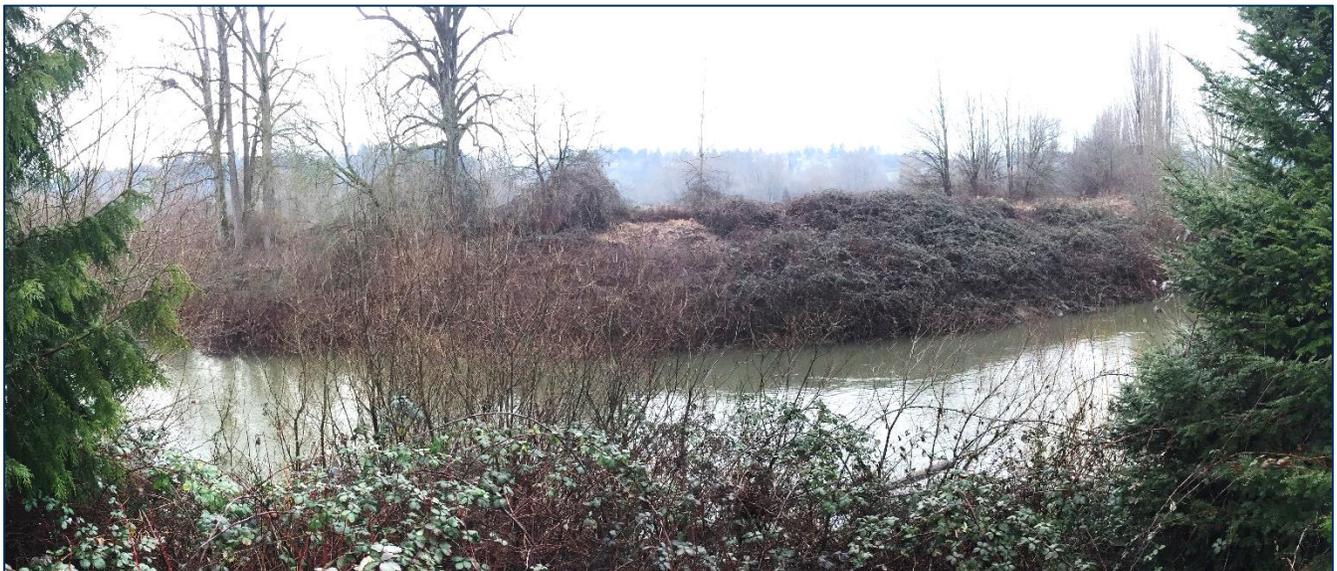
**Figure 1.** Photo of the project site from the east bank during the site visit on January 26, 2016. Note eagle's nest in far left cottonwood tree on the far bank.

The site was visited on January 26, 2016 with Jack Bjork and Eric Harlow from Cardno, and Jennifer Rice, Kerry Bauman, and Fatin Kara from King County. The site was first viewed from the east bank bike trail on the Russell Road levee, and then the team drove to the other side of the river and entered through the locked gate and walked over to the two geotechnical investigation bore holes. Project issues and constraints were described, along with past and potential land-use issues. The Green River was flowing at approximately 2950 cfs (as measured at the USGS Auburn gage 12113000) and was higher than the typical spring flow, obscuring the bank below the vegetation line. The eagle's nest was noted, along with the vegetated bank conditions, i.e., almost complete coverage of the bank with Himalayan blackberry. Cultural resources and potential contamination issues were not expected to be issues at the project site portion of the property.

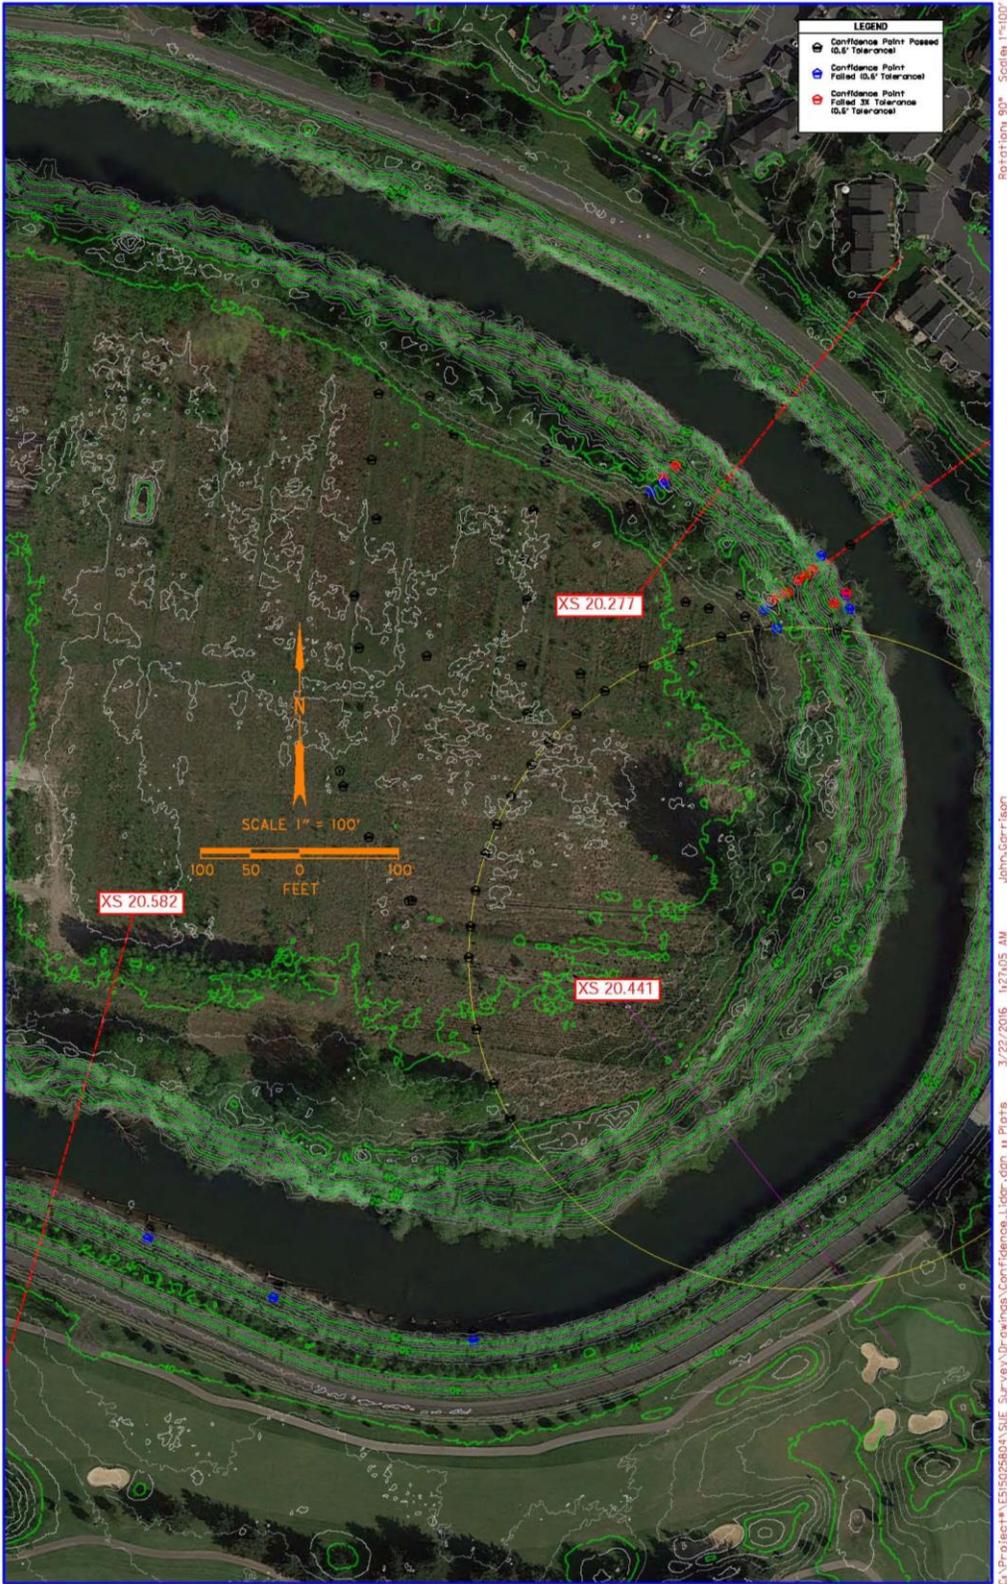
Figure 2. Survey confidence point map.

were within acceptable tolerances, but several points along the sloping bank did not pass (Figure 2). This result is expected given the steep and variable surface along the stream bank.

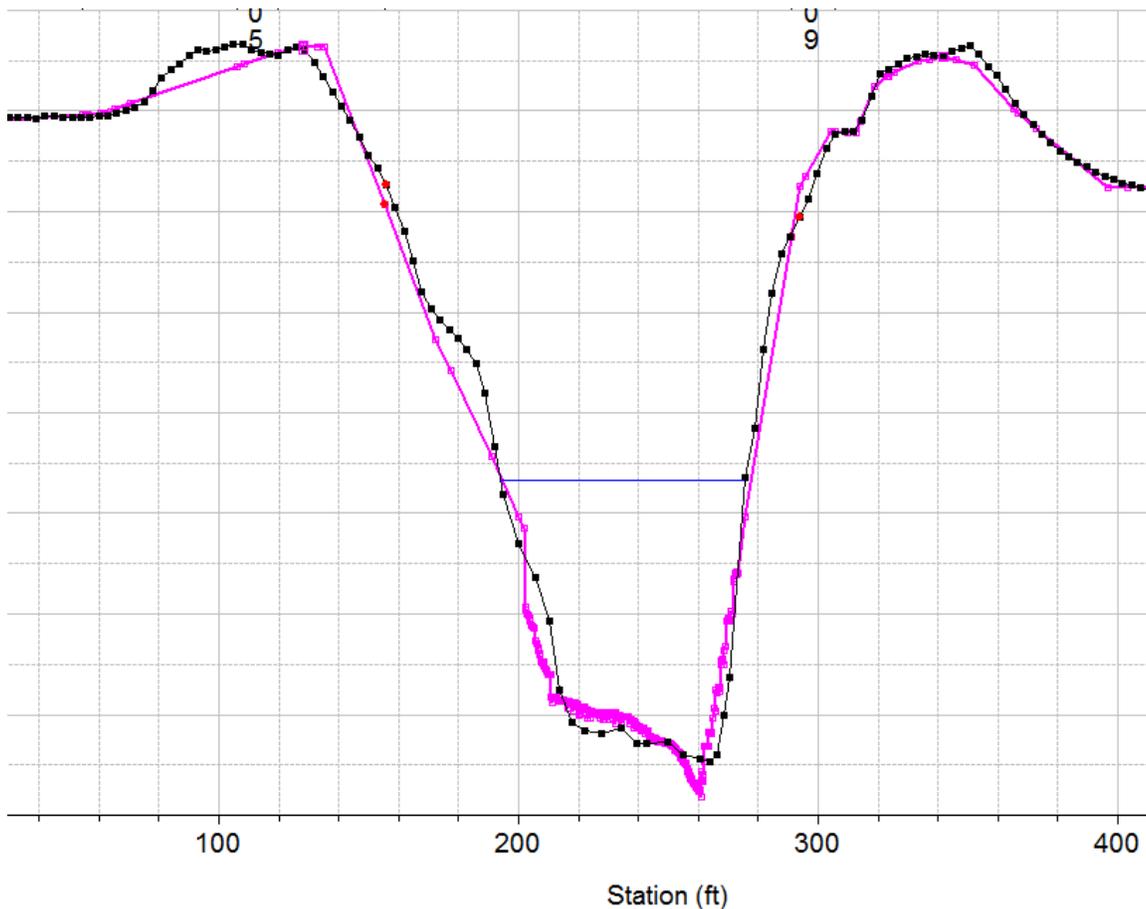
**Figure 3.** Preliminary cross section 20.277 at the downstream end of the project area. Vertical scale is 2 feet, and horizontal scale is 20 feet (10:1 vertical exaggeration). The pink line represents the 2006-2007 cross section and the black line represents cross section data collected in March 2016.

The resurveyed cross sections of the bottom of the channel did not change dramatically since the last survey in 2006. Figure 3 shows a preliminary cross-section comparison for cross section 20.277, which is located at the downstream end of the project area. The cross sectional area did not change much over the 10-year period, although the left bank and the maximum depth decreased by about 1.5 feet at the thalweg. For purposes of hydraulic modeling and construction for this project, the changes in bathymetry since 2006 are minor and unlikely to have much of an effect.

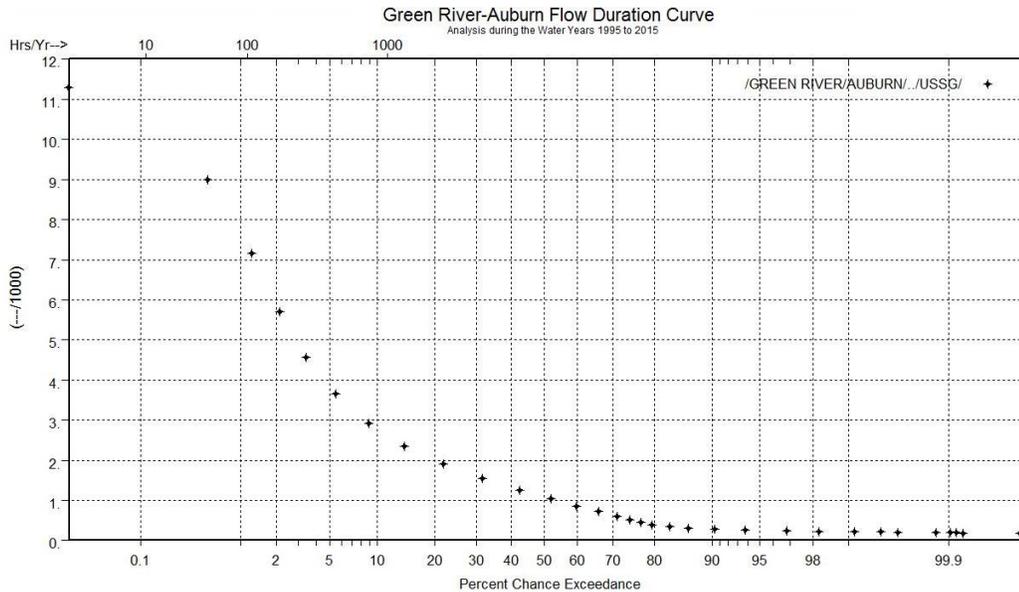
**Figure 4.** Flow duration curve for USGS gage 12113000 at Auburn. Horizontal axis is in 1000s of CFS.

The nearest active USGS gage is located at 200<sup>th</sup> street in Kent (USGS 12113344), which is approximately three river miles downstream from the project site. The gage at Kent, however, only has discharge records dating back to the end of 2011. The USGS gage located approximately 12 river miles upstream at Auburn (USGS 12113000) is the nearest upstream active gage to the project site and has a record of discharges dating back to 1936. Figure 4 is a preliminary flow-duration curve based on flows at the Auburn gage.

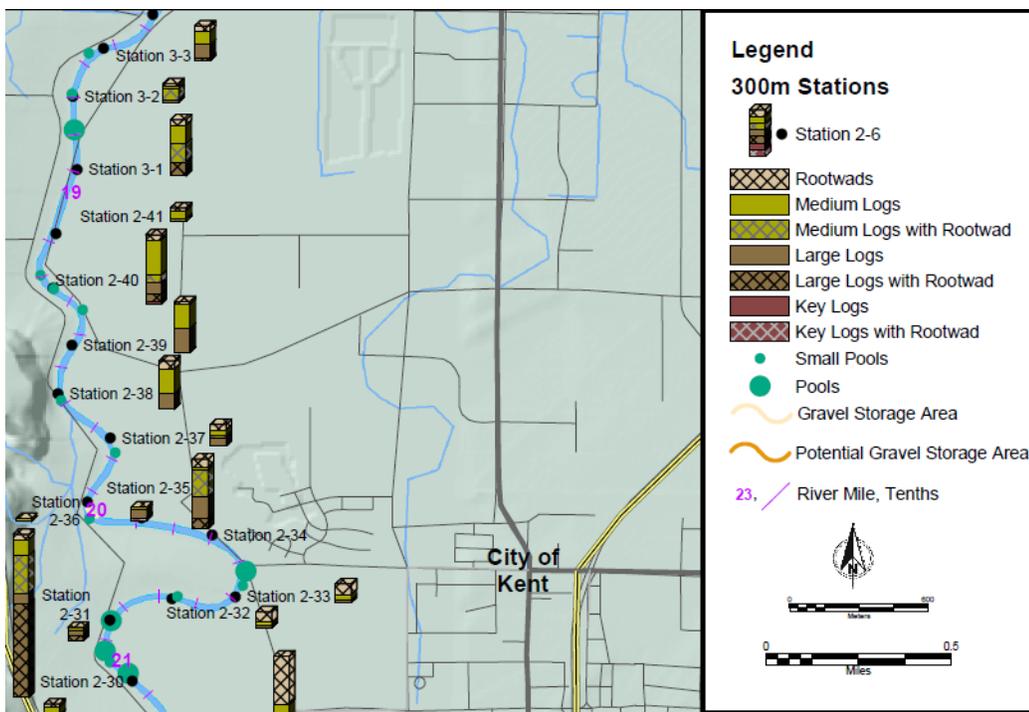
Figure 6. Aquatic Habitat as identified in the Final Lower Green River Baseline Habitat Survey Report, Anchor QEA 2004.

The project site is located on the inside of a meander bend of the Green River so flow velocities are slow and sediment (mostly sand) tends to be deposited. A large lateral scour pool formed by scour against riprap along the right bank was identified by Anchor QEA in 2003 (pool dimensions 175 m long, 18-20 m wide, and 1.0 m residual pool depth; Anchor QEA 2004), but R2 (2014) characterized the entire area as glide in 2013 (Figure 6, Figure 7). The Muckleshoot Indian Tribe bathymetric survey also identified a pool along the outside bend of the right bank, as well as a sand bench along the inside bend of the left bank (Figure 8; MIT 2014). An accumulation of small wood is currently present within a portion of the project area (Figure 9). **The Green River is a Shoreline of the State and is mapped XX in the Kent....**

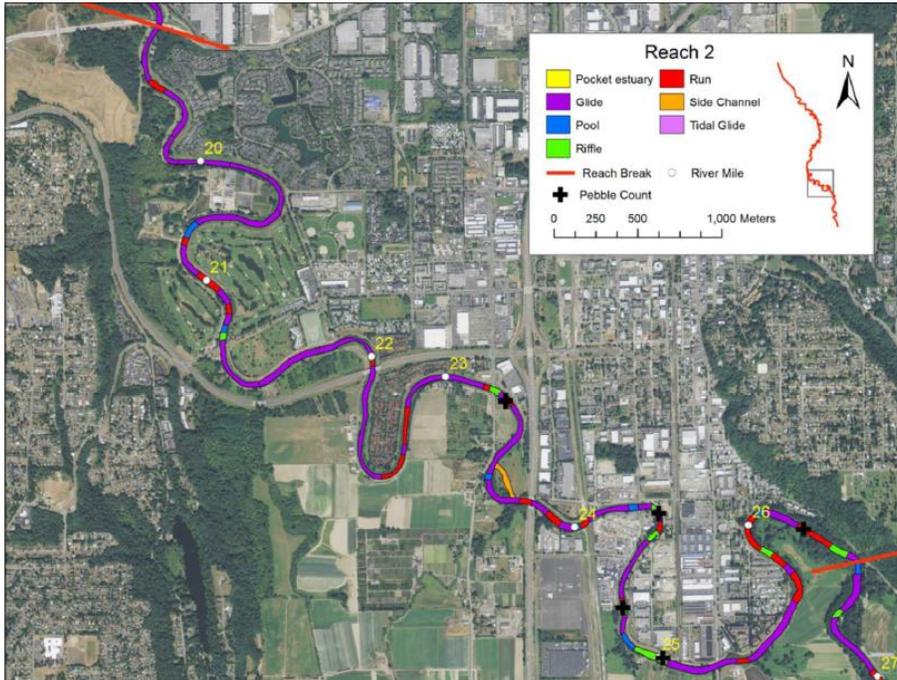
Figure 7. Aquatic Habitat as identified in the Lower Green/Duwamish River Habitat Assessment, R2 Resource Consultants 2014.

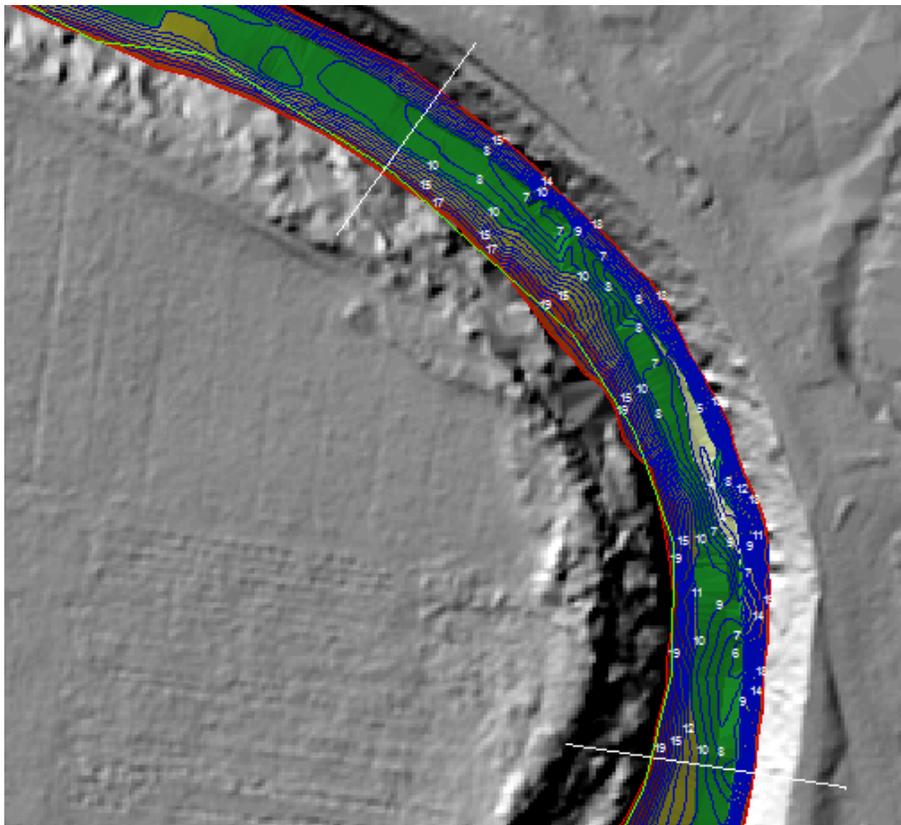
Figure 8. Aquatic Habitat as identified in Muckleshoot Indian Tribe Bathymetric Survey, MIT 2014. The bare earth digital elevation model is from Green River LiDAR data collected 12/07/13; King County GIS.

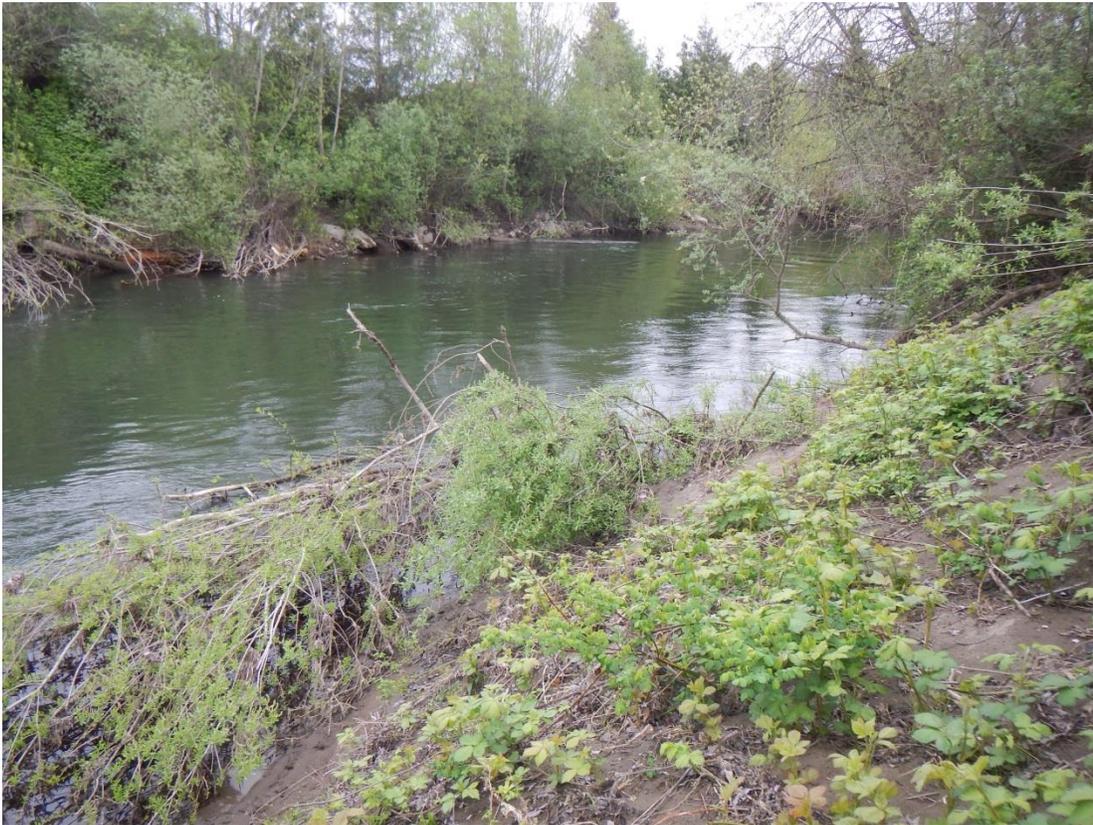
Figure 9. Teufel wood addition project site looking upstream, April 15, 2016.

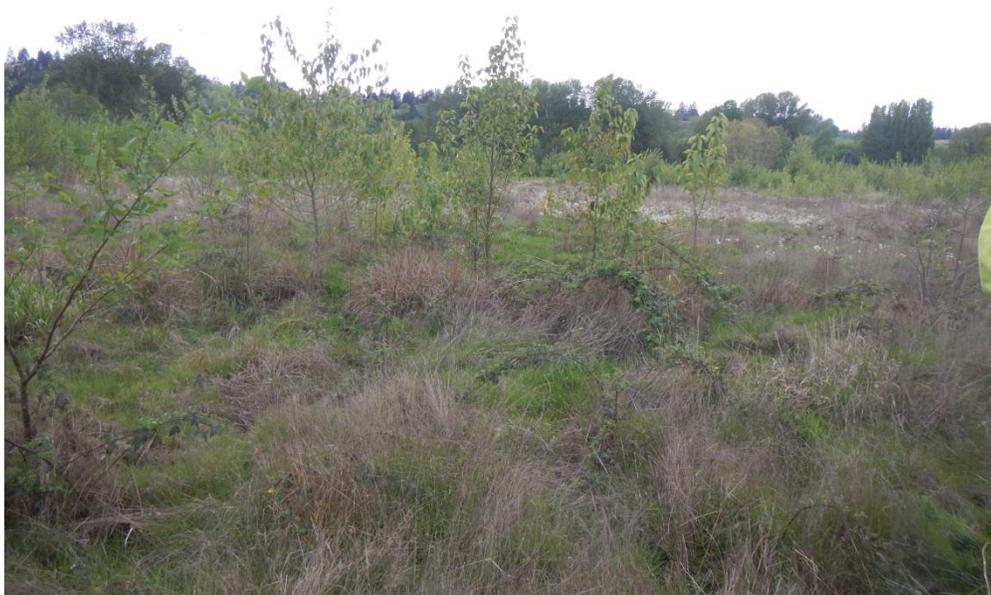
Figure 10. Typical vegetation at the Teufel property, April 15, 2016.

Vegetation throughout the project site is disturbed by previous land-use as a nursery. Few large trees are present although many cottonwood saplings (*Populus balsamifera*) have colonized the site; grass and weedy forbs dominate the herbaceous layer (Figure 10). The riverbank within the wood addition project site is dominated by dense Himalayan blackberry (*Rubus armeniacus*, Figure 11 ). A small stand of two or three mature cottonwoods is located at the upstream end of the wood addition project site; these trees provide some shade to the river and an active bald eagle (*Haliaeetus leucocephalus*) nest is located in one of them (Figure 12). A lone Oregon Ash (*Fraxinus latifolia*) also shades the river in the wood addition project area.

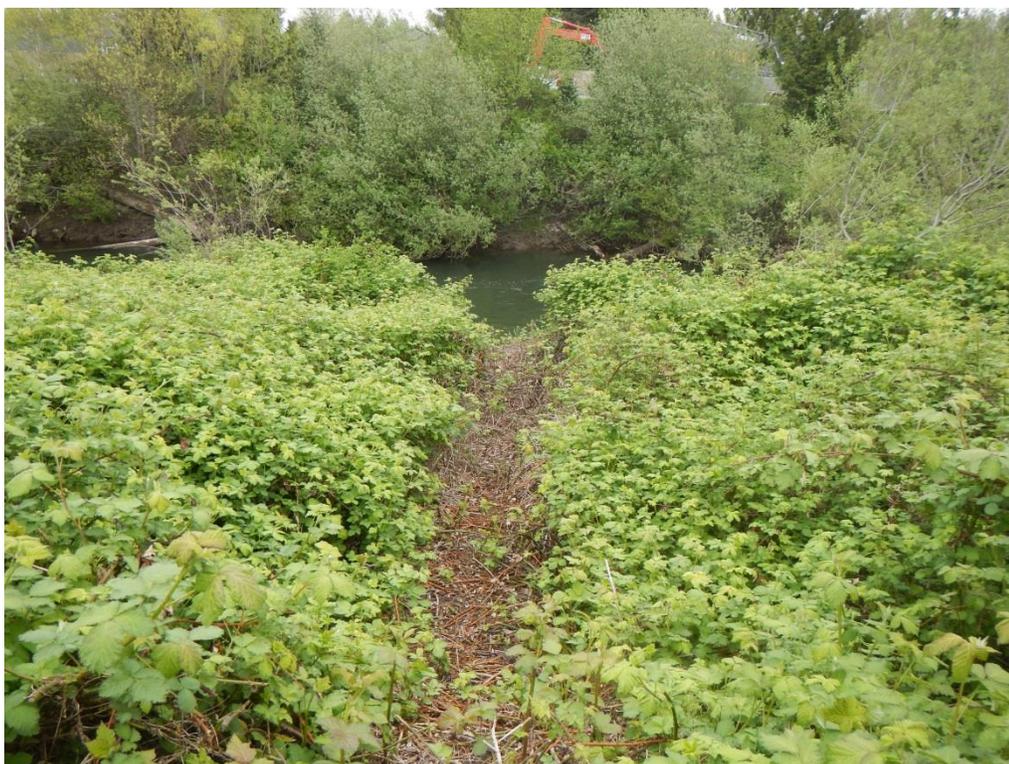
Figure 11. Path through the blackberries to the Teufel wood addition site, April 15, 2016.

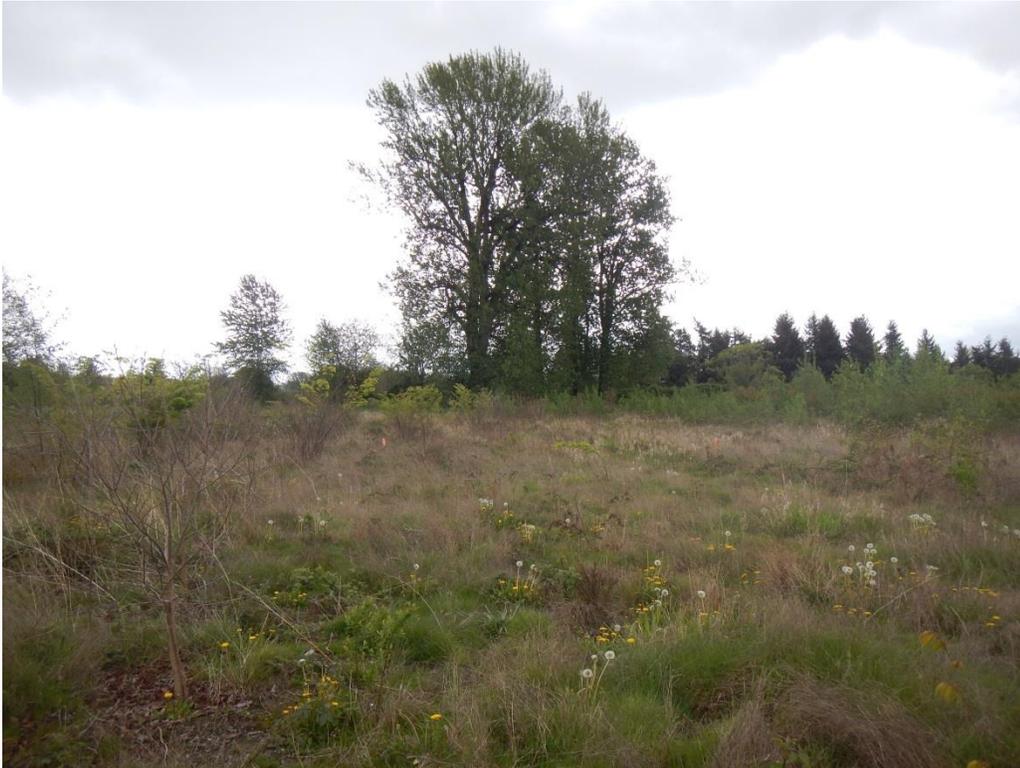
Figure 12. Stand of cottonwood trees; active bald eagle nest is located in the rightmost tree.

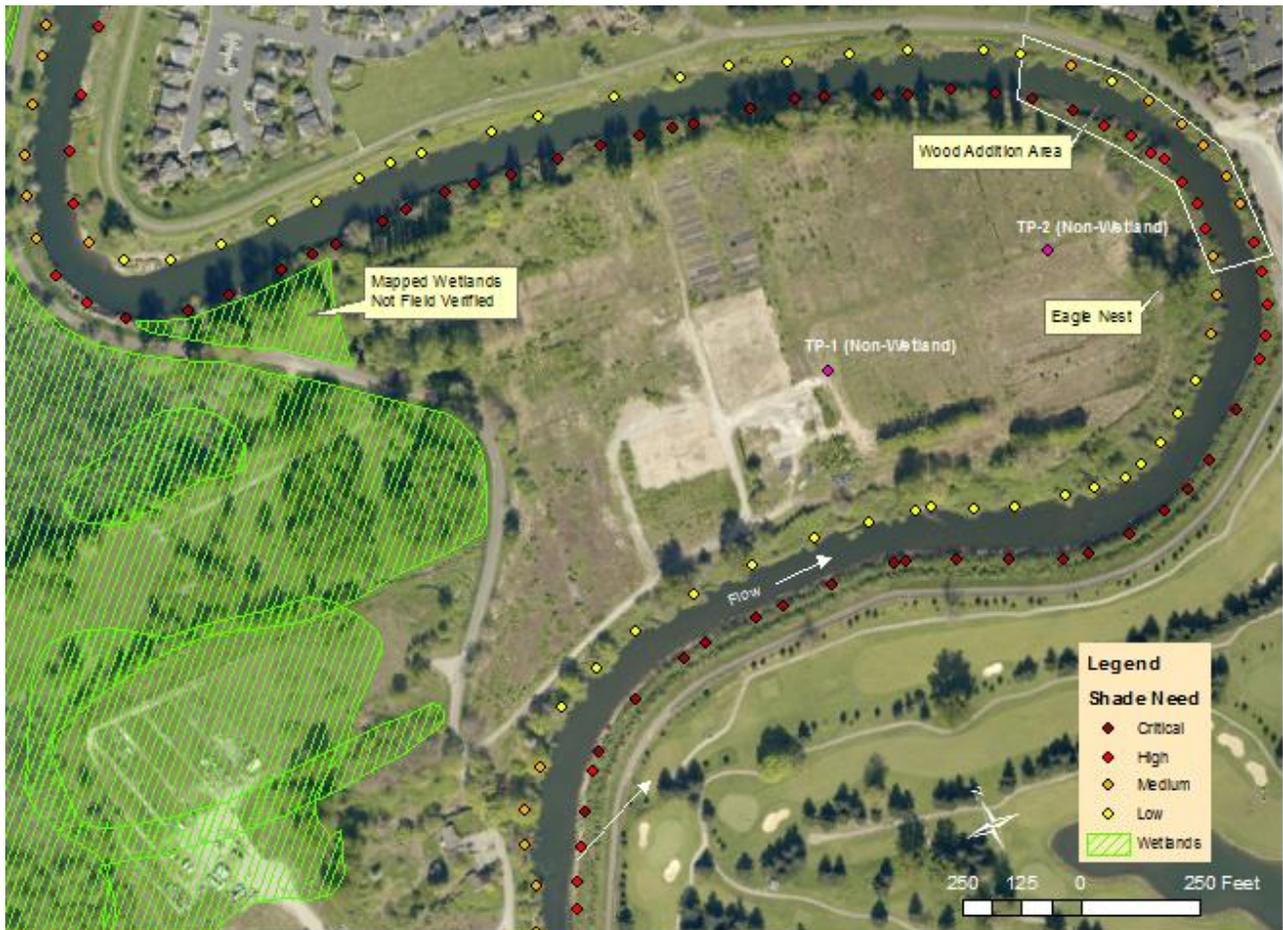
Figure 13. Wetland plots, mapped wetlands, and Muckleshoot Indian shade priorities on the Teufel property.

The King County “all wetlands in King County” GIS layer identifies a large wetland across Frager Road from the Teufel property, and a portion of this wetland extends onto the northeast corner of the property (Figure 13). This wetland was not field verified on April 15, 2016 because it is not within the large wood addition portion of the project area. However, the area may be within the revegetation portion of the project area, in which case it will be evaluated for the presence of wetlands and the planting plan will be developed accordingly.

The wood addition site and entire northern border of the Teufel property have been identified as having high and critical solar aspect for providing shade to the river (Figure 13) No seismic, earthquake, or landslide hazard areas are located within the project site (King County GIS), the site is not in a channel migration hazard (King County GIS), and there are no single source aquifers located on the project site (King County GIS). **Check Kent critical areas maps.**

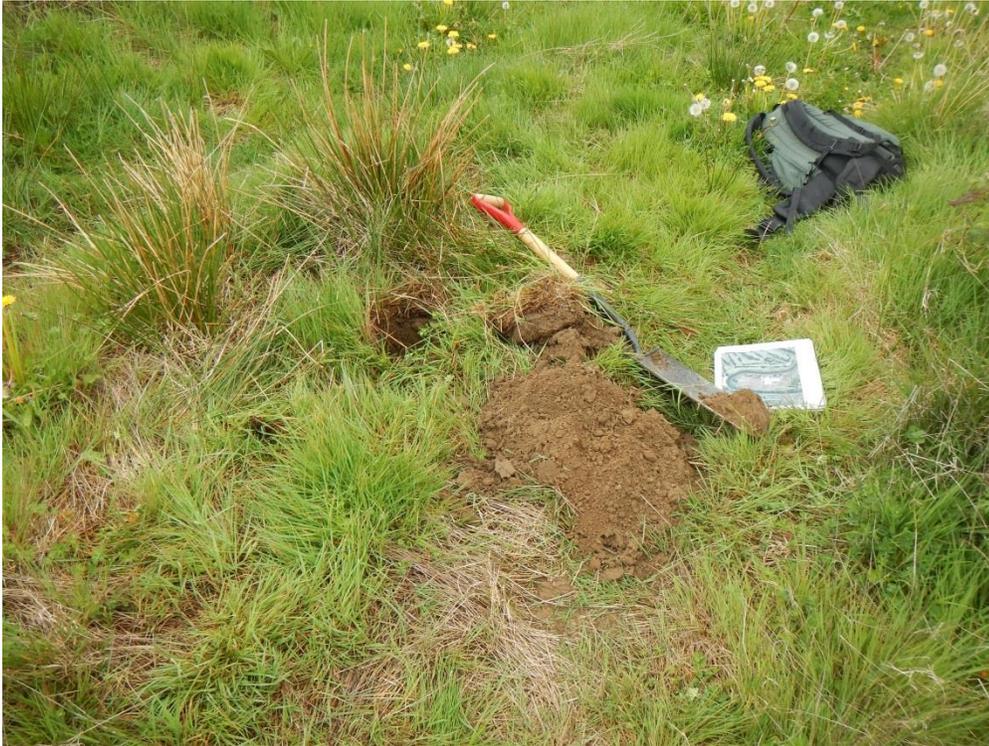
Figure 14. Wetland Test Plot-1; no wetland. April 15, 2016.

The project vicinity and access routes were evaluated for wetlands on April 15, 2016; none were found. Two wetland plots (TP-1, TP-2; Figures 13-15) were established in areas that appeared most likely to have wetland characteristics based on the presence of soft rush (*Juncus effuses*). Although vegetation met hydrophytic vegetation criteria in both plots, neither hydric soils nor wetland hydrology were present (Appendix A). The test plots were therefore identified as non-wetland because all three wetland indicators (hydrophytic vegetation, hydric soils, and wetland hydrology) must be present for a test plot to be wetland.

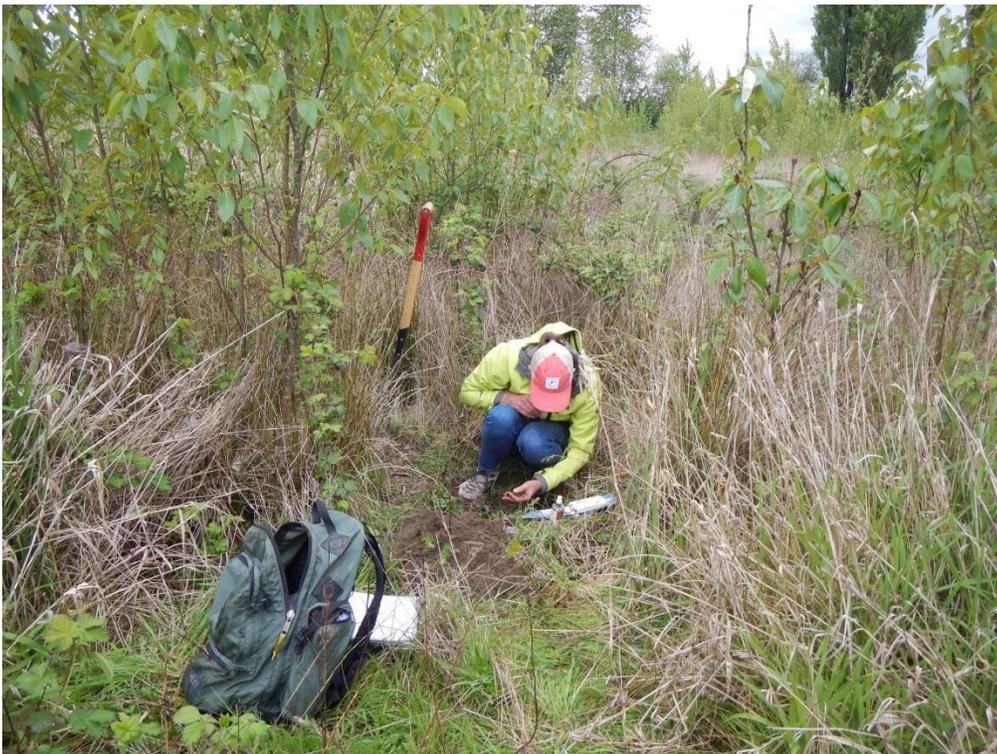
Figure 15. Wetland Test Plot-2; non-wetland. April 15, 2016.
