Small but Mighty: VideoRay ROV is Versatile Member of the Environmental Lab Crew

By Jim Devereaux, Environmental Laboratory Environmental Services Unit

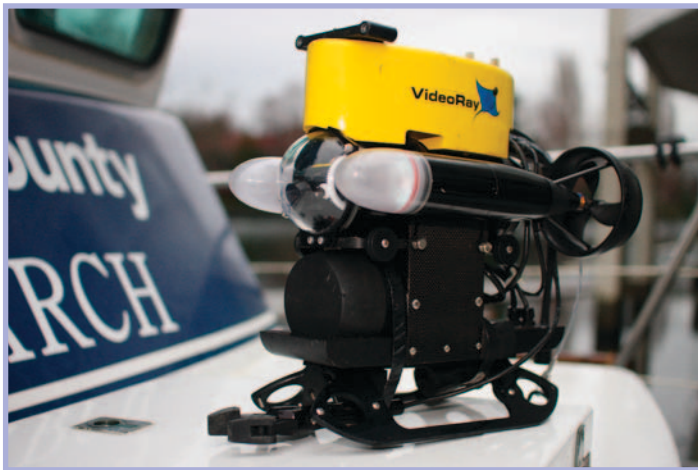
This remotely operated video camera goes where divers or other equipment cannot go, used for projects ranging from eelgrass surveys, wastewater facility inspections, lost equipment recovery to searches for submerged human bodies.

The VideoRay ROV is one of the smallest ROVs available on the market, making it extremely versatile and capable of going places that larger units can't access. Considering its small size, the ROV is very capable, with two cameras, lights, sonar, two high-powered thrusters and a manipulator.

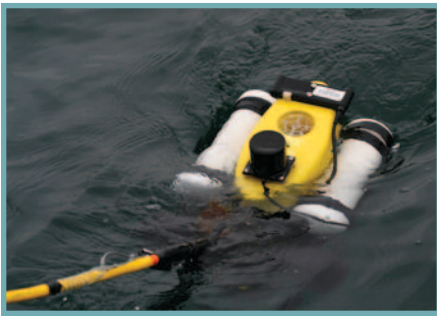
Bowman said the crew was surprised to discover that the 53rd Avenue Outfall was completely blocked in at least two areas with sand that filtered in from apparent pipe separation.

The Renton EBO was a difficult inspection because of extremely low visibility, making the sonar capabilities vital for navigating more than 500 feet of pipe, and for determining the condition of the outfall diffuser structure. Based on the sonar images, staff was able to determine that there was a significant build up of sediment at the end of the structure.
