Is it elk, deer, cattle, human...
or what?

Source tracking
in Boise Creek's stormwater system

King County

WLRD Stormwater Services

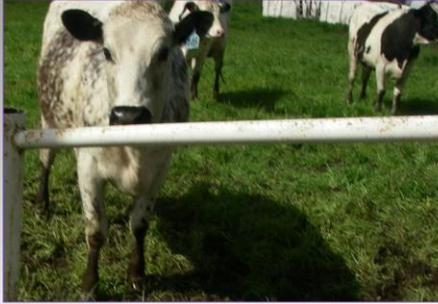
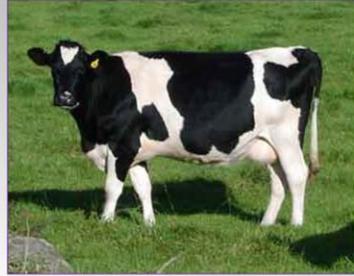
Boise dairy cows

There are dairy cows in the basin.
Cow manure is kept in piles and lagoons in the basin.
Manure is spread as fertilizer, as well.

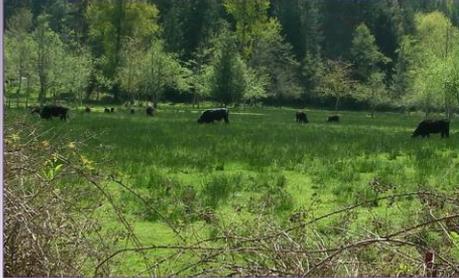
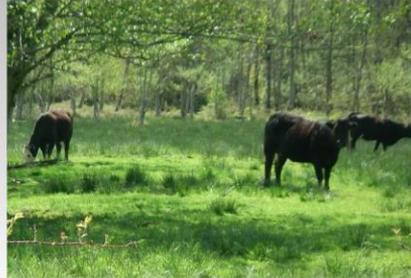
Boise beef cattle

There are also beef cattle in the basin. In many cases cattle have been observed in and near ditches.

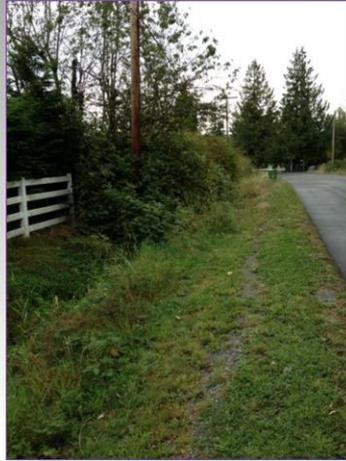
Stormwater system

County ditches

Boise Creek's stormwater conveyance system is comprised of roadside ditches, and closed conveyance including pipes, catch basins and manholes, discharging via outfalls to the Creek.

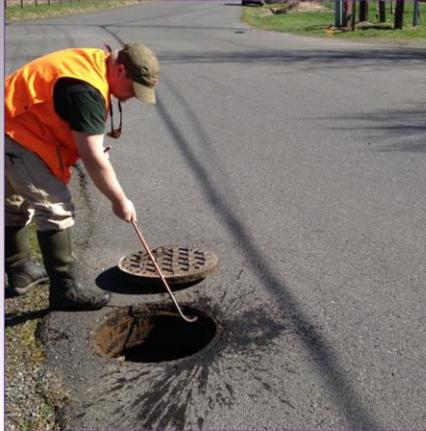
Stormwater system

Catch basins & pipes

Boise Creek's stormwater conveyance system is comprised of roadside ditches, and closed conveyance including pipes, catch basins and manholes, discharging via outfalls to the Creek.

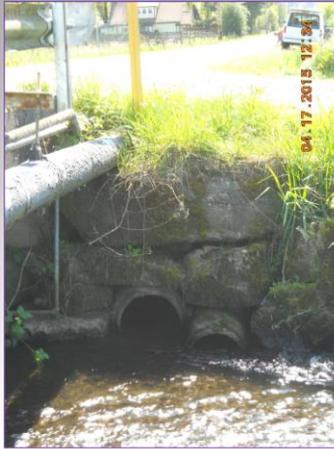
Stormwater system

Stormwater pipes
outfalling to
creek

Boise Creek's stormwater conveyance system is comprised of roadside ditches, and closed conveyance including pipes, catch basins and manholes, discharging via outfalls to the Creek.

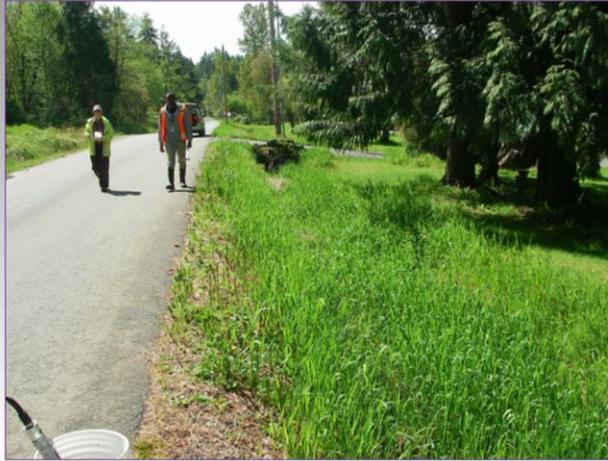
Got out there with our eyes, ears and noses!

We then drove and walked the basin, familiarizing ourselves with the stormwater system of ditches, pipes and catch basins. We selected sampling points in our MS4 to screen and sample for high levels of bacteria. Water samples for Coliscan Easygels and for fecal coliform, human *Bacteroides* and ruminant *Bacteroidales* have been tested. Slide shows Jeanne Dorn and Terae Jones walking near a County roadside ditch in Boise Creek.

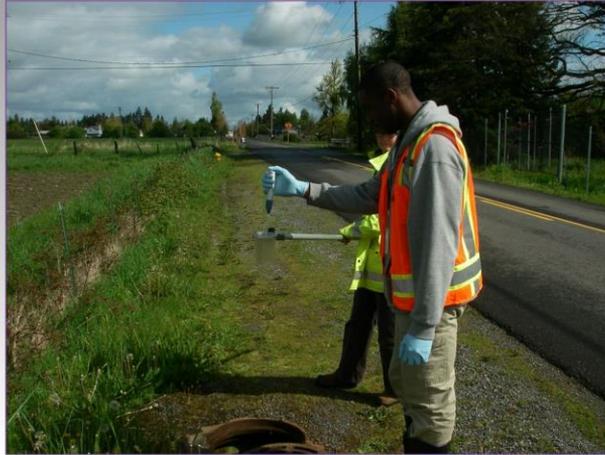
Conducted water sampling

Slide shows Terae and Jeanne obtaining water from a stormwater catch basin to culture a Coliscan Easygel (rapid *E. coli* culture method, commercially available).

We also submitted samples to our County lab for analyses for Hu-1-Bacteroides and Ruminant-2-Bacteroidales. Later the method for human gut bacteria DNA was changed to Hu-2-Bacteroides, a more specific and less sensitive genetic marker, which we consider more reliably indicates the presence of human waste than Hu-1 did.

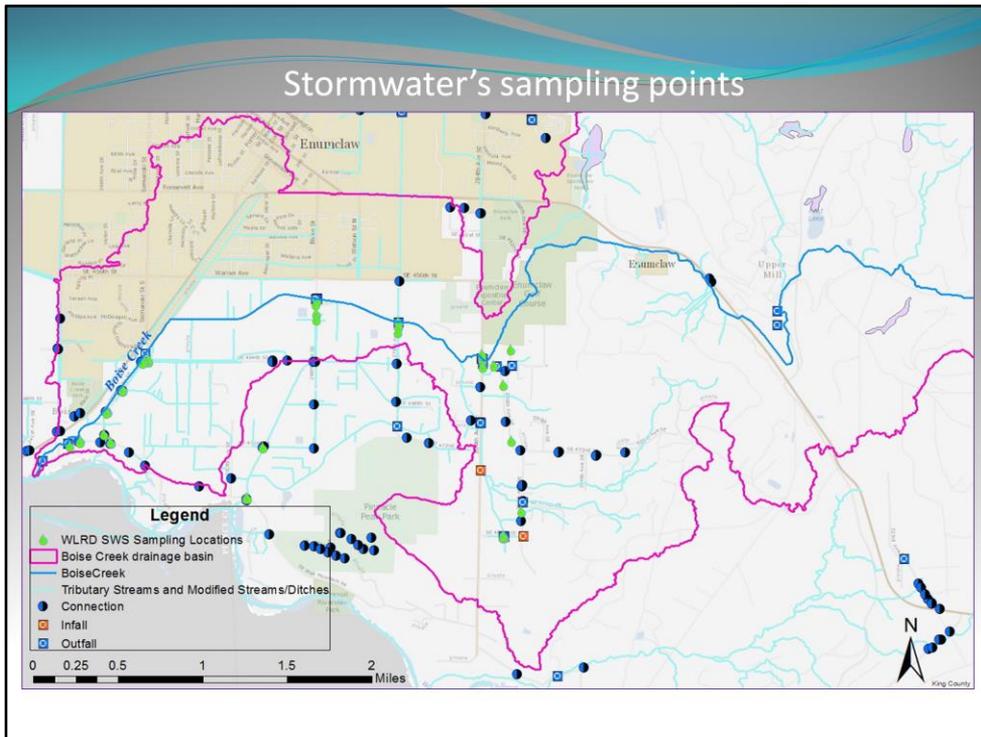
We established 45 sample locations in the stormwater conveyance system so far.

Green dots are SWS sampling points.

Blue question marks are places where stormwater leaves King County conveyance system.

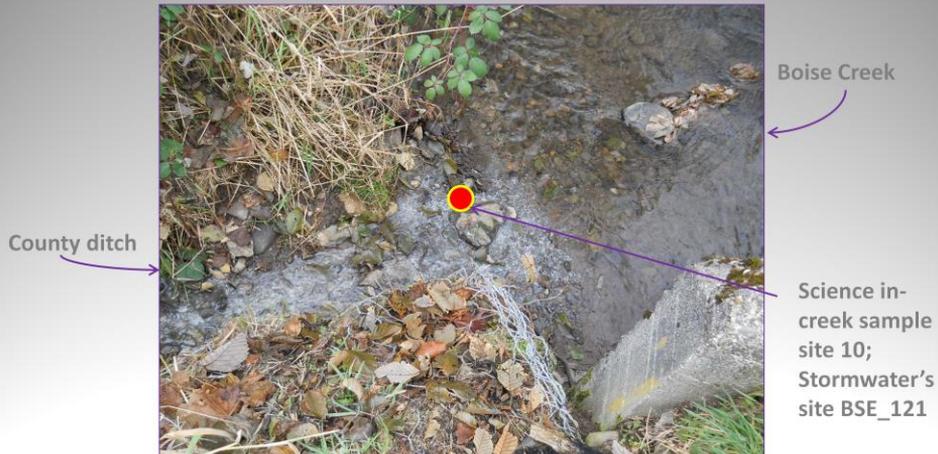
1st illicit discharge

High hits of Hu-1-*Bacteroides* in 2011 found by Science.

This slide shows Science's sample location 10, which is where a County ditch discharges to Boise Creek. Ray found high hits of Hu-1-*Bacteroides* at his station 10, which is at the intersection of the creek and a County stormwater ditch. Creek at top right is Boise, flows westward (toward top of slide).

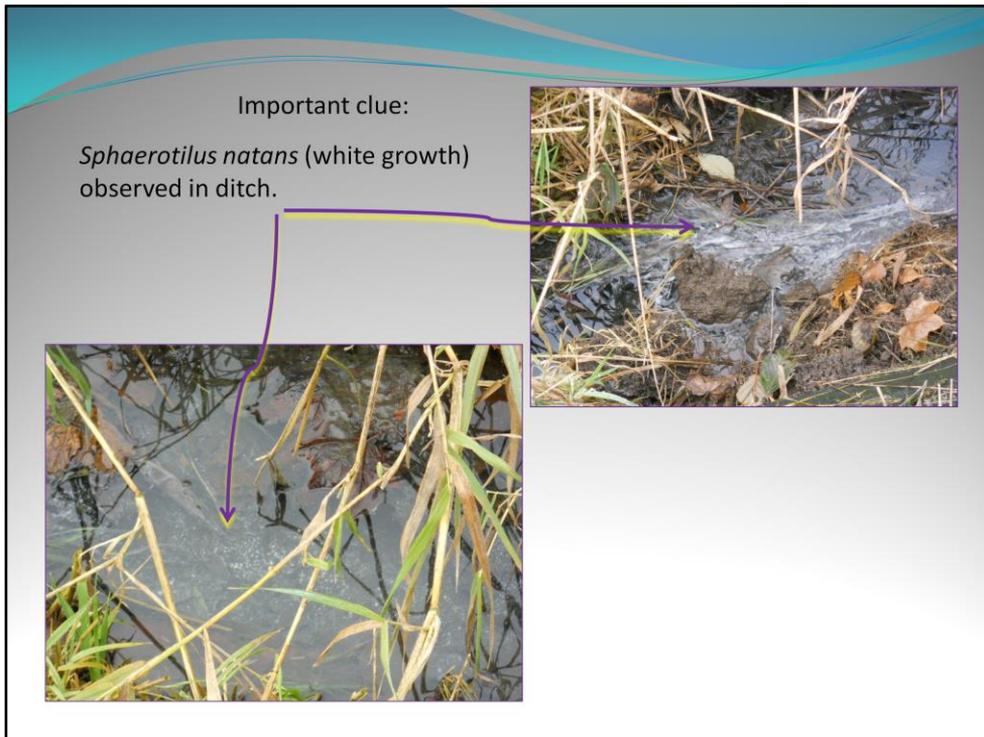
Science reported the high levels of Hu-1-*Bacteroides* to Stormwater Services. We followed up by sampling numerous points up the ditch, and confirmed high levels of Hu-1-Bac in the ditch. At time of first Stormwater Services visit in late December 2011, a white filamentous growth was noted and photographed. Later, we determined this could be *Sphaerotilus natans*, a bacteria that flourishes in flowing sewage.

More testing confirmed human waste.

Our Health Dept performed inconclusive dye testing of the residence, so we never found pathway mechanism of this discharge.

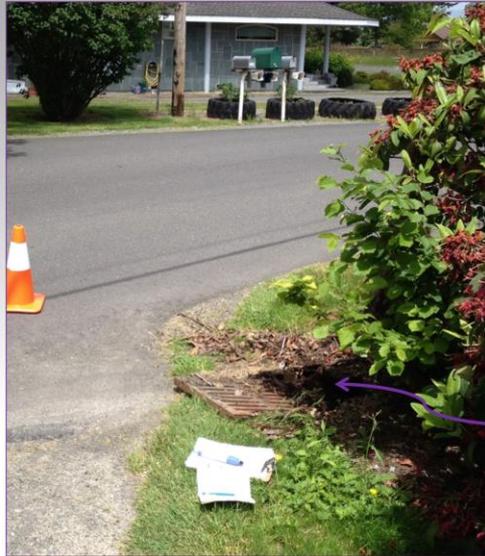
2nd illicit discharge

Found during dry weather screening at BSE_115 site (catch basin north across street here).

Illicit discharge tracked to CB here.

While performing one of the iterations of screening and sampling in the Boise Creek MS4, a catch basin (Sample BSE_115) on the north side of the street (background of this picture) was found that had milky-appearing water flowing in from the catch basin on the south side across the street (foreground of picture).

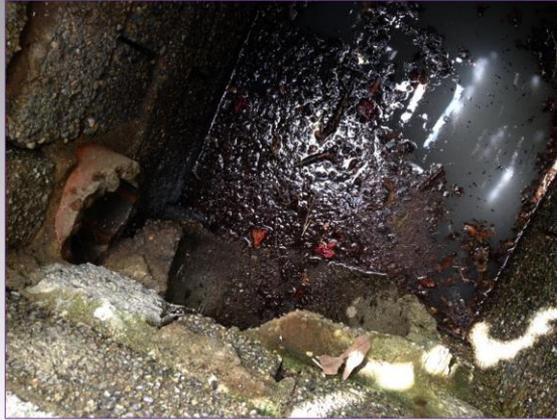
Ugly water flowing into this County CB from a private pipe.

Coming from a cattle ranch with an old house on septic system.

Milky, ugly, smelly water found in County catch basin, trickle flow of this water observed in private discharge pipe coming from the area of an old house, on septic system, on a cattle ranch.

Property was a home on a cattle ranch in Boise. We needed to differentiate between cattle and human waste, so grabbed a sample of the CB water the following week, and sent it to a private lab to conduct qPCR tests on two human waste tracers and two cow waste tracers. Tests came back positive for human tracer, negative both cow tracers.

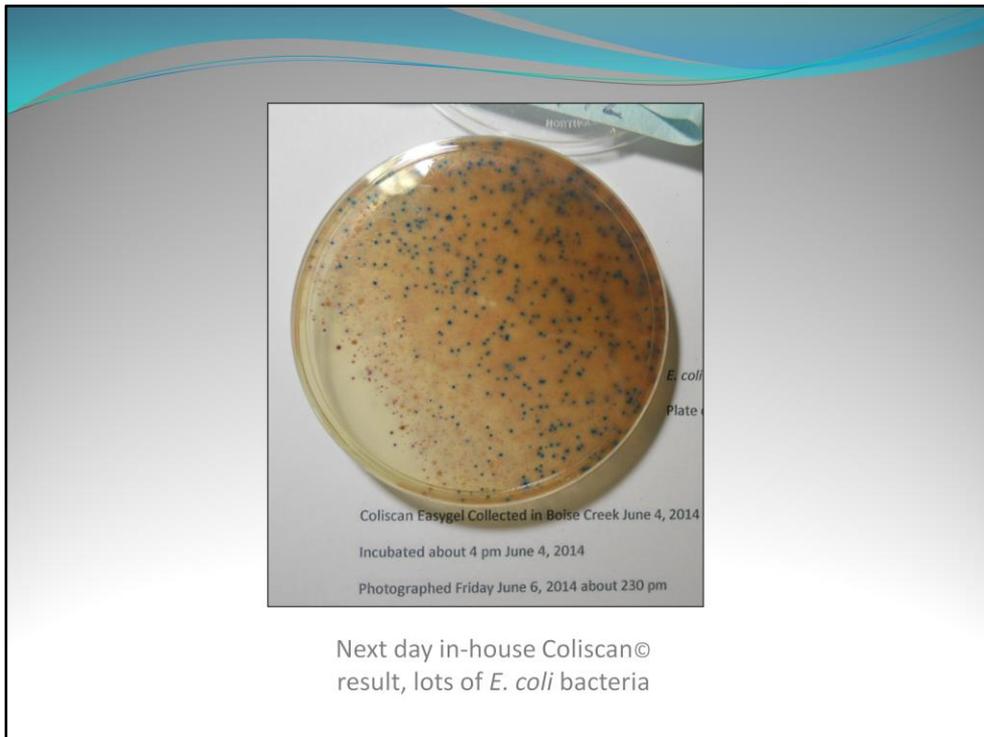
The Coliscan Easygel test on a sample of the inflow was immediately sampled the day of the discovery; we incubated it overnight in our downtown Seattle office building lab room. Test results the next day (right slide) in our office confirmed high levels of *E. coli*.

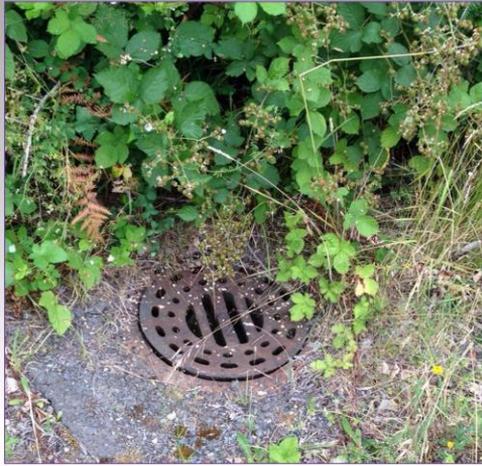
Stormwater's sample site BSE_109
(catch basin)

During dry weather screening and sampling, test results for FC and Hu-2-*Bac* came back high for this catch basin, which discharges directly to Boise Creek.

Sampling done dry weather September 2014. No Rum-2-*Bacteroidales* detected.

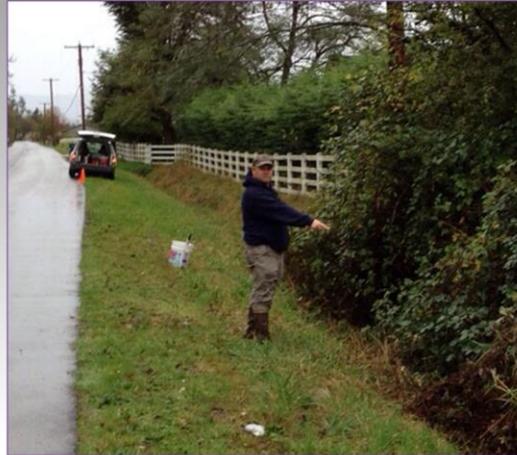
Ray points at just-discovered illicit discharge pipes--covered by blackberry vines

Jeanne and Ray conducted follow-up work at this site during a rain event in October 2014.

Ray noticed the sound of flowing water in a location we'd never heard that sound.

We poked around in overhanging blackberry vines until we discovered a pipe with flowing water (later was discovered to be two adjacent pipes, one discharging sewage, one discharging laundry washwater).

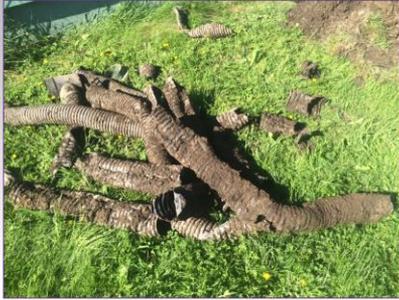
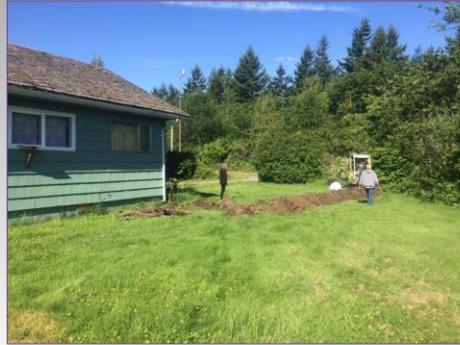
Pipes after removal; photos by property owner

Excavating & removing illicit drainage pipes

Two illicit pipes to County ditch (sewage and wash water) were subsequently ripped out, after our Health Dept contacted owner and requested they design a septic system repair.
