***In Situ* Water Quality Monitoring During
Sediment Remediation Construction Activities
at the Denny Way CSO**

Scott Mickelson

King County Marine and Sediment Assessment Group

Areas A & B Nearshore Interim Sediment Cleanup Project

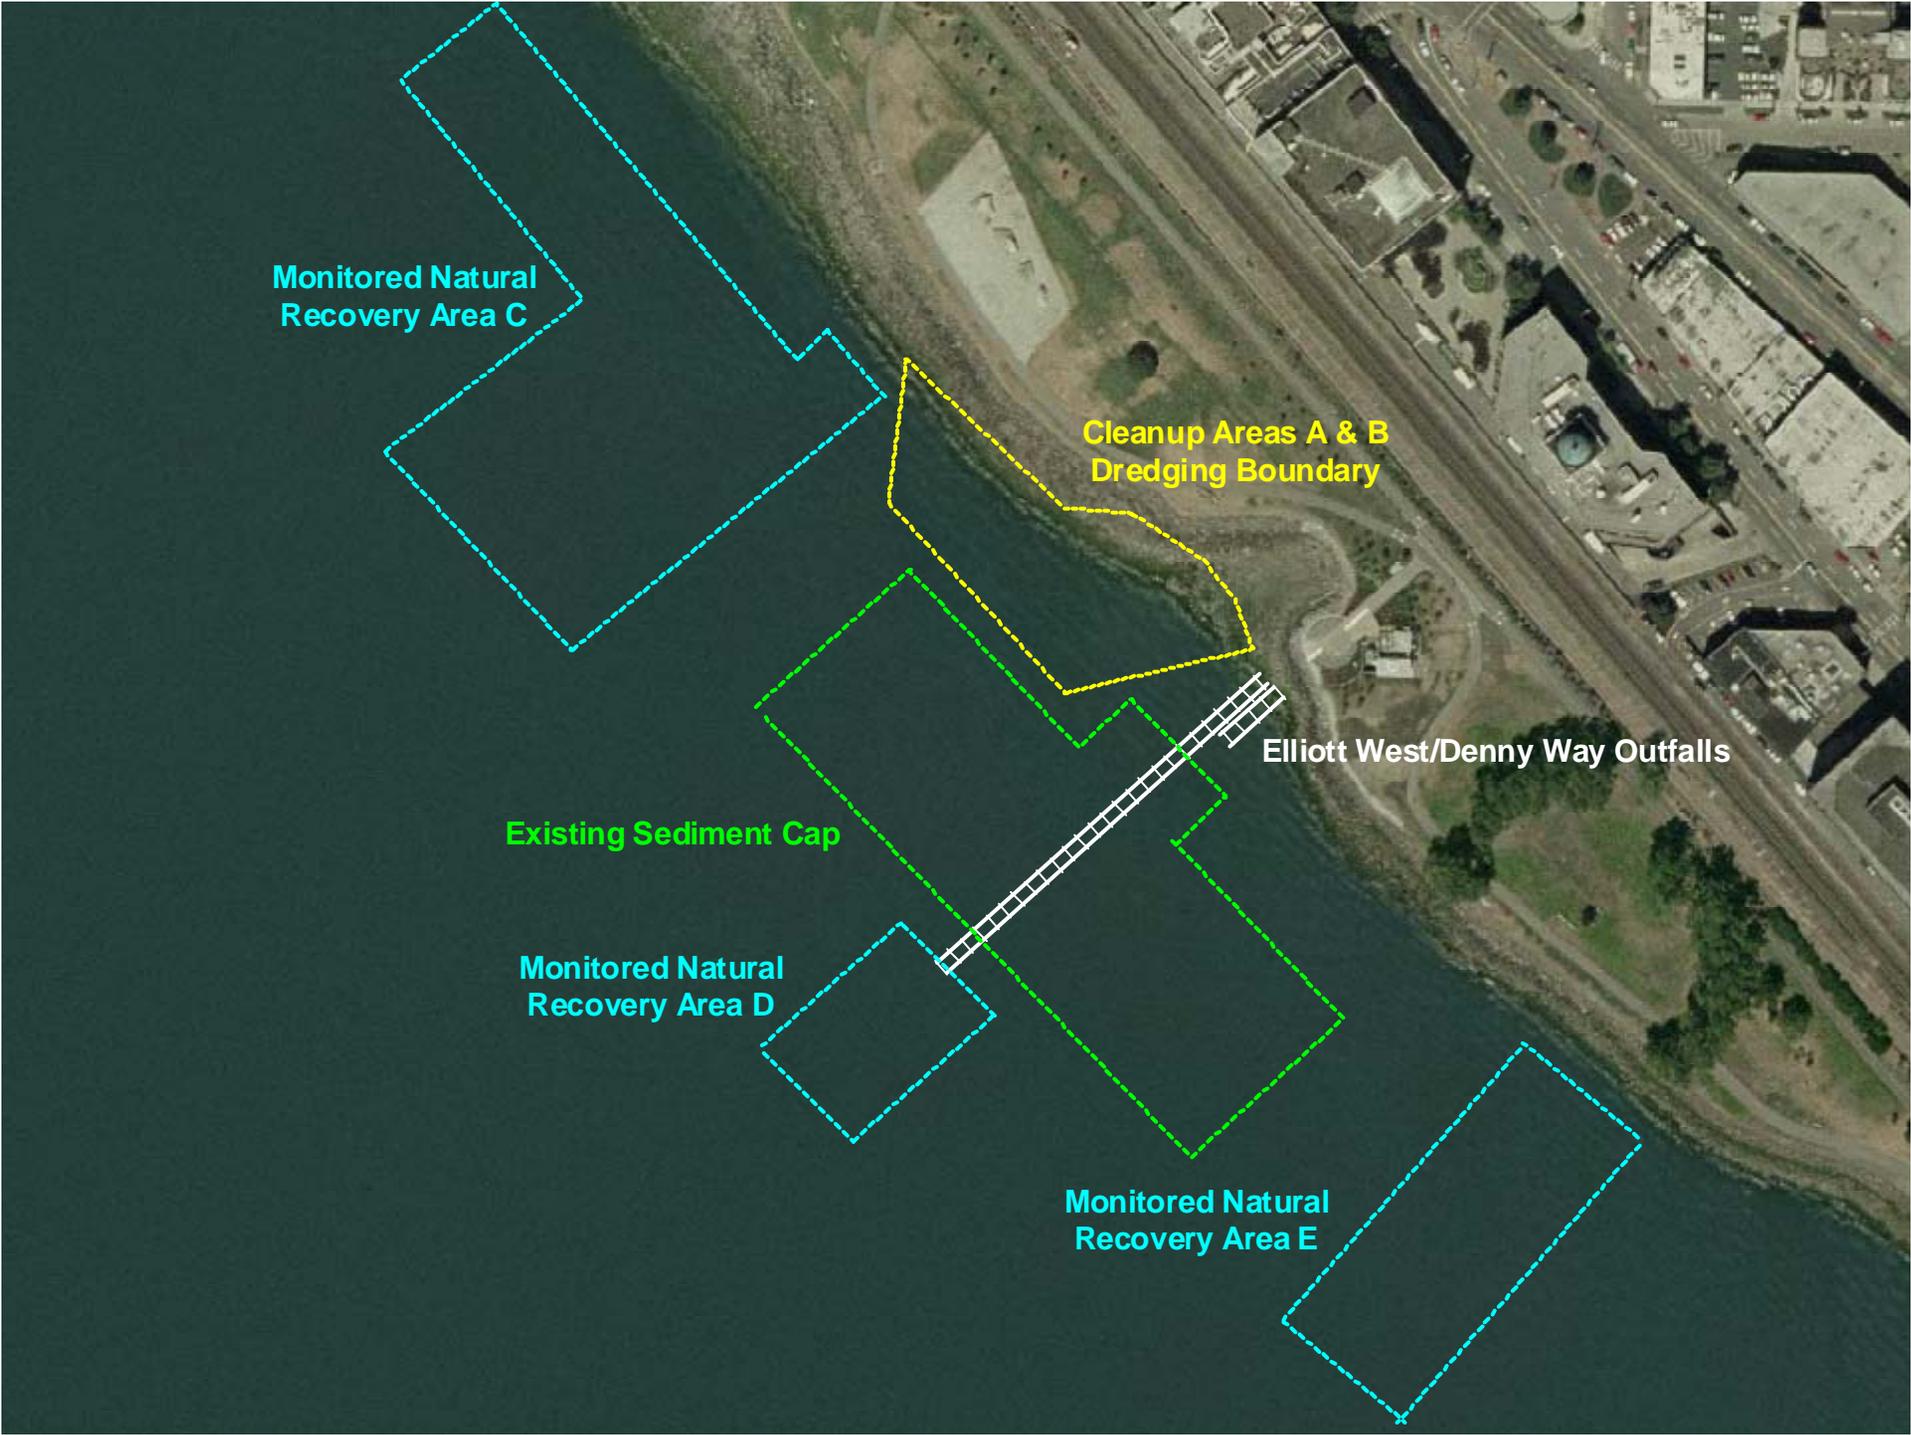
Monitored Natural
Recovery Area C

Cleanup Areas A & B
Dredging Boundary

Elliott West/Denny Way Outfalls

Existing Sediment Cap

Monitored Natural
Recovery Area D

Monitored Natural
Recovery Area E

- legacy contamination at Denny Way site from CSO and other sources has required sediment remediation
- contaminated sediment were capped in 1990 and monitored for 10 years
- three offshore areas around cap currently being monitored for natural recovery
- one area inshore of cap required active remediation

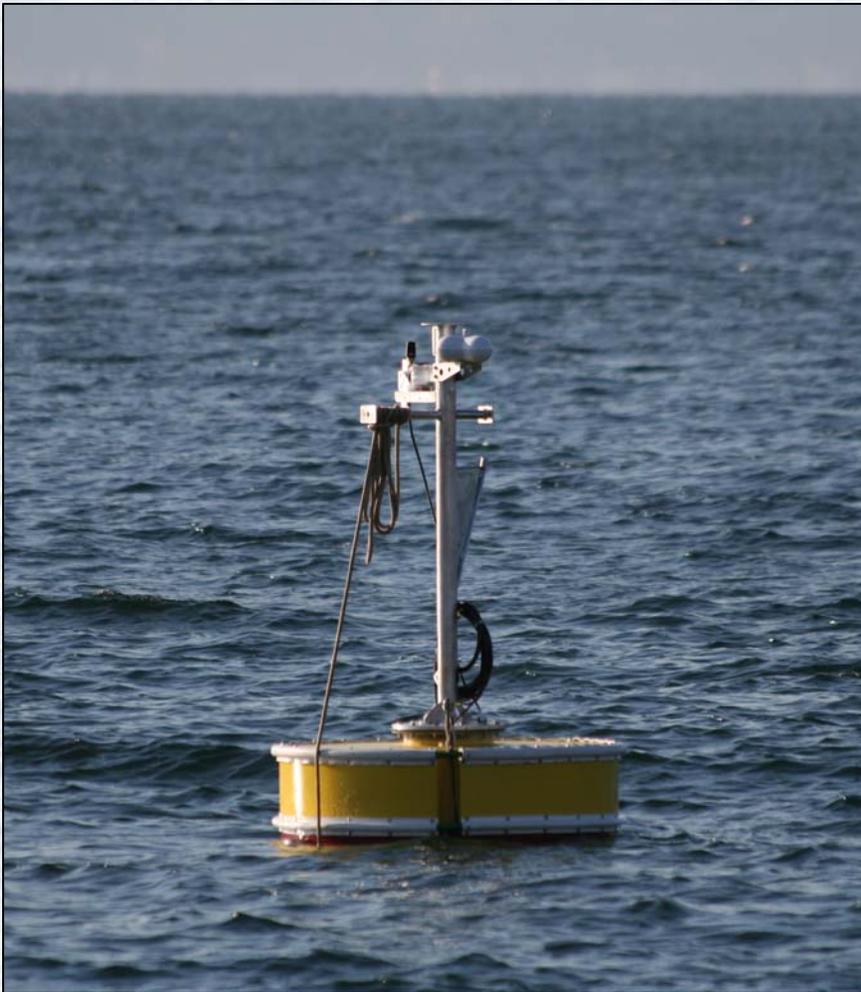
***In situ* water quality monitoring using stationary buoy**

- preferred over once-daily discrete sampling with laboratory analysis
- less labor intensive
- real-time data
- web-accessible to all project staff

Water Quality Monitoring Buoy

Dredging Boundary

Net Current Flow

Elliott West/Denny Way Outfalls

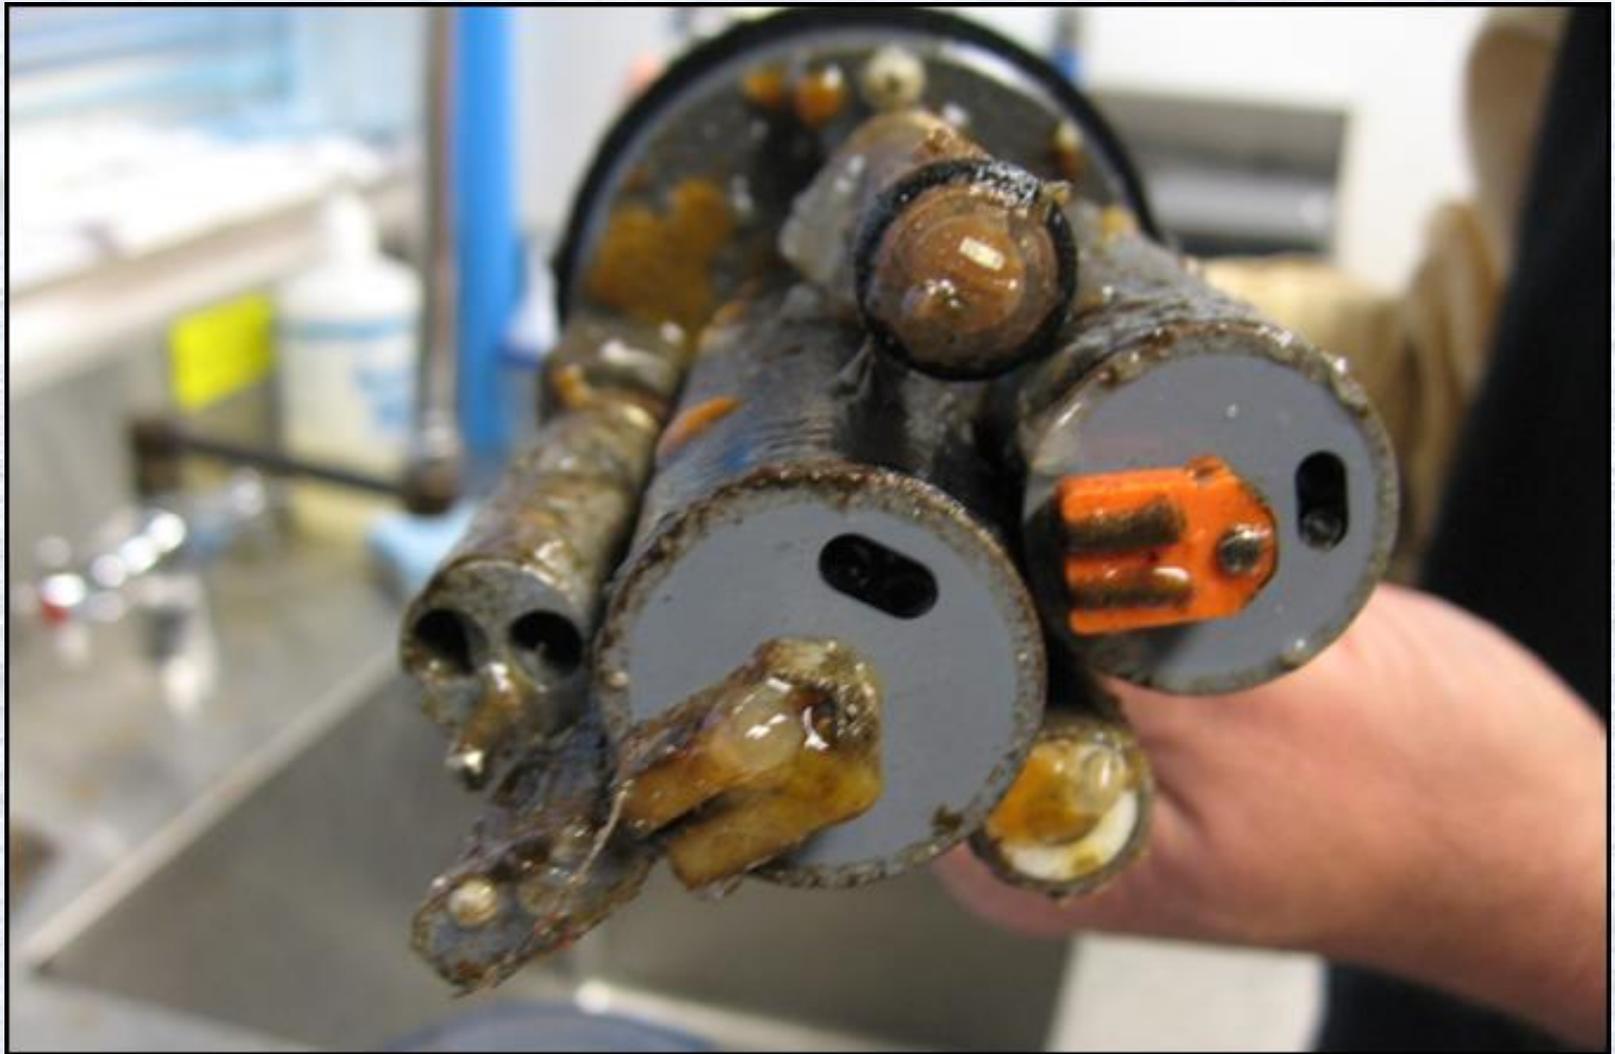
YSI Data Sonde

YSI 6600EDS Multi-Parameter Sondes

Specifications for the YSI 6163 Turbidity Probe are:

- Range of 0 to 1,000 nephelometric turbidity units (NTU).
- Resolution of 0.1 NTU.
- Accuracy of $\pm 2\%$ or 0.3 NTU.

Sound Ocean Systems, Inc. (SOSI) Offshore Data Buoy

SOSI ODB-48-1500 buoy body with the following:

- Aluminum mast with sensor mounting plates.
- Autonomous mast light and radar reflector.
- Antifouling paint and rubber “rub-rails” at two heights.
- Cable fittings.

Water Quality Monitoring System

- water quality monitoring sensors mounted on a buoy at the construction site
- high-frequency data averaged every 15 minutes and uploaded through telemetry to a website
- water quality criteria for both turbidity and dissolved are relative to background
- reference station was established as a permanent sensor installation at the Seattle Aquarium

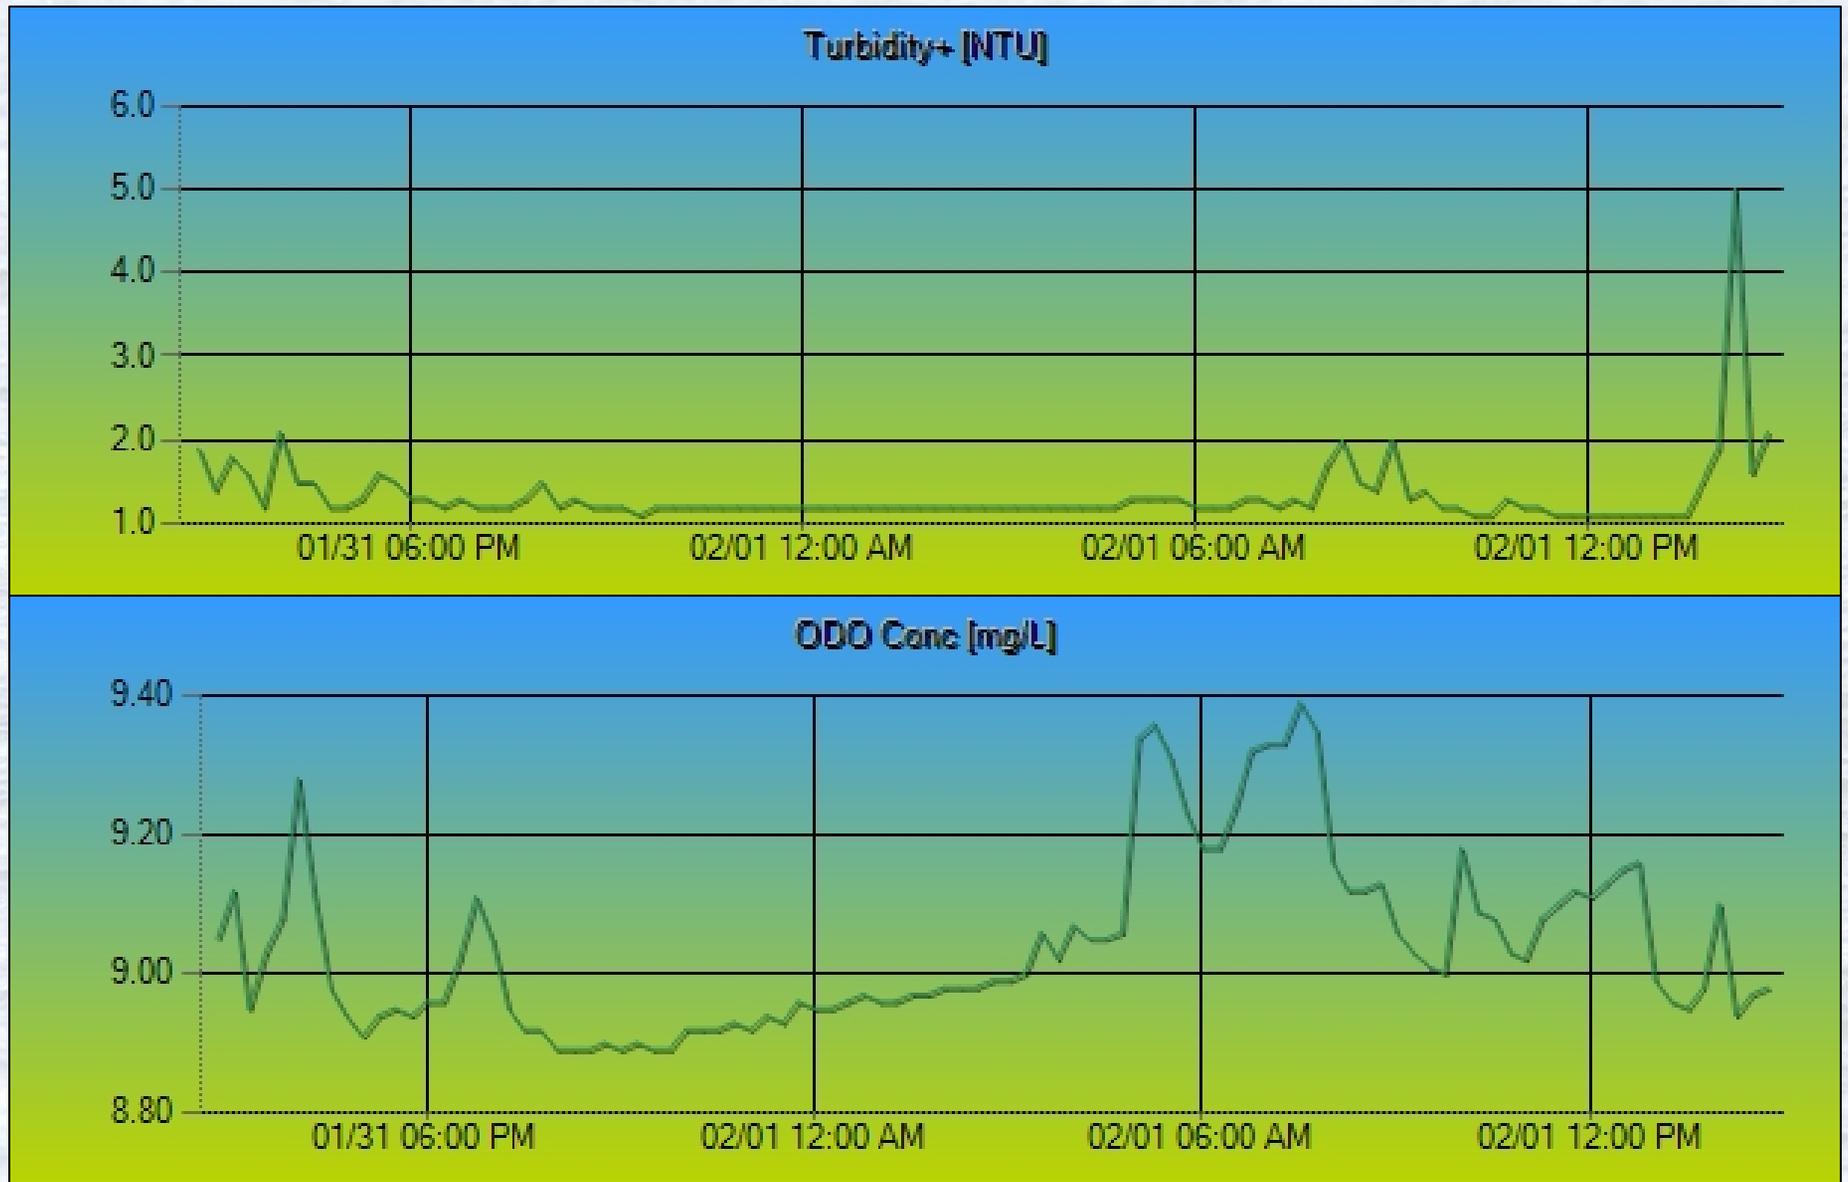
24-Hour Snapshot of Water Quality Data

Exceedences

- no exceedences of DO standard during entire project
- only 1 exceedence of turbidity standard during dredging activities – quickly mitigated through use of BMPs
- several exceedences of turbidity standard during backfilling activities – no real problem – due to amount of fine material in backfill material (clean)

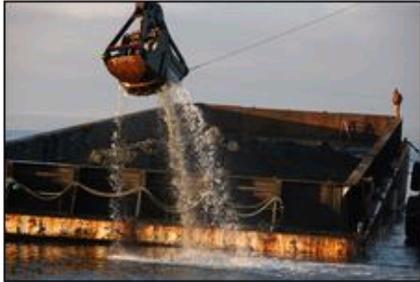
About an acre of sediment is being dredged just off Myrtle Edwards Park as part of efforts to remove contamination from combined sewer outfalls.

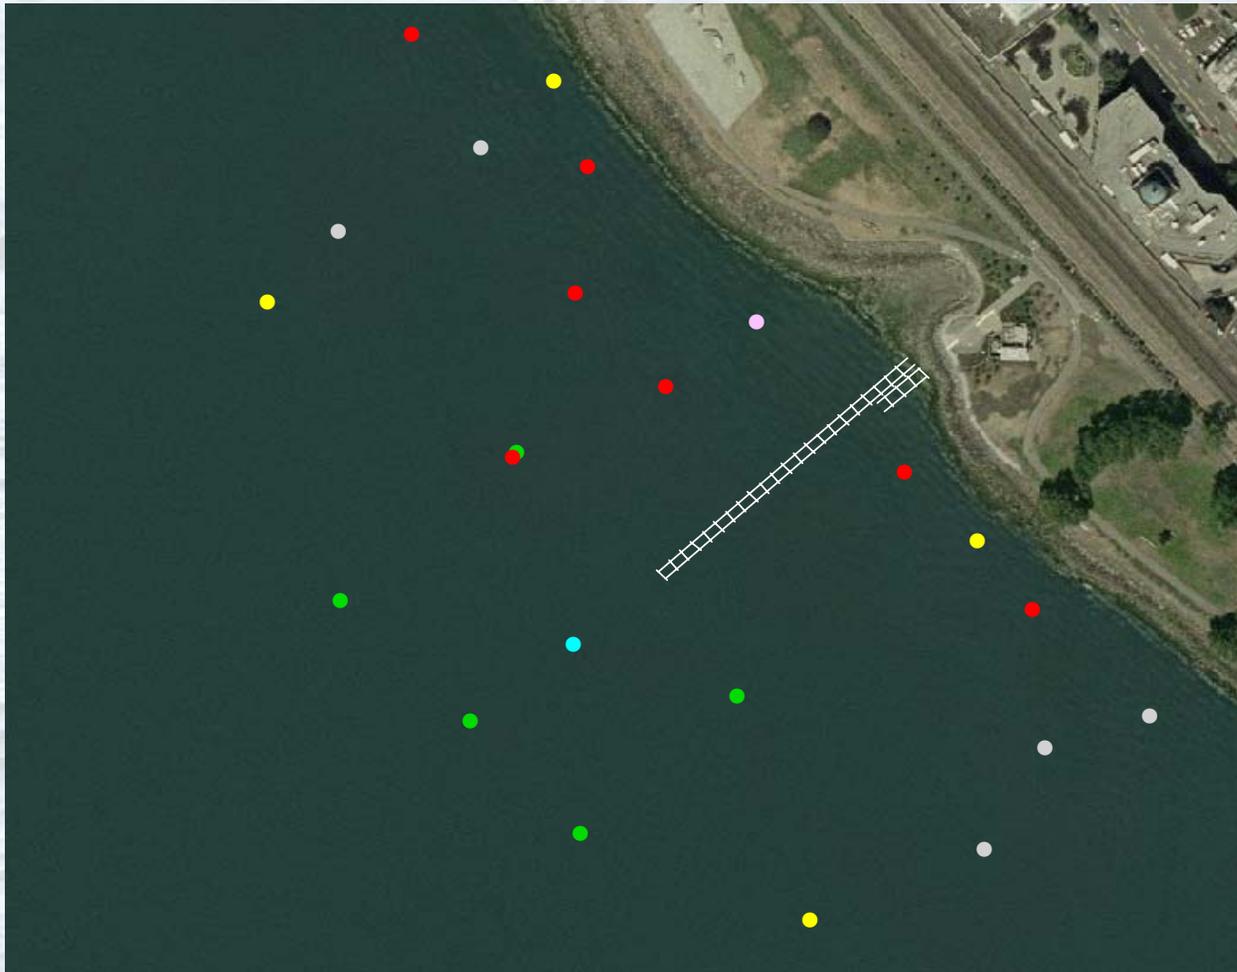
Denny Way Sampling Stations

- A and B Cleanup (0 to 10 cm)
- Biological Opinion (0 to 10 cm)
- Biological Opinion/NPDES (0 to 2 cm)
- Biological Opinion/MNR (0 to 10 cm)
- Biological Opinion/MNR/NPDES (0 to 2 and 0 to 10 cm)
- Biological Opinion/A and B Cleanup (0 to 10 cm)
