Developing the Historical
Context for
Understanding Present Day Land
Use-Water Quality Relationships

Julia Michalak

University of Washington
Urban Ecology Research Lab

October 27, 2009

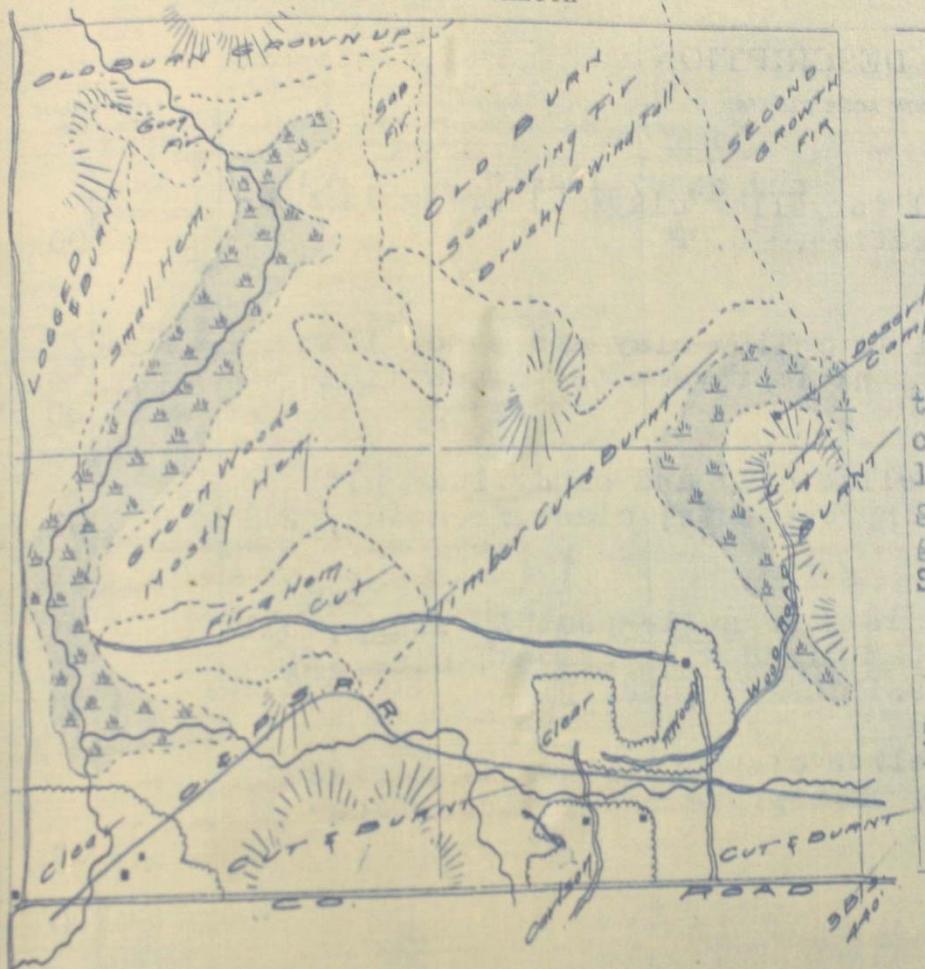
TN22 RN06 Sec 2 - Taylor

Timber Cruise 1907-8

TOPOGRAPHIC SKETCH

\$
E $\frac{1}{2}$ SE $\frac{1}{4}$ owned by Robert Witty, rents for \$5 per month; house 18 x 28 1 $\frac{1}{2}$ story (green) poorly built inside,	600
Barn 16 x 40 (poor)	25
SW $\frac{1}{4}$ SW $\frac{1}{4}$ owner, Howard, of Seattle, leased by Ed Hudson; house 1 story white 18 x 24 (old)	150
Barn 24 x 40	250
Orchard of 25 poor trees; 16 acres cleared; good land	25
SW $\frac{1}{4}$ SW $\frac{1}{4}$ near the corner built on wrong land by mistake; 1 $\frac{1}{2}$ story, drab, 18x24; e11, 12x16,	300

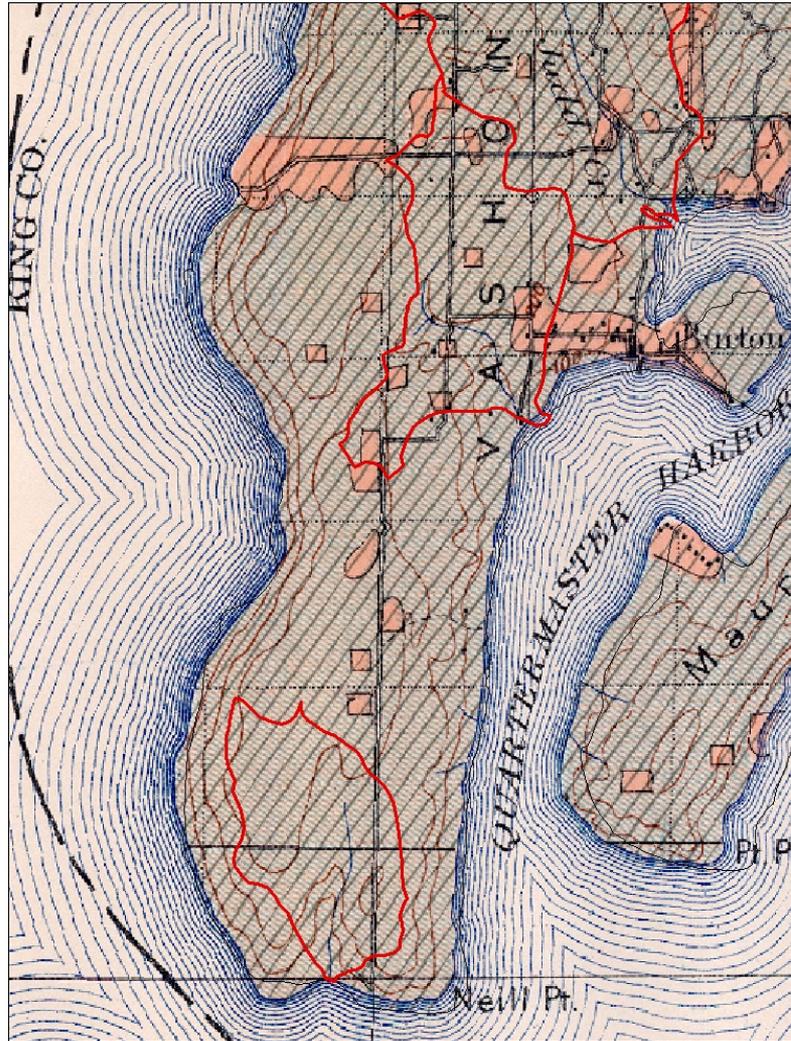
1911 Soil Survey

1:125,000

Logged - off or
Burned-over areas.

Cultivated Lands.

Lands adapted to Intensive
Farming, Pasturage and Fruit Growing.

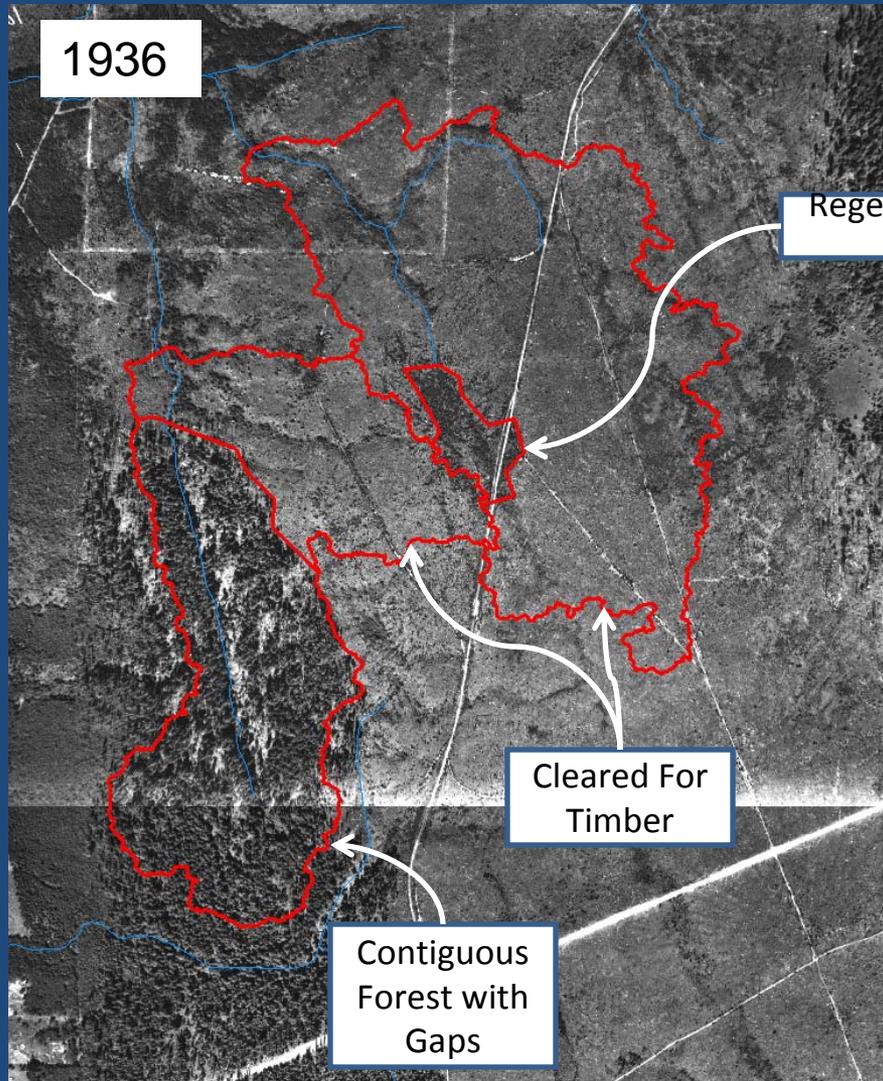
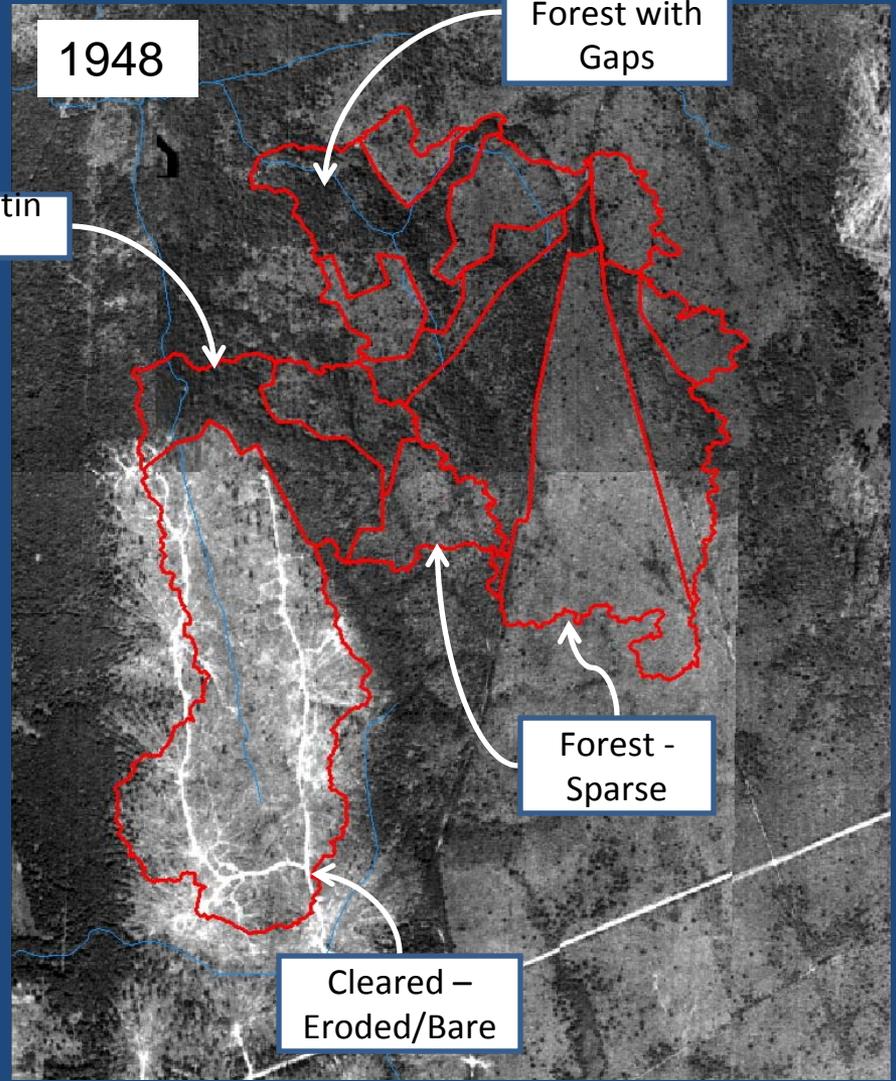
Land Cover Polygons

South and East Seidel

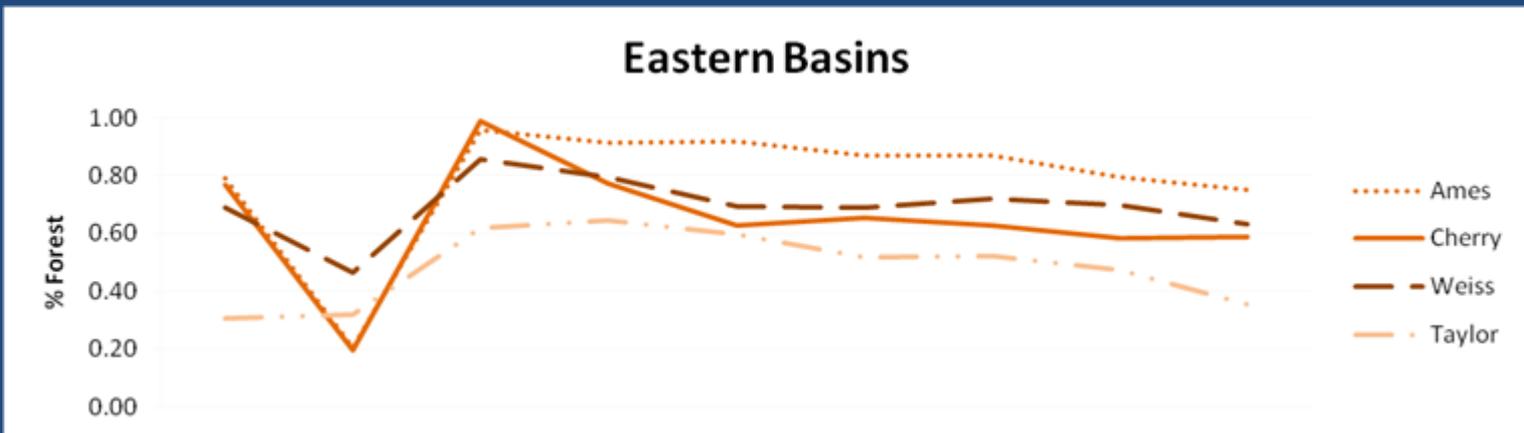
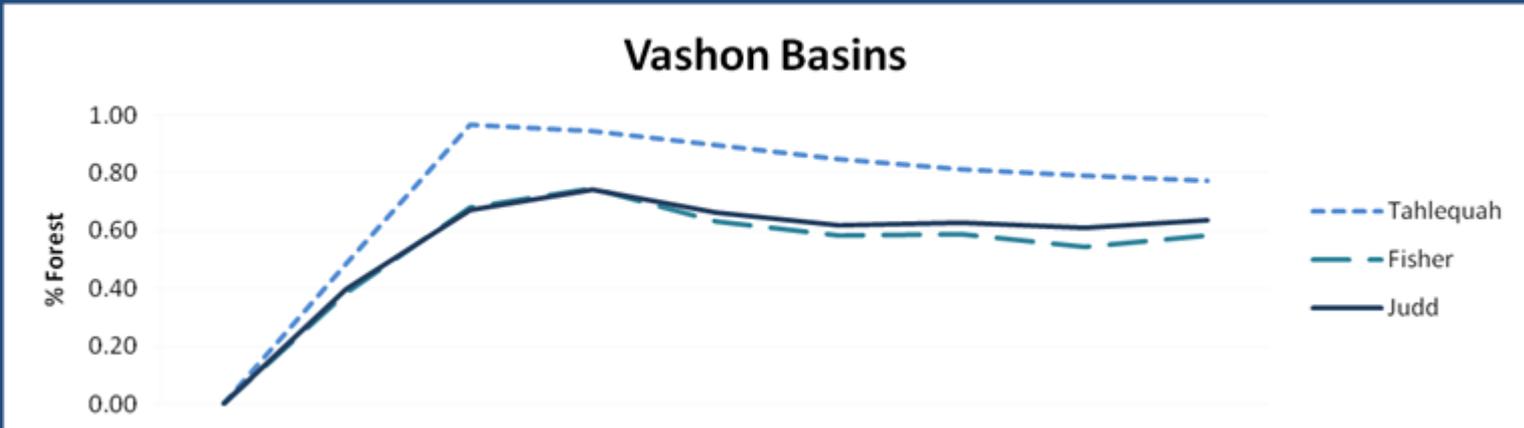
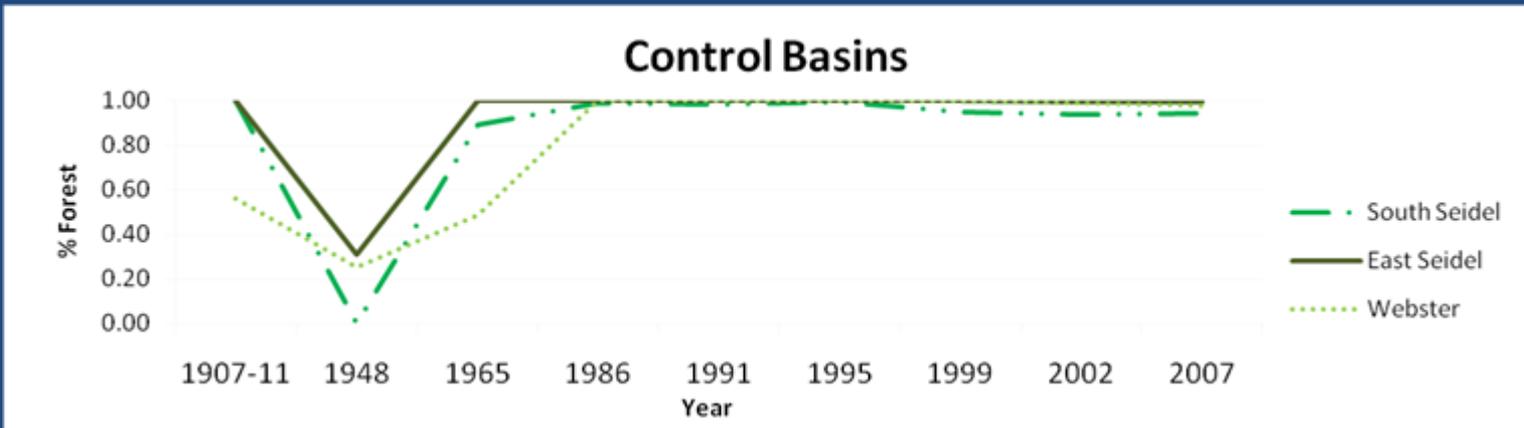
Change in % Forest Cover - 1907-11 to 2007

Forest Cover

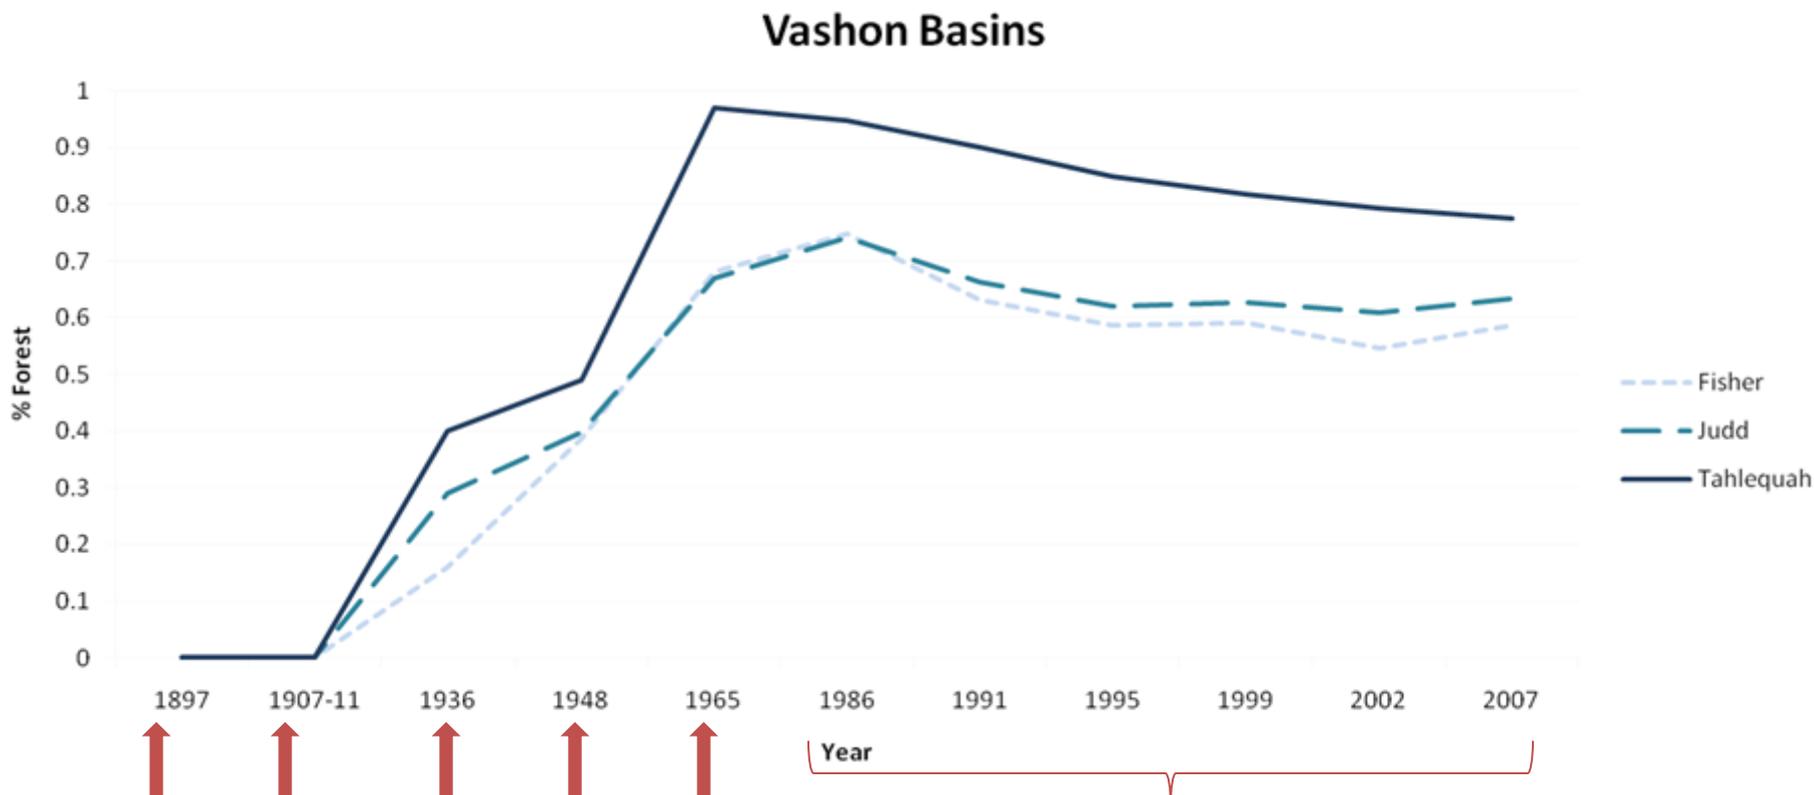
Forest Cover - Vashon

USGS Land Class 1:250,000 (1897)

USGS Soil Survey 1:125,000 (1907-11)

Aerial 1:800 (1936)

Aerial 1:20,000 (1948)

Aerial 1:60,000 (1965)

Landsat 30 m resolution (1986-2007)
