Juanita Creek Basin Geomorphic Analysis - DRAFT

Prepared for:
King County
Department of Natural Resources

February 2010

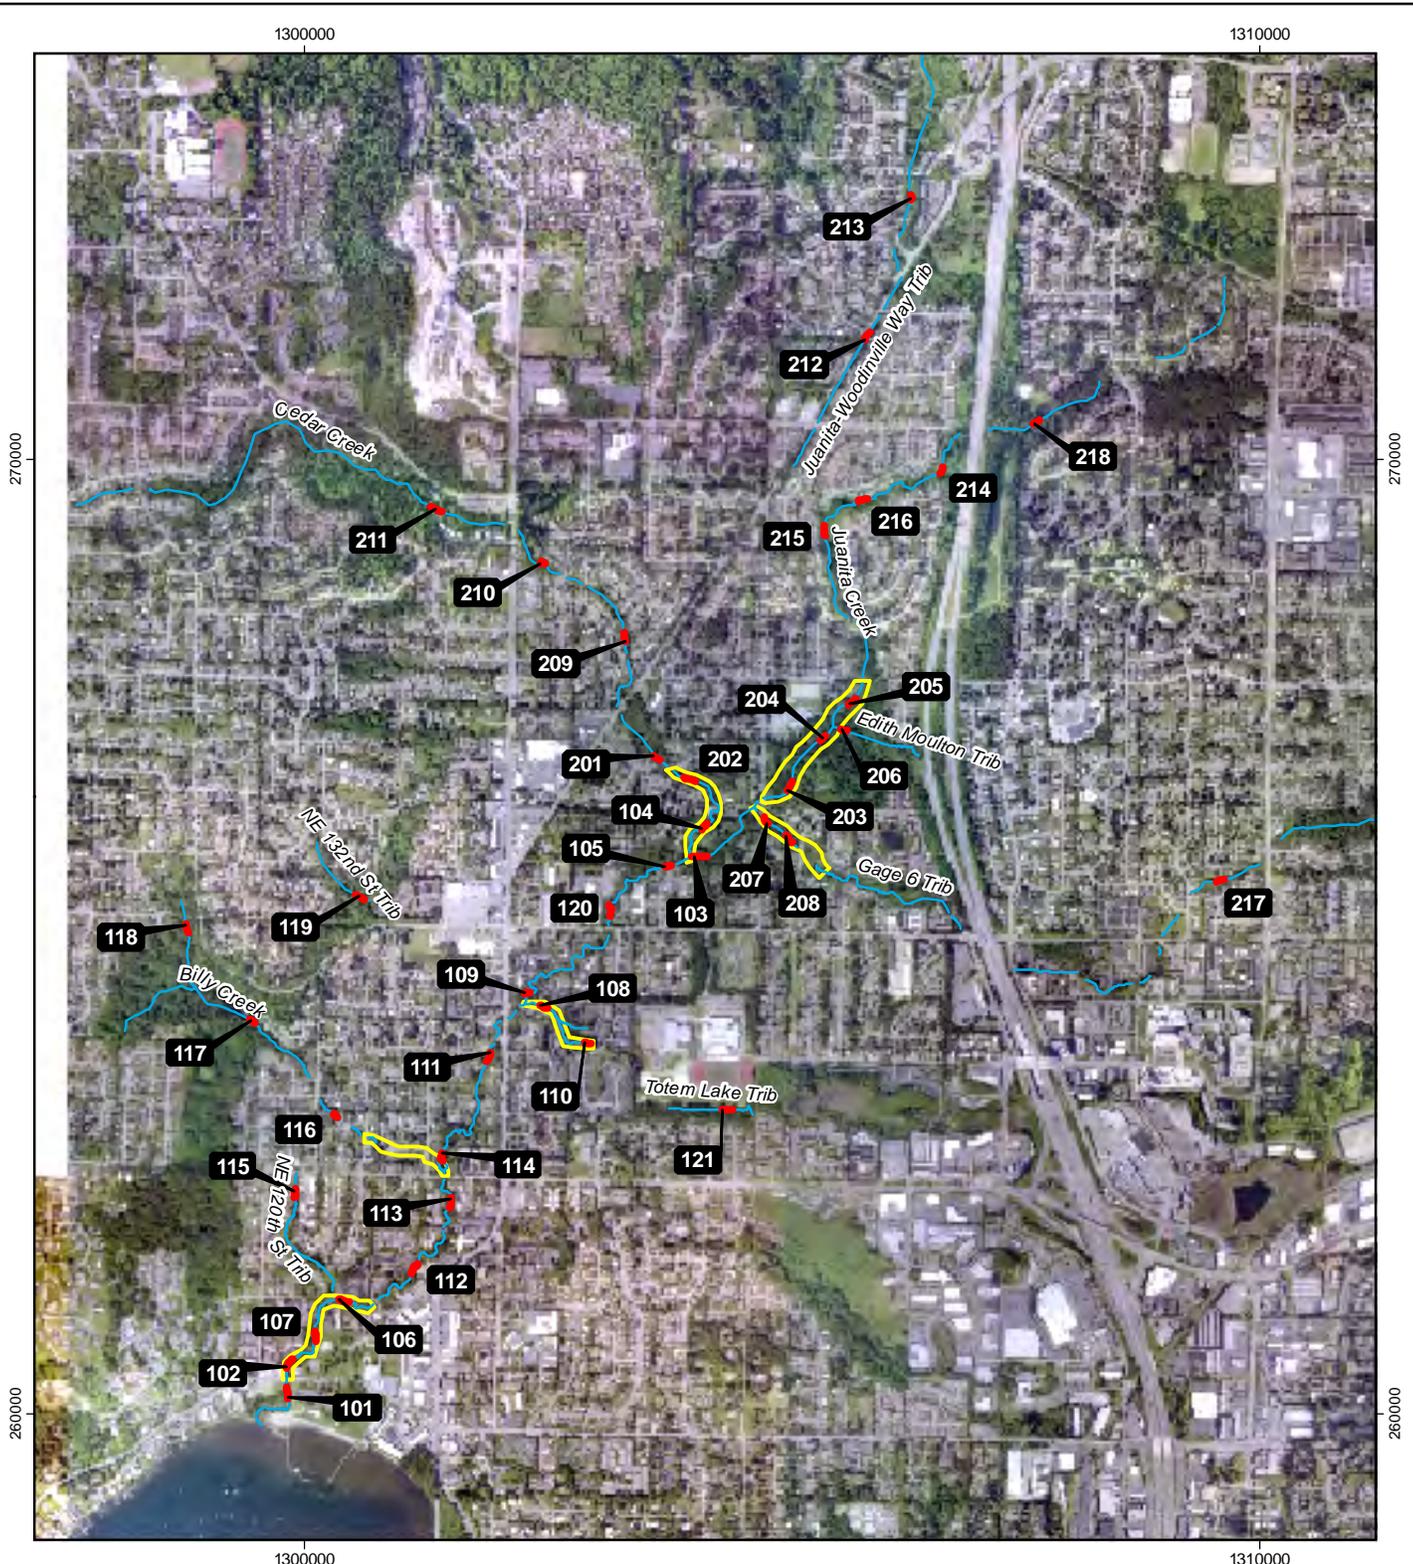
Figure 1

Juanita Creek Geomorphic Assessment Reaches

As part of this work, the NHC team observed geomorphic parameters for 39 assessment reaches on the Juanita Creek mainstem and nine tributaries (Figure 1). These parameters included:

Bankfull channel dimensions were measured only for assessment reaches within the County-defined priority reaches. The five priority reaches (shown on Figure 1), correspond to stream reaches in the vicinity of County flow gages for which the County was interested in more detailed hydraulic and sediment transport information. Bankfull elevations were noted in the field during NHC's hydraulic survey for all cross sections for which they could be readily defined. These were linked to the geomorphic assessment reaches by identifying the hydraulic cross section closest to (or otherwise most representative of) the assessment reach. For representative cross sections for which bankfull elevations were not identified in the field, the bankfull channel was estimated in the office from the surveyed section profile by an experienced engineer/geomorphologist.

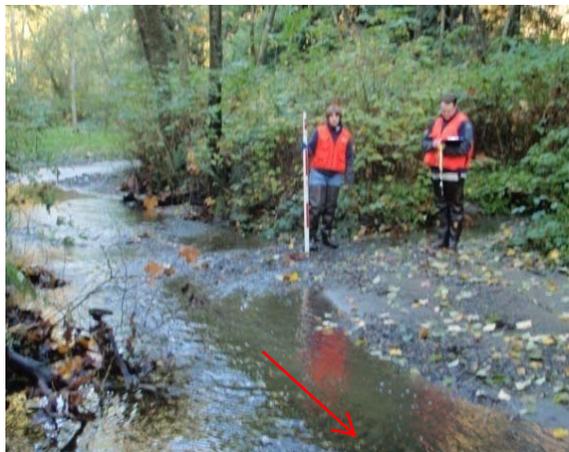
Photo 1. Juanita Creek confluence with left bank tributary in Edith Moulton Park showing extensive sand deposit.

are higher concentrations of fine sediment upstream of NE124th Street, likely due to backwater effects from the culvert and possibly recent activity in the creek (Jenny Gaus, personal communication), and the reach of Juanita Creek through Edith Moulton Park. The latter reach corresponds with an area of locally flatter slope and occurs downstream of a small tributary draining off of I-405 that is very unstable and appears to be a source of significant fine sediment, as evidenced by a visible sandbar deposit at the confluence (Photo 1).

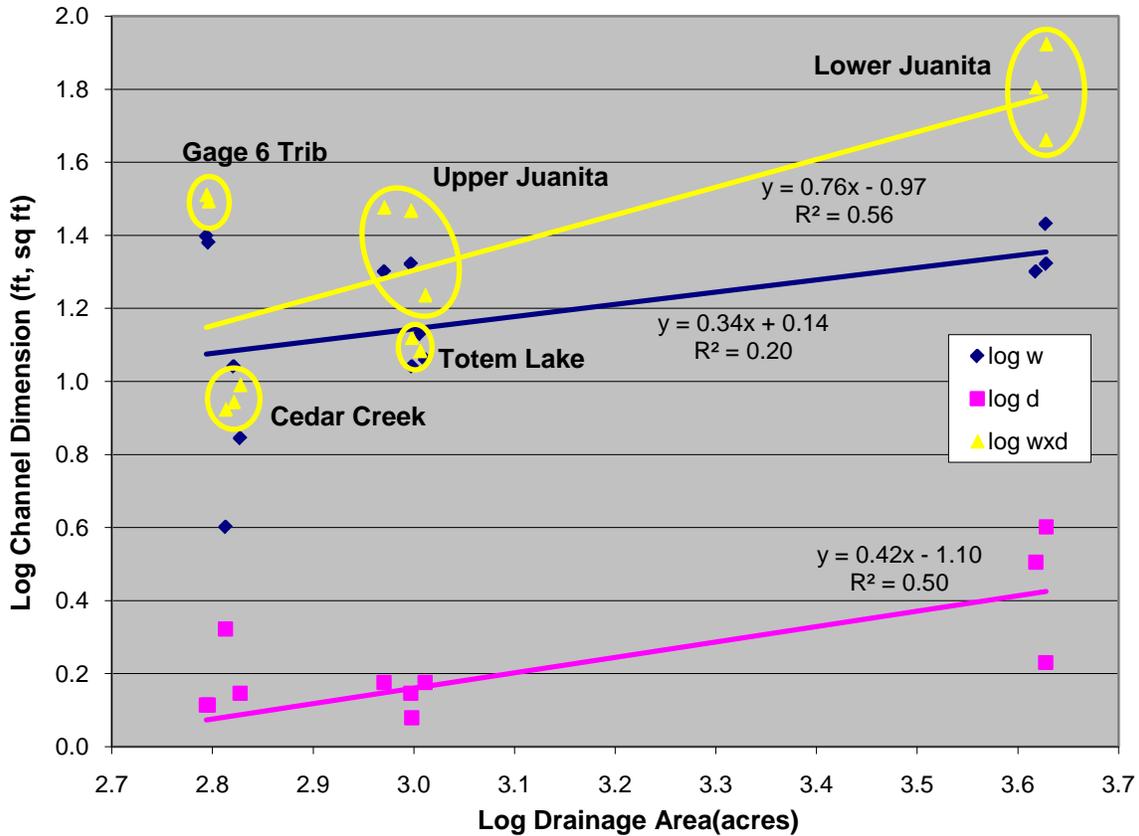
Figure 3. Plot of bankfull dimensions (width, depth, and bankfull area [= w × d]) for the five priority reaches. Labels highlight the grouping of the bankfull area points by priority reach.

Both overall patterns and some systematic diversions are expressed in the data from Juanita Creek (Figure 3).

As we have observed in other such studies, the variability in both width and depth is greater than that of their product (i.e. bankfull area), but even those data show only a fair correlation with drainage area ($r^2 = 0.56$). This is likely explained, however, by the presence of two different “populations” of channels amongst the five priority reaches with respect to peak flows: namely, Gage 6 tributary relative to Cedar Creek (50 to 100 percent greater discharges) and Upper Juanita relative to Totem Lake tributary (15 to 50 percent greater discharges). Removing the two “higher discharge” reaches results in a very coherent trend with respect to the channel area-drainage area relationship—an r^2 very close to 1.0 (0.96) and regression equations with exponents (i.e. the multiplicative factor of x) that closely match published ranges. It is thus reasonable to infer that the Gage 6 Tributary and Upper Juanita Creek have seen a disproportionately high magnitude of channel expansion within the Juanita Creek stream network as a result of historic watershed changes.

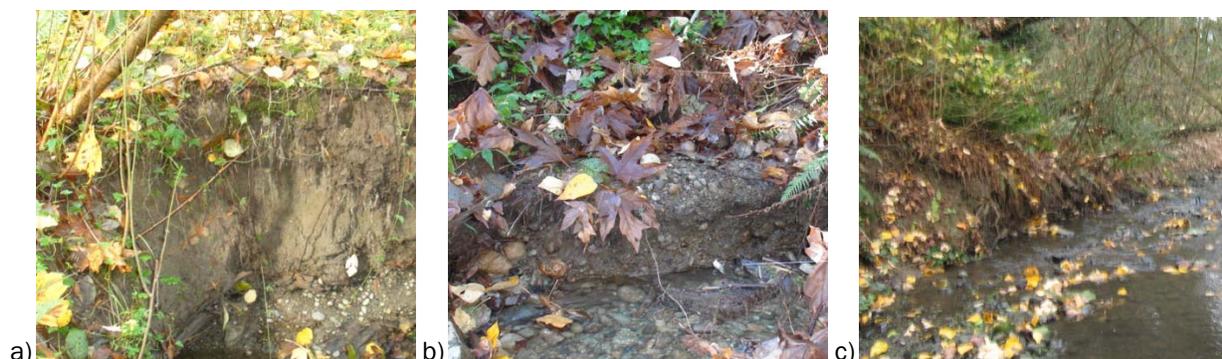
Photo 2. Examples of bank erosion throughout the Juanita Creek stream network: a) Juanita Creek just above Cedar Creek (site 103), b) Upper Billy Creek (site 118), c) Gage 6 Tributary (site 208)

Given the widespread instability in the system, a primary source of fine sediment is likely bank erosion. Photo 2 shows examples of bank erosion from three different parts of the basin.
