*Current & Future*

# Conditions Report

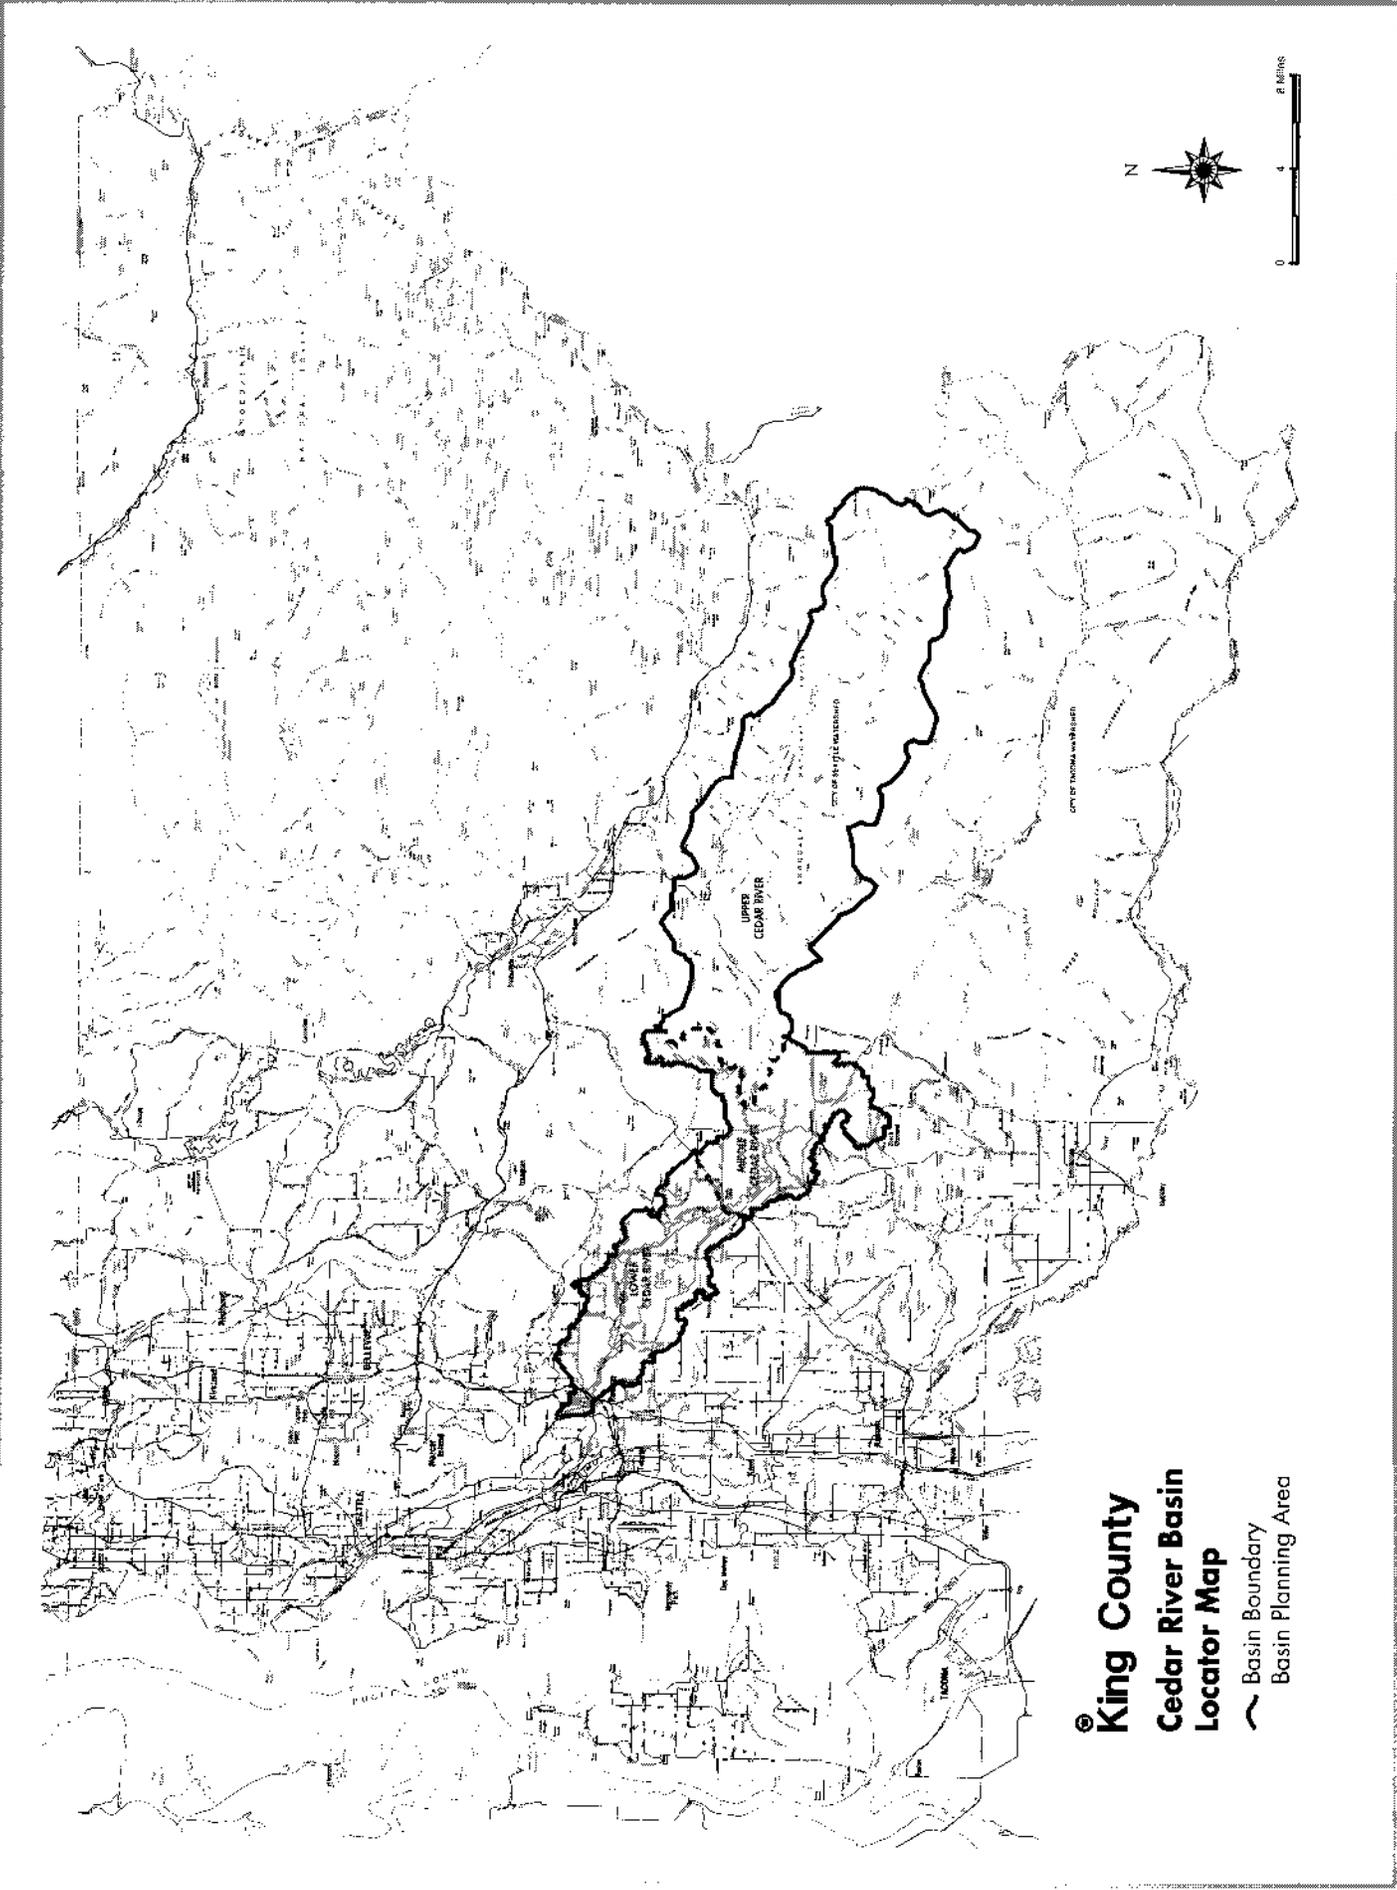
**King County**  
**Cedar River Basin**  
**Locator Map**

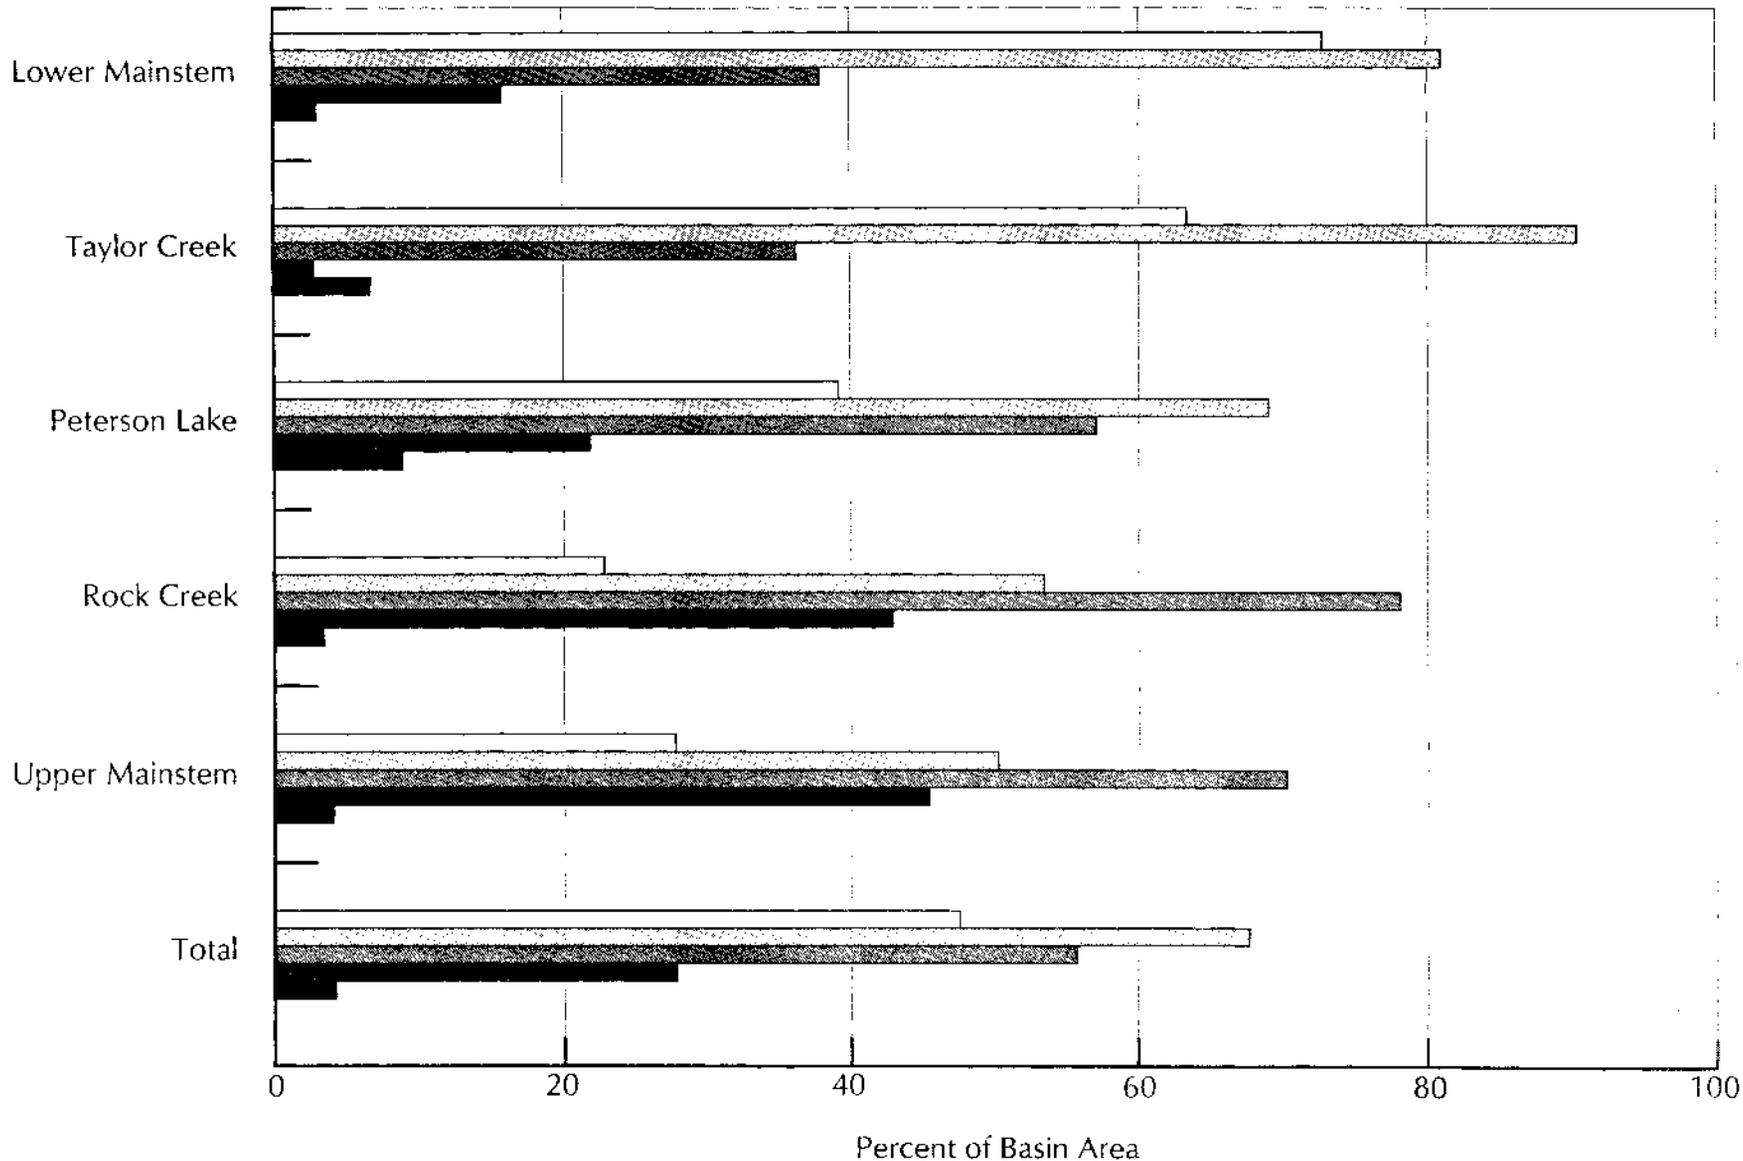
**Figure 1-1 Comparison of Current and Future Land Use/Land Cover**

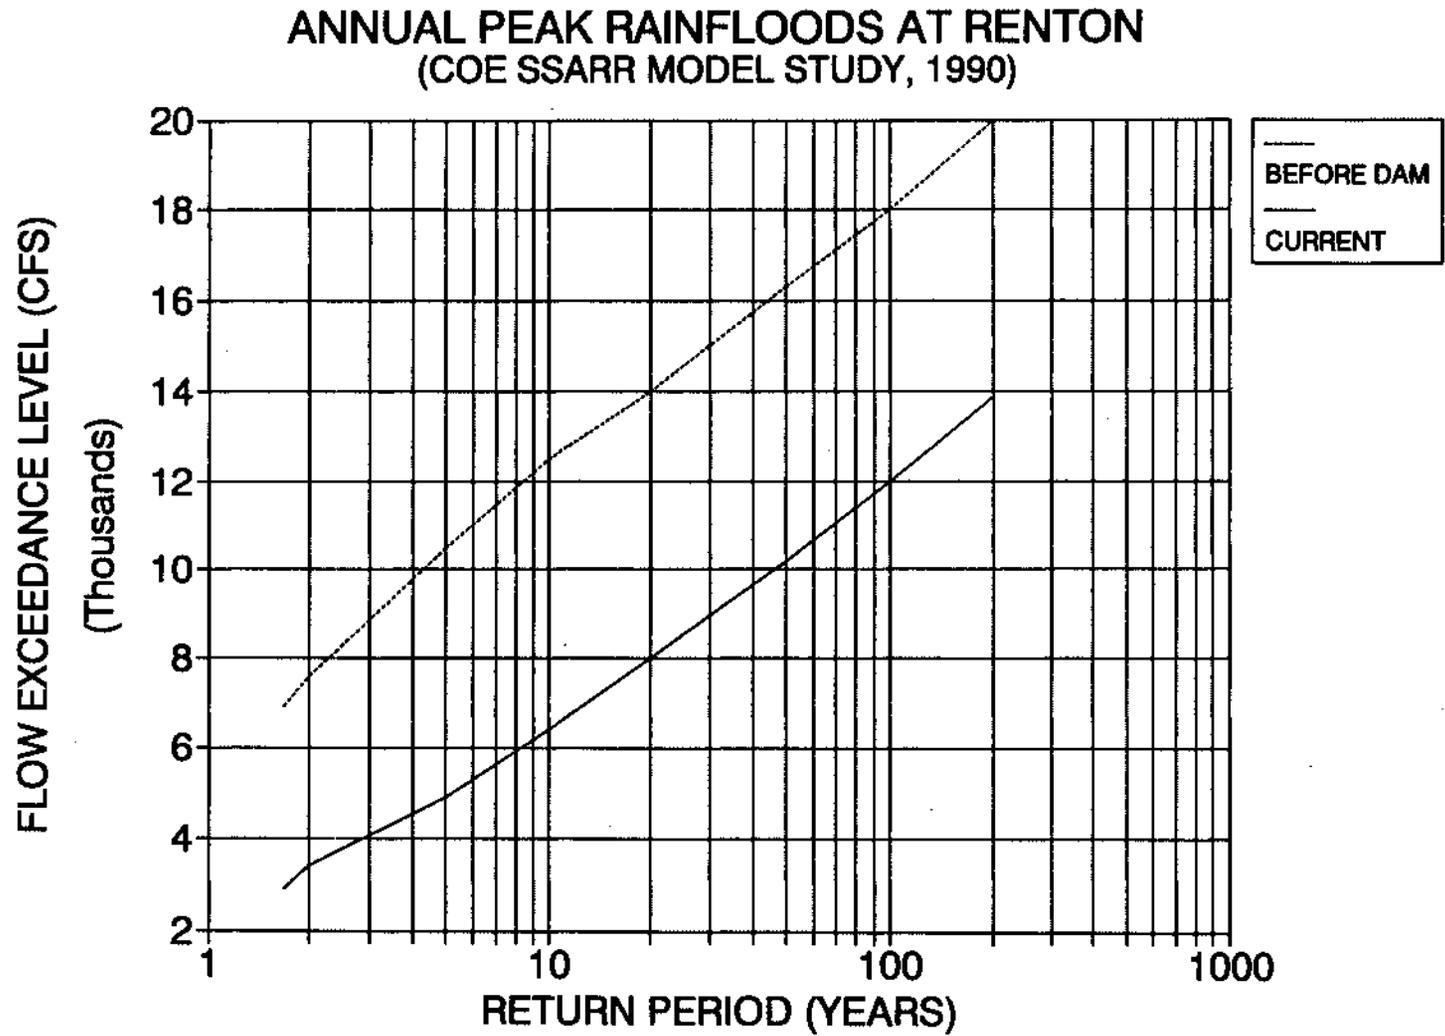
## **Estimated Effect of City of Seattle Current Operations on Mainstem Floods**

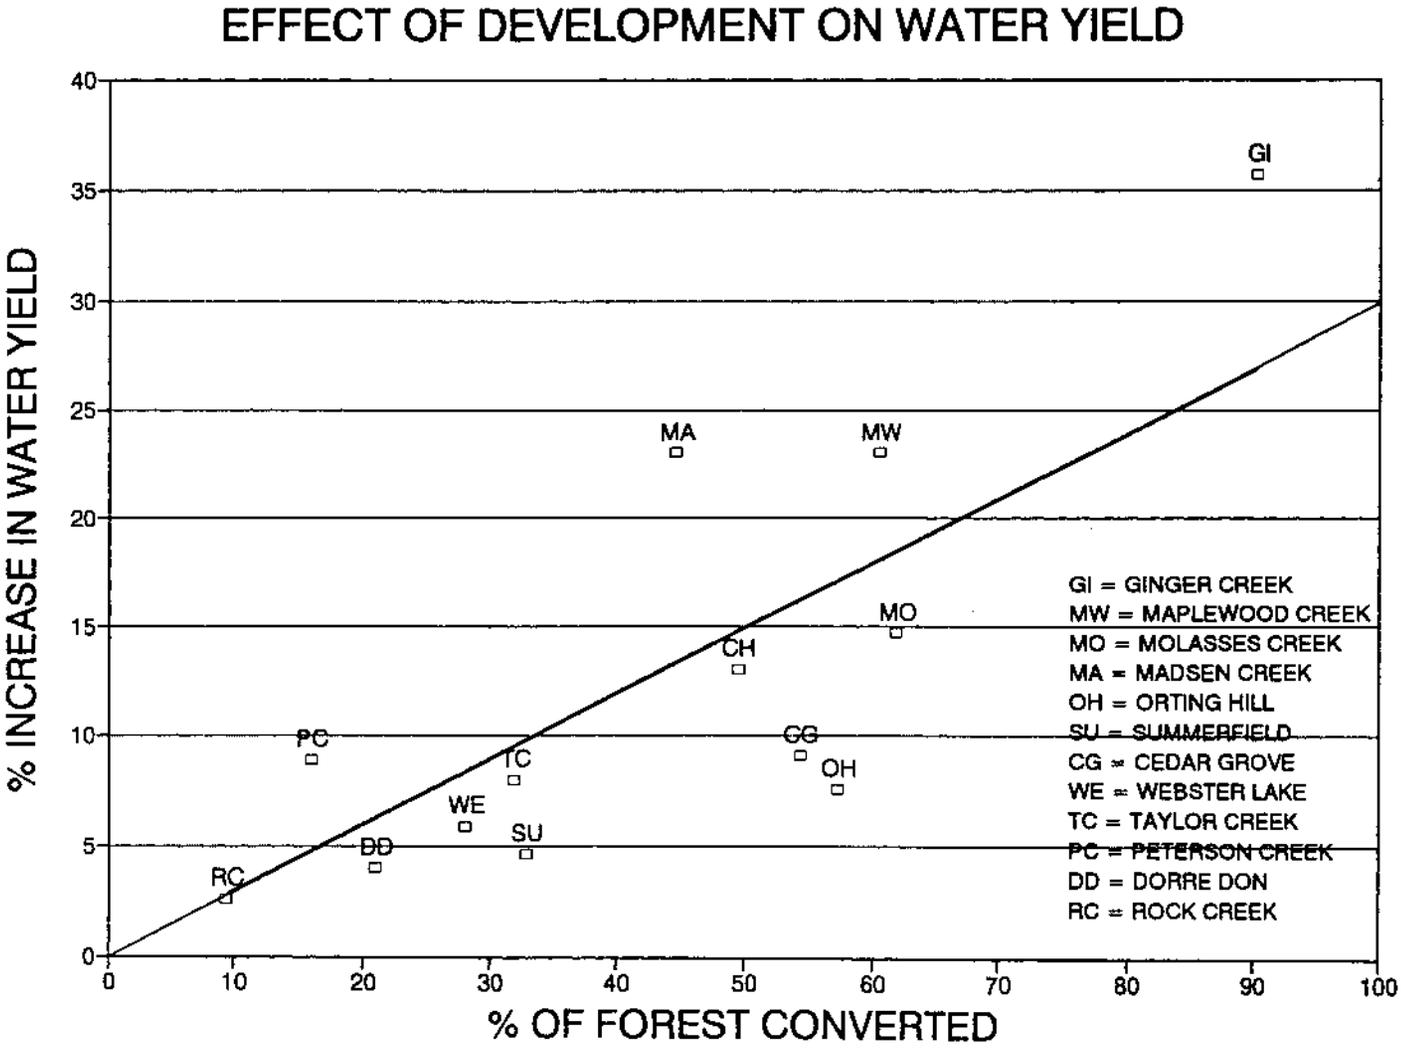
The second major diversion of Rock Creek is made by the city of Kent at its Clark Springs site (RM 1.7 of Tributary 0338 in catchment R-2). Kent has diverted water for municipal use from this site since the early 1900s. USGS records suggest that diversions increased from less than 1.0 to 4.0 cfs during the 1946–1973 gaging period. Kent's diversions continue today and have averaged 6.2 cfs in recent years—26% of Rock Creek's mean annual flow. More importantly, current diversions represent the majority of the creek flow during the low-flow months of September and October. For example, for two weeks in October 1992, only 1.7 cfs remained in the creek while the City of Kent diverted 5.8 cfs (City of Kent, 1992). The depletion of flows in Rock Creek and associated downstream fish resource problems have been a concern for several years (DOF, 1984).

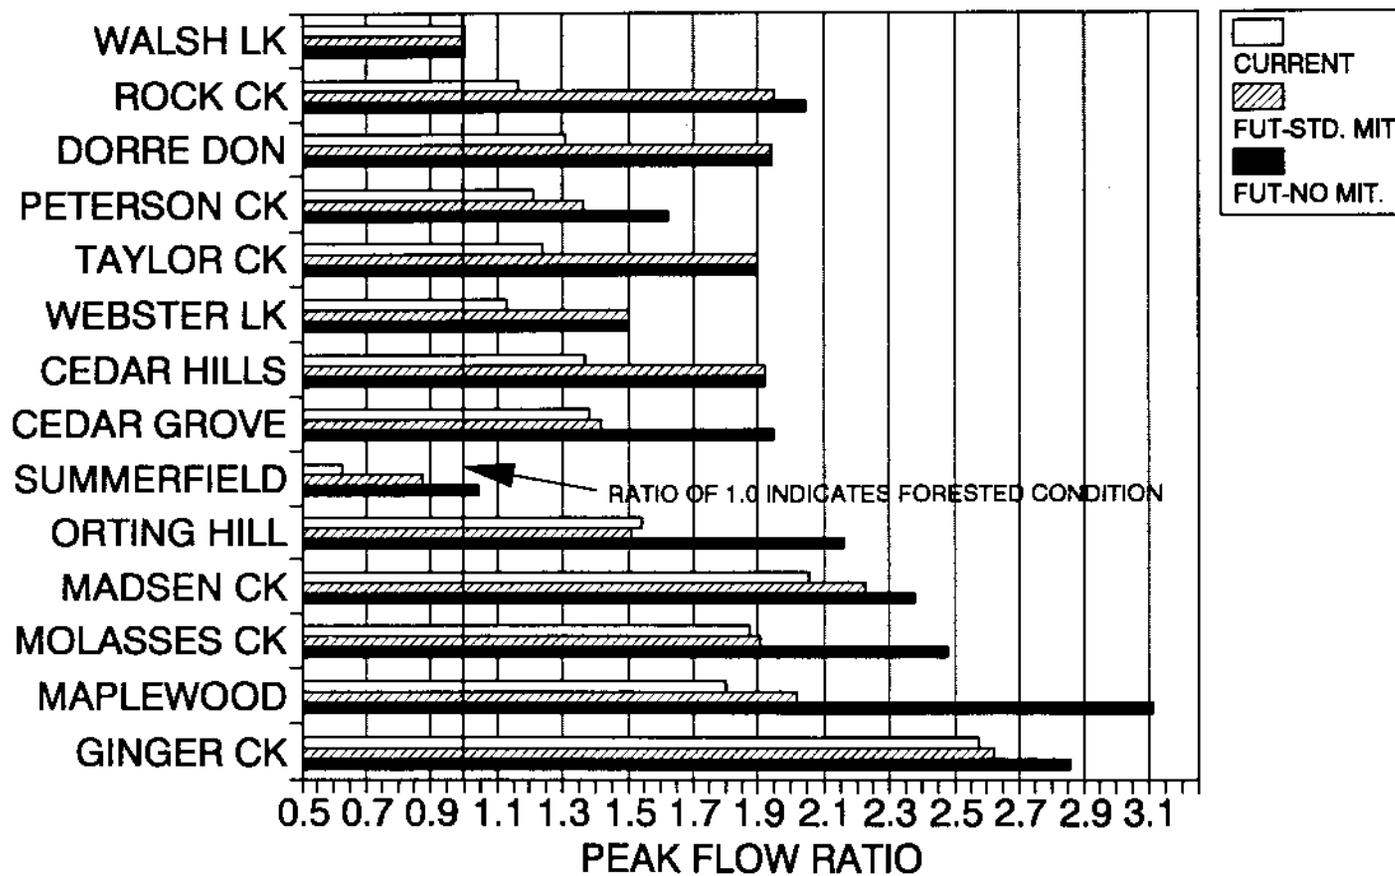
designed to receive and detain the increases in surface runoff and interflow caused by the replacement of forest cover with less pervious grass cover and impervious surfaces. The ponds release storm water at a lower rate than the inflow rate but over a longer period of time. Thus, potential increases in stream flood peaks caused by development can be substantially reduced.

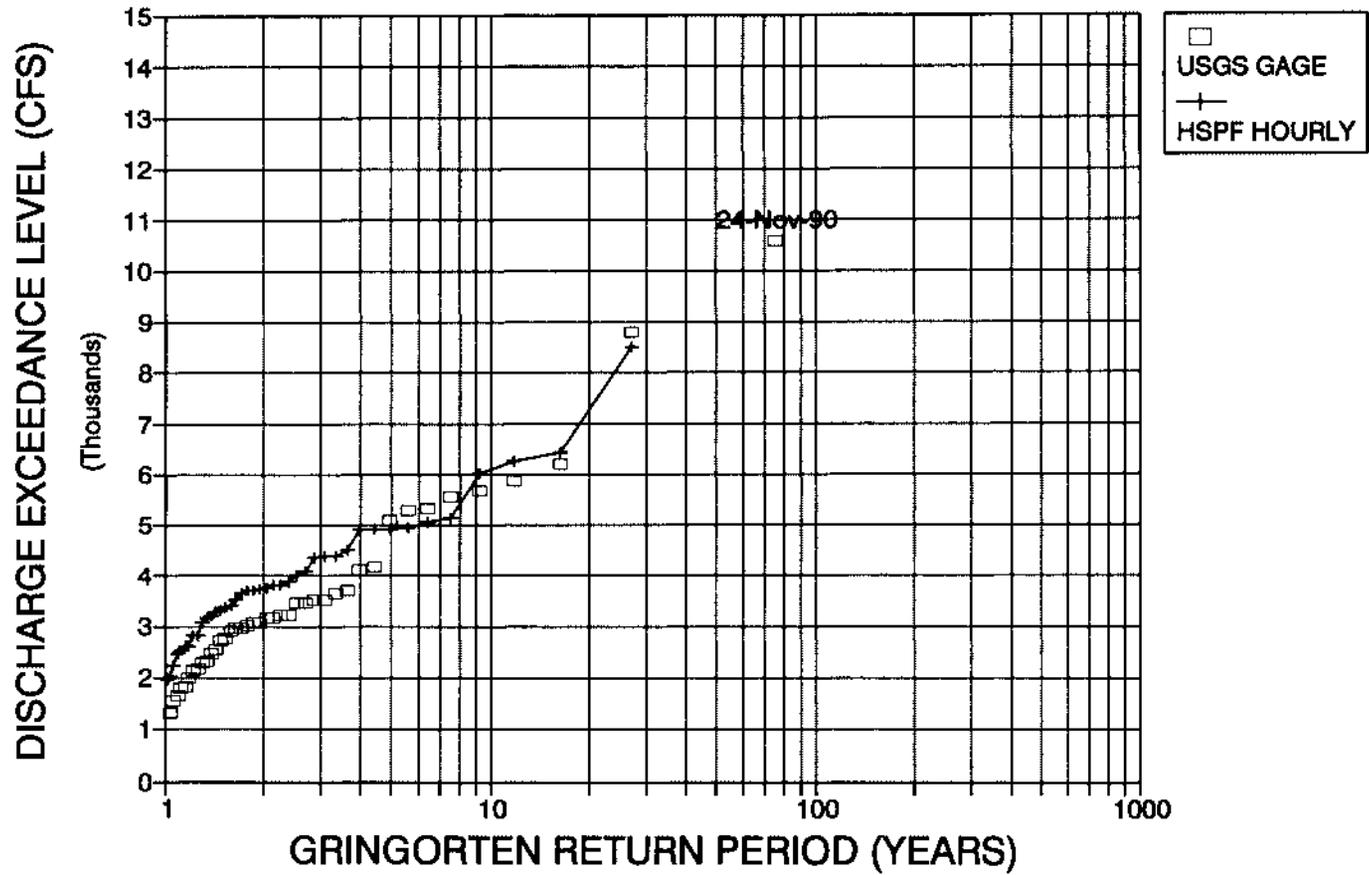
## Peak Annual Flow Frequencies

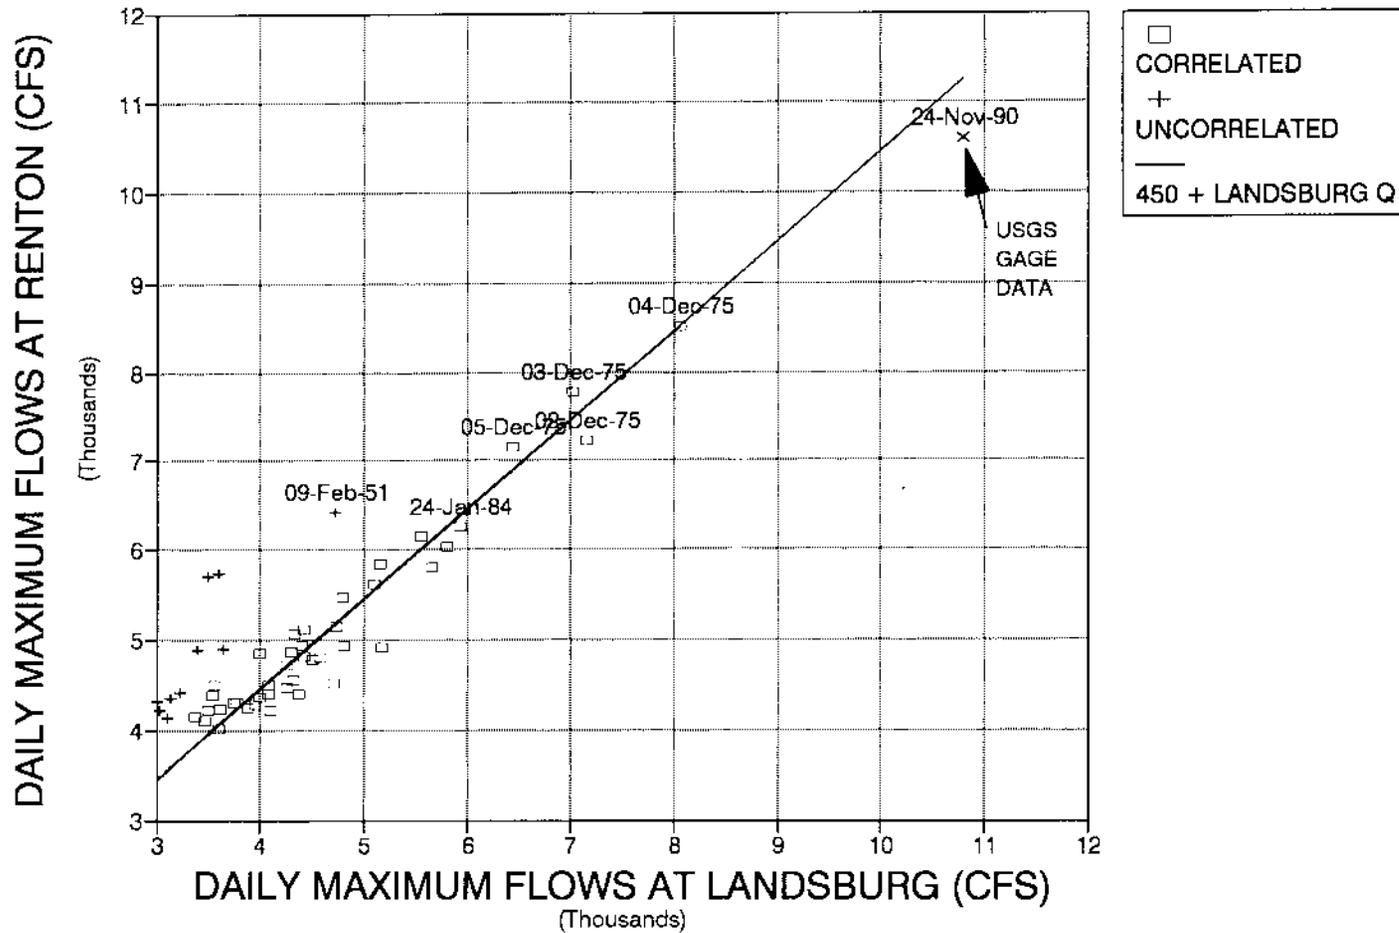
## EFFECT OF UPPER BASIN ON RENTON FLOODS (DAILY MAX ABOVE 4000 CFS IN RENTON)

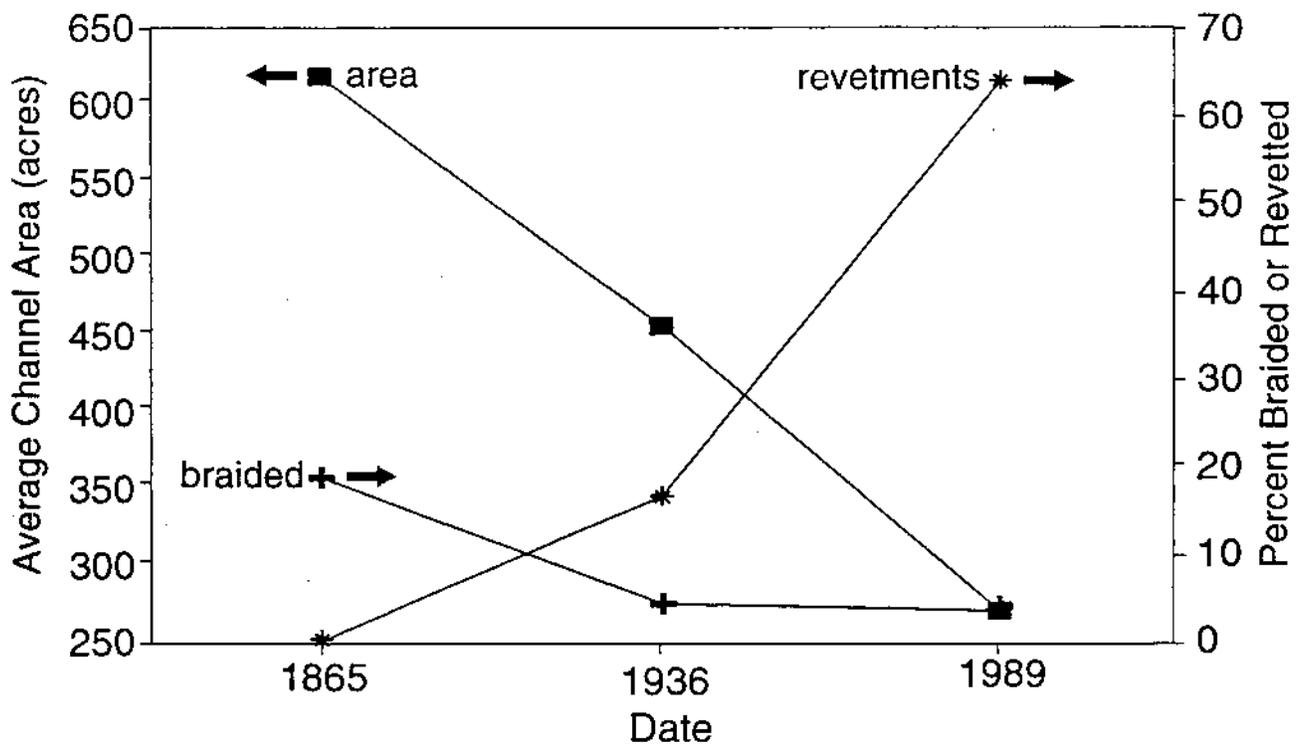
from a braided river pattern, with multiple channels, to a sinuous, generally single-thread pattern; however, single-thread reaches also became narrower. After 1936, the river channel narrowed an additional 35% to its present average width of 110 feet. From aerial photographs, it appears that most of the narrowing took place by 1970 and was accomplished by growth of vegetation on formerly active gravel bars as well as abandonment of braid channels in several reaches. It is interesting to note that although the 1912 channelization decreased the width of the Renton Reach (Reach A) to narrower than the rest of the river, subsequent narrowing of the rest of the river has now made Reach A the widest reach.

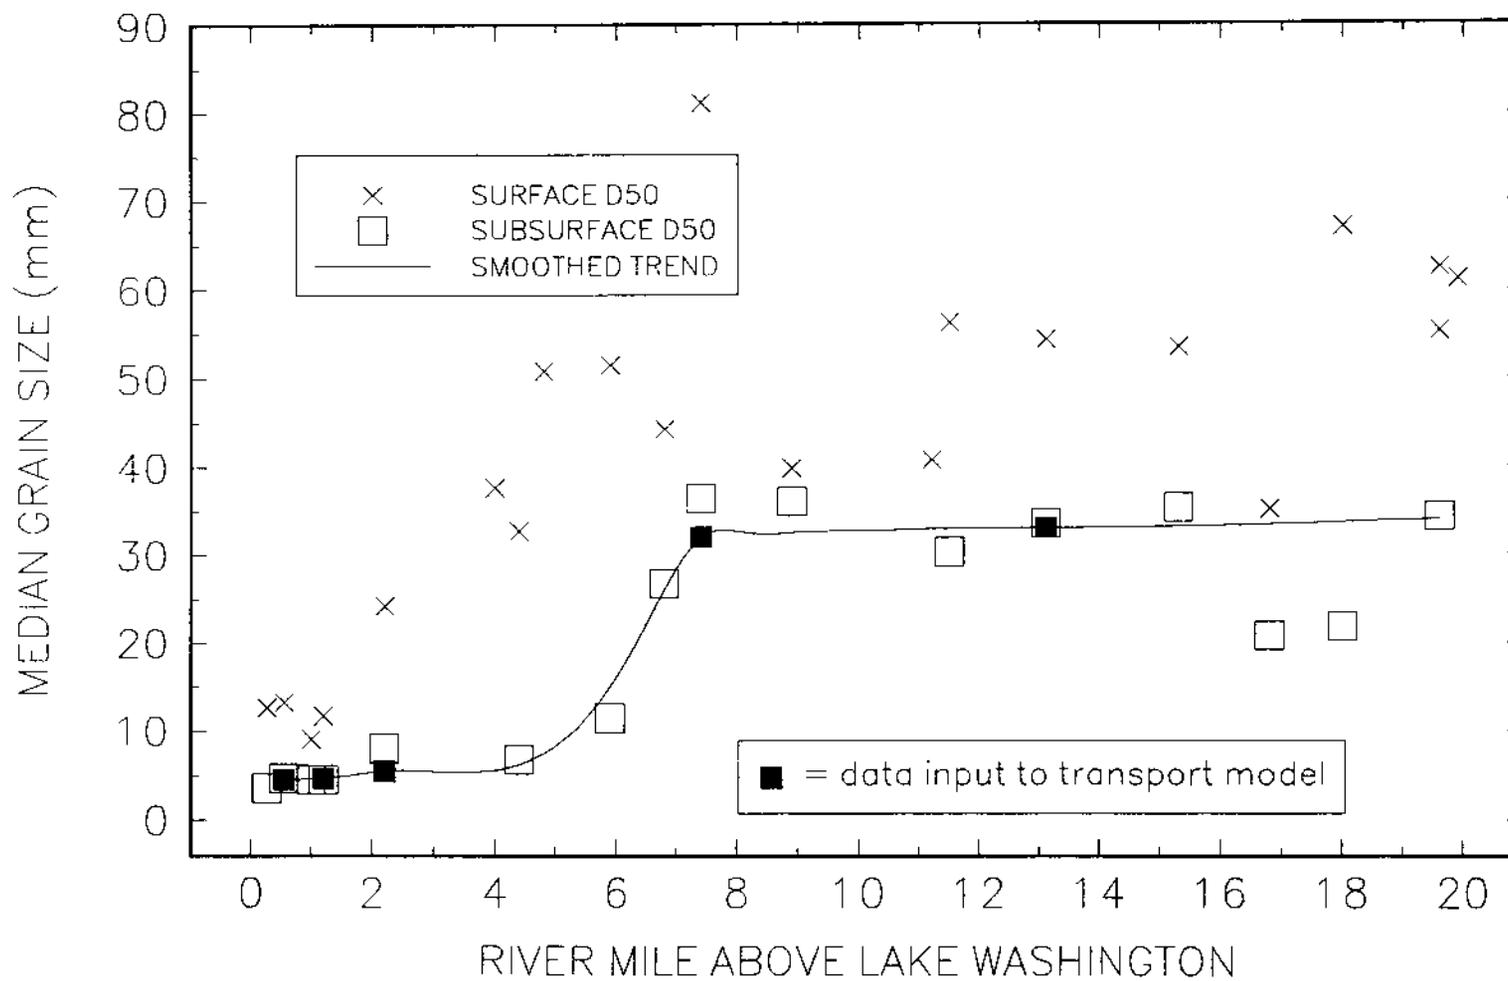
***Sediment Transport Modeling—Introduction*** The movement of sediment along the stream system depends on both the supply of sediment to the channels and the competence of the flow to move that material. These two factors are not wholly independent: increased sediment loads cause deposition, which tends to steepen the gradient of the channel and so increase competence; and increased competence will tend to increase the sediment supply to downstream reaches, by scouring the channel bed and banks.

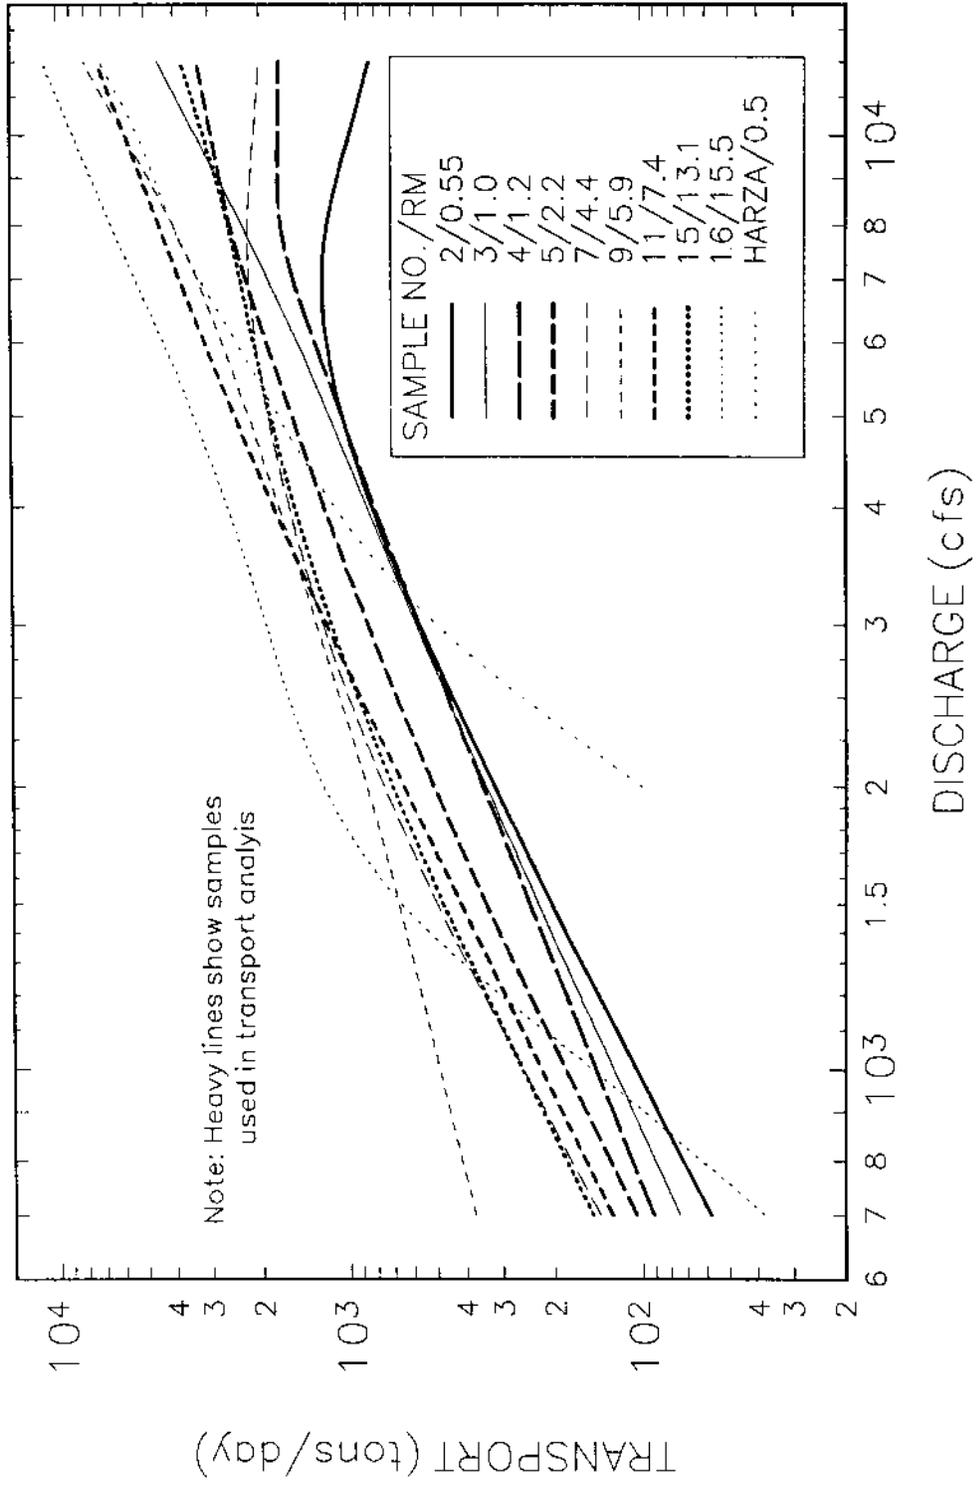
bed sediment. In addition, the Bagnold equation returns instantaneous rates of transport, in units of kilograms per second for a specified water discharge. To convert this instantaneous rate to total amount transported, it must be multiplied by the duration of the discharge that produces this transport rate. The total transport is then the combination of all such products of duration and instantaneous rate, summed over the full range of discharges. For this analysis, flow durations under current conditions were used; under future conditions, the average durations increase by 17% and predicted sediment-transport rates would increase commensurately (see *Chapter 3: Hydrology*).

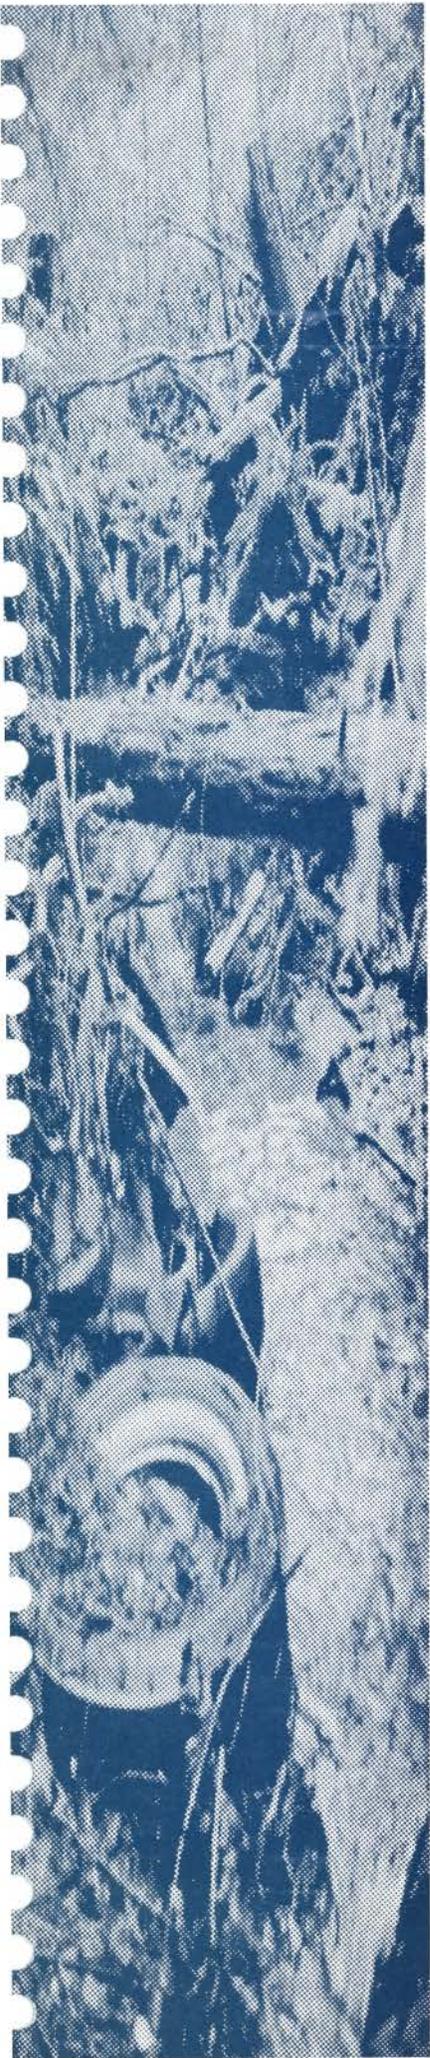
## Water Quality: Figures and Tables

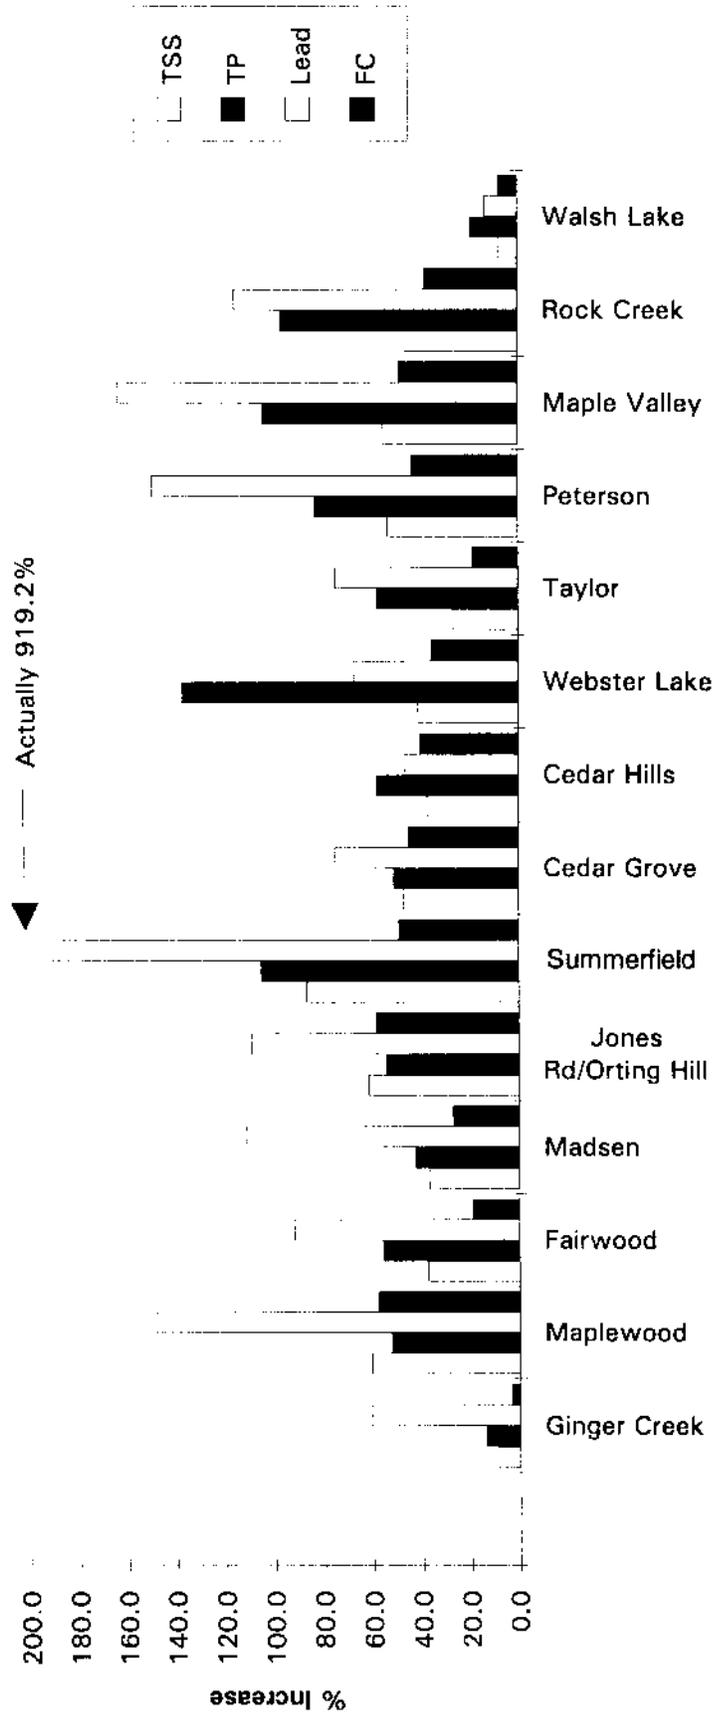
Figure 6-3 Predicted Pollutant Increase by Wetland

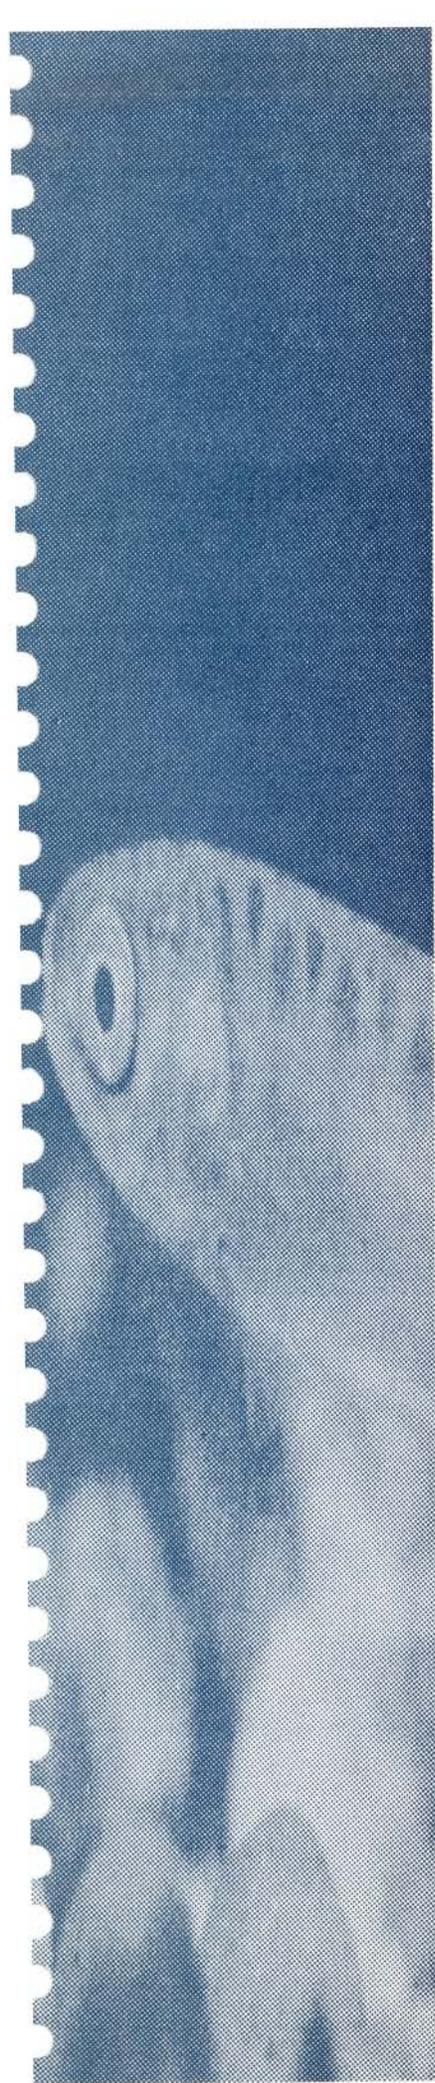
## **Aquatic Habitat: Figures and Tables**

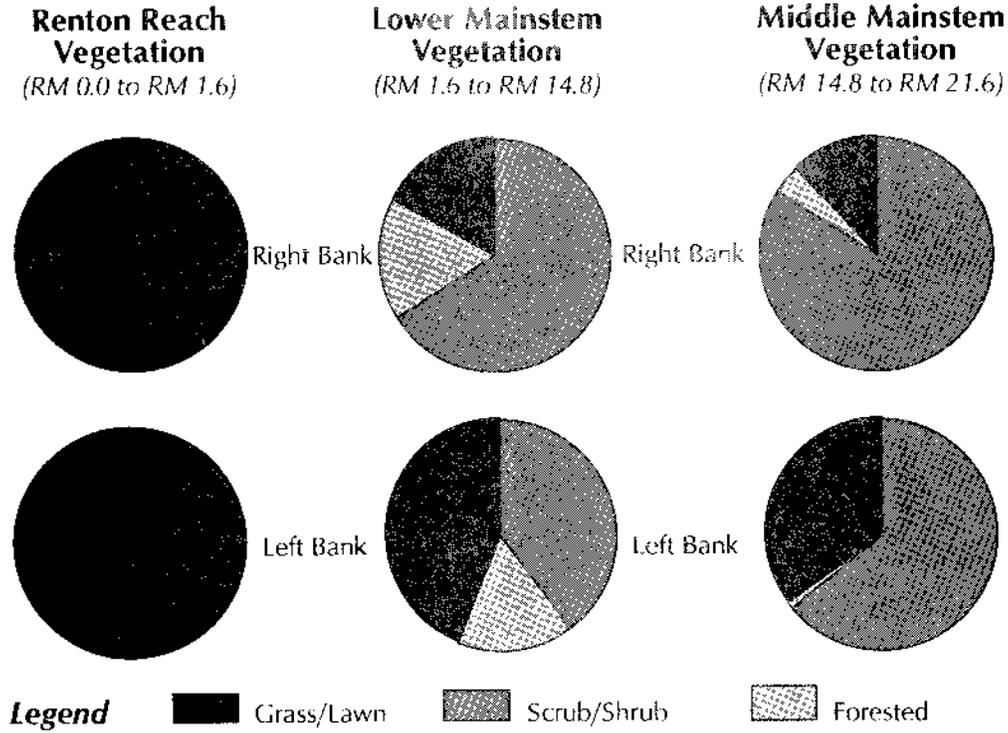
## Summary of Large Pool<sup>1</sup> Habitat Types Cedar River Mainstem Below Landsburg

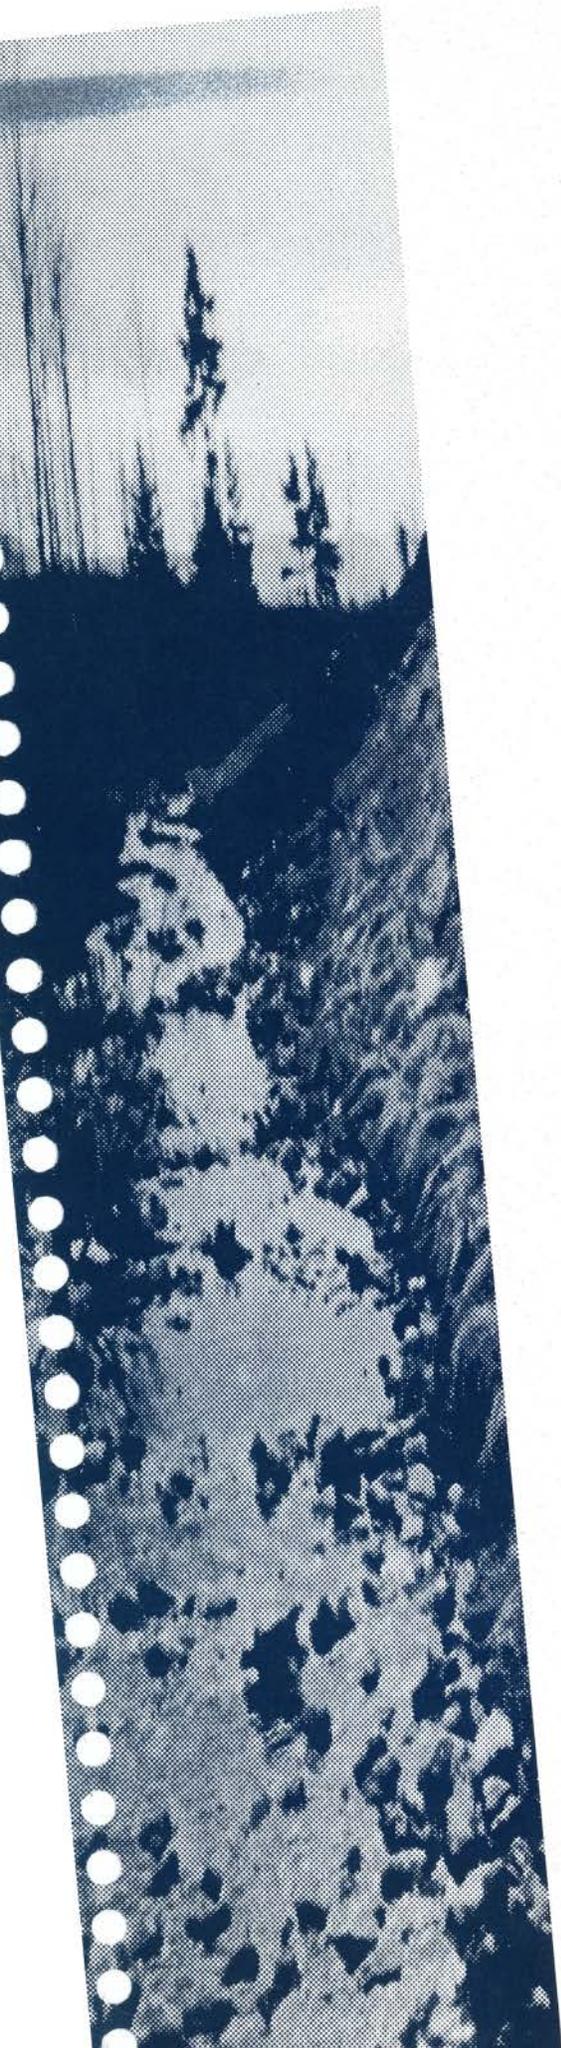
Appendix A  
**Observed Conditions  
Summary**

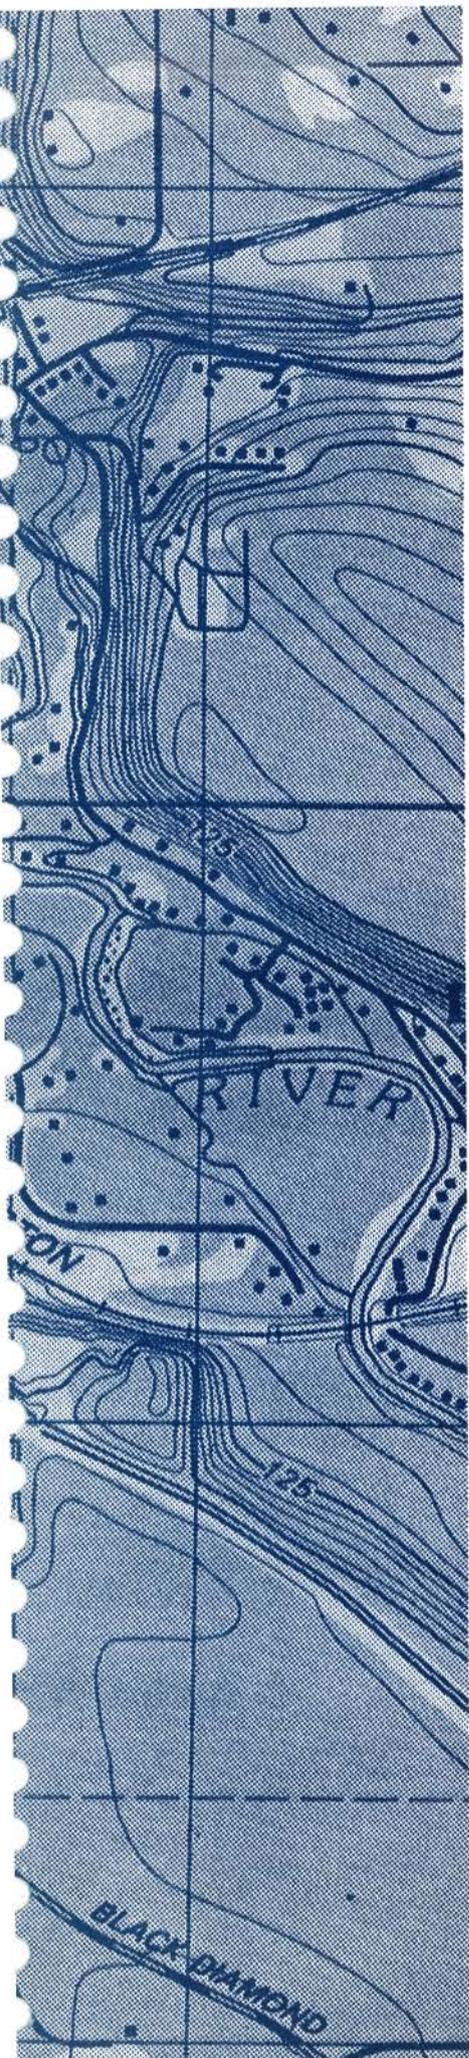
- \*\*\* Extremely Significant
- \*\* Very Significant
- \* Significant
