*Current & Future*

# Conditions Report

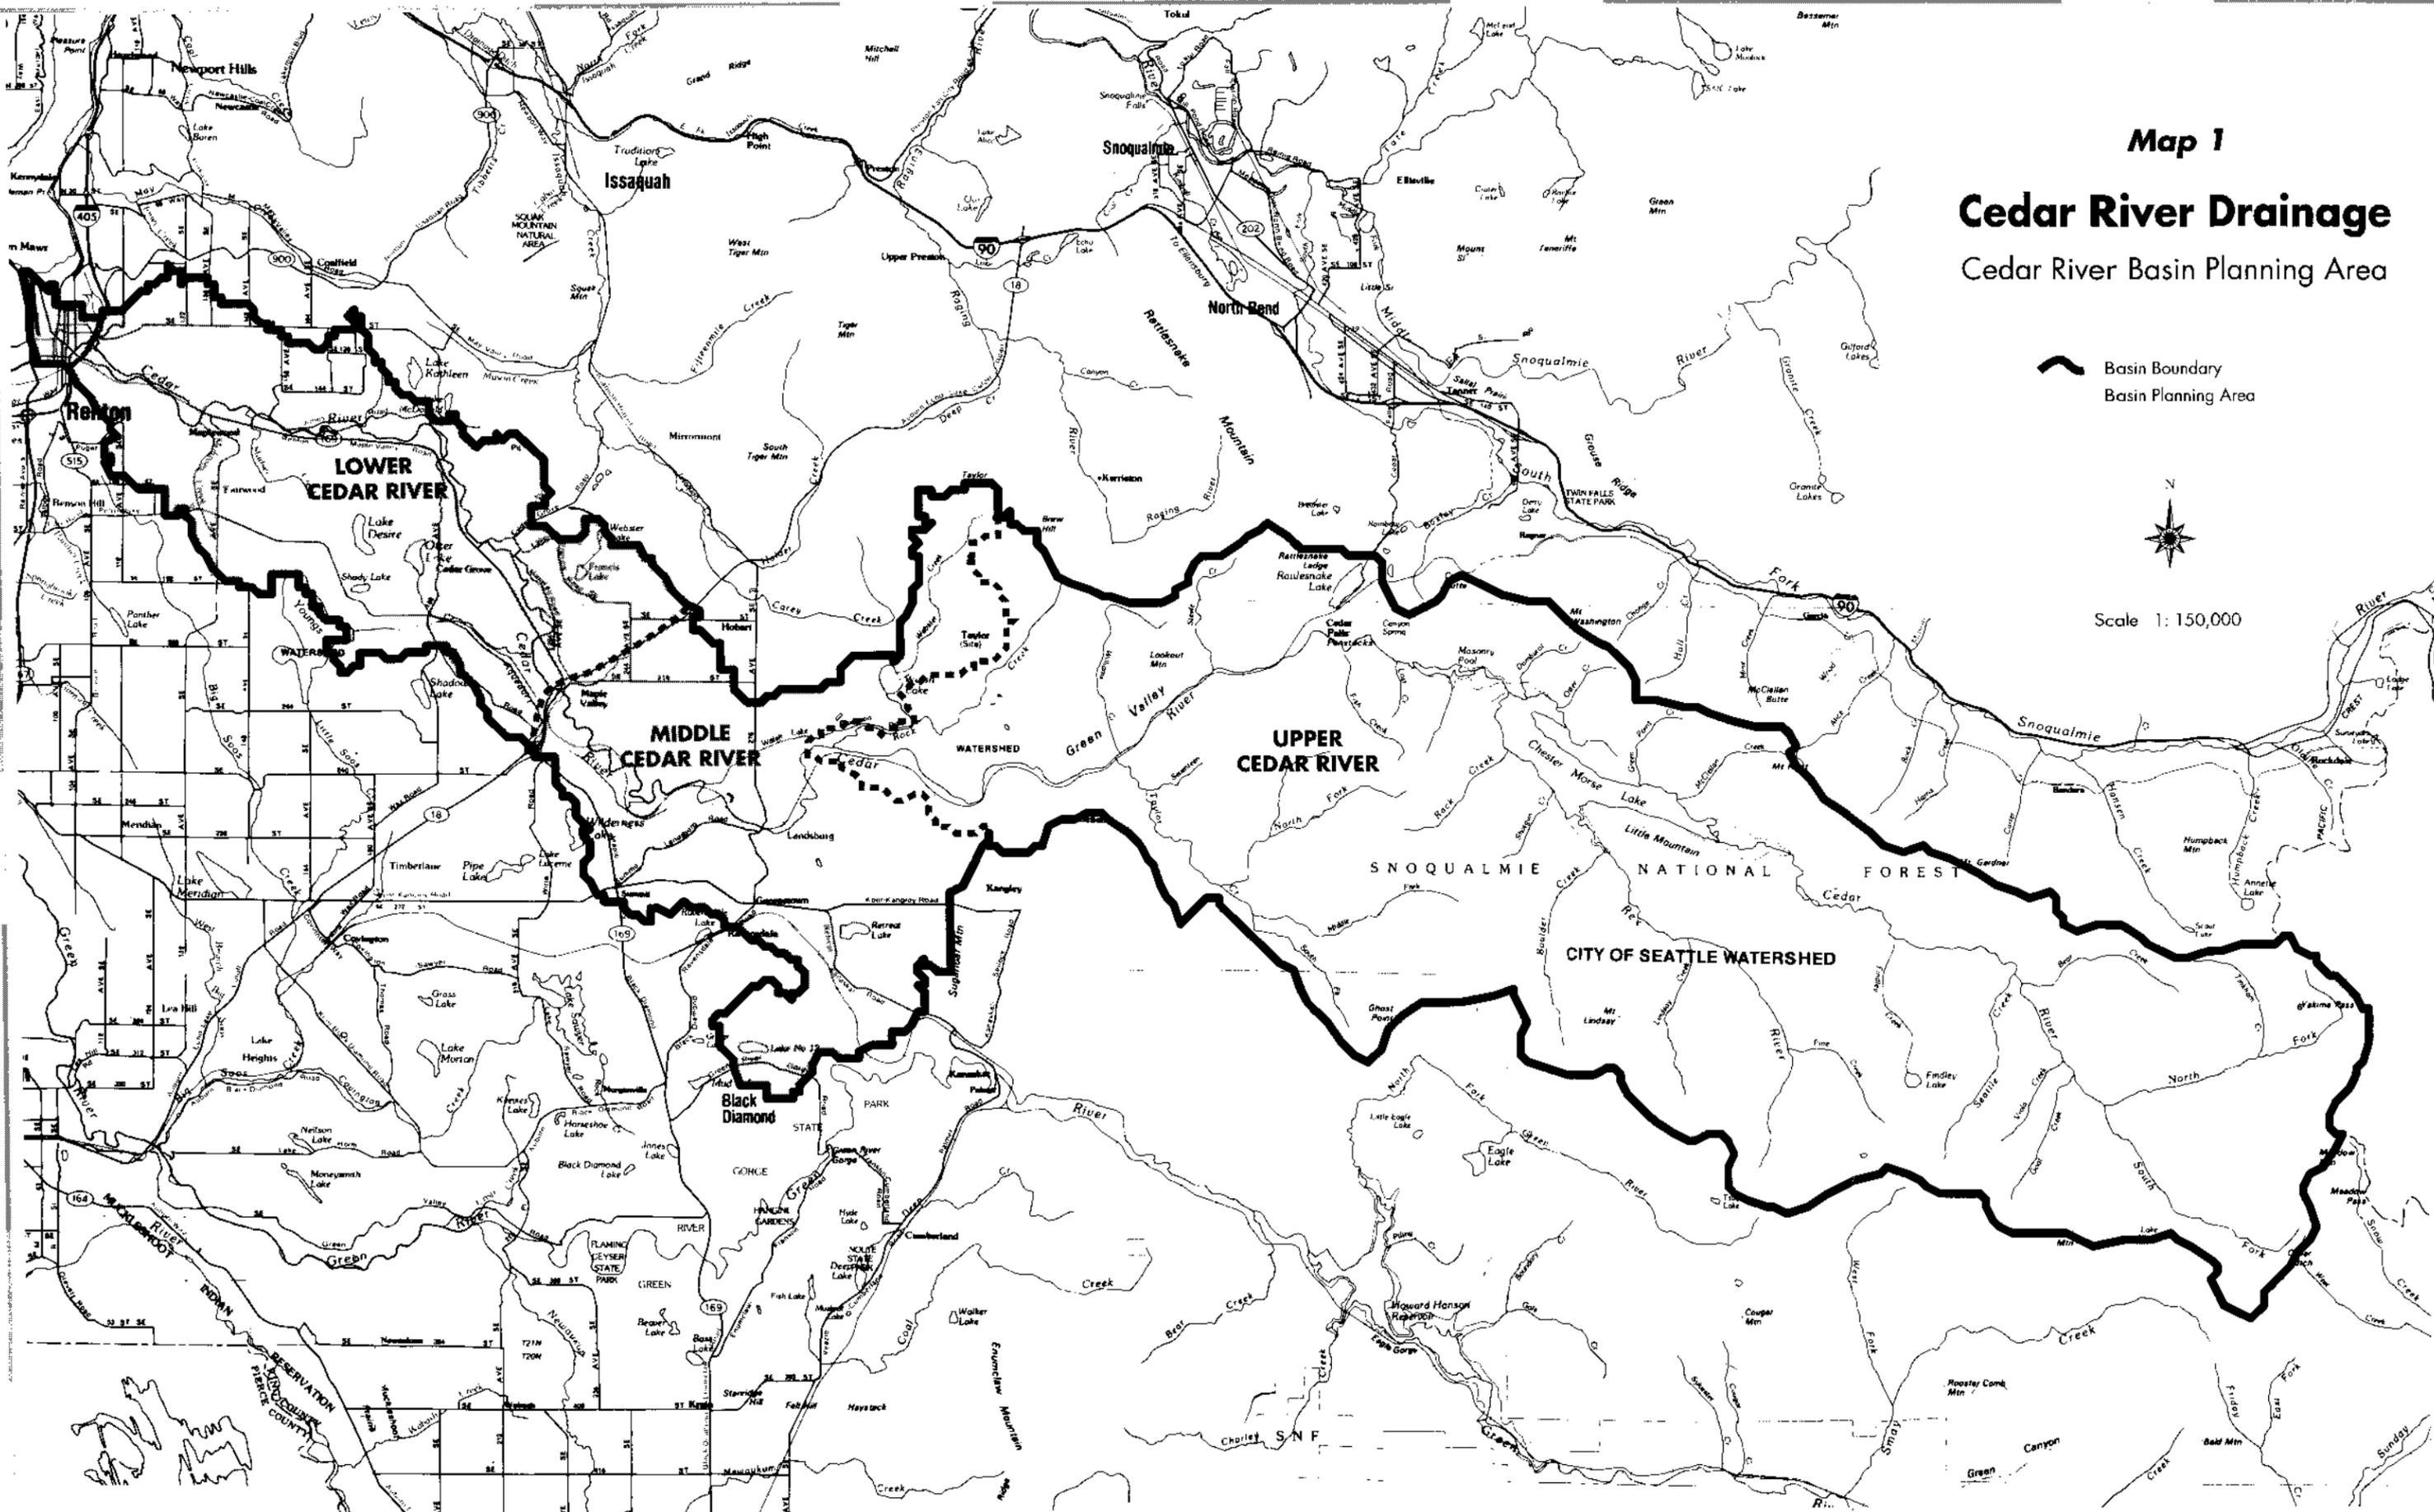
- Map 25** Middle Cedar River Mainstem and Subbasins Conditions
- Map 26** Peterson Creek Subbasin Conditions
- Map 27** Taylor Creek Subbasin Conditions
- Map 28** Rock Creek Subbasin Conditions

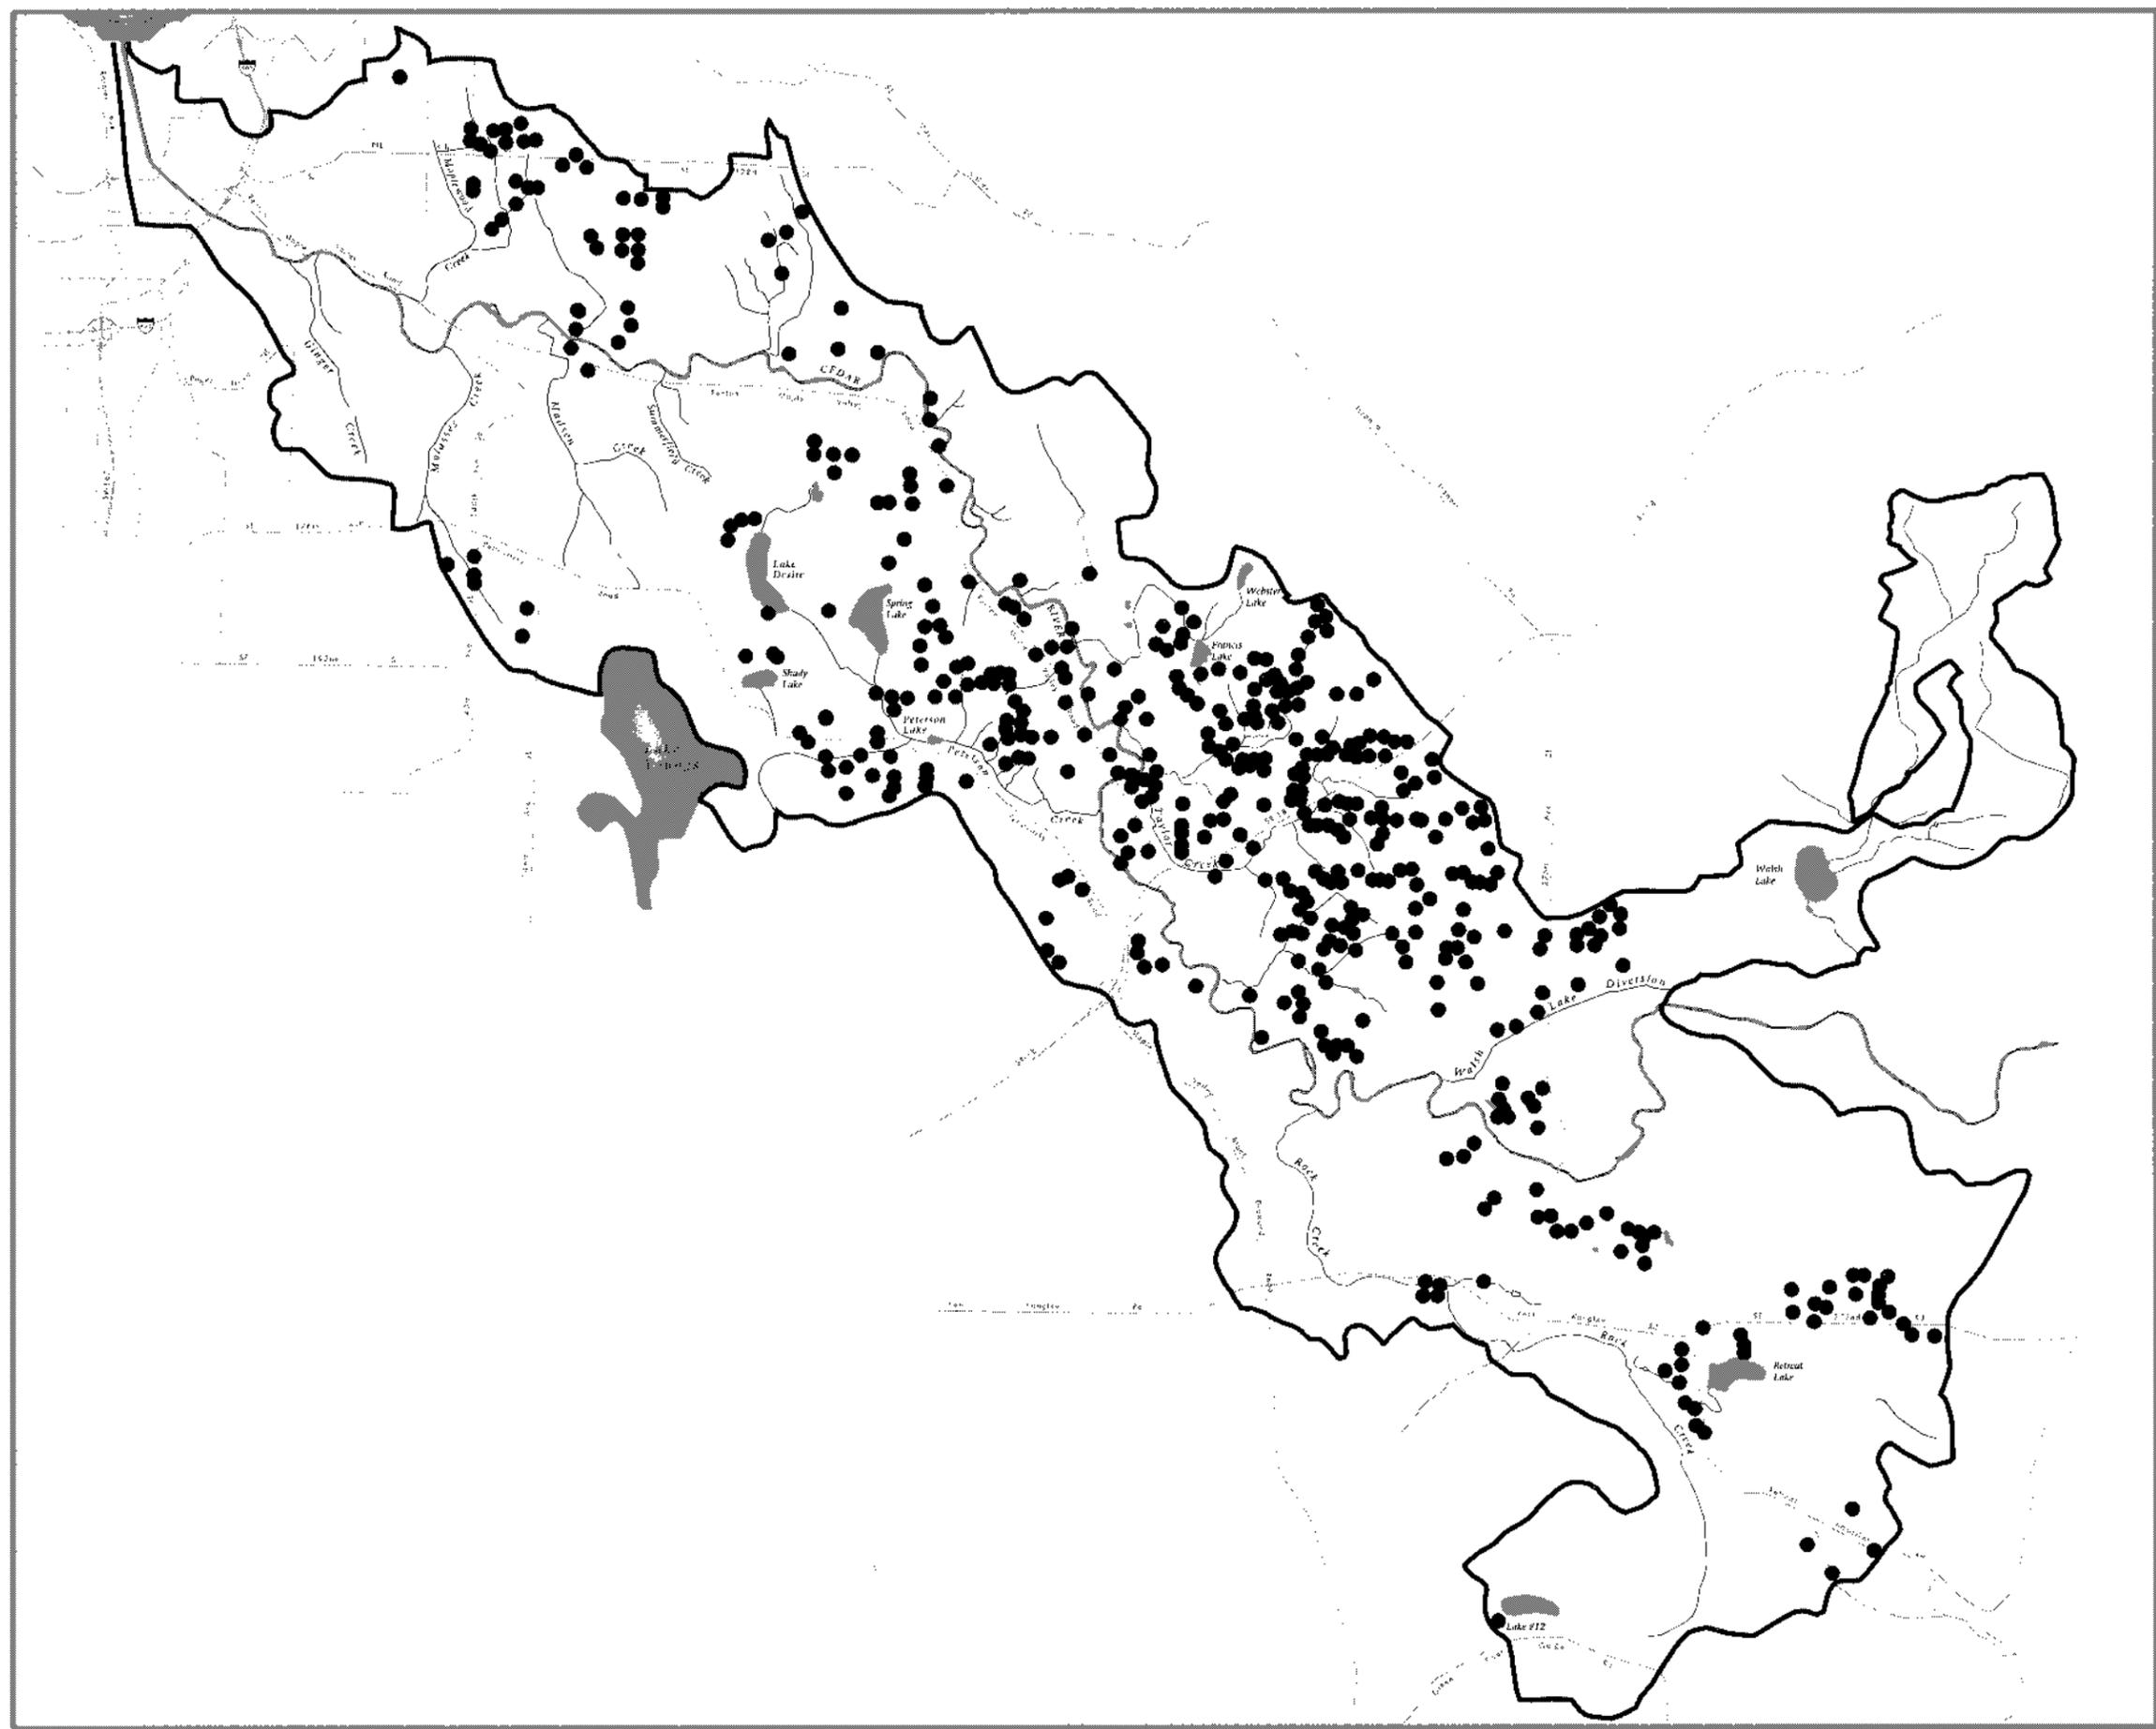
USDA Puget Sound Cooperative  
River Basin Team

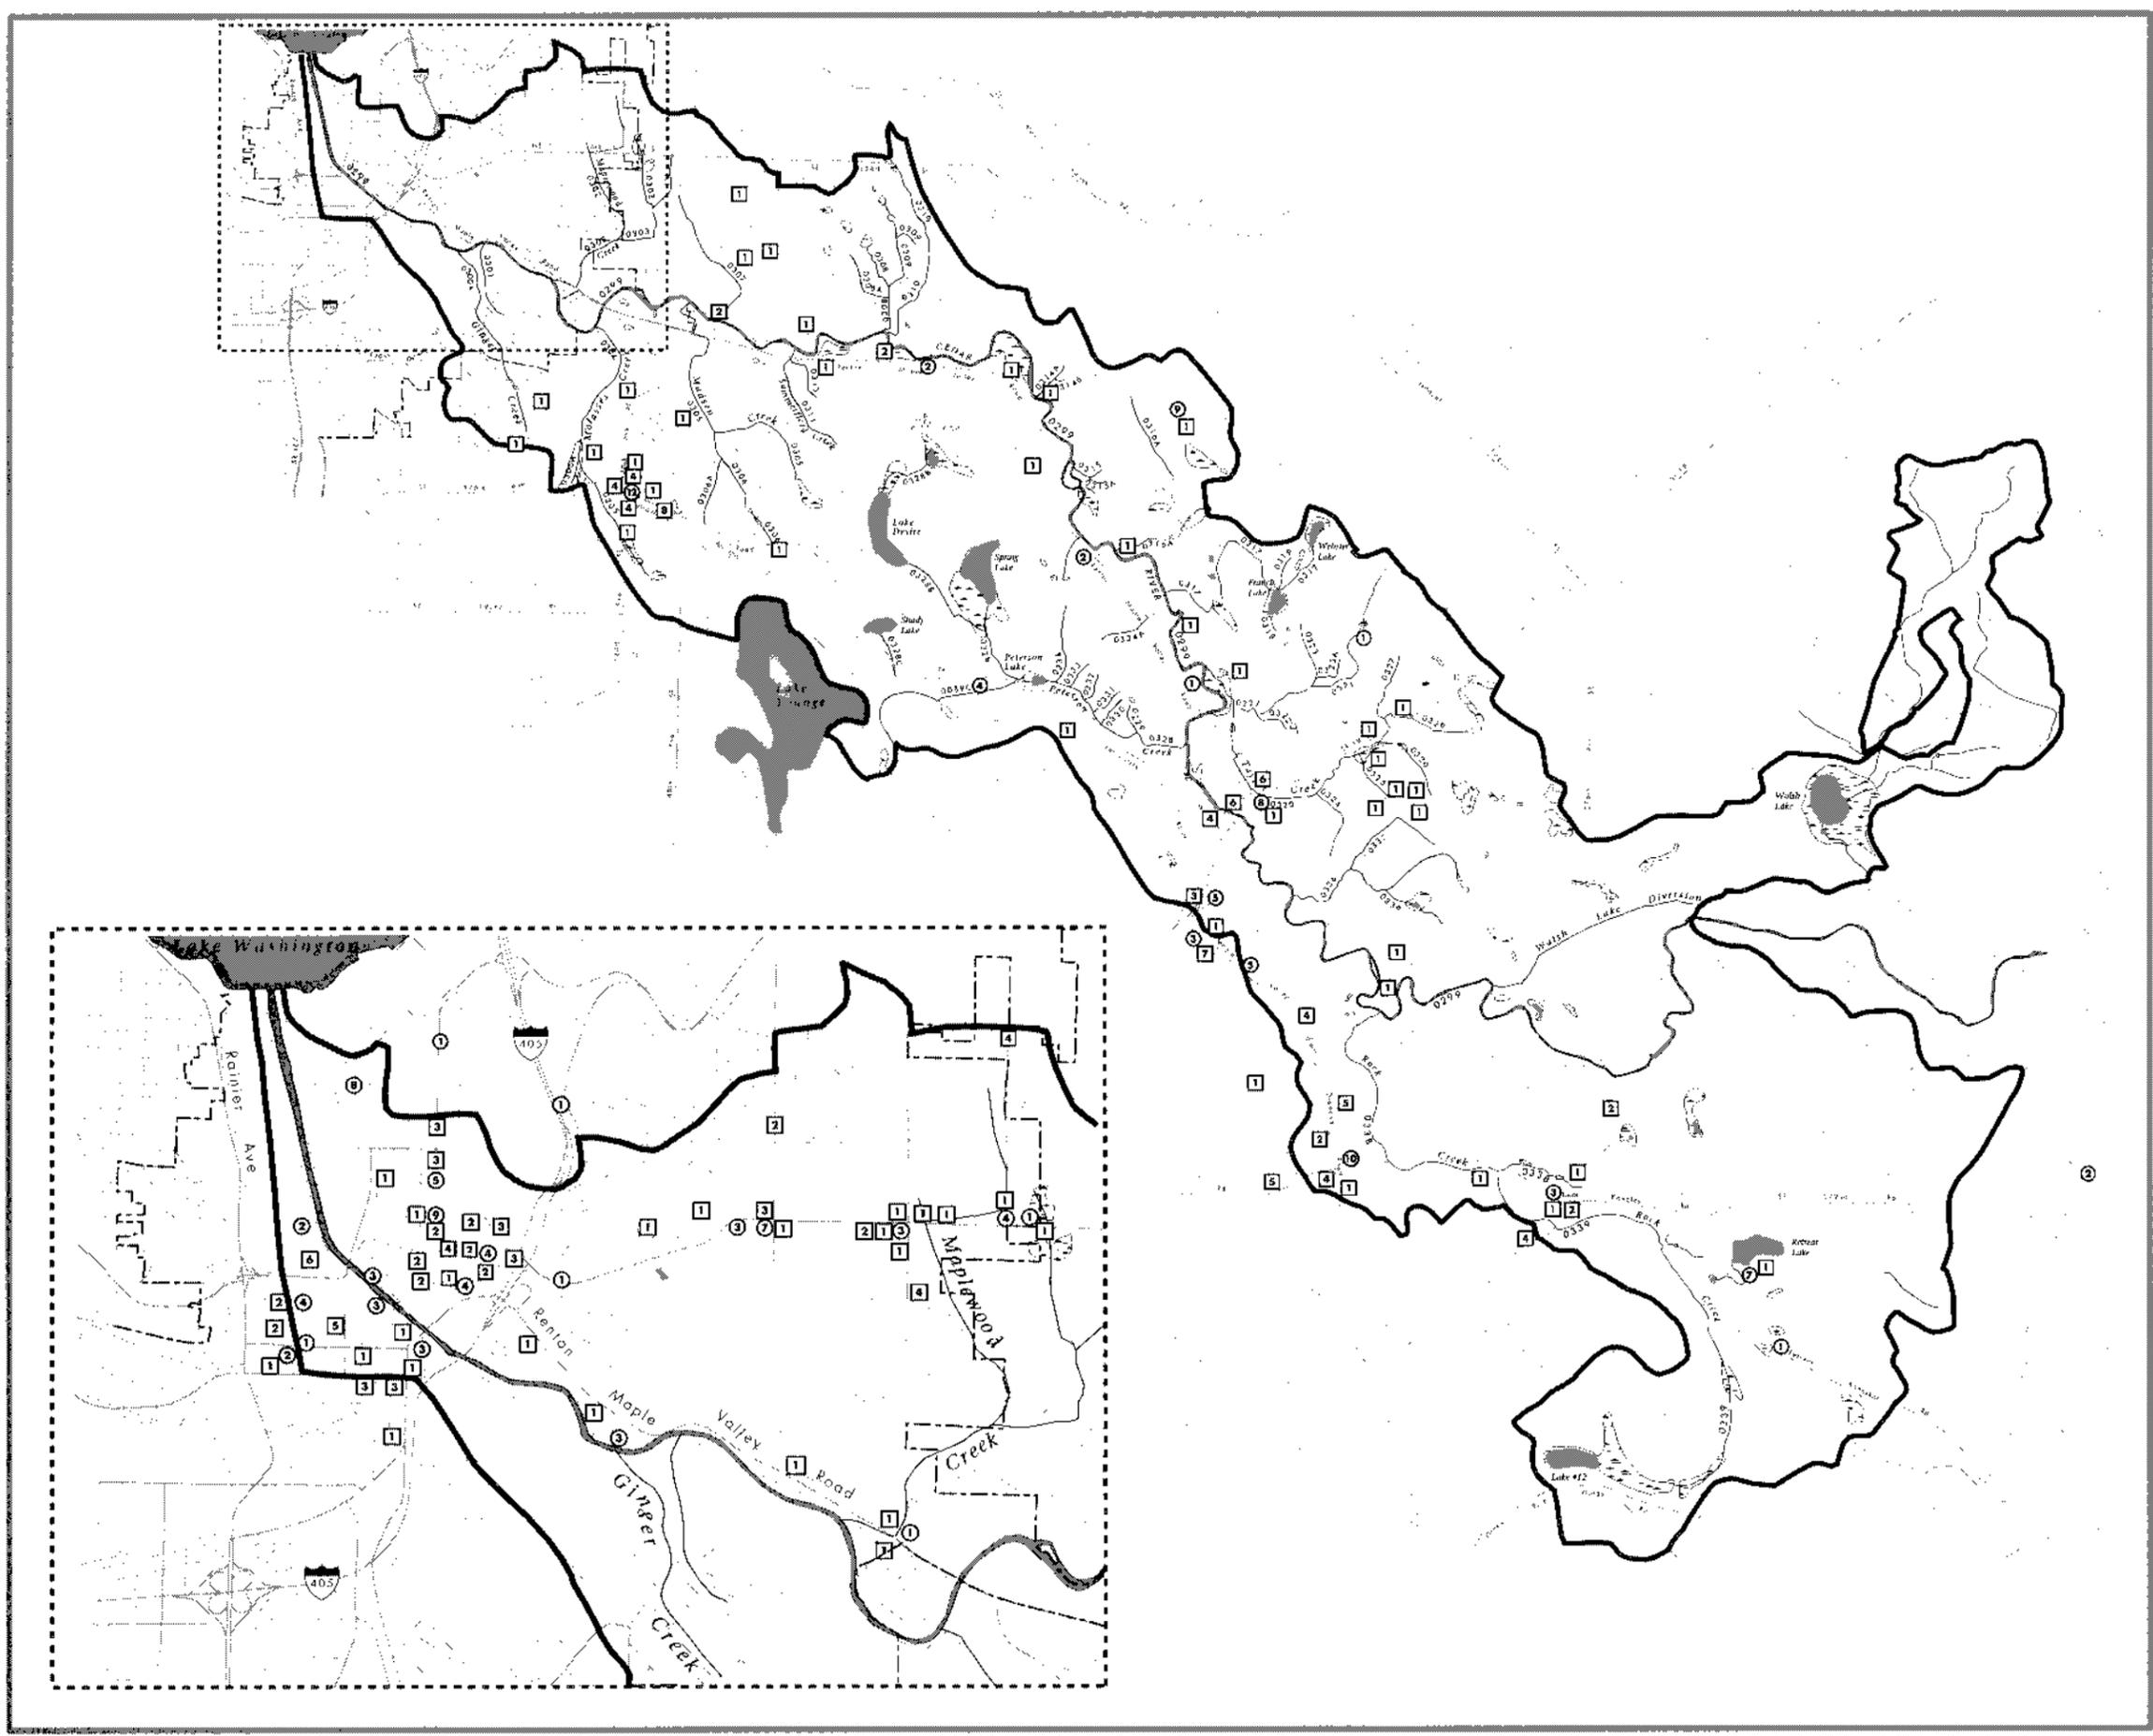
Survey Completed in 1991

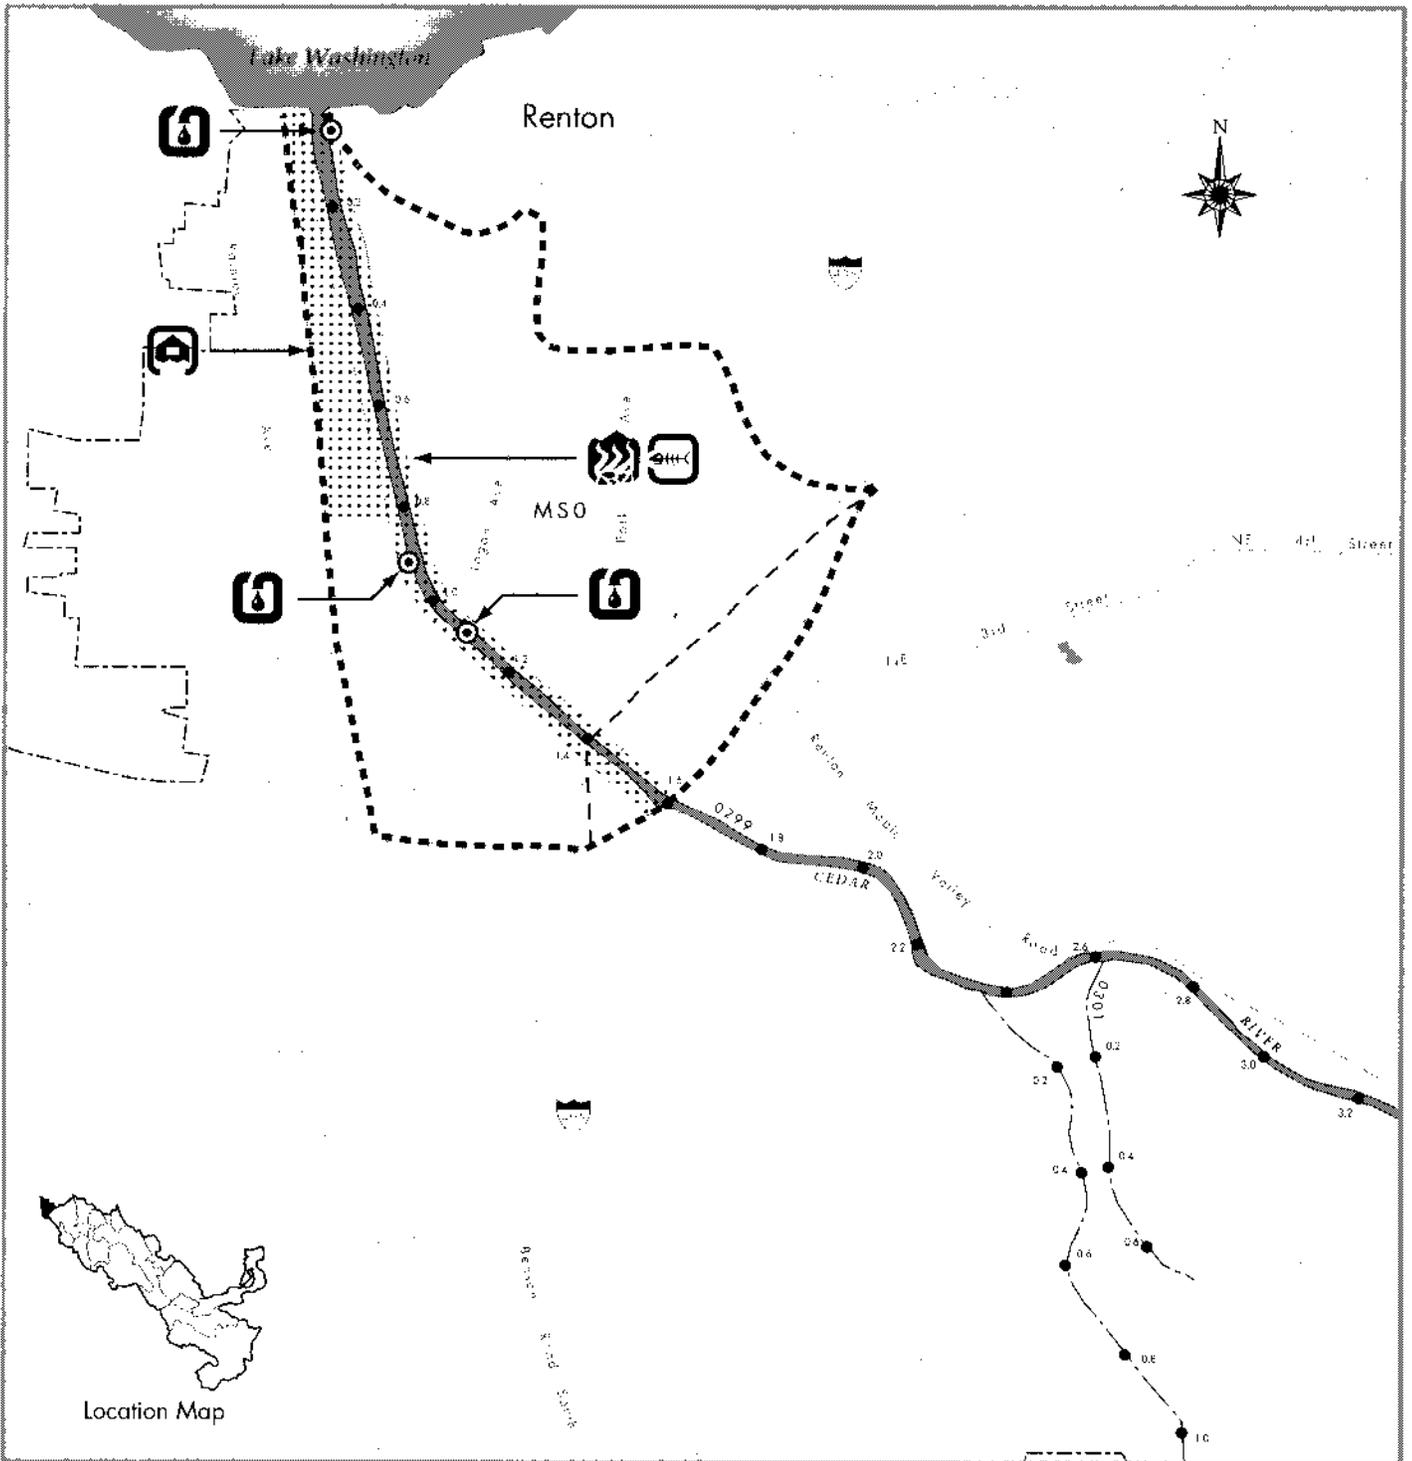
# Renton Reach Subbasin Conditions

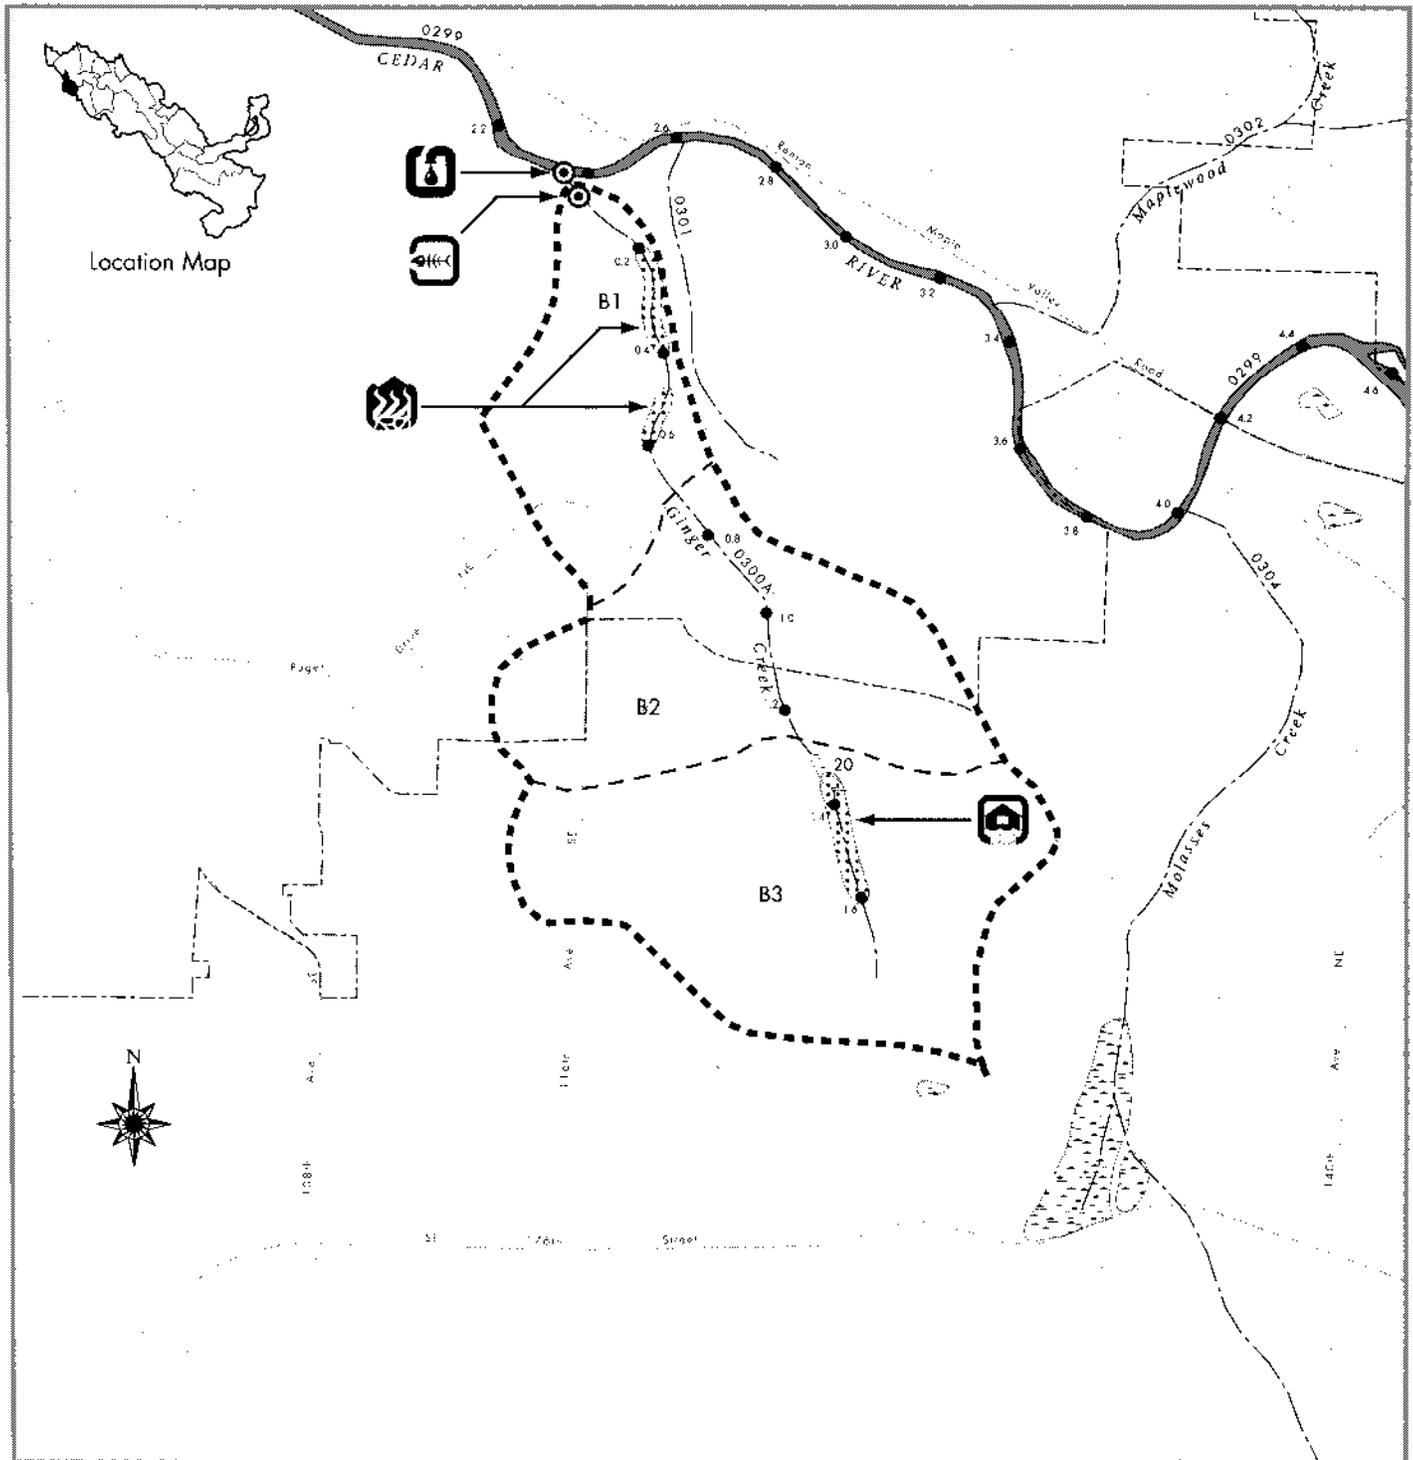
# Ginger Creek Subbasin Conditions

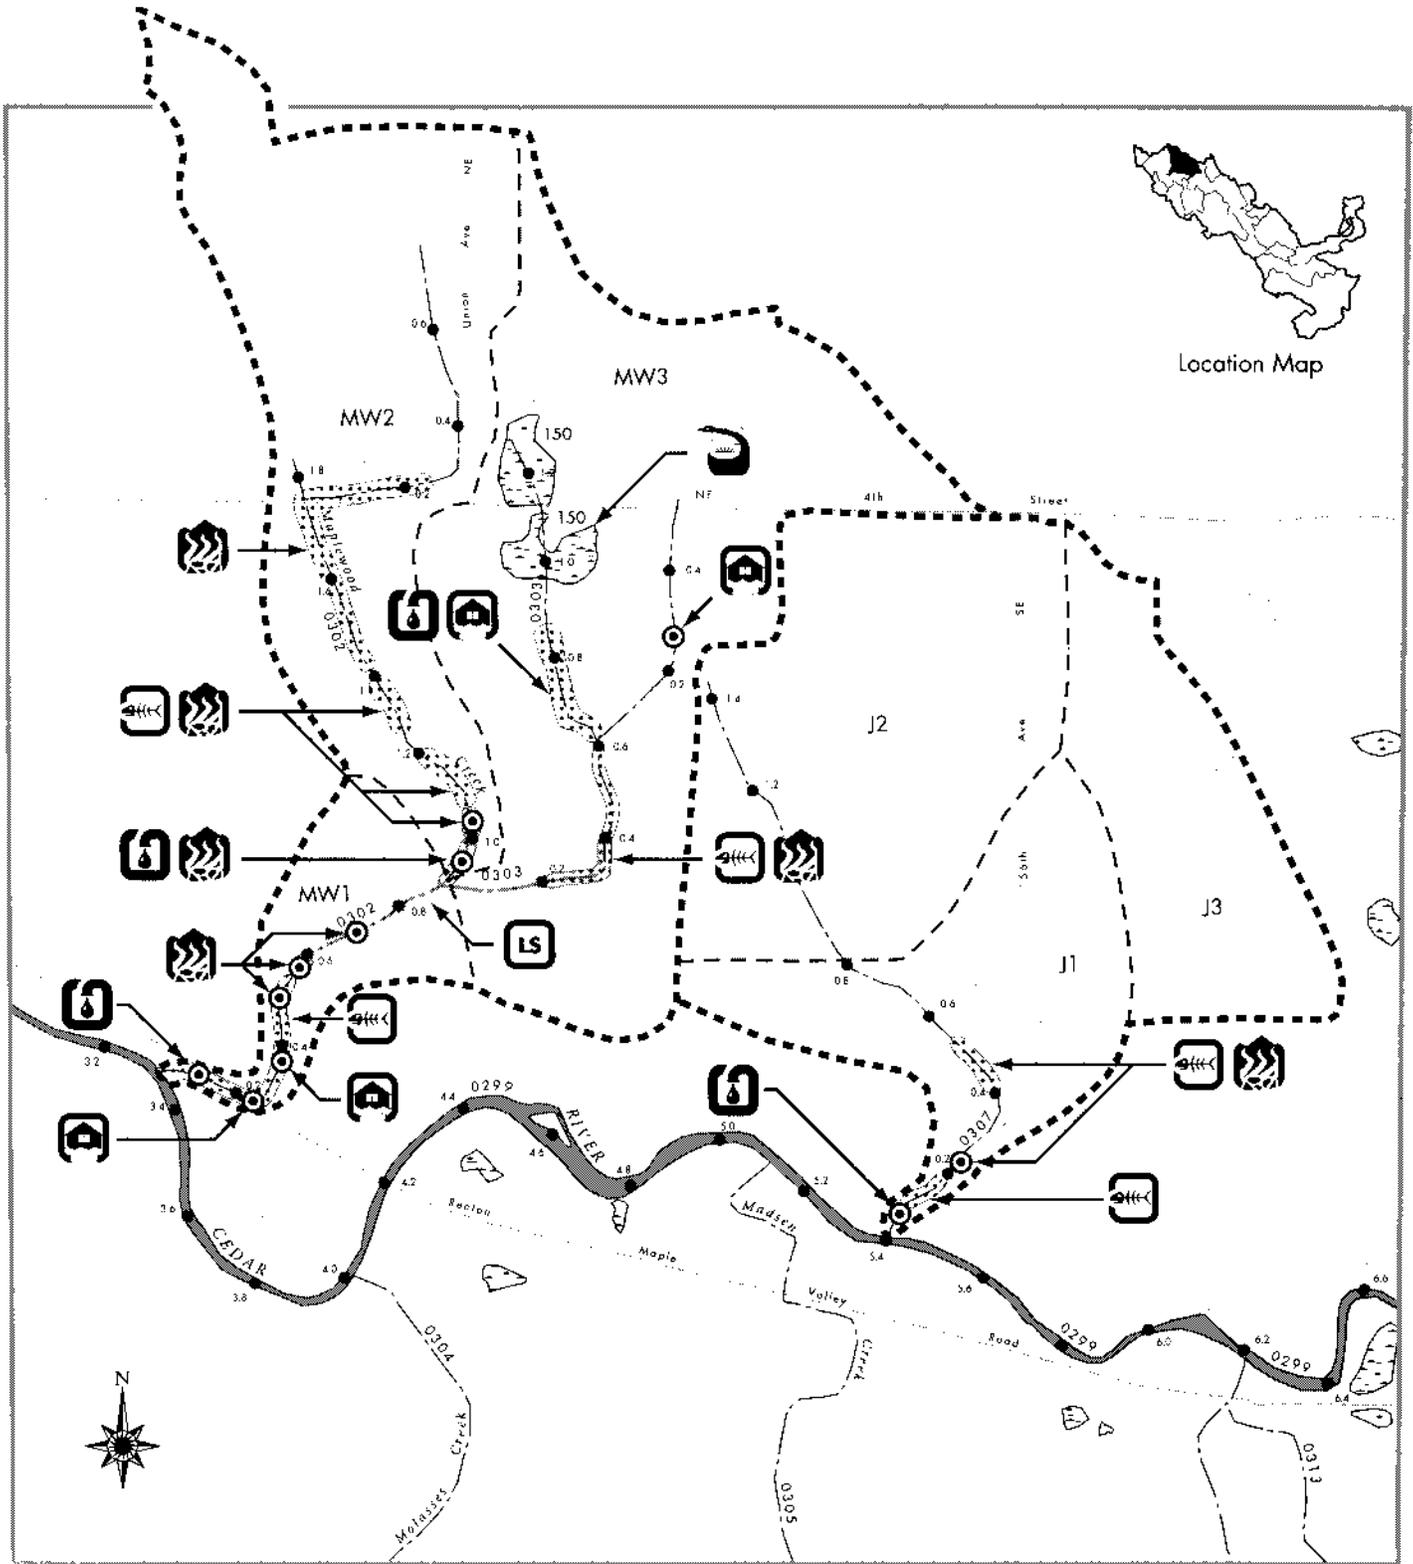
# Maplewood & Orting Hills Subbasin Conditions

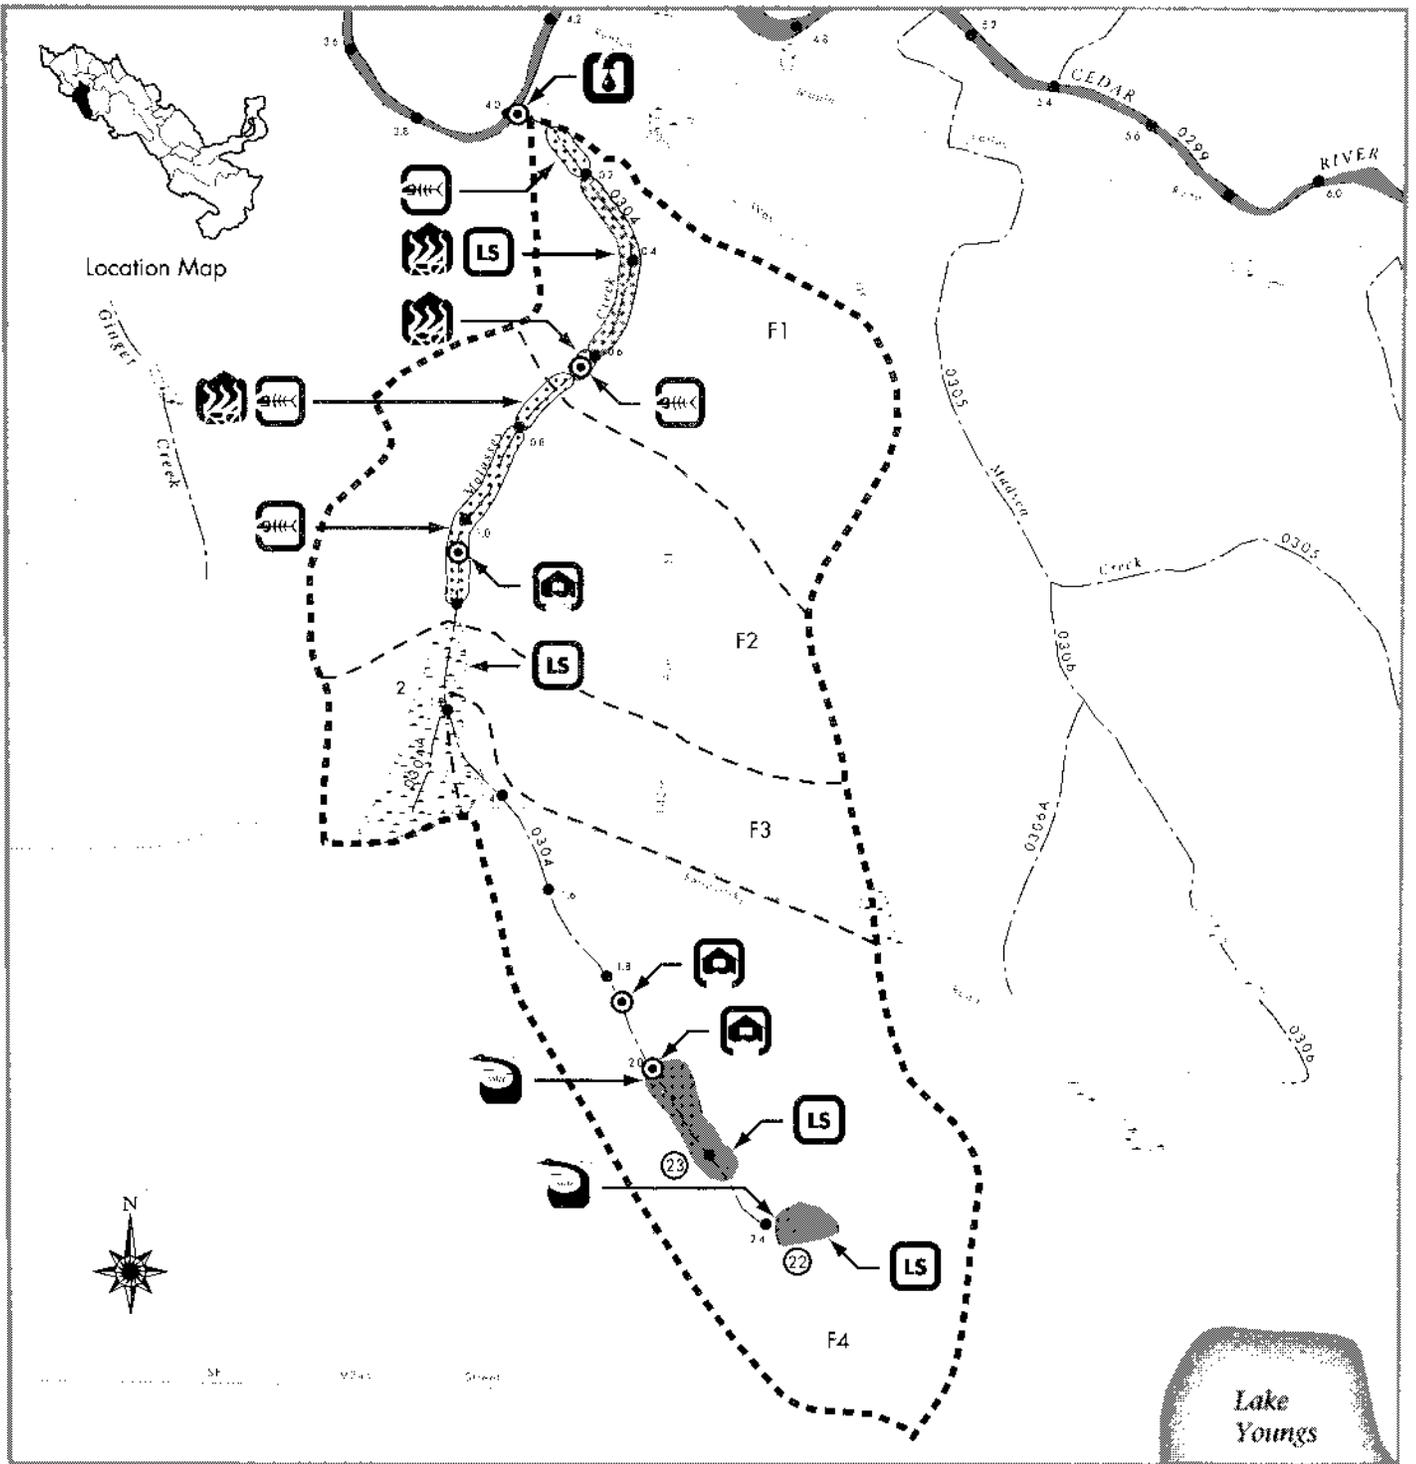
# Molasses Creek Subbasin Conditions

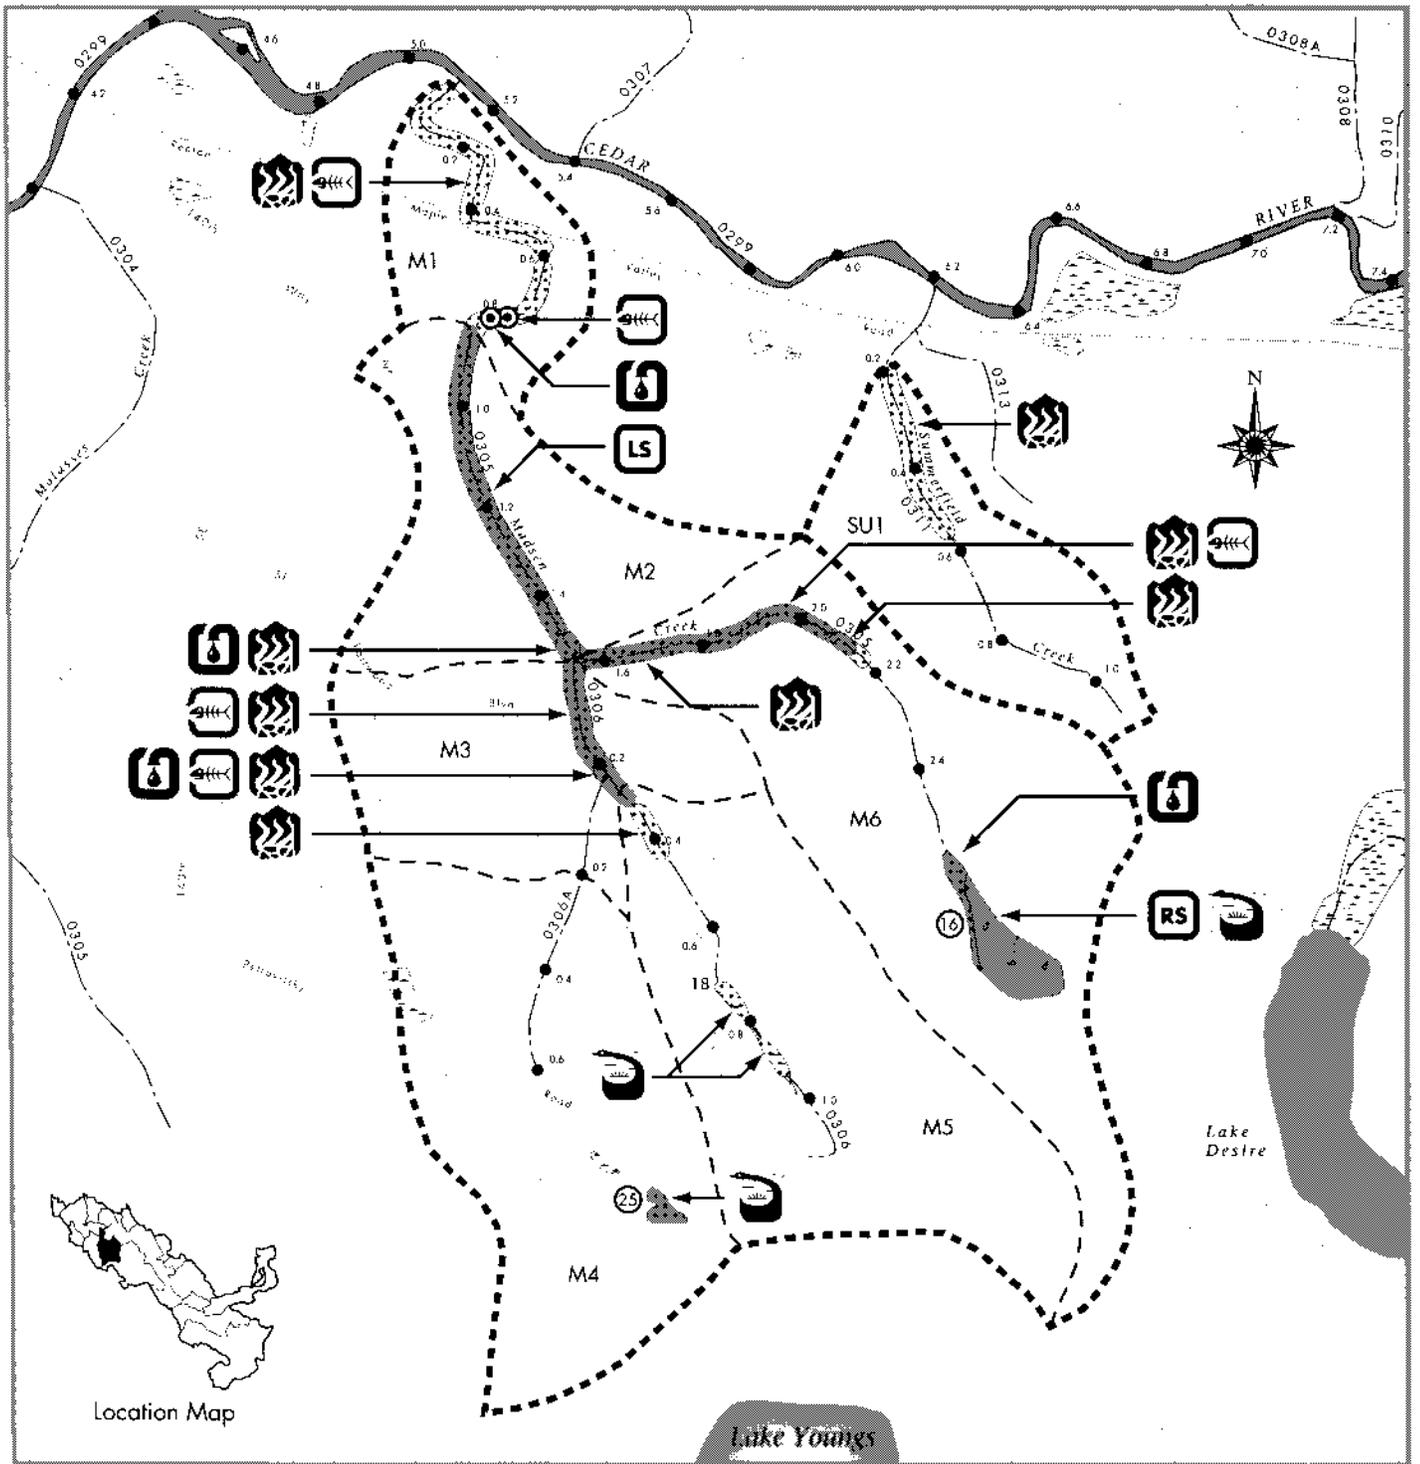
## Madsen Creek & Summerfield Subbasin Conditions
