*Current & Future*

# Conditions Report

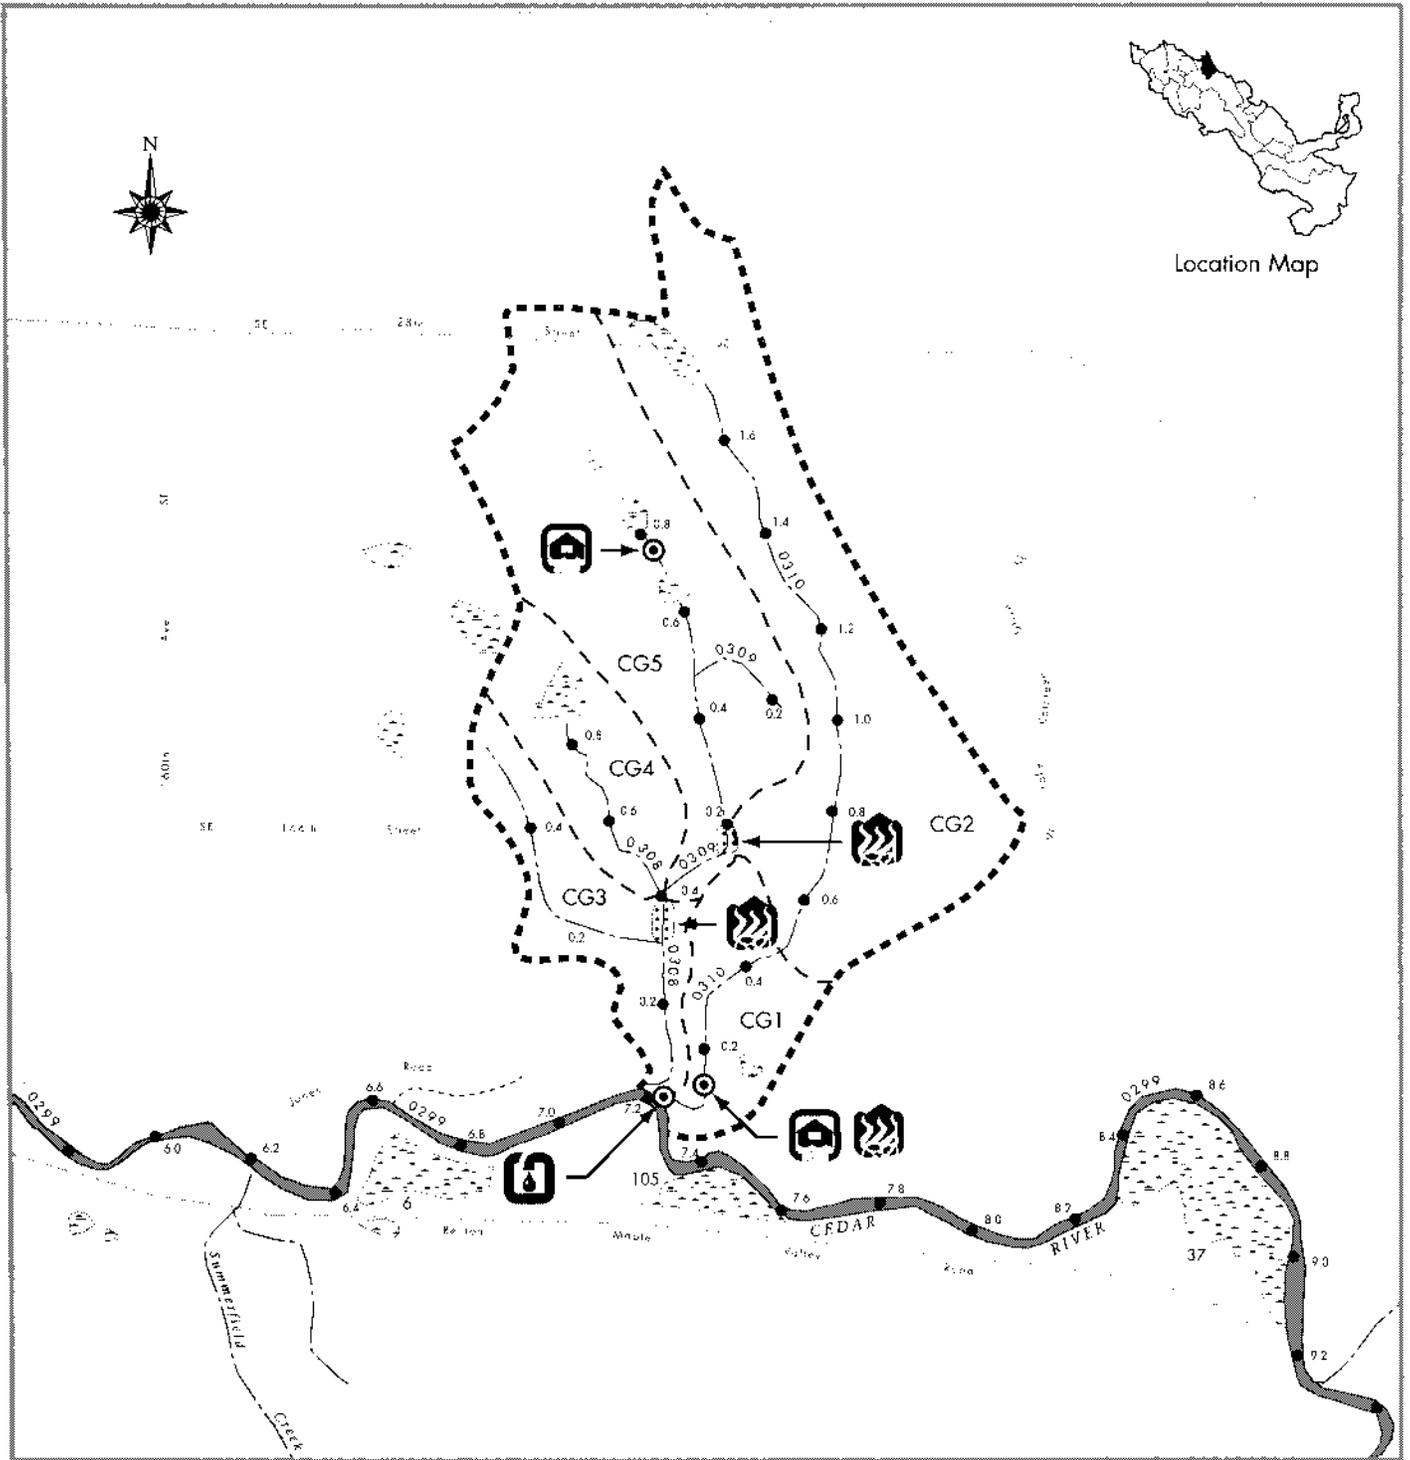
# Cedar Grove Subbasin Conditions

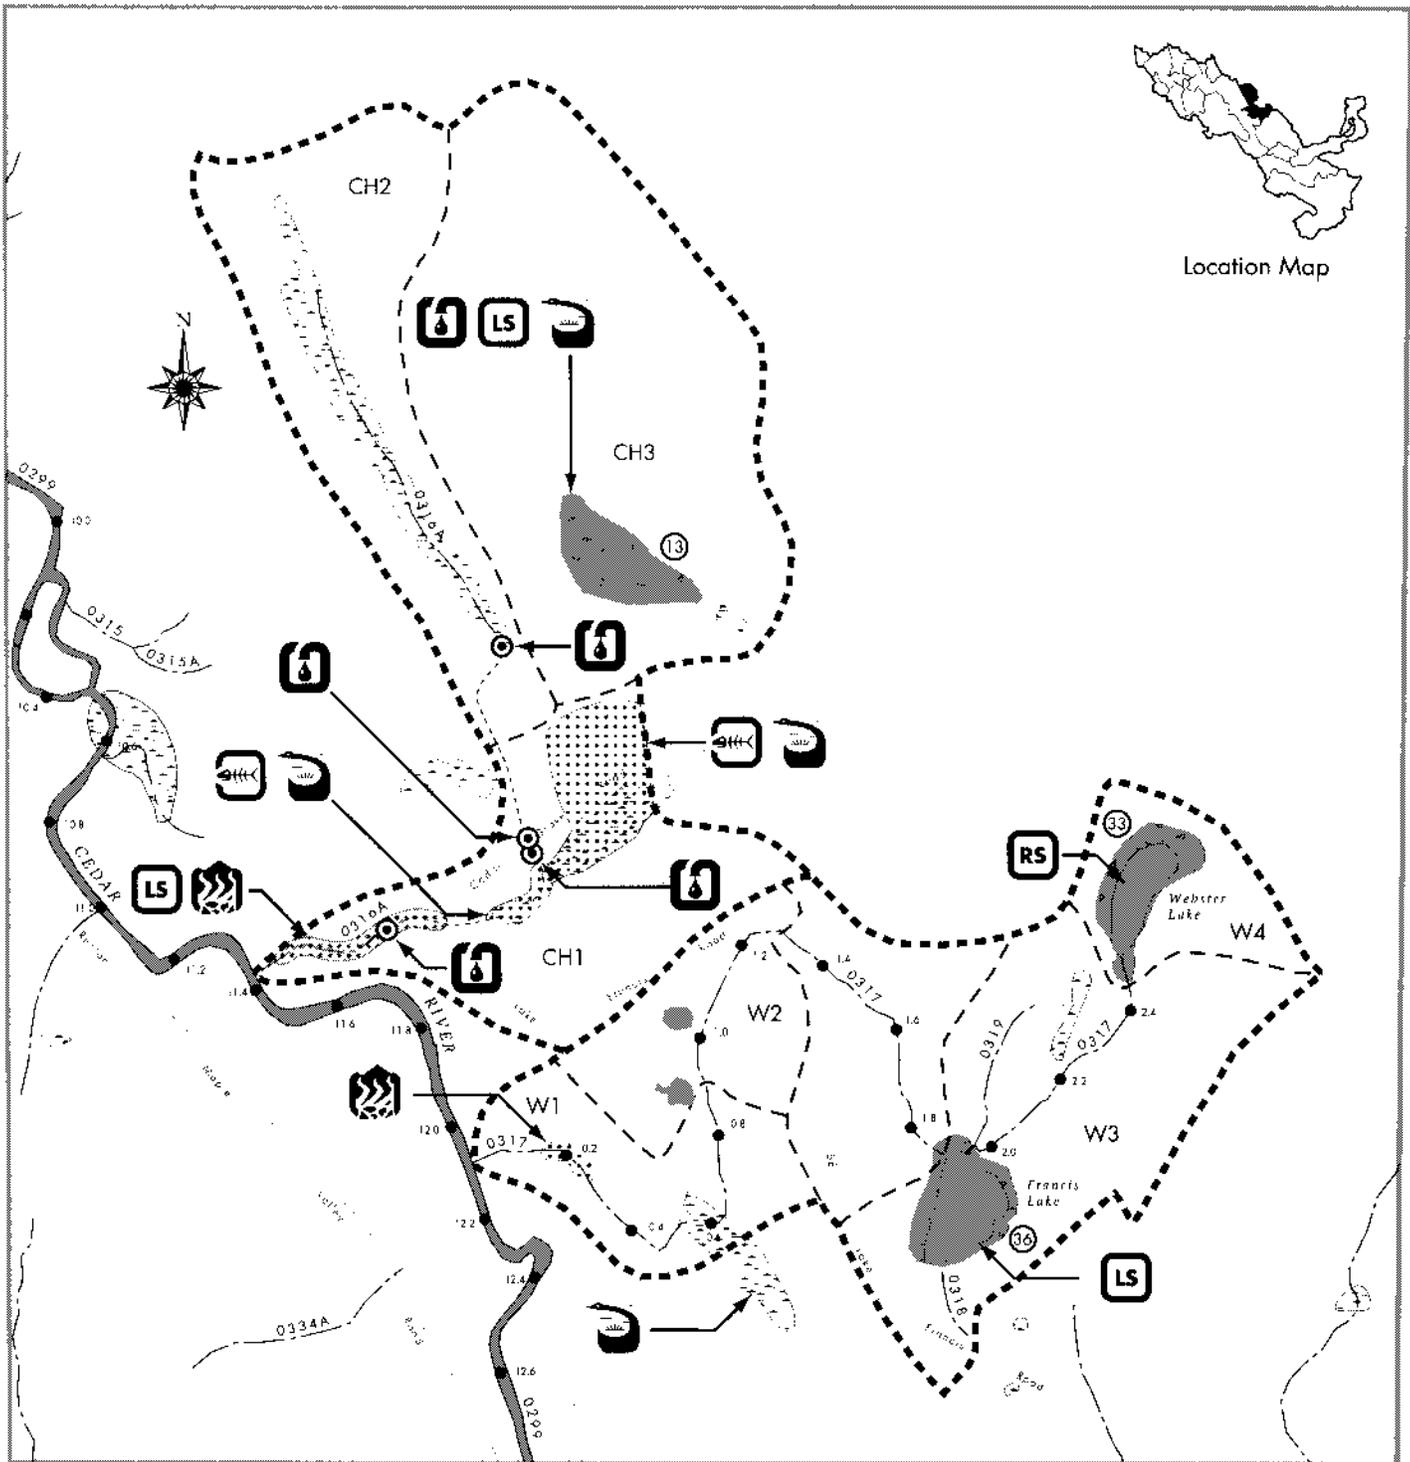
# Cedar Hills & Webster Lake Subbasin Conditions

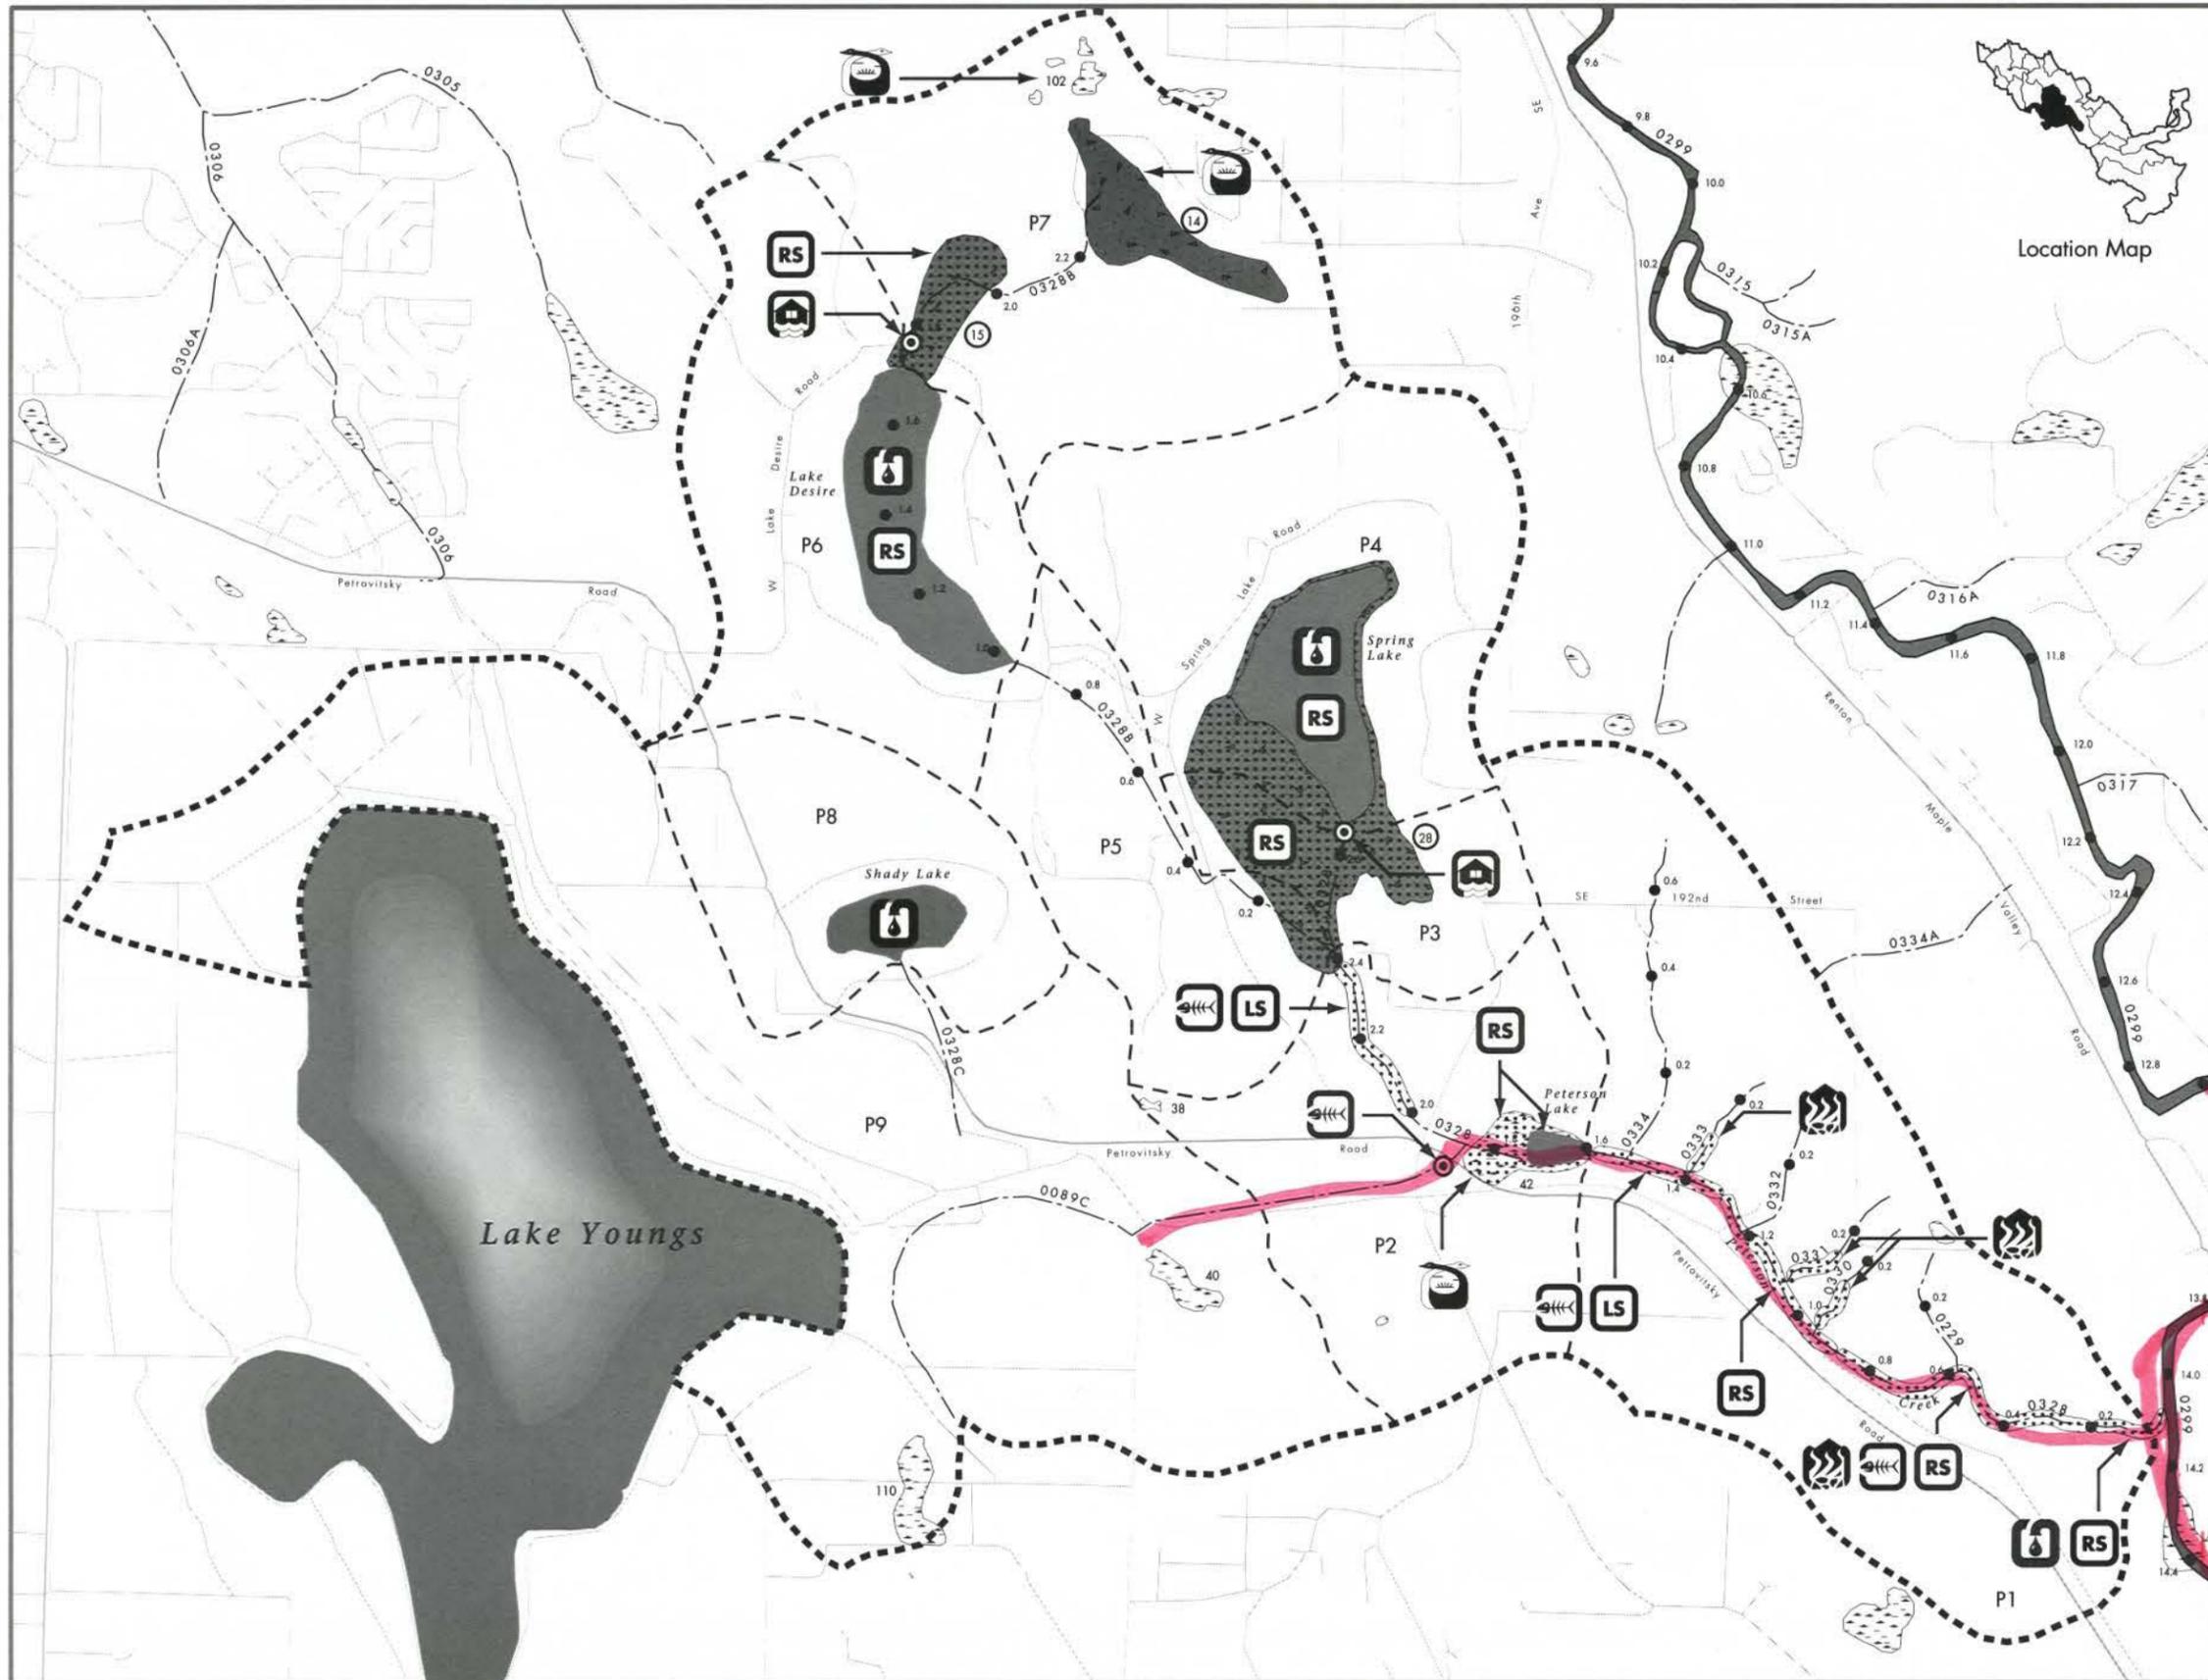
**Map 26**  
**Peterson Creek Subbasin**  
**Conditions**  
 Cedar River Basin Planning Area

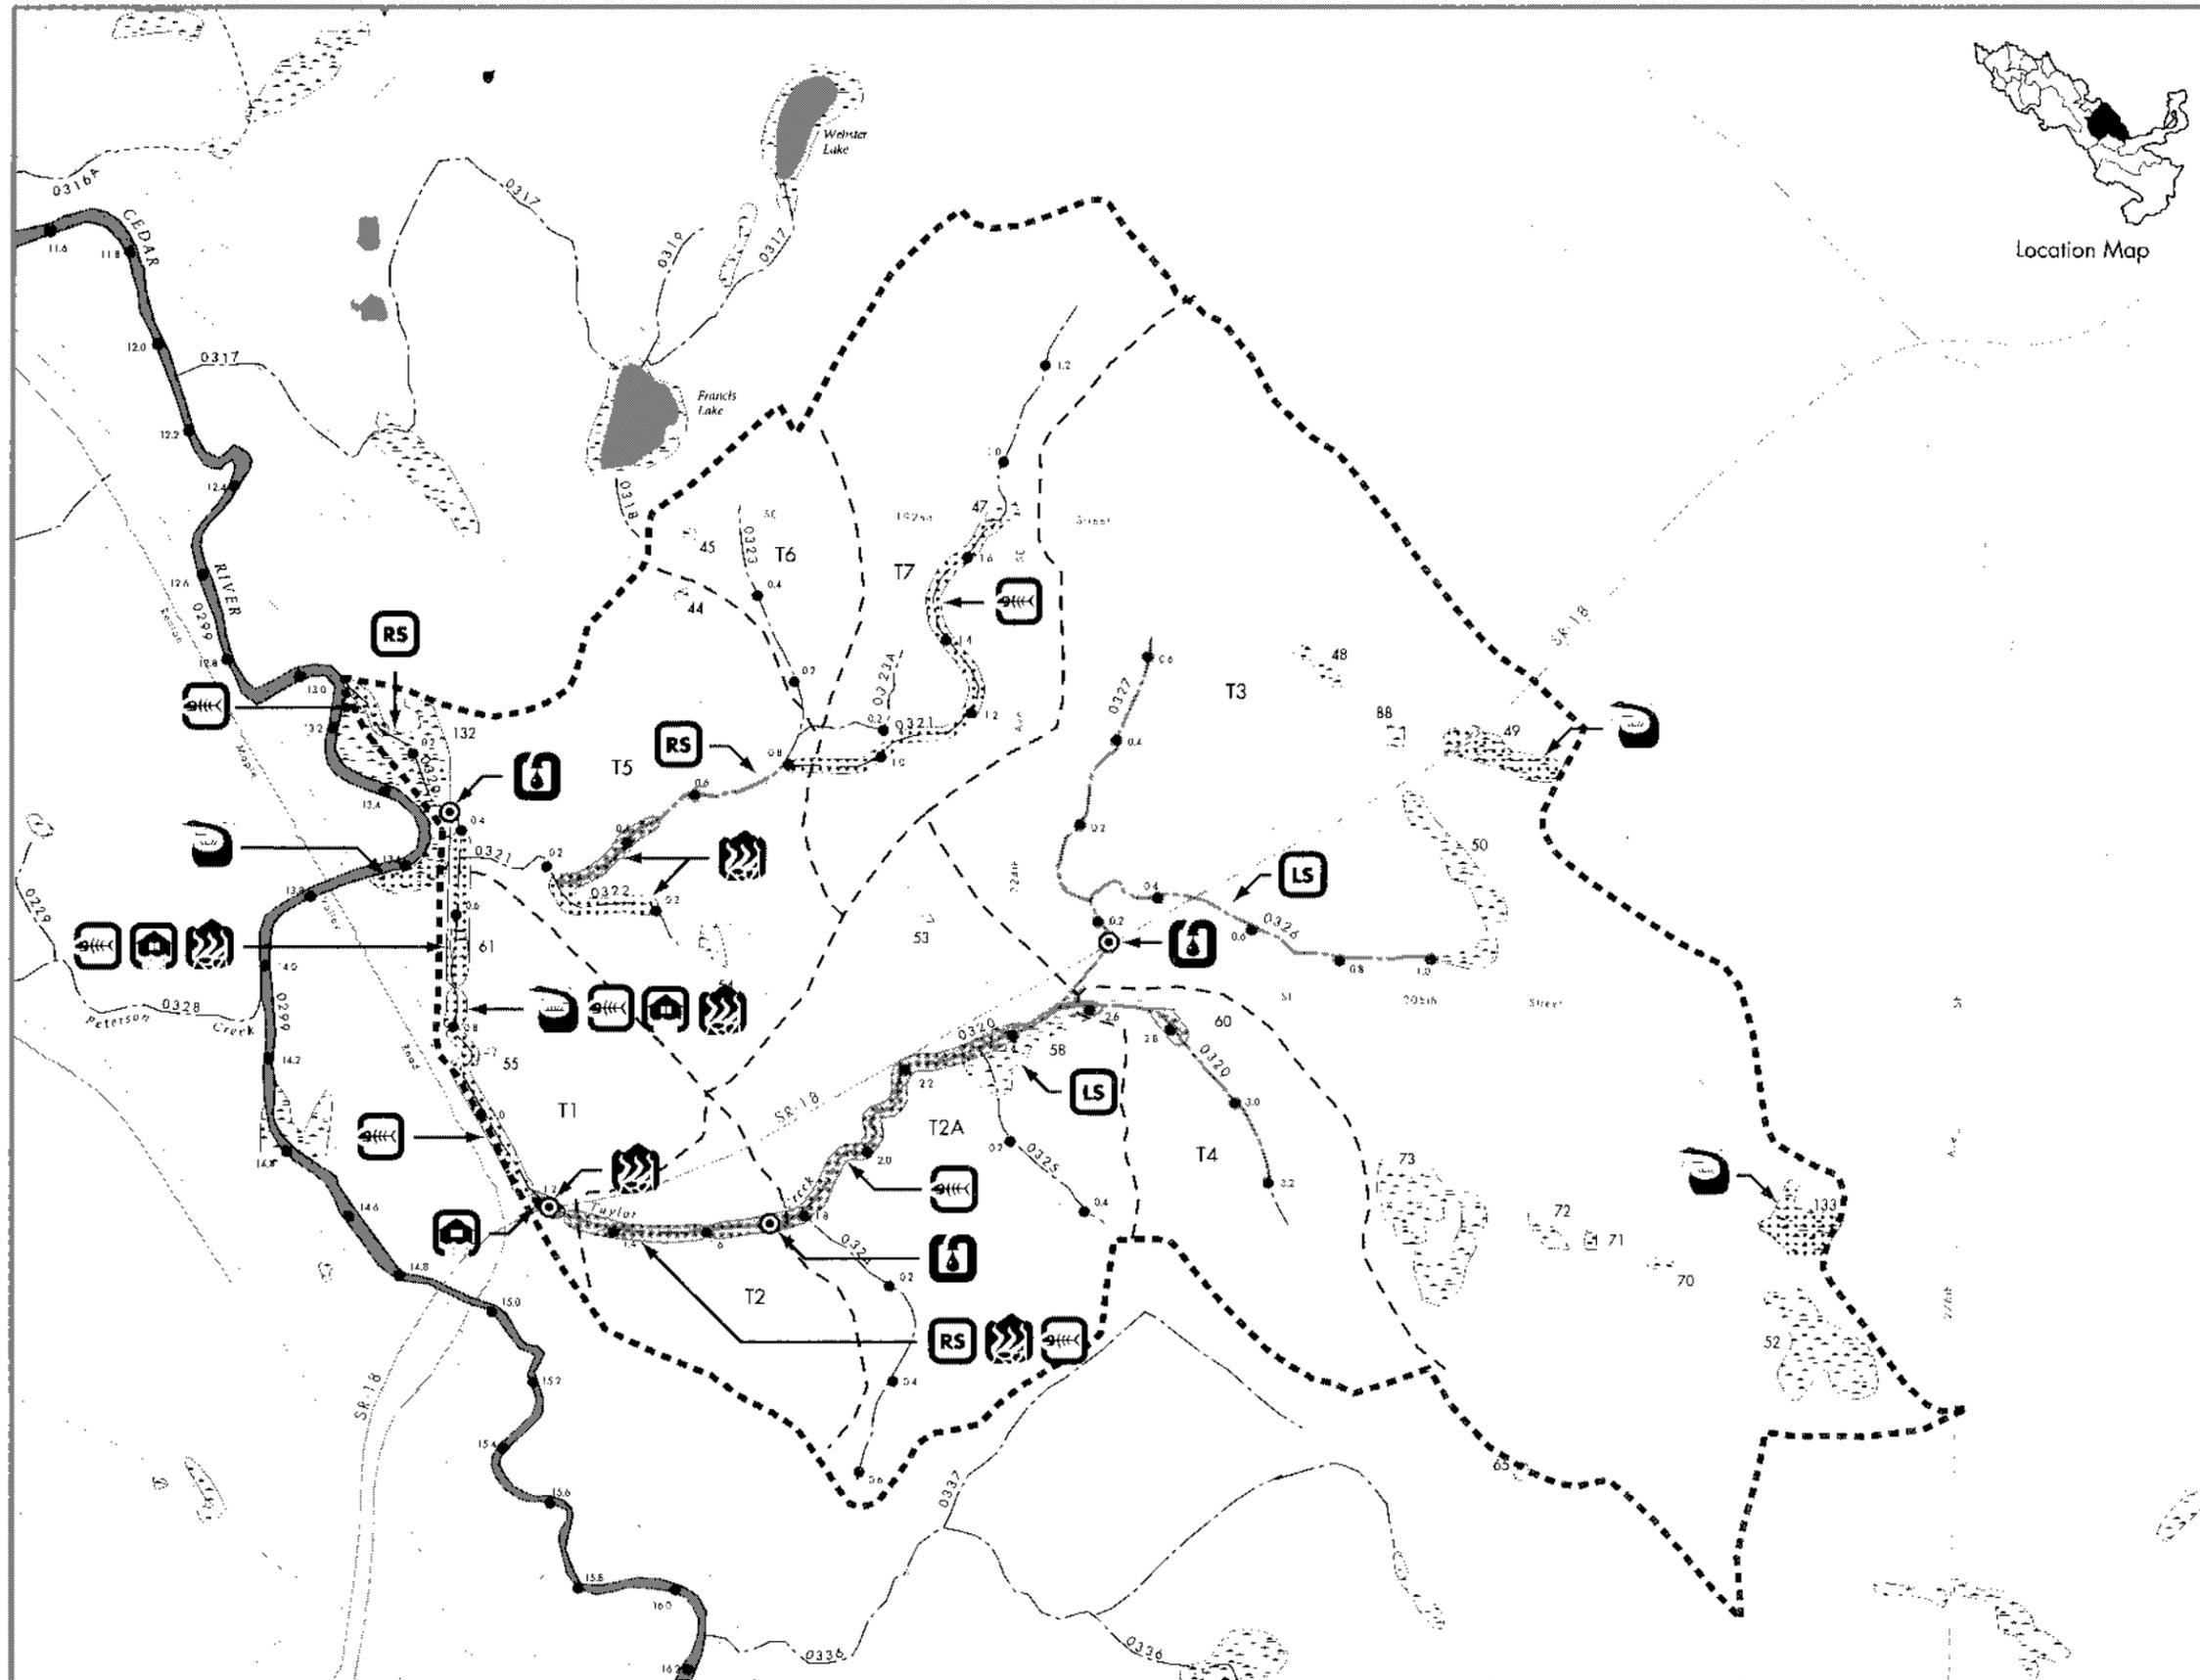
**Map 27**  
**Taylor Creek Subbasin**  
**Conditions**  
 Cedar River Basin Planning Area

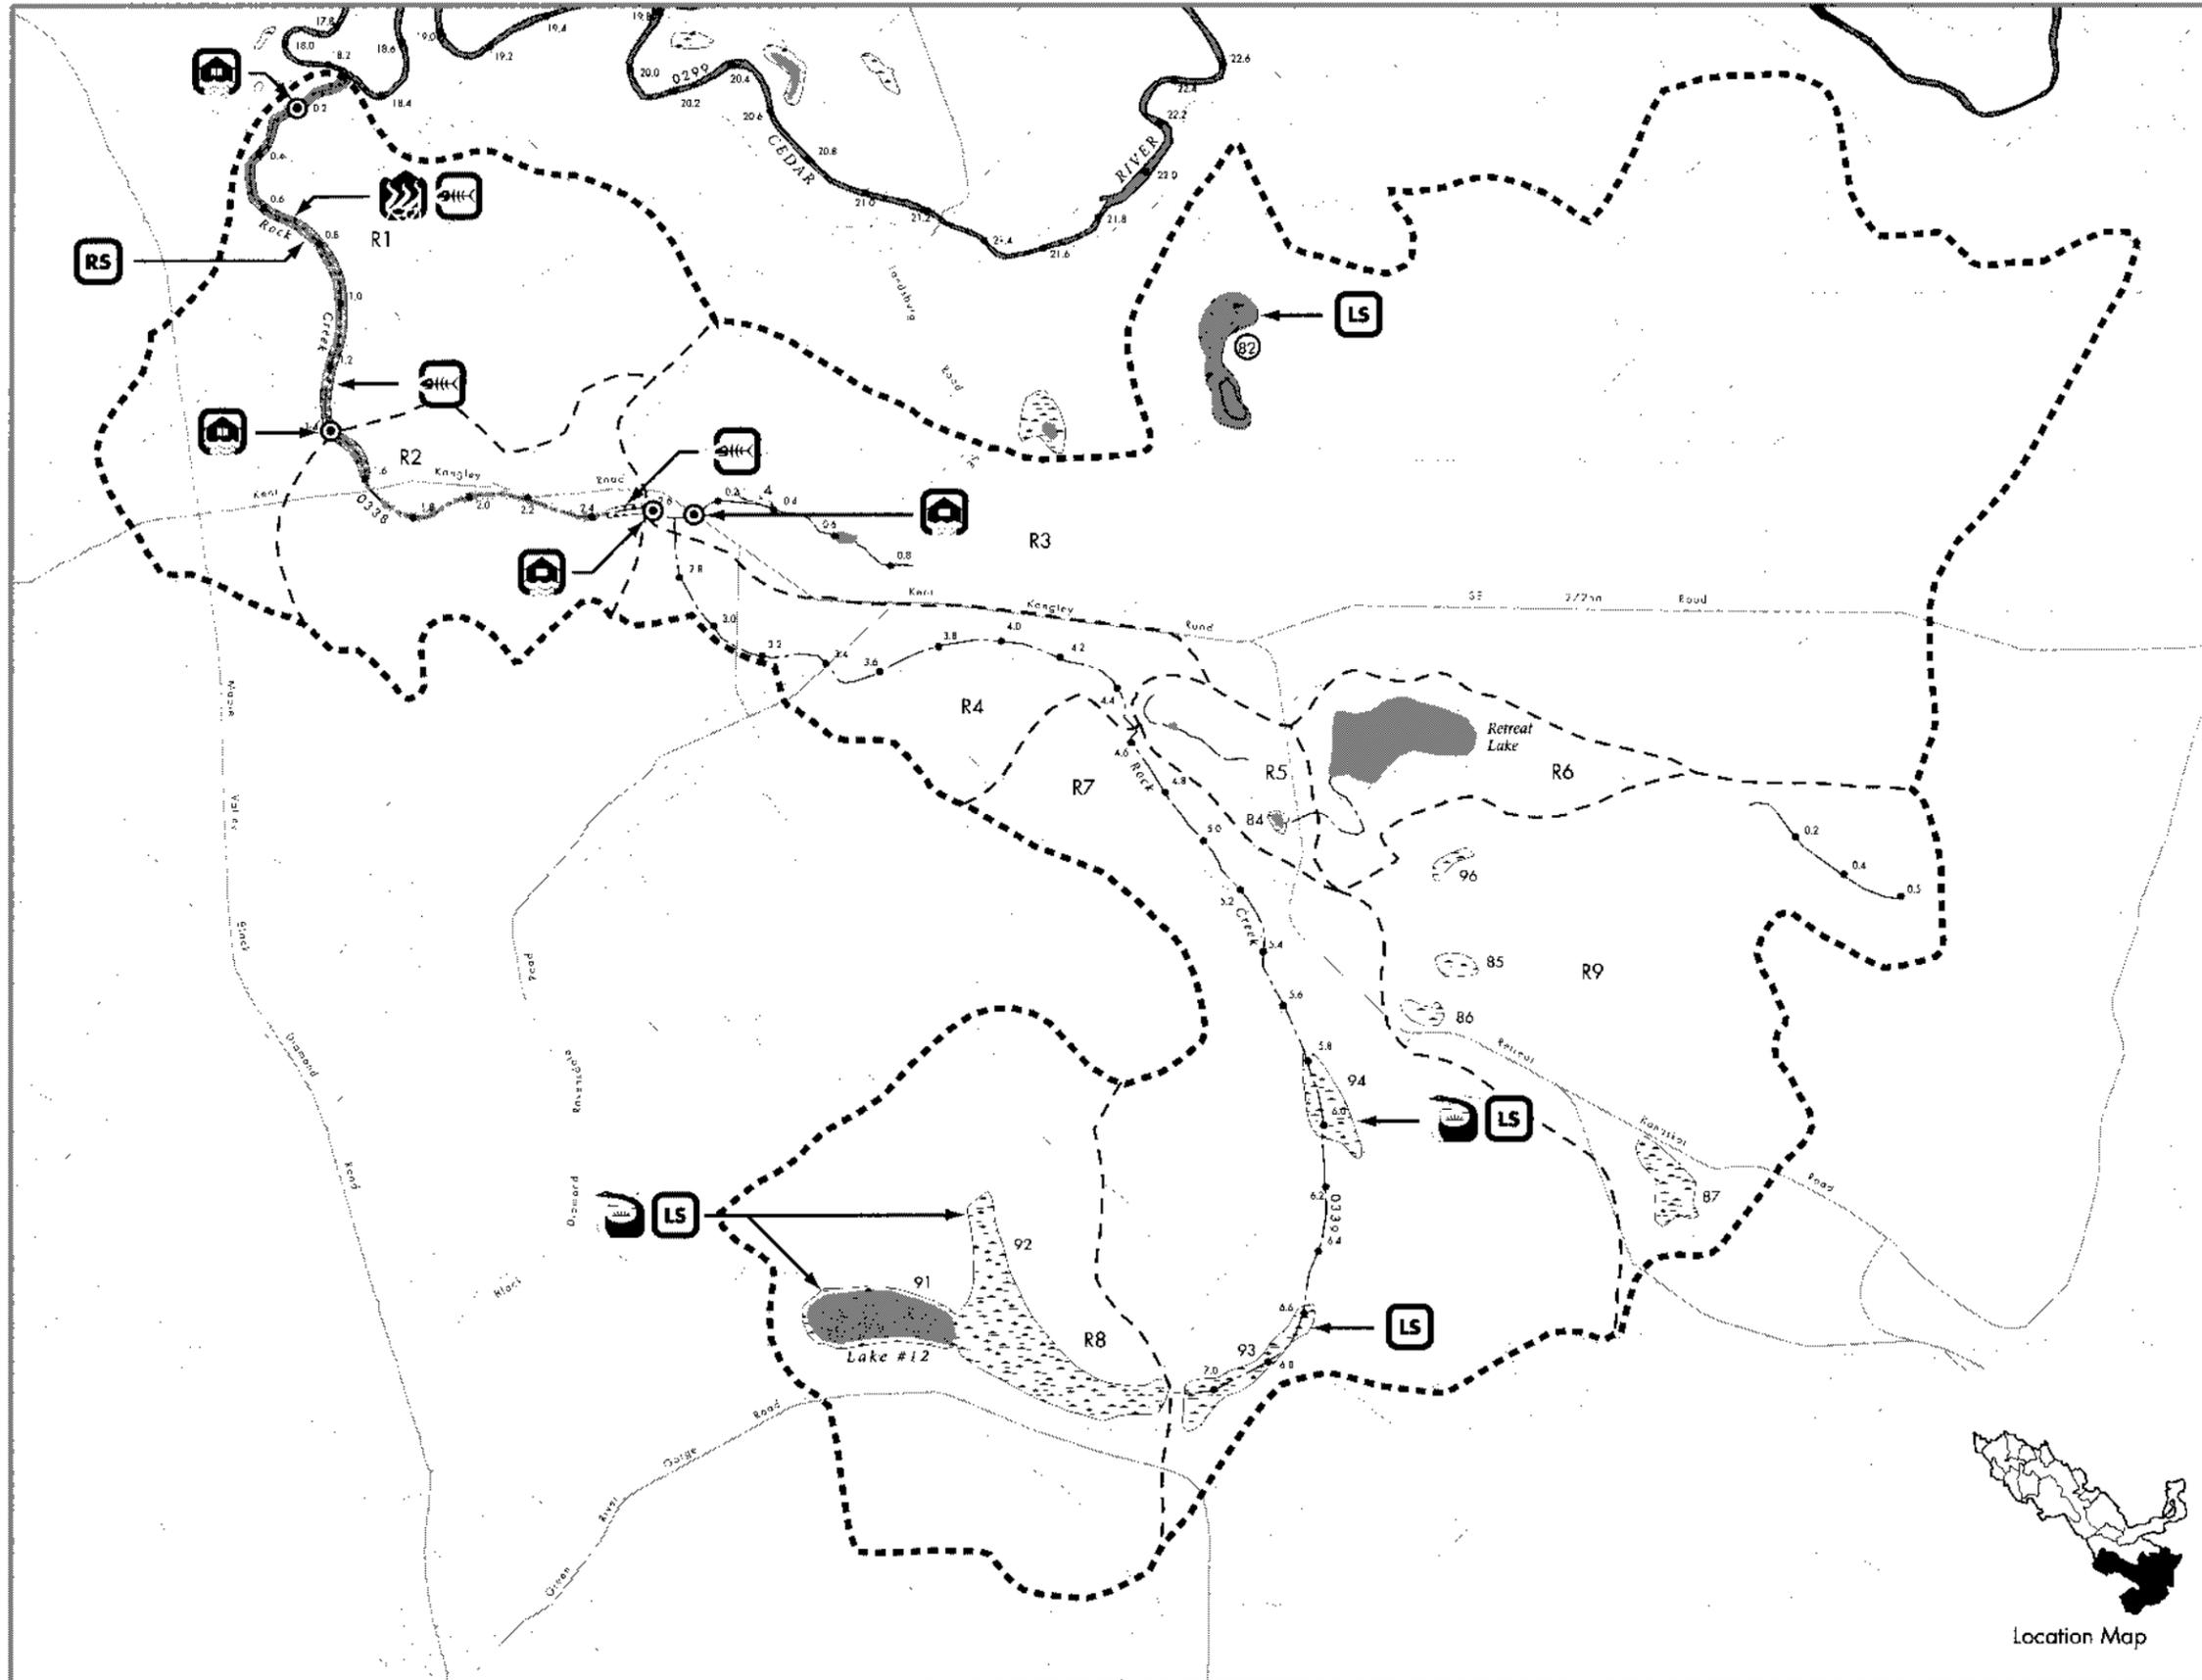
**Map 28**  
**Rock Creek Subbasin**  
**Conditions**  
 Cedar River Basin Planning Area
