In-Line Ditch BMP Installations

148th Avenue SE

In-line ditch best management practices (BMPs) for 148th Ave SE were installed on Thursday, June 4, 2009 in a section of ditch on the east road shoulder just south of SE 102nd Street. The BMPs, designed to provide stormwater quality treatment are a series of modified rock check dams that contain a compost-gravel mixture encased in geotextile fabric. A total of three BMPs were installed at this location following engineering designs prepared by King County Roads Maintenance Section (KCRMS) and approved by the Washington Department of Ecology (Ecology) under Stormwater Management Implementation Grant Number G0900039. The installation was completed by a KCRMS crew from Division 3 (Star Lake facility).

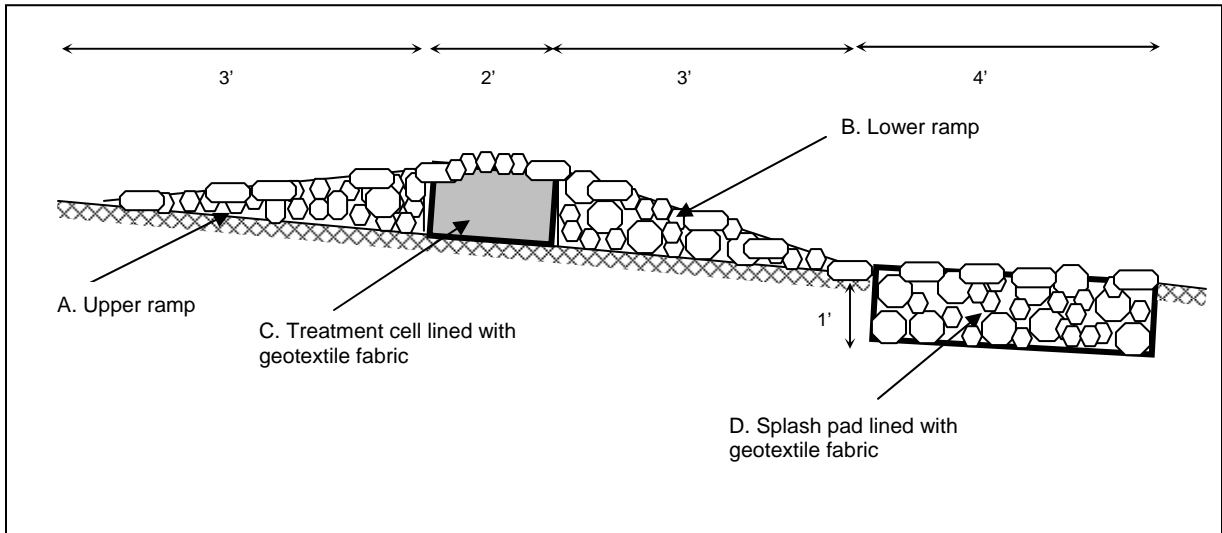
Figure 1. Profile of In-line Ditch Modified Rock Check Dam BMP

The BMPs are based on a modified rock check dam design (see Figures 1 and 2) that encase a media filled “treatment cell” (in this case a compost-gravel mixture) wrapped in a highly permeable, non-woven geotextile (Figure 1, C). The check dam holds the media in place while allowing stormwater to filter through the cell. Higher flows will bypass over the top of the weir.

The check dam consists of two ramps built from a mix of 4-8” and 2-4” inch angular rock (Figure 1, A and B). The ramps are placed with a 3 to 1 slope; each ramp is three feet long, sloping up to a peak height of one foot above the floor of the ditch. The treatment cell is placed in a 2 foot gap left between the upper and lower ramps (Figure 5).

A rock-filled “splash pad”, consisting of a small rock filled trench with a geotextile fabric liner is located just downstream of each check dam (Figure 1, D). The splash pads provide energy dissipation, erosion control and allows for infiltration of stormwater. Splash pads are also installed just down-slope of flumes placed in the ditch for flow monitoring.

The splash pad is constructed as a 4 foot long by 1 foot deep trench immediately down-slope from the check dam. The trench is lined with geotextile fabric and filled with the rock mixture. The length of each BMP, including the splash pad is 12 feet.

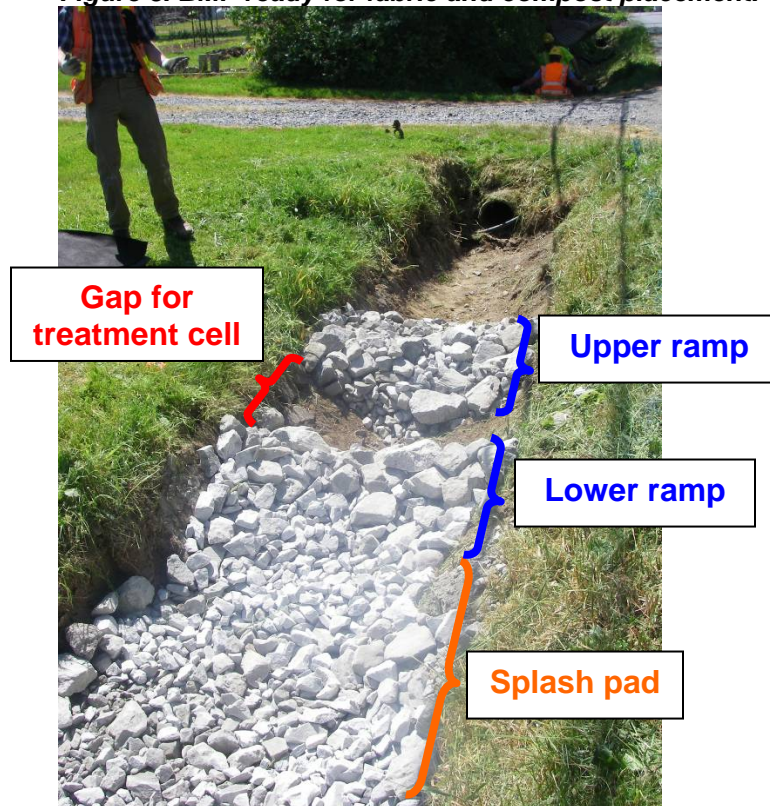
Figure 3. BMP ready for fabric and compost placement.

When the splash pads were finished, the backhoe placed mixed rock immediately upslope from each pad. This rock was positioned by hand to form the lower ramp. Additional rock was placed two feet above the lower ramp to form the upper ramp while leaving an open space for the treatment cell.

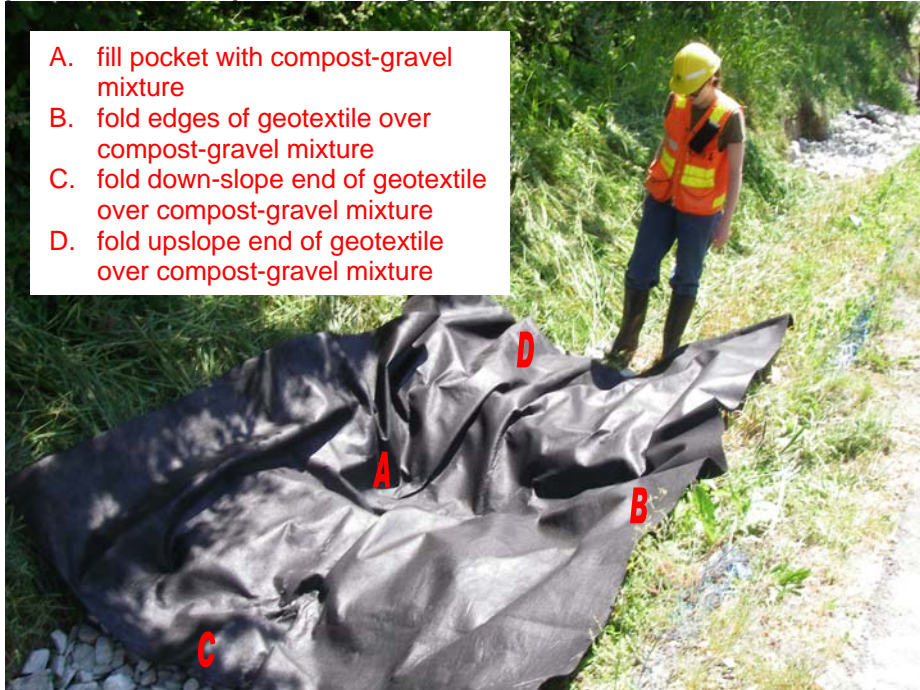
Figure 4. Fabric (801 geotextile) placed over crushed rock weir ramps in preparation for placement of compost-washed gravel mixture.

A pre-cut piece of geotextile was laid over the area of the treatment cell in the gap between the two ramps. The fabric covered cell was then filled with the compost-gravel mixture from the trailer. The compost and gravel had been brought to the site pre-mixed; it was given additional mixing using shovels before placement in the treatment cell. The compost mix was placed by filling 5-gallon buckets with the mixture and pouring them by hand onto the fabric (see step A in Figure 4). Between eight and nine 5-gallon buckets (or about 5½ cubic feet) of compost-gravel mix was used to fill each treatment cell. The fabric was folded over the compost with the sides folded in (see step B), then the down-slope fabric was folded up (see step C) and finally the upslope fabric folded down (see step D). The fabric was then secured with rock to complete the BMP.

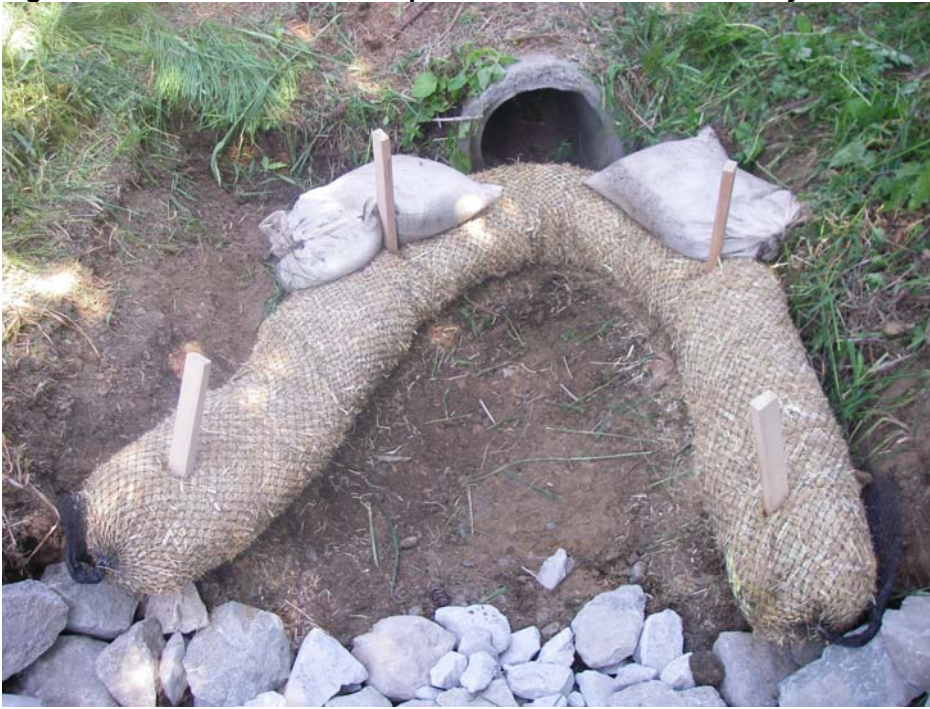
Figure 7. Straw wattle secured upstream of culvert immediately below treatment cell.

Straw wattles were placed (temporarily) at the upstream side of each culvert below BMP work areas. The repaired bank section was covered with jute netting staked in place. The crew completed work and left the site by 2:30pm. EU staff remained onsite to re-install the downstream flume. Re-installation of the downstream and upstream flumes was finished by EU staff on June 8, 2009.
