## **In-Line Ditch BMP Installations**

### ***SE 136<sup>th</sup> Street***

The in-line ditch best management practices (BMPs) for SE 136<sup>th</sup> Street were installed on Thursday, June 11, 2009 in two sections of roadside ditch located on the north side of SE 136<sup>th</sup> Street between 169<sup>th</sup> Avenue SE and 170<sup>th</sup> Avenue SE. The BMPs use the same water-quality treatment design as the BMPs placed at the 148<sup>th</sup> Avenue SE site on June 4, 2009. They are comprised of a series of modified rock check dams that contain a compost-gravel mixture encased in geotextile fabric. A total of four BMPs were installed at this location following engineering designs prepared by King County Roads Maintenance Section (KCRMS) and approved by the Washington Department of Ecology (Ecology) under Stormwater Management Implementation Grant Number G0900039. The installation was completed by a KCRMS crew from Division 3 (Star Lake facility).

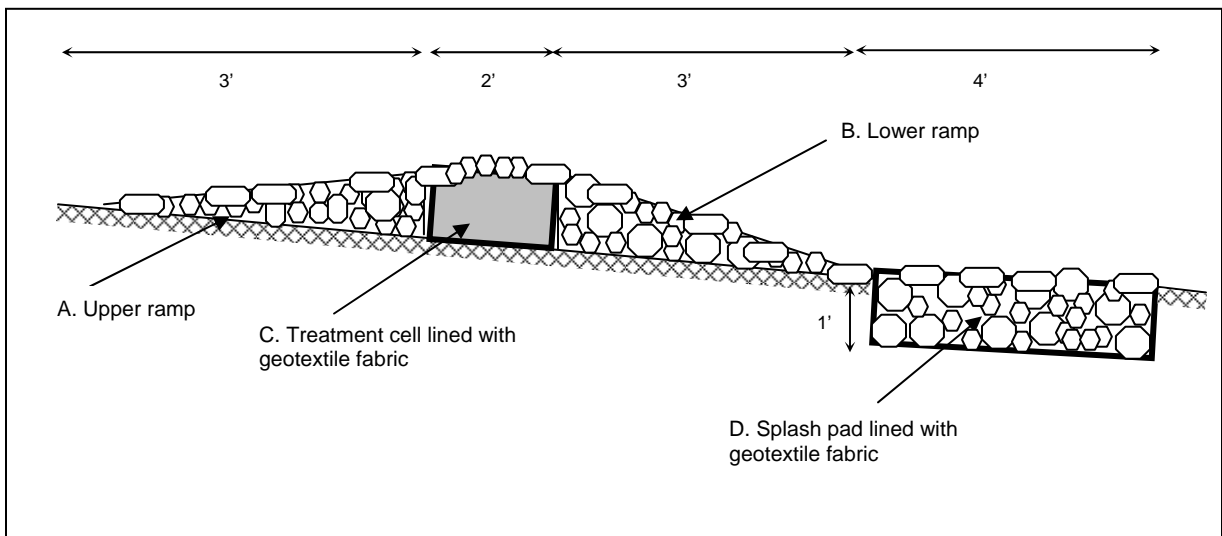
The BMPs are based on a modified angular rock check dam design (see Figures 1 and 2) that encase a media filled “treatment cell” (in this case a 3 to 1 mixture of compost and ½-minus washed gravel) wrapped in a highly permeable, non-woven geotextile (Figure 1, C). The BMP holds the media in place while allowing stormwater to filter through the cell. The BMPs are designed to allow higher flows to bypass over the top of the check dam.

The check dams consist of two ramps built from a mix of 2-4” and 4-8” angular rock (Figure 1, A and B). The ramps are placed with a 3 to 1 slope; each ramp is three-feet long, sloping up to a peak height of one foot above the floor of the ditch. The treatment cell is placed in a two-foot gap left between the upper and lower ramps (Figure 5).

A rock filled “splash-pad” consisting of a small rock filled trench with a geotextile fabric liner is located just downstream of each check dam (Figure 1, D). The splash pads provide permanent energy dissipation, BMP erosion control, stormwater storage and infiltration areas.

**Figure 1. In-Line Ditch Modified Rock Check Dam BMP**

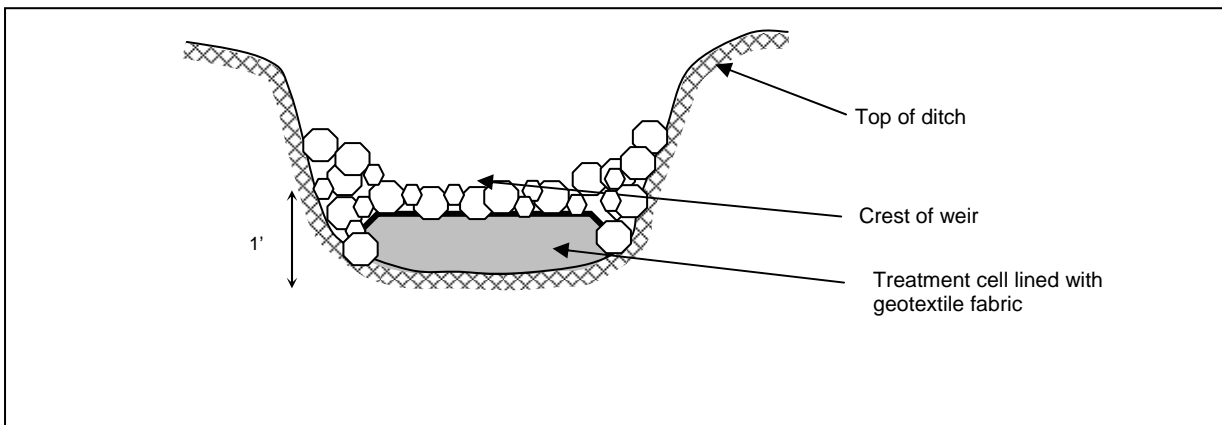
**Figure 2. Cross-section of ditch with In-Line Ditch Modified Rock Check Dam BMP**

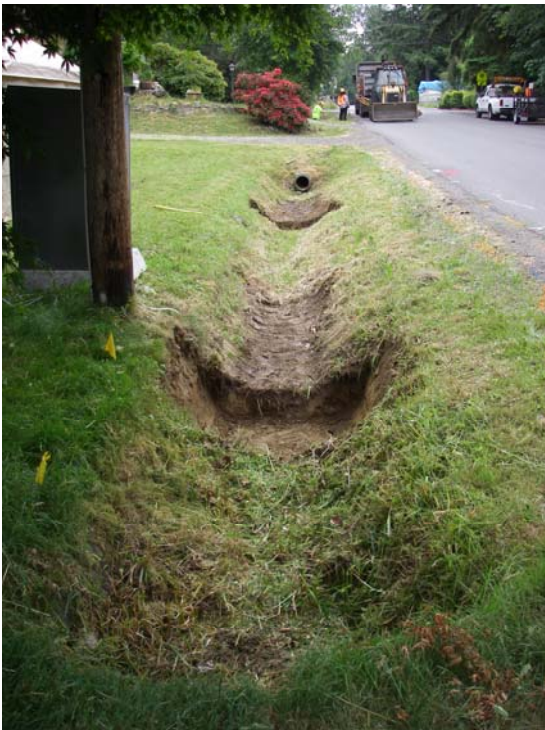
As described above in the BMP Design Description, the splash pad trenches were excavated four-feet long by one-foot deep as shown below in Figure 3.

*Figure 3. Ditch section prepped for BMP placement with excavations for spill pads. Lower end of ditch looking east.*

The complete crew assembled on site by 8:30am on the day of installation and weed-wacked the tall grass where the BMPs would be installed. The backhoe prepped the site by excavating all of the splash pads. The ditch area just upstream from the splash pads was given a light scraping by the backhoe to remove vegetation and a thin layer (1-2 inches) of topsoil (figure 3) that provided better surface contact for the treatment cell.

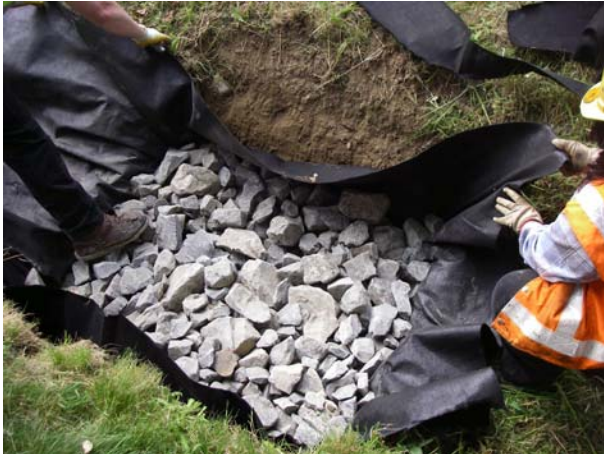
The splash pad trenches were lined with geotextile fabric and filled with the angular rock mixture. The ends of the fabric were partially wrapped inward over the splash pads and secured with additional rock as shown in Figure 4.

*Figure 4. Splash pad trench lined with geotextile fabric, filled with angular rock mixture, and wrapped inward over the splash pad edges, which is then secured with angular rock.*

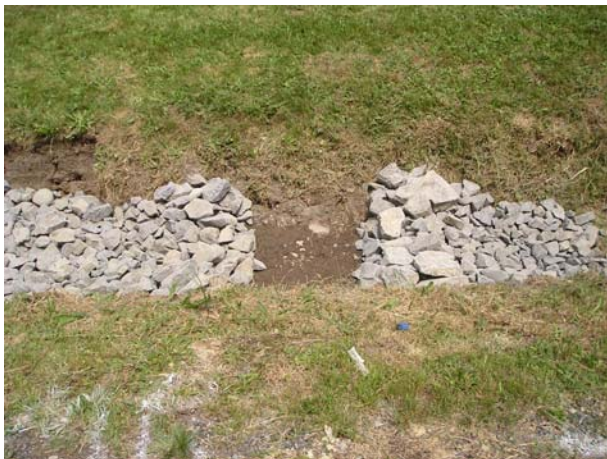
When each splash pad was completed, the backhoe placed mixed rock immediately upslope from the pad. This rock was positioned by hand to form the lower ramp. Additional rock was placed two feet above the lower ramp to form the upper ramp while leaving an open space for the treatment cell as shown below in Figure 5.

*Figure 5. Lower rock ramp and upper rock ramp installation with 2-foot long gap left to allow for treatment cell installation.*

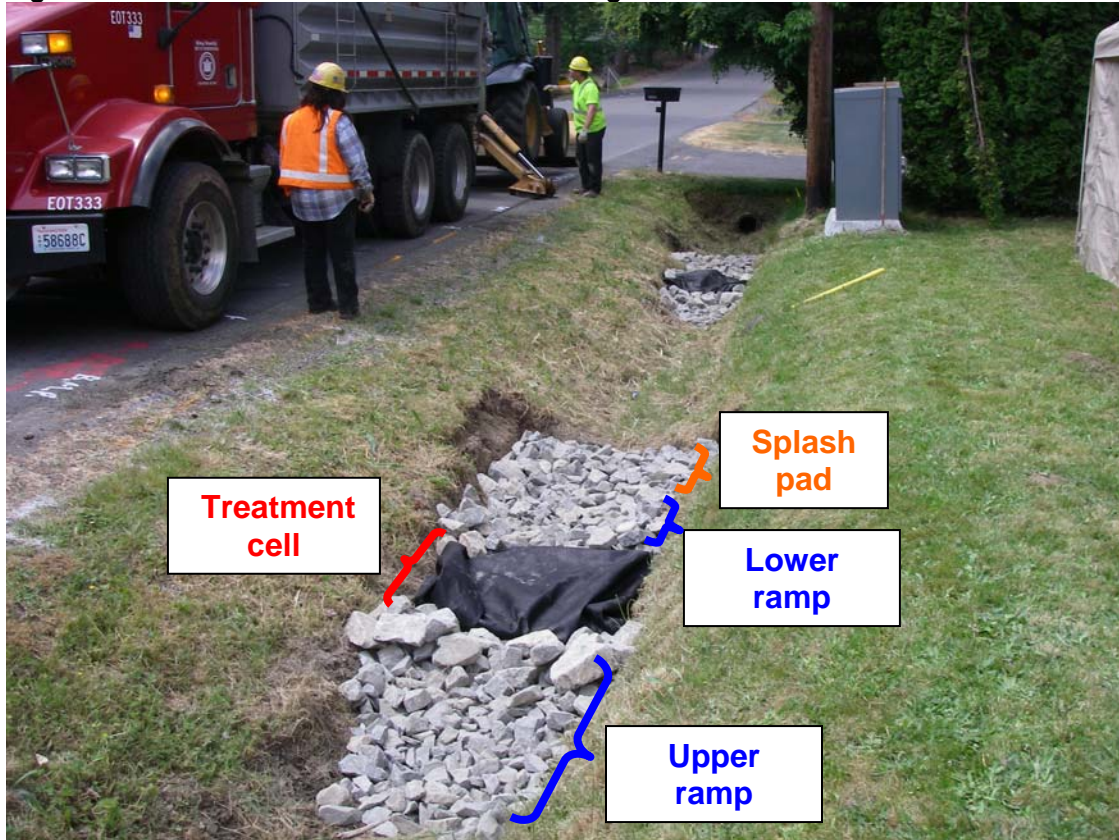
compost-gravel mix was used to fill each treatment cell. The fabric was folded over the compost with the sides folded in, then the down-slope fabric was folded up, and finally the up-slope fabric folded down as shown below in Figure 6. The fabric was then secured with rock to complete the BMP as shown in Figure 7.

**Figure 6. BMP detail. Lower end of ditch looking west.**

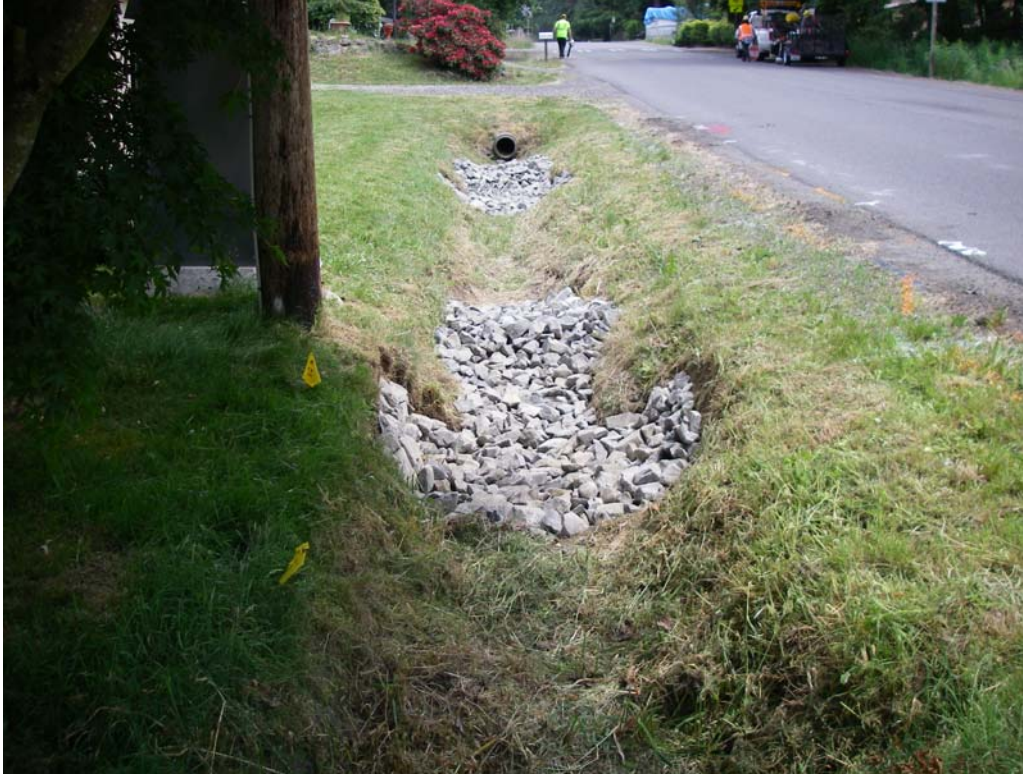
**Figure 7. Completed BMPs. Lower end of ditch looking east.**
